Robe Valley Deposits Façade Stand-Off Distance Memo

From	Xuzheng Gao
Department	Mine Engineering Geotechnical (MEG)
To	Melinda Brand; Fiona Bell
CC	Agus Rachman; Solomon Oppong
Reviewed By	Agus Rachman; Solomon Oppong
Reference	
Date	13 November 2017
Number of pages	37

Executive Summary

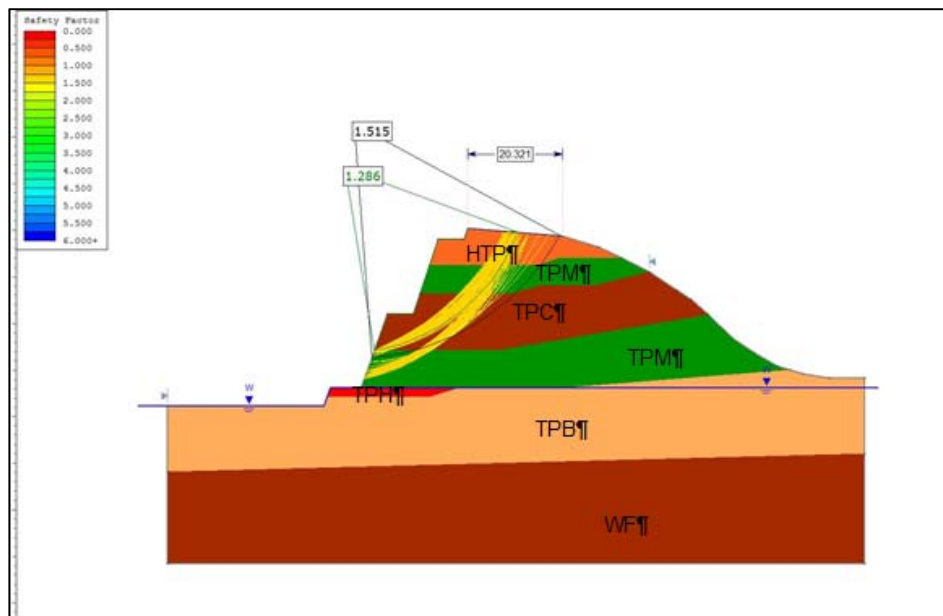
Figure 22. 2016 Mesa H Section Stability with 20m Stand-Off Distance on Pit Side (FoS=1.5).

It was found that the FoS for the façade is below 1.5 using a 20m stand-off distance and above 1.5 with 30m stand-off distance. It was recommended that a minimum 30m stand-off is required between the Mesa H pit crest and façade crest.

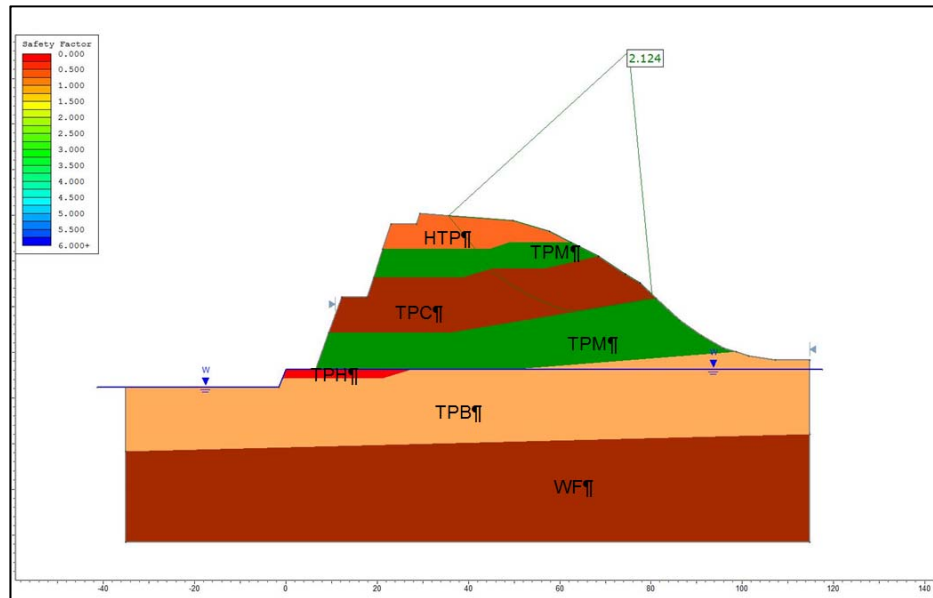
Figure 23. 2016 Mesa H Section Stability with 20m Stand-Off Distance on Façade Side (FoS>1.5).

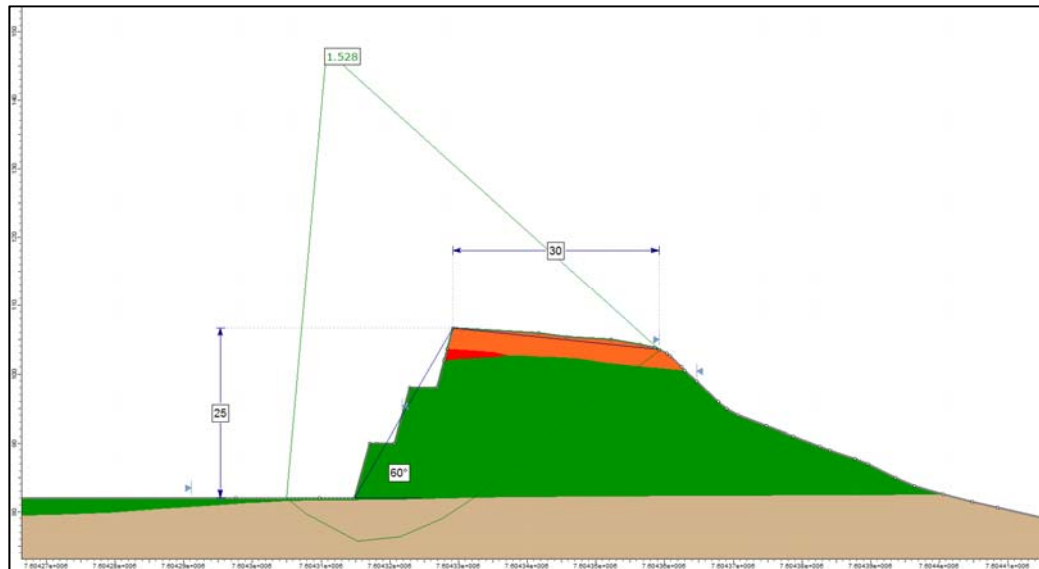
The SLIDE modelling results shown that the Factor of Safety meets the geotechnical DAC for both the estimated and lower quartile rock mass strength. The result also shows that the Factor of Safety of the façade is greater than 1.5 even with lower quartile rock mass strength and 30m stand-off distance as shown in Figure 27.

Figure 27. 2017 3rd Rock RV Study Mesa B Section A Façade Factor of Safety =1.53 with Lower Quartile Strength 30m from façade.

- The slope stability results for Rio Tinto's designs for all three Mesas show that the Factor of Safety (FoS) for all sections are greater than Rio Tinto's Design Acceptance Criteria; in most cases significantly greater. This is because the final pit slopes are shallow and will perform well in competent cemented material; and
- The slopes were optimised in order to increase the overall slope angles and to reduce the façade width (that is the distance between the crest of the pit and that of the mesa's natural slope) to a minimum of 30m.

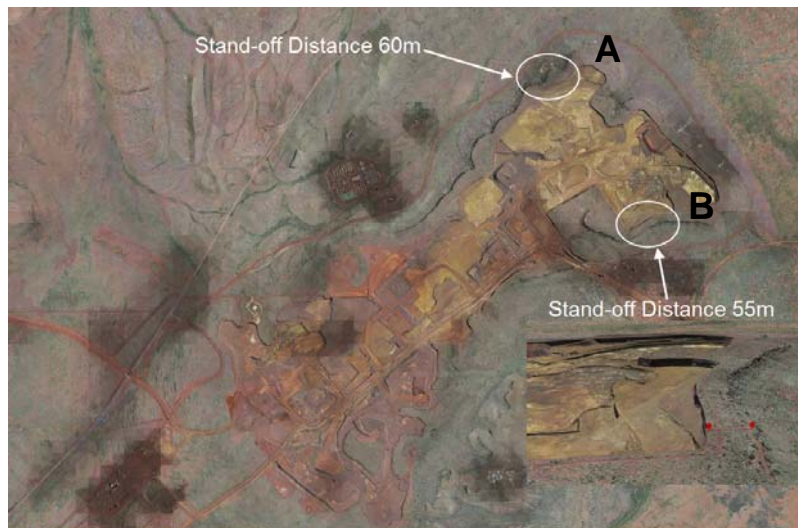
In Robe Valley, Mesa A, Mesa J and Warramboos are currently in an operational stage. Other deposits are currently under assessment. As there is no façade in Warramboos, only the current as-built slopes in Mesa A and Mesa J were reviewed. The existing walls have minimum stand-off distance of 50m as shown in Figure 29 and Figure 32.

Figure 29. Mesa A As-Built Stand-Off Distance

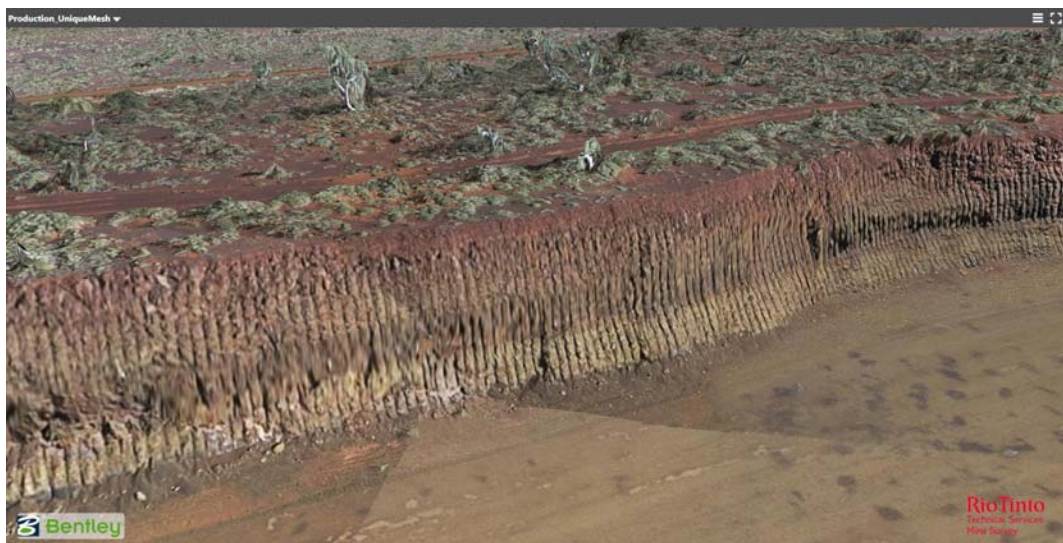
The as-built wall conditions for Mesa A and Mesa J are shown in Figure 30, Figure 31, Figure 33 and Figure 34. Compared with Mesa J slope, the top benches in Mesa A demonstrated better performance. It was estimated that better wall performance in Mesa A contributed by more competent material intersected in the wall (HTP, TP TPM, and TPB). Mesa J has softer material (Alluvium and Colluvium) on the top benches. However, there were no indications that this condition has any impact on the façade.

Figure 30. Mesa A Area A Wall Conditions.

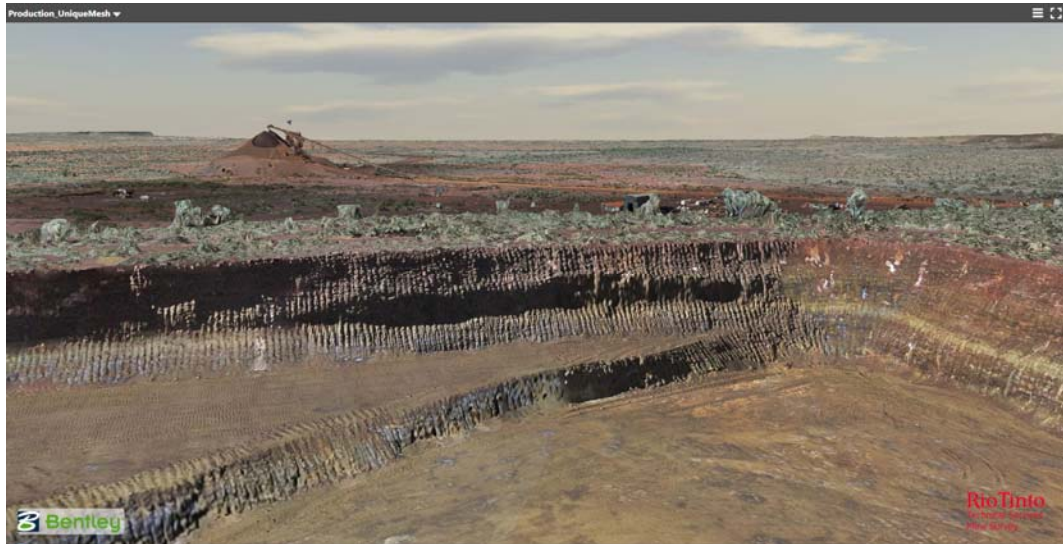
Figure 31. Mesa A Area B Wall Conditions.

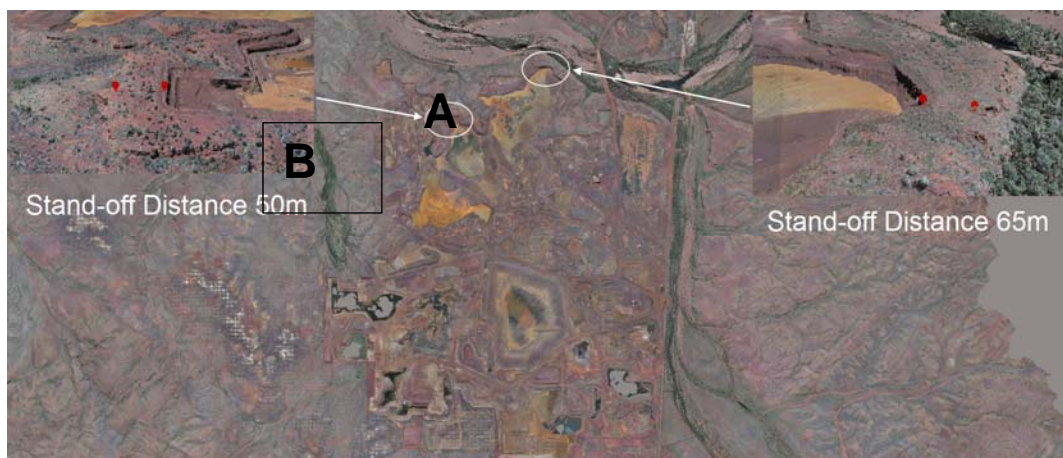
Figure 32. Mesa J As Built Stand-Off Distance.

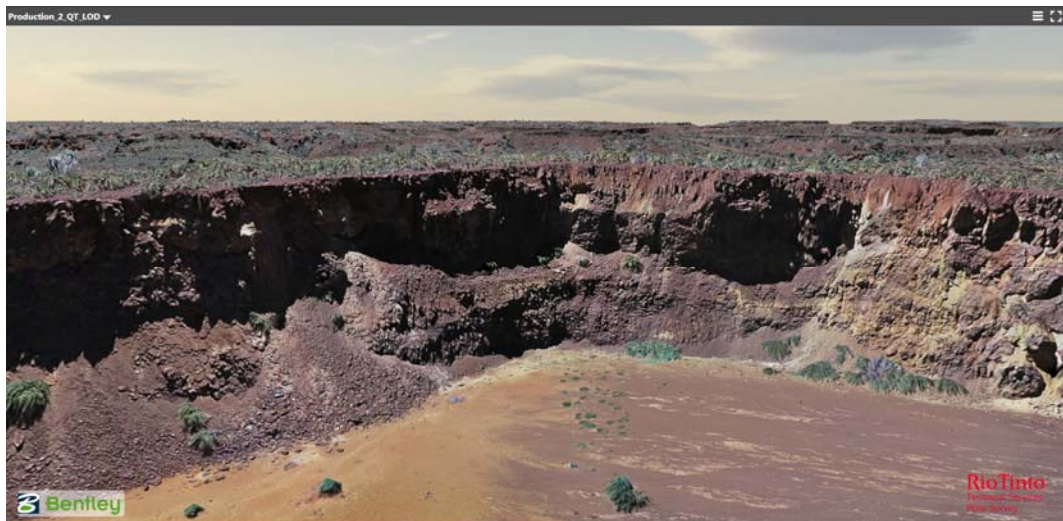
Figure 33. Mesa J Area A Wall Conditions.

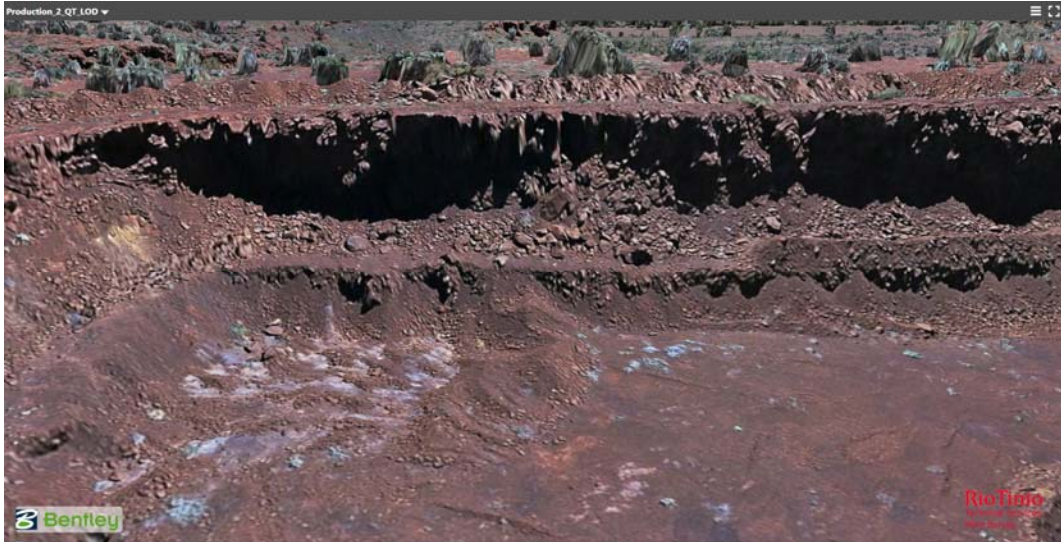
Figure 34. Mesa J Area B Wall Conditions.

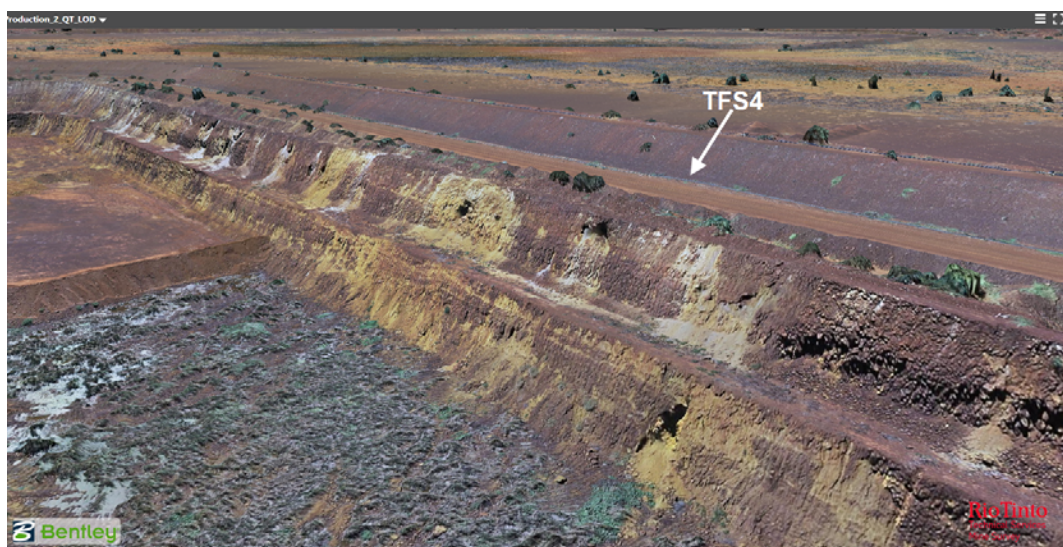
There is a Tailings Storage Facility (TSF4) behind the east wall of Pit 8 in Mesa J. The distance between the pit crest and the toe of TSF4 is around 25m. In total there are 17 prisms installed on the wall; 145mRL (prisms #17 and #18), 155mRL (prisms #10 to #16) and 161mRL (prisms 1 to 9) and monitored since February 2017 to monitor the impact of TSF4 to the pit 8 stability. The prisms locations are shown in Figure 37 and the as-built wall conditions are shown in Figure 38.

Figure 38. Mesa J Slope Under TFS4 Wall Conditions.

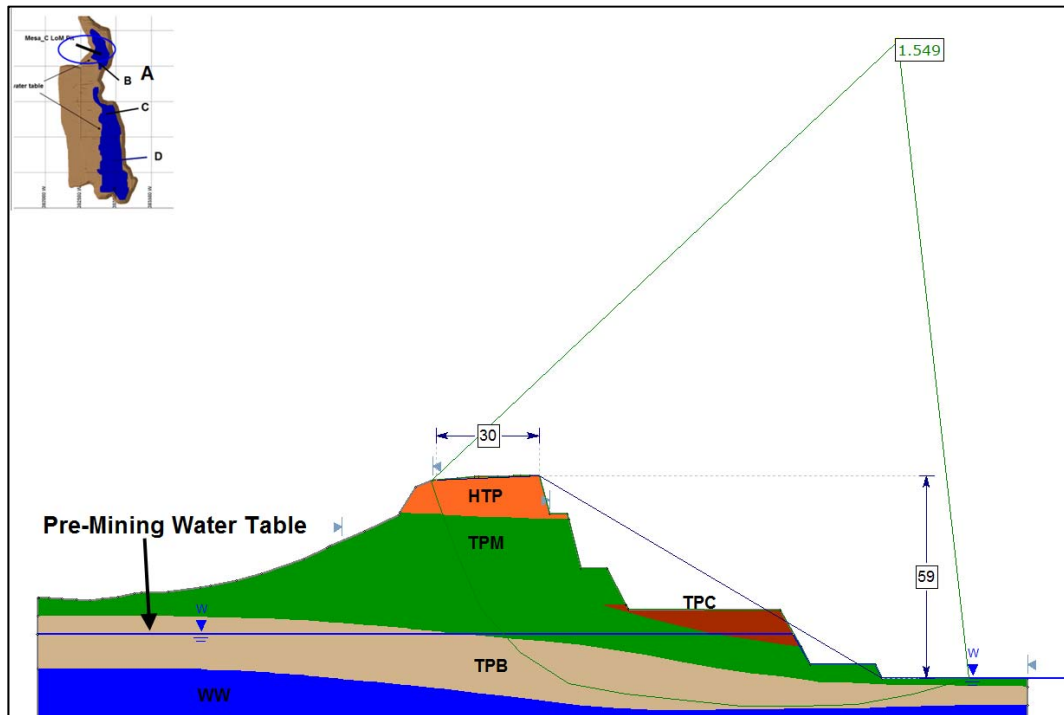
Figure 44. Section A Mesa C Slope Stability after Closure (FoS > 1.5).

Both models show that the FoS in area within 30m from the pit crest were higher than Rio Tinto Design Acceptance Criteria (>1.5). Backfilling proposed in the closure plan will increase the wall stability. Therefore, it is concluded that a minimum 30m façade is considered as adequate from a stability perspective and to protect the identified environmental and heritage values.

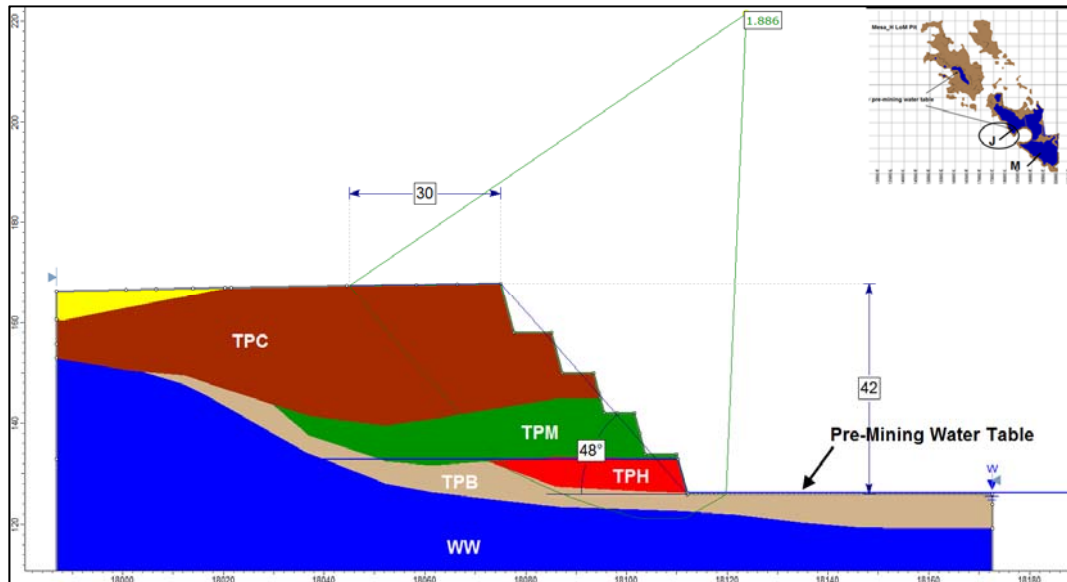
Figure 45. Section J Mesa H Slope Stability after Closure (FoS > 1.5).
