Wiluna Gold

Dewatering Discharge License Report (DDLRL) Jan 2005 – Dec 2005

March 2006

Dewatering Discharge License Report

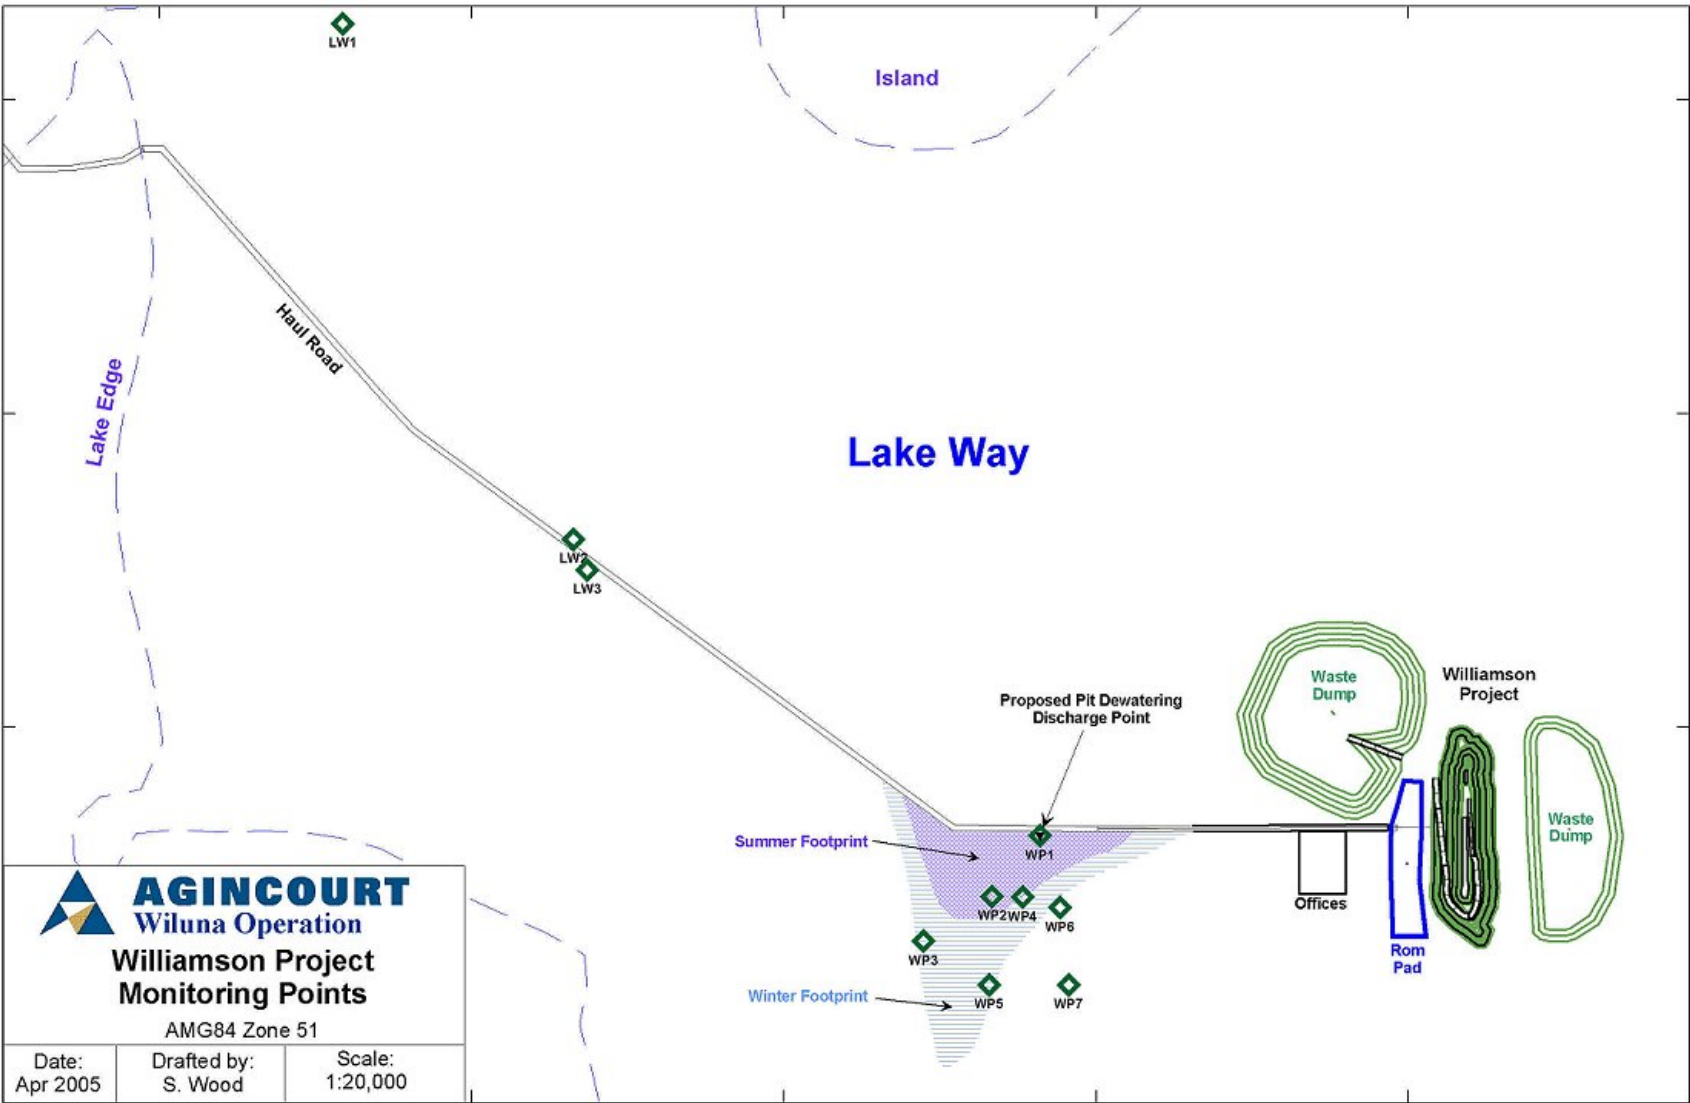
Figure 3 Williamson Pit, biological monitoring points

At Williamson Pit, the predicted summer and winter footprints were determined in hydrological studies of the local area (Morgan 2005, **Figure 3**). Since commencement of dewatering discharge in 2005 from two locations, the actual dewatering discharge footprint appears to match closely with the predicted footprint (compare **Figure 3** with white salt crusting evident in **Plate 2**). A tail stemming from the discharge footprint in a westerly direction can be seen in **Plate 2**. This has occurred when the dewatering discharge is mixed with storm water following a period of above average rainfall. On these occasions substantial dilution of the dewatering discharge by storm water is expected to lower the average salinity of water in the footprint and the tail, reducing the impact of the discharged water (Bond, 2005). This implies that there have been no unexpected impacts in terms of discharge footprint, from the Williamson dewatering discharge.

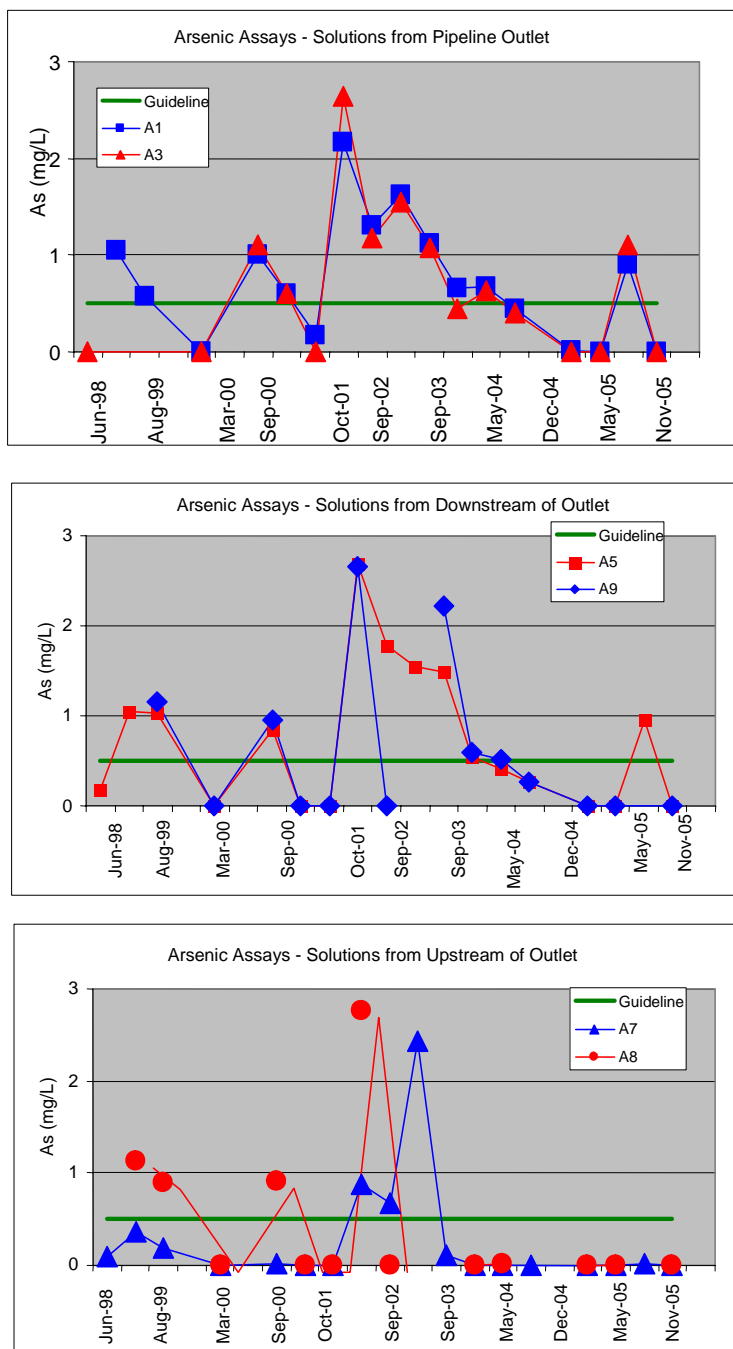
Figure 5 Solution Assays - Arsenic (mg/L)- Active Areas

The only heavy metal parameter measured at a level higher than the guidelines was that of Arsenic. The following graphs (**Figure 5**) show the trends for individual sampling sites solutions since the

There was a peak in arsenic levels in April 2002, but this peak was also evident in the background areas so it is likely that these high readings are due to a laboratory error. It was stated in the 2003 report that if future readings supported this supposition the readings for April 2002 would be omitted from calculations. The trend has certainly lowered, however a smaller peak can be seen over the course of the 2005 reporting period which has not been reflected in the results taken from control sites. These results and trend will be reviewed in the next report, and additional assessment of the anomalies will occur if appropriate.

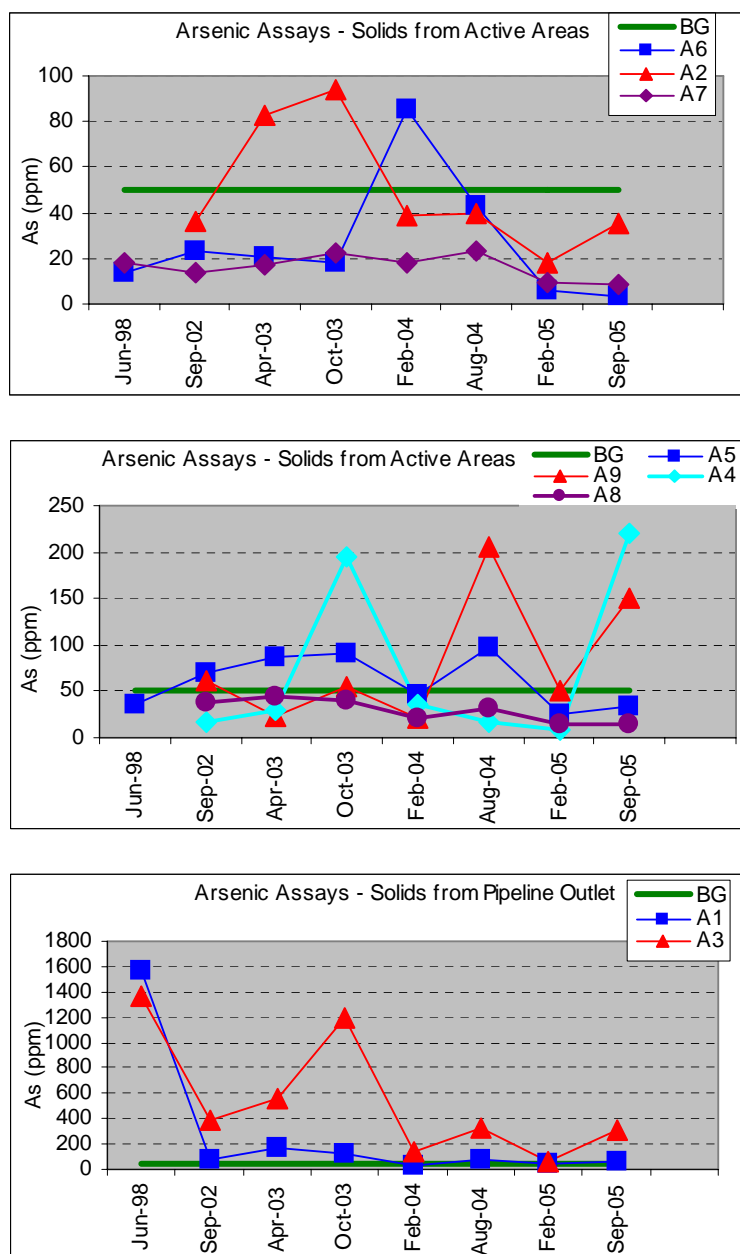
Figure 6 Sediment Assays - Arsenic (where ppm equals mg/kg) - Active Areas

As stipulated in 15(d) of the DoE license 5206/8 sites surrounding Lake Way and the West Creek discharge point were analysed for Arsenic bi-annually. The graphs displayed below show the trends for individual sampling sites levels of Arsenic in sediments since the sampling program commenced in 1998 (**Figure 6**) The 'background' value is plotted on the same graph as a guideline.

From the three graphs of 'active' areas it can be seen that historically, the only sediments that have arsenic assays above background levels are the samples LW-A1 and LW-A3. These are the sediment samples taken from 50 metres upstream and 50m downstream of the pipeline discharge, and have definitely been impacted by fines settling out from mine water. This occurrence of fines in the mine water ceased many years ago due to a change in the dewatering strategy (pumping the water via a pit rather than settling ponds) and it is noted that the trend since then has been downward, especially for LW-A1. It is highly likely that arsenic is naturally high in Lake Way therefore the concentrations probably reflect local geology (OES, 2004).
