W2 Diversion – Day 4

<p>STUDY PHASE WAIO PROJECT YANDI CLOSURE LANDFORM SPS SURFACE WATER ENGINEERING DESIGN REPORT</p>	<p>Doc No.: PREP-1200-C-12142/B</p> <p>Page: 112 of 114</p>
---	--	---

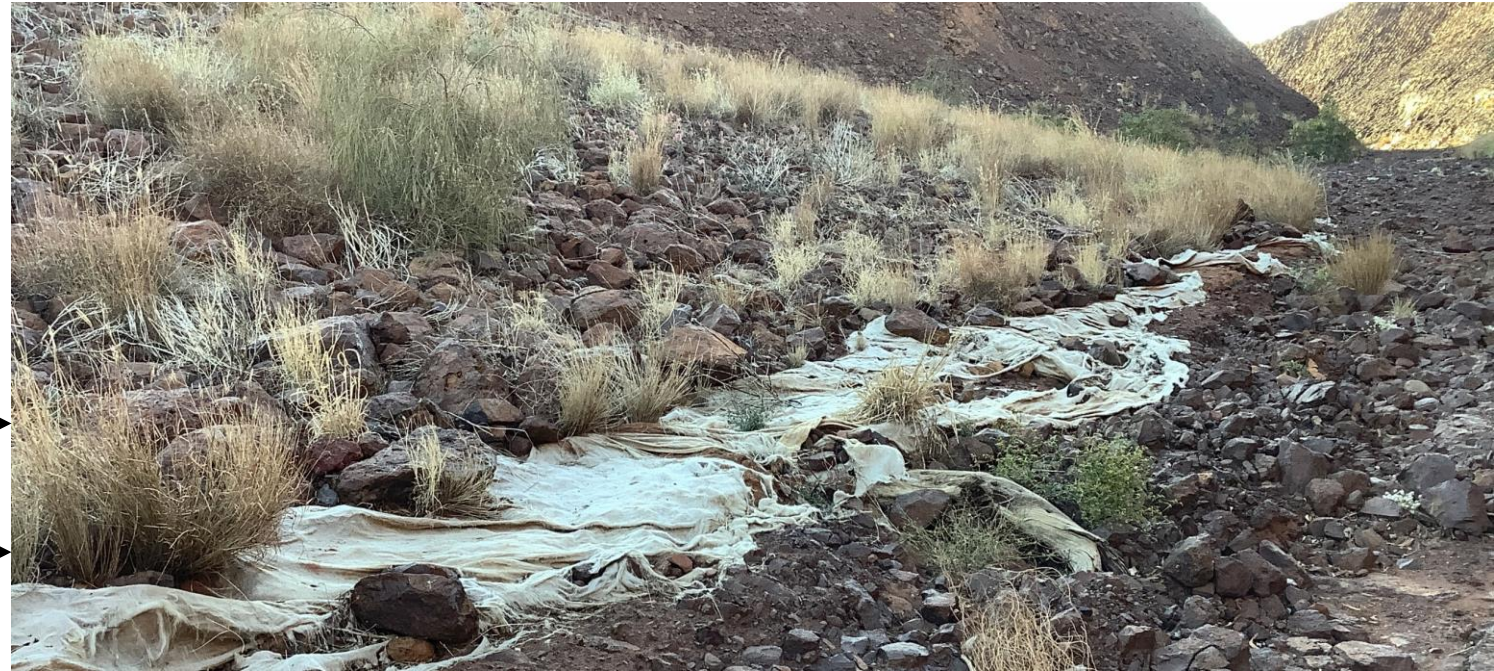
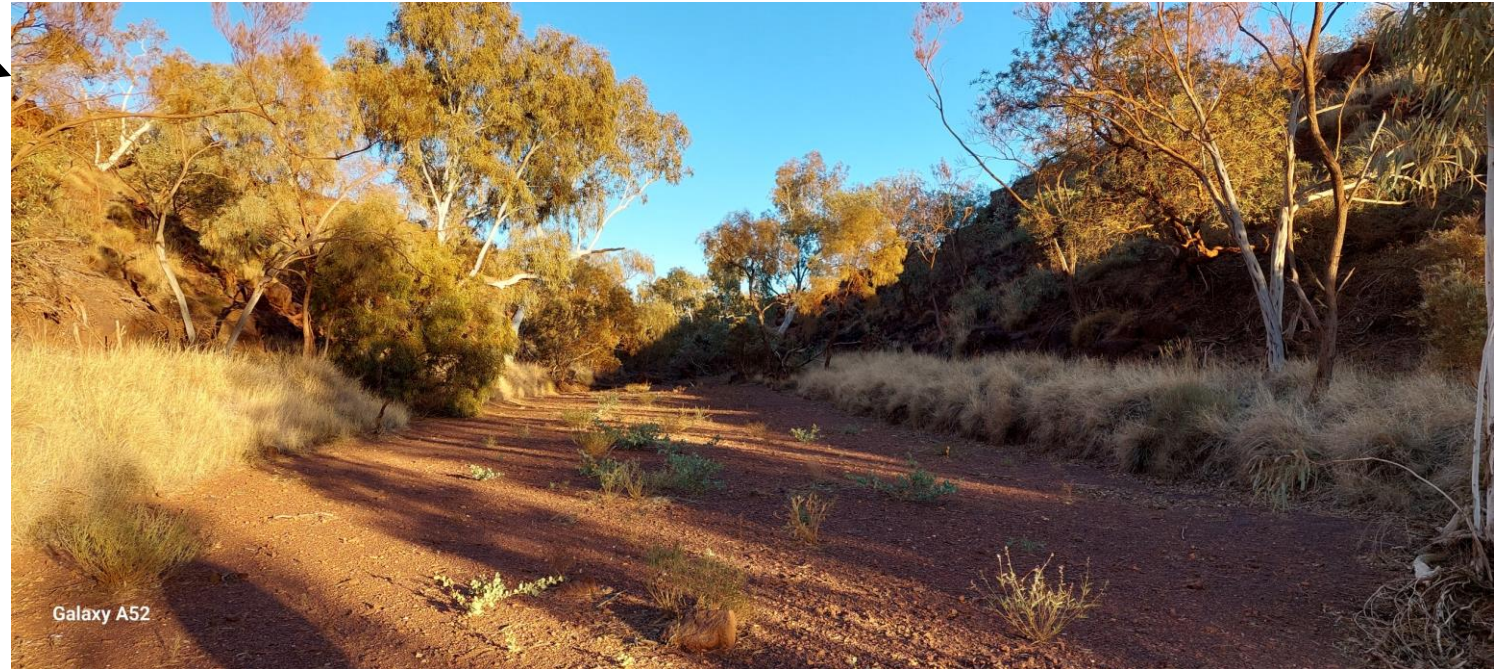
- There is some, but not much, room at the top if required for bund raising.
- Flood bund has very small armour rock – will need to be upgraded. →
- Geofabric exposed at toe of bund as it cannot be keyed into ground (CID) →
- Upstream natural analogue shows the creek ~20m wide with trees on the side with an alluvium base. →
- Works required for this diversion include widening of cut, work to create an aquifer throughout entire length of diversion and placement of larger armour rock on the bund.

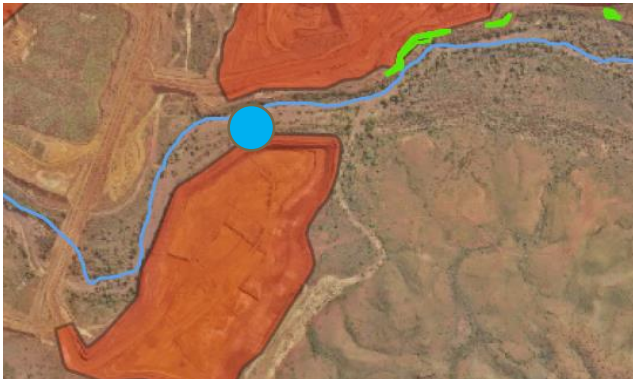
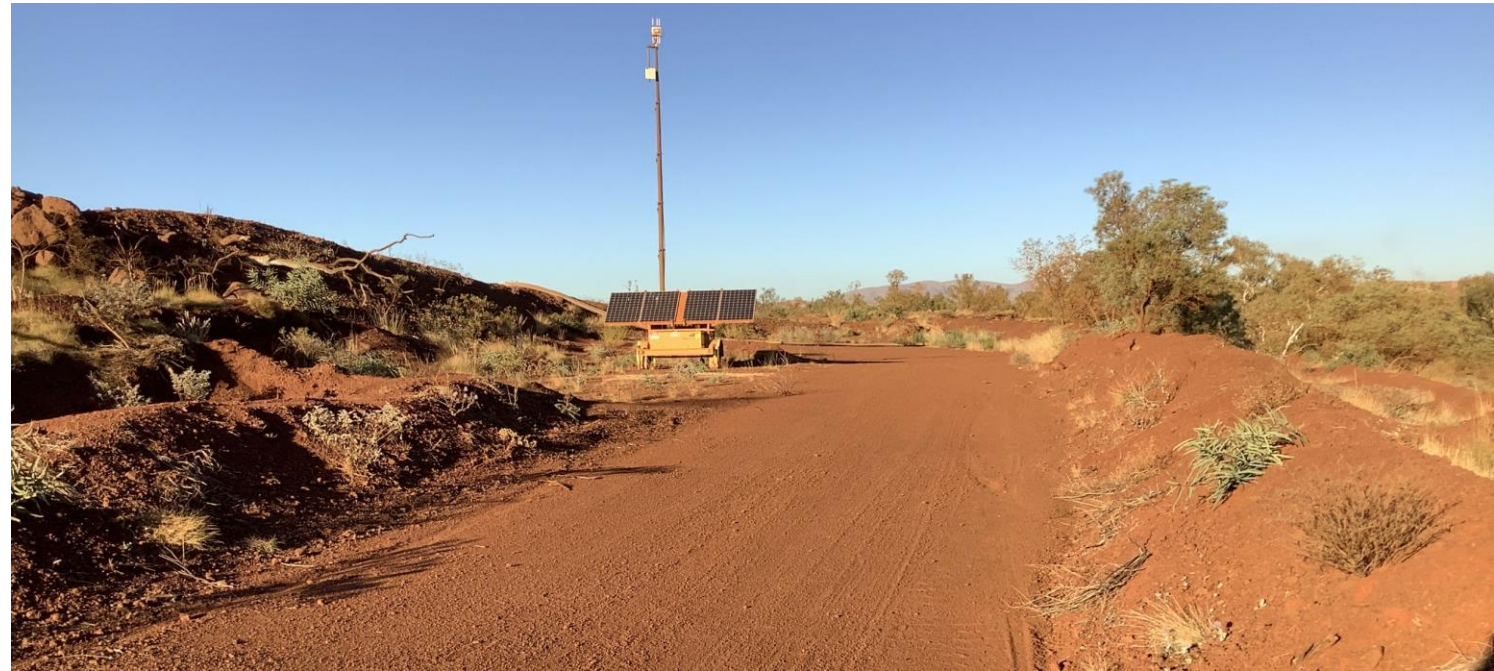
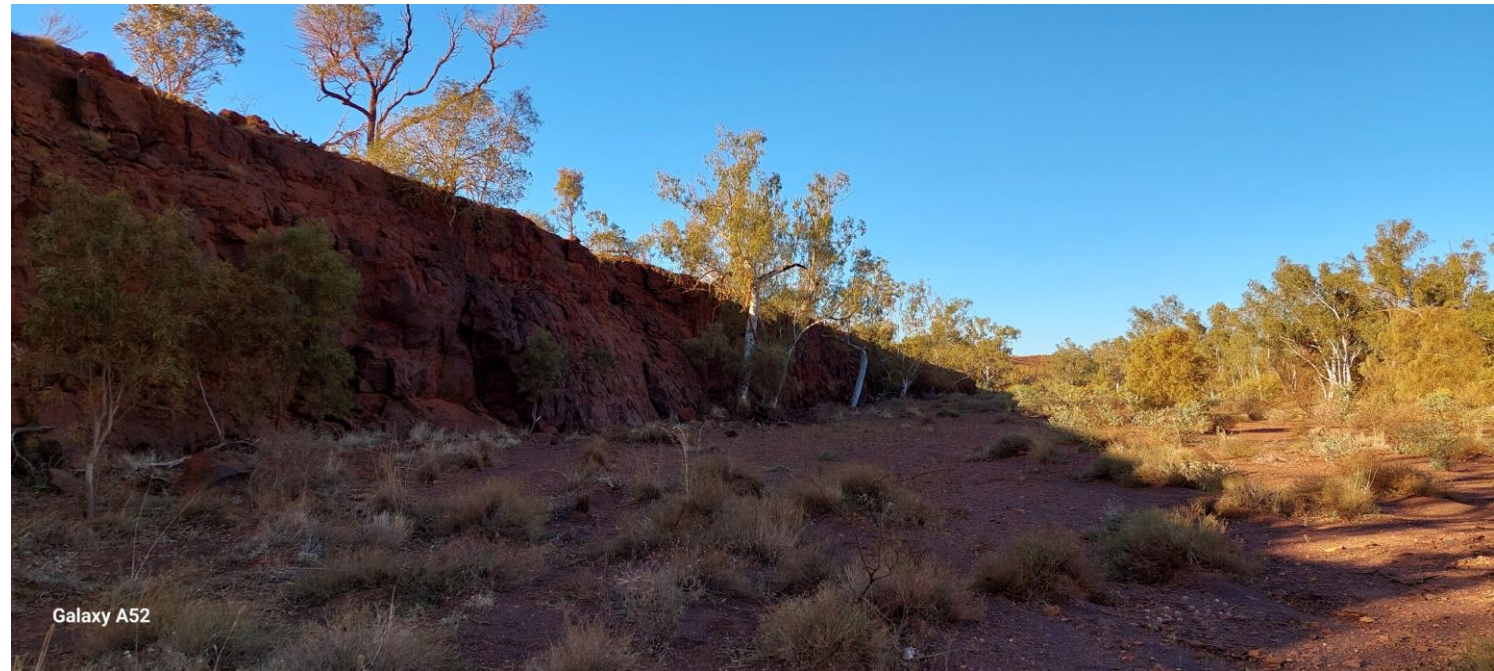
W3 Pit – Day 2

- This section will see high water levels due to the constriction of W3-W4 immediately downstream.
- Northern remnant CID appears to be sufficiently high with room (LV track) to construct a small bund on top of the CID on the north-west side, if required. →
- This section will see flows hit at a right angle, potentially very high velocity and depth if the W1-W4 link flood channel is removed. Modelling to confirm levels, but rock appears suitable. ↘

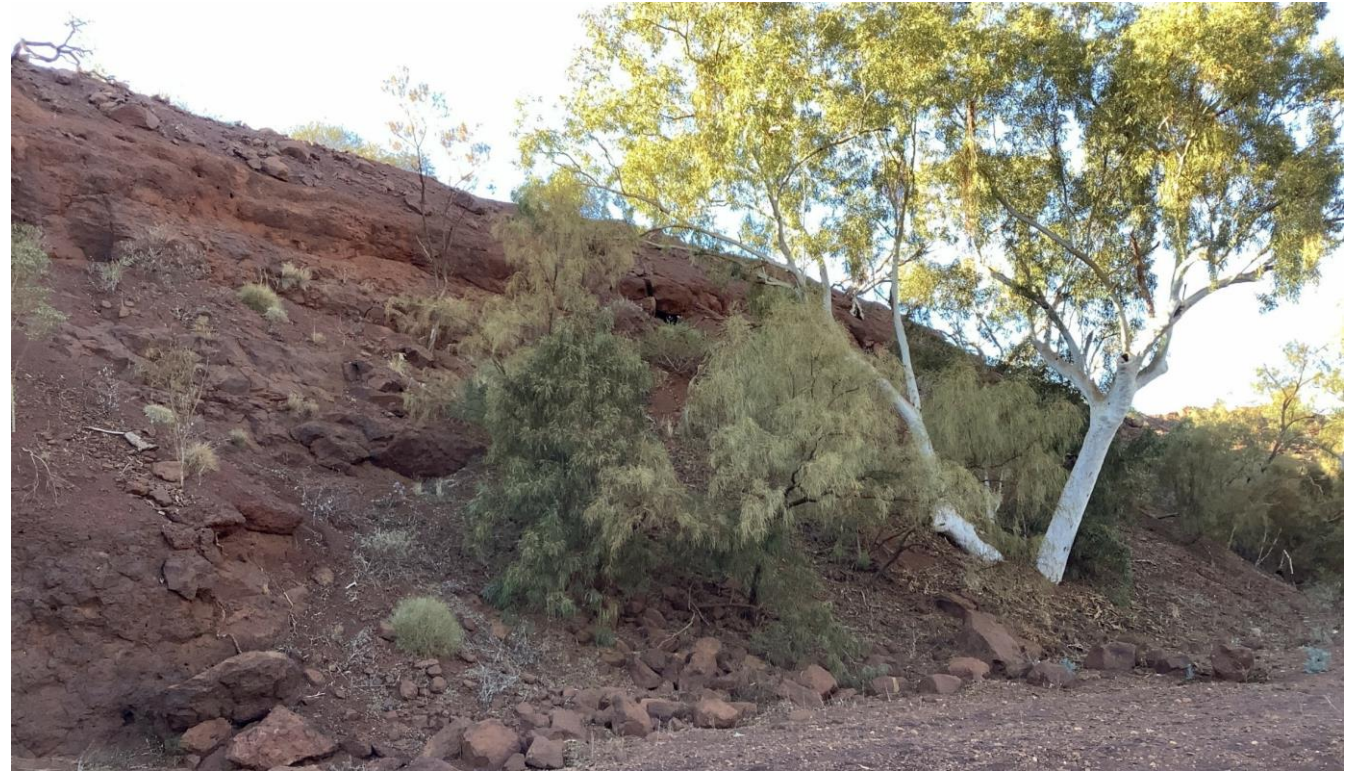
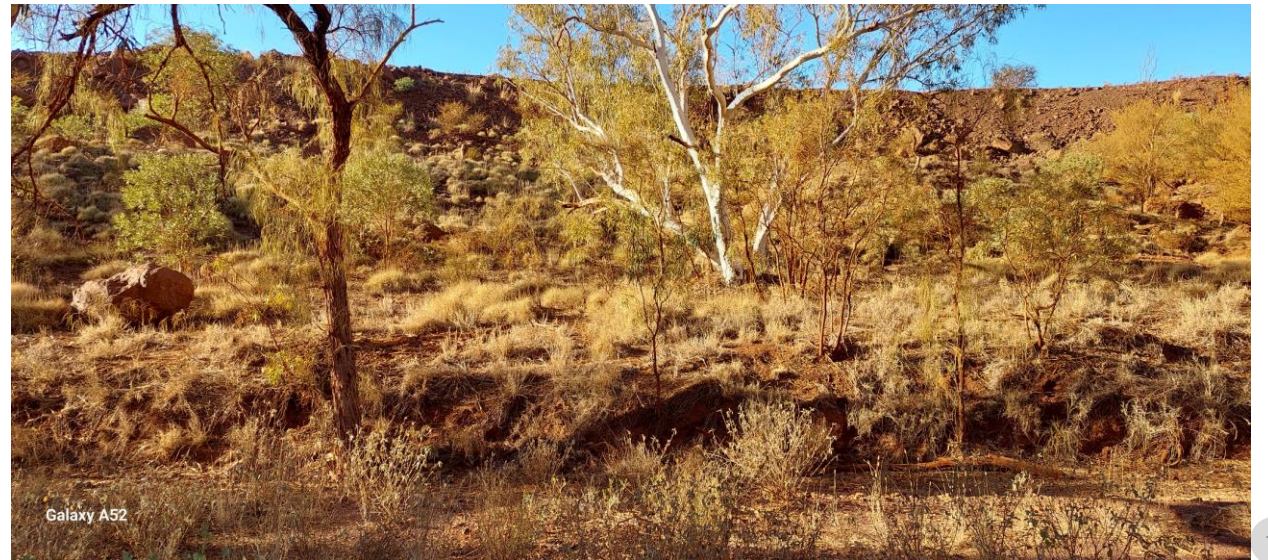
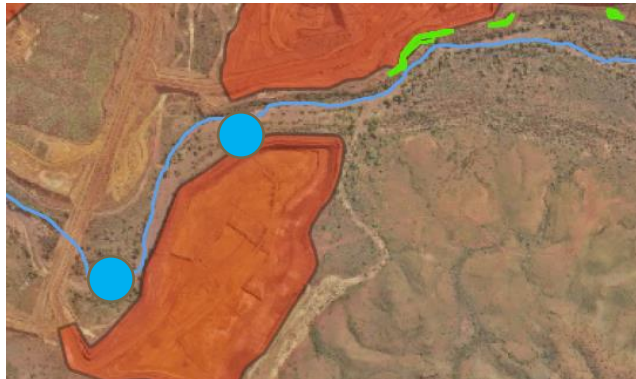
W3 Pit – Day 2

- West CID wall appears to be particularly high with CID being competent. Localised areas of loose material suggest material has been pushed over from pit into creek.
- Small section in south-west corner that will be wet but lower velocity. Haul road ramps up into W3 Pit and is unlikely to be removed. Material is stabilised by vegetation and appears suitable for the lower velocities predicted here ($< 2\text{m/s}$)

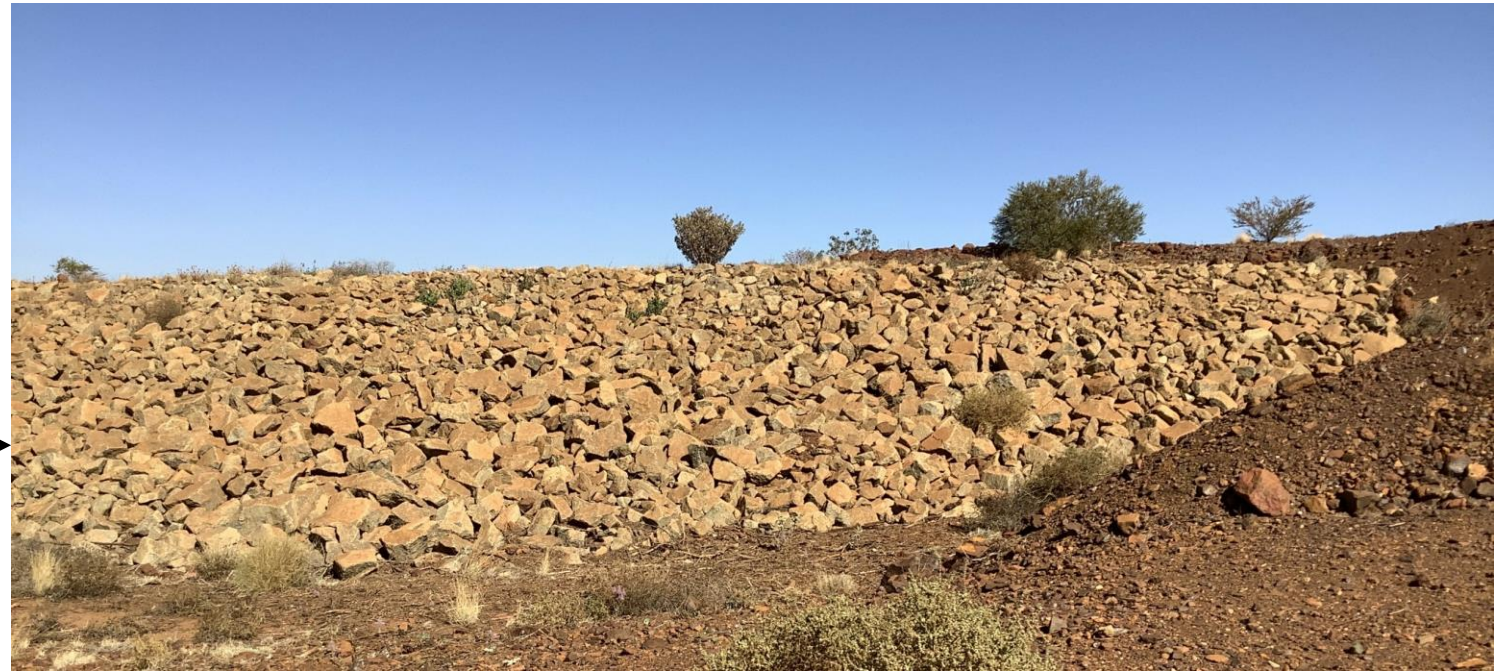
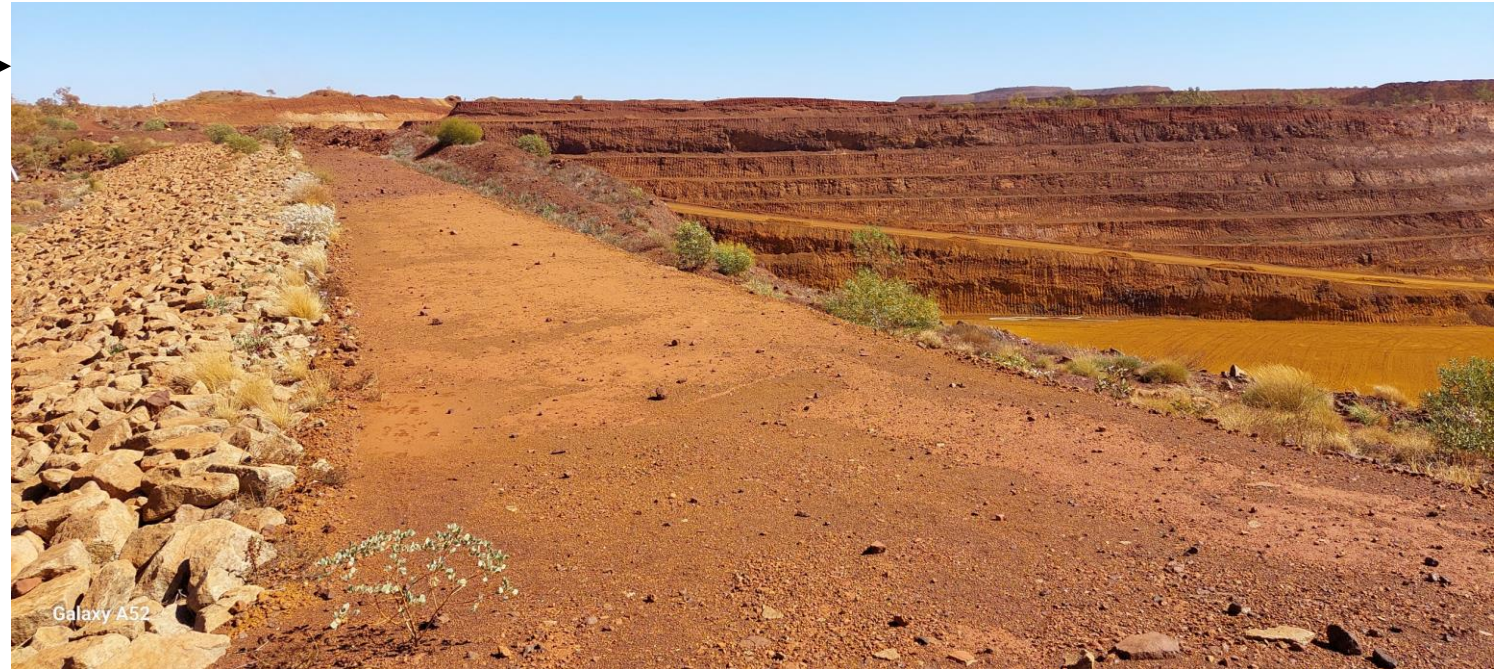
W3 Lamb Creek Diversion – Day 2

- Lamb Creek bunds appear to be well constructed - need to check rock size on as-built and design drawings and compare with photos taken. →
- Unlikely that submerged rock toes were constructed. Need to check latest flood levels for 0.1% AEP to determine if they need to be raised.
- Upstream bund may need to be raised; however, there is no room to south due to tenement boundary and no room to north due to pit wall drop-off. →

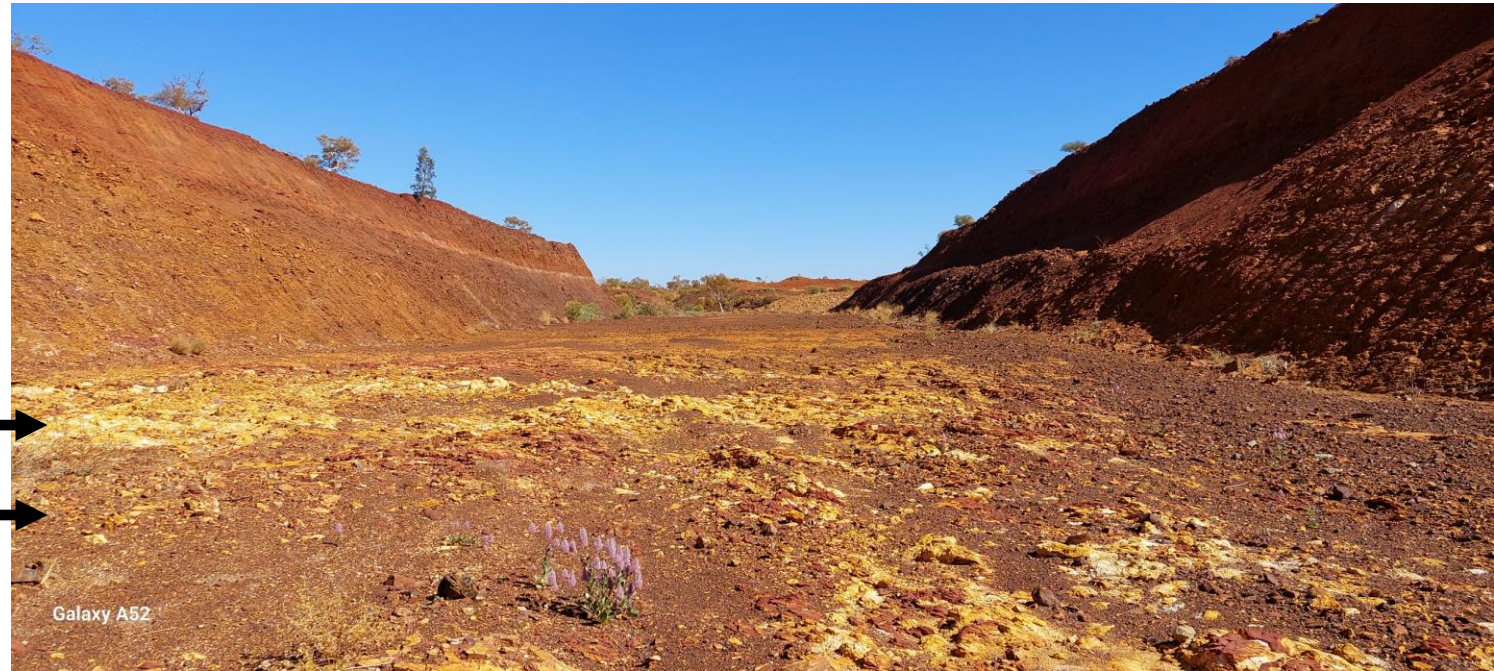
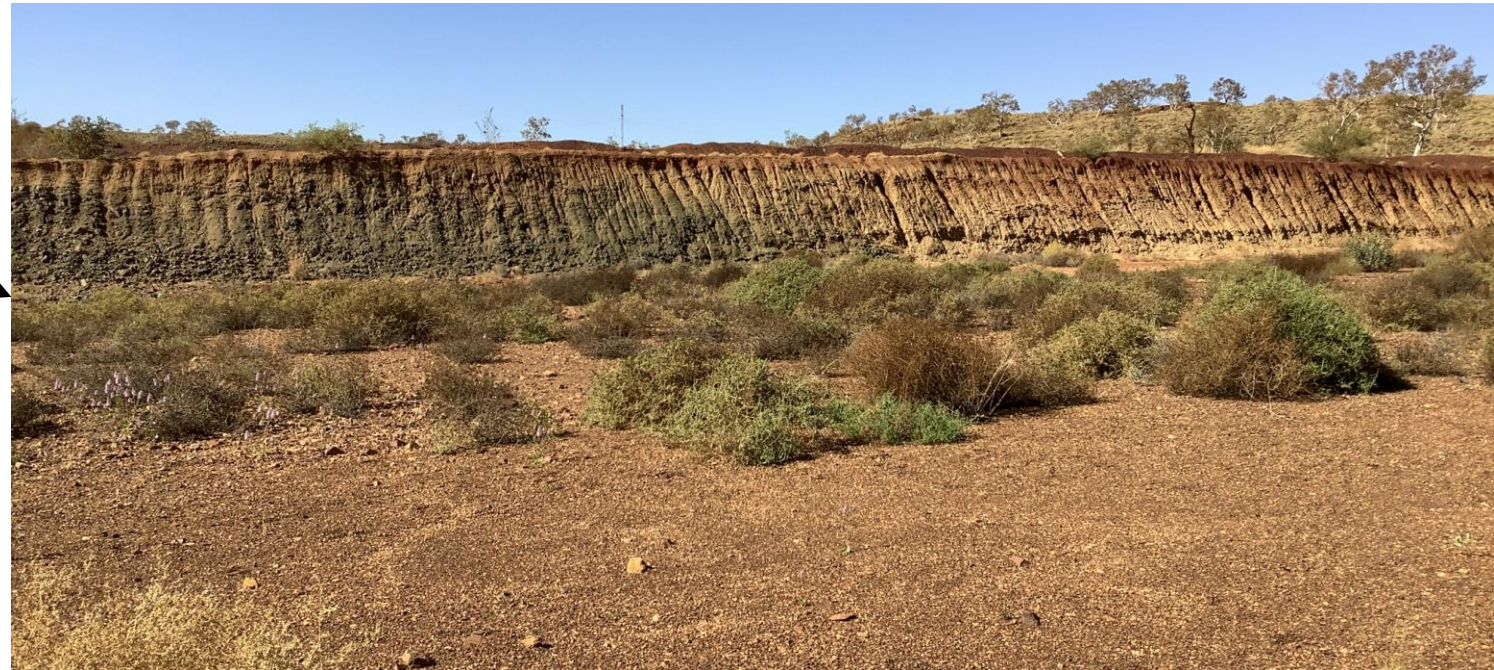
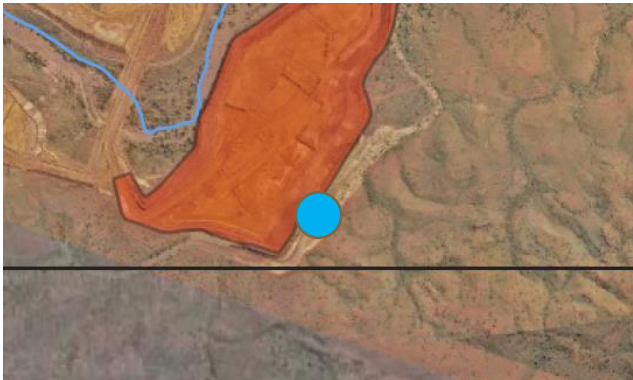
W3 Lamb Creek Diversion – Day 2

- Diversion will need some work for closure. Exposed bedrock throughout the upper reaches suggests no over-blasting to form shallow aquifer substrate to support tree/veg growth.
- Very little vegetation has established (especially compared with other Yandi diversions). Evidence of erosion on the outside of the bend and potential deposition, or lack of erosion, on the inside bend. Undercutting of the diversion wall in some areas.
- Downstream section of diversion that is wider has steep sides cut into soil with evidence of rill erosion. Exposed weathered dolerite in some areas. May need to be cut back or some other actions to improve performance.

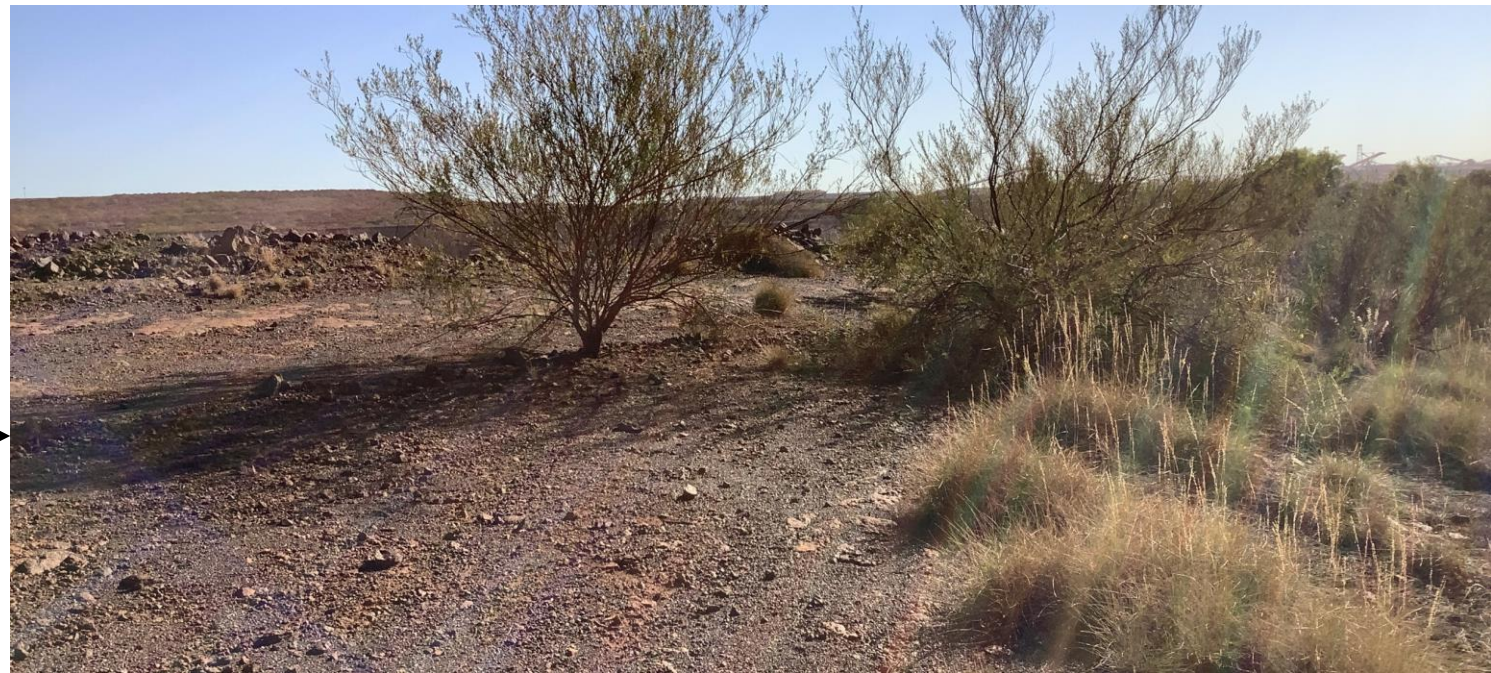
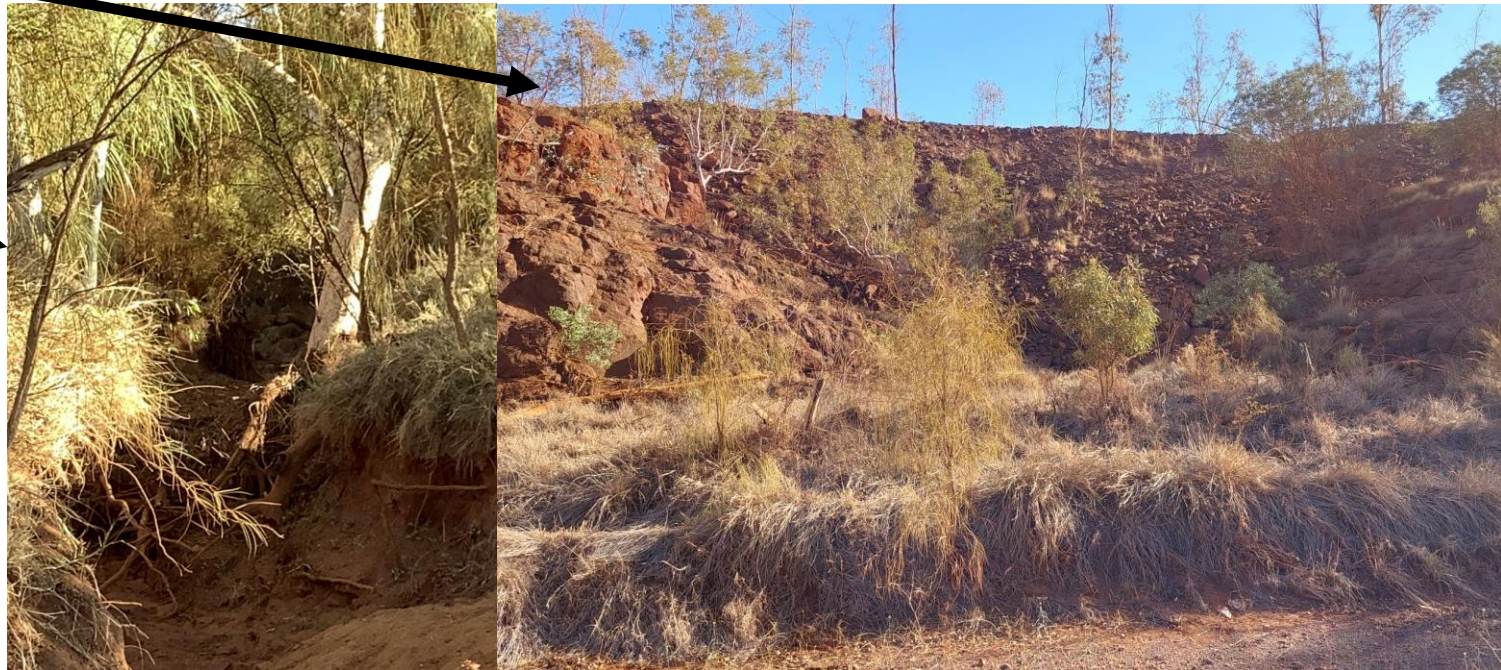
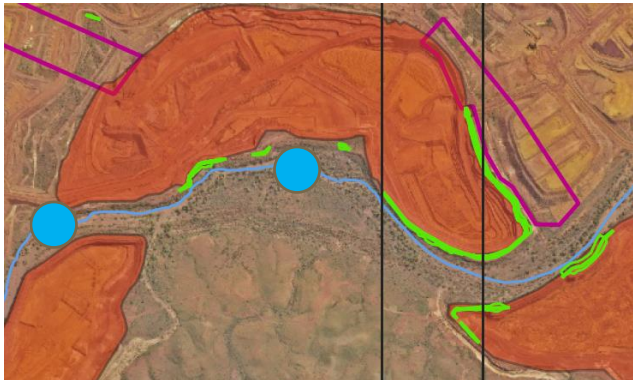
W4 West – Day 2

- If the W1-W4 link flood channel is removed, this section sees very high water levels due to the natural landbridge constriction. We could not inspect the area due to heritage site and haul roads; however, there appears to be sufficient room to build additional bunds on top of the remnant CID and haul road. →
- Some sections where remnant CID is not continuous and material appears to have been loosely dumped to fill gaps. Unclear whether underlying material is intact CID or if it is all placed material. Unclear whether bunds required and if so whether they would fit on top or need to be built into the creek.
- There is a tributary intersection coming into Marillana just upstream of W4 Pit. It is deeply incised and comes through a heritage area. →

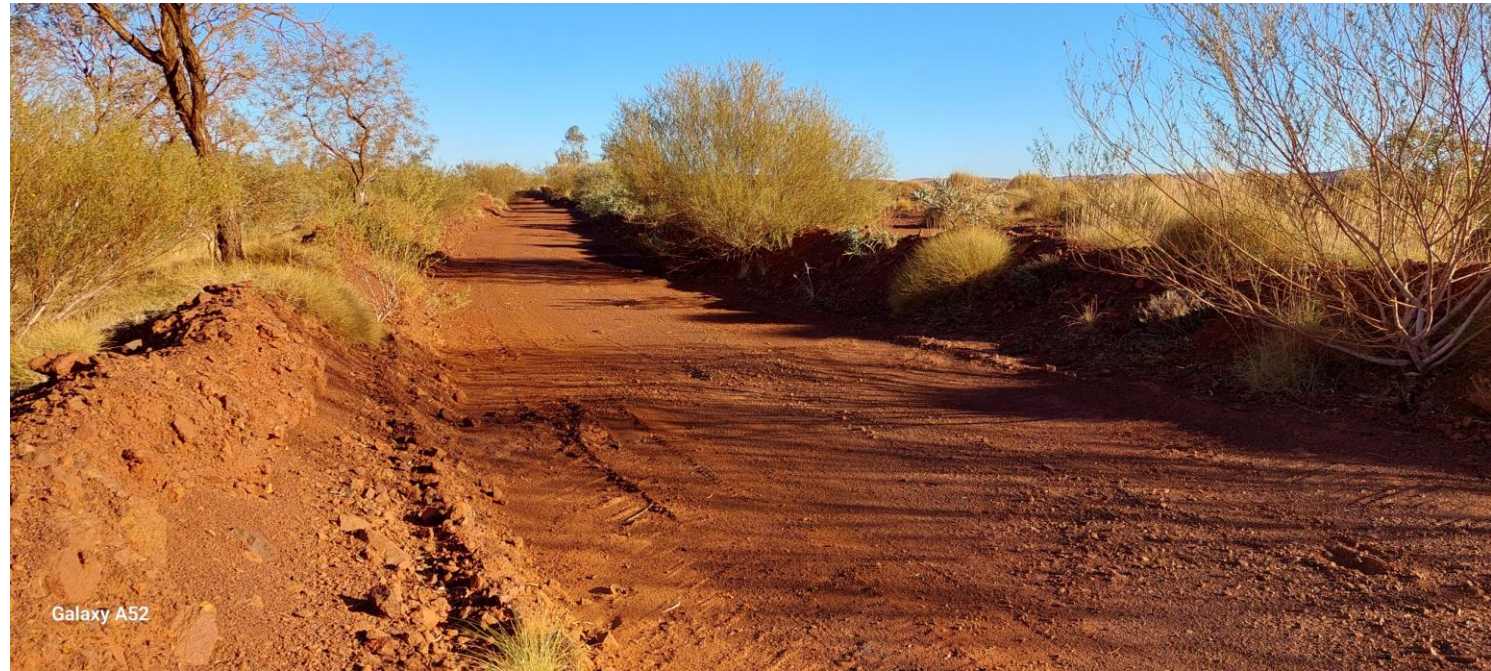
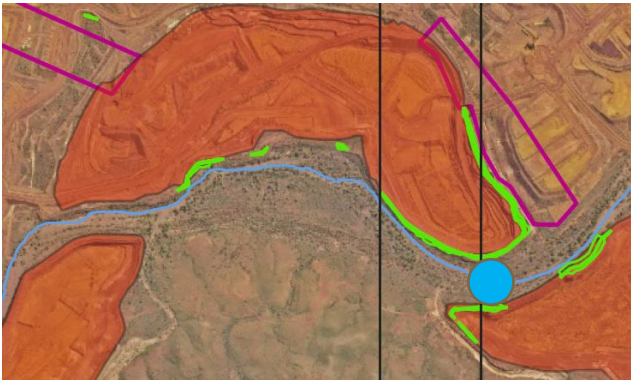
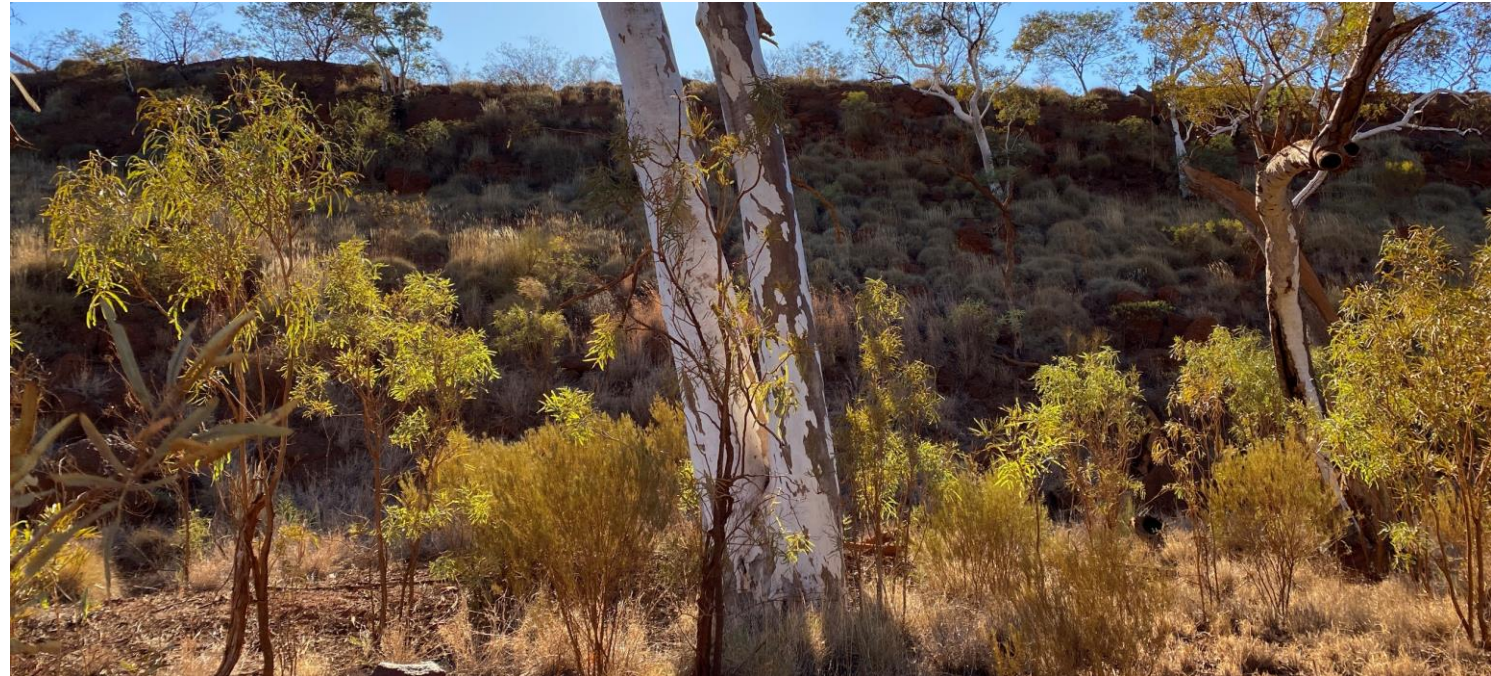
W4 East – Day 4

- Sufficient room at top of CID to raise bund if required. There is a single lane LV track as well as a ~5m variable distance from the track to the pit wall. Track appears to be used to access dewatering bore and other infrastructure. →
- CID appears to be competent; slope is slightly relaxed compared to other areas and is vegetated.
- Bund location at corner of pit could be constructed close to pit wall and would be small in height.
- Lots of mature melaleuca trees in this section, avoiding any works in the creek even more important →

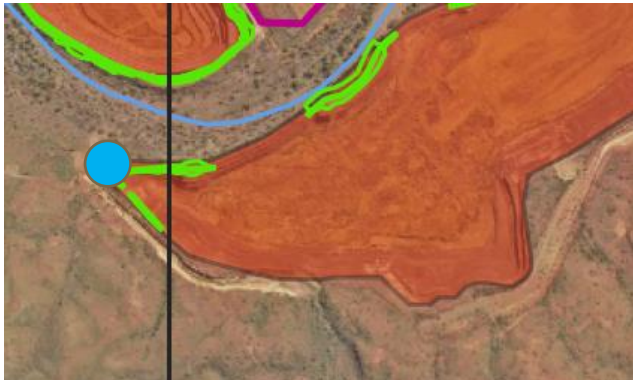
Diversion outlet some trees

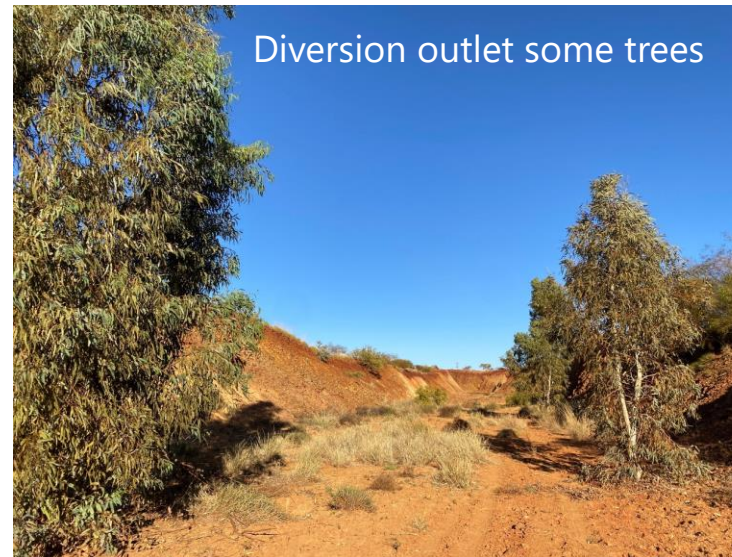
- W5 western corner of remnant CID is low and appears disturbed (material dumped over the top, or CID replaced by loose material) – it is not clear if there is sufficient room to put a bund on top, probably not. →
- Outlet of W5 diversion is OK with some trees. Majority of diversion where in cut has no alluvium/aquifer and no trees. →
- Cut slopes are steep and showing signs of erosion in places. However, the sediment does not appear to be accumulating sufficiently in the channel to support tree/veg growth. Suggests that diversion channel may require upgrading to support revegetation. →

Where in cut, no trees or alluvium

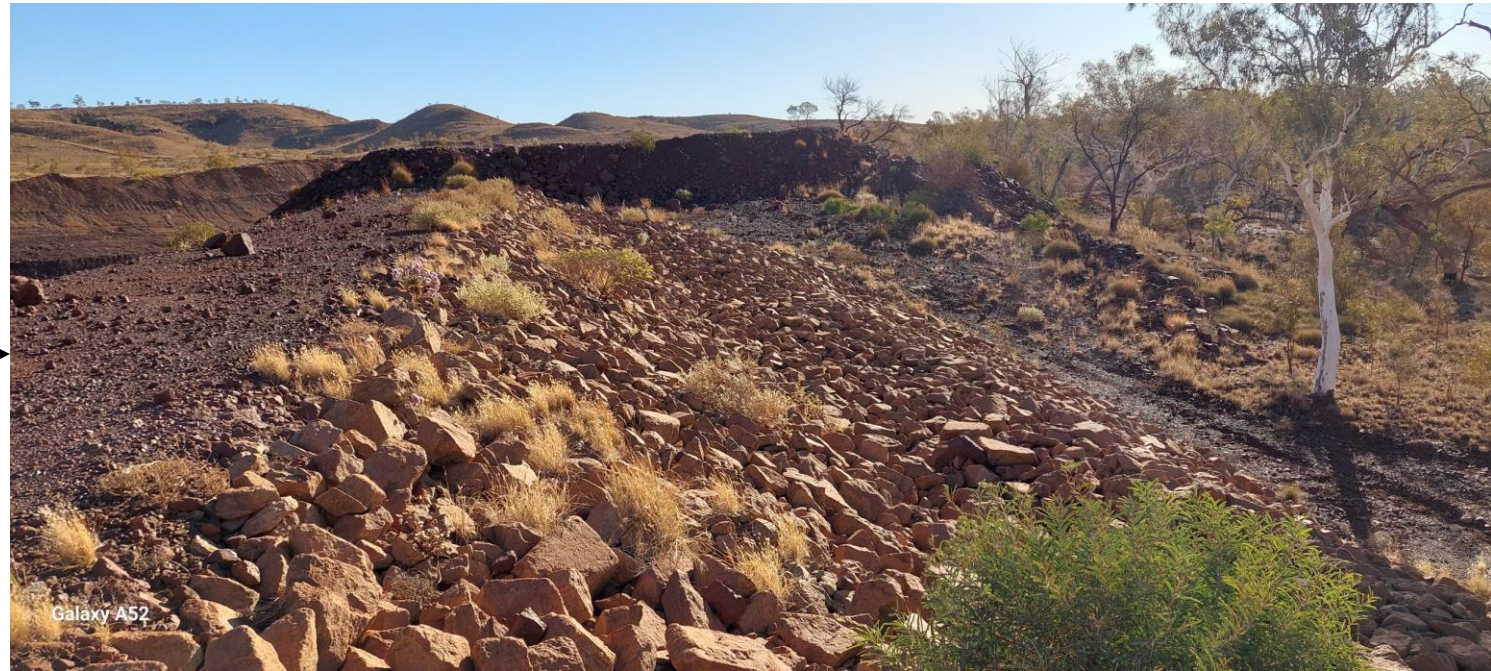
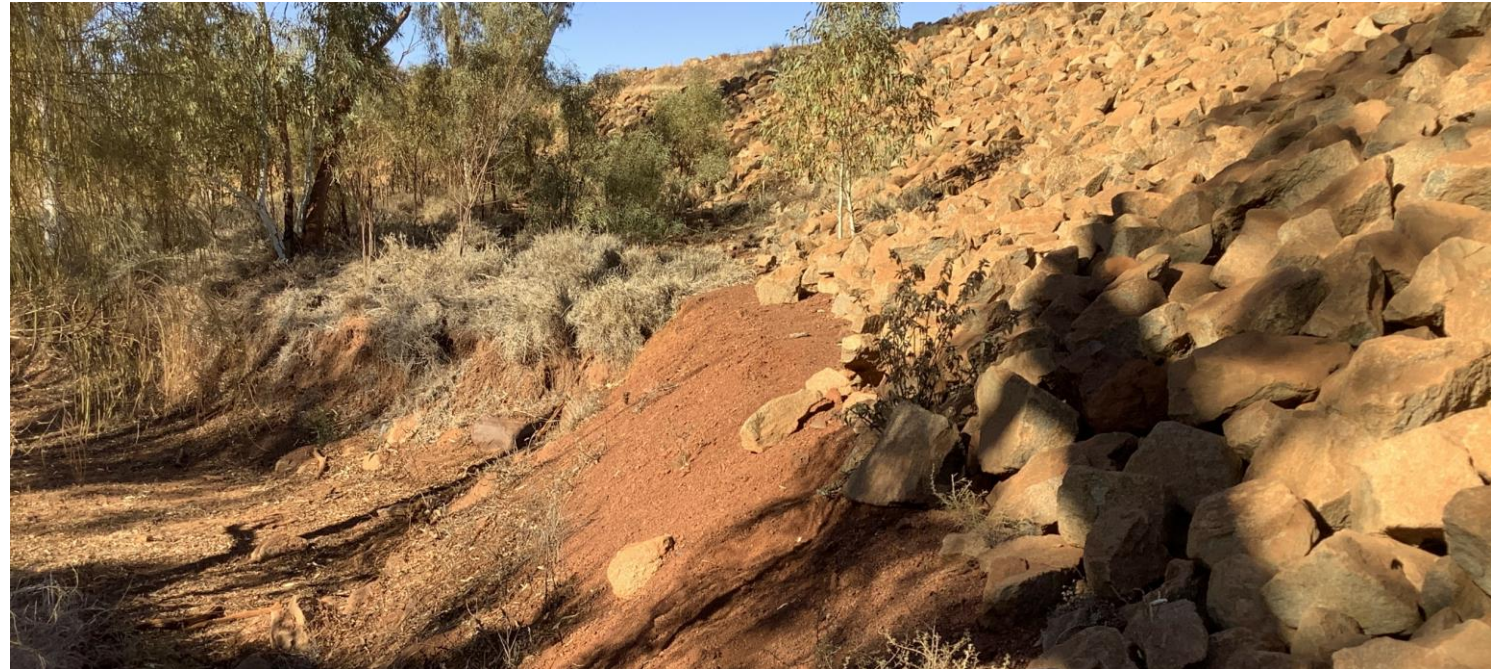
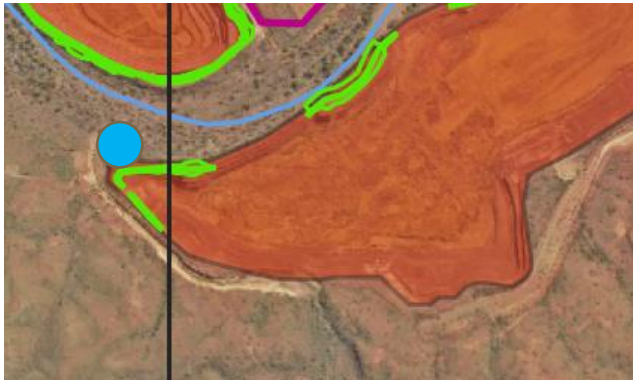
W5 Pit South – Day 2

- W5 bunds appeared to be well constructed, with launchable toes and suspected Light Class armour rock (as per design). →
- Lack of access and available space will make raising bunds difficult.
- Armour rock doesn't protect old tributary channel as the launchable toe protects it by launching rock into place following erosion. →

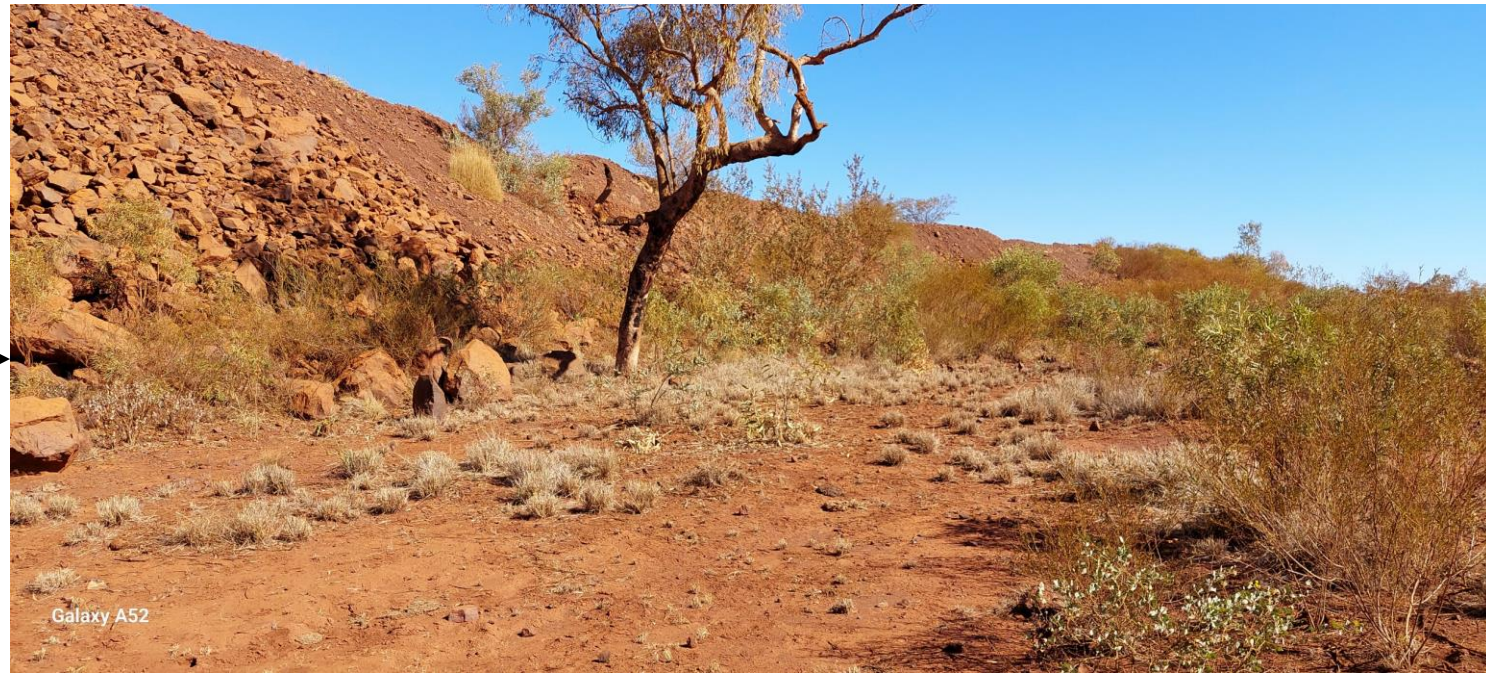
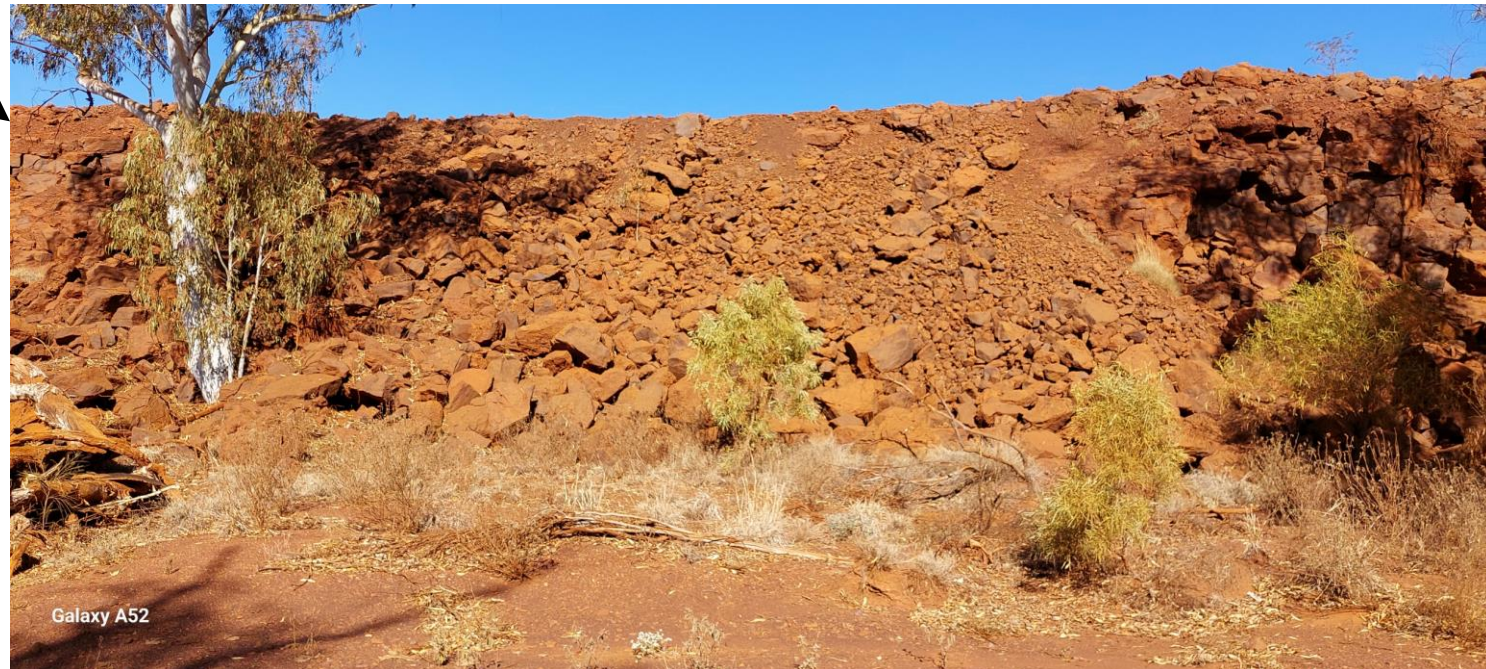
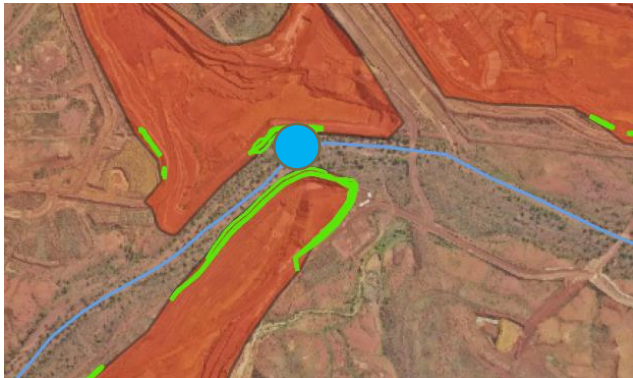
W5 Pit North – Day 3

- Similar to W6, majority of remnant CID is not intact/continuous. Consists of a mix of:
 - Eroded/failed CID (perhaps caused by blasting damage due to thin section left)
 - Loosely end-tipped material
 - Gaps
- Major uncertainty is whether CID exists beneath tipped material; however, the CID observed was likely not suitable as flood protection. This will drive a more expensive closure design
- Drill pad windrows left in creek unrehabilitated
