W2 Diversion – Day 4

<p>STUDY PHASE WAIO PROJECT YANDI CLOSURE LANDFORM SPS SURFACE WATER ENGINEERING DESIGN REPORT</p>	<p>Doc No.: PREP-1200-C-12142/B</p> <p>Page: 112 of 114</p>
---	--	---

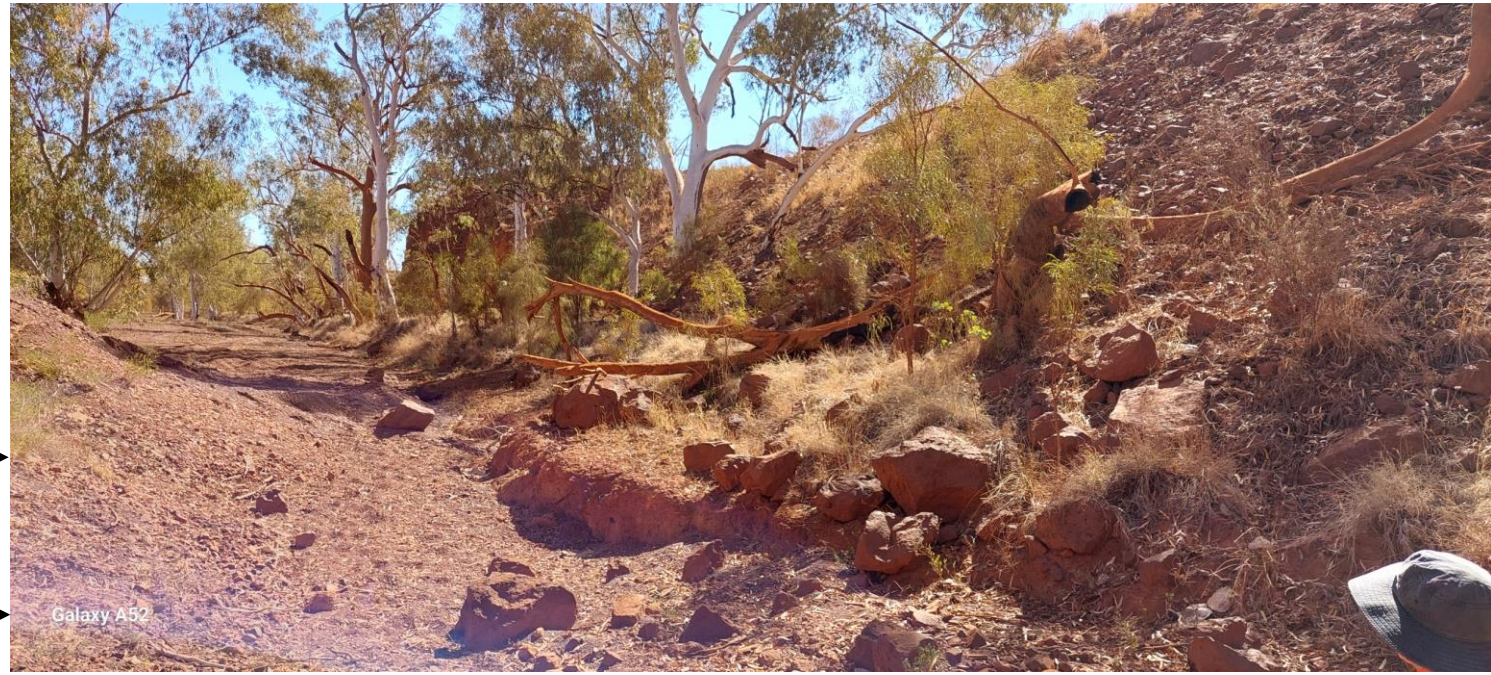
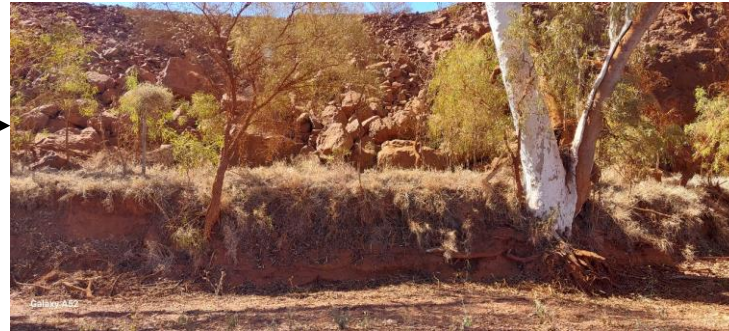
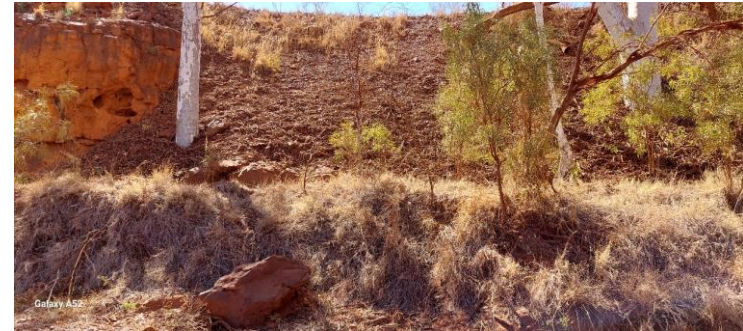
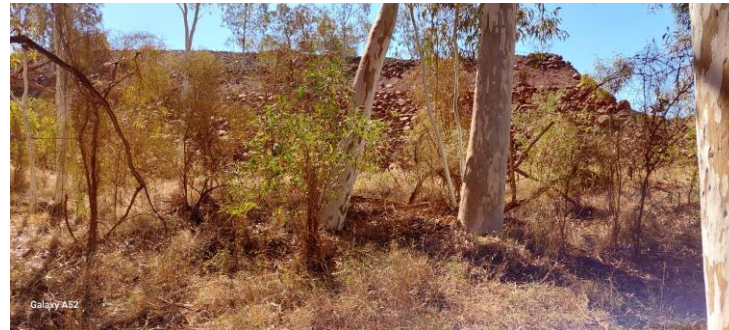
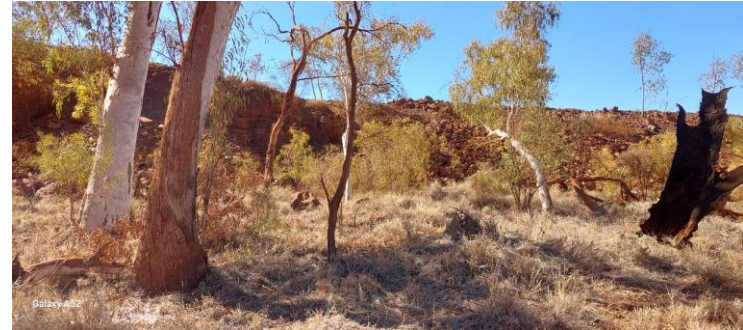
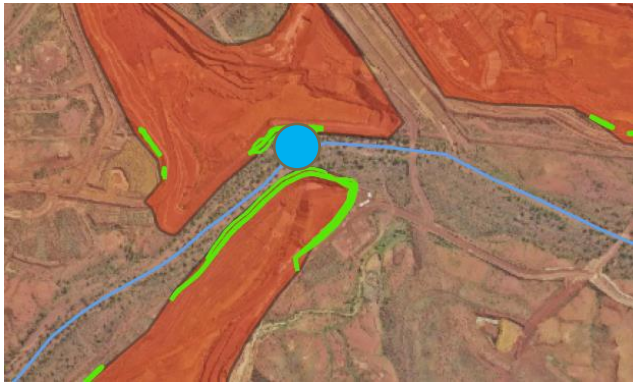
W6 - Day 3

- Material protecting pit is not 100% remnant CID. Intact CID only observed in a few discrete locations, with the majority of length appearing to be dumped material, some with rocks end tipped from the top into the creek. →
- Unclear if intact CID exists beneath the dumped material or not. This is a major uncertainty and will drive a more expensive closure design →
- Many sections with no rock armour at all, or only with end tipped rock that is unsuitable →
- Flood/erosion risk for operations, and not suitable for closure – will require significant upgrade works or building bunds into the creek. →

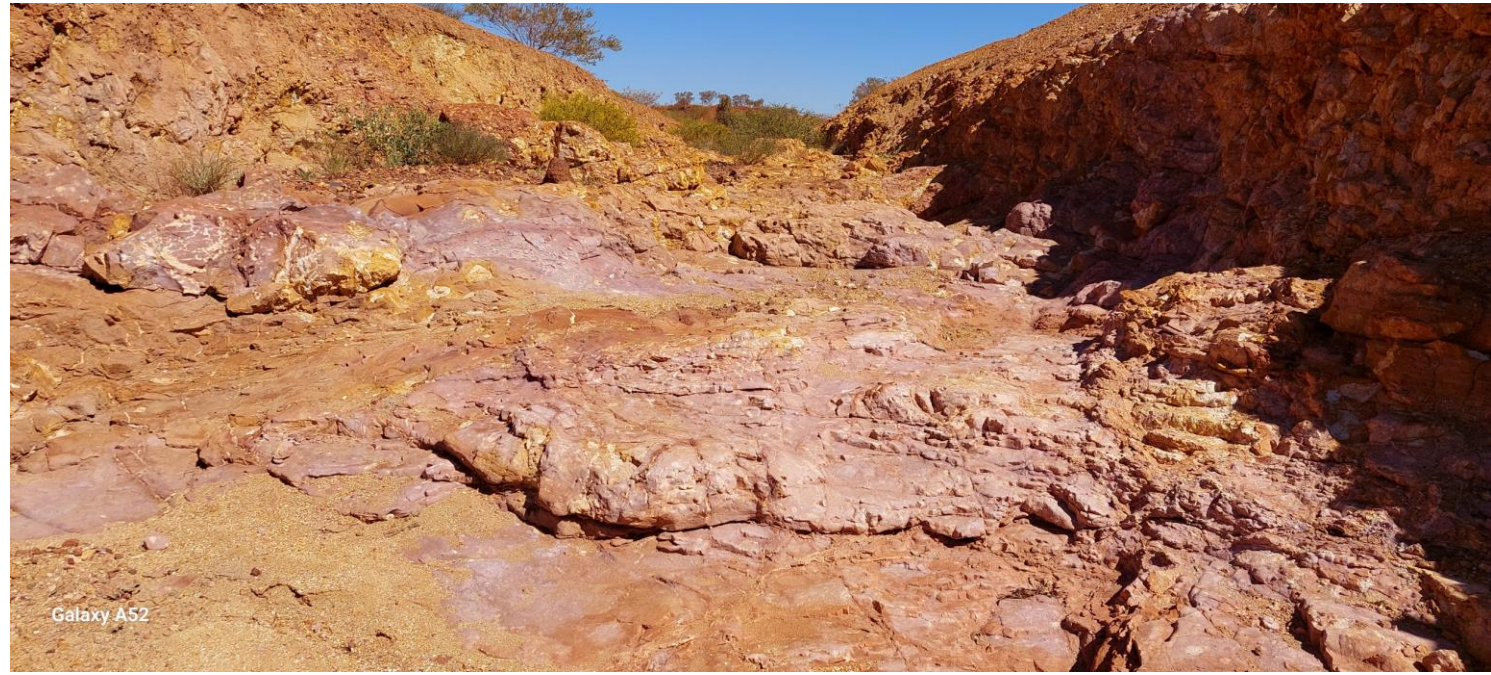
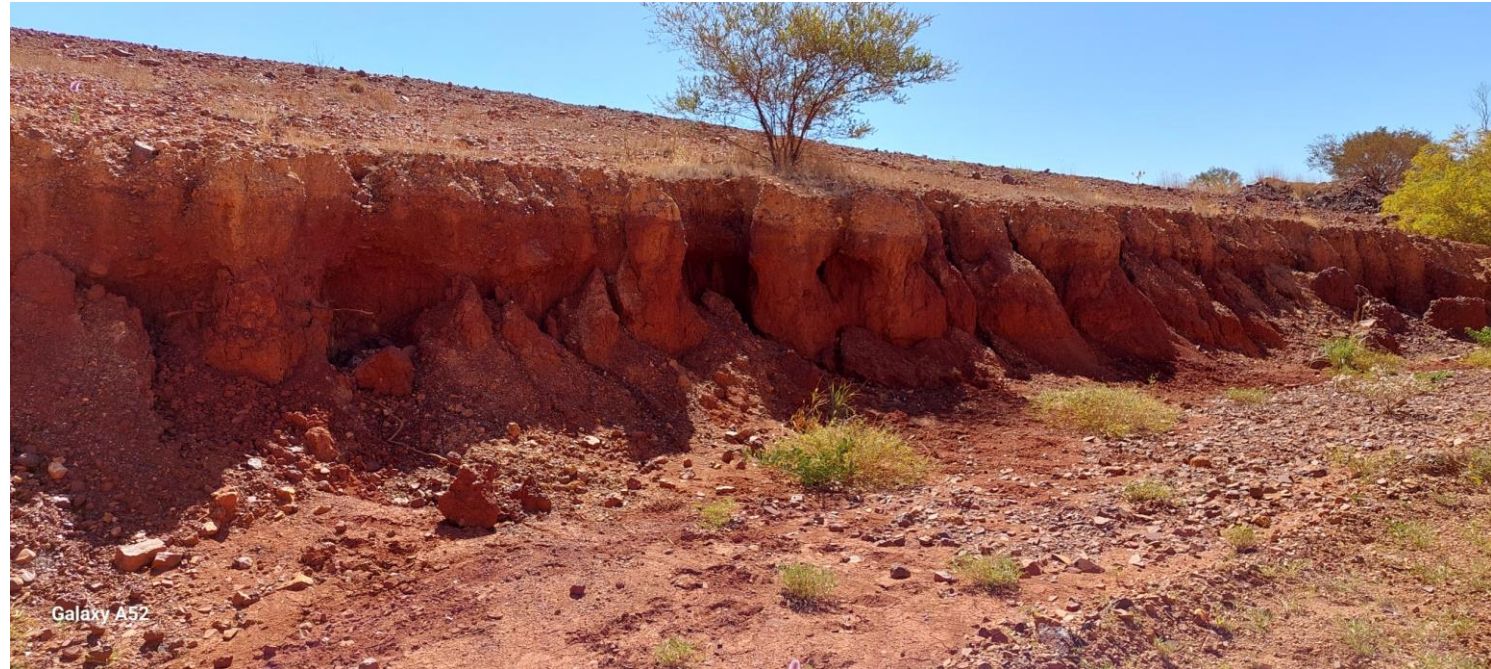
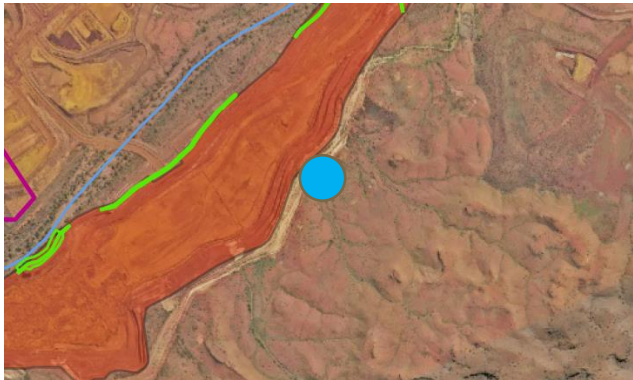
W5 Pit East Diversion – Day 3

- Diversion appears to be too narrow, even more so in some areas, with steep longitudinal grade and exposed bedrock in many places →
- Significant erosion at the downstream end observed that has the potential to migrate into W5 Pit – not suitable for closure and perhaps a risk for operations →
- Need to widen the diversion and provide substrate needed to support a shallow aquifer and revegetation. →

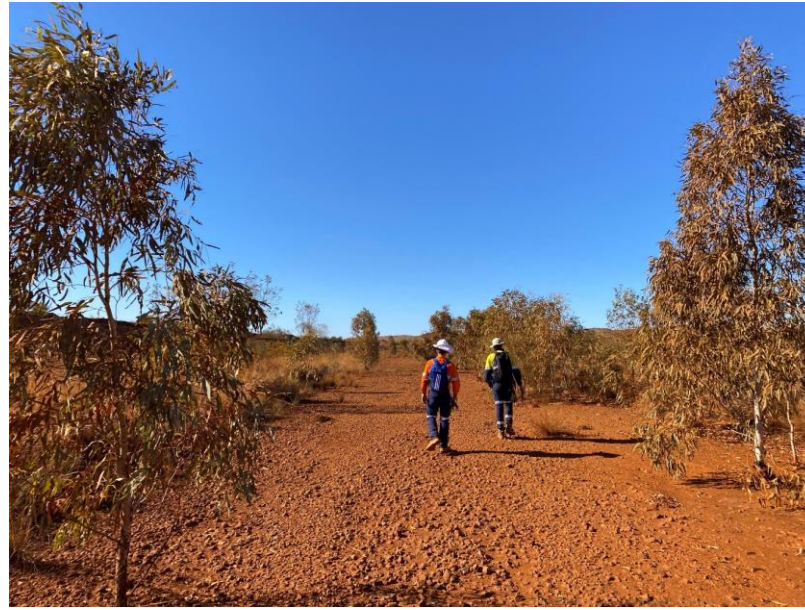
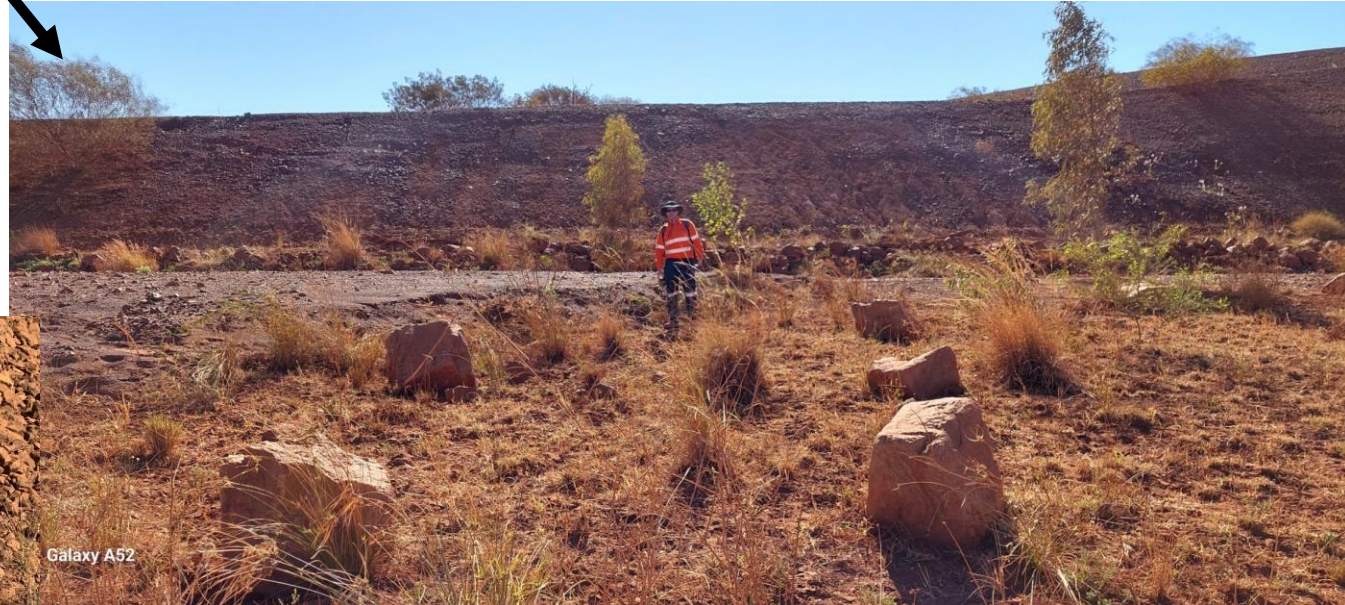
Herbert's Creek LB – Day 4

- Trees are growing in the diversion, up to 5-6 m tall. Roots are expected to have extended to the depth of the GCL (~1 m) and may have even punctured it (unconfirmed)? →
- Sediment transport into the land bridge and deposited near inlet. Large sediments slug evident in upstream section (up to 0.6 m). ↘
- Several sections of the flood bunds on the land bridge have rock armour that is undersized for mine closure (<Facing Class). ↙

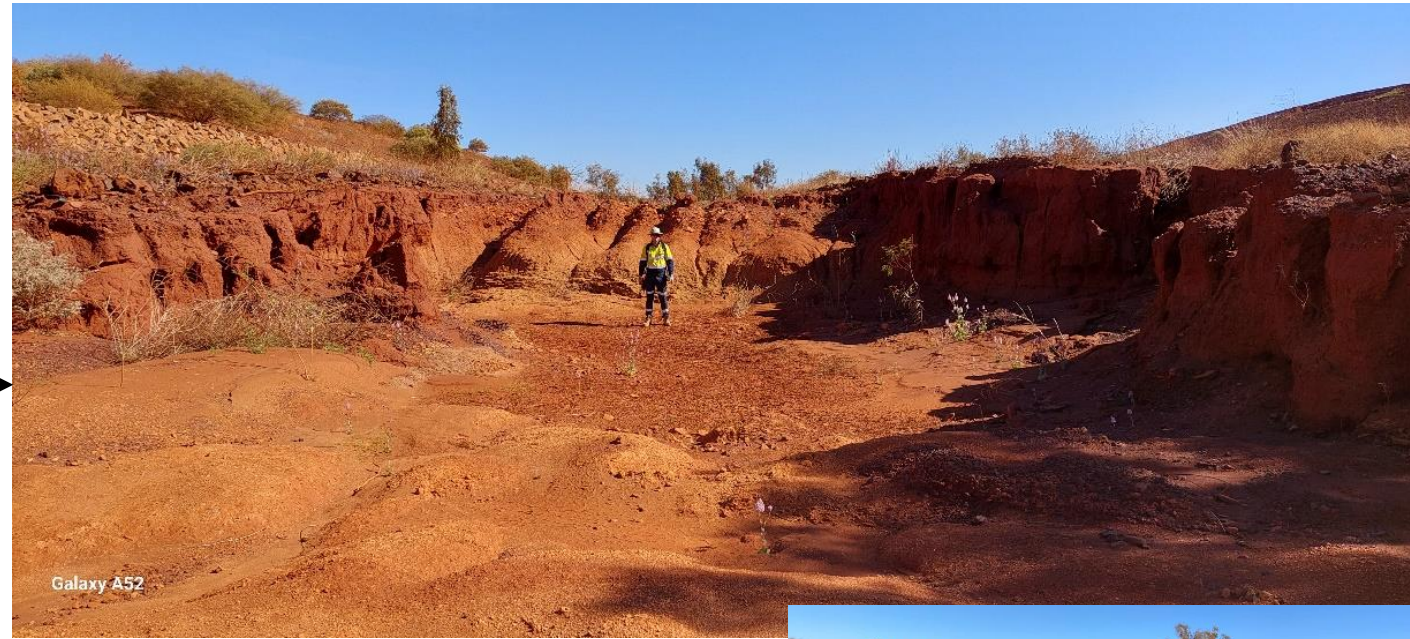
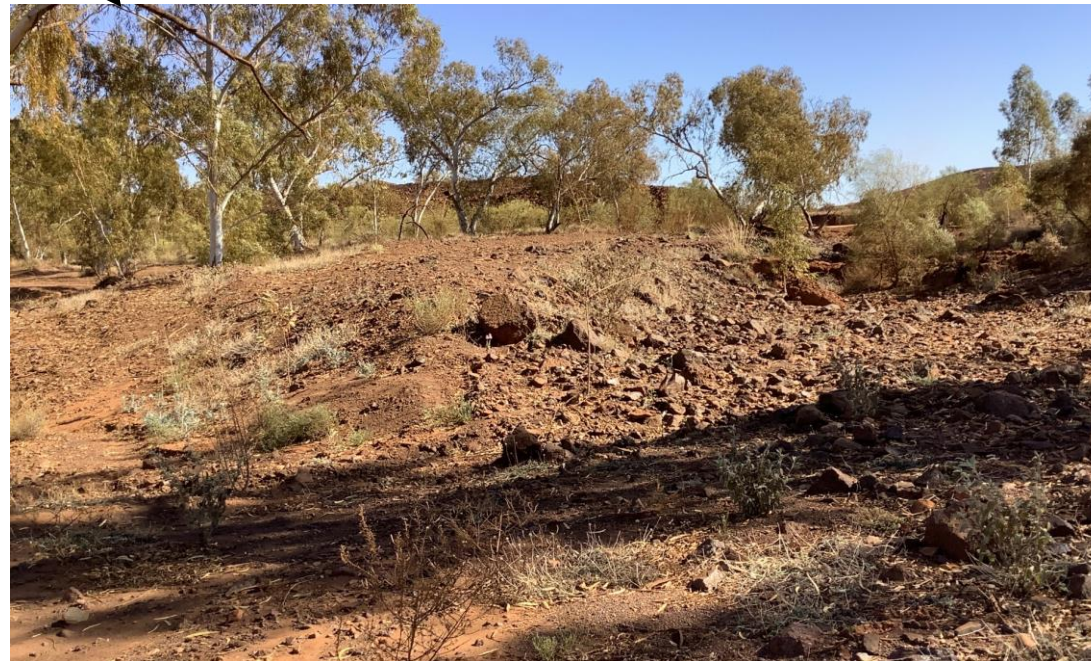
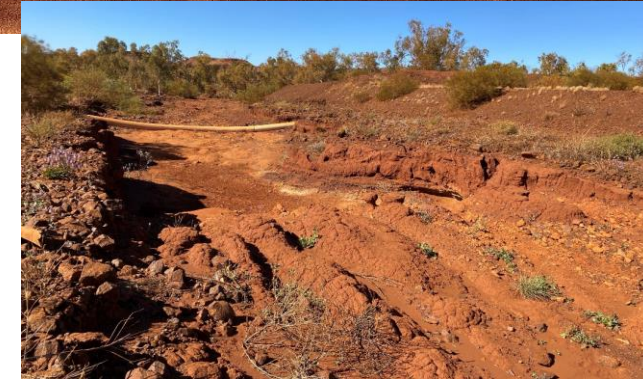
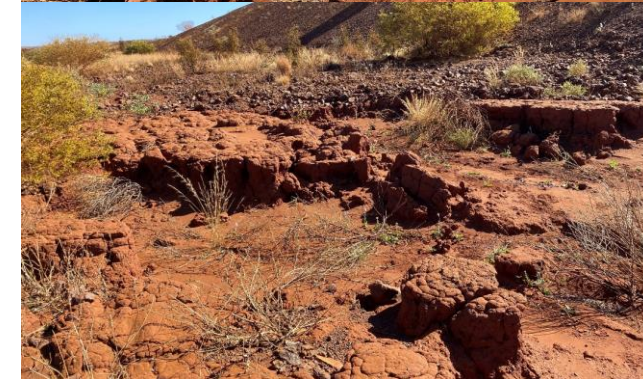
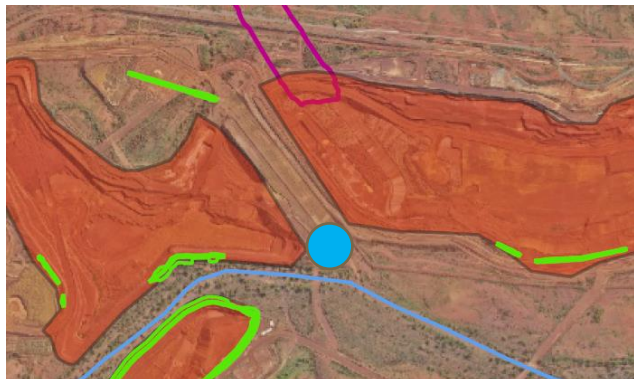
Herbert's Creek LB – Day 4

- 3 m deep scour at outlet, head cutting does not appear to have stopped. Potential for it to cut back to location of the flood bunds.
- No visible evidence of competent UCID in immediate vicinity to stop headcutting
- Lots of deposition from this erosion has settled out in Marillana Creek

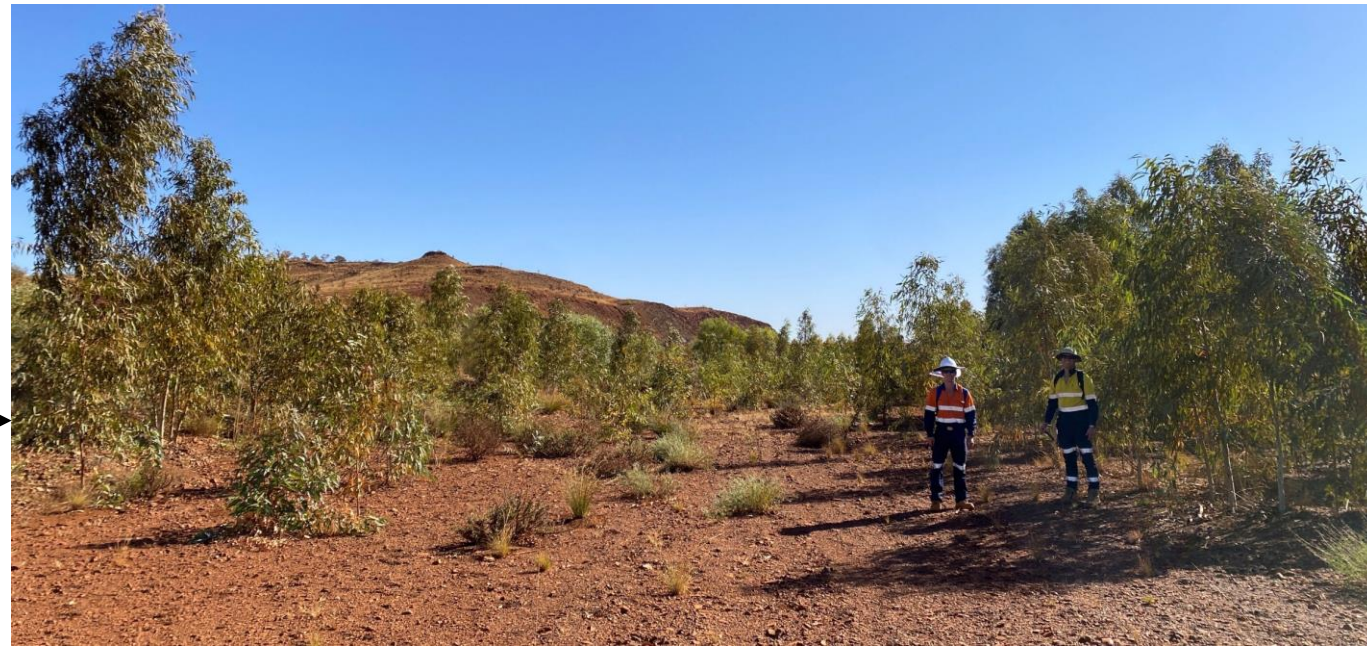
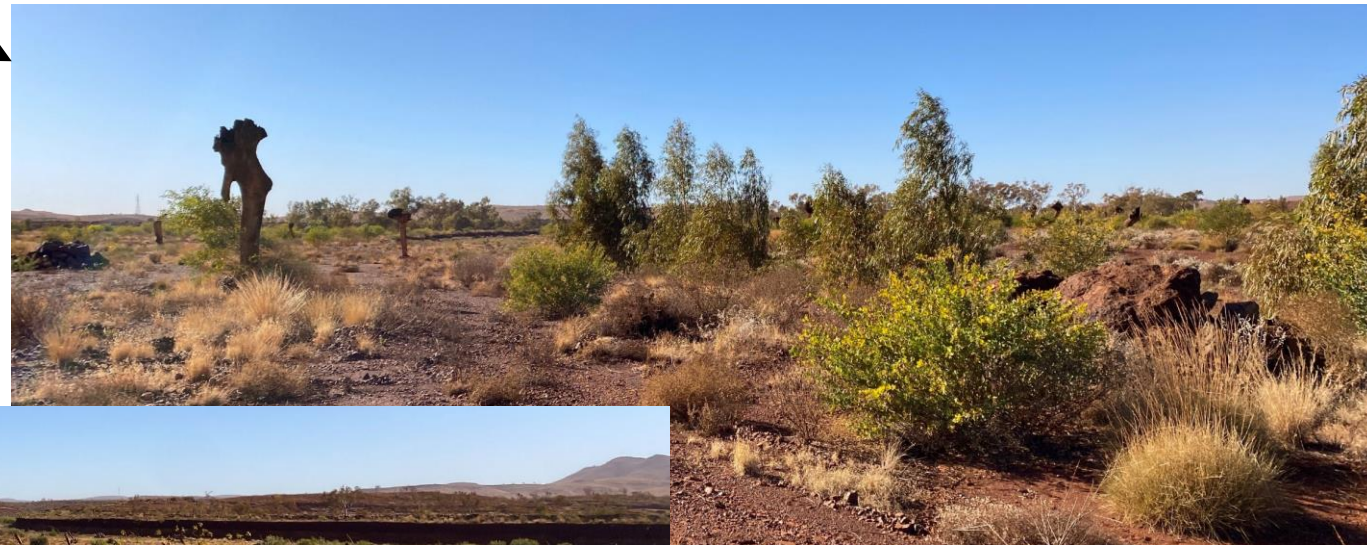
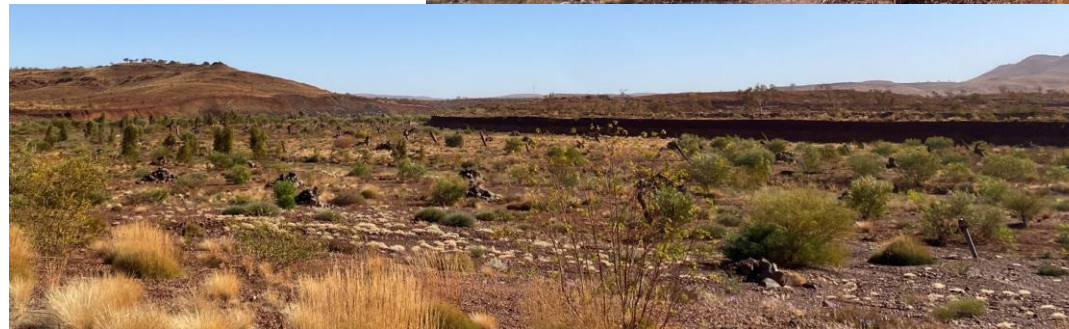
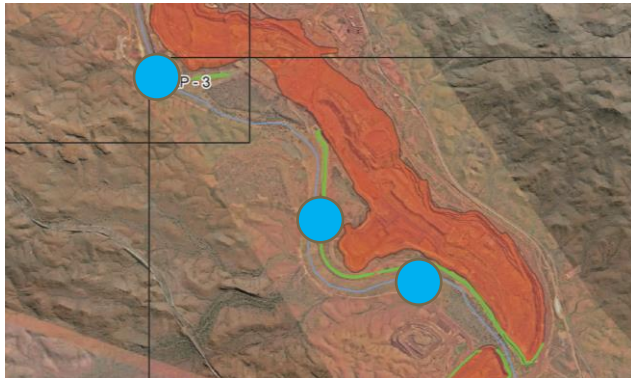
E1 and E4 Diversions General – Day 3

- Vegetation growth is doing very well, many trees 5 m to 6 m high noted in main channel with smaller shrubs and trees on floodplain areas. →
- Roughness elements (tree stumps, rock piles, boulder piles) have performed well, evidence of deposition and vegetation growth behind these elements as intended. ↘

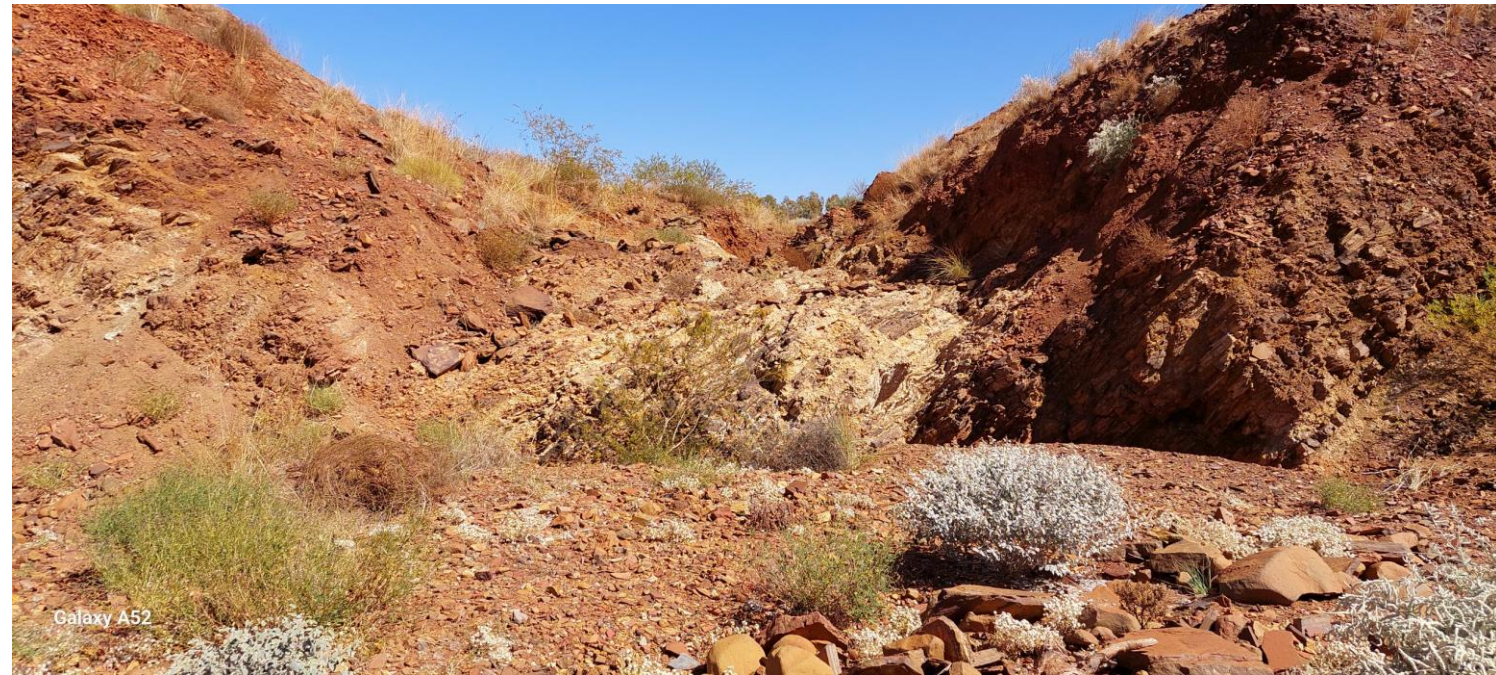
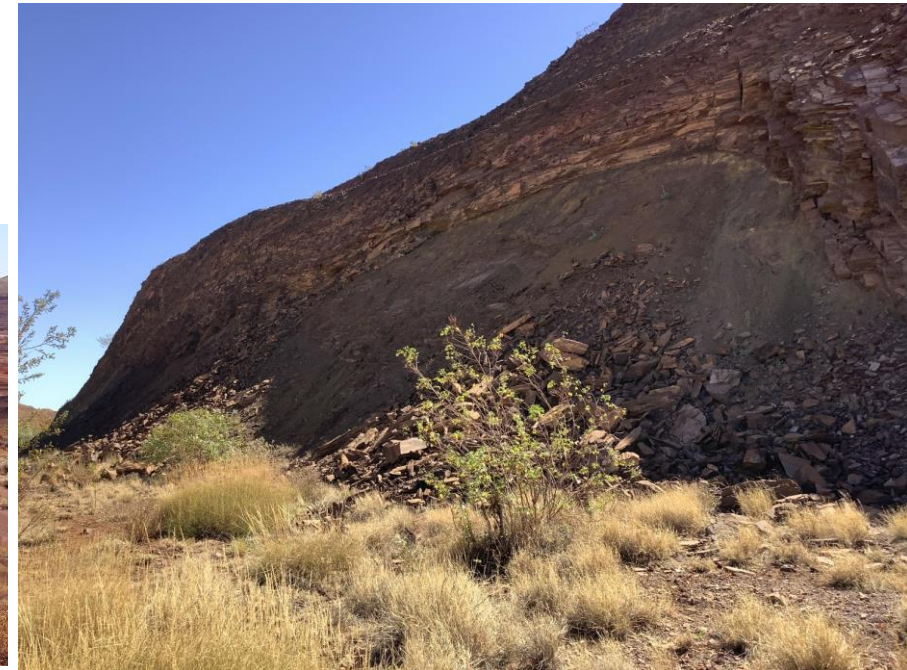
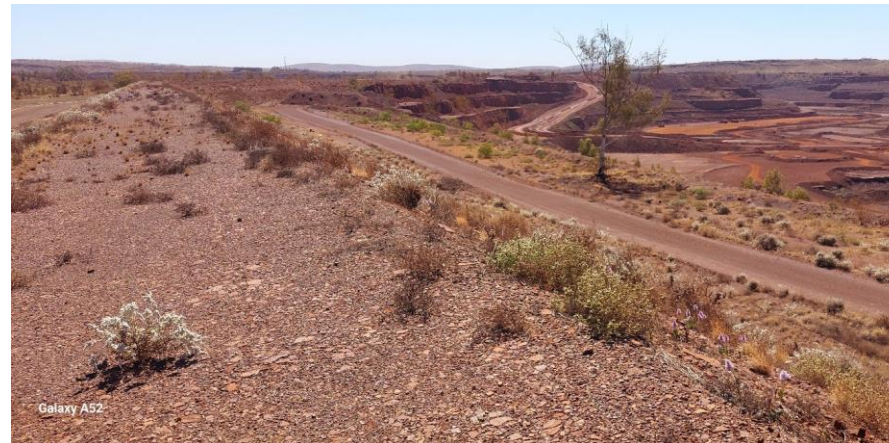
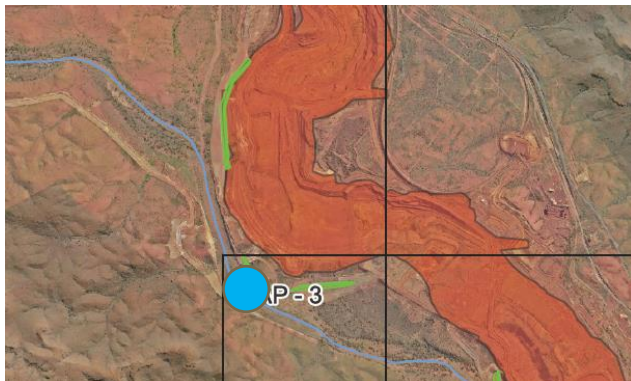
E1 Diversion – Day 3

- E1 Bund 1 – plenty of room to raise on the upstream side (apart from northern end identified by trade off study)
- Significant scour/head cutting of tributary cutback; however, the extent upstream is not far and appears to have stabilised on protruding BIF. Sediment deposited in creek appears to be integrating into the landform.
- Some failures/erosion of eastern cut face.
- Plenty of room to raise E1 Bund 4 on upstream side

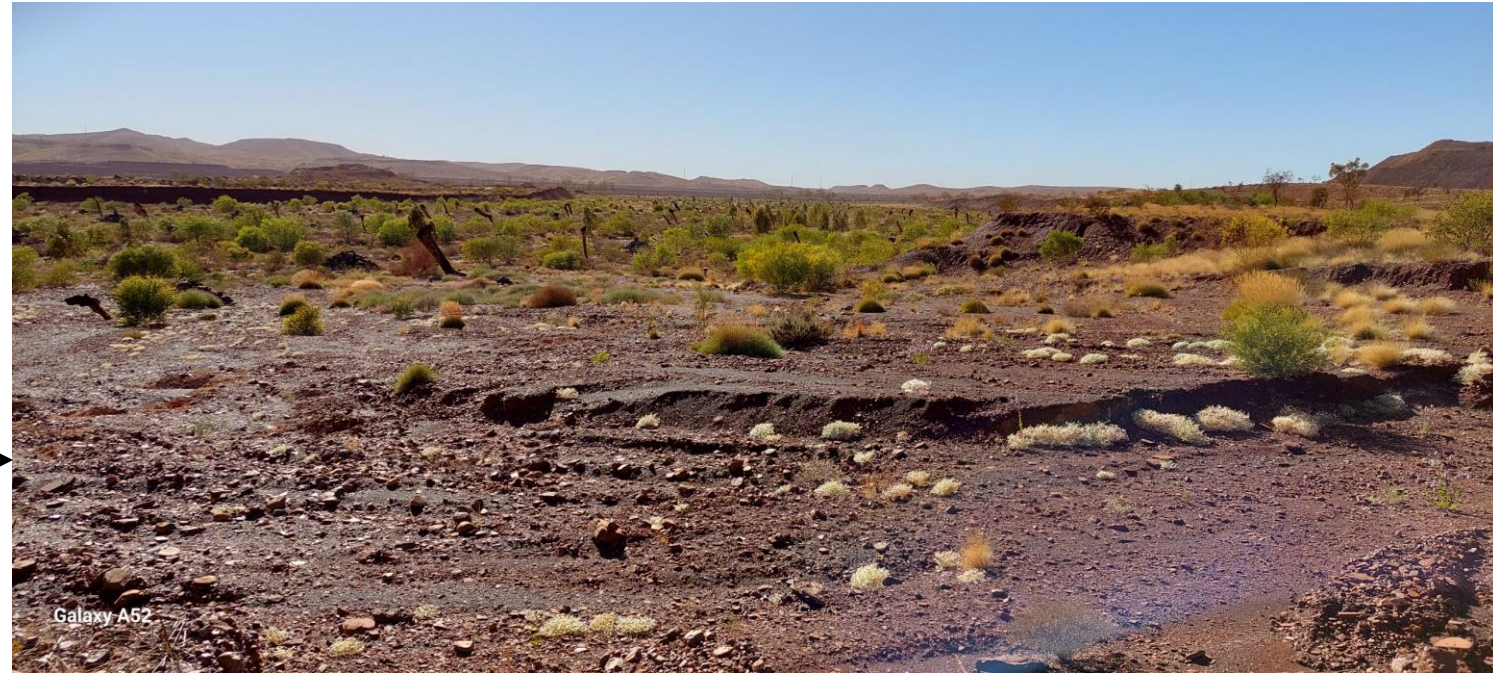
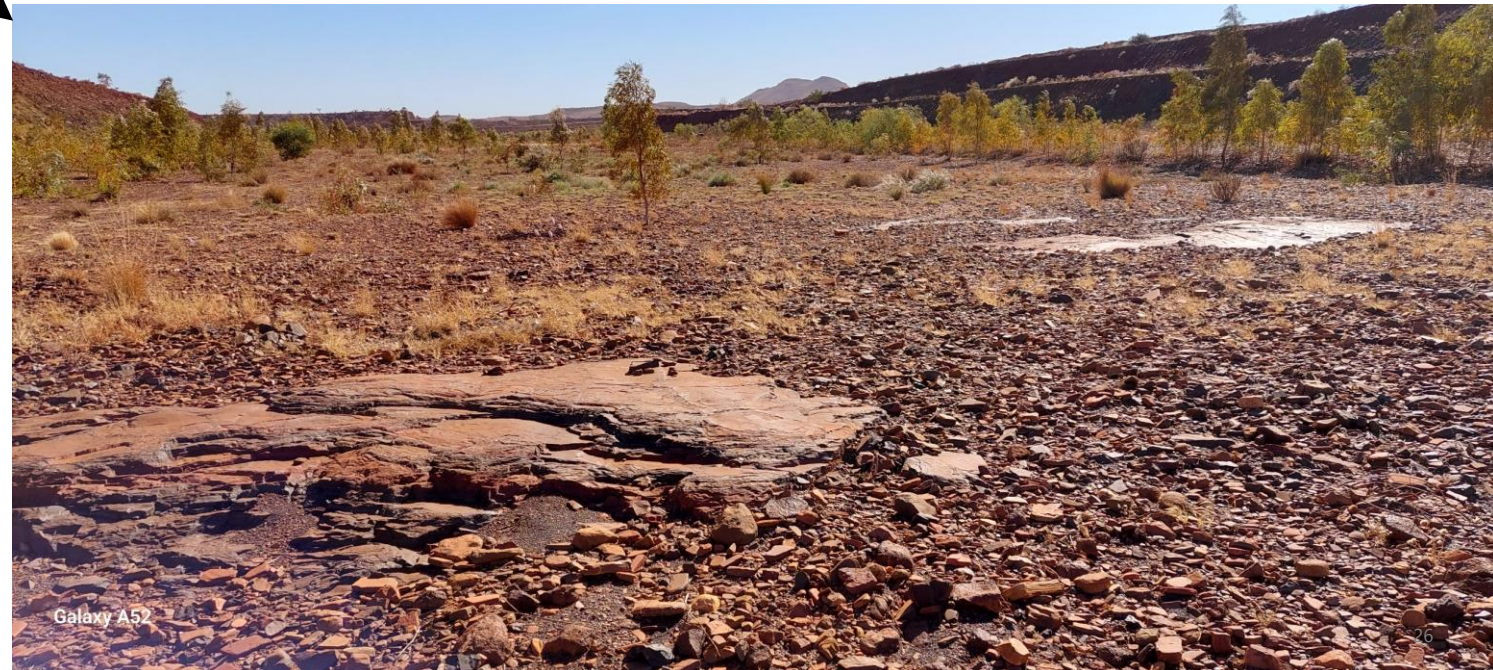
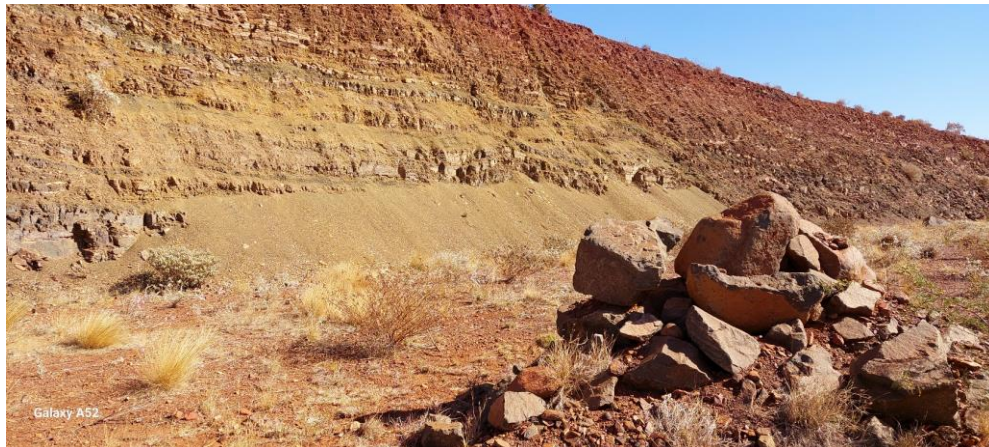
E4 Diversion – Day 3

- Large tributary inflow is generally doing well, despite localised scour/head cutting from the main low flow channel. Broader alluvial fan is integrating well with diversion with vegetation stabilising the slope
- Rock bar is outcropping in localised areas. Potential to utilise this area for creation of a pool if desired
- Scree/colluvium forming locally on diversion cuts adding to sediment load

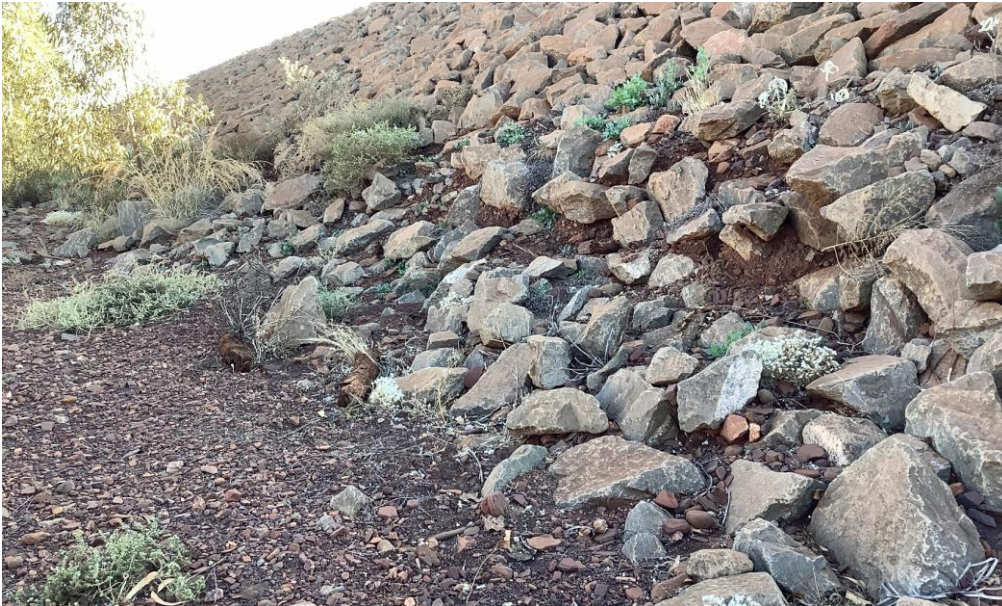
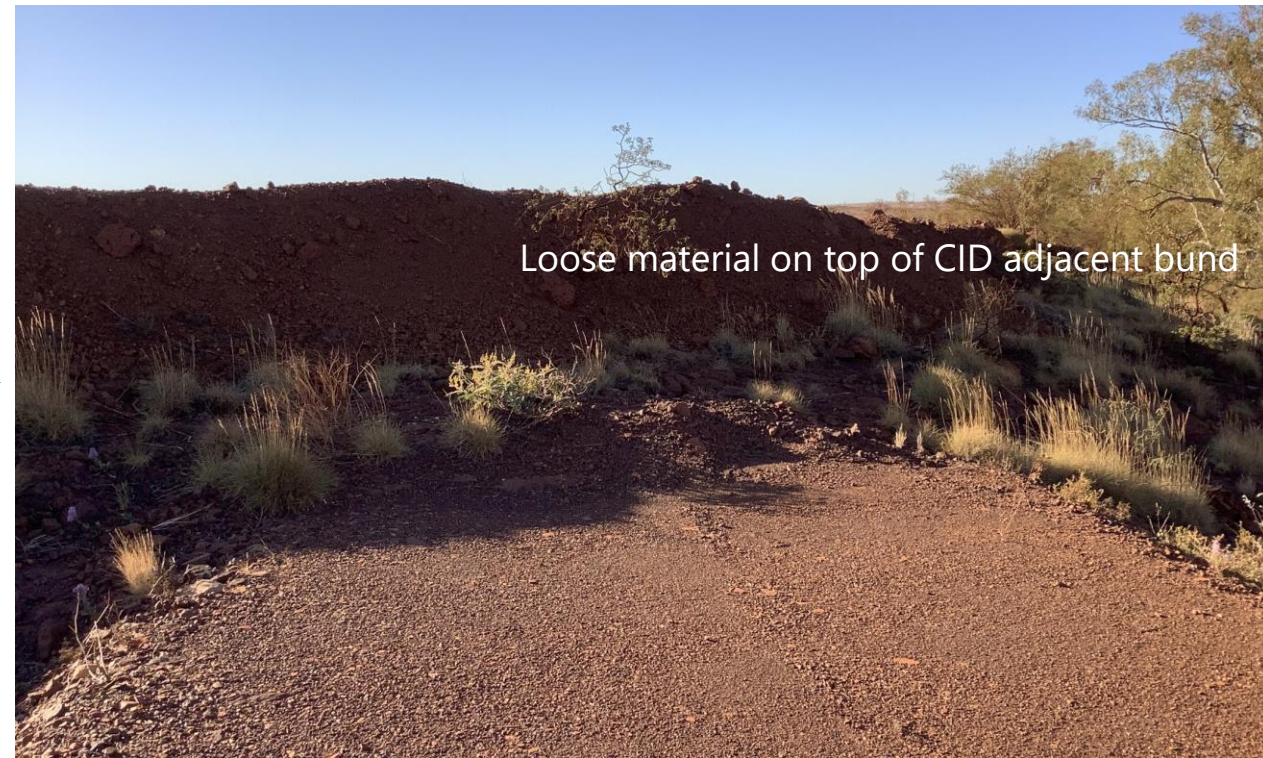
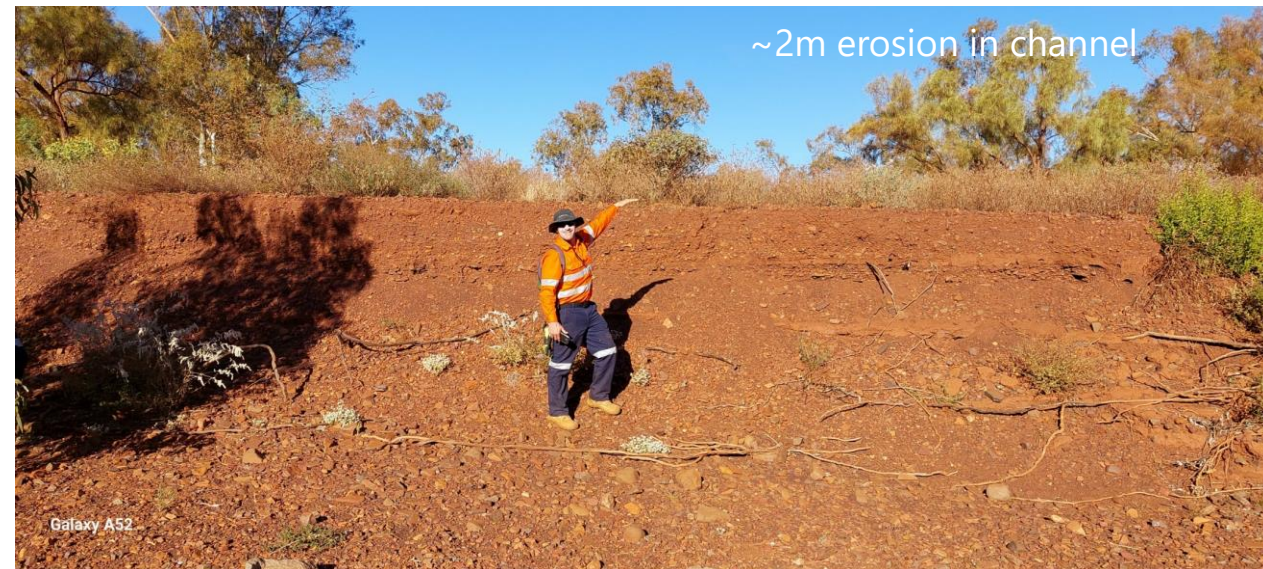
E4 Diversion Bund 3 – Day 3

- Remnant CID visually appears higher than on the E7 side; however, the top 1-2 m adjacent to the flood bund is loose material, possibly dumped on top of CID as a windrow →
- Channel shows up to 2 m erosion in places
- Erosion of toe of existing E4 Bund 3 rock armour, with the low flow channel migrated against the toe. No significant flood events have occurred since construction, nothing much larger than a 50% AEP ↓

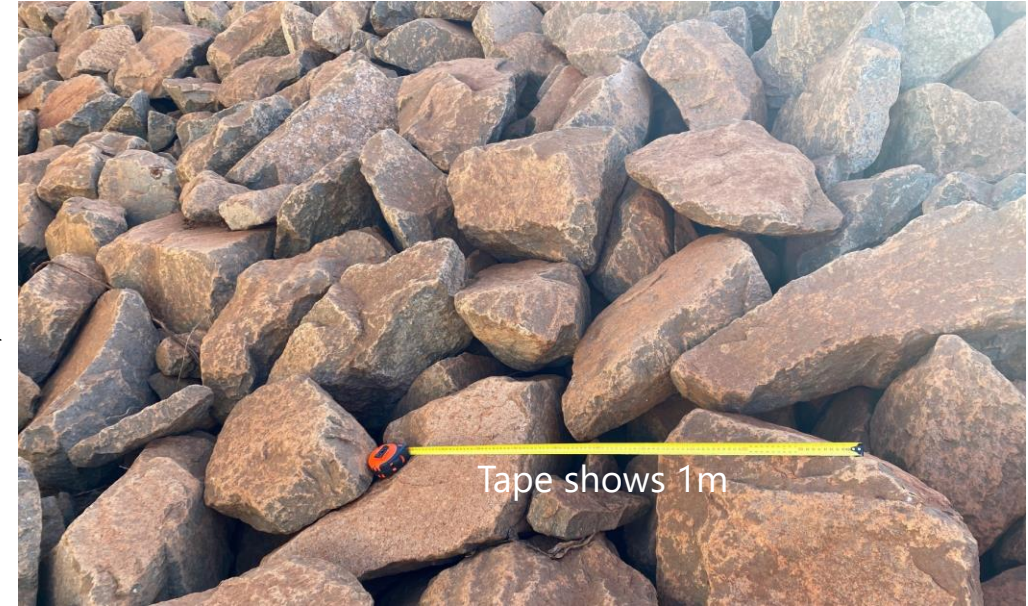
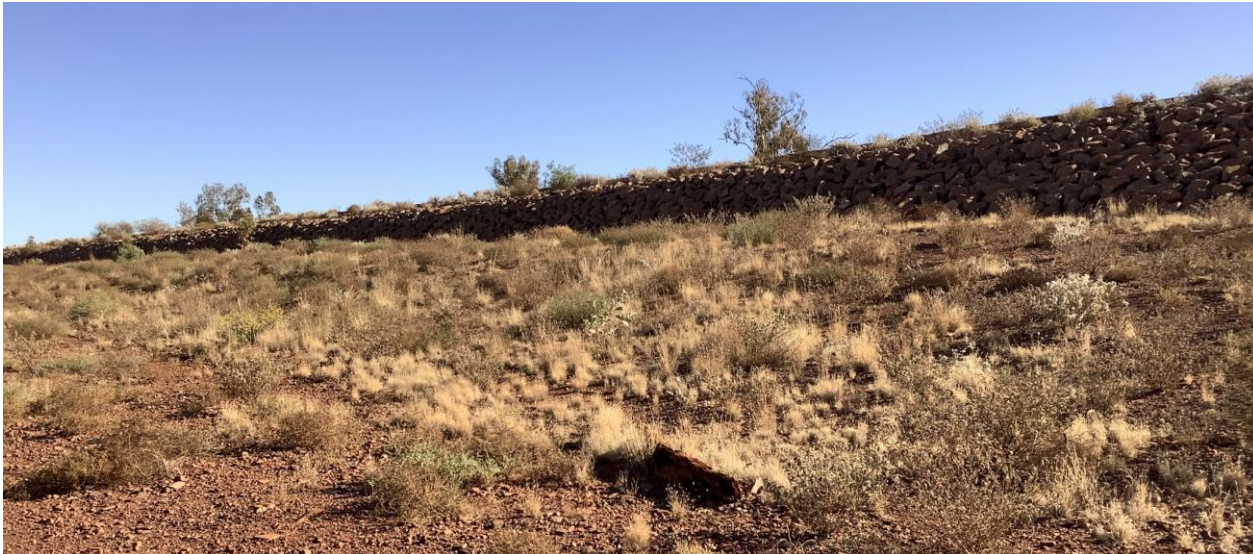
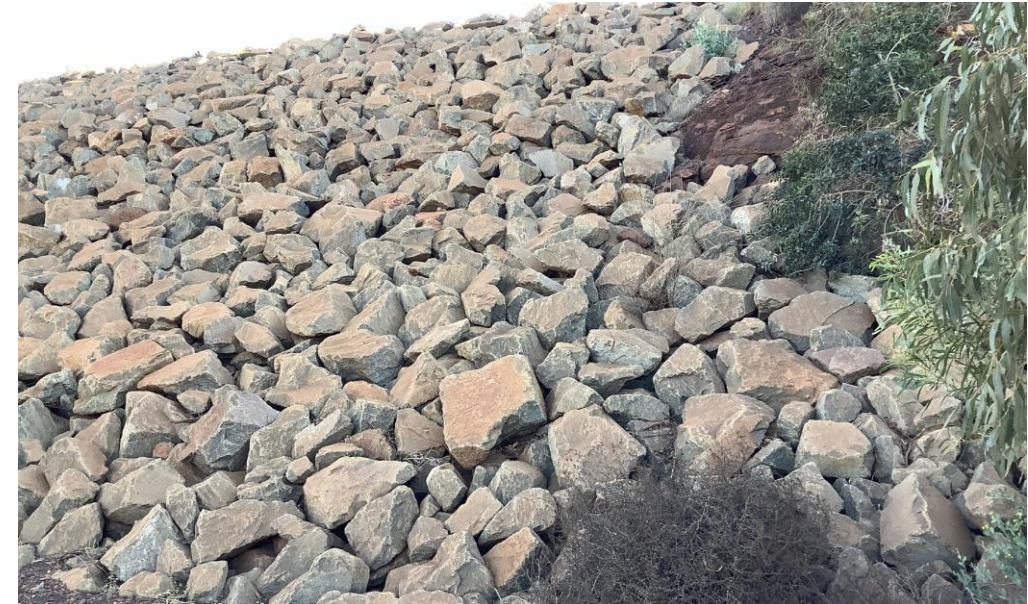
E4 Diversion Bund 3 – Day 3

- Rock appears to be 1/4 Tonne Class as per design; however, 3 m deep toe appears to be absent
- E4 Bund 2 sits upon a raised, constructed floodplain, and it is unlikely that the rock armour would extend far below the surface as it was designed for operations only. Closure designs would have the rock extending down below the maximum depth of scour in the main channel to protect from lateral migration.

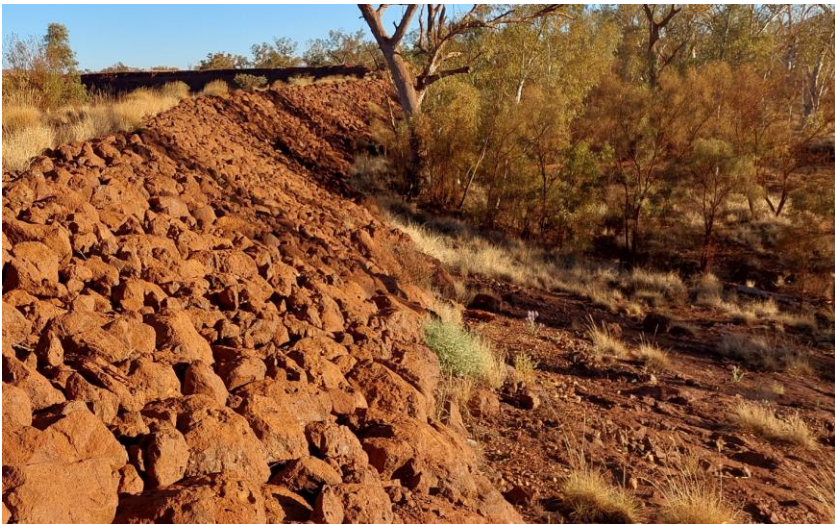
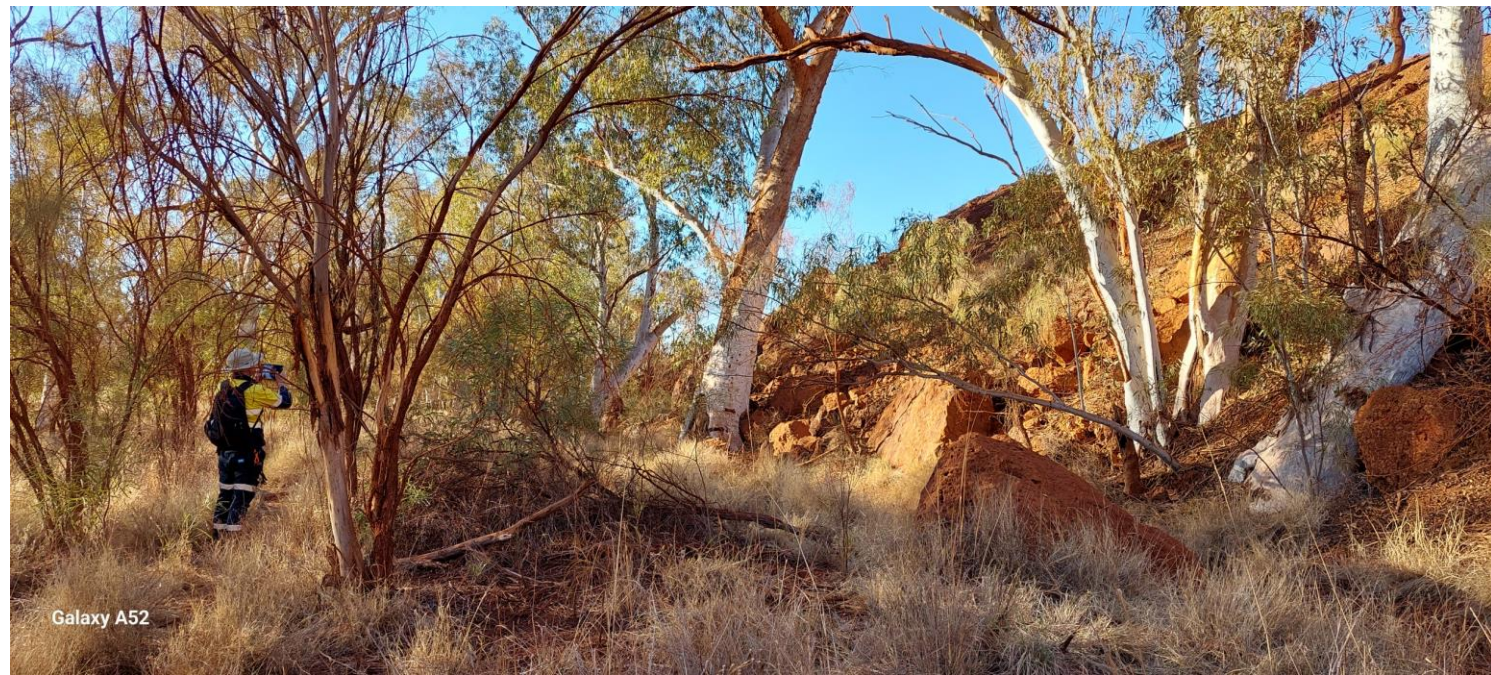
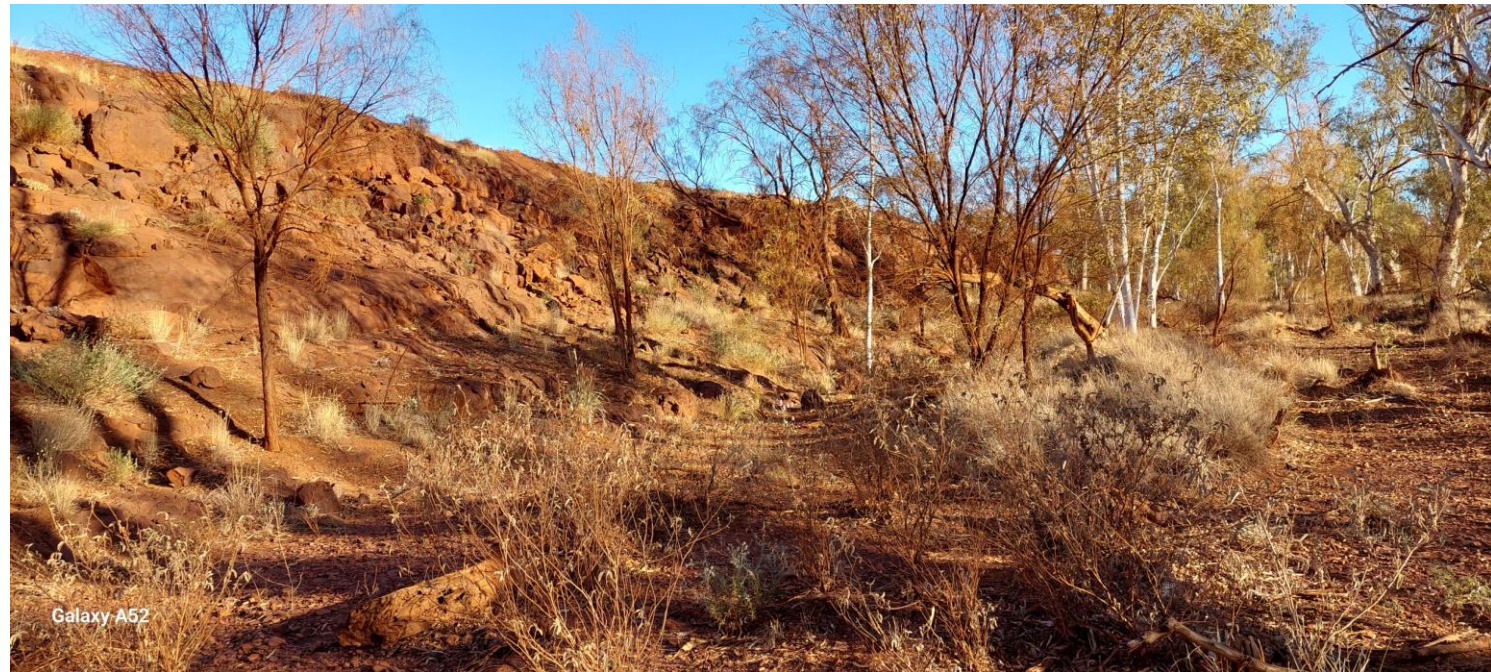
E7 Land bridge – Day 3

- Remnant CID against E7 appears low (modelling confirms this) and there is little room at the top to build higher on top.
- Large trees growing right at the base of CID, would require a lot of vegetation to be cleared if building out into the creek
- Existing bund at south of E7 CID wall may need upgrading (level and rock size)
- Buttressing of pit, recommended by trade off study, is still considered the best option.
