*Appendix E*  
*Rehabilitation Benchmarking Study*

**REHABILITATION BENCHMARKING STUDY**  
**Prepared for Gunson Resources Limited**  
**by URS Australia Pty Ltd**

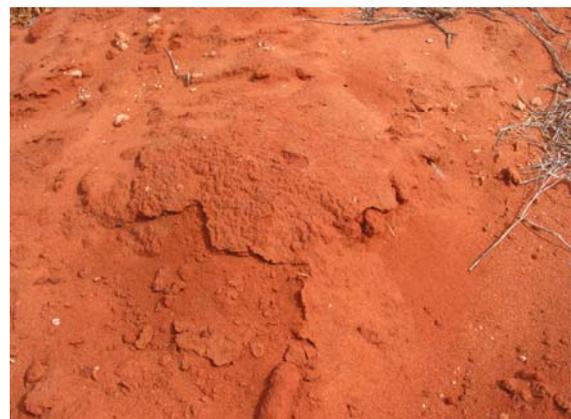
There was no evidence of wind erosion at the site. Much of the soils on the test pit site had formed a weak surface crust (n = 37, 41%; Plate 4, Diagram 2). A further 30% (n = 27) of the area had formed a crust that was located under a thin layer (2-10mm) of mobile sand. A total of 11% (n = 10) of the area had not formed a crust, with the remaining area being covered by brush (dead vegetation).

**Plate 4.** Crust formed on the sand surface.

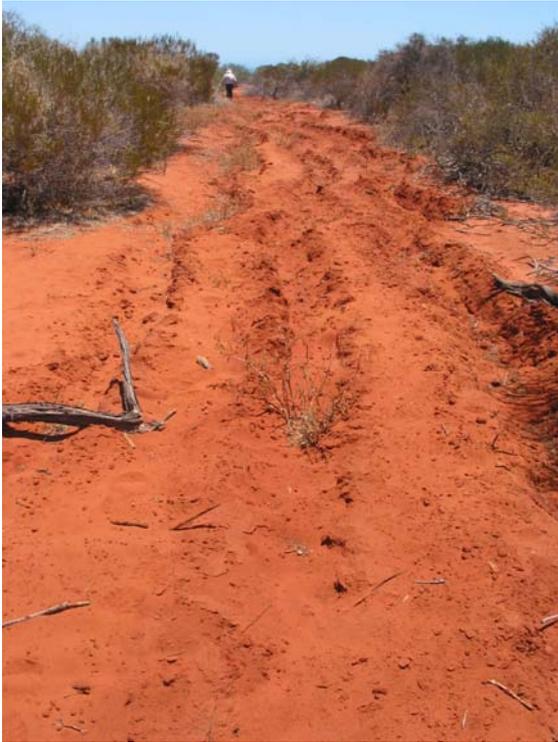
The soil was found to have formed a thin crust in places, although large areas of soil retained a thick crust (approximately 20cm), which was likely to have been caused by previous compaction. No vegetation was found growing on these compacted areas.

**Plate 1.** Peron road rehabilitation site showing the low vegetation cover and ripped soil.

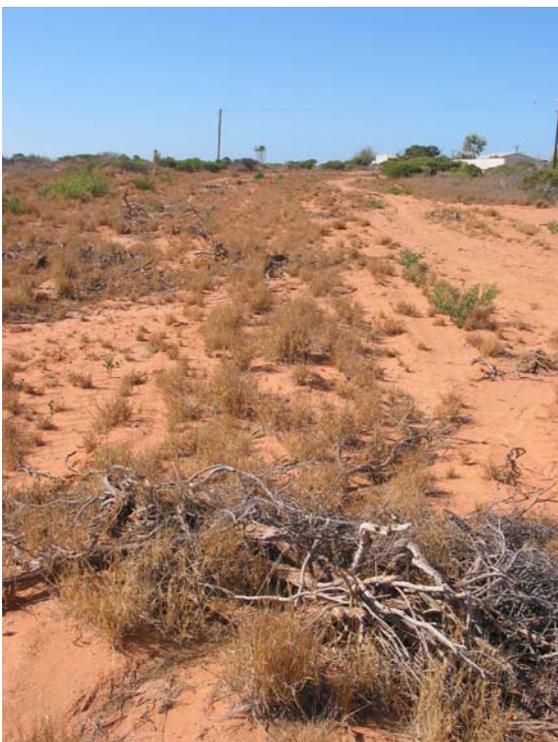
The Denham road site had a vegetative cover of 20% (Plate 2). Approximately 3% of this cover was provided by brush (dead vegetation).

**Plate 2.** Denham road site showing rehabilitation over a 12 month period.

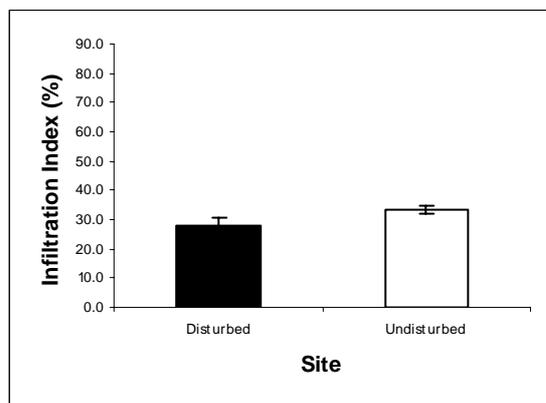
The undisturbed sites showed greater infiltration indices than the disturbed sites (Diagram 2). Therefore, the undisturbed sites showed a greater ability to infiltrate water, and therefore decrease water, soil and nutrient loss from the local area, than the disturbed sites.

**Diagram 2.** Zone Infiltration comparison for disturbed refuse tip site and undisturbed analogue site.

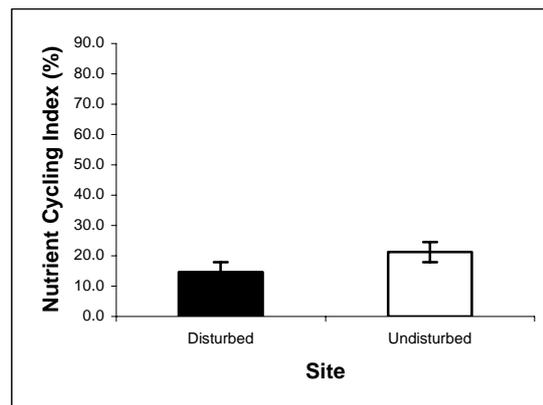
The potential for nutrient cycling differed between sites (Diagram 4), with the undisturbed sites showing a greater ability to return organic matter and nutrients to the soil.

**Diagram 4.** Zone Nutrients comparison for disturbed refuse tip site and undisturbed analogue site.

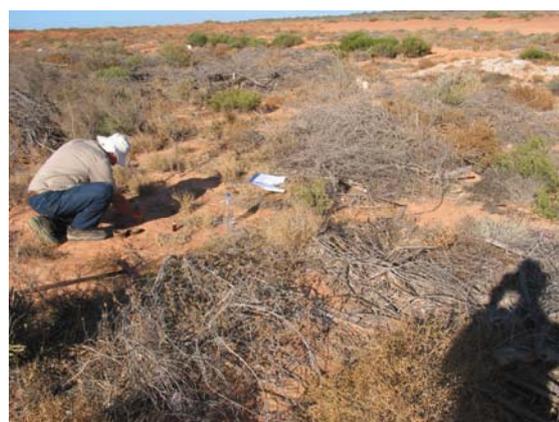
There was also a difference in species diversity between disturbed sites ( $10 \pm 0.7$ ) and undisturbed sites ( $18 \pm 1.2$ ). In addition, the dominant species between sites differed. The disturbed area had a high prevalence of dead vegetative cover (34%) due to the brushing programme implemented by the Shark Bay Shire. *Salsola kali* provided the highest average amount of foliage cover (4%). A range of weed species also inhabited this area, including species such as *Cenchrus ciliaris* (buffel grass), *Rumex vesicarius* (ruby dock), and *Mesembryanthemum crystallinum* (iceplant). (Plate 2).

**Plate 2.** The disturbed refuse tip site showing the brushing laid by the Shark Bay Shire and the subsequent vegetation regrowth.

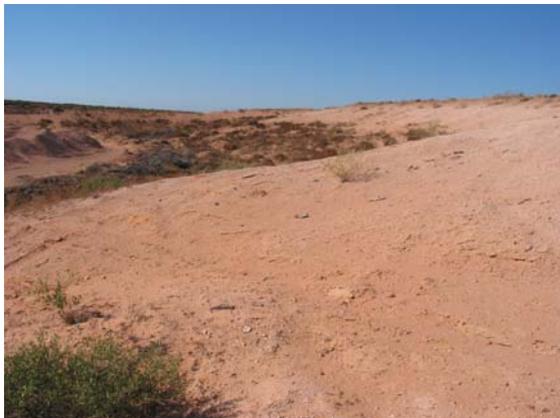
Not all the rehabilitation area had been provided with brush (dead vegetation). One area of note was a section of approximately 50 metres on top of one battered wall on the southern side of the refuse tip site (Plate 4). This area is particularly open to wind and had the steepest slope of approximately 30°. Where brushing had been provided no evidence of soil erosion was found and the vegetation was of a comparative growth to the rest of the rehabilitation site. However, where no brush had been laid there was evidence of slight wind erosion and a noticeable lack of vegetation growth.

**Plate 4.** Refuse tip site with battered wall showing signs of slight wind erosion and lack of vegetation establishment.

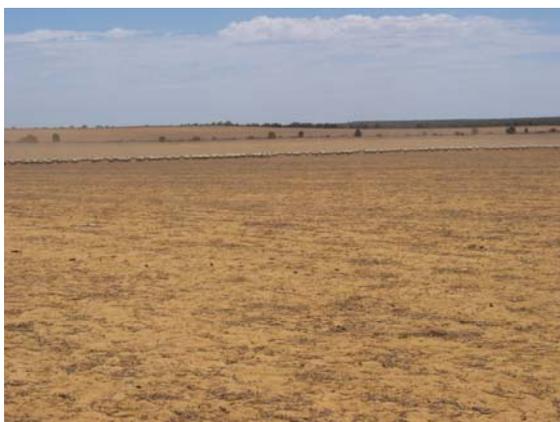
**Plate 4.** Cropped and grazed area on Eurardy Station showing soil surface disturbance that regularly occurs due to the presence of sheep (centre picture).

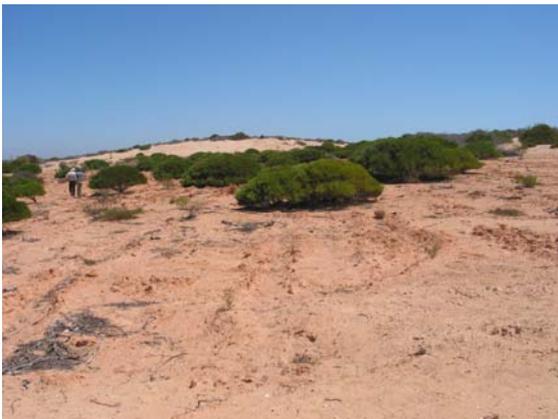
**Plate 2.** Useless Loop rehabilitation site showing the low vegetation cover and dominance of *A. ligulata*.
