FORTESCUE METALS GROUP LIMITED  
**PILBARA IRON ORE AND INFRASTRUCTURE PROJECT**  
**DESKTOP STUDY AND SITE VISIT**

P6514.03-AB Rev 0  
25 June 2004

**RE: PILBARA IRON ORE AND INFRASTRUCTURE PROJECT  
GEOTECHNICAL DESKTOP STUDY AND SITE VISITS**

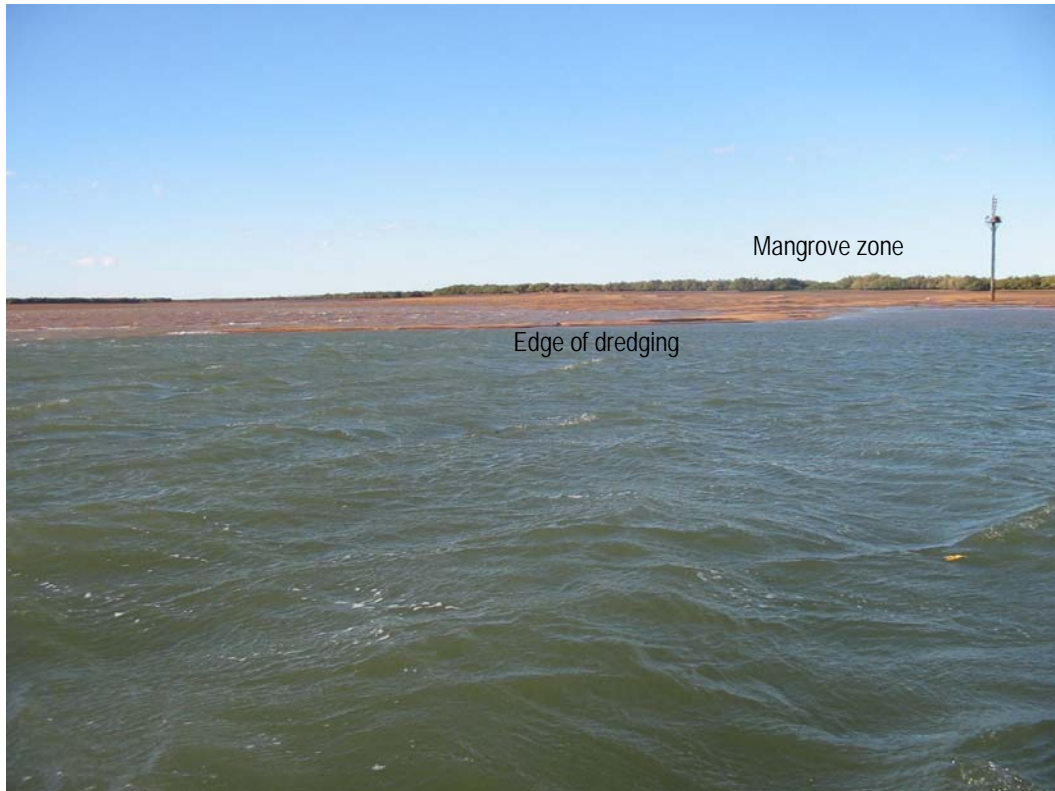
Photograph 1 – View of Anderson Point (eastern side).

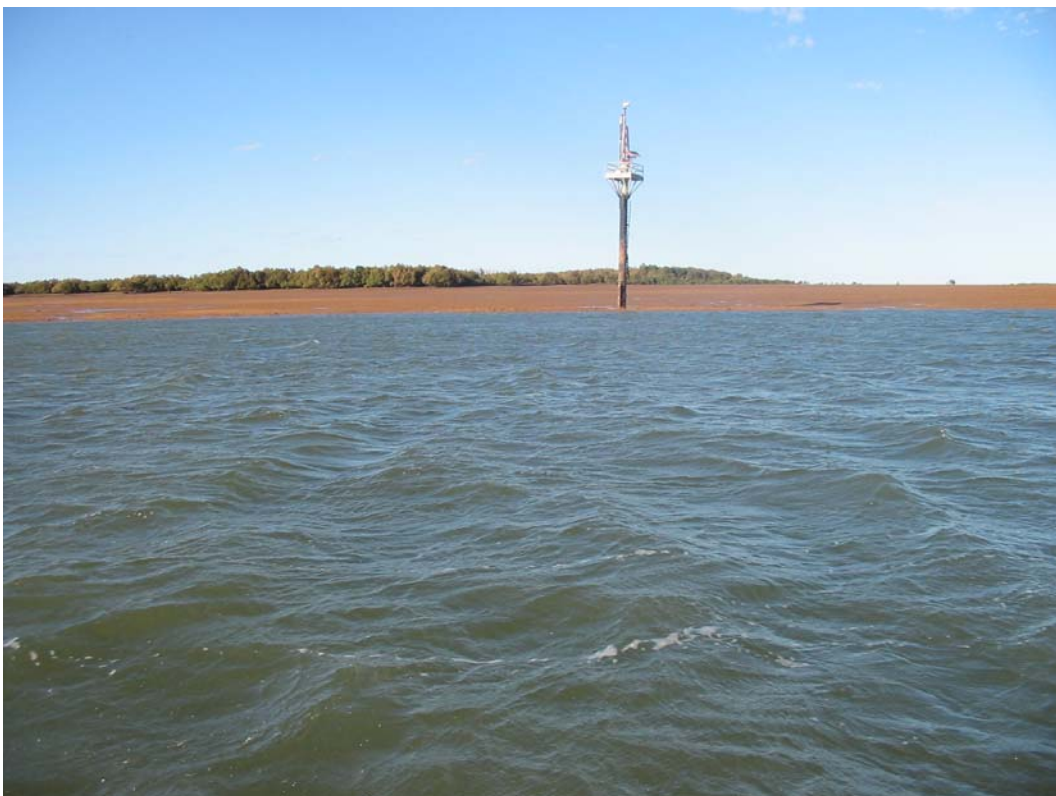
Photograph 2 – View of Anderson Point (western side).

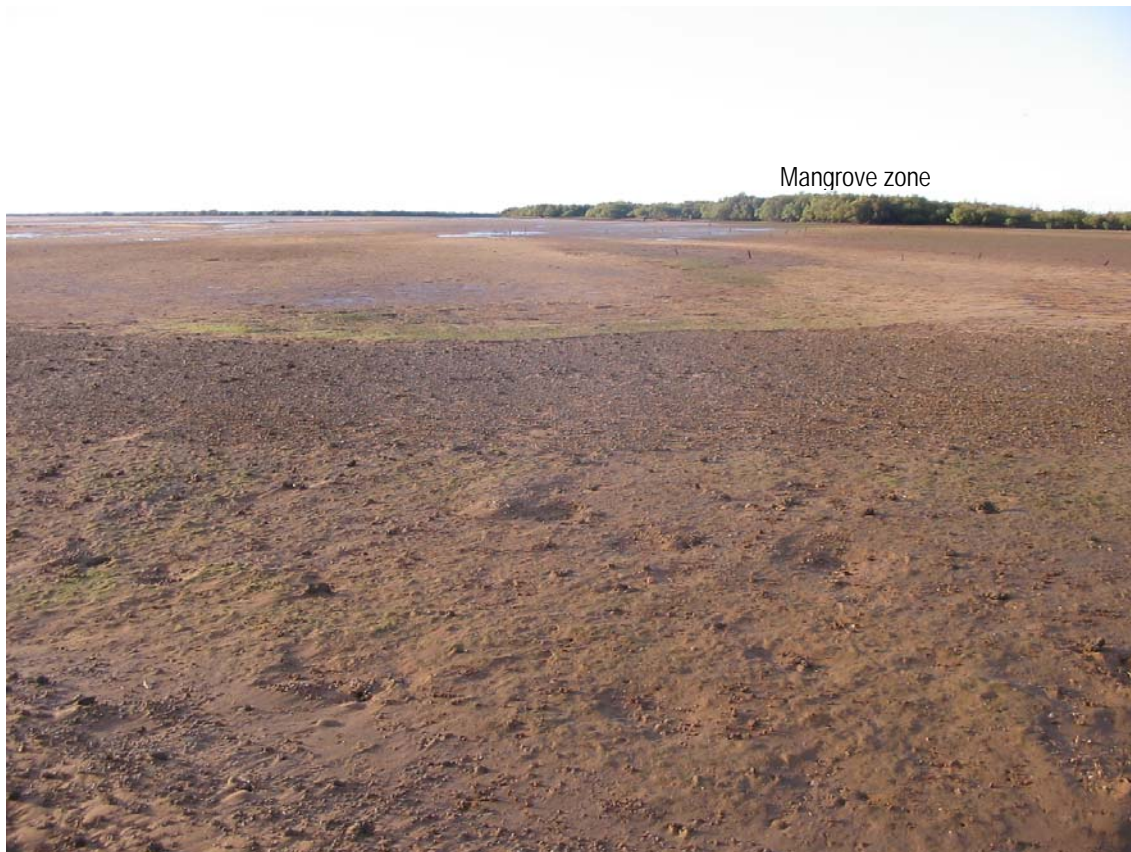
Mangrove zone

Photograph 3 – Typical surface conditions at Anderson Point (low tide).

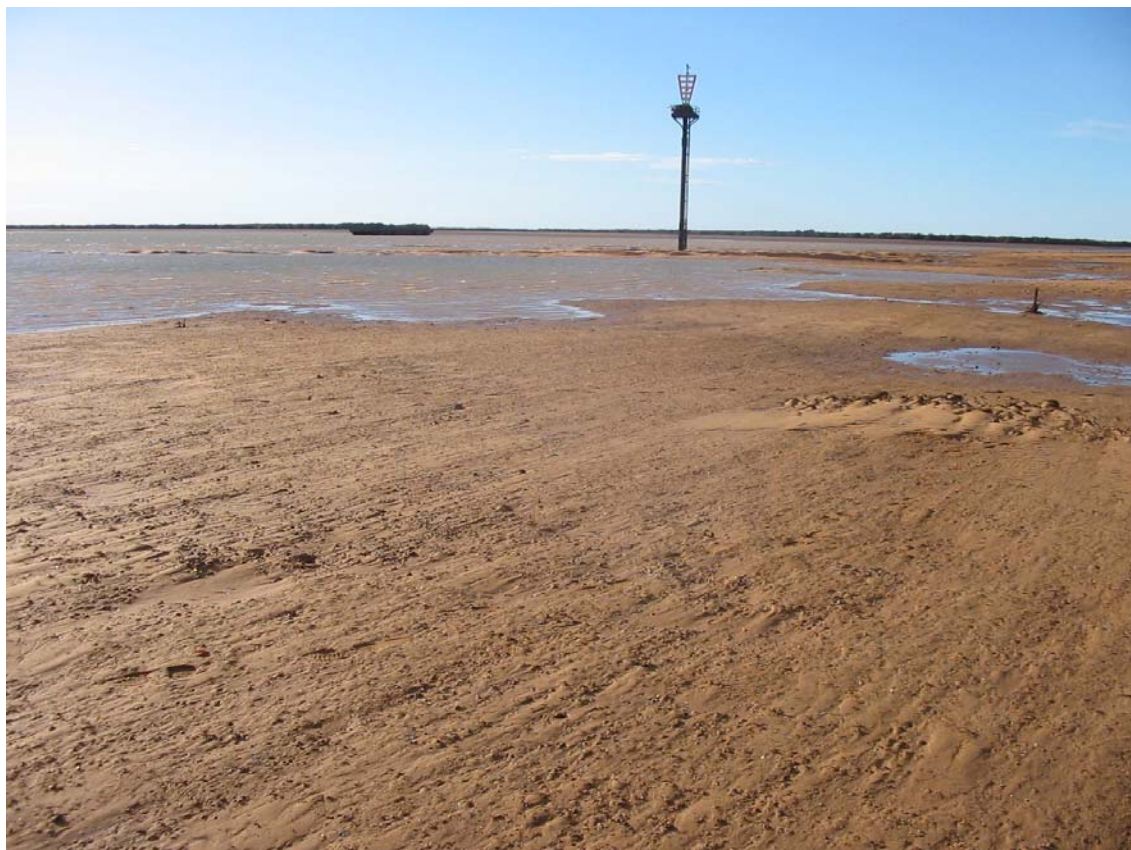
Photograph 4 – Typical view of waters edge at Anderson Point (low tide).

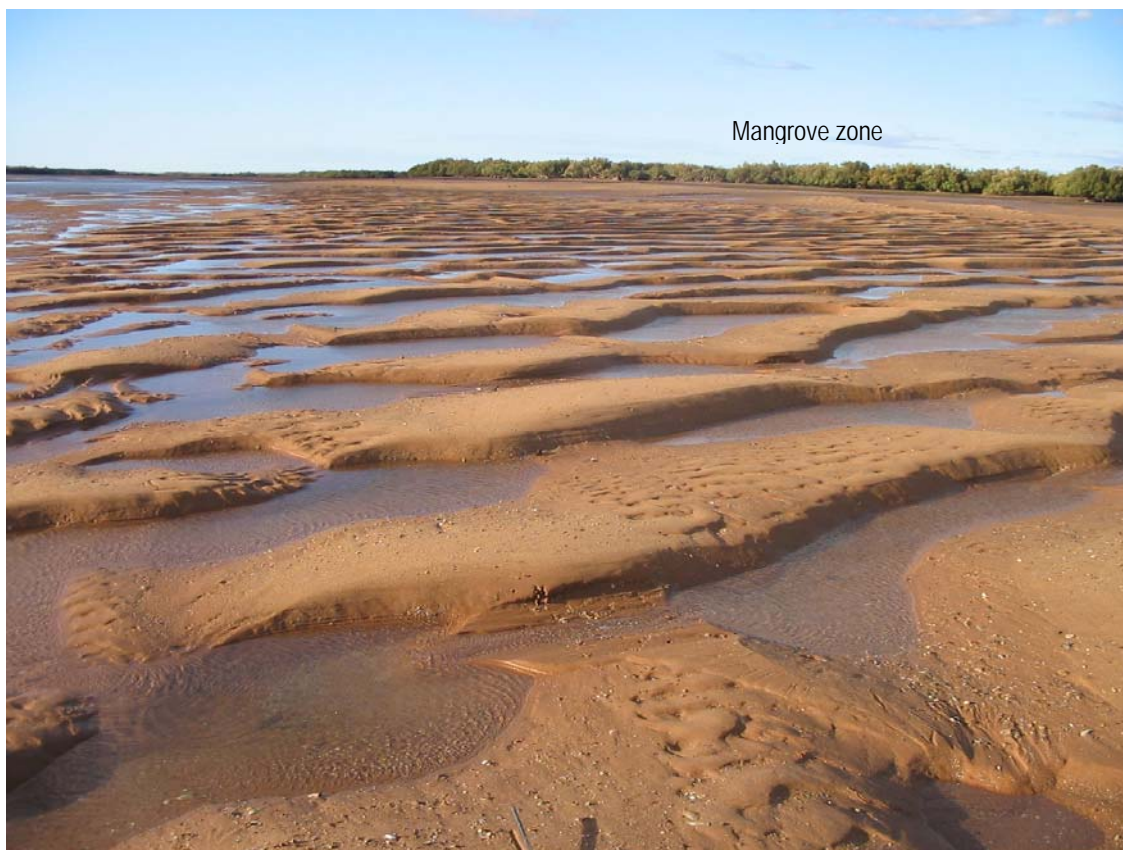
- Surface conditions in the centre of Area 1 were undulating, as shown on Photograph 5, and at low tide the eastern side of Area 1 was inundated with nominally 0.5m of water and was generally inaccessible by boat or by foot.
- Access was only available during low tide, as this area was inundated with several metres of water at high tide. Trafficability was generally good during low tide with occasional muddy areas, however access was poor as the tide rose and the surficial soils became saturated. This tends to confirm the visual assessment that the surficial soils are predominantly sandy.

Photograph 5 – Undulating surface caused by tidal movements and currents in the South West and South East Creeks.

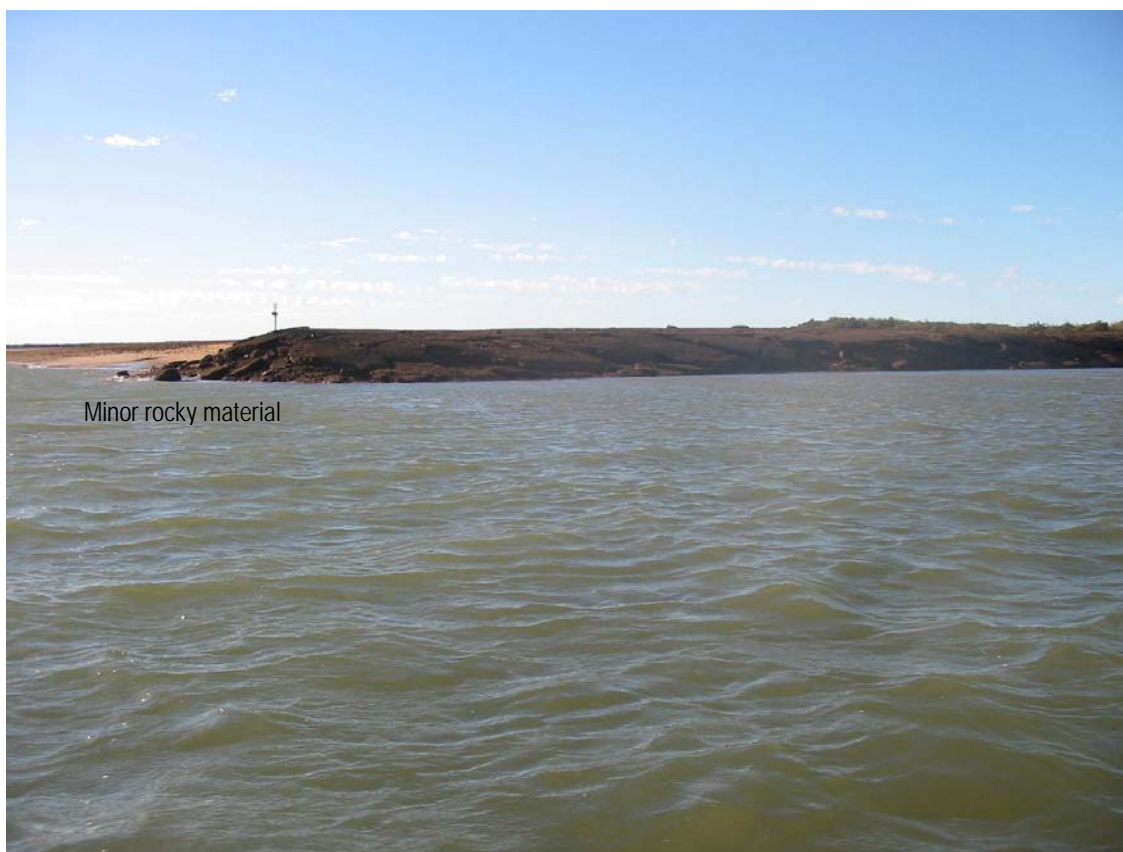
Photograph 6 – Elevated ridge adjoining the South West Creek.

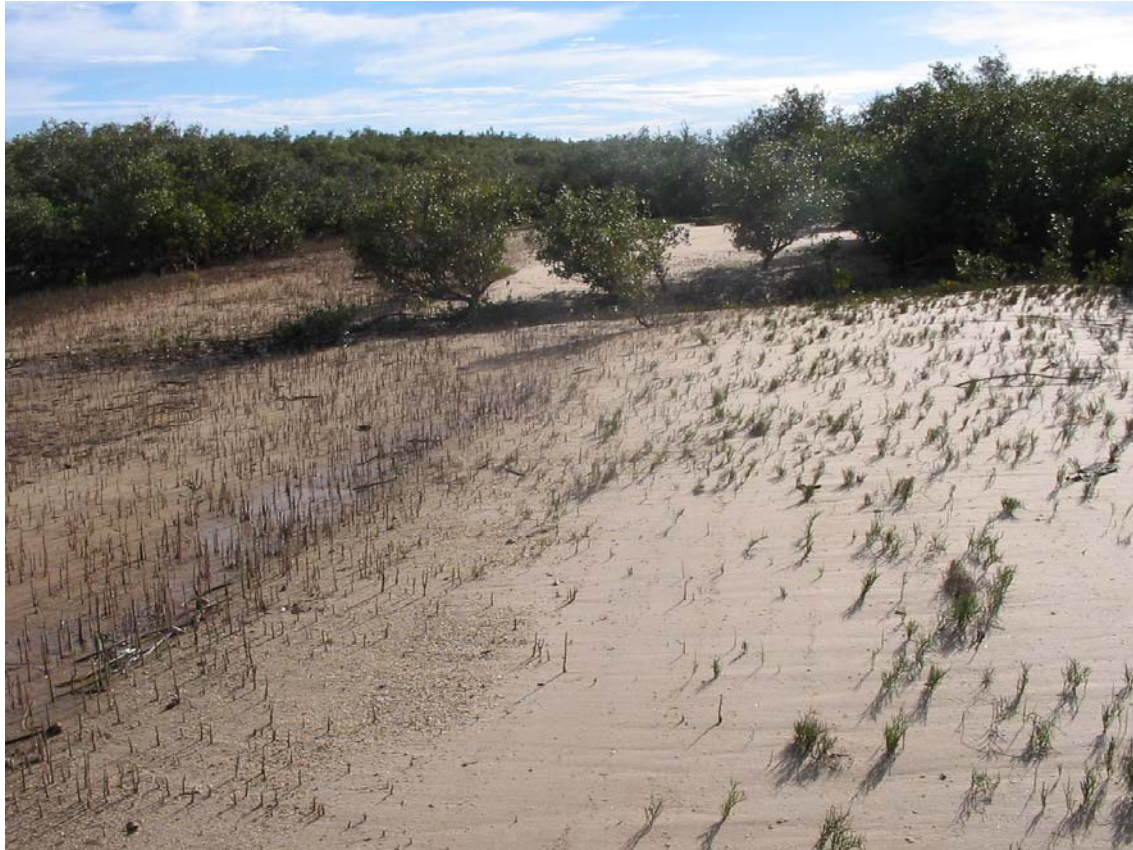
Area 2 is located in the area immediately south of Anderson Point where a bunded area is to be constructed to contain dredged spoil. The area was surrounded by a fringe of thick Mangrove vegetation, as shown in Photographs 7 and 8, and surface conditions in and around the Mangrove vegetation generally comprised Mangrove mud, particularly in the north-west corner of Area 2. The centremost parts of Area 2 were devoid of Mangrove trees and surface conditions generally comprised clay/clayey sands and thick grasses, however some elevated shelly / sandy banks were also present and are denoted by the whiter zones shown on Figure 1.

Photograph 7 – Typical view of the Mangrove fringes surrounding Area 2.

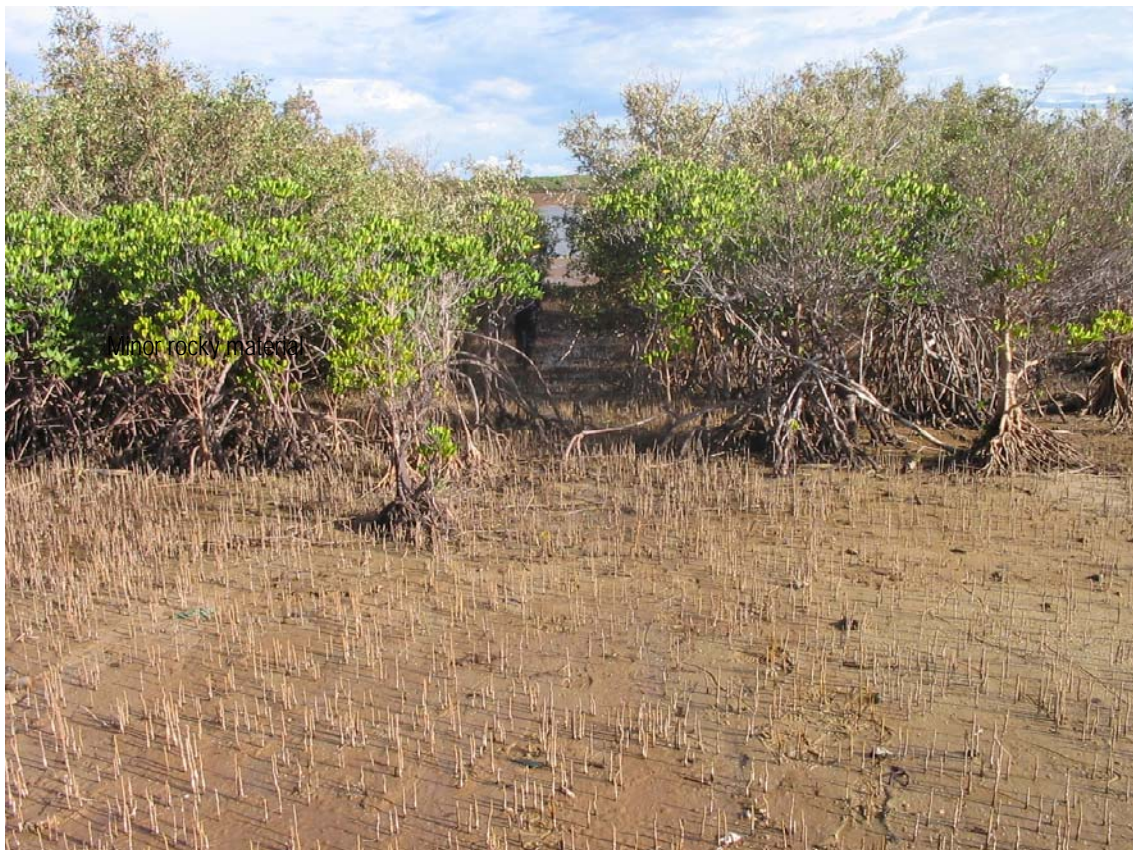
Minor rocky material

Photograph 8 – View of a narrow track through a relatively thin Mangrove zone.

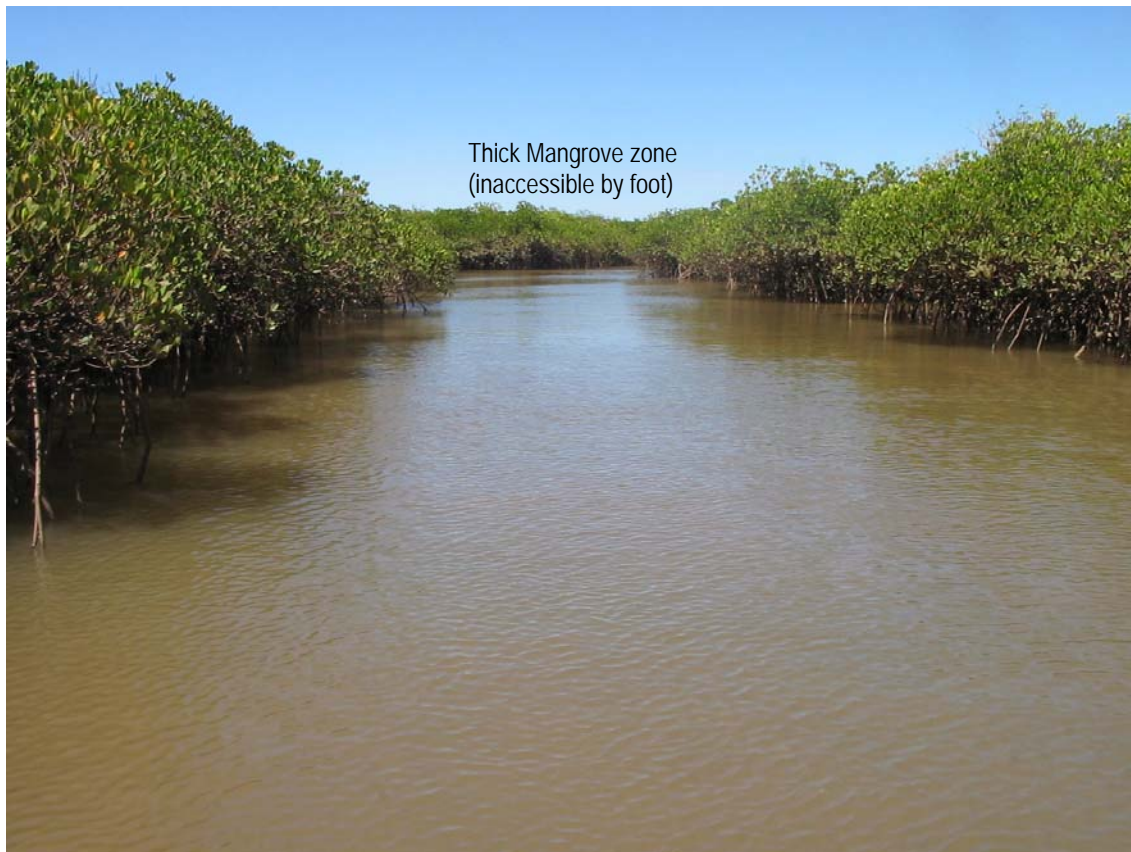
Thick Mangrove zone  
(inaccessible by foot)

Photograph 9 – View of the northern drainage system.

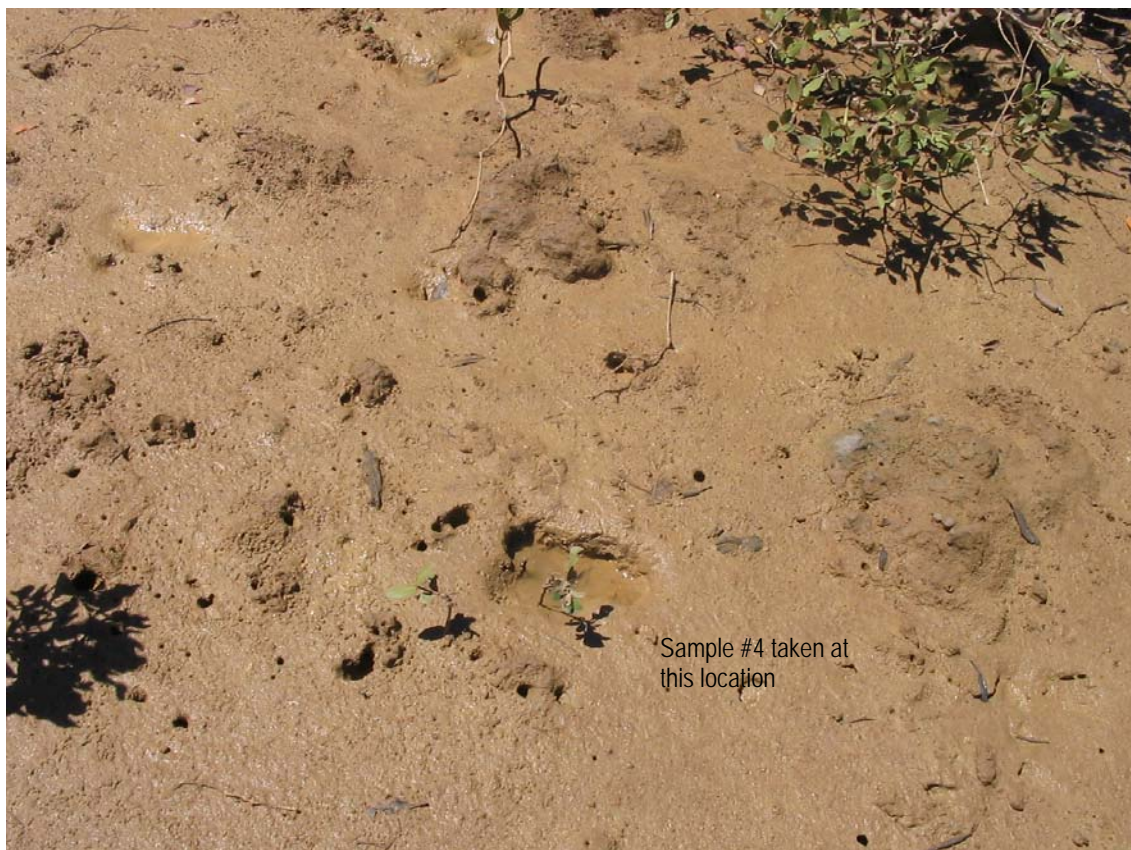
- Surface conditions in the southern parts of Area 3 generally comprised sands/clayey sands (Photograph 11), with soft clayey mud present at the (south) end of the northern drainage system (Photograph 10).

Sample #4 taken at  
this location

Photograph 10 – View of typical soft clayey muds in the Mangrove zone of Area 3.

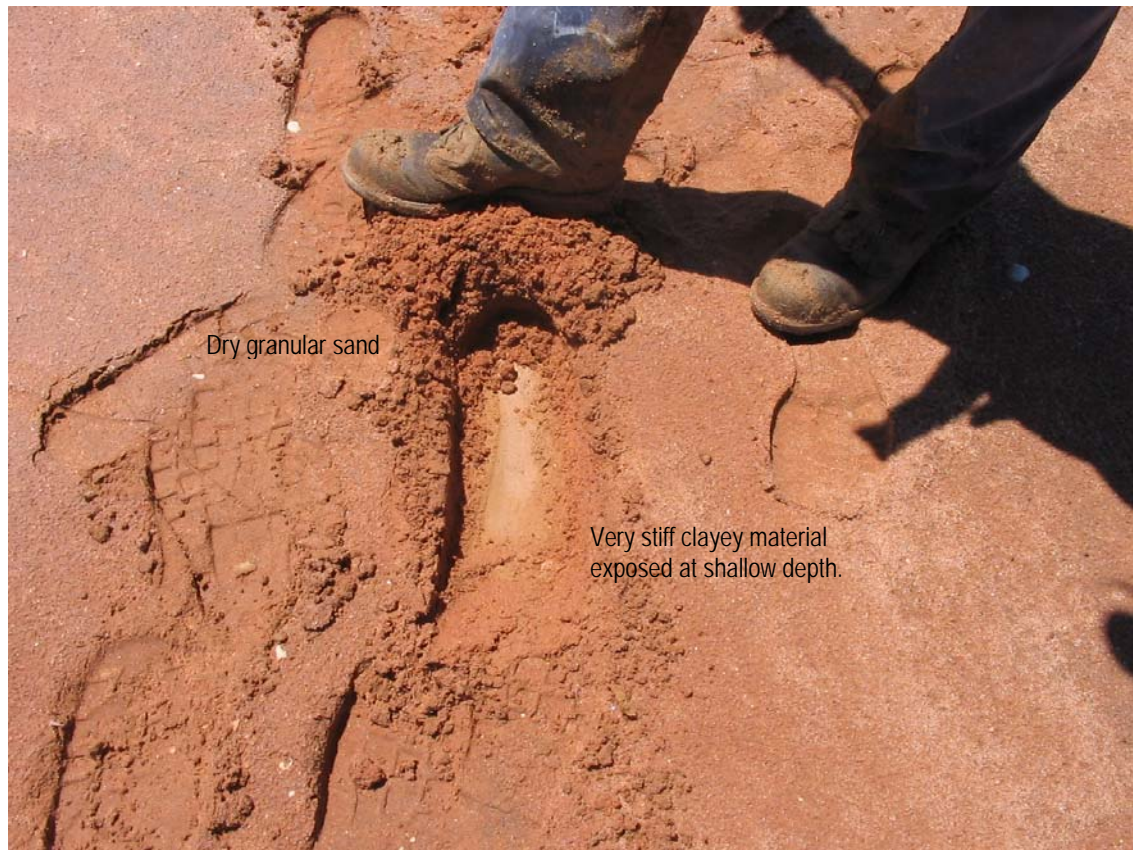
Photograph 11 – Typical view of shallow surficial sands / silty sands in Area 3.

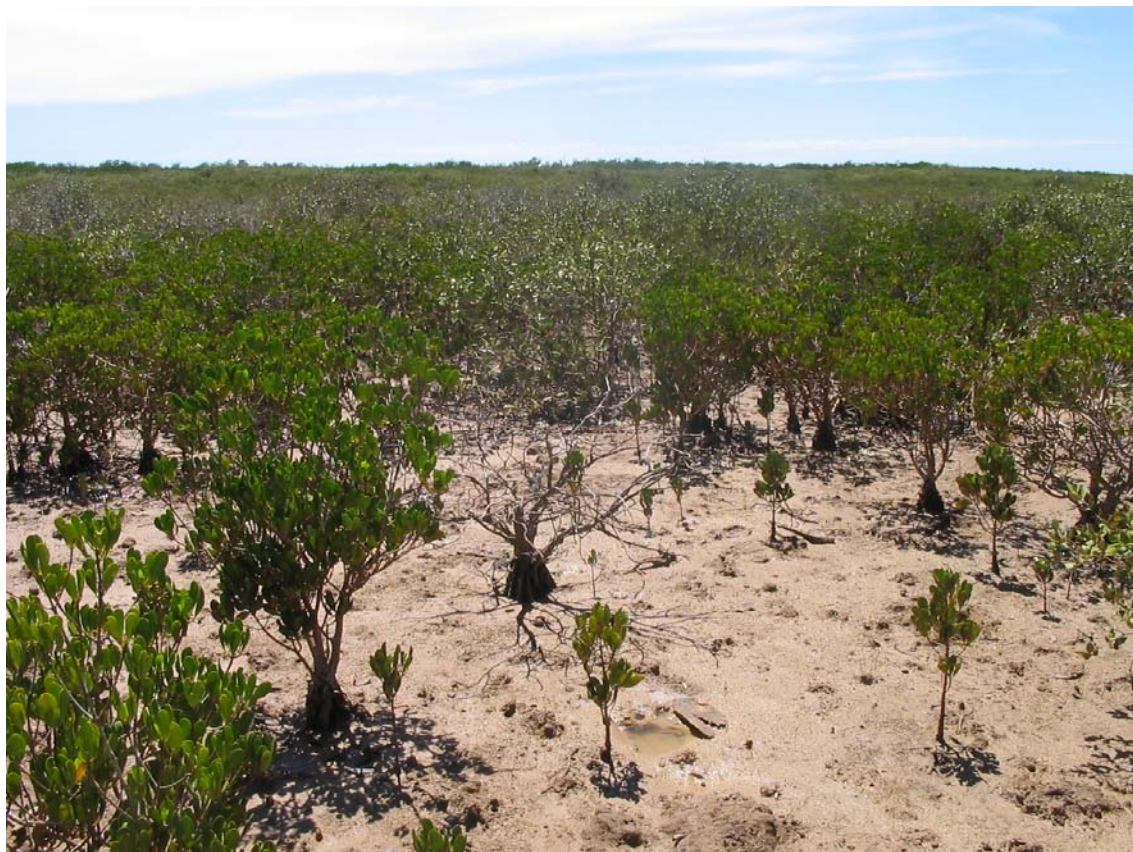
Photograph 12 – Low lying Mangrove areas in the north-west parts of Area 3.

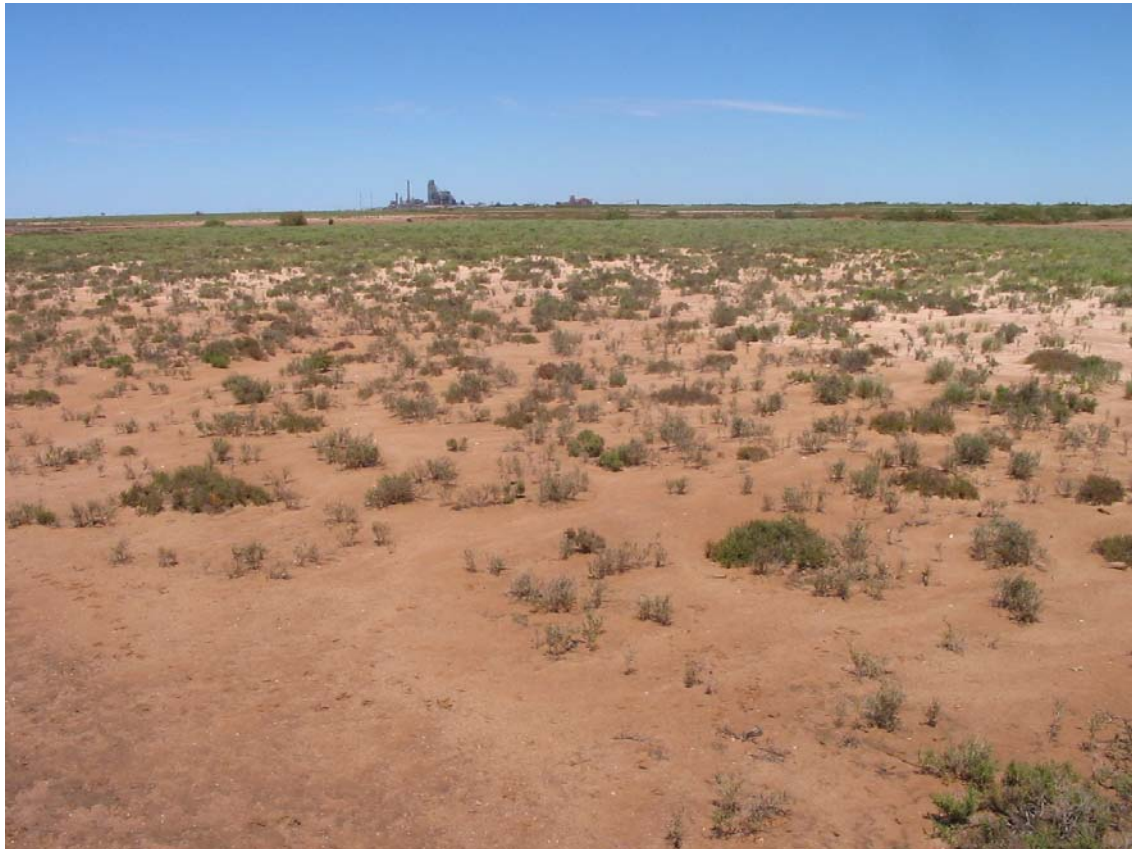
Photograph 13 – Typical view of surface cover in the south-west parts of Area 3.

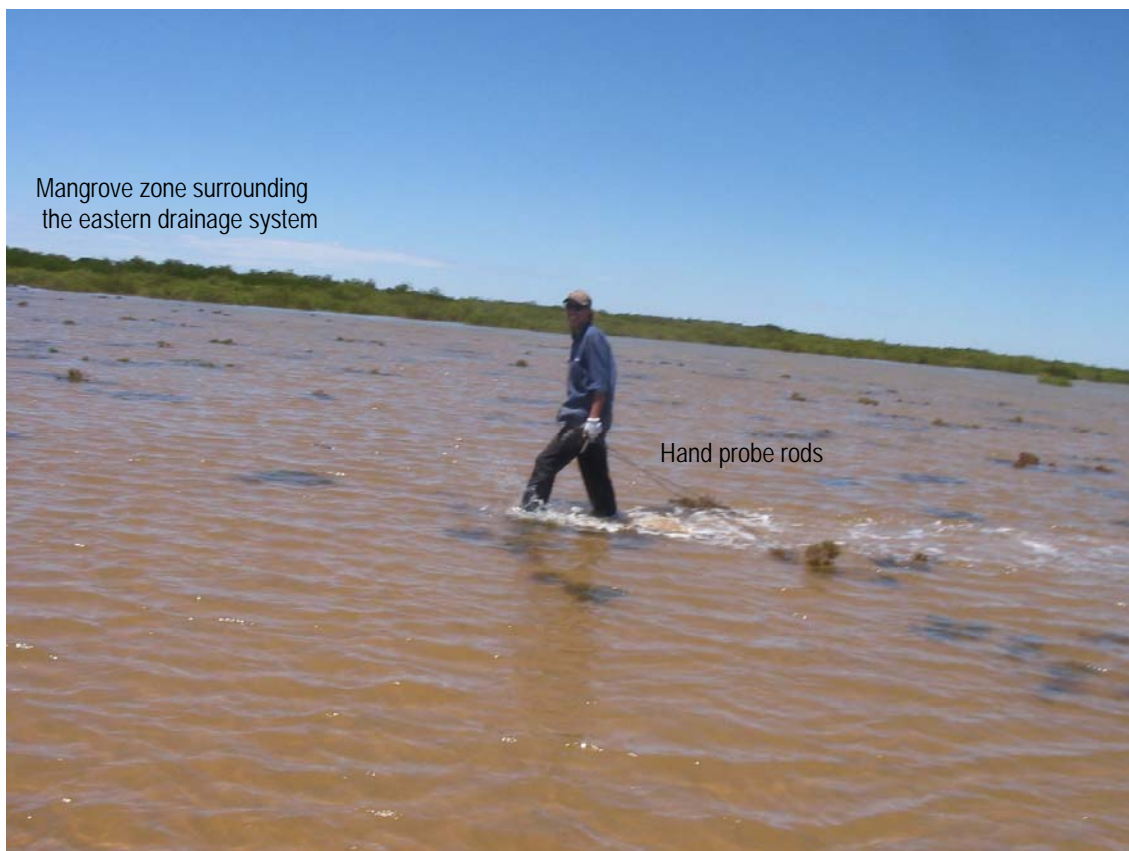
Photograph 14 – View of the southern parts of Area 3 during high tide.

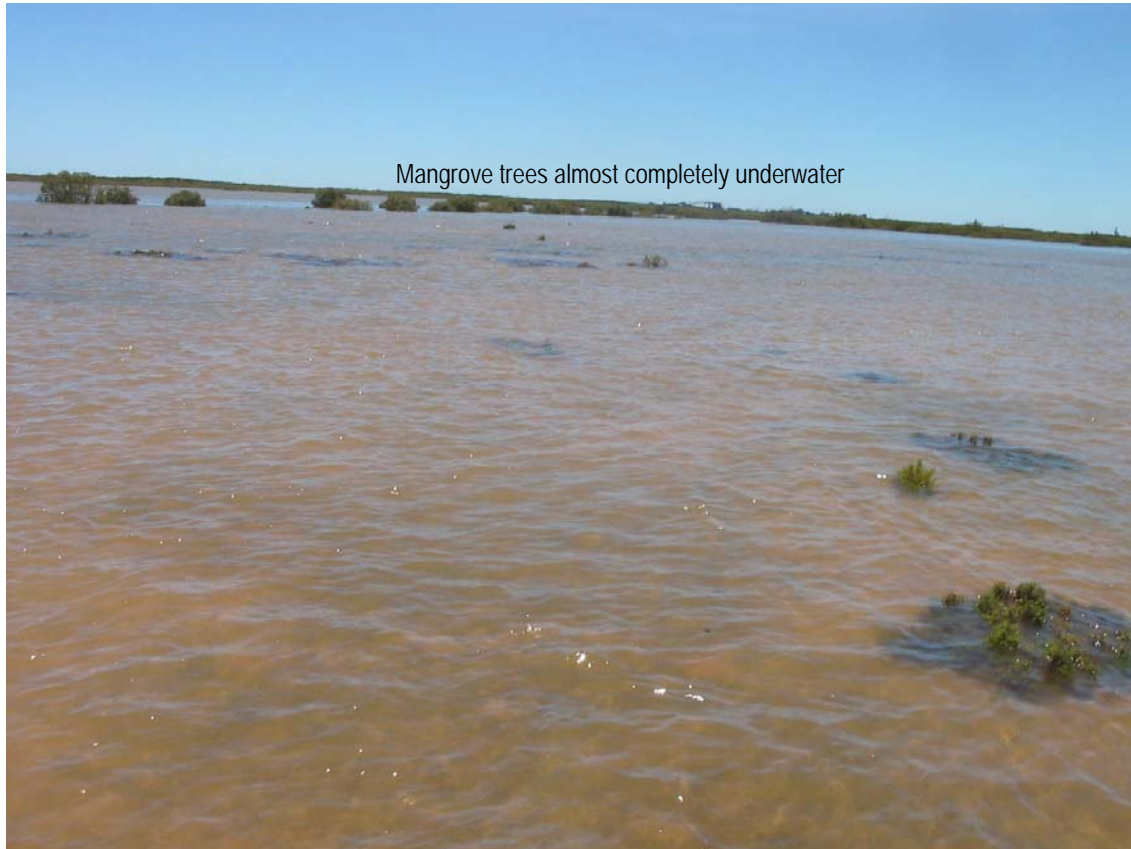
Photograph 15 – View of the central parts of Area 3 during high tide.
