EMPIRE OIL & GAS NL

MULLERING ONSHORE 3D SEISMIC SURVEY

REVIEW OF REGENERATION ON 1989 SEISMIC LINES

May 2007

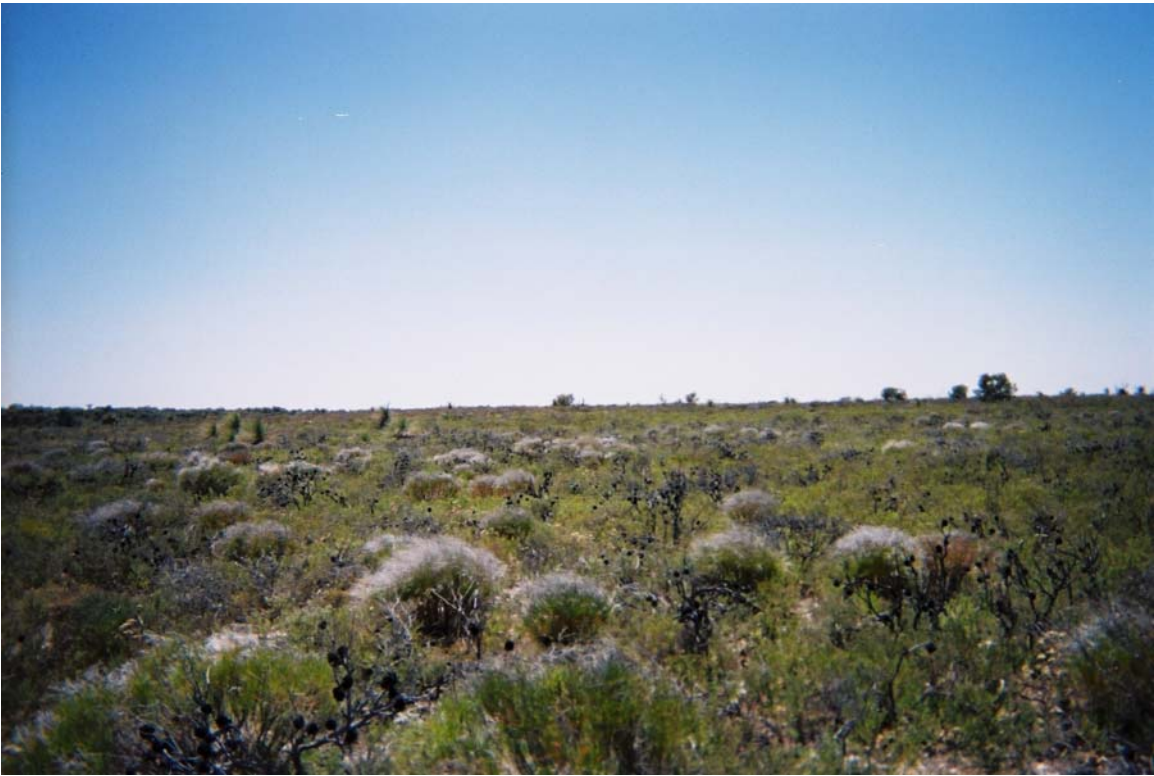
Photo 1: Community H1 (Seismic Line B89-439)

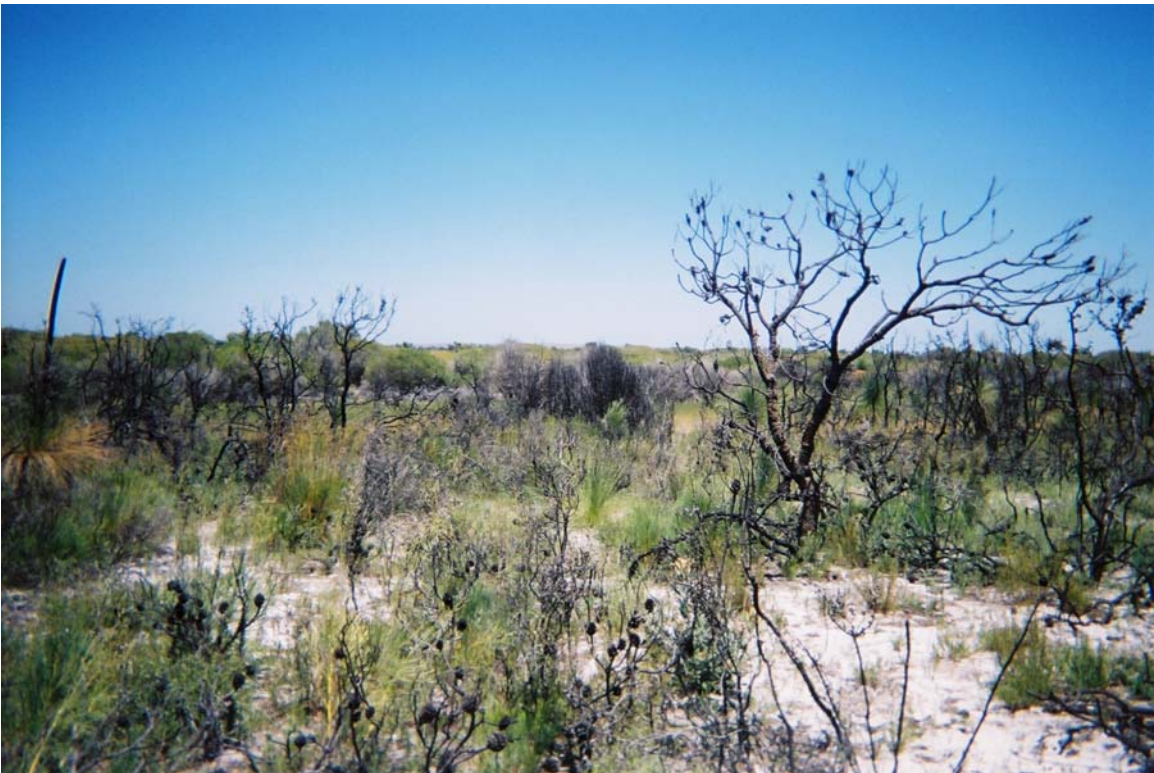
Photo 2: Community H1 (Seismic Line B89-441)

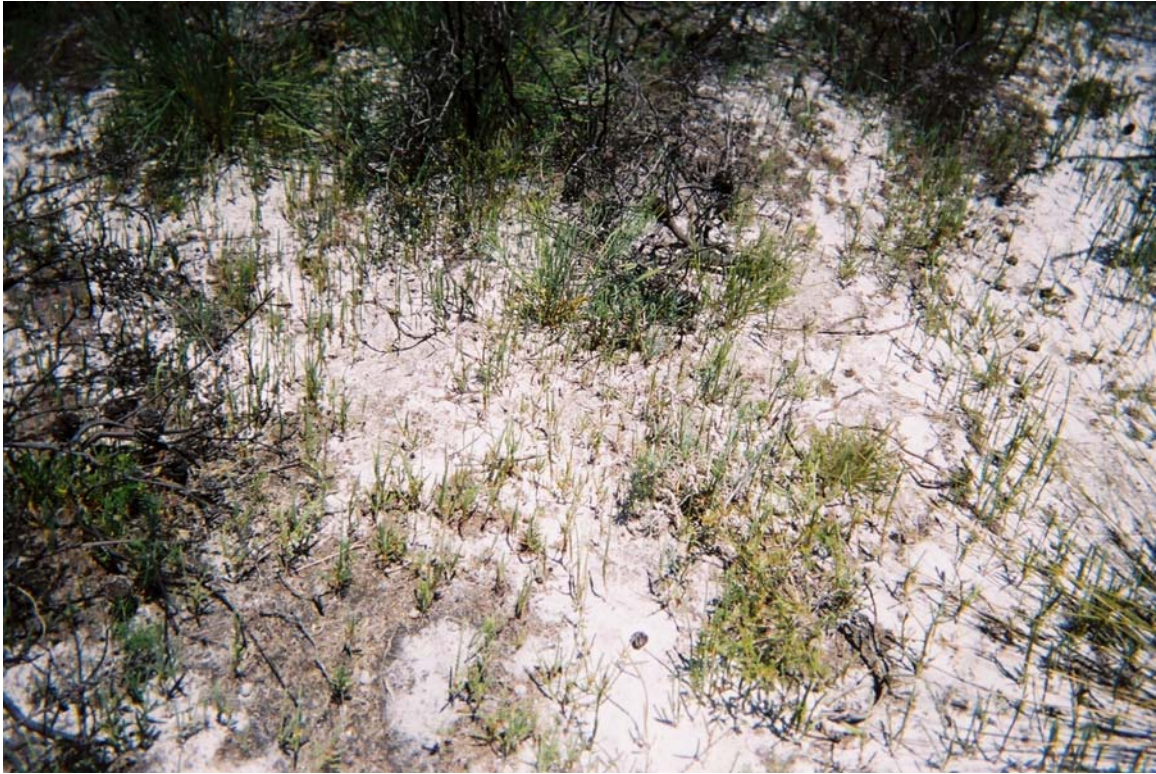
Photo 3: Community H1 germination on line (Seismic Line B89-441)

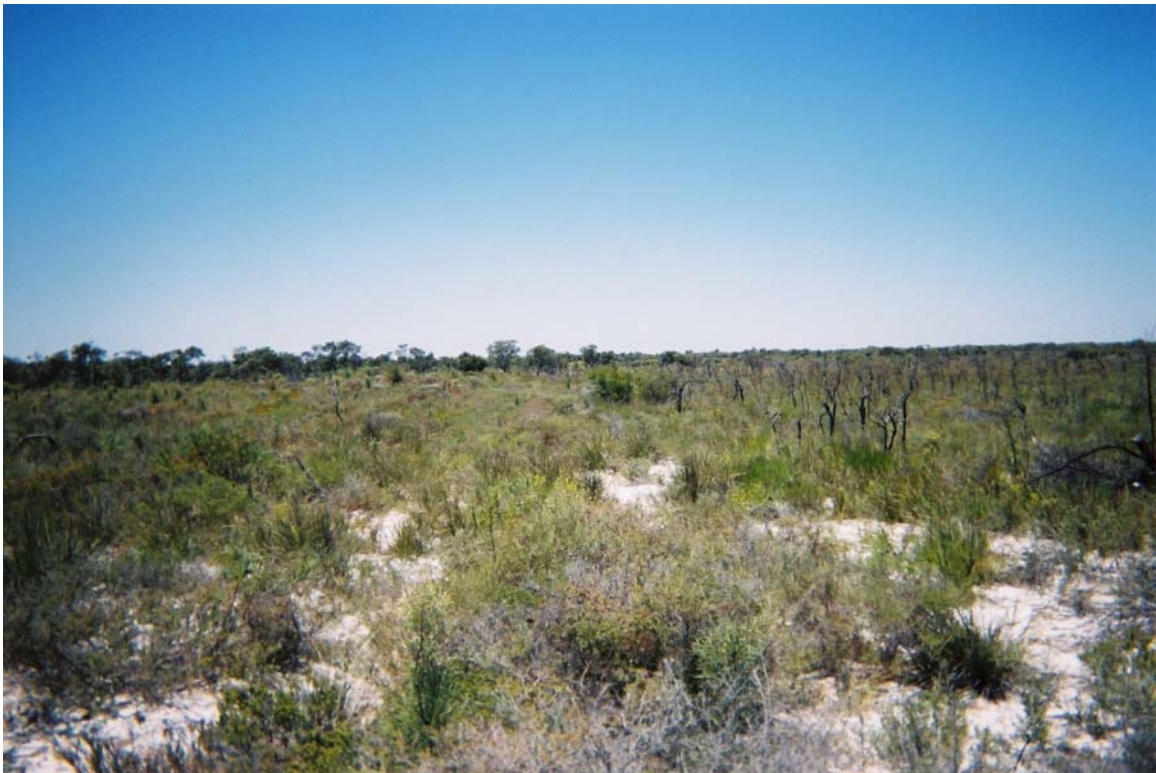
Photo 4: Community H1 (Seismic Line B89-438)

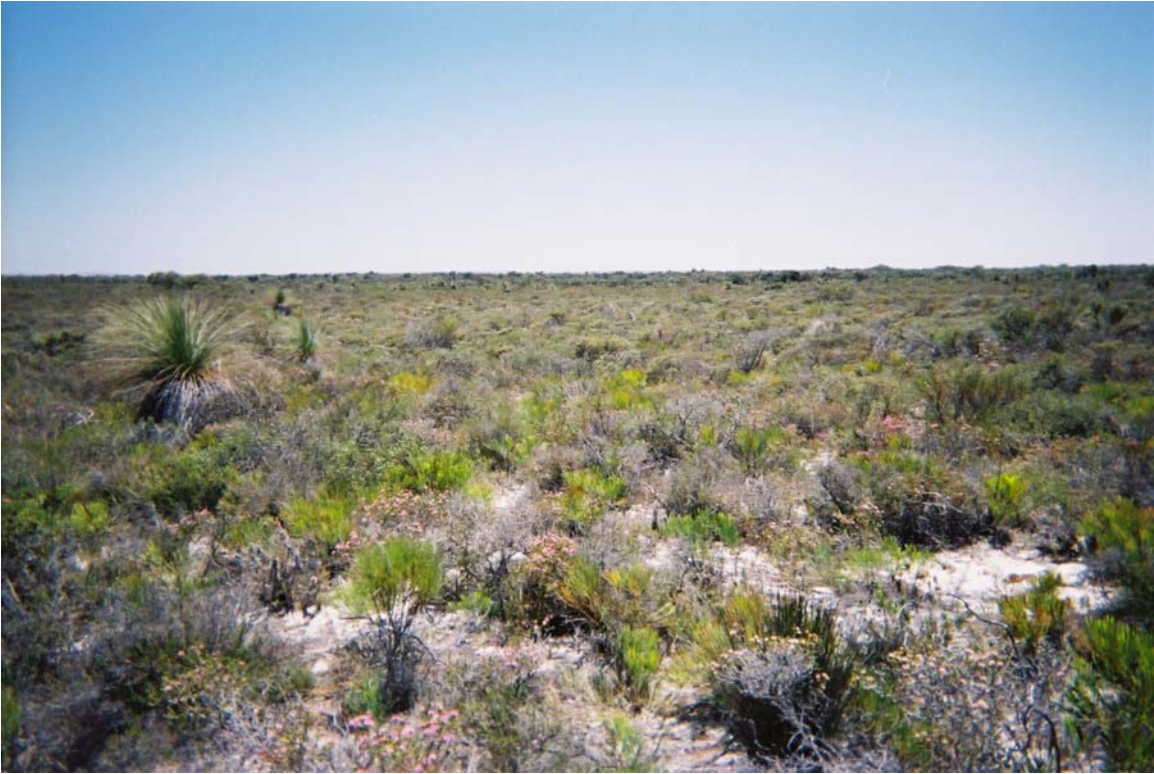
Photo 5: Community H3 (Seismic Line B89-440)

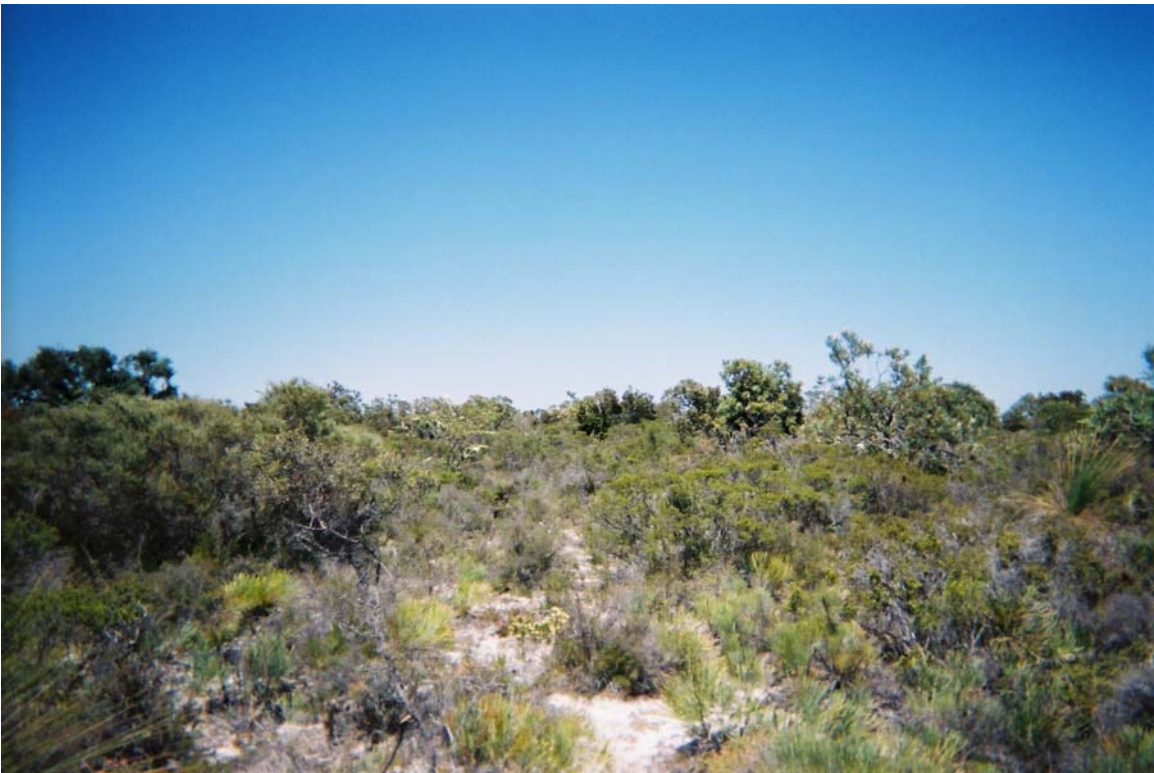
Photo 6: Community H3 (Seismic Line B89-440)

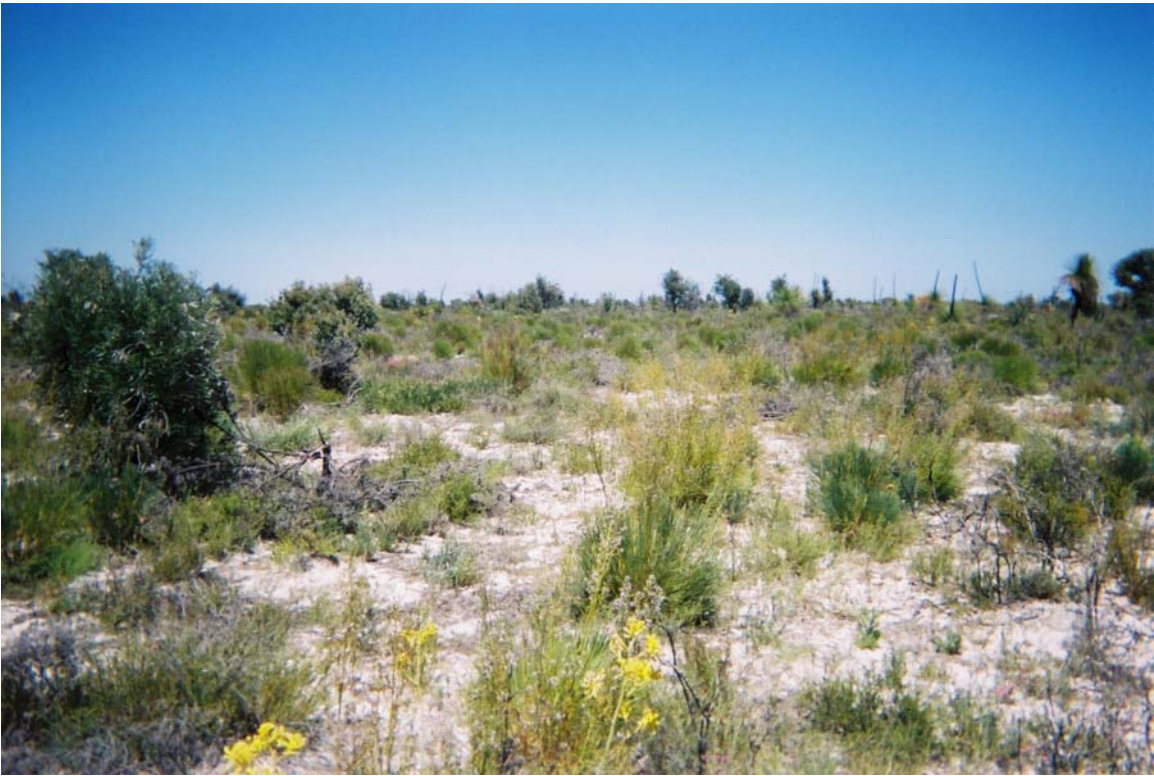
Photo 7: Community W3 (Seismic Line B89-104)

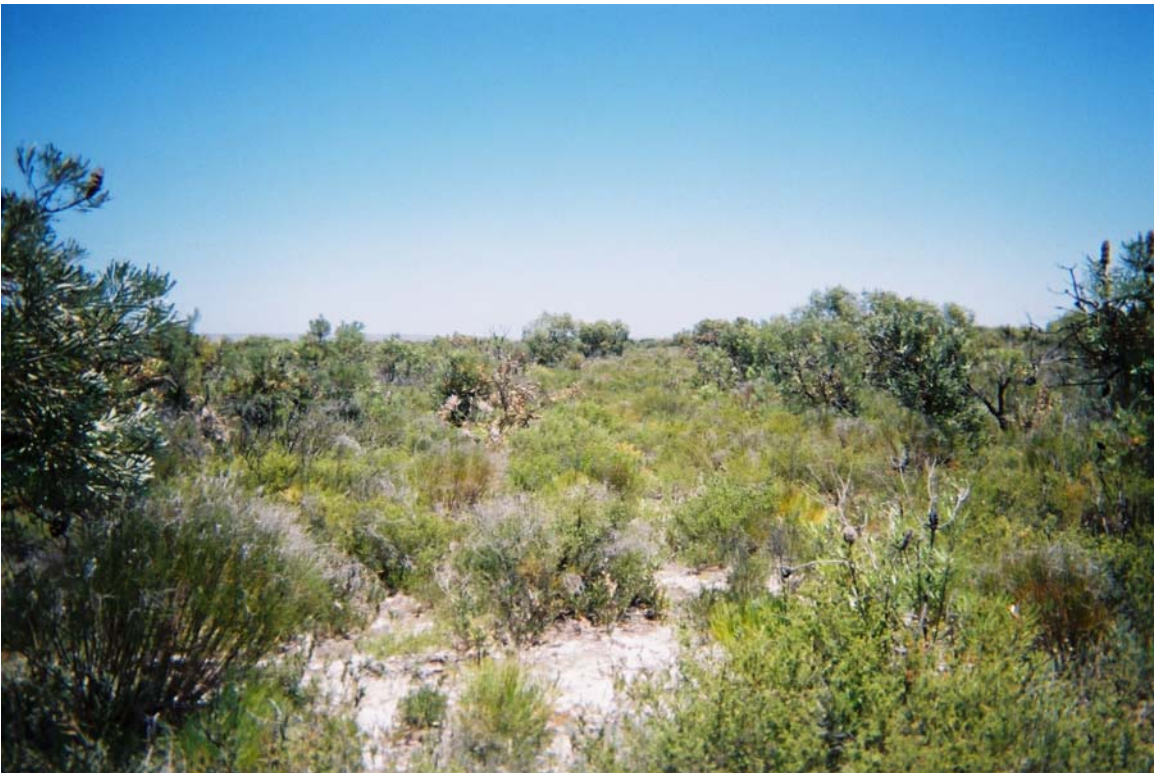
Photo 8: Community W3 (Seismic Line B89-439)
