## TECHNICAL MEMORANDUM

**Reference No.** 20360083-009-M-RevA

### **BYFORD RAIL EXTENSION – GROUNDWATER AND SURFACE WATER LEVEL MONITORING EVENT – JANUARY 2021**

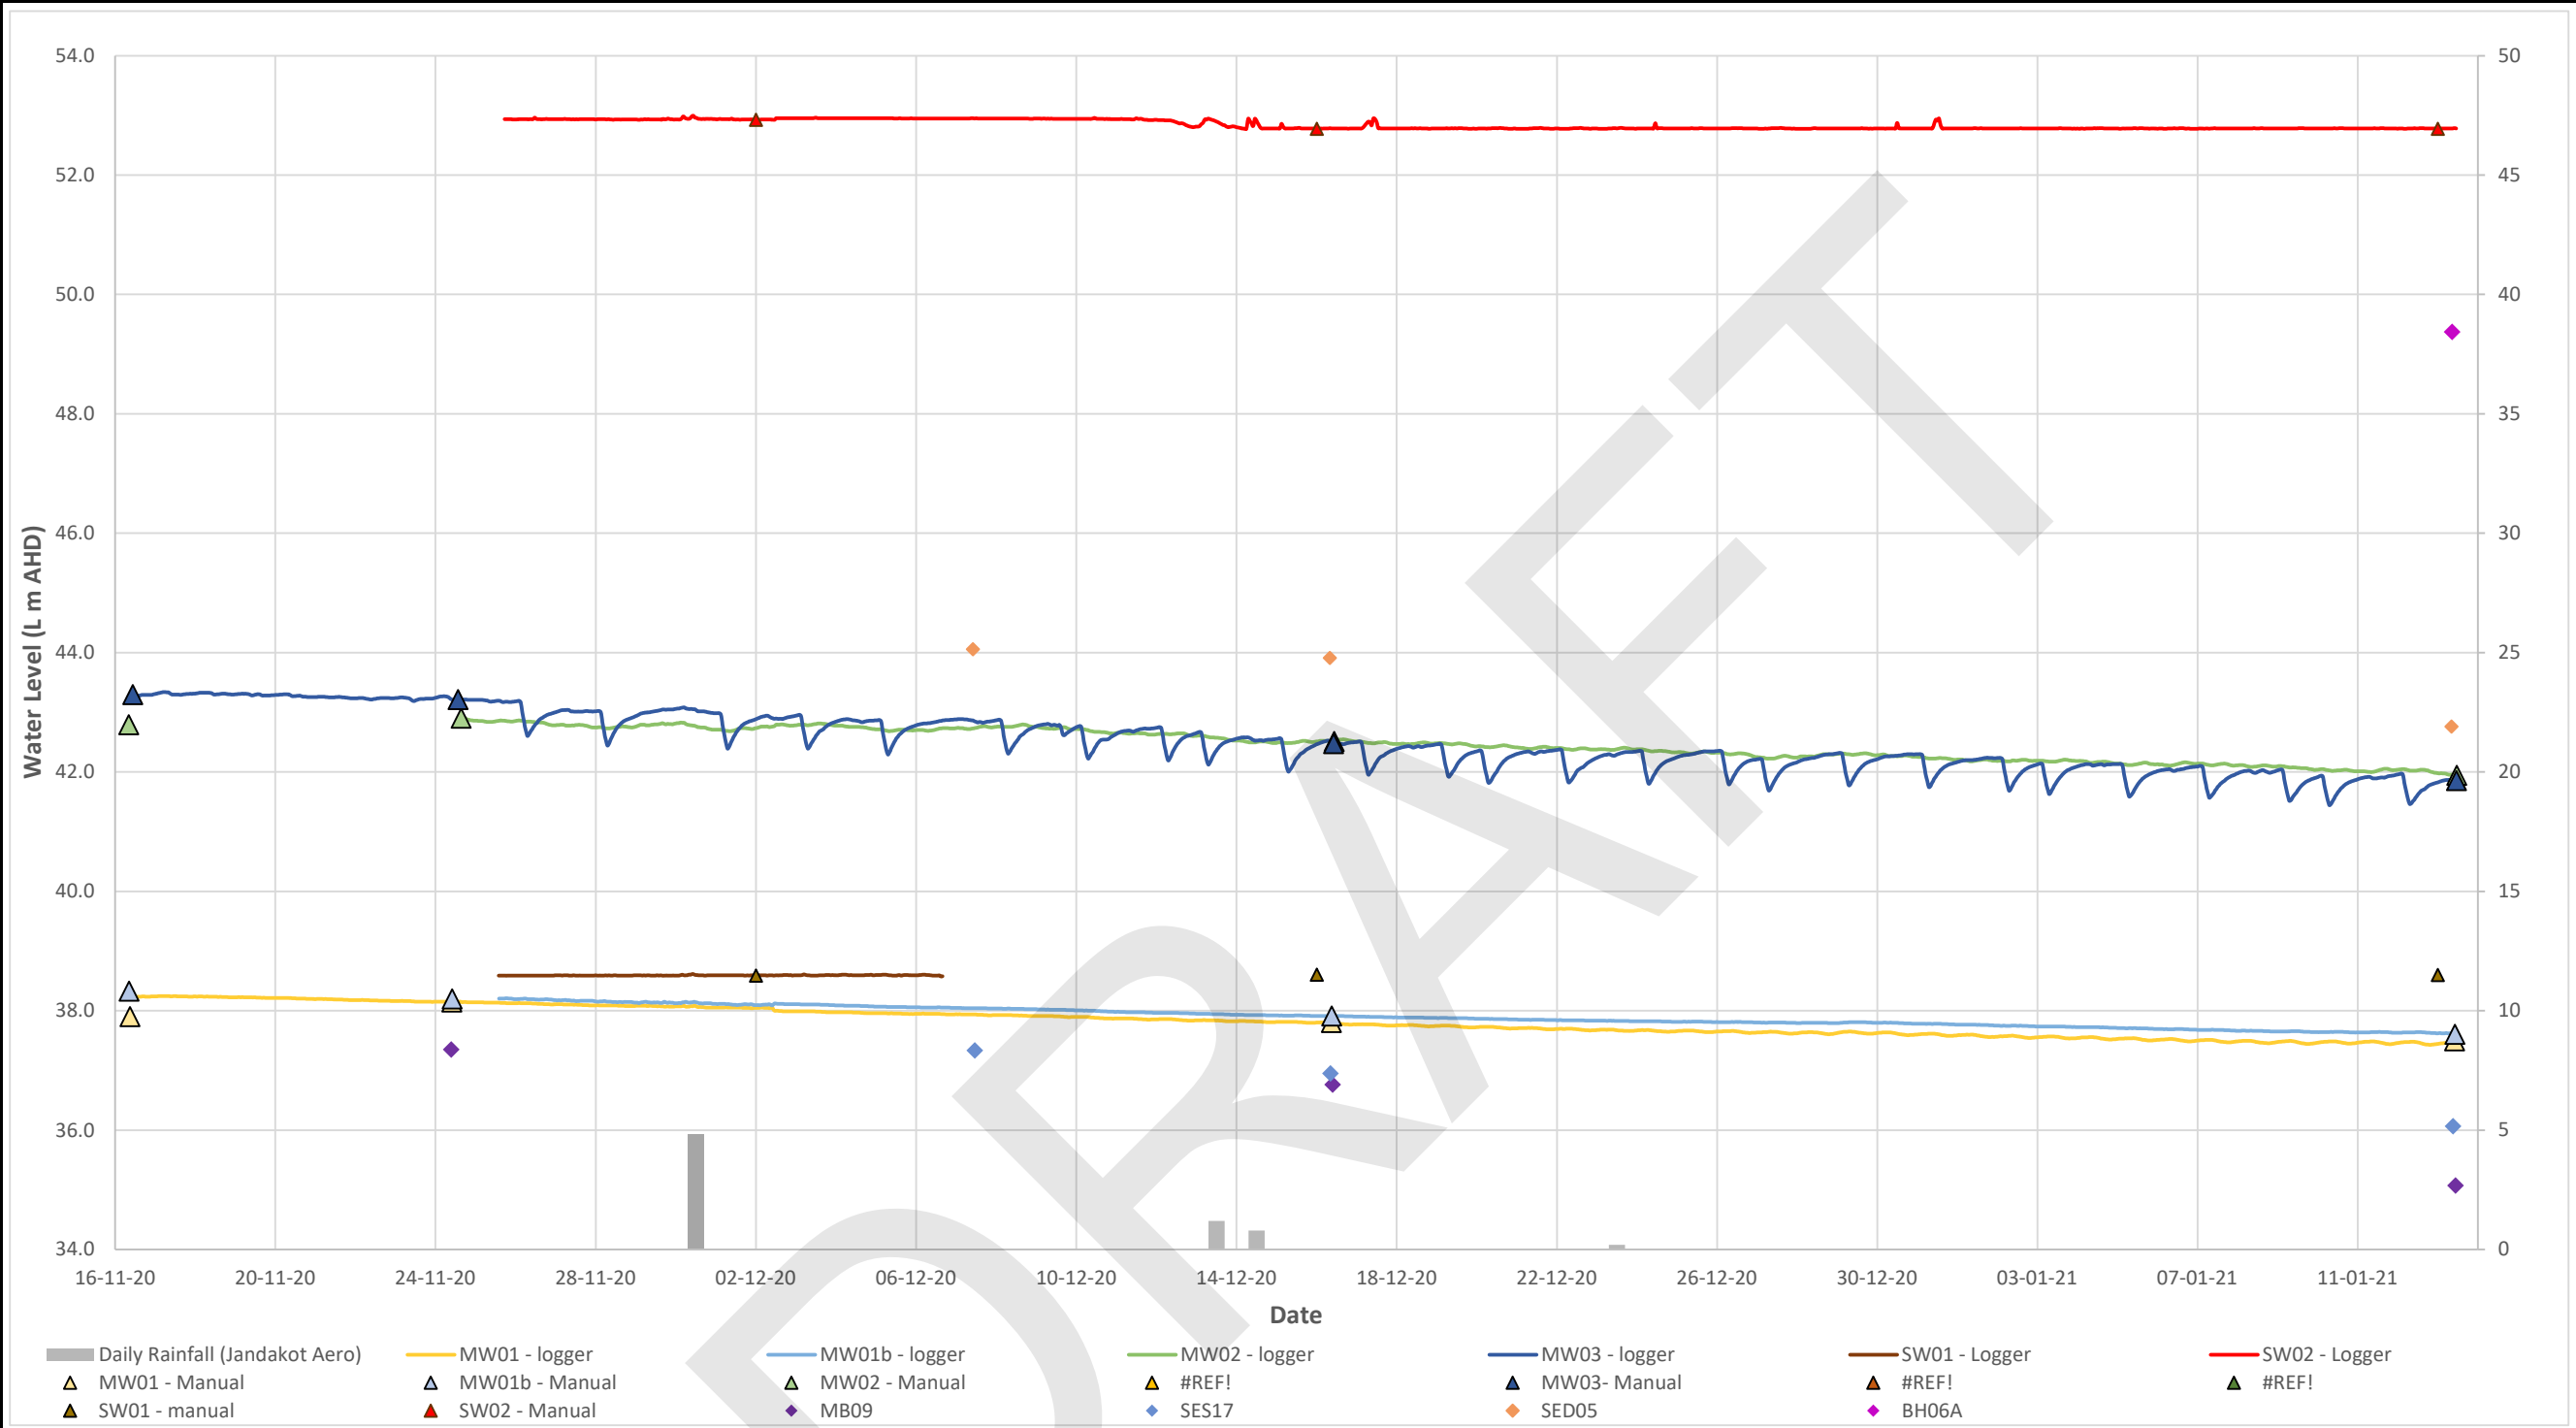
- Groundwater levels show a decrease (up to 1.69 m) between December 2020 and January 2021 in locations that could be monitored during this period (12), which is consistent with the current climate conditions (summer season, minimal rainfall).

NOTES:  
1. THE MONITORING WELLS MW02b, MW04 AND MW04b ARE CURRENTLY DRY.  
2. THE DRAIN WHERE SW03 IS LOCATED AND THE POND WHERE SW02 IS LOCATED ARE CURRENTLY DRY.  
3. SW04 LOCATION IS CURRENTLY INACCESSIBLE.

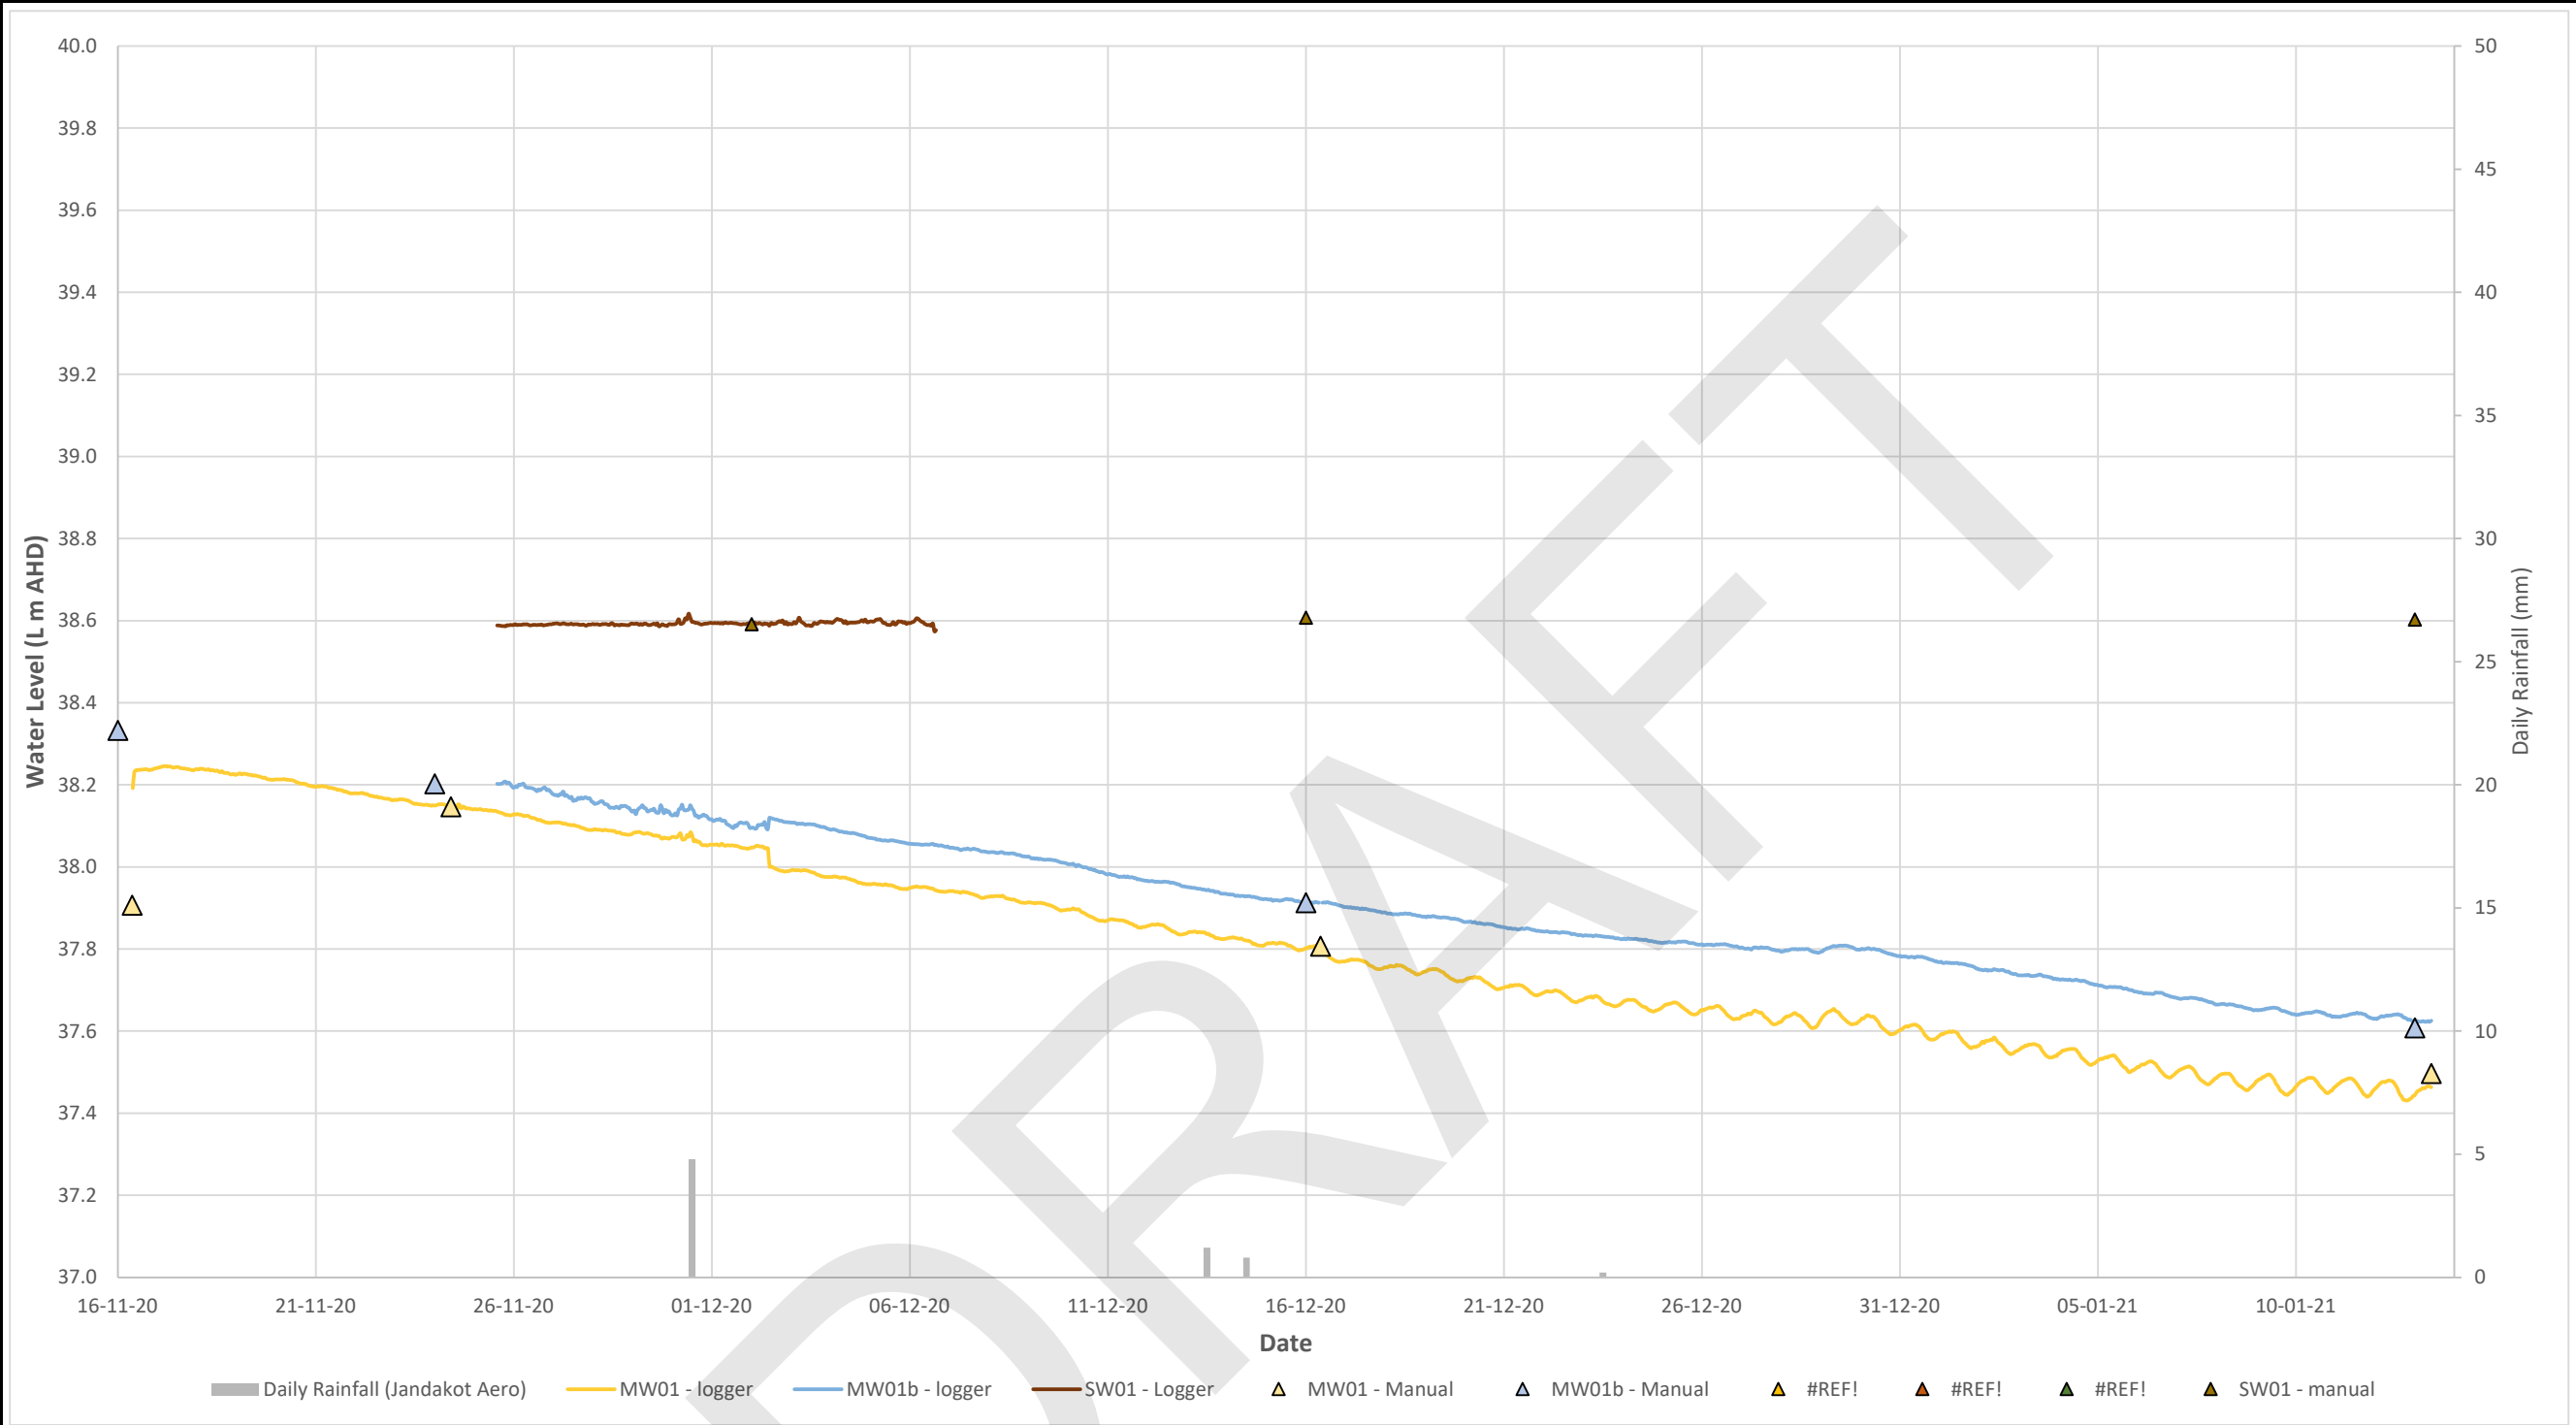
- At the time of this monitoring event, perched water was present within only one shallow well (MW01b). Data at MW01 and MW01b indicate a relationship (a similar slightly downward trend with little variation) between perched water and the aquifer at this location. There is a downward vertical gradient between the perched and Superficial aquifer. The surface water level, information is limited due to the loss of the transducers, but results indicate a steady surface water level. The surface water levels are also higher than the groundwater level measured in both the perched and Superficial aquifer, which indicates that during the dry period the Wungong Brook may not be groundwater dependent at this location. The perched groundwater ranges between 0.4 and 1 m below the stream water level and therefore may be connected to the groundwater during the wet period when groundwater levels are anticipated to rise.

1. THE LOGGER LOCATED AT SW01 WAS MOVED BETWEEN THE 02 AND THE 16 DECEMBER 2020. BETWEEN THE 16 DECEMBER 2020 AND THE 13 JANUARY 2021, THE LOGGER WAS STOLEN. THEREFORE, NO DATA COULD BE COLLECTED FROM THE 2 DECEMBER 2020.

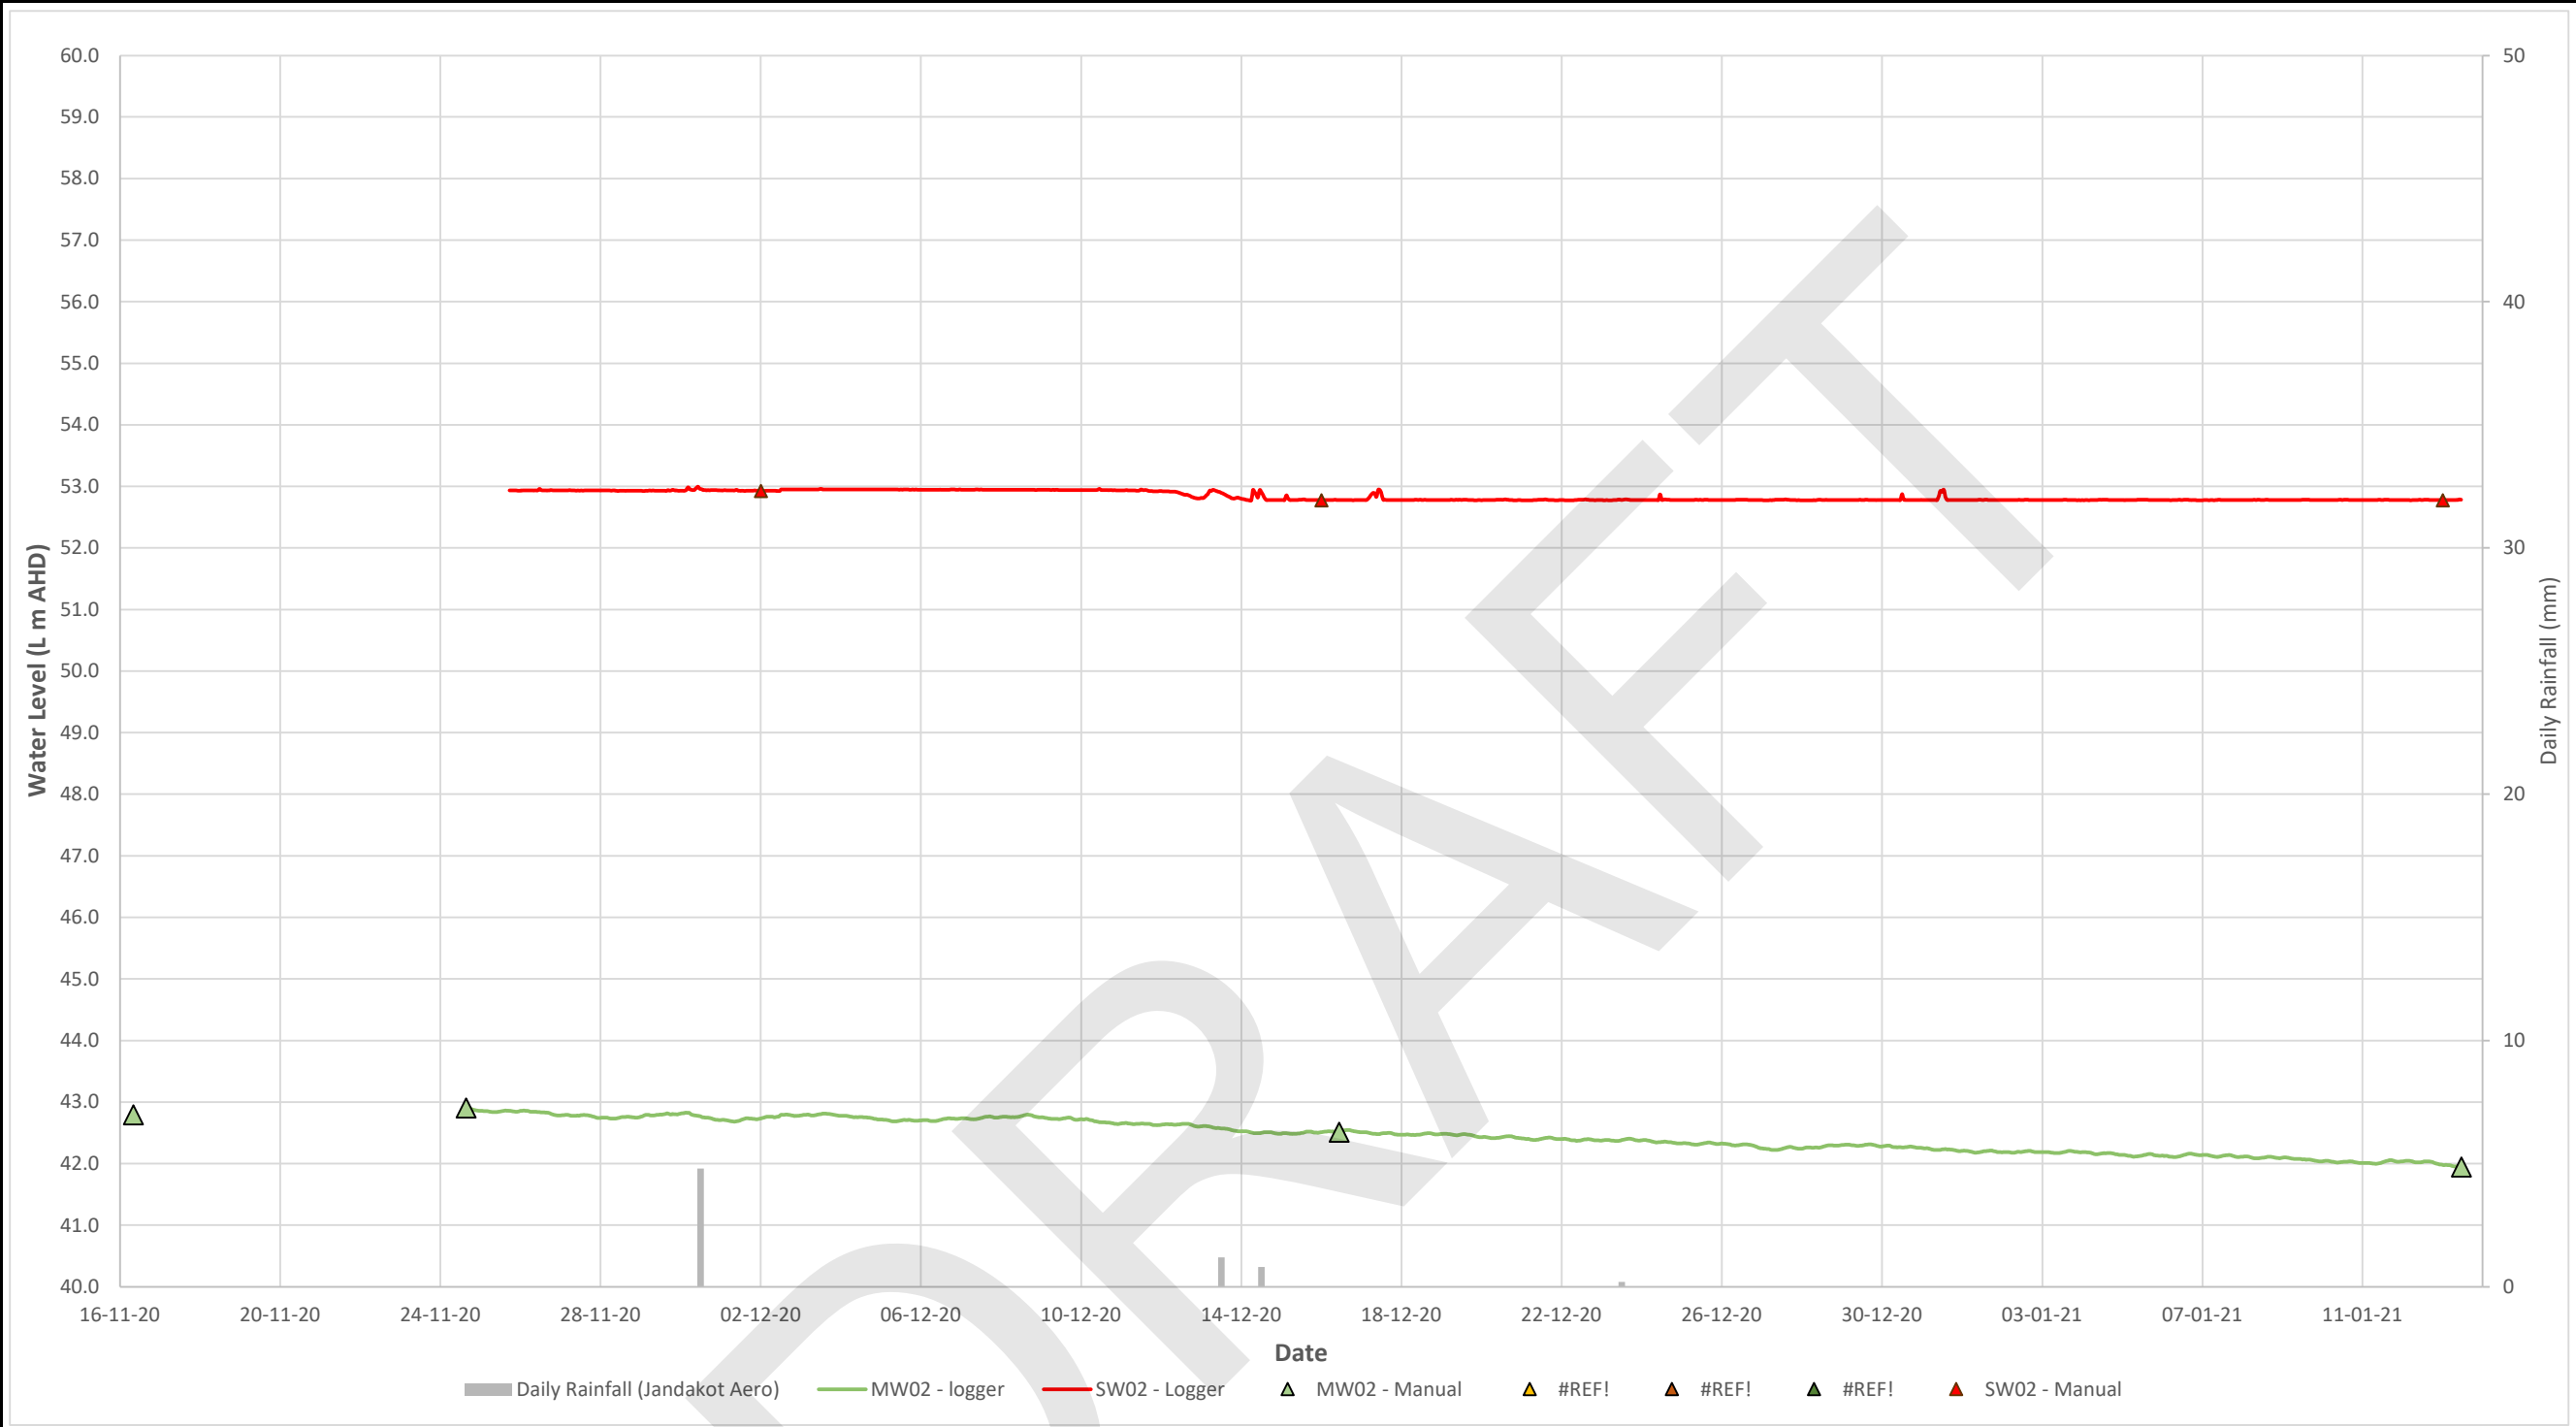
- The surface water level at SW02 is approximately 10 m more than the groundwater (MW02) and variations in the surface water level are not reflected in the groundwater level. This indicates that currently there is likely no connection between groundwater and surface water.

NOTES:  
1. THE SHALLOW MONITORING WELL MW02b, WHICH MONITORS PERCHED WATER CONDITIONS, IS CURRENTLY DRY.  
2. THE CREEK WHERE SW02 IS LOCATED IS CURRENTLY DRY.

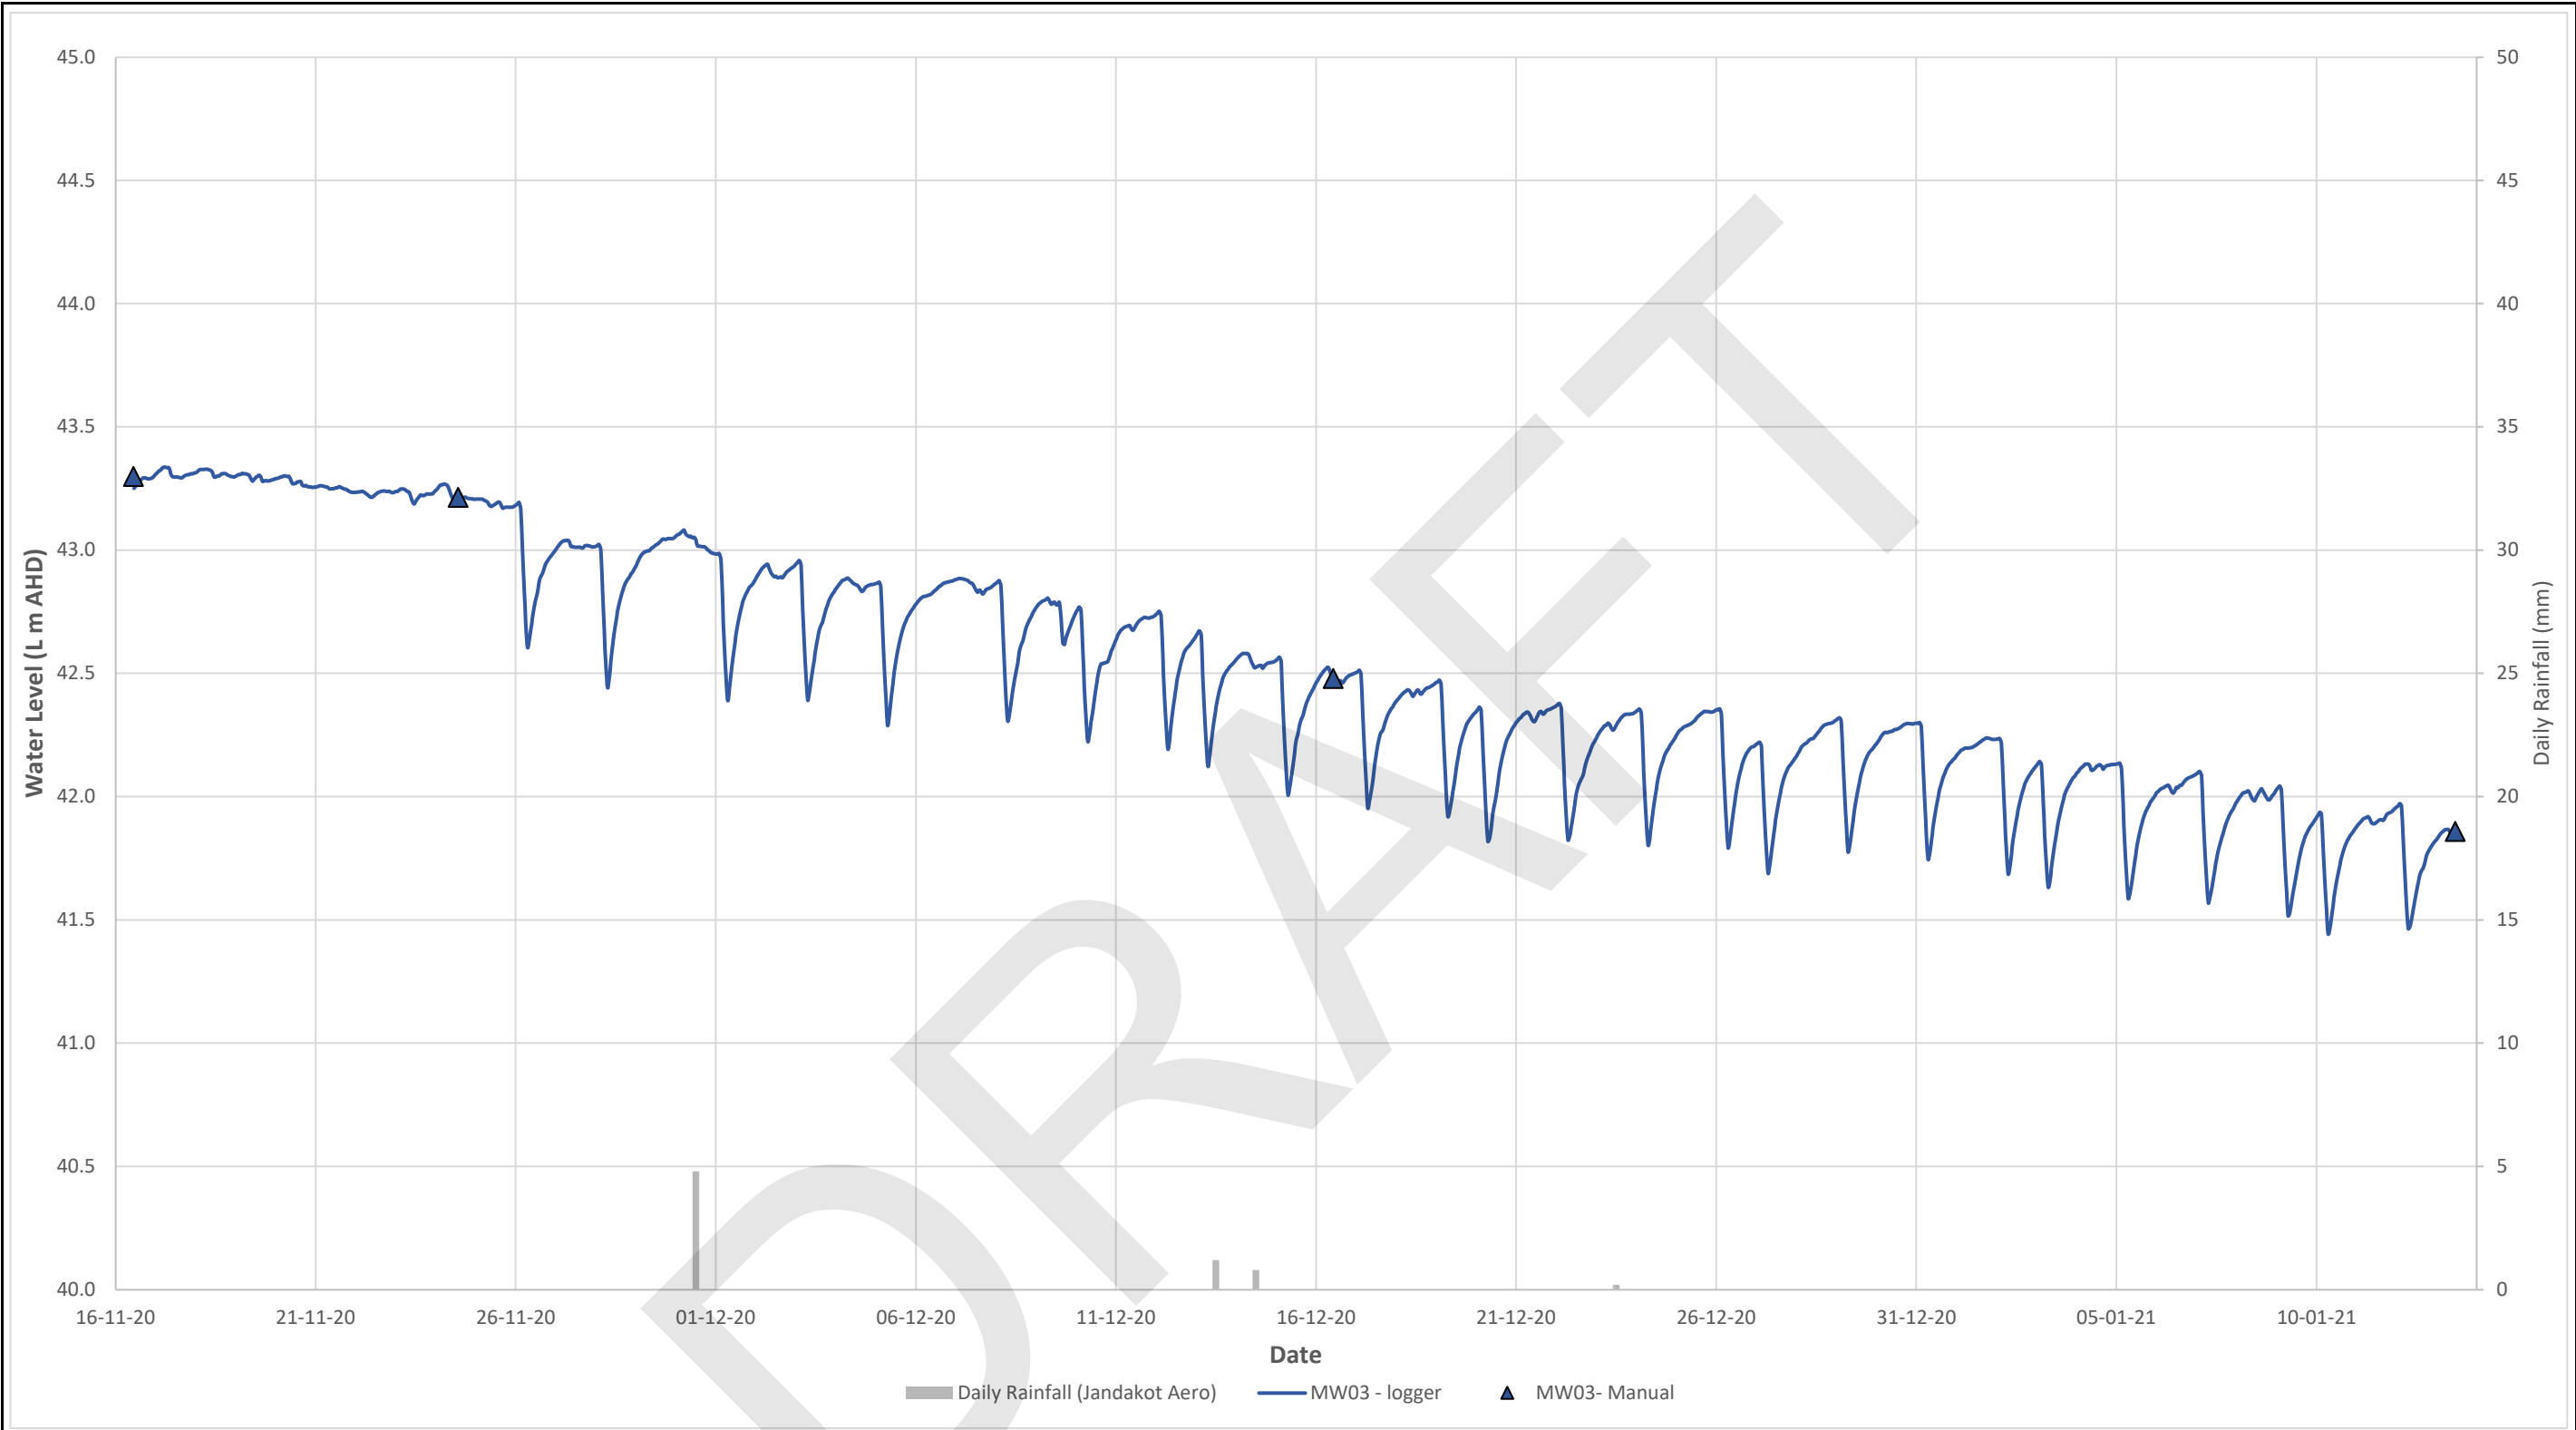
- Groundwater level at MW03 was noted to decrease suddenly between 2 and 3 am and again between 7 and 8 am every second night from 26 November 2020. Construction wells details and data logged during drillings works indicate that the aquifer is confined in this area (groundwater level at MW03 higher than the base of the CLAY formation). Information from the Water Register<sup>1</sup> indicate the presence of a 5C licence well (160738) located within a park (Massell Way) about 200 m to the south-west of MW03. The 5C licenced well abstracts groundwater from the Superficial Aquifer. In a confined aquifer the coefficient of storage is very low and the groundwater level drawdown from an abstracting well can extend a great distance. Accordingly, variations observed on MW03 hydrograph are likely to correspond to pumping cycle of the 5C licenced well. PTA has lodged a query with the City of Armadale to confirm the location of the abstraction well.

NOTES:  
1. THE DRAIN WHERE SW03 IS LOCATED IS CURRENT DRY

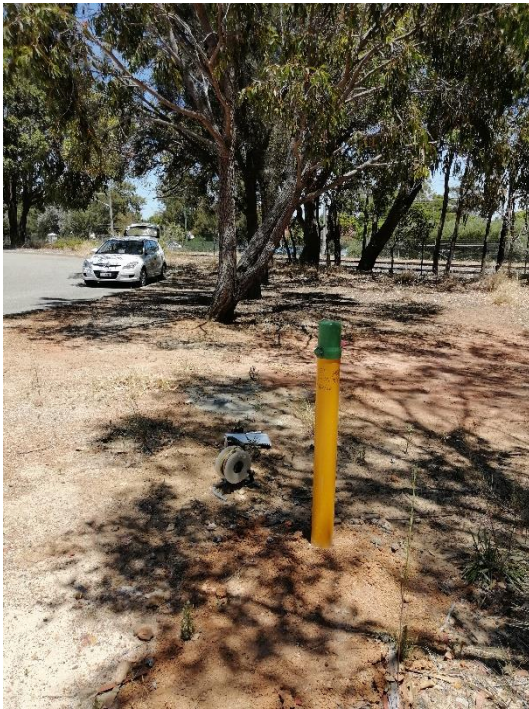
BH3 (Flush Gatic) & BH3A (Monument)

- Deep wells covered by a monument were locked and therefore not accessible by Golder.
- BH5 and BH5A are located within the rail reserve and Golder could not obtain an authorisation to access the area.
- BH7A was noted to be blocked with mud.
- The PVC pipe in BH3A was found broken and could not be dipped.

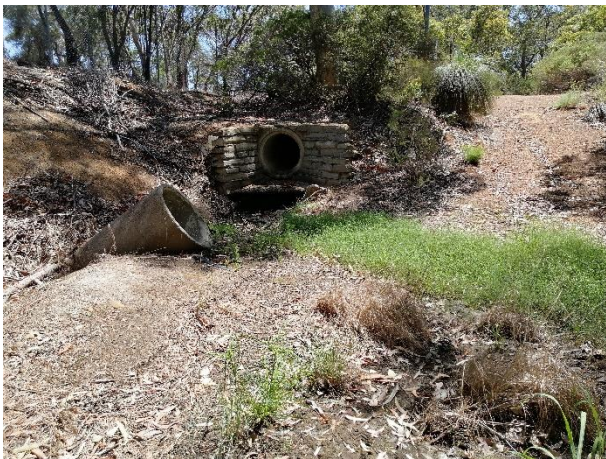
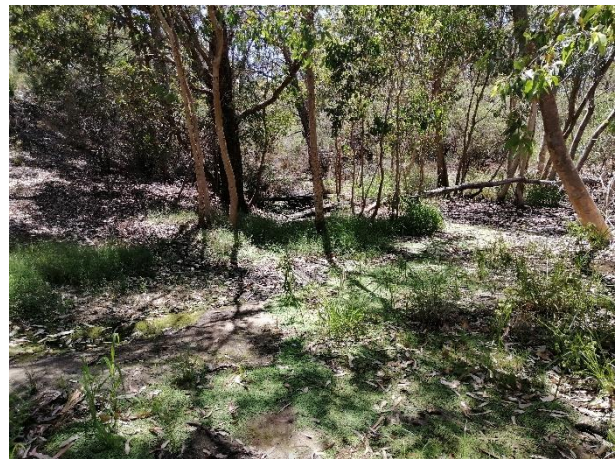
- The logger installed at the surface water location SW01 has been stolen therefore only a manual water level could be provided for this monitoring event (see photographs in Attachment A).
- The creek at SW02 was found to be dry (see photographs in Attachment A).

- The creek where SW02 is located was found completely dry since the 16 December 2020. This is also consistent with the current climate conditions (summer season, minimal rainfall).

SW02 – Dried Creek

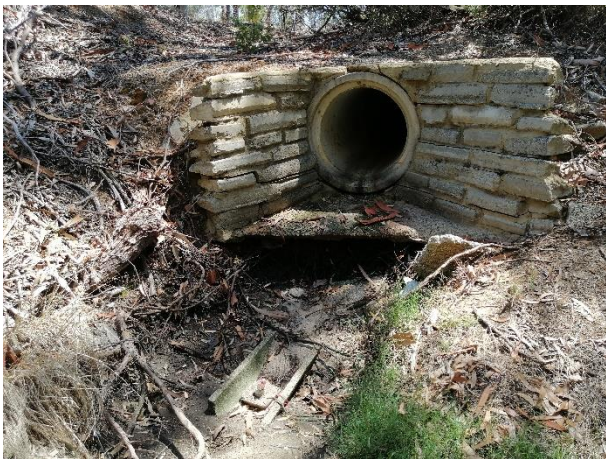
SW02 – Logger's location dry

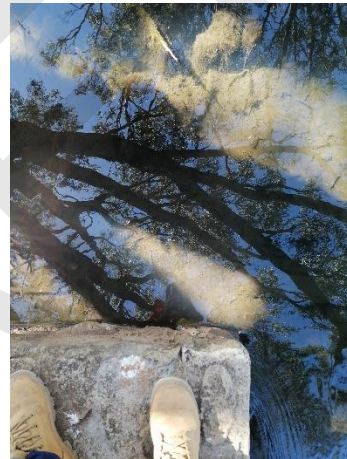
SW01 - Stolen
