TECHNICAL MEMORANDUM

Reference No. 20435097-004-M-Rev0

OCTOBER 2022 GROUNDWATER LEVEL MONITORING EVENT SMITHS BEACH DEVELOPMENT

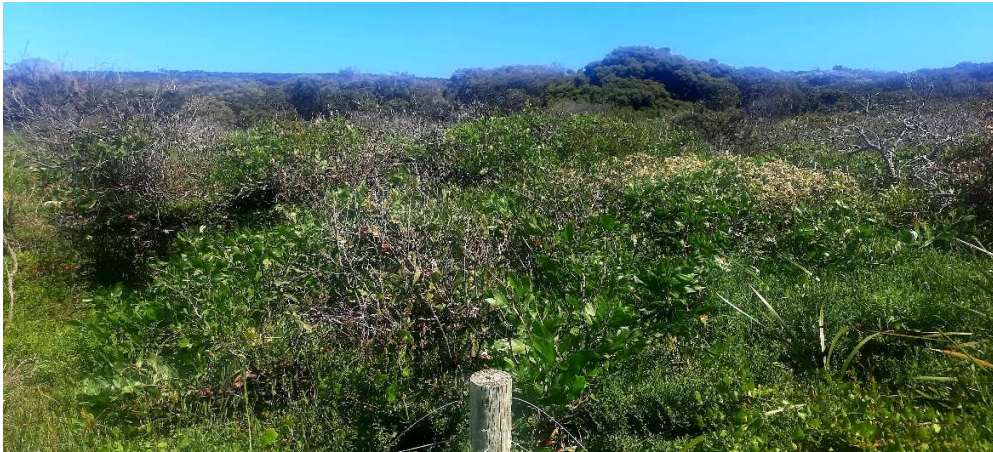
Figure 2: GB04 location on 21/10/2022

Manual groundwater measurements and transducer download could not be completed for GB04 monitoring well due to overgrown vegetation which limited access (Figure 2). In reviewing the data, it is noted that the four transducers at GB03, GB05, GB06 and GB09 ceased logging in September 2022 and are currently not collecting additional measurements.

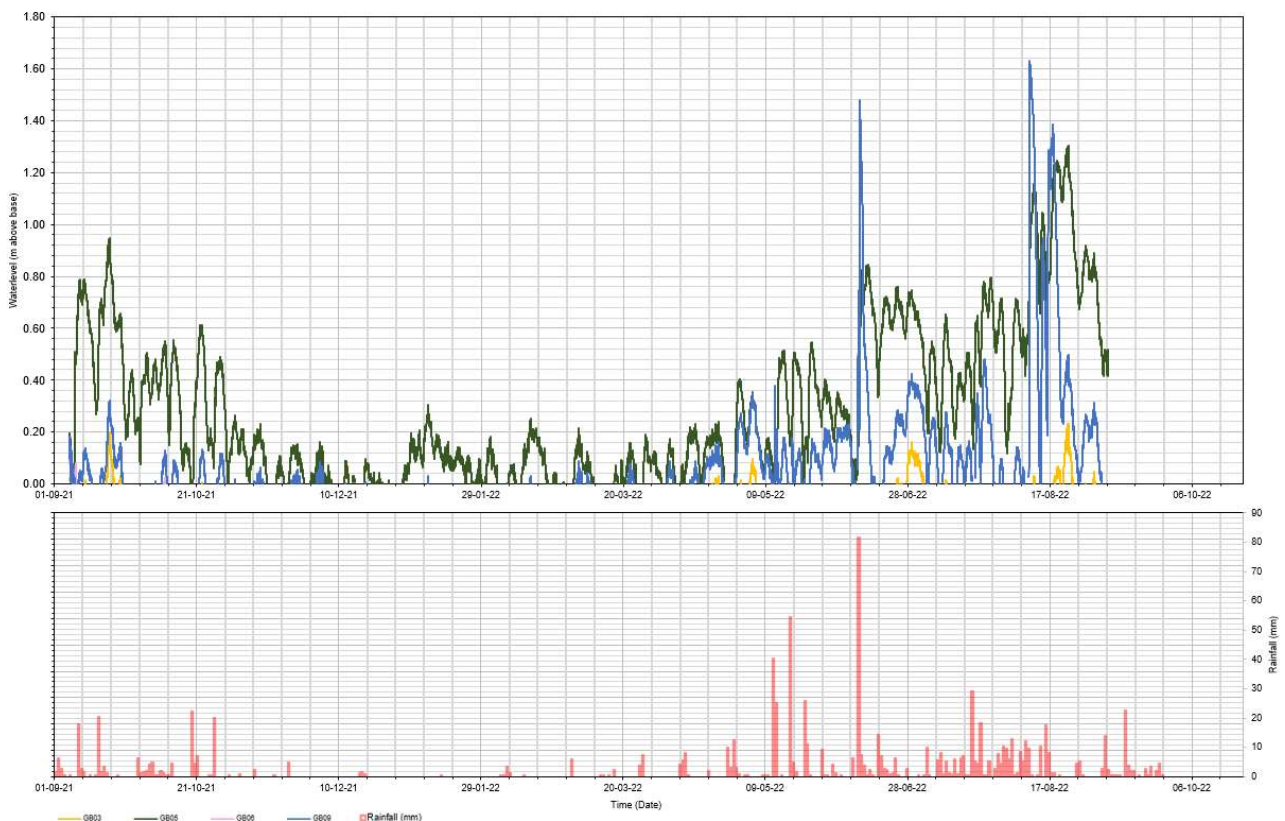
Figure 3: Rainfall and groundwater levels (m above base of well) – 6 September 2021 to 6 September 2022

The hydrographs indicate that GB06 and GB03 are predominantly dry and only occasionally have detectable groundwater. In comparison, GB05 and GB09 frequently detect groundwater in the monitoring well. GB05, which is located in proximity to the spring contained groundwater during the last sampling event in October 2021. The groundwater levels at GB05 appear to be only partially influenced by rainfall, with increases in groundwater levels noted at other times.

The results indicate that perched groundwater is present above the bedrock following rainfall events.
