Our Reference: 15630-21-EOLR-1Rev0_210805

Re: Roy Hill Mine – Surface Water Flows – Memo, August 2021

Roy Hill
 Surface Water Flows Memo
Figure 1: Overview Map

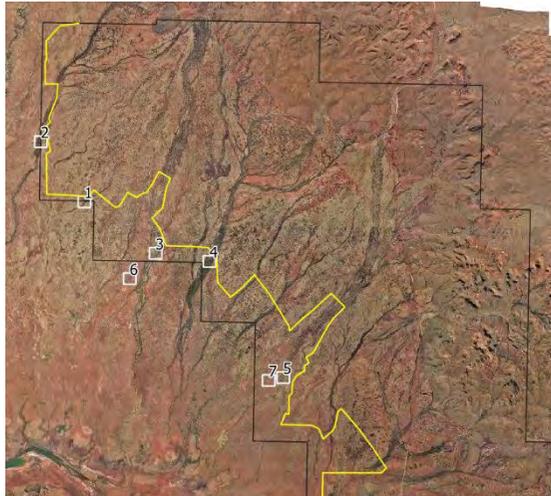
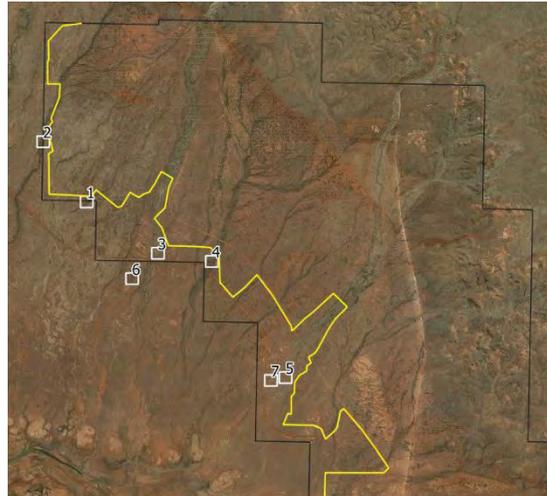
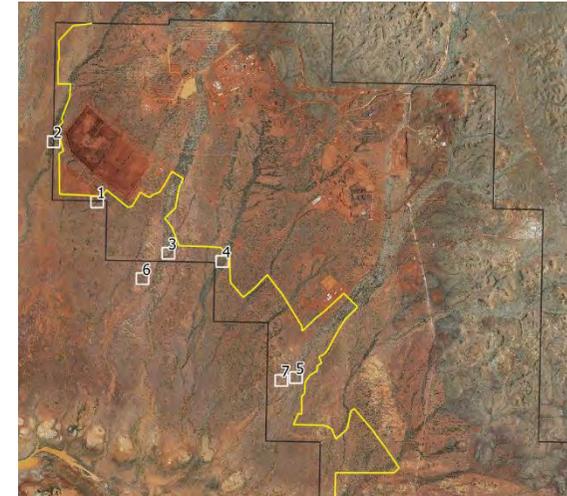
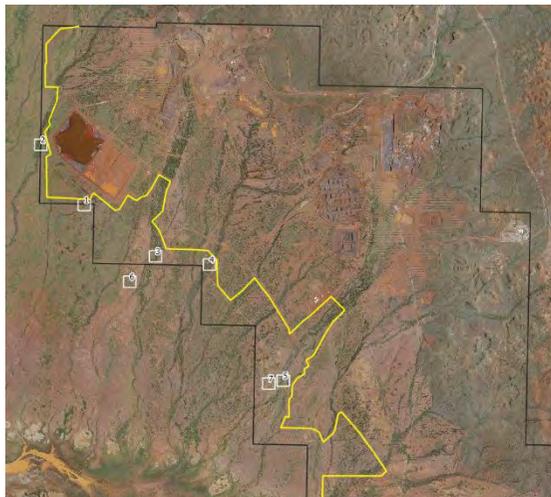
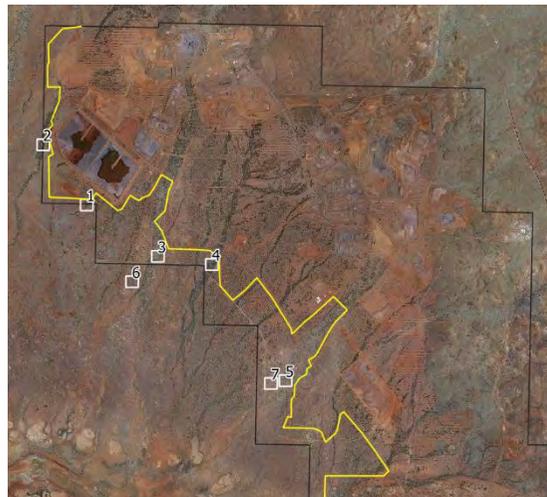
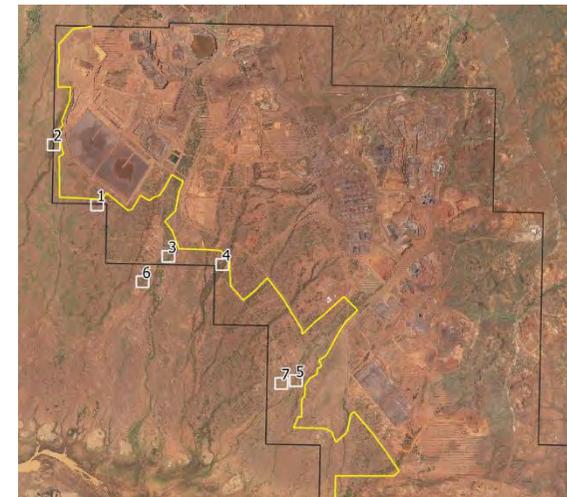
Inspection of target areas (Attachment 1, Plates 1 to 8) did not reveal any major change to vegetation since baseline that might be attributed to mining. In general, vegetation communities remained intact, with no obvious areas of tree death and no major change in tree density or spatial arrangement. Overall, there was no evidence of structural change – riparian zones did not expand or contract for minor drainage lines (Plate 2), major drainage lines (Plate 3) or creeks (Plates 4, 5 and 6), and banded mulga formations were unchanged (Plates 7 and 8). Canopy cover (foliage thinning) and understorey cover appeared to vary over time, which can be attributed to rainfall. Imagery from December 2020 showed slightly thinner canopies than imagery from December 2018 and February 2017, however lower rainfall was received leading up to the December 2020 capture date compared to the December 2018 and February 2017 capture dates (Attachment 1, Table 2). Other differences in the images were attributed to unrelated factors including image resolution, sun angle and shading.

Plate 1: Change in Mine disturbance area between 2006 (baseline) to 2020. Includes disturbance boundary for Revised Proposal (yellow line) and location of vegetation extract areas shown in Plates 2 to 8.

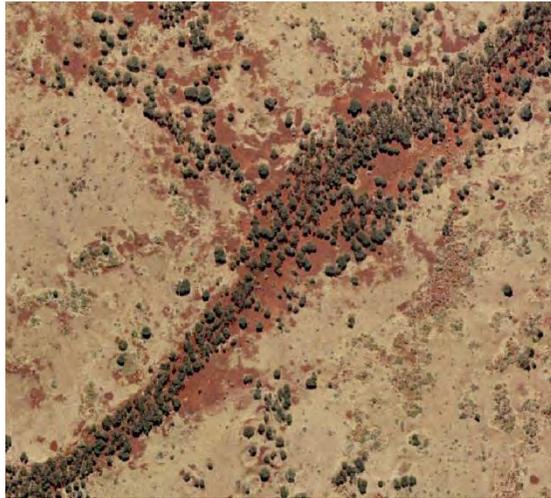
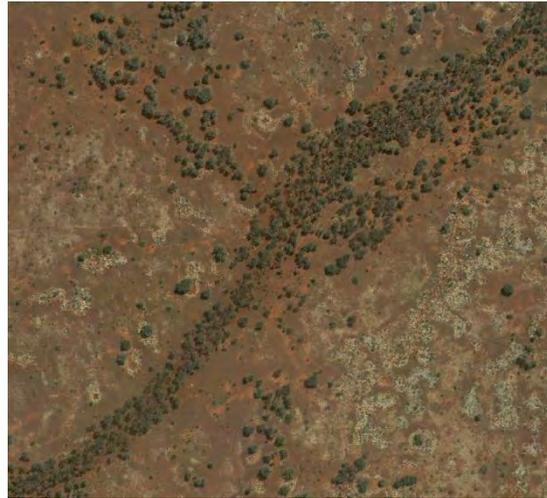
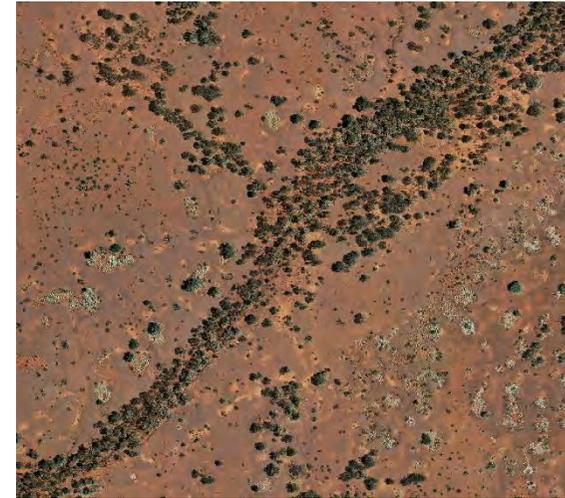
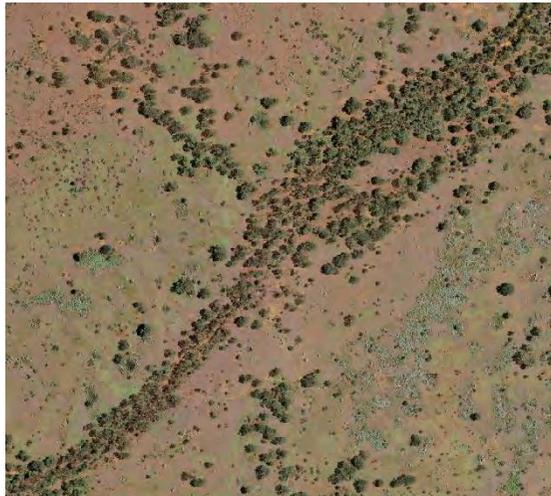
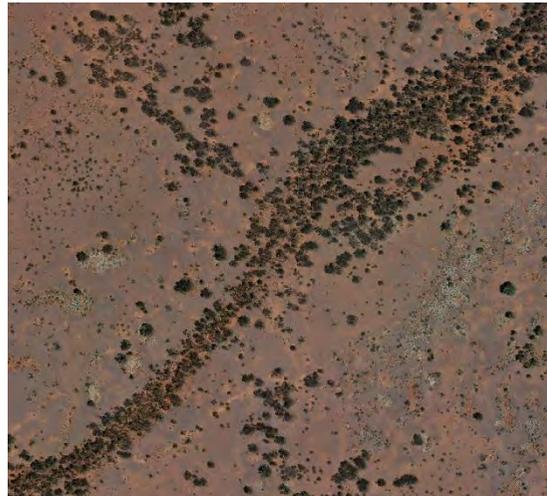
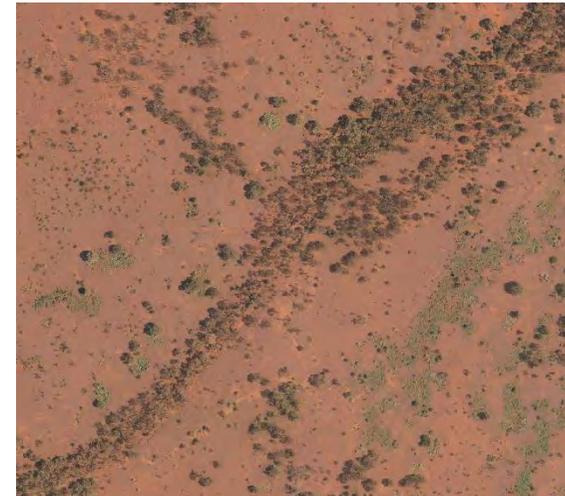
Plate 2: Change in vegetation along a minor mulga drainage line intersected by the tailings storage facility between 2006 (baseline) to 2020 (vegetation extract area number 1).

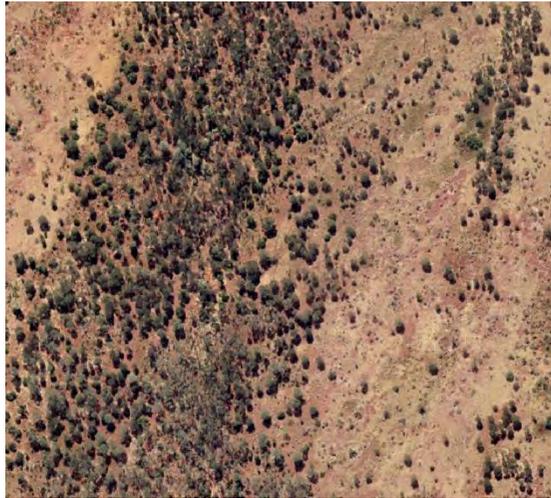
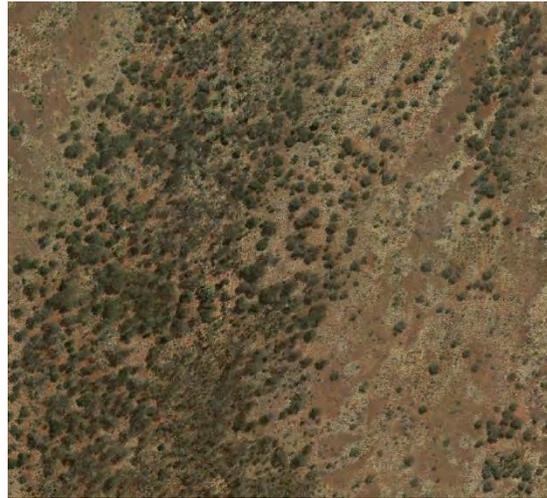
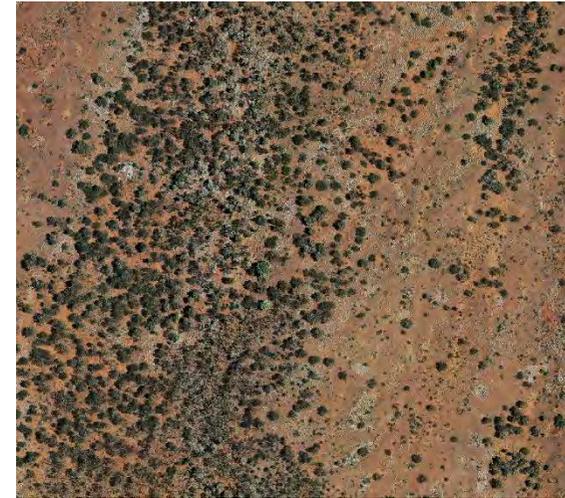
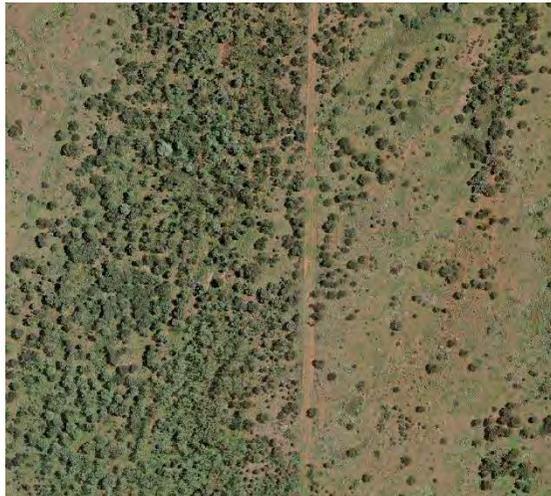
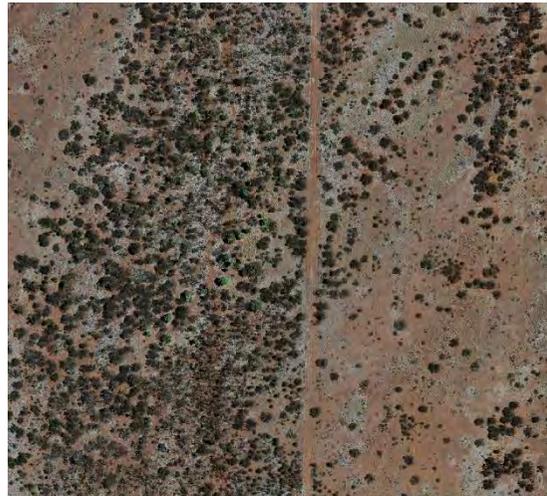
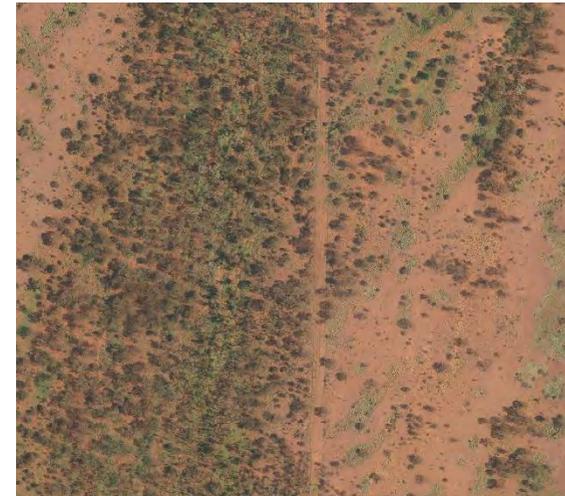
Plate 3: Change in vegetation along a mulga drainage line at GHD reporting location 1 between 2006 (baseline) to 2020 (vegetation extract area number 2).

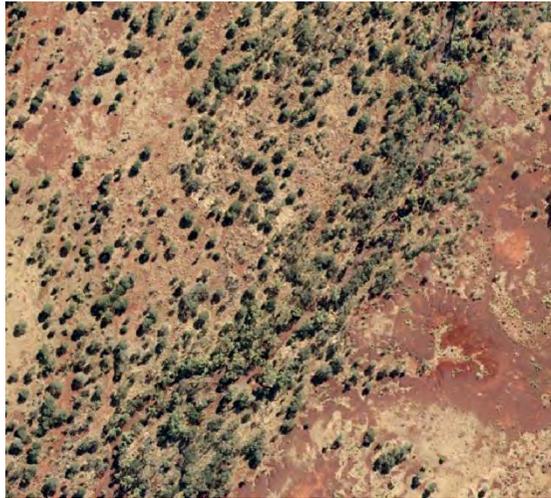
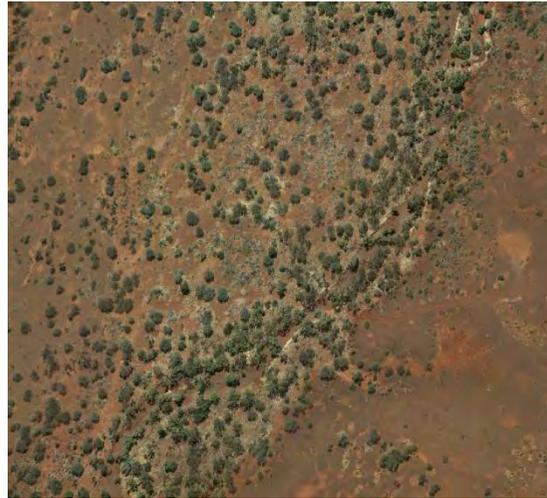
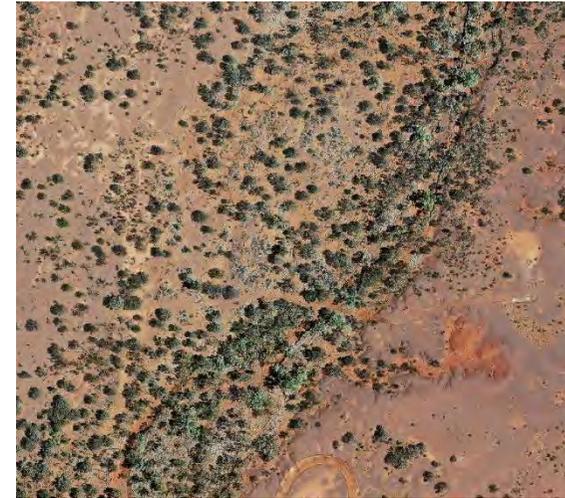
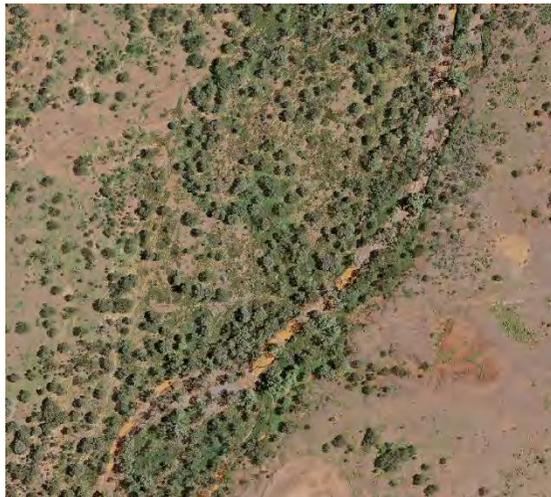
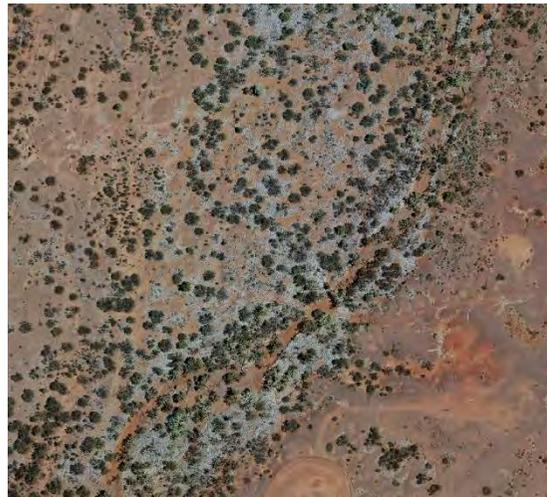
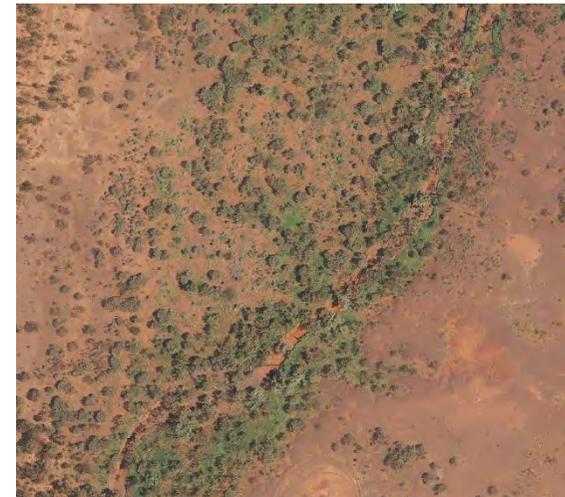
Plate 4: Change in vegetation along No Name Creek at GHD reporting location 2 between 2006 (baseline) to 2020 (vegetation extract area number 3).

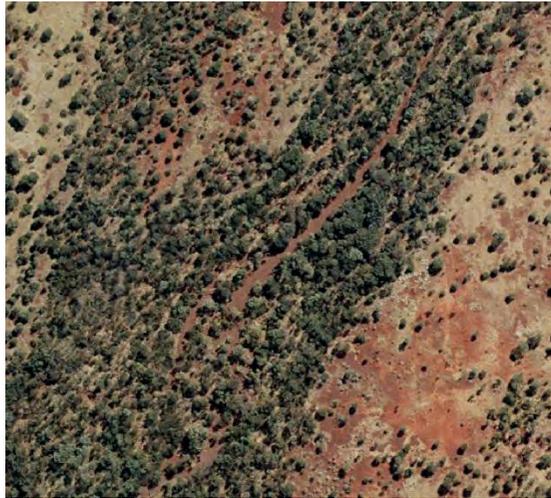
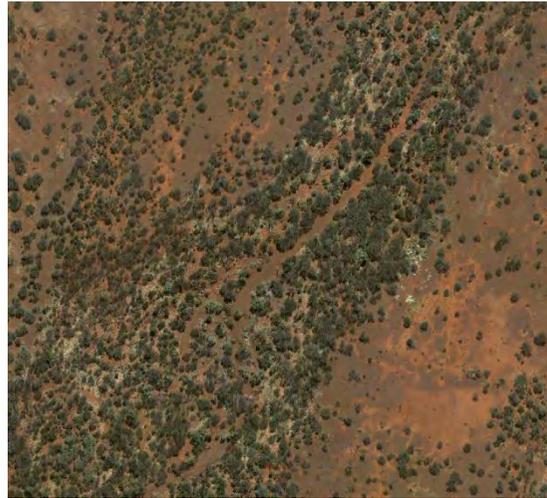
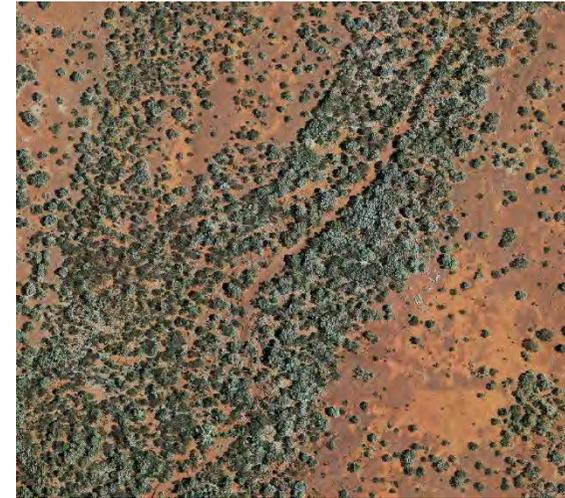
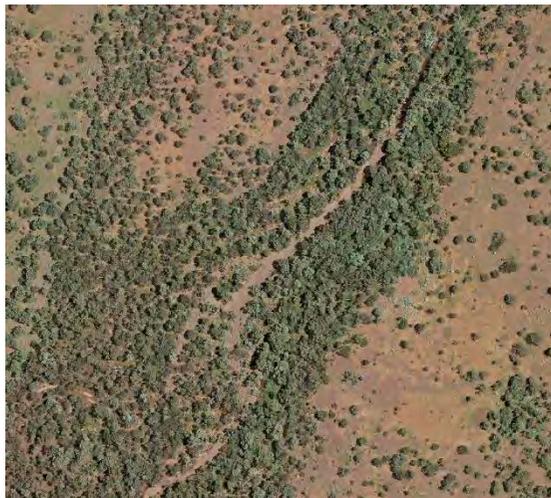
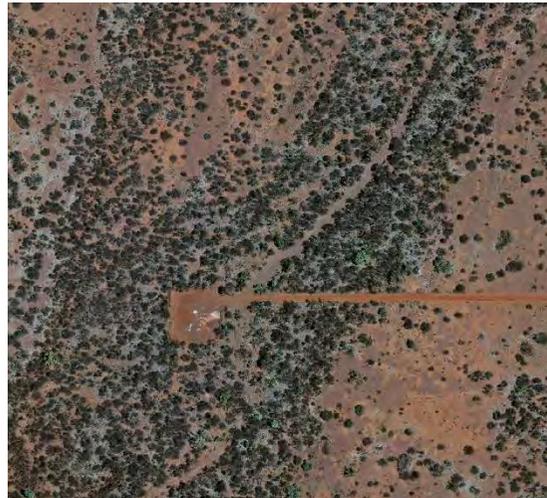
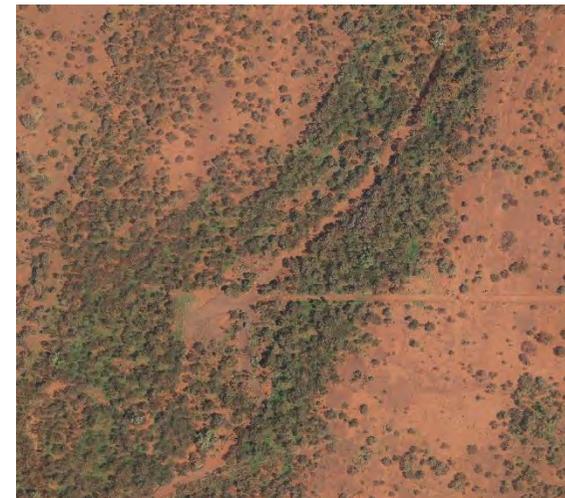
Plate 5: Change in vegetation along West Kulbee Creek at GHD reporting location 3 between 2006 (baseline) to 2020 (vegetation extract area number 4).

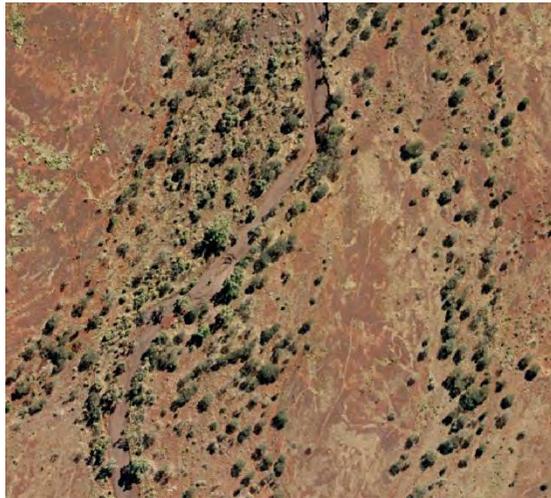
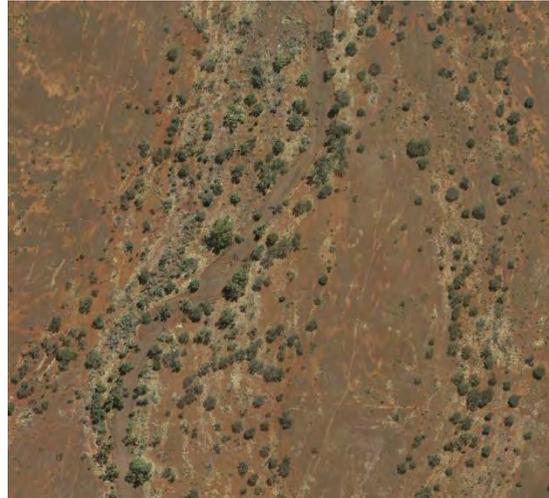
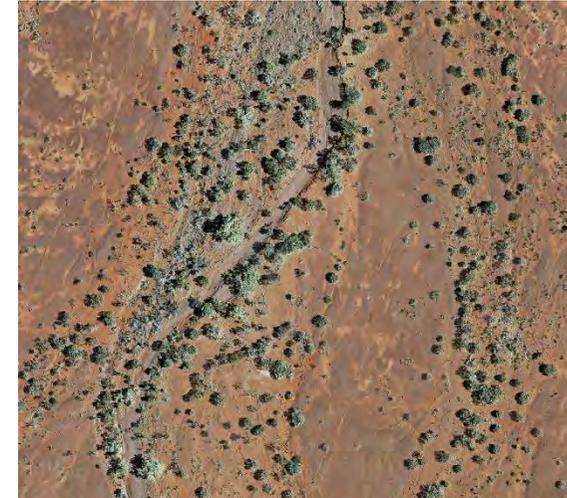
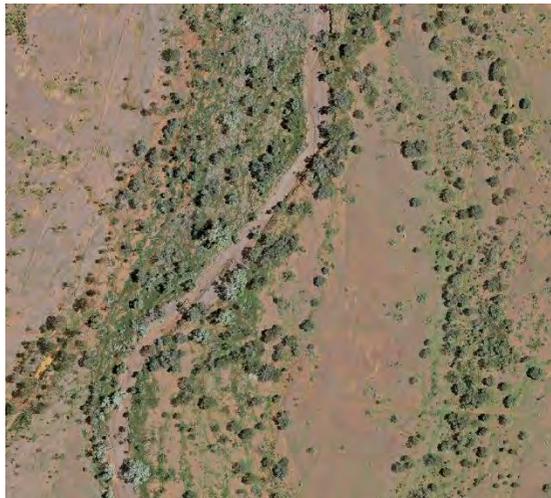
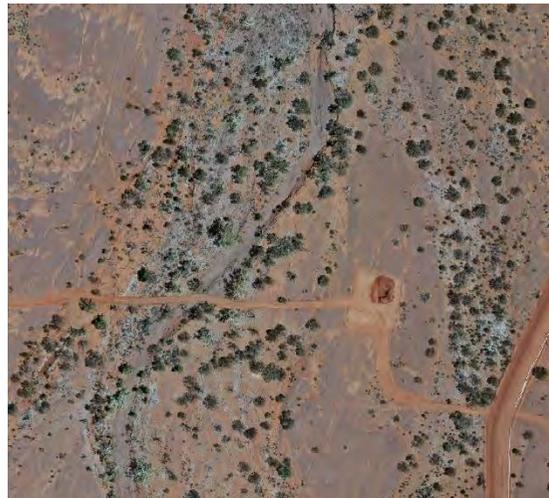
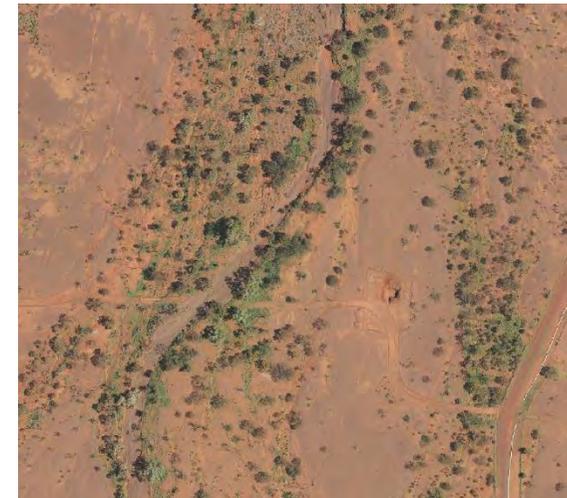
The waterways most likely to display some form of permanent vegetation change are those associated with reporting locations 5 and 6, but these changes may take years to evolve, and may only lead to a reduction in tree density rather than major changes to vegetation structure or community composition. Reporting location 5 is located along a mulga drainage line without a main channel for water flow, whereas reporting location 6 is located along the major channel of Kulbee Creek. Of note, these areas are covered by active vegetation monitoring sites. For reference, these sites include WLI2 near reporting location 5, sites GDVI3 and GDVI4 near reporting location 6, and site MAR.3 further downstream of Kulbee Creek.

Plate 6: Change in vegetation along Kulbee Creek at GHD reporting location 6 between 2006 (baseline) to 2020 (vegetation extract area number 5).

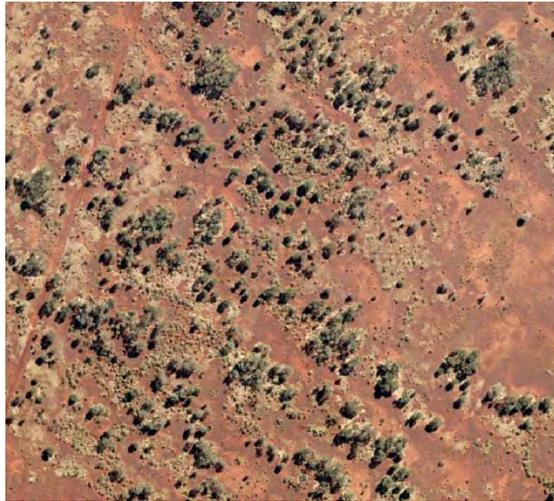
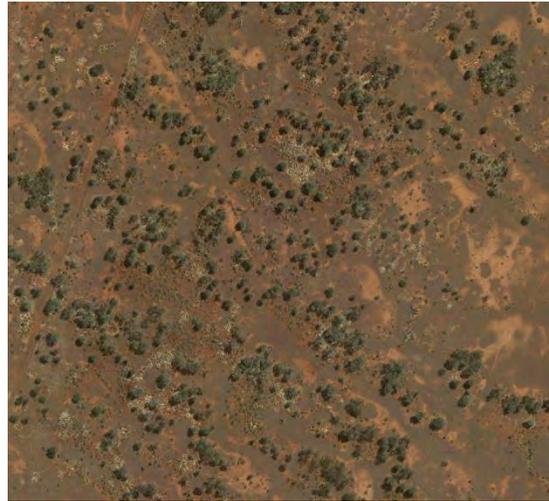
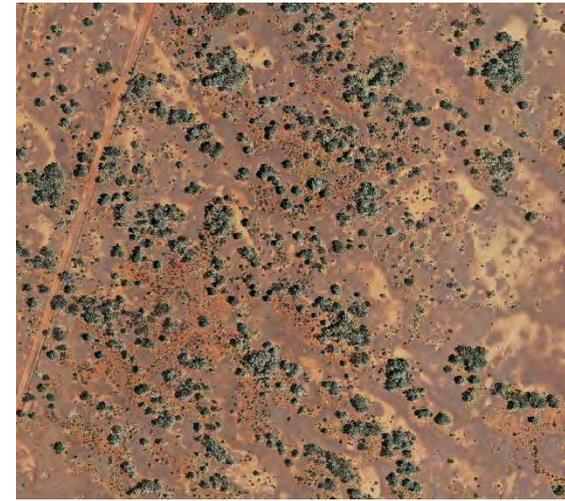
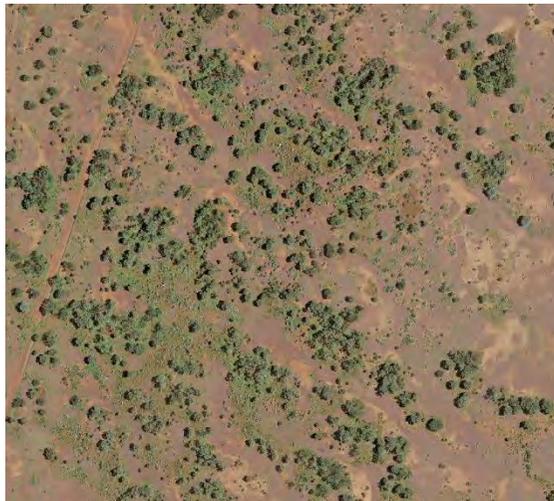
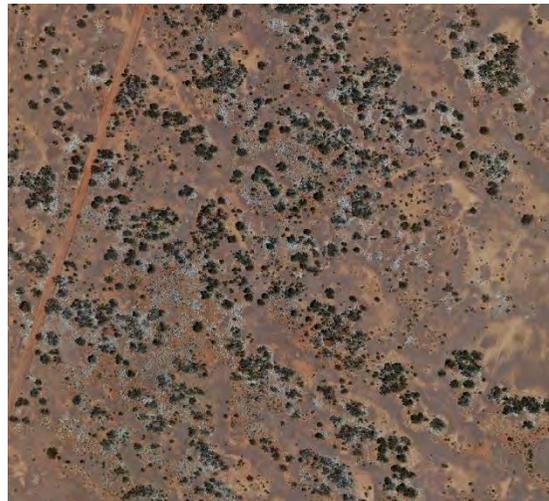
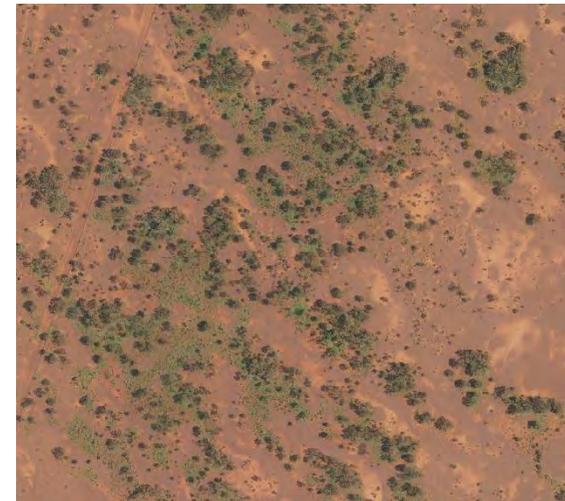
Plate 7: Change in vegetation in banded mulga adjacent to No Name Creek and downstream of GHD reporting location 2 between 2006 (baseline) to 2020 (vegetation extract area number 6).

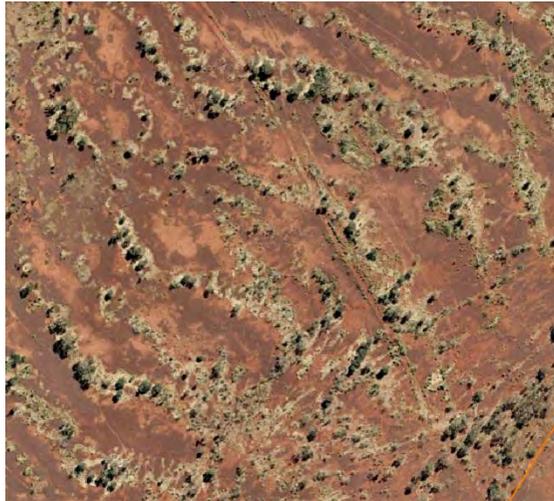
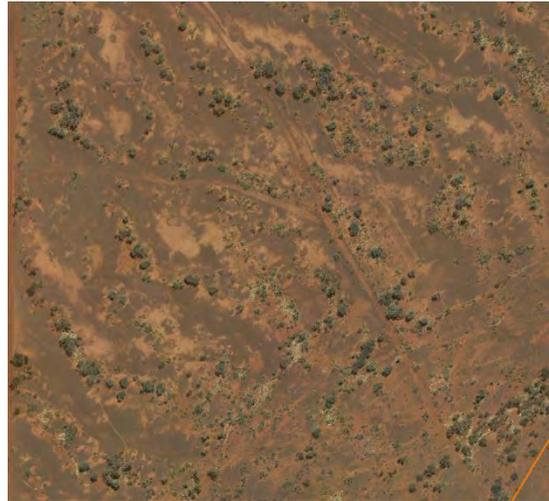
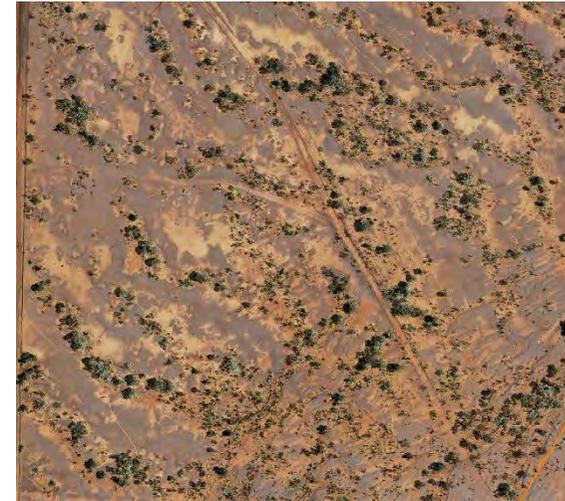
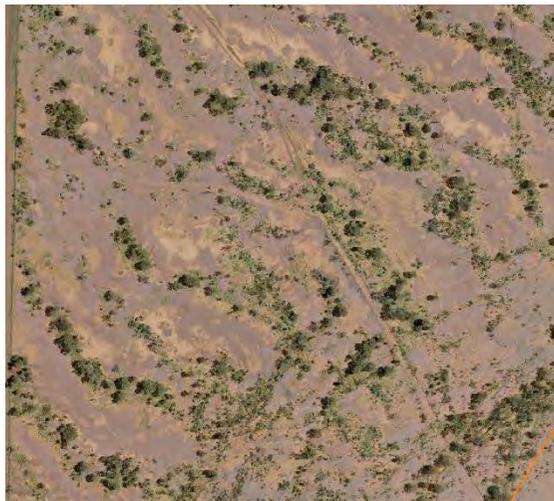
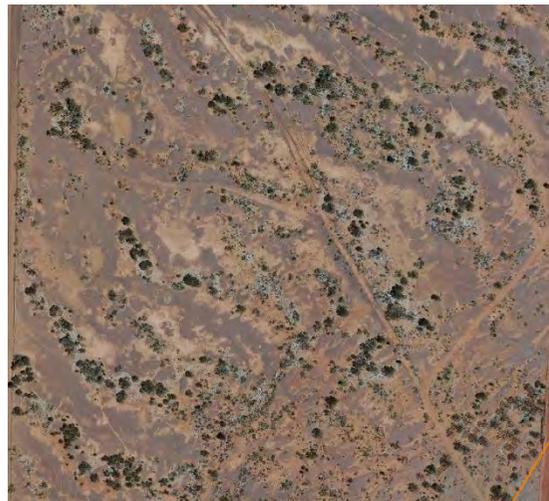
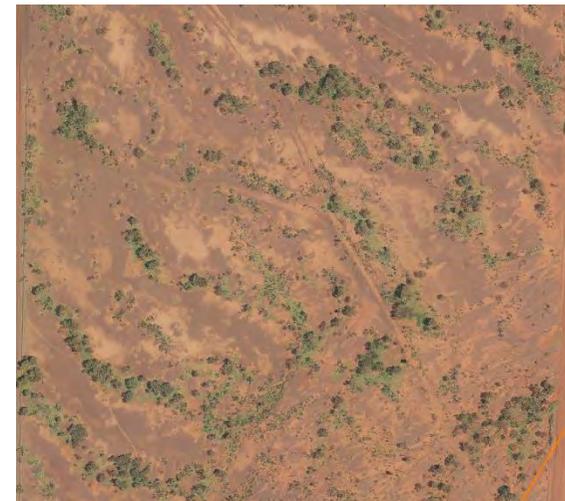
Plate 8: Change in vegetation in banded mulga adjacent to Kulbee Creek and GHD reporting location 6 between 2006 (baseline) to 2020 (vegetation extract area number 7).
