4 August 2021

TANTABIDDI BOATING FACILITY, NORTH WEST CAPE, WA

FACTUAL GEOTECHNICAL INVESTIGATION REPORT

Department of Transport PER2020-0495AG Rev1

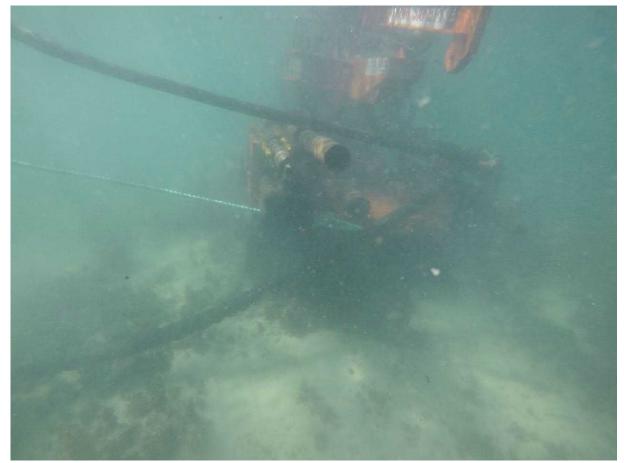
Rear view of subsea rig – note faint impression of rubber track in sandy substrate at lower left.

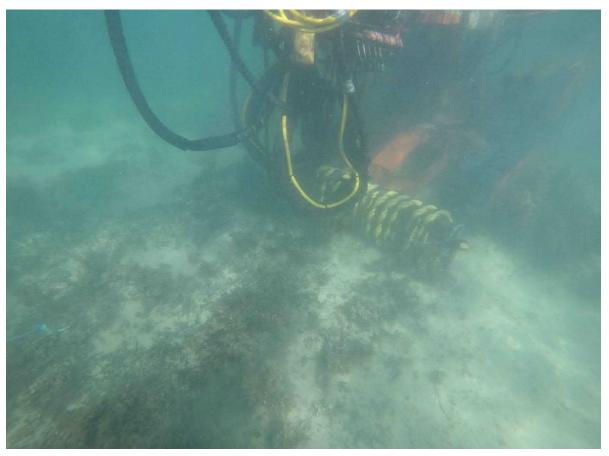
The rubber tracks of the rig made a faint impression in the sandy substrate as illustrated on the before (Photos 4 and 5) and after photos (Photo 6). These are very faint and will likely by undiscernible after a few hours of wind and wave action. The leading blade at the front of the rig was wrapped in rope to prevent damage to the sea floor (Photo 4) at the borehole site when used to steady the rig when the mast is erected. Similarly, the metal mast plate that contacted the seafloor had a piece of timber strapped to it to prevent damage to the seabed.

Figure 4 Seabed state prior to rig advancing - note rope on front blade to prevent abrasion of the seabed

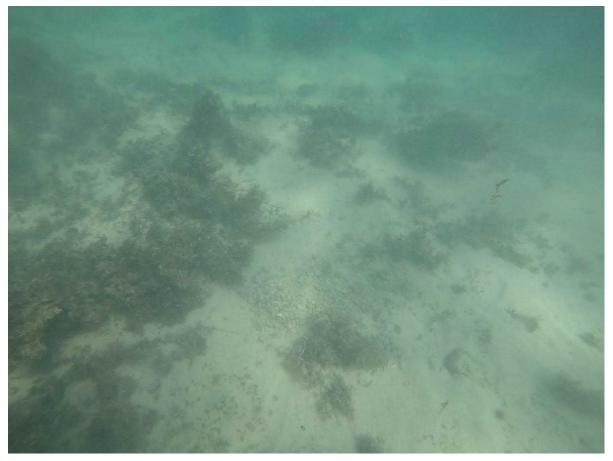
Figure 5 Seabed state bprior to advance of subsea rig

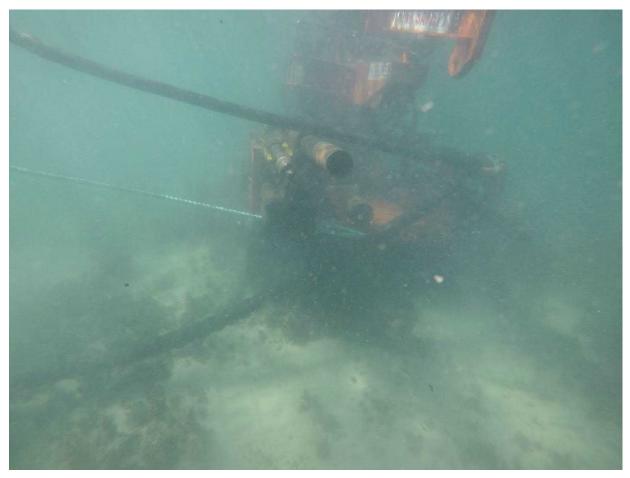
Figure 6 Rear view of subsea rig - note faint impression in sand veneer from rubber tracks at bottom left

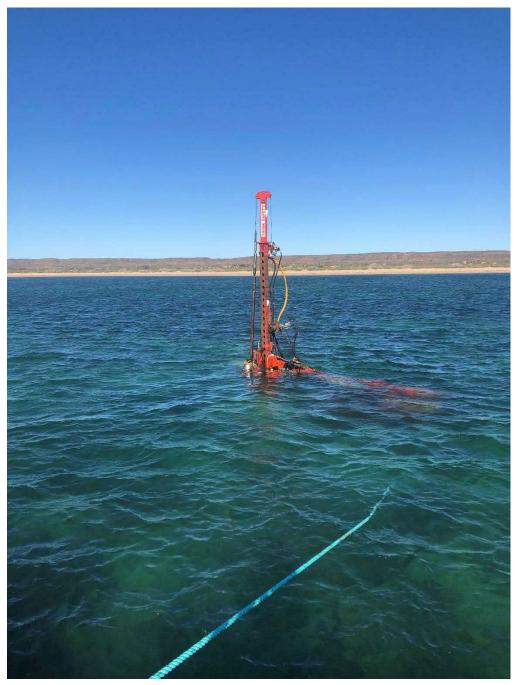
Turbidity was noted to be very slight (negligible) with some drilling mud venting into the water column but not enough to affect visibility and completely dispersing in the water current within 2 m of the borehole (Photo 7).

Figure 7 Rotary coring underway at BH12 with negligible turbidity from flush returns

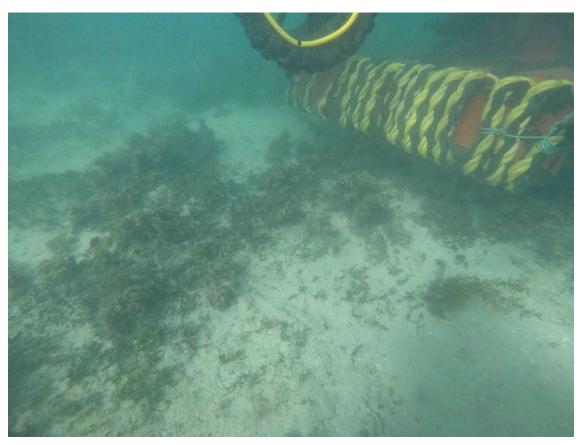
Photos are provided during the tracking (Photos 3, 4 and 5) from BH012 to BH01. The photos again confirm that faint tracks were left in the sand which will likely become undiscernible after a few hours of wave action. Precautions detailed in the Daily Site Diary for 7 May 2021 to reduce impact or damage to sea floor were taken and will continue to do so for the remainder of this drilling campaign.

Figure 6 Faint impression in seabed sand from leading blade visible near BH12

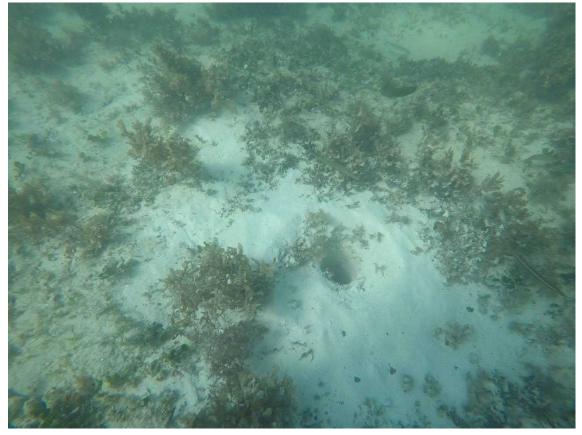
Figure 7 Area of seabed sand following completion of BH12 (hole visible)

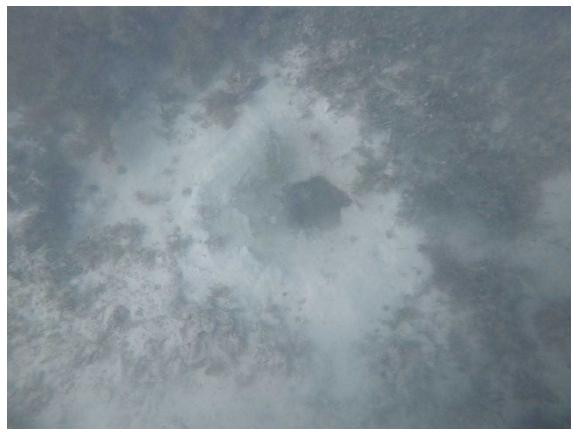
Figure 9 Seabed around BH01 following completion

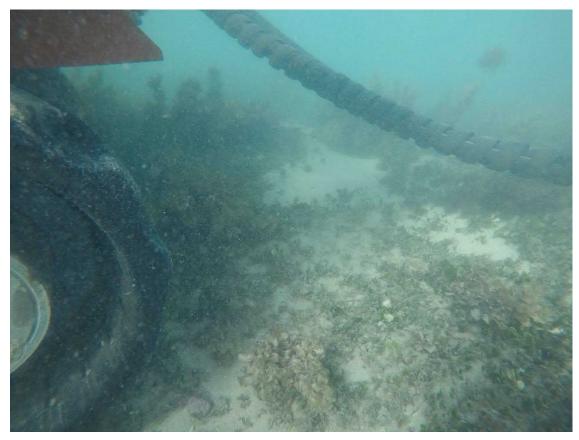
Figure 4 View of rear of subsea rig tracking left to right – no discernible imprints observed from tracks

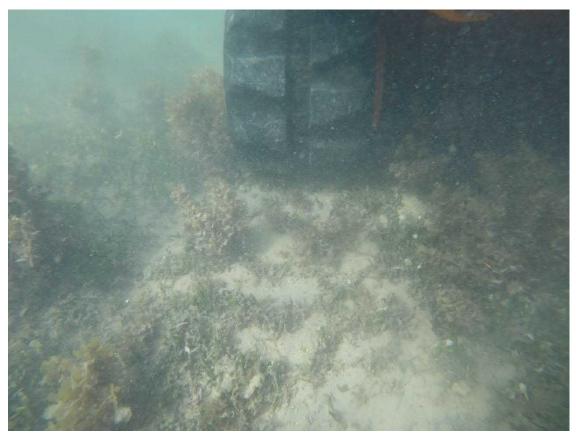
Figure 3 Track impressions in sandy substrate during tracking between BH02 and BH03

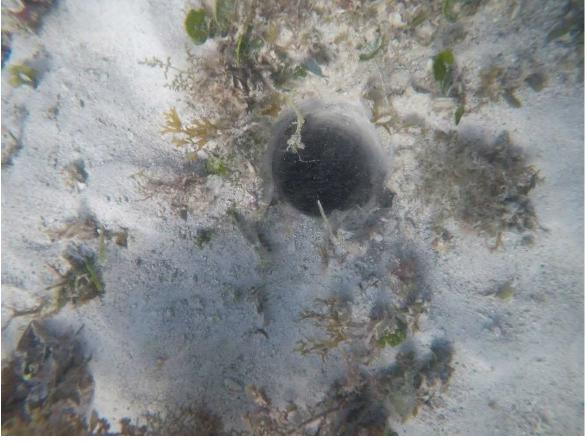
Figure 6 Close-up of seabed at BH16 following completion (11 May 21)
