Memo

Subject: Parker Point Benthic Community and Habitat Survey – January 2021

MScience Pty Ltd

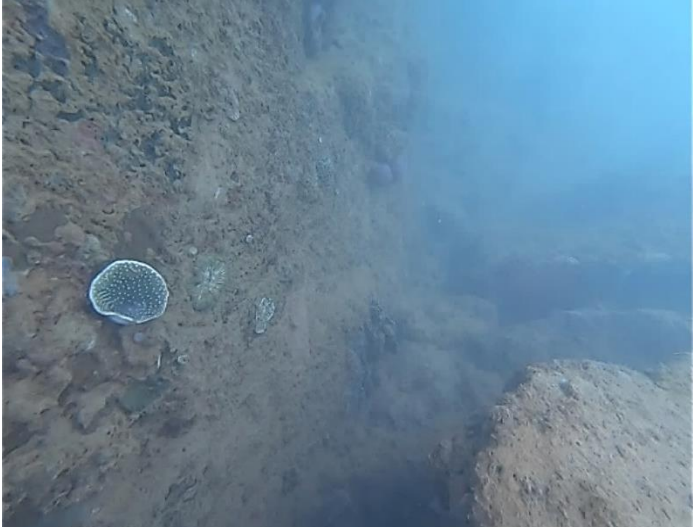
Area #	Location	Classification/Description	Representative Image
1	Northeast of the Parker Point fuel berth.	<p>Bare Sand with Sparse Mixed Benthos supported on the rockwall</p> <p>The survey area ranged between 4 to >12 m water depth.</p> <p>In 8 to >12 m, disturbed, bioturbated, uncolonised and unconsolidated silt and fine sand were observed – Bare.</p> <p>The rockwall adjacent to the shoreline was occupied by turf algae, occasional sparse coral, sponges and zoanthids. Segments of the rockwall which had fallen into deeper water (4 – 8 m) close to the fuel jetty supported turf algae and macroalgae, with occasional small corals and sponges – Sparse Mixed Benthos.</p> <p>Most common coral taxa: <i>Turbinaria mesenterina</i></p> <p>Estimated range % live coral cover: 0 – 3 %</p>

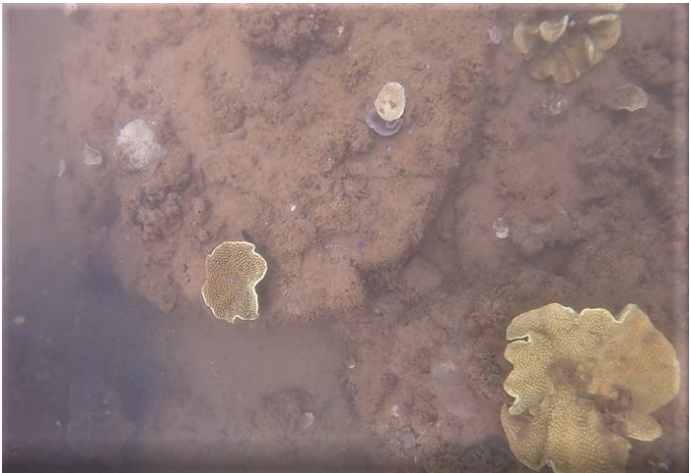
Area #	Location	Classification/Description	Representative Image
2	Shiploader / fuel jetty to Rock Wall (south of Parker Point)	<p>Mixed Community</p> <p>A shallow rocky outcrop extending ~30m was observed at the northern end of the rockwall. The substrate consisted of seawall boulders between hardground and rubble supporting turf algae, occasional small (<30 cm) coral colonies and sparse sponges and zoanthids.</p> <p>Most common coral taxa: <i>Turbinaria spp</i></p> <p>Estimated range % live coral cover: 3 – 5 %</p>

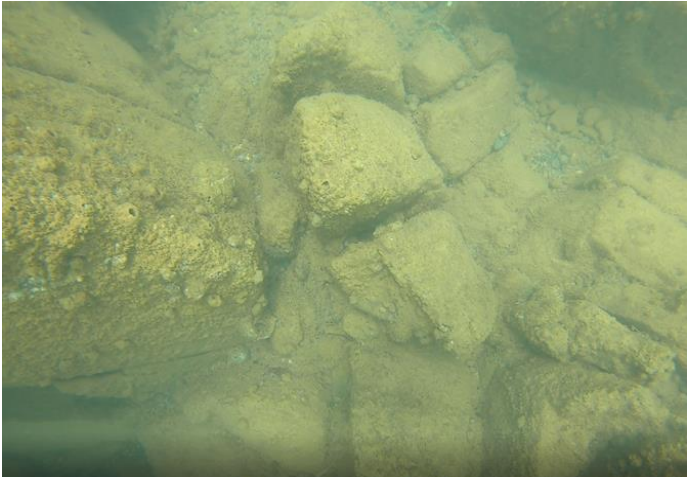
3	Rock wall (south of Parker Point)	<p>Bare</p> <p>Uncolonised artificial hard substrate surrounded by bare fine sediment.</p> <p>Most common coral taxa: N/A</p> <p>Estimated range % live coral cover: 0 %</p>

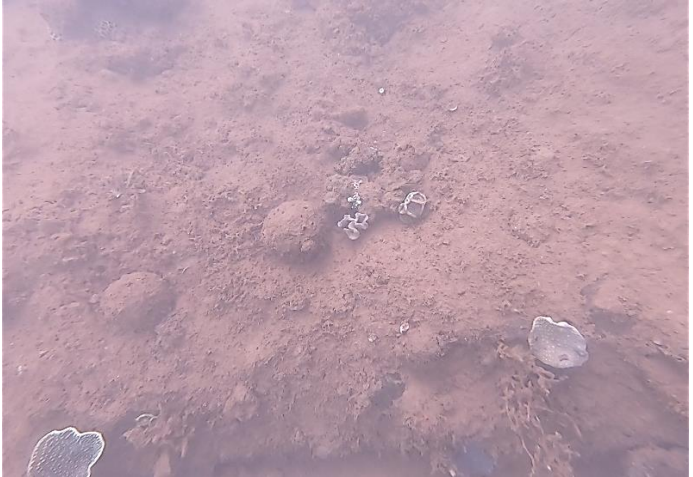
Area #	Location	Classification/Description	Representative Image
4	Rock wall (south of Parker Point) to power station pond	<p>Sparse Mixed Benthos</p> <p>A single transect was surveyed in the area. The habitat transitioned from fine to medium burrowed sand to patches of hard substrate, supporting turf algae, macroalgae and occasional corals and sparse sponges.</p> <p>Most common coral taxa: <i>Turbinaria mesenterina</i></p> <p>Estimated range % live coral cover: 0 – 5 %</p>

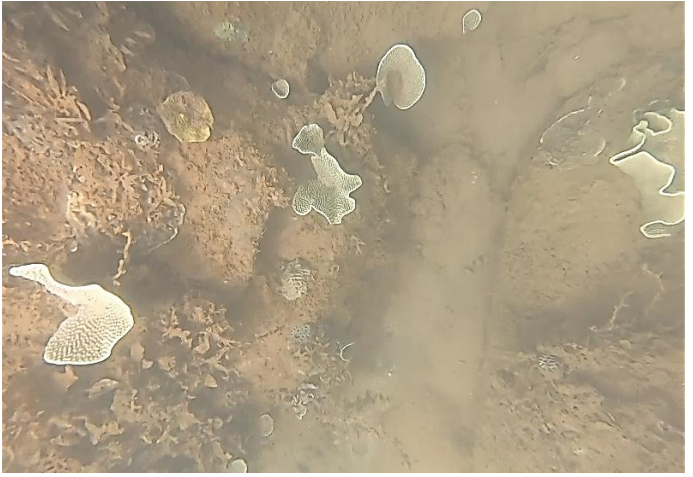
5	Power station pond	<p>Mixed Community</p> <p>Patches of hard rubble substrate, supporting turf algae, macroalgae, and sparse corals, surrounded by medium grained sand.</p> <p>Most common coral taxa: <i>Turbinaria spp</i> and <i>fungiids</i></p> <p>Estimated range % live coral cover: 3 – 10 %</p>

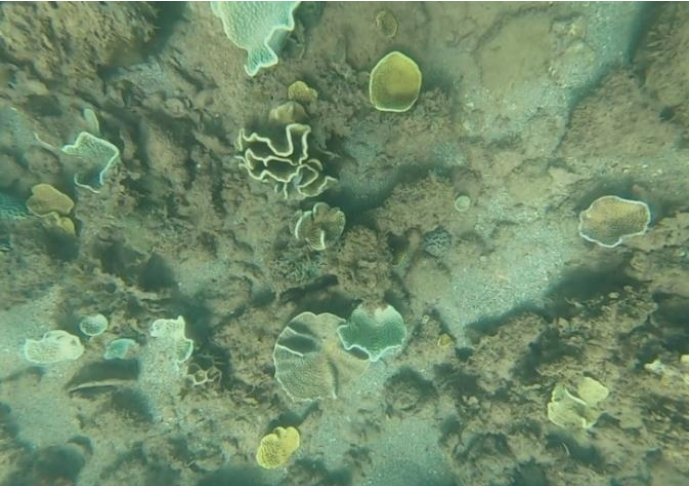
Area #	Location	Classification/Description	Representative Image
6	South of the power station pond	<p>Mixed Community (Coral habitat adjacent to Peninsula Palms)</p> <p>Patches of hard substrate and cobble habitat surrounded by medium grained sand. The hard substrate support turf algae, macroalgae, corals and sponges. Sections of the transect surveyed adjacent to the Peninsula Palms accommodation had coral cover estimated at 100%.</p> <p>Most common coral taxa: <i>Turbinaria spp</i></p> <p>Estimated range % live coral cover: 5 – 70 %</p>

The most significant habitat mapped was the reef along the front of what was the old Training Centre to the south-east of the intake pond. That area shows locally exceptional coral cover at 50-70%. The continued presence of coral cover above 25% at Tidepole Island is encouraging given that previous long-term monitoring conducted by RTIO had suggested that area was declining in coral cover (MScience 2010).

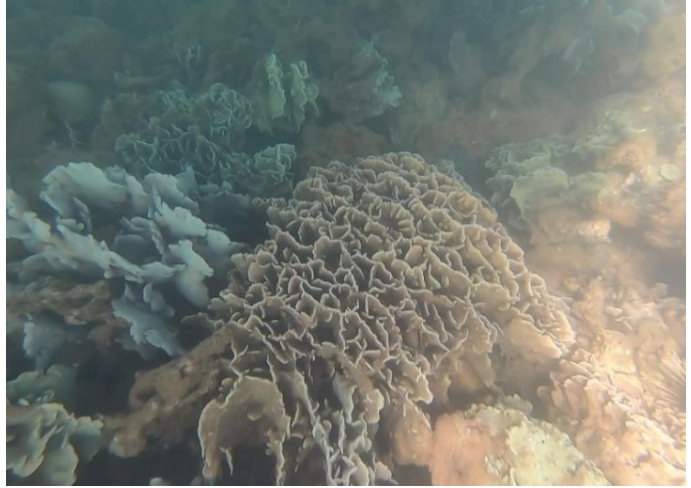
7	Tidepole Island	<p>Coral</p> <p>Natural hard substrate and reef supporting turf algae, macroalgae, coral colonies and sponges.</p> <p>Most common coral taxa: <i>Pavona</i>, <i>Porites</i> and <i>Goniastrea</i></p> <p>Estimated range % live coral cover: 25 – 50 %</p>

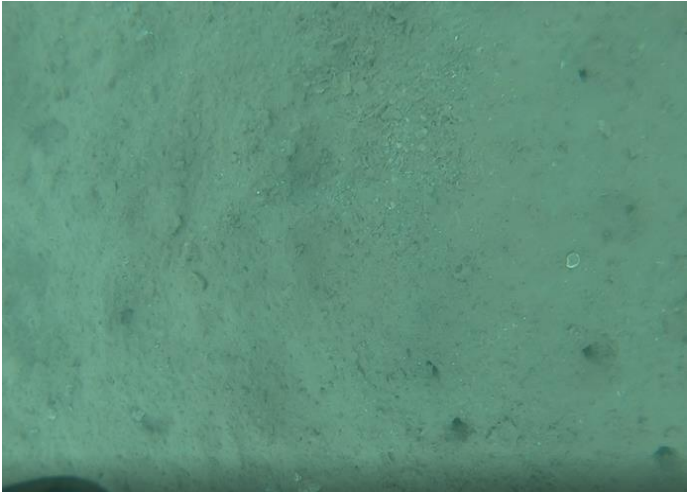
Area #	Location	Classification/Description	Representative Image
8	Parker Point Southern Swing Basin	<p>Bare</p> <p>The survey area ranged between 7 to ~ 12 m water depth. Most of the transects consisted of disturbed, bioturbated, unconsolidated, silt and fine sand. One of the 20 transects surveyed in the area, closest to Tidepole Island, exhibited a transitional rubble substrate which hosted very sparse patches of gorgonians, sponges and turfing algae at < 2% cover. These organisms were in poor condition and covered in sediments.</p> <p>Most common coral taxa: N/A</p> <p>Estimated range % live coral cover: 0 %</p>

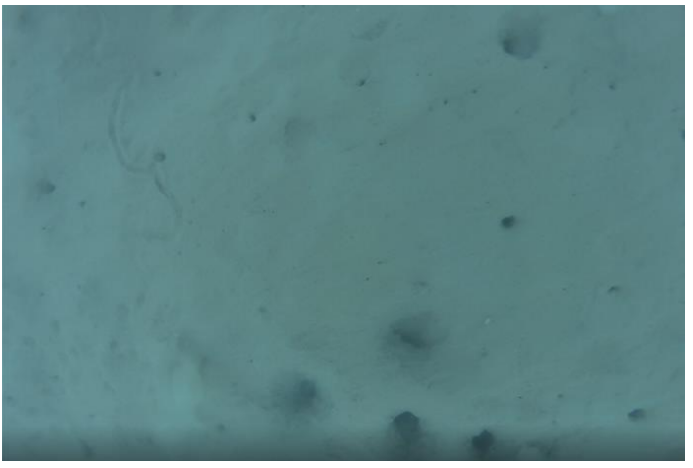
10	Offshore from fuel berth	<p>Bare</p> <p>Disturbed, bioturbated, uncolonised and unconsolidated silt and fine sand.</p> <p>Most common coral taxa: N/A</p> <p>Estimated range % live coral cover: 0 %</p>

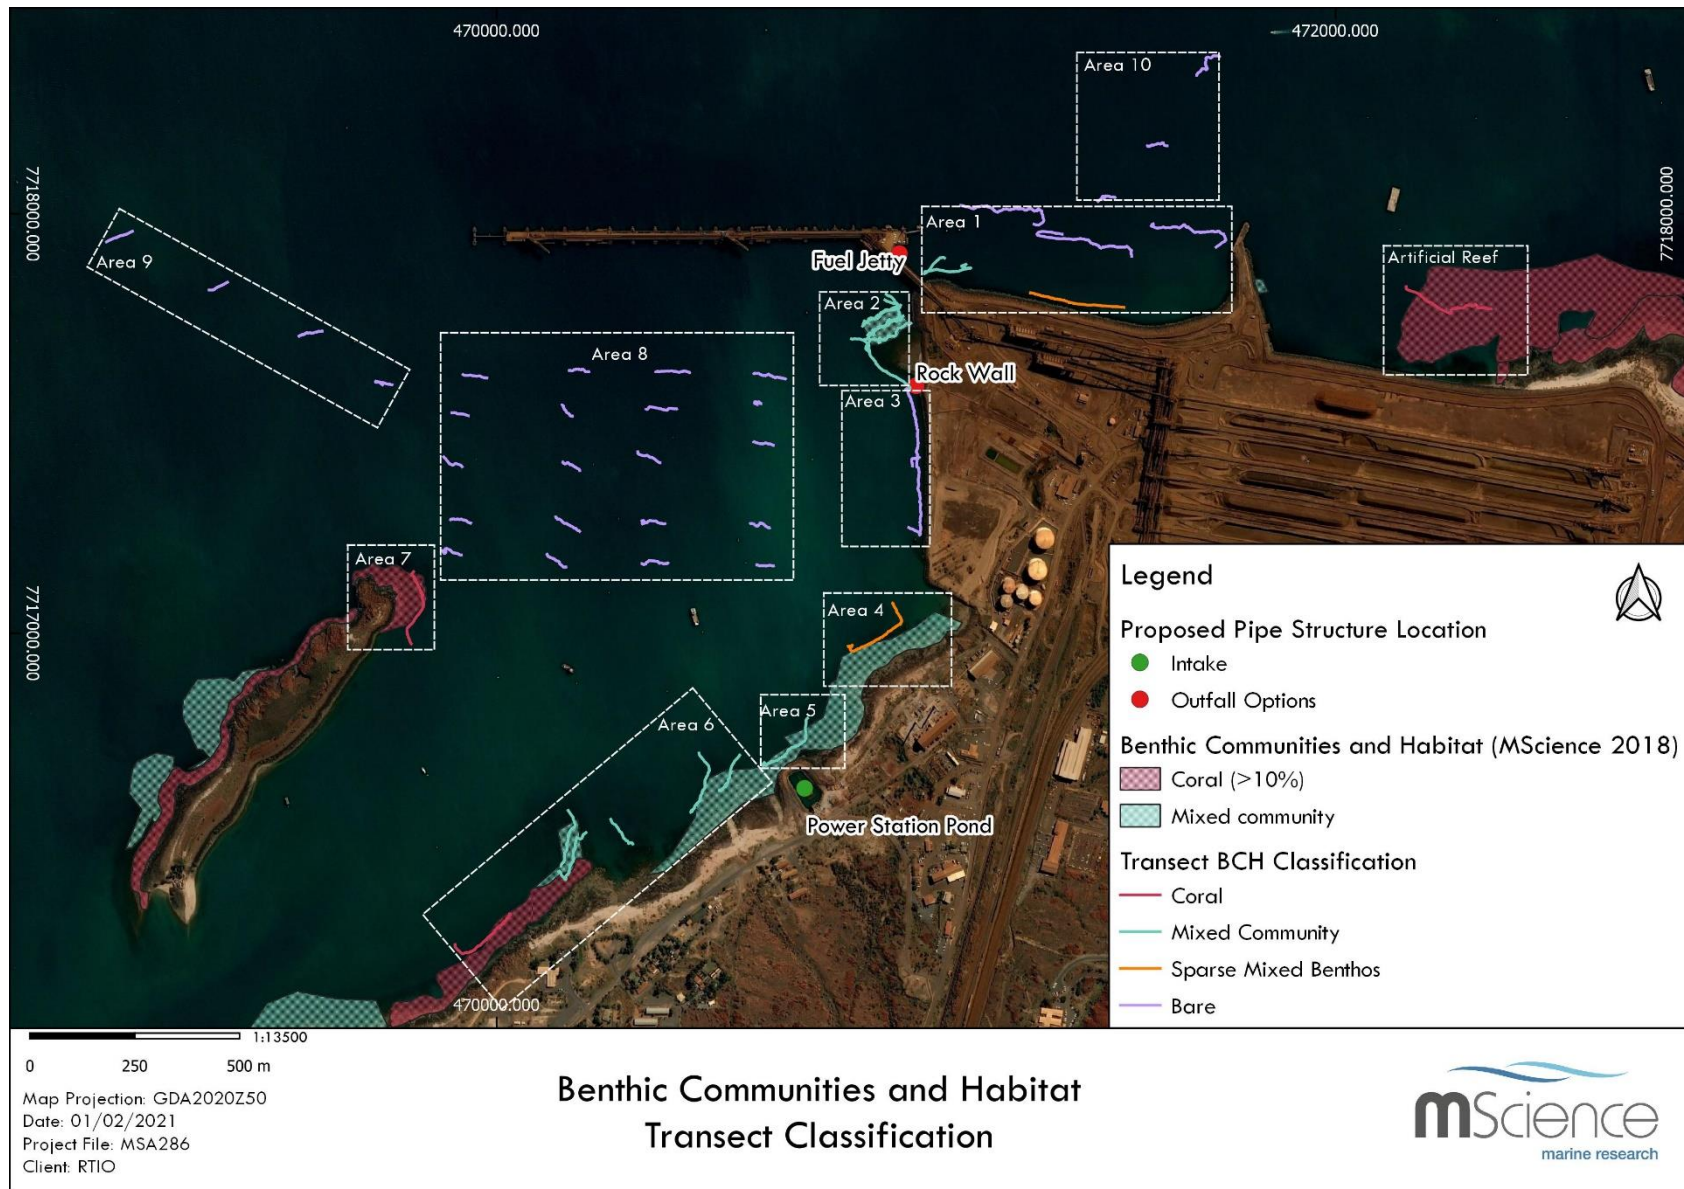
Figure 2. BCH classification of the transects

The BCH composition and distribution within the study area were consistent with previous studies and align with the habitat map produced by MScience (2018), as shown in Figure 2.

Transects surveyed within the predicted spatial extent of the brine discharge plume (Areas 8, 9 and 10) consisted of disturbed, bioturbated, uncolonised and unconsolidated silt and fine sand. Most of the predicted spatial extent of the brine discharge plume falls within areas which have previously been dredged or areas regularly subjected to propeller wash from ship and tug movements.
