Technical Appendix E1

Cultural Heritage Assessment and
Management Plan – Proposed Gorgon
Development, Pilbara, North-Western Australia

**Cultural Heritage Assessment &
Management Plan - Proposed Gorgon
Development, Pilbara, North Western
Australia**

Technical Appendix E2

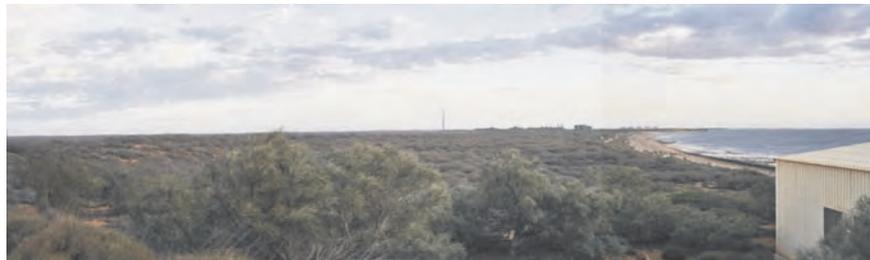
Figure 2. Viewing simulation looking north on ridgeline from Chevron Camp, approximately 4km from LNG Plant and port facilities site.

Where the LNG Plant, port facilities and construction camp is viewed within the drainage line flat or upon the nearby surrounding ridgeline (within the 5km viewshed) the visual effect will be moderate to substantial as the structure contrasts with the immediate landscape.

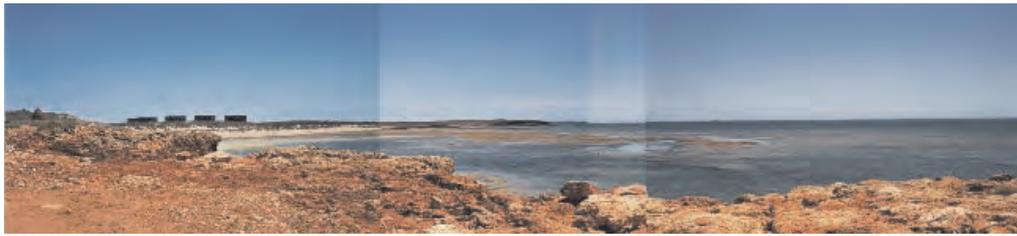
Figure 2.7 – View in northerly direction from Town Point showing oil Terminal Tanks on left and centre right Apache oil rig monopods visible on the ocean horizon.

Existing man-made infrastructure is situated and viewed readily along this coastline (ie. Barge docking infrastructure, 5 large oil terminal tanks, new and old Airports, Well Infrastructure and the Chevron Camp site).

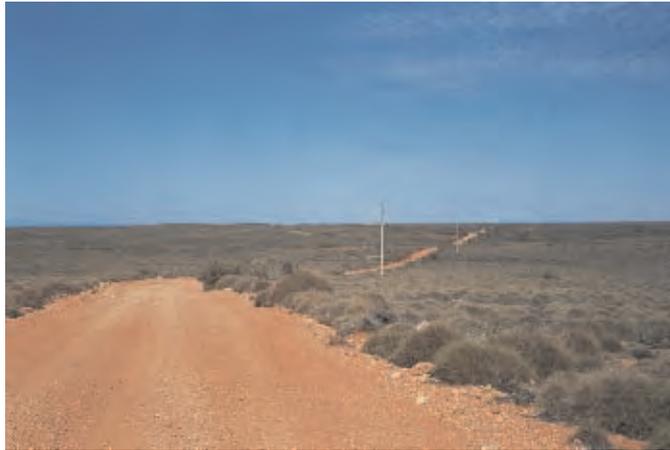
Figure 2.9 - View easterly from the central uplands towards terminal tanks proposed LNG plant showing vegetation, power poles, and road easement. East-west gas pipeline is proposed to run through this area along side road easement.

This landscape unit has limited capacity to absorb visual impacts especially if low screening vegetation is damaged or removed.

A large proportion of the proposed pipeline corridor is located in this landscape character unit.

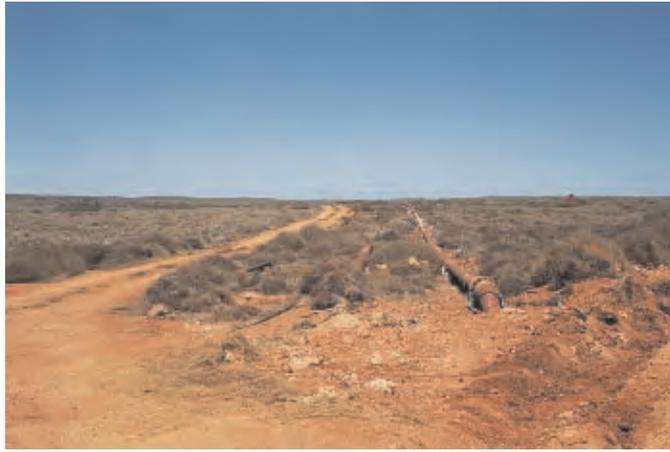
Figure 2.10 - View westerly from terminal tanks towards the central uplands showing main oil distributor pipe. Views along the pipe easement are in contrast to views adjacent the pipeline easement where low vegetation can screen pipeline views.

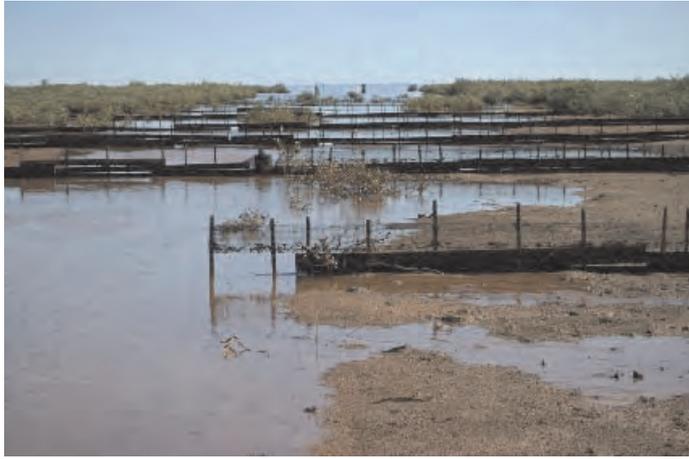
Figure 2.13. illustrates rehabilitation technique (fenced structure) used to shelter and encourage new Mangrove growth. This break in the Mangrove stand has occurred due to the existing gas easement.

Figure 2.13 - View west showing existing pipeline easement through the shoreline vegetation and rehabilitation works involved with mangrove re-establishment.

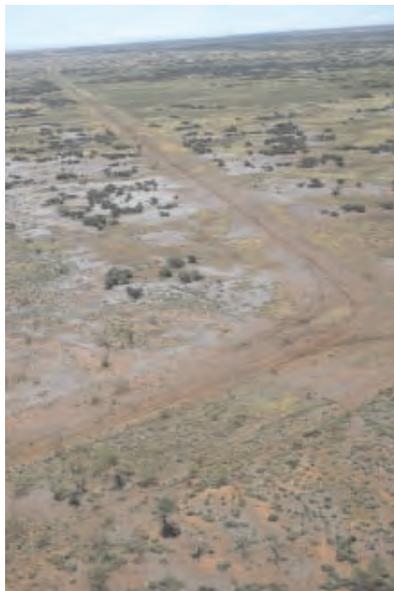
Figure 2.16 – Aerial viewing west near Compressor Station One. This view shows existing pipeline easement within the low lying shrub and grassland landscape.

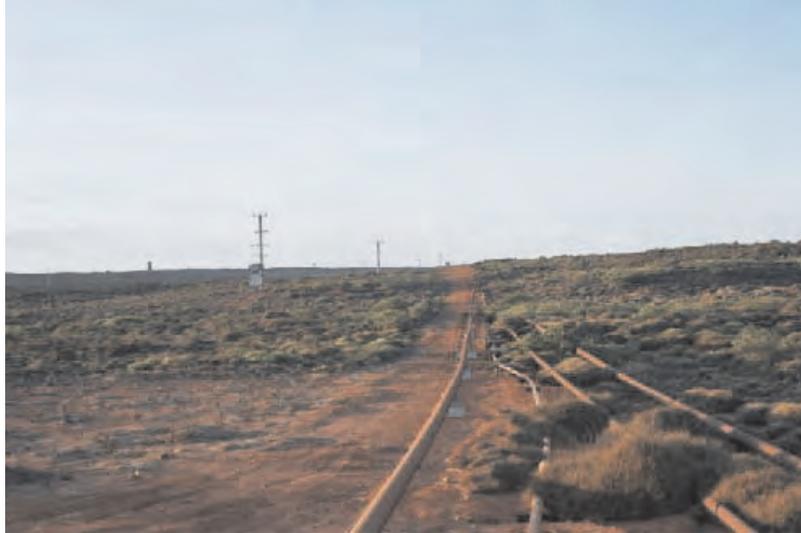
Fig 2.22 Viewing south showing typical pipeline and power easement at junction of north south and east west roads

Not until approaching this east-west road to Town Point has the pipeline corridor shared other main existing infrastructure easements. Whereas in this area there are a number of existing oil pipe and power easements snaking there way through the landscape often visually obstructed by slightly undulating land or existing vegetation. It is not until the viewer is aligned with one of these easements that a clear view of the infrastructure corridor is apparent as seen in Figure 2.22.

-
- when the pipeline angle is misaligned with the viewer on relatively flat ground the visual obtrusion becomes greater the further you can see along the easement. This is mostly experienced when the pipe easement crosses the road as seen in Figure 2.22 below;

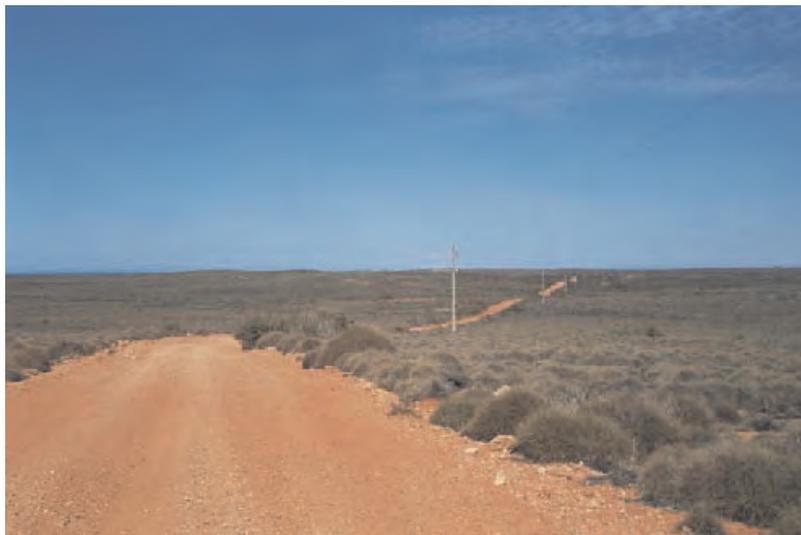
Fig 2.23 Viewing east along the east west road showing proposed pipeline corridor and existing power easement in a typical 'Limestone Ridges' landscape unit.

The roadside vegetation on the uplands becomes increasingly sparse on the limestone ridges this allows filtered views to the aligned corridor as the viewer travels along the east west road.

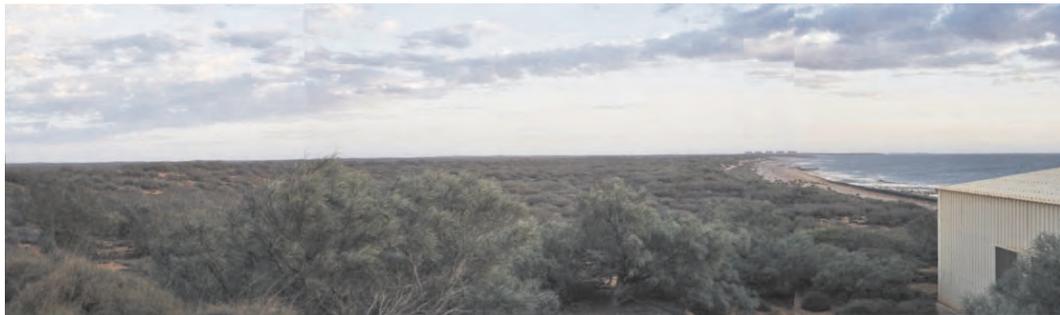
Fig 2.24 Viewing north from Chevron Camp towards proposed LNG Plant Site
The view shows a large open flat bordered by the Chevron Camp ridgeline and the Terminal Tank ridgeline to the north.

From the existing Chevron Camp looking north as indicated in Figure 2.24 below, the LNG Plant Site sits within a ‘Creek or Existing Drainage Line’ landscape unit. Limestone ridges to the north, south and west border the broad low-lying flat, with the land sloping gently down to the shoreline bordering to the east.

Vegetation on this flat is relatively tall (1-1.5m) and there is a dense cover of spinifex, *Triodia pungens*.

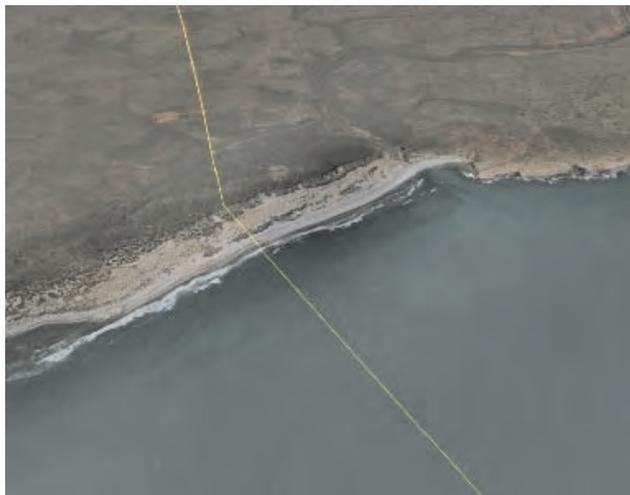
Fig 3.1 Aerial viewing east towards White's Beach showing proposed pipeline corridor and existing road running adjacent to shoreline.

An access road passes a few hundred metres adjacent on the ridgeline east of North White's Beach as seen in Figure 3.1 below. A track would need to be developed to allow construction equipment access down a moderate gradient to the site.

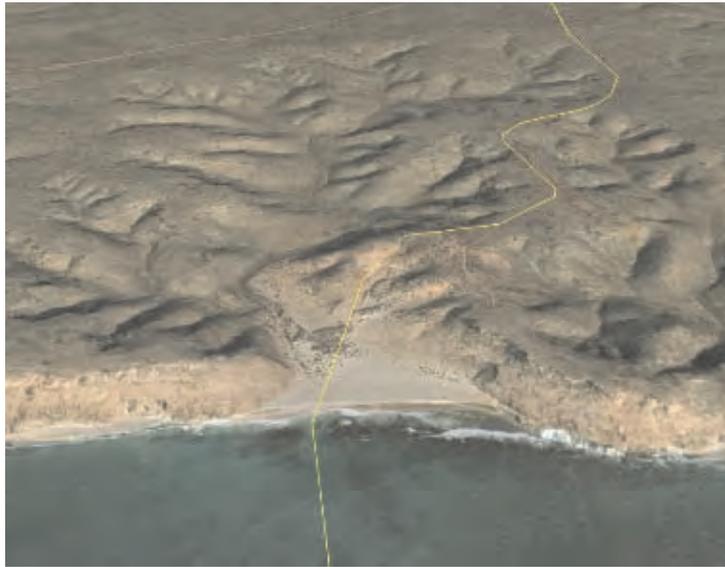
Fig 3.2 Aerial viewing east towards Flacourt Bay showing proposed pipeline corridor and existing road terminating on ridgeline south of beach.

The existing road terminates on a ridgeline to the south of Flacourt Bay as seen in Figure 3.2 following page. A track would have to be developed down a steep sided valley to allow construction equipment access to the site.

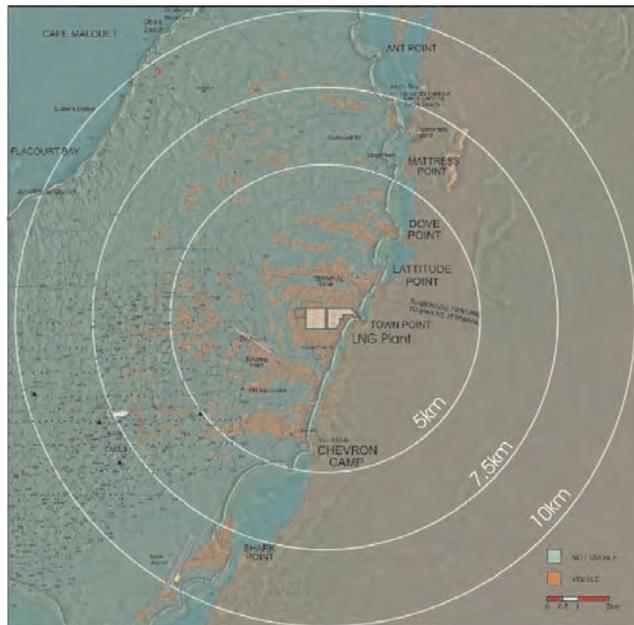
Figure 3.4 - Viewshed of LNG Plant site

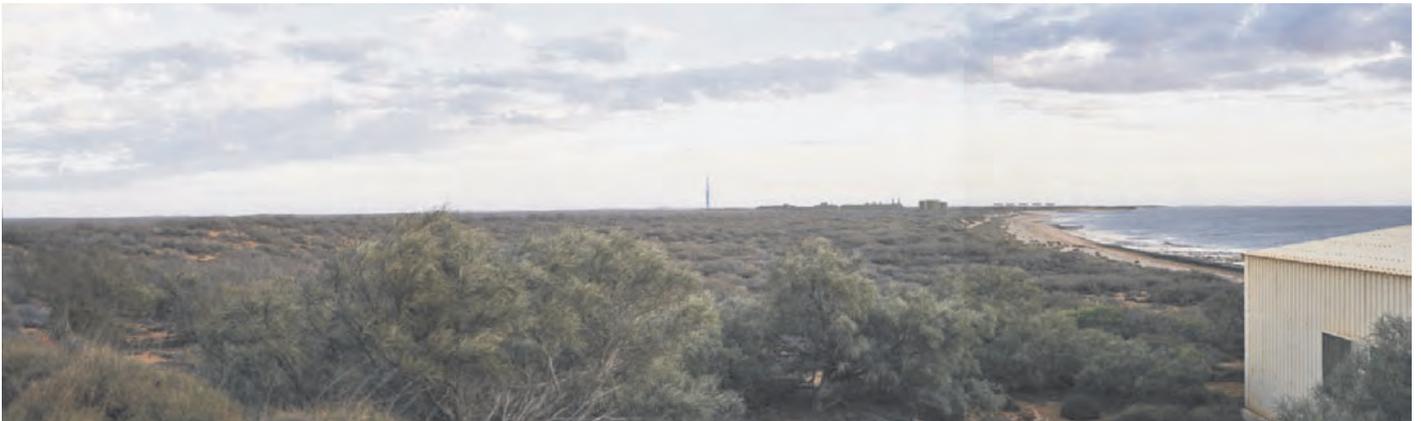
Figure 3.7 – Simulation of LNG Plant & Port Facilities at completion of works from Viewpoint 1 – Chevron Camp

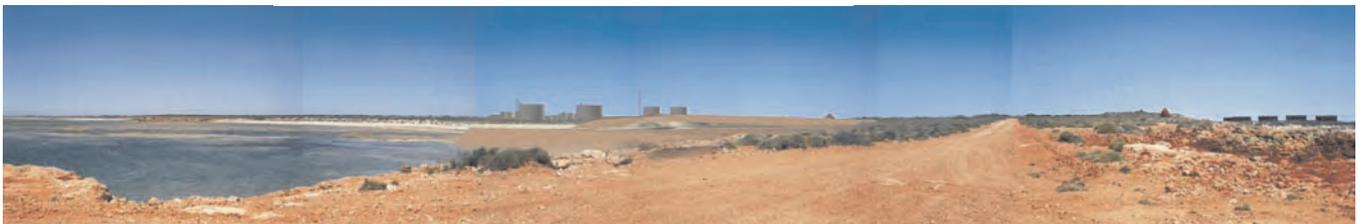
Figure 3.9 – Simulation of LNG Plant at completion of works from Viewpoint 2 – Town Point

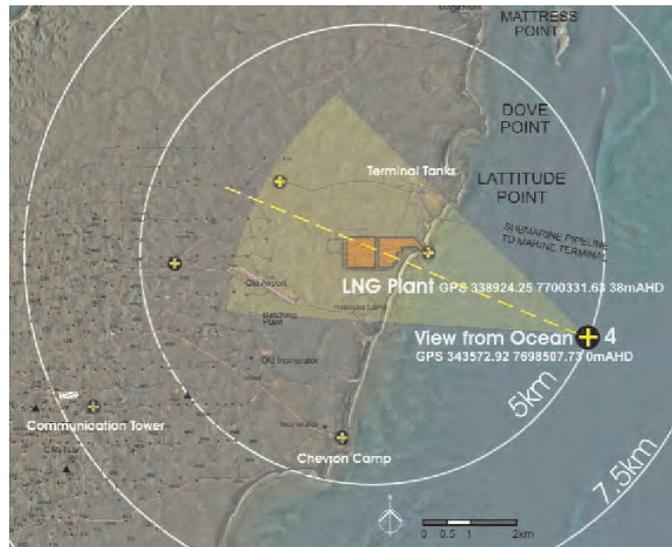
Figure 3.12 – Viewpoint 4

The view is looking west from 5km east of the proposed LNG Plant.

From this viewpoint the LNG Plant has a moderate to substantial visual impact and the view indicates how the LNG Plant and Port Facilities form a recognisable new element within the landscape.

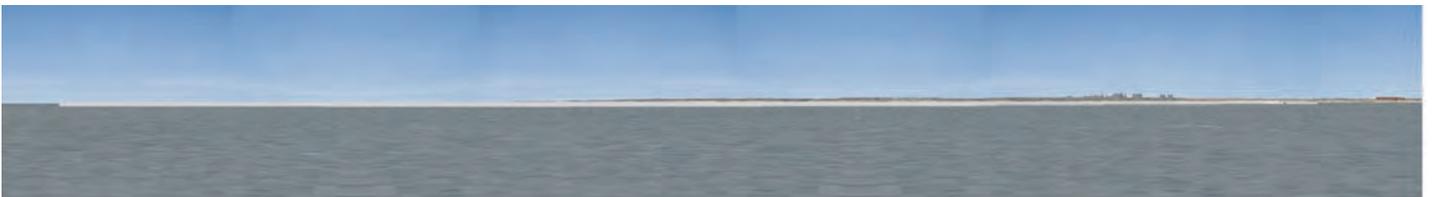
Figure 3.13 – Simulation of LNG Plant at completion of works from Viewpoint 4 – Ocean View at 5km east of LNG Plant. View at left of figure shows extent of Ship Gas Loading facility.

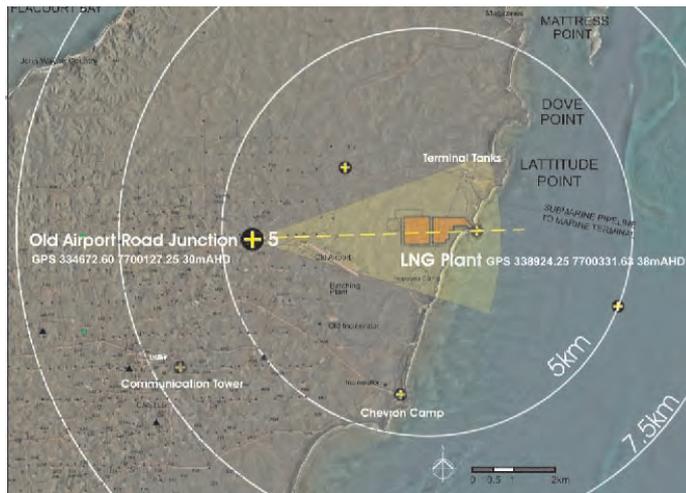
Figure 3.14 – Viewpoint 5

This view is looking due east from a major road junction 1.5km west of the old Airport and 4.9km due west of the Proposed LNG Plant site.

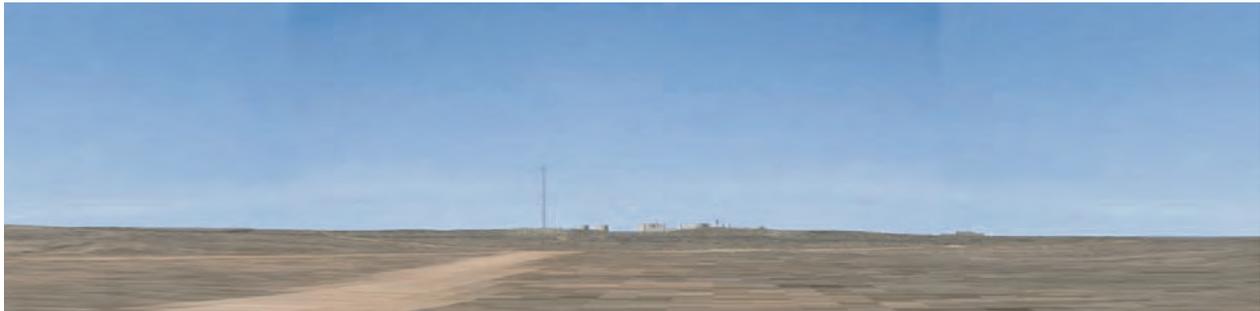
Figure 3.15 – Simulation of LNG Plant at completion of works from Viewpoint 5 – Road Junction, Old Airport

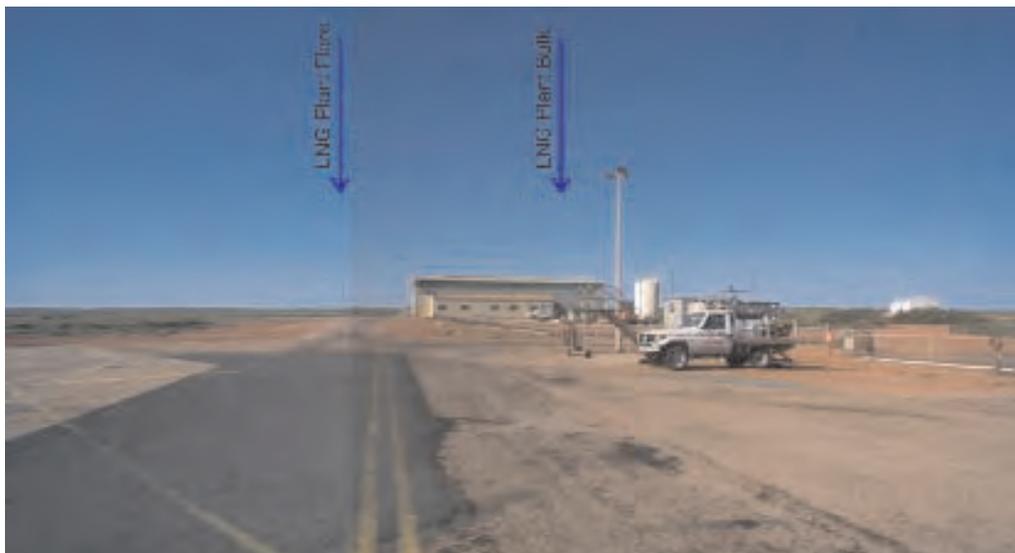
Figure 3.17 – This view is looking north north-east from the New Airport passenger terminal at Barrow Island 9.7km south west of the of the Proposed LNG Plant site.

have of the development site. From this viewpoint the bulk of the development sits behind the helicopter hanger and the flare is the only structure that can be faintly seen. The bulk of the plant sits below a ridgeline and structures that sit above form, from this distance, part of the landform.

The visual impact of the development from the New Airport passenger terminal would be described as negligible to none.

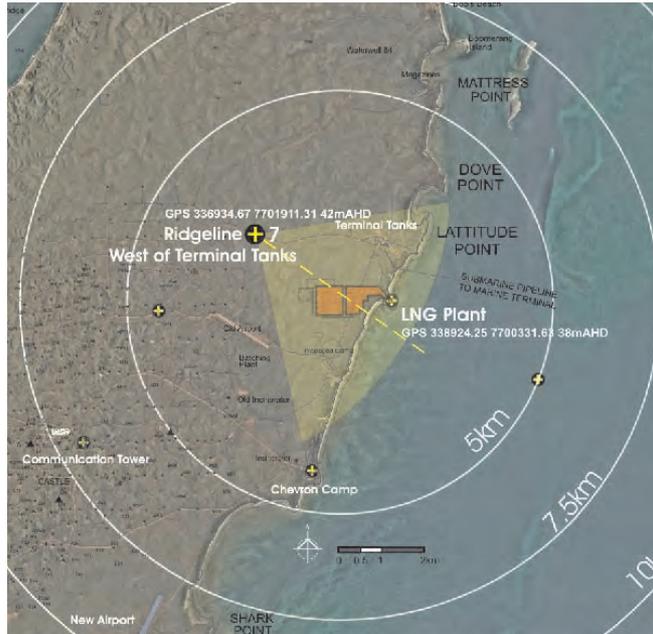
Figure 3.18 – Viewpoint 7

This view is looking south east from a main road that leads west from the existing Terminal Tanks. This view is from the highest point of the ridgeline that surrounds the development site. It is situated 3km west of the Terminal Tanks and 2.5km north west of the development site.

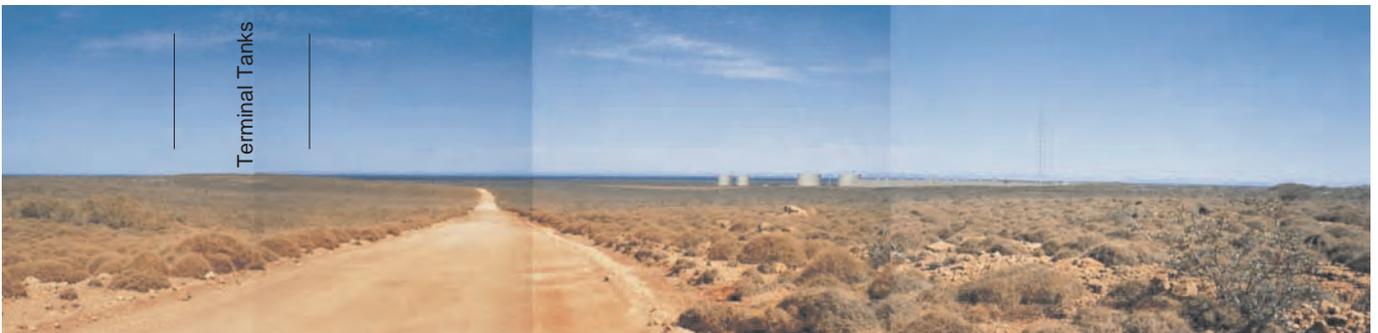
Figure 3.19 – Simulation of LNG Plant at completion of works from Viewpoint 7 – Ridgeline West of Terminal Tanks

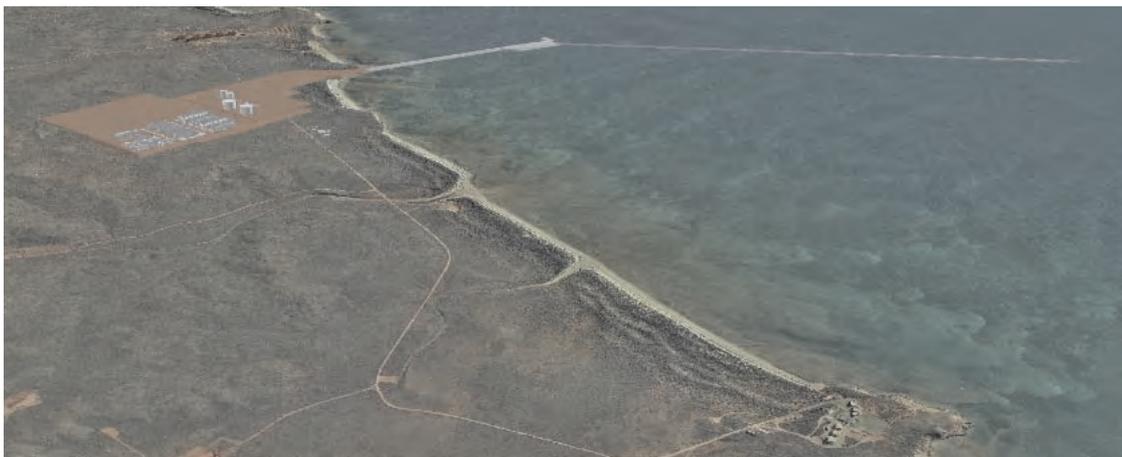
Figure 4.1 – Proposed aerial view simulation of LNG Plant at completion of works. View shows LNG Plant & extent of Port Facilities. Chevron Camp can be viewed on the lower right hand corner of the simulation.
