LANDBANK

PROPOSED DEVELOPMENT AT McCABE STREET

PUBLIC ENVIRONMENTAL REPORT

VOLUME II

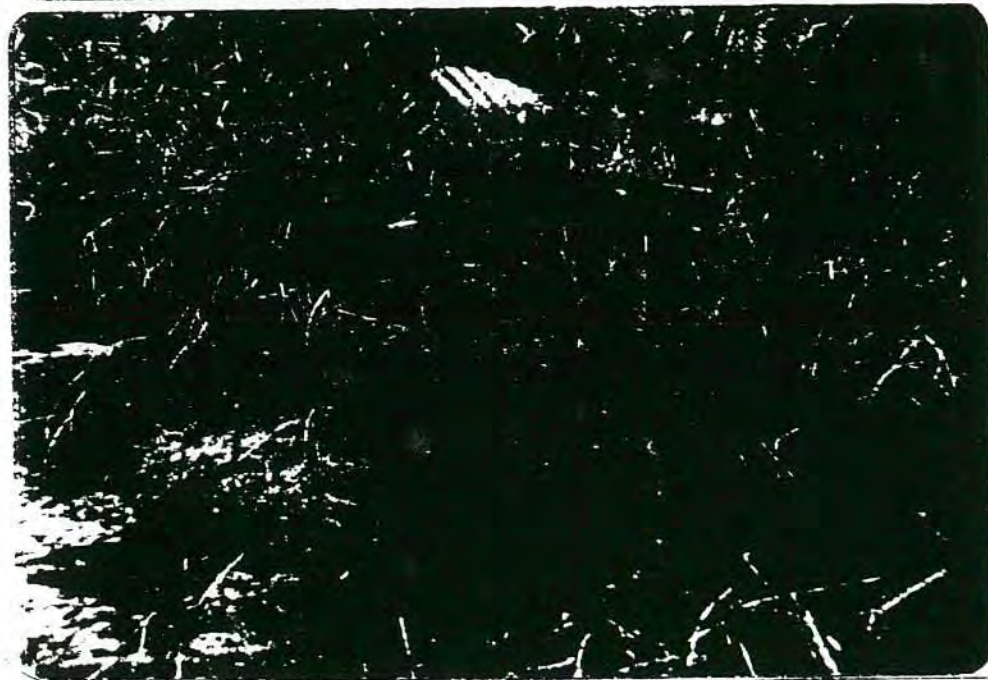
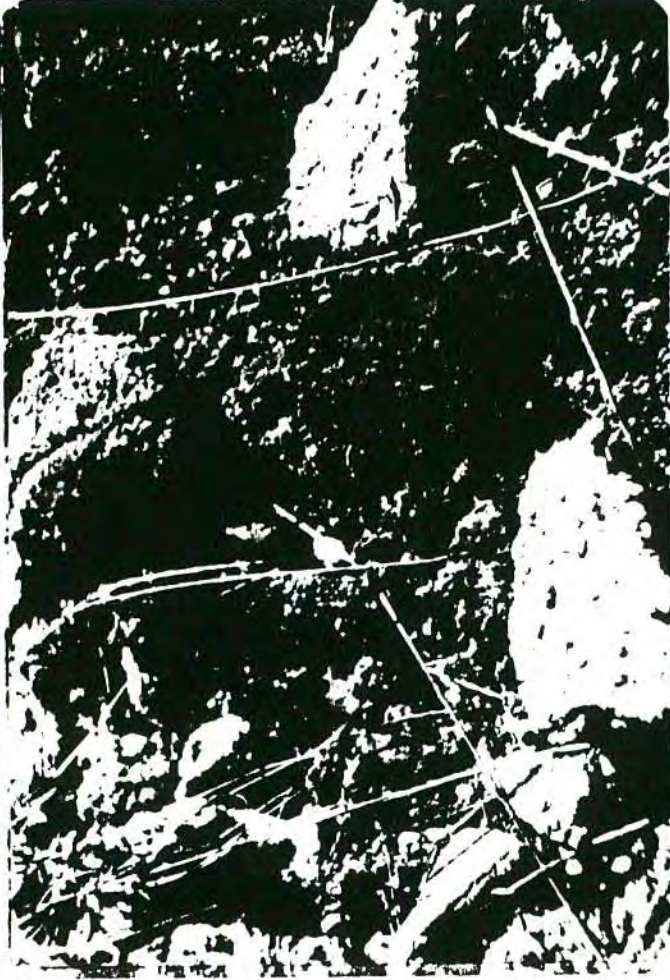
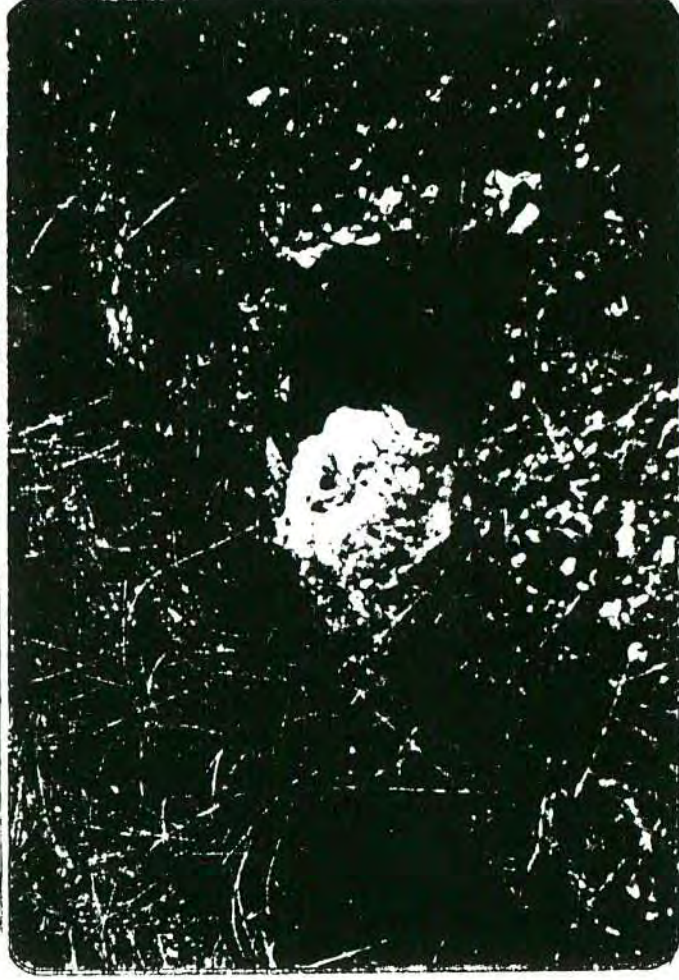
See photographs 1 - 5 below:

Dump site near
borehole 4

Fertilizer waste

Magnified area of
fertilizer waste.

Phosphate and
copper waste 1.

Phosphate and
copper waste 2.

Analysis of a portion of contaminated soil from photograph 5 gave the following results.

Copper	6950 PPM
Lead	90 PPM
Zinc	635 PPM
Bismuth	10 PPM
Cadmium	20 PPM
Iron	6000 PPM
Mercury	0.27 PPM
Arsenic	29 PPM

Copper is in excess of that which would cause toxicity to plants (25 PPM E.D.T.A. soluble Cu is maximum most plants can tolerate).

Lead is not at a sufficiently high level to cause concern.

Zinc is in excess of that which would cause toxicity to plant (25 PPM E.D.T.A. Zn is maximum most plants can tolerate).
