**GRIFFIN GAS PIPELINE DEVELOPMENT
CONSULTATIVE ENVIRONMENTAL REVIEW**

**Volume II
Appendices**

GRIFFIN GAS PIPELINE DEVELOPMENT

CONSULTATIVE ENVIRONMENTAL REVIEW GUIDELINES

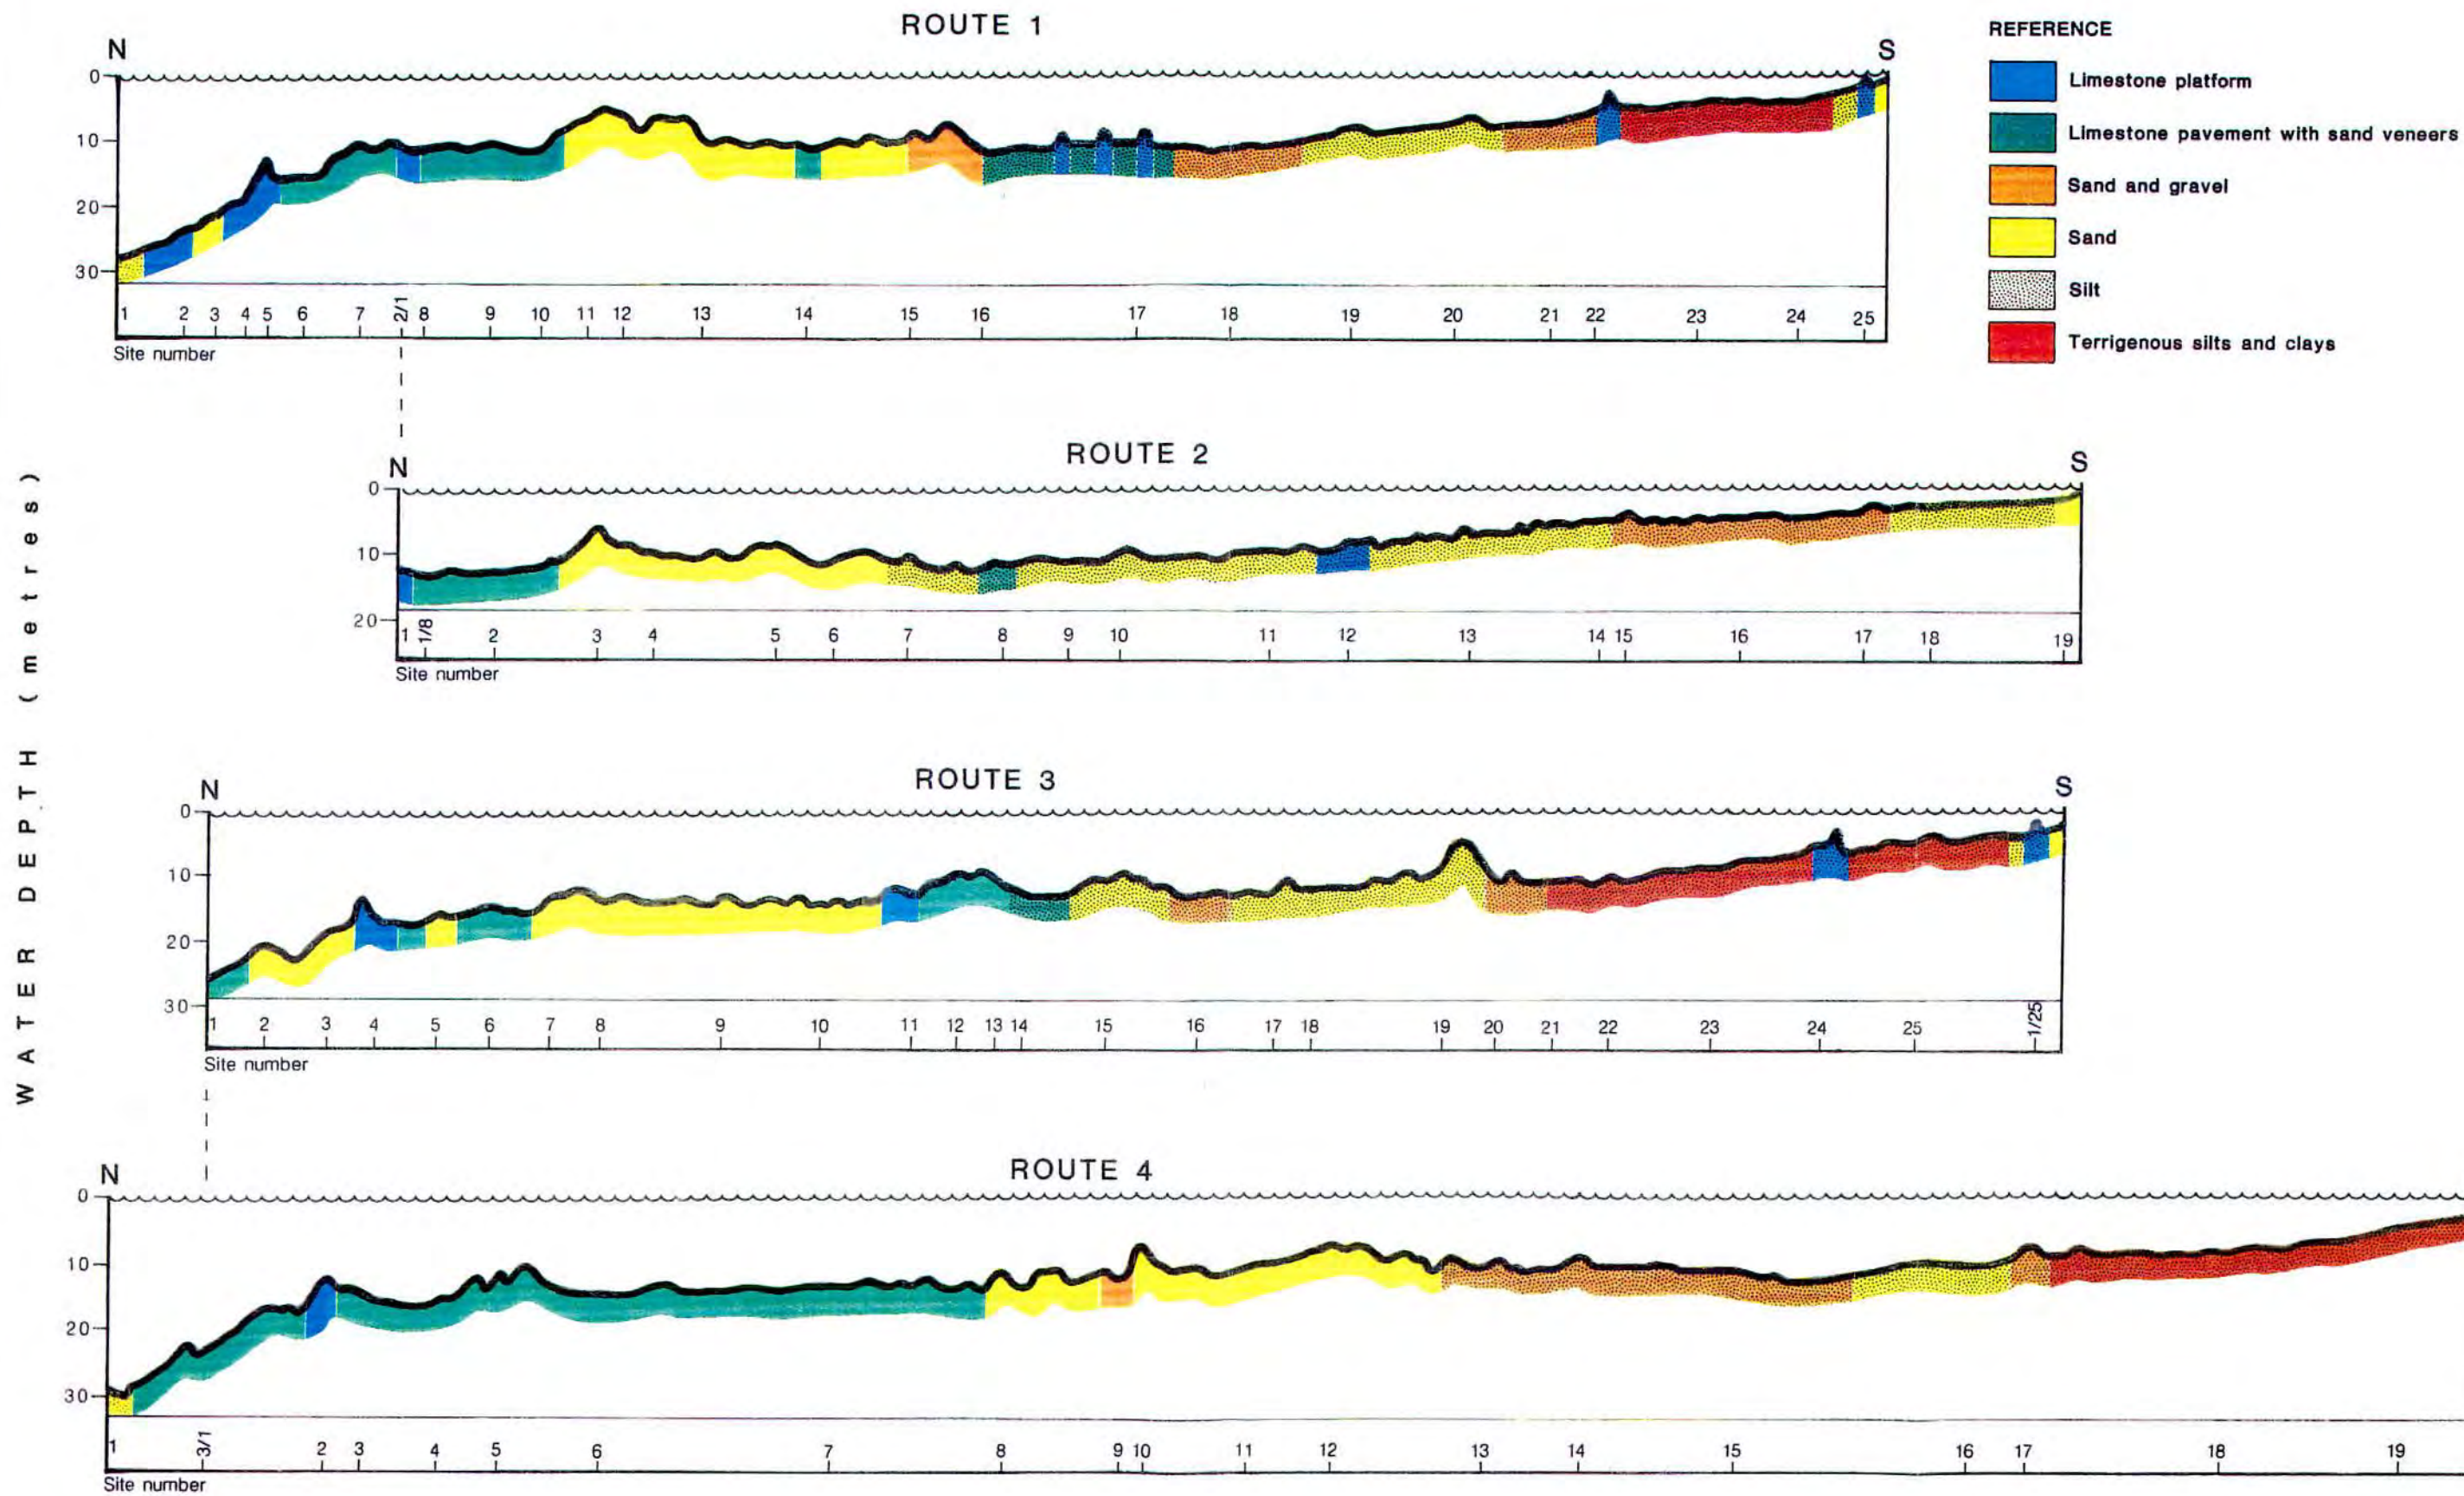
Figure
3

BHP Petroleum Pty Ltd
Griffin Areas Oilfield Development - Submarine Gas Pipeline
SEAFLOOR SURVEY OF POTENTIAL ROUTES
**BATHYMETRIC PROFILES
AND HABITAT DISTRIBUTION
ALONG POTENTIAL PIPELINE ROUTES**

The pertinent biophysical features which were found along each of the four routes are described below, and should be read in conjunction with Figures 2 and 3 and Tables 1A-D.

Between 22 m and 20 m, there was a terraced area covered by a thick (>1 m) sheet of fine sands colonised by a sparse epibiota (Figs 2, 3). This substrate type extended to the next portion of the incline, which comprised an exposed limestone pavement that was inspected at a depth of 17.5 m (site 1/4; Figs 2, 3). Benthic biota remained sparse (~10% cover; Table 1A), but there were areas of raised and broken limestone forming low ledges and shelter for fish and crustaceans (Plate 1).

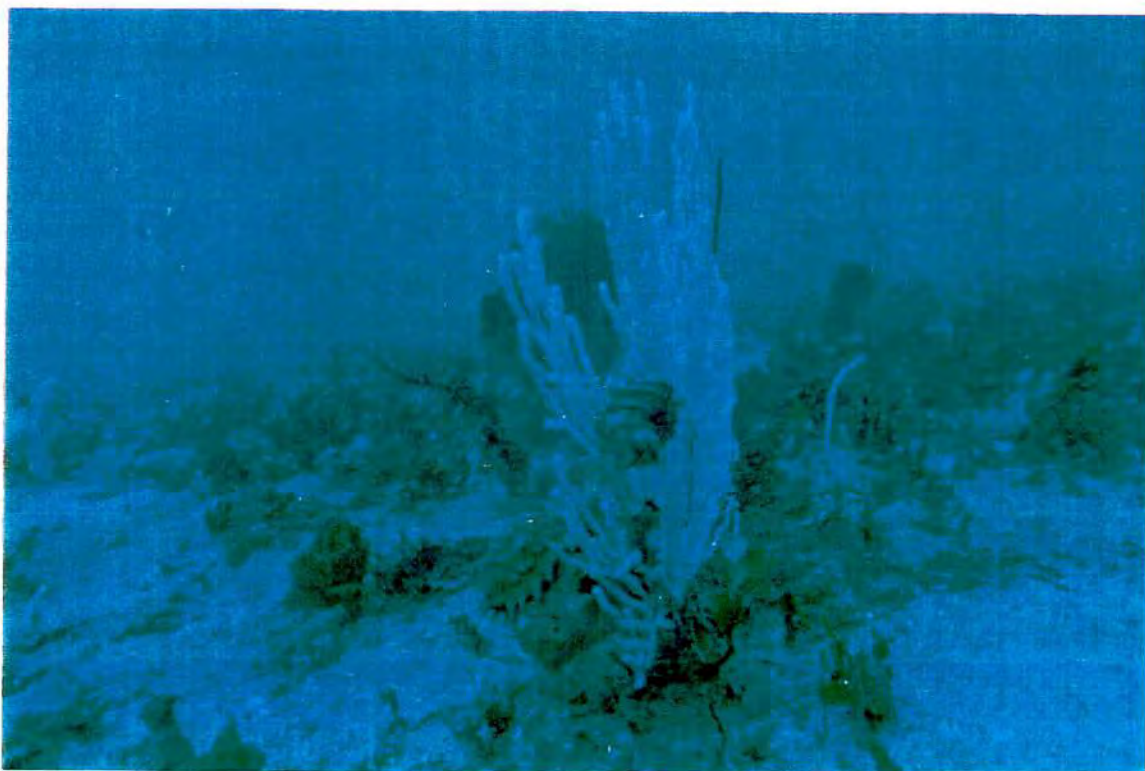
Plate 2: Limestone pavement with a thin (<2 cm) veneer of sand at 12 m depth - Site 7, Route 1. Sea fan (*Gorgonacea*), feather star (*Crinoidea*), sea cucumber (*Holothurioidea*) and calcareous green algae (*Halimeda* sp) in foreground are associated with protruding limestone. In the background are sponges (*Porifera*), solitary ascidians (*Ascidacea*), a sea whip (*Gorgonacea*) and brown algae (*Sargassum* sp).

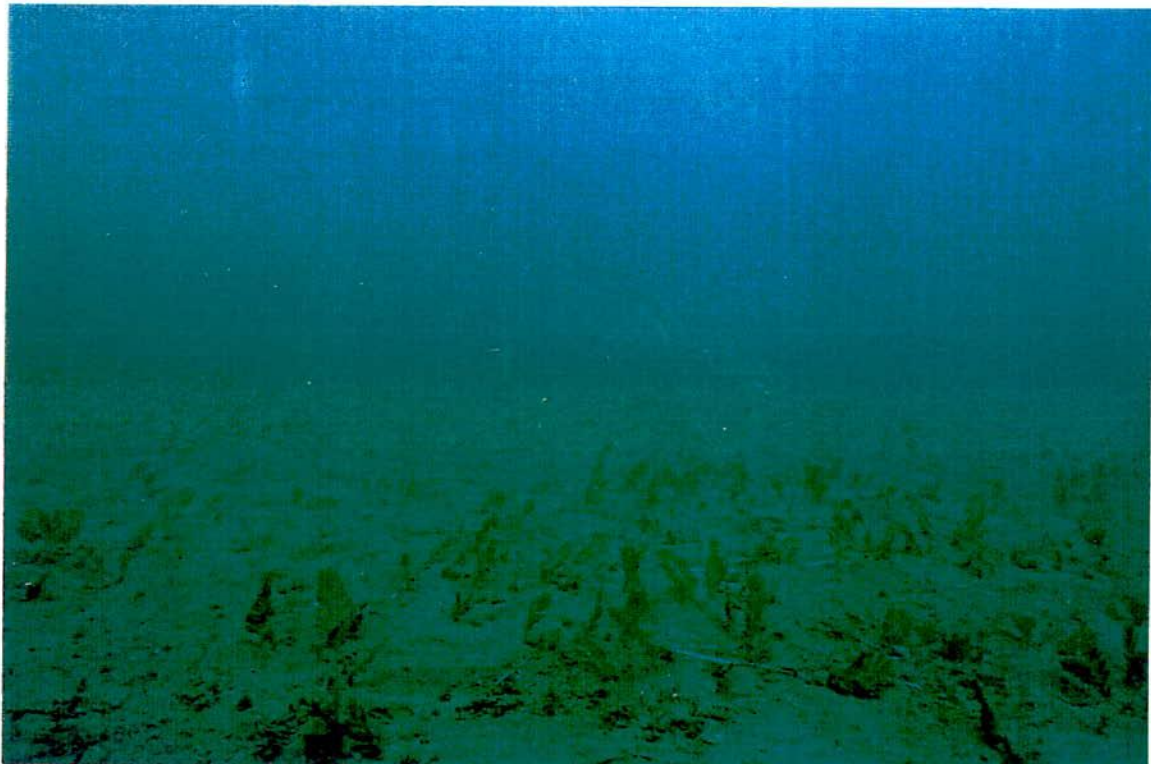
Plate 4: Sand bank at 10 m depth - Site 10, Route 4. Sand is medium texture with seagrass (*Halophila spinulosa*) and a colonial hydroid (*Hydrozoa*). Seagrass cover on the bank reached 25% by area.

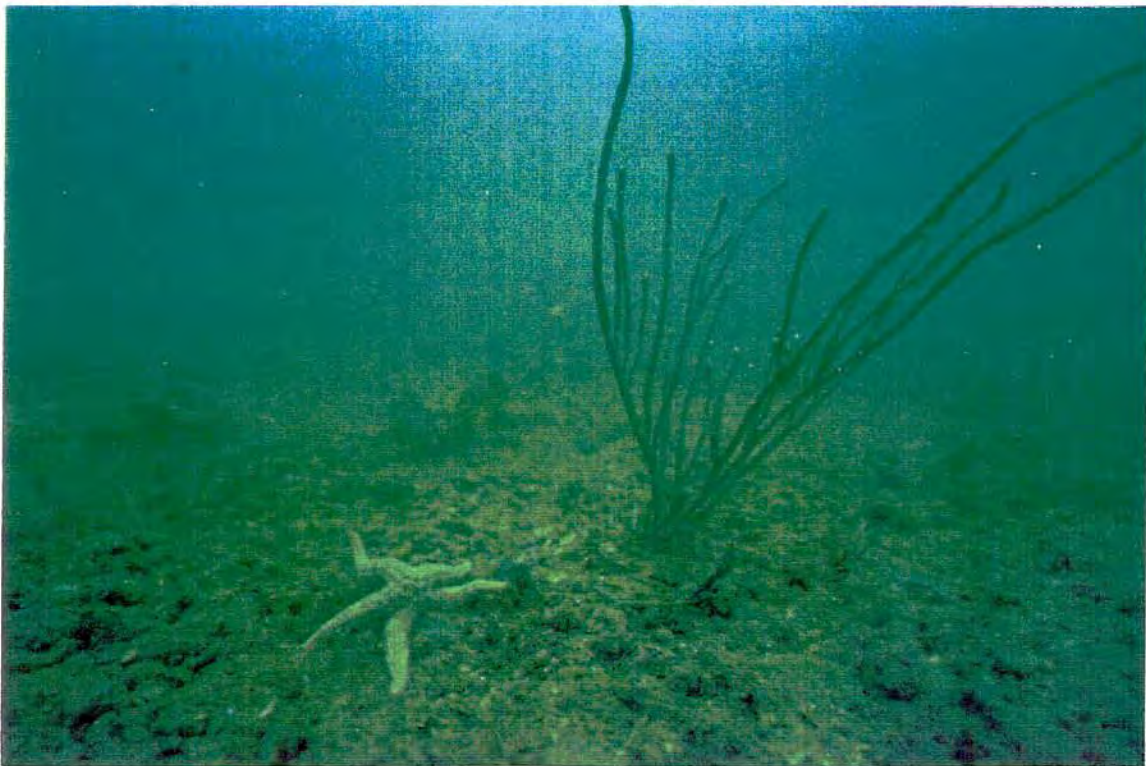
Plate 5: Trawl ground, showing typical substrate of coarse sand and gravel with shell fragments and silt, at 9 m depth - Site 14, Route 4. Small gorgonians (*Gorgonacea*) and sea stars (*Asteroidea*) as shown, as well as small sponges (*Porifera*), hydroids (*Hydrozoa*) and ascidians (*Ascidacea*) are the main components of the very sparse epifauna in these areas.

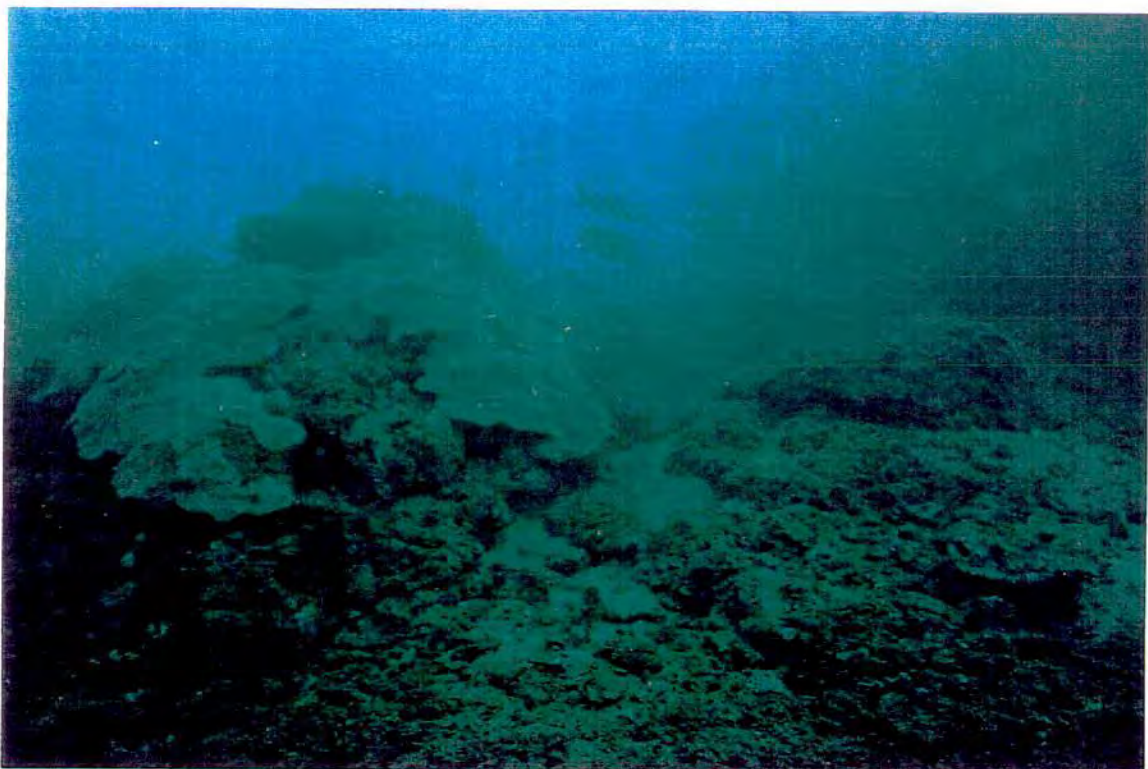
Plate 6: High-relief limestone at 8 m depth - Santo Rock. *Porites* coral colony at left and silt veneer/algal turf over substrate were typical for the area.

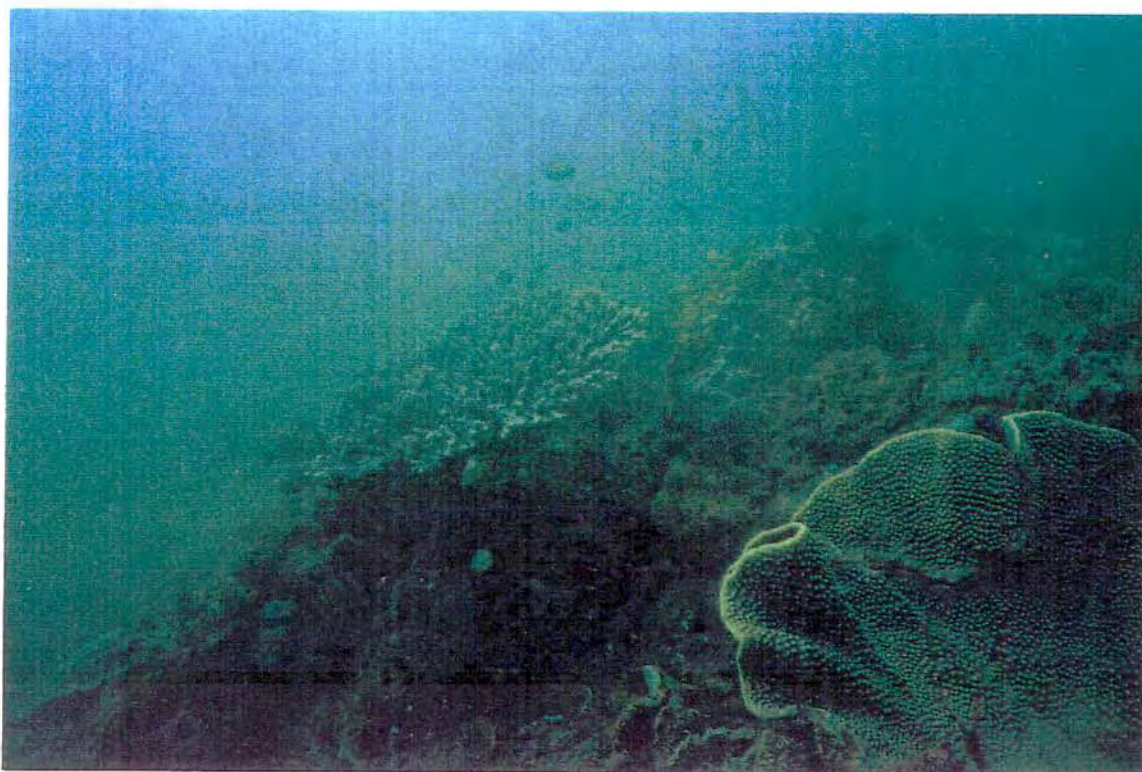
Plate 7: High-relief limestone at 4 m depth - East Locker patch. Sparse (10%) hard coral cover was dominated by *Turbinaria* (foreground) *Montipora*, *Acropora* (centre) and *Porites*. A silt veneer was present over most of the substrate.

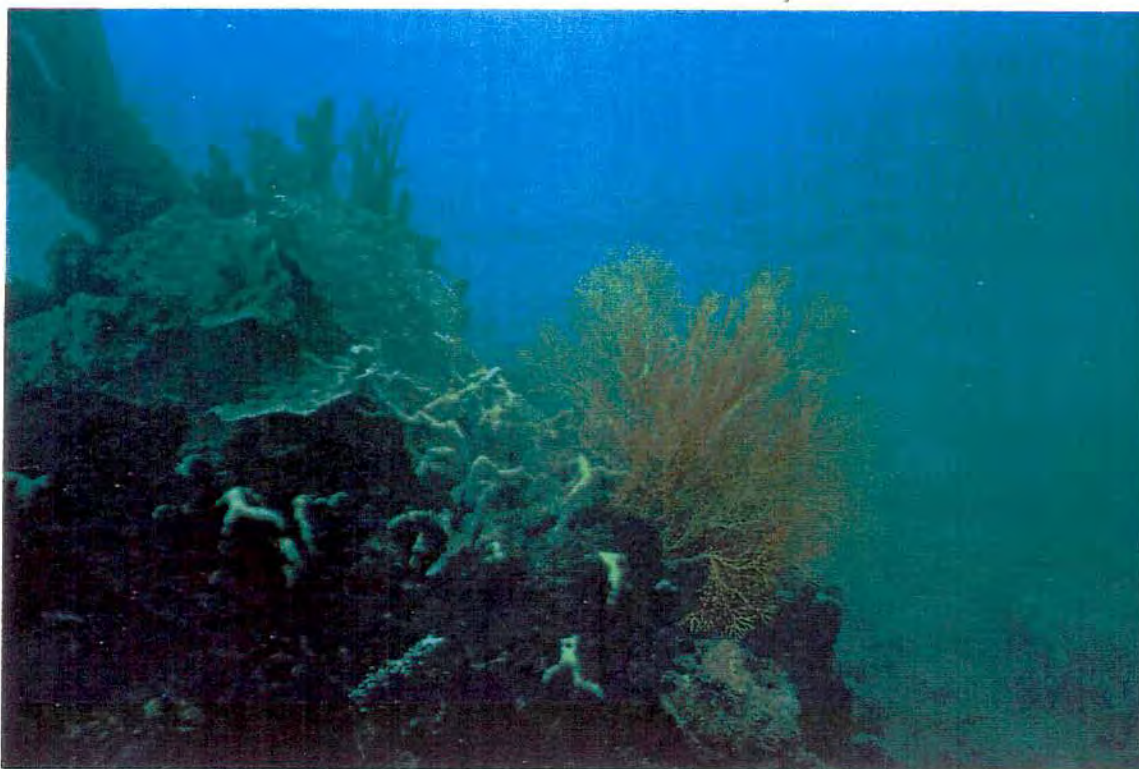
Plate 9: Reef top at 5 m - Locker Reef. Cover of encrusting *Montipora* hard coral (at left) was about 60% in this area. Also shown are the hydrocoral *Millepora* in the foreground and a sea fan (*Gorgonacea*) at right.

Locker Reef comprises an area of exposed limestone of moderate relief, rising 2-3 m from the surrounding seafloor. One area on the reef top had a 60% coverage of *Montipora* coral plates (Plate 9), with favid corals and gorgonian fans also present. Towards the edge of the reef top several species of tabular *Acropora* were found, and these colonies provided an 80% coverage of living hard coral.

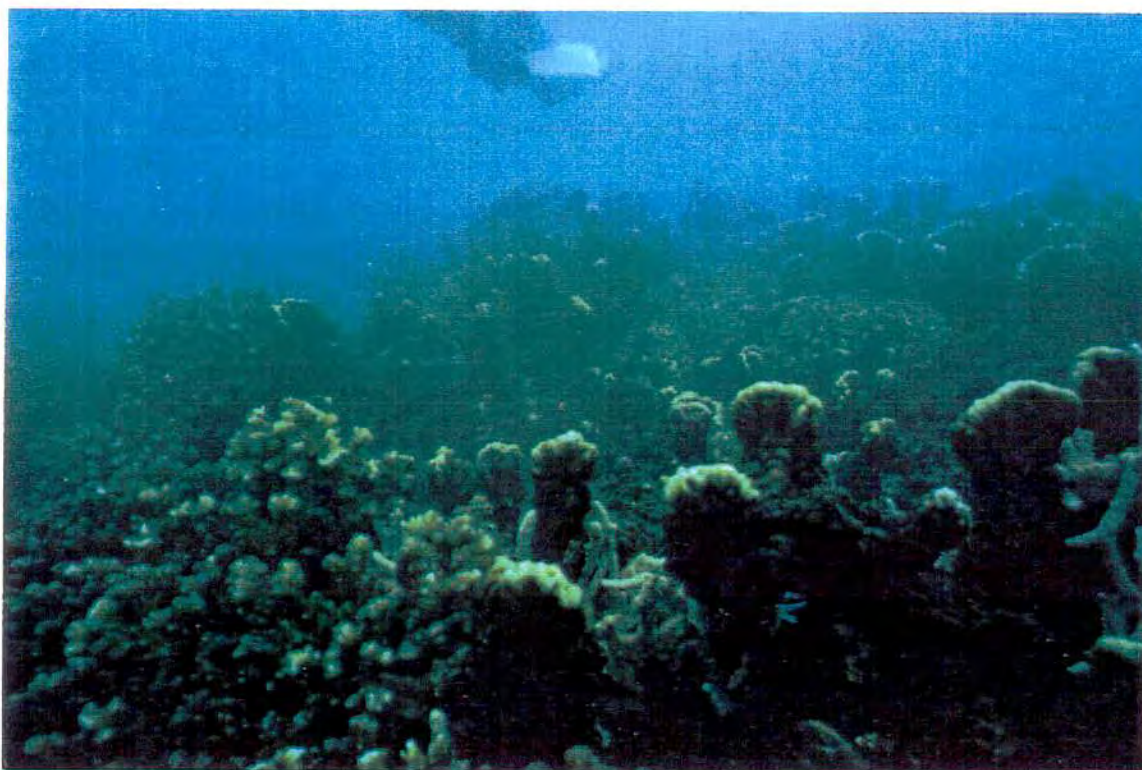
Plate 10: Reef top at 5 m - Locker Reef. Cover of the hard coral *Pocillopora* (left foreground) was 60% and cover of the hydrocoral *Millepora* (right foreground) was 10% in this area. Other hard coral species contributed a further 10% cover of the substrate.
