Kemerton Silica Sand

Public Environmental Review Extension of Kemerton Silica Sand, Dredge Mining

Volume 2: Appendices

November 2009

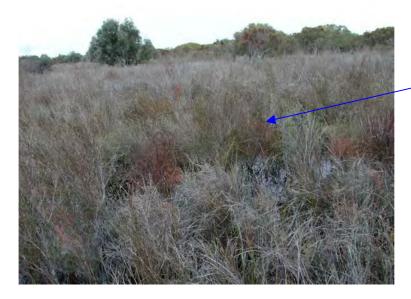
Shrubs of *Boronia juncea* subsp. *juncea* readily identified by their red colour. Photograph taken in September. Standing water visible.

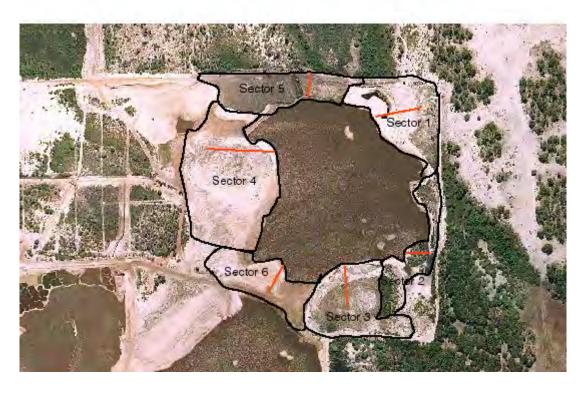
Figure 3. Aerial photograph from 2006 showing Sectors around North Lake. Topsoil has been recently applied to Sector 5 in the photo. Position of monitoring transects are shown by red lines.

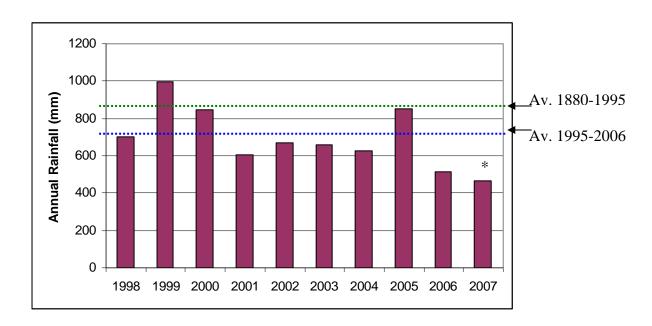
Figure 6. Annual rainfall for Bunbury for the period 1998-2007 compared against average annual rainfall for 1880-1995 (long-term; green broken line) and 1995-2006 (recent; blue broken line). (* rainfall for 2007 up to and including June when assessment was carried out).

The rehabilitation period 2001–2006 was one of the driest periods on record (Figure 6). With the exception of 2005, each year was not only substantially below the long term average, but also less than the recent (1996–2006) average. The year 2006 was very close to the lowest annual rainfall on record.

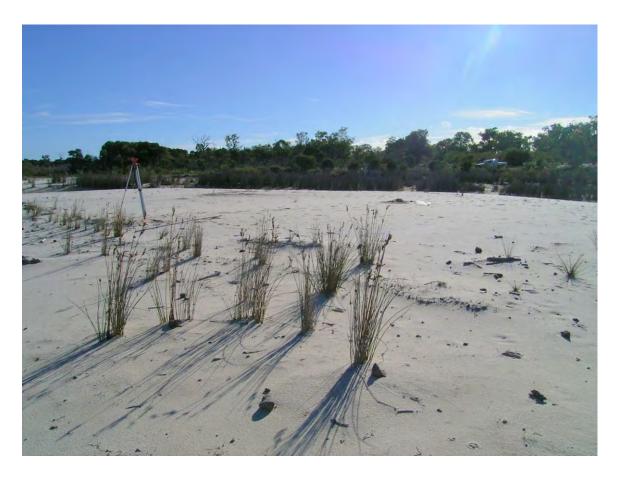
Plate 1. Rehabilitation in Sector 1. The foreground shows a mostly bare area believed to the result of recent soil deposition via wind. The background shows typical revegetation within Sector 1 with sedges dominating at low elevations and shrubs and small trees on higher ground.

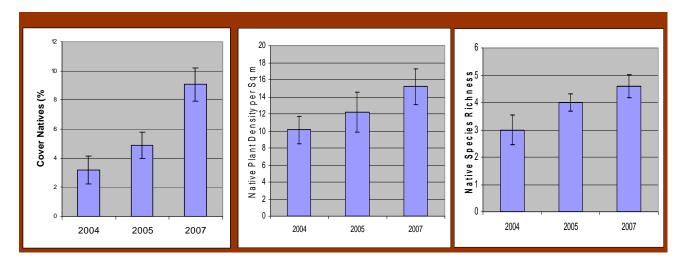
Figure 7. Graphs of % native cover, plant density and mean species richness for 2004 and 2005 Mattiske studies (Mattiske Consulting Pty Ltd, 2004, 2005) and this study (June 2007) for Sector 1.

Sector 1 has experienced steady and statistically significant increases in plant cover, plant density and number of native plant species over time (Figure 7). However plant species richness and cover remain relatively low (i.e., less than 10% native plant cover on average, and only 4.5 plant species per 4 m²quadrat, on average).

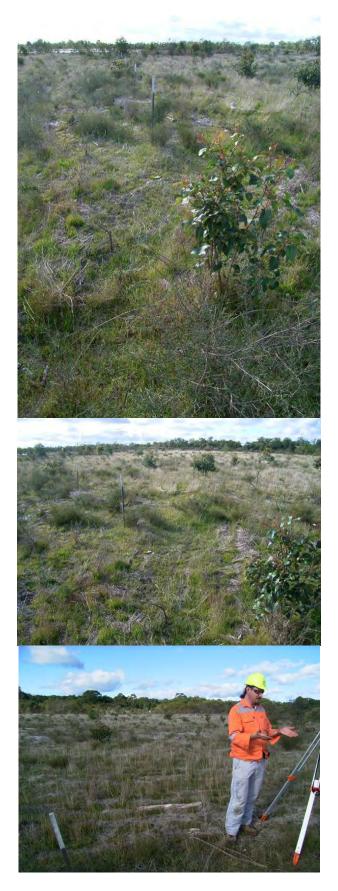
Plate 3. Monitoring quadrats of Transect #5 within Rehab Sector 3 taken during June 2007.

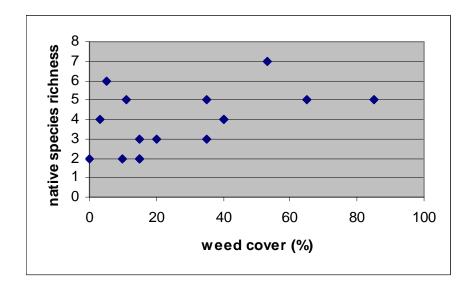
Figure 11. Scatter plot showing relationship between percentage native plant species richness and cover of weeds at Area 3 monitoring quadrats. There is a significant positive correlation (r = +0.48; p<0.001) indicating that weeds generally decrease in line with the number of native species.

species are possibly responding to the same environmental parameters and that high weed cover is not necessarily a barrier to native plant growth in this Sector (contrary to the situation in Sector 1). It is possible that that weeds have filled gaps left as native species died out in this Sector. Also weeds may have responded to fertilising the year before with little evidence that herbicides have been effective (perhaps they weren't actually applied as reported). Weed levels decline towards the lake, suggesting their preference for drier, sandy soils, or avoidance of winter waterlogged sites.

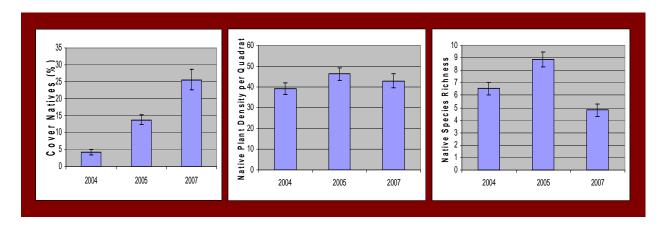
Figure 12. Graphs of % native cover, plant density and mean species richness for 2004 and 2005 Mattiske studies (Mattiske Consulting Pty Ltd, 2004, 2005) and this study (June 2007) for Sector 4.

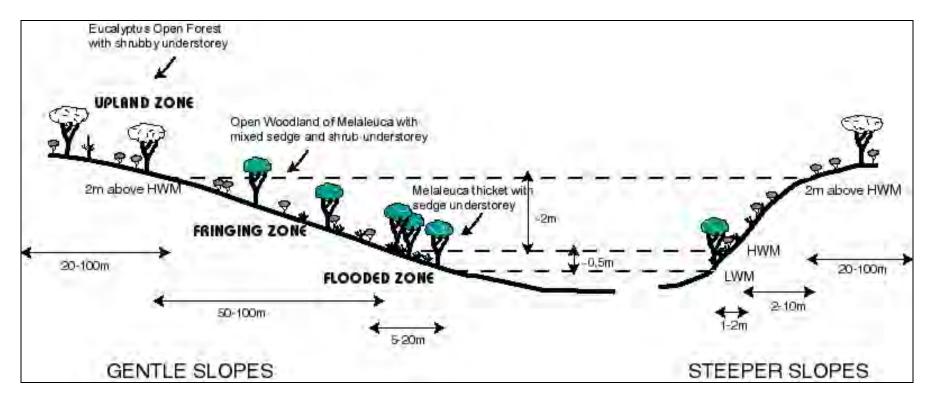
Figure 20. Generalised topographic profiles showing position of three rehabilitation zones relative to lake water levels (HWM refers to high water mark as reached in typical spring; LWM refers to low water mark as seen in typical autumn). Two profiles are shown: typical gentle slope (right) and steeper slopes (left; e.g., Sectors 1 & 2). Approximate horizontal distances and brief vegetation descriptions for each zone are also given. Note vertical and horizontal axes are at different scales.

key species. Flooding regimes vary from lower slopes (more or less permanently flooded) to upper reaches (flooded for a few weeks only) of this zone; therefore careful locating of species according to their preferred flooding regime will be required.

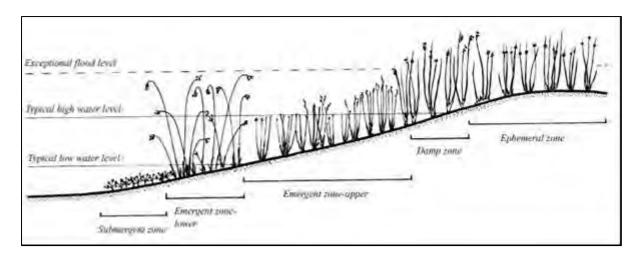
Figure 21. Example of differences in flooding regime and subsequent zonation in 'flooded' zone of wetlands. (Source: Water and Rivers Commission, 2001.)

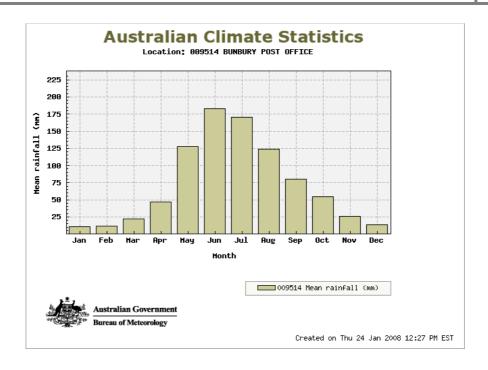
Figure 3. Average monthly rainfall for Bunbury P.O. (1880-1985) (Source: Bureau of Meteorology 2008).

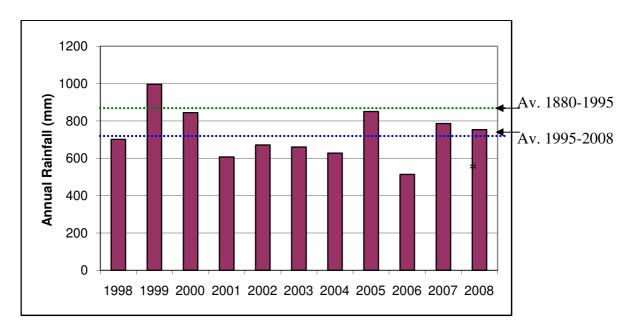
Figure 5. Annual rainfall for Bunbury for the period 1998-2008 compared against average annual rainfall for 1880-1995 (long-term; green broken line) and 1995-2006 (recent; blue broken line)

year 2006 was very close to the lowest annual rainfall on record. Since then, two years (2007-8) just under the long-term average have occurred.

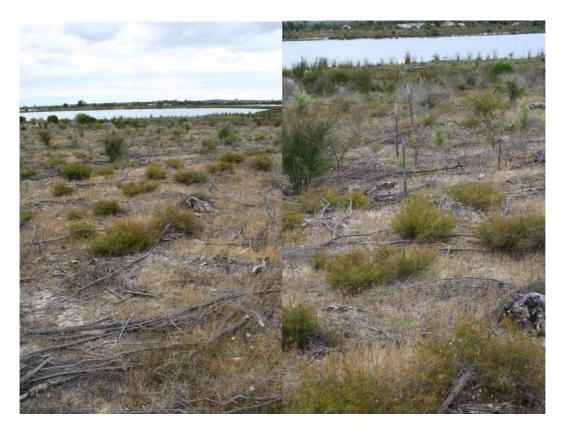
Plate 2 a,b. Rehabilitation in Sector 1 (along transect #1) showing patchy native shrub cover and abundant weeds.

these seedlings established following direct seeding in Autumn 2006 and appear to be drought impacted. In contrast, new shrub species such as *Aotus gracillima*, *Astartea scoparia* and *Pericalymma ellipticum* have established in middle to lower reaches of the sector; these most likely represent delayed germination from the 2006 seeding presumably responding to good winter rainfall in 2008. It is recommended that more planting and/or seeding of typical upland species of the local area be conducted, with accompanying weed control, in areas >2m above the lake height.

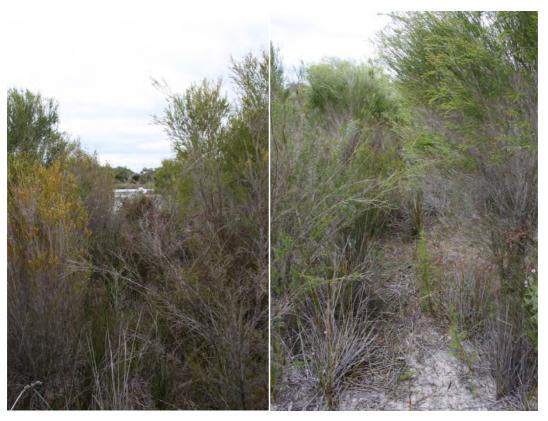
Plate 3 a,b: showing dense and tall rehabilitation in Sector 2 (along transect #4).

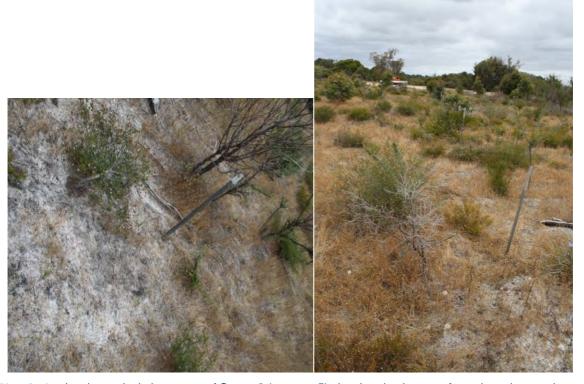
Plate 3 a,b: showing typical plant cover of Sector 3 (transect 5) showing dominance of weeds and stunted tree and shrub growth.

Despite the improvements in rehabilitation, this area remains species poor and structurally simple for 7 year old rehabilitation, especially compared to Sector 2 adjacent. The higher topography is likely to be cause with most of Sector 3 greater than 2 m above high lake levels. It is recommended that ongoing work in seeding/planting of upland species and weed

control occurs in this Sector. If any excess upland topsoil is available, it should be spread on this Sector.

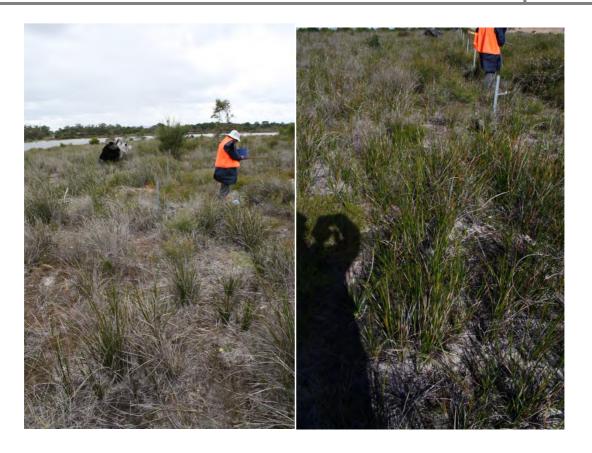
Plate 4 a,b. showing typical plant cover of Sector 4 (along transect 7) showing dominance of *Lepidosperma longitudinale*.

Sector 4 received topsoil treatment later than those described above but is generally superior in terms of plant cover and species diversity (Figs 6-9). Cover is continuing to increase on average (Fig 9) with quadrats closer to the lake experiencing increased cover and abundance. Encouragingly, many seedlings were recorded in monitoring quadrats; these included both existing plant species and species not recorded in quadrats previously. Such colonisation by new species has resulted in average species richness significantly increasing since 2007 and is now approaching the peak in species richness found in 2005. Despite significant increases in species numbers, species richness is relatively low at just over 7 per quadrat, although this value is actually similar to that of the successful Sector 2. Of more concern is the simplicity of structure and unevenness of species dominance; although cover is reasonable for 5 year old rehabilitation, Sector 4 is clearly dominated by Lepidosperma longitudinale and some low shrubs like Hypocalymma angustifolium and Kunzea recurva. The absence of taller shrubs and trees like tea trees and paperbarks (Melaleuca spp.) is a concern especially in low lying areas close to the lake. The presence of very young Melaleuca rhaphiophylla near the lake edge is therefore encouraging especially as they seem to the result of washed-up and/or windblown seed. If such seedlings do not establish into trees, consideration needs to be given to planting, brushing and/or seeding with Melaleuca close to the lake edge.

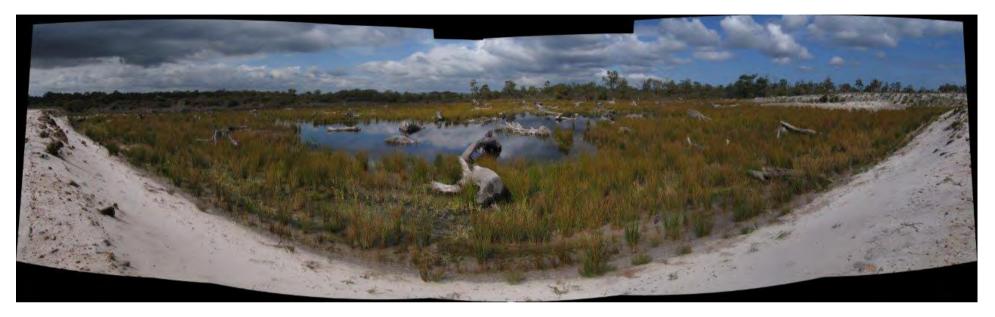
Plate 7. This panorama shows rehabilitated wetland in early 2008, whereas the photo below show wetland at time of monitoring in November 2008 showing high cover and dominance by *Juncus pallidus*.. Photos by Clint McCullough.

This area was low lying and at November 2008 contained large areas submerged by water (see Plate 7–Plate). Areas under shallow water or waterlogged had very high plant cover in the order of 60-100%. This represents prolific growth over just over one year post rehabilitation and confirms the readiness for plant establishment in low lying areas which are flooded or waterlogged for most of the years as long as appropriate (i.e., wetland or fringing wetland) topsoil is used. This area did not contain any upland areas, i.e. areas >2m above water table.

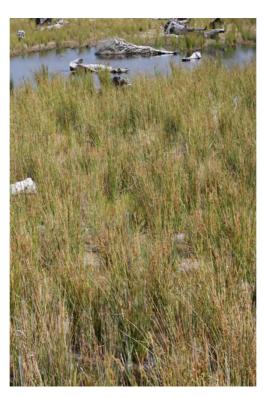
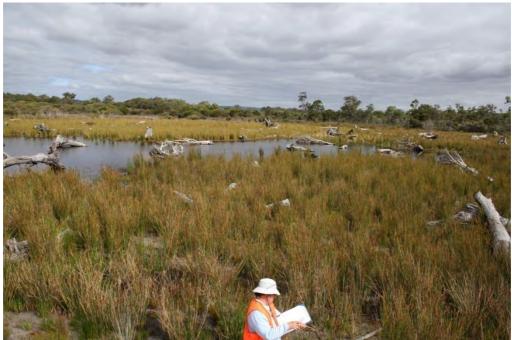
Plate 8 a,b. Extensive cover of rushes and sedges in new rehabilitation south of dredge pond (transect 11).

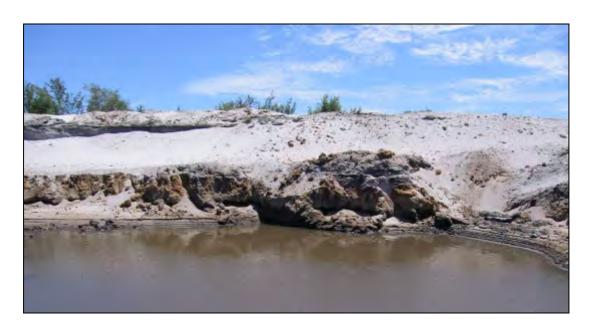
Plate 1. The confining layer of coffee rock overlaying the quartzite ore body.

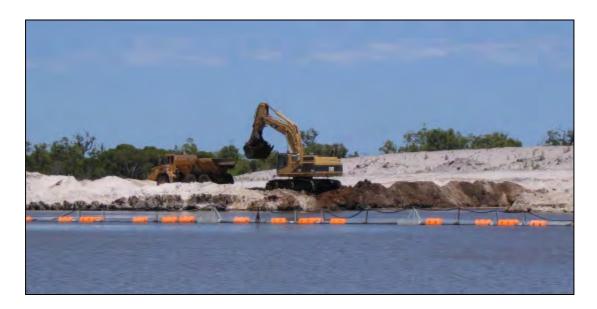
Plate 2. Removal of coffee-rock confining layer following prior removal and stock piling of top-soil (1 m) and over-burden.

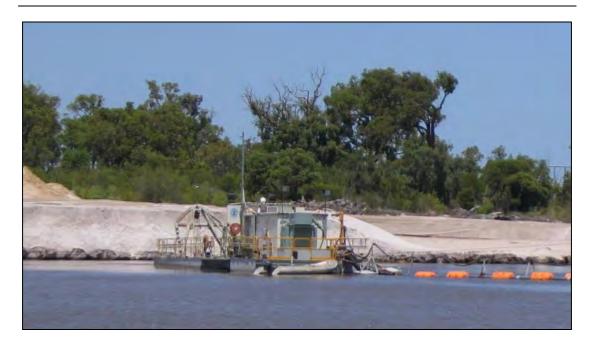
Plate 3. Final dredging to 7–10 m of quartzite ore.

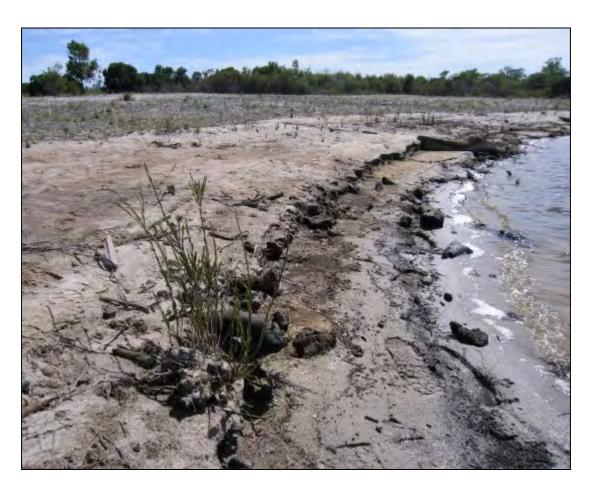
Plate 4. Erosion of topsoil, accumulation of coarse woody debris and coffee rock along western shores of Lake 1.

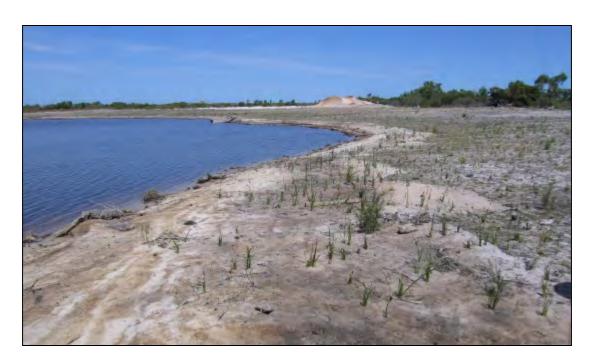
Plate 5. Accumulation of coarse woody debris and coffee rock along western shores of Lake 1.

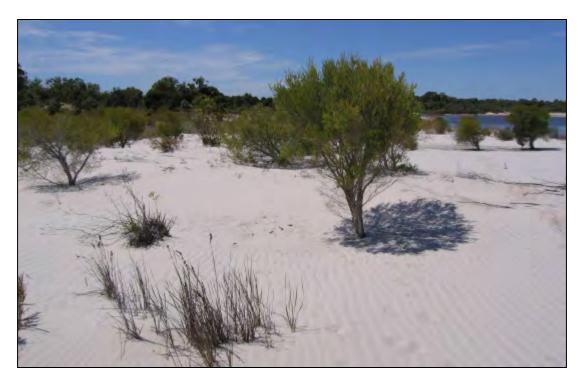
Plate 6. Naturally regenerating shrubby vegetation being smothered by blown sands along eastern shores of Lake 1.

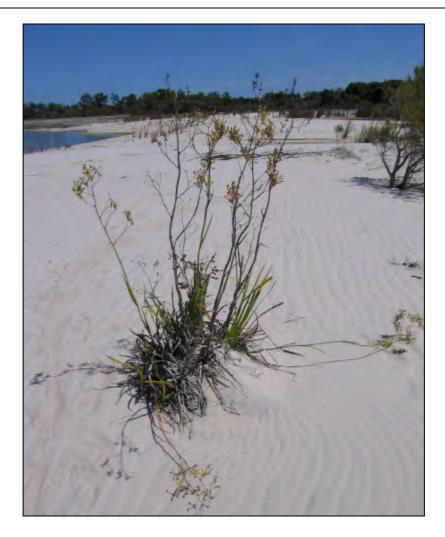
Plate 7. Kangaroo paw being smothered by blown sands along eastern shores of Lake 1.

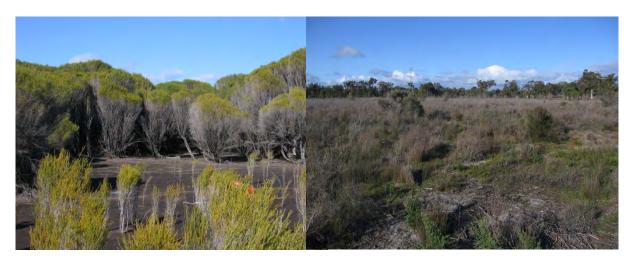
EPP4 Site 4 (CCW1)

Site 4 is a dampland located in the wetland that surrounds the EPP4 sumpland (Figure 6). Van Etten *et al.* (in prep) and McCullough *et al.* (2007) have found EPP4 is unique on the KSS project site as a perched wetland with distinct flora and fauna. EPP4 appears to be in good condition. As such, it appears that the dampland is the catchment for EPP4. Although dry at the time of our visit, anecdotal evidence from KSS staff suggest that in the past the wetland has flooded. EPP4 wetland habitat appears to be in very good condition.

Figure 6. Photographs of EPP4 (June 2007) and Site 4.

In order to protect the unique aquatic ecological values of EPP4, we recommend that EPP4 and the surrounding dampland be excluded from the proposed expansion area.

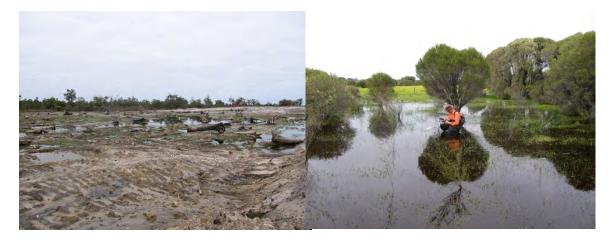
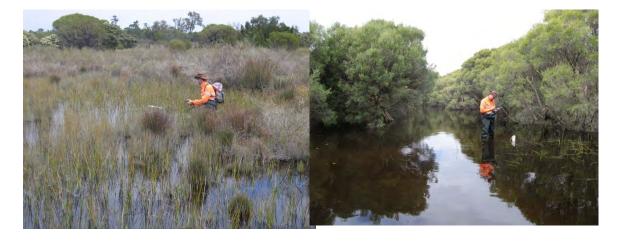
Figure 14. Photographs of EPP5 and Sites 14 (CCX), 17 (CC5) and 18 (CC5P).

Site 17 (CC5) is located on a slight slope and represents a series of shallow pools (<0.2 m deep) that during wet conditions can interlink and flow down towards Site 18. The shallow pools could be considered mini sumplands. Site 18 (CC5P) is located at the bottom of the valley and is a predominantly closed canopy paperbark sumpland. The degree of connectedness CC5P has to EPP5 is not known.

All these wetlands form part of sumpland S120 (SW) as listed in Hill *et al.* (1996). However, these wetlands are certainly not part of a giant sumpland but rather a series of distinct sumplands surrounded by damplands which in particularly wet years connect the sumplands with surface water (Figure 14). All these sites contained water at the time of sampling. Site 14 (CCX) is a new sumpland created by KSS, it has a base of wetland top soil and has a number of logs scattered over the surface to provide

habitat. 2007 was the first year of filling after rehabilitation. EPP5 is a large sumpland, that has been heavily impacted by feral animals (in particular pigs and rabbits), although wetland vegetation remains relatively intact.

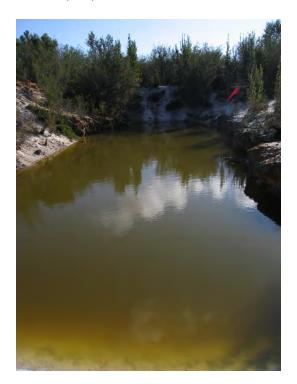
Figure 16. Photographs of Sites 12, 15 and 16.

These sites are all former dredge ponds. Site 12 (NO) is a small, probably test dredge site with no rehabilitation (Figure 16). Site 15 is the large rehabilitated lake, referred to by Lund *et al.* (2008) as North Lake (NL). To the north-east and south-east of Site 15 are two small satellite wetlands identified as Site 16 (NS). These satellite wetlands are shallow and at times of high water are joined to North Lake. However, in summer they separate from the main lake.

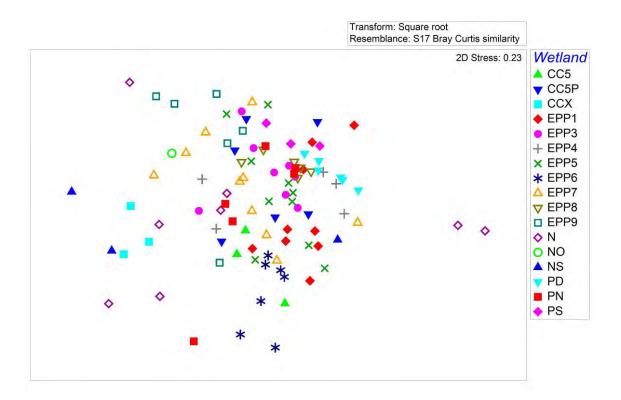
Figure 24. nMDS ordination of aquatic macroinvertebrate communities in KSS project area wetlands. Different colours indicate different wetlands.

An nMDS ordination of KSS macroinvertebrate communities showed outliers for a replicate of North Lake and EPP6 littoral. When these outliers were removed the ordination still showed a high stress of 0.23 as a result of the large number of data points collected (Figure 24).

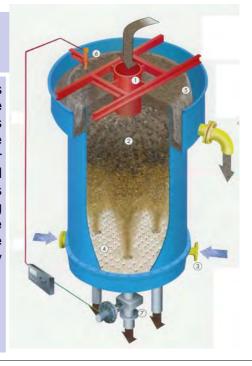
- (1) Water and sand enter the flat bed classifier through a central feed well.
- (2) The sand and water enter the settling chamber where an upcurrent of water is injected from the base of (4) plenum chamber.
- (3) As the up current of water travels to the top of the settling chamber carry-

ing the smaller size sand particles (product) over the lip. (5) The coarser product (or waste) which is heavier settles to the bottom of the flat bottom classifier. A sensor monitors the density of the sand and water mixture, allowing valves under the FBC to open releasing the coarse product (waste). The solids which discharge from the underflow are then pumped away for further processing.

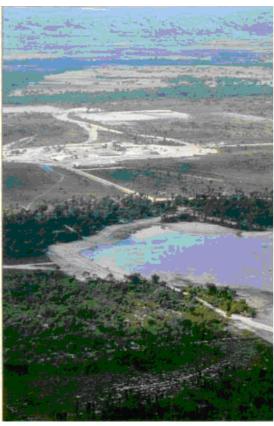
Aerial view of the Kemerton minesite showing the settlement pond in the foreground and the plant and dredge pond in the background.

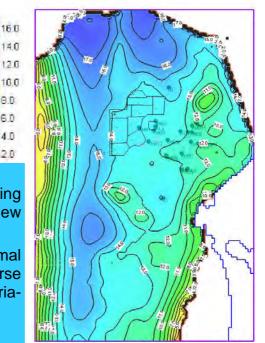
Predicted groundwater levels at the end of mining

The results of the modelling showed that the minimal change in groundwater level is unlikely to cause adverse impact in the surrounding environment as the natural variations in the groundwater level is in the order of 1.5m.

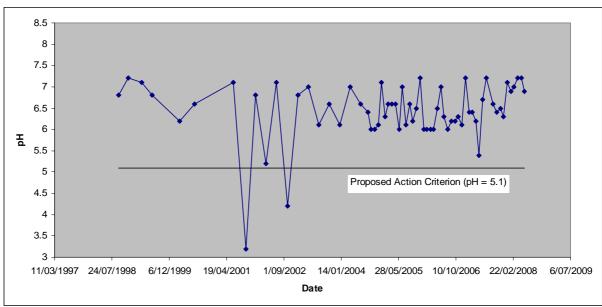
Chart 1: Monthly pH Values for Water Samples from Monitoring Bore KMB8

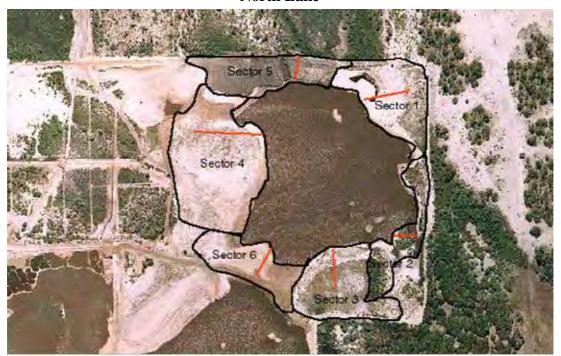
Figure 2: Aerial Photograph from 2006 showing Rehabilitation Sectors around North Lake

Note: Position of monitoring transects are shown by red lines.

Assessment of exiting rehabilitation was made through re-measurement of existing permanent monitoring transects established by Mattiske and Edith Cowan University in 2007 (van Etten et al. 2008b). van Etten et al. (2008b) identified six distinct rehabilitation areas (Sectors) around the northern dredge pond based on location and age of rehabilitation. These are presented in Table 7 and shown in Figure 2. Transects were also established across several natural wetlands over the same time period to characterise the biotic patterns of such wetlands, identify likely processes which drive or influence such patterns and to examine likely dynamics in vegetation (van Etten et al. 2008b). Each monitoring transect was positioned transverse to the slope and extended from the lake shoreline to the end of the rehabilitation at the top of the slope. They varied in length from 80 to 200 metres. At each five metre interval along transects a two by two metre sampling quadrat was established and the cover and abundance of each plant species was recorded.
