APPENDIX 3: Poznan (Poland) Bottom Ash Processing Photos

POZNAN PLANT (POLAND): BOTTOM ASH TREATMENT AREA

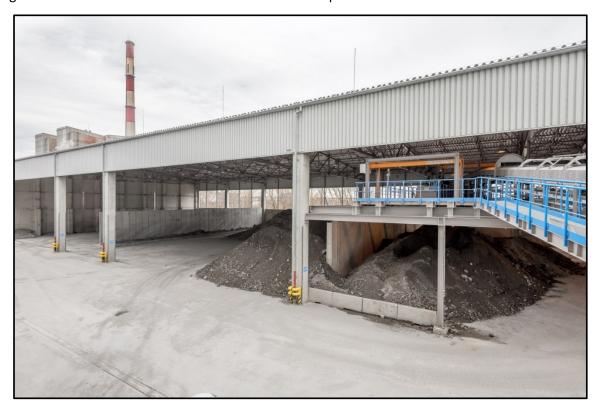
Belt conveyor on the right hand side of the photo, the intermediate storage of approximately five days storage. To the left is the maturation area with movable separation walls.

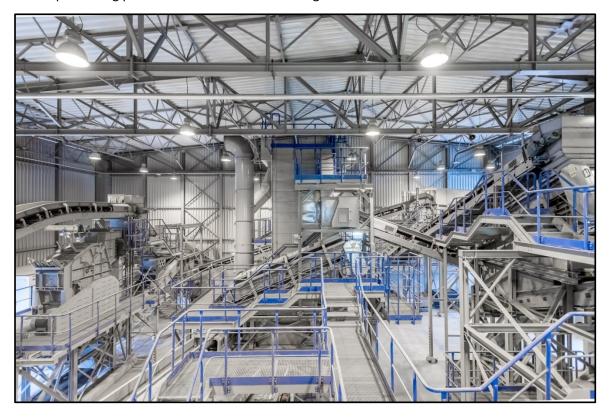
Bottom ash processing plant within an enclosed building shown below.

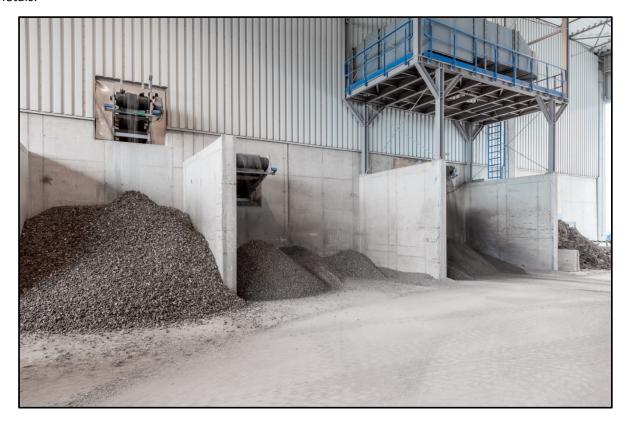
Processed bottom ash sorted into different particle sizes. On the far right of the photo are recovered metals.
