The Rio Tinto Iron Ore GIS Team conducted the Visual Impact Assessment (VIA) for the proposed changes to the Warramboo mine & the proposed Mesa B/C Iron Ore Mine, located approximately 43 km west of Pannawonica. Field work was undertaken in July and August of 2016 and the assessment was undertaken as part of the environmental impact assessment for the proposed changes to the Waramboo mine site and for the proposed Mesa B/C mine development.

This report outlines the Warramboo & Mesa B/C VIA scope, methodology and results. The GIS Team was engaged to prepare a VIA report, which was developed in conjunction with several other environmental studies and reports to provide an overview of the likely impacts.

The overall objective was to assess the visual impact of the proposed mining operations at Warramboo & Mesa B/C and illustrate these impacts through photo montages. The key objectives were to:

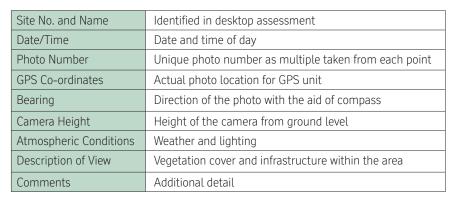
The data shown in Table 1 were collected from each photograph location to assist in the next phase of the assessment.

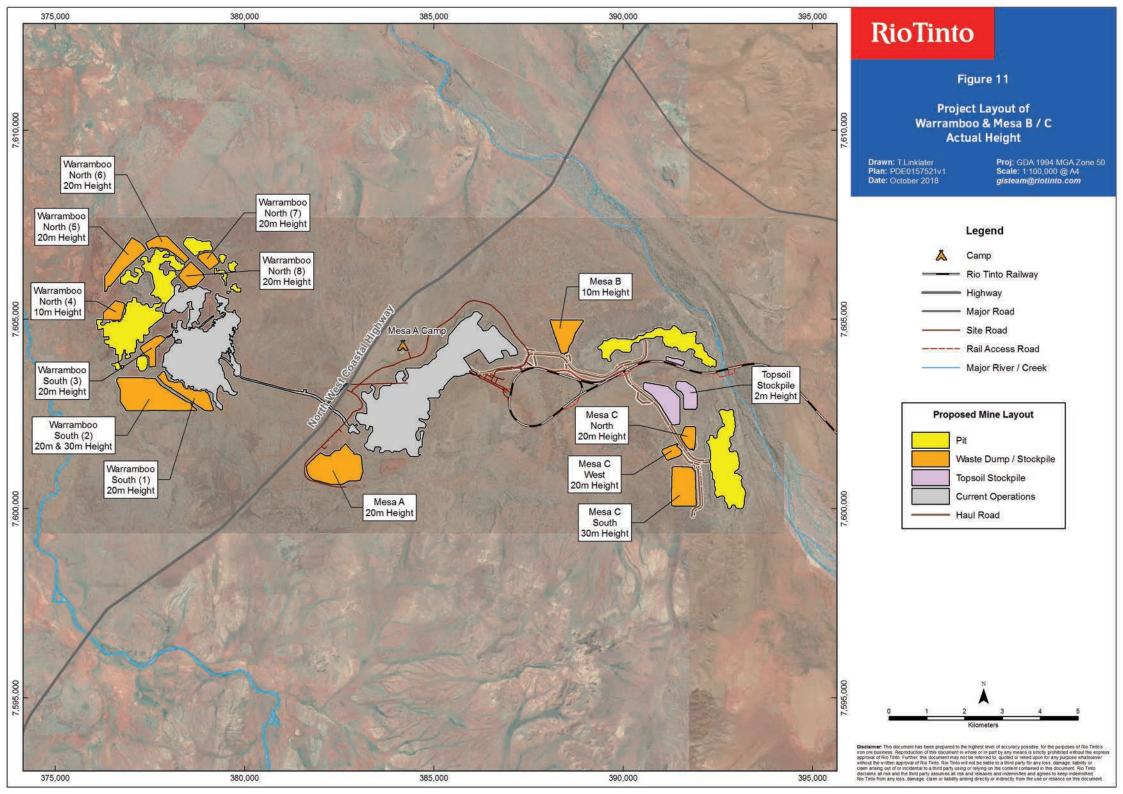
Figure 11 - Project Layout (Actual Height of Infrastructure)

The desktop assessment resulted in the output maps of the Infrastructure Actual Height, Viewshed Analysis and Photo Location. These assisted the team into the second phase of the Visual Impact Assessment.

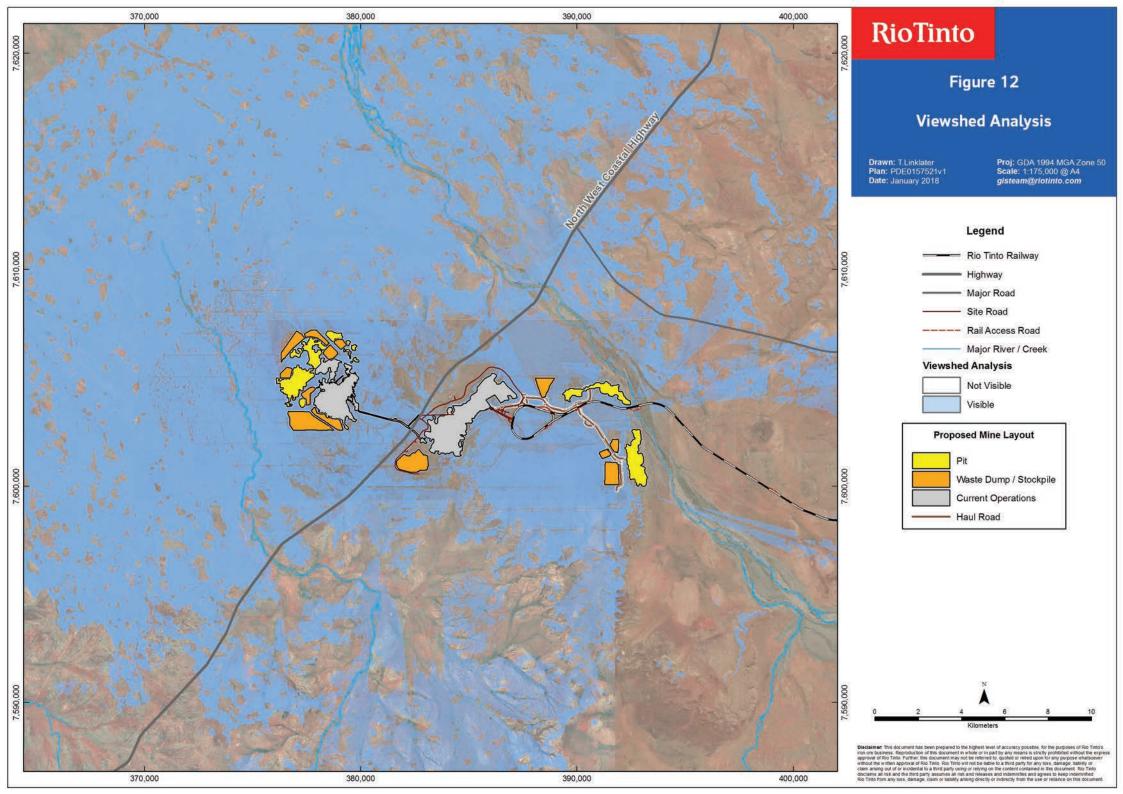
Figure 12 - Viewshed Analysis - Map shows the blue shaded area shows all locations where any component of the Mesa A Hub Proposal may be visible based on the topography of the area and the dimensions of the proposed infrastructure.

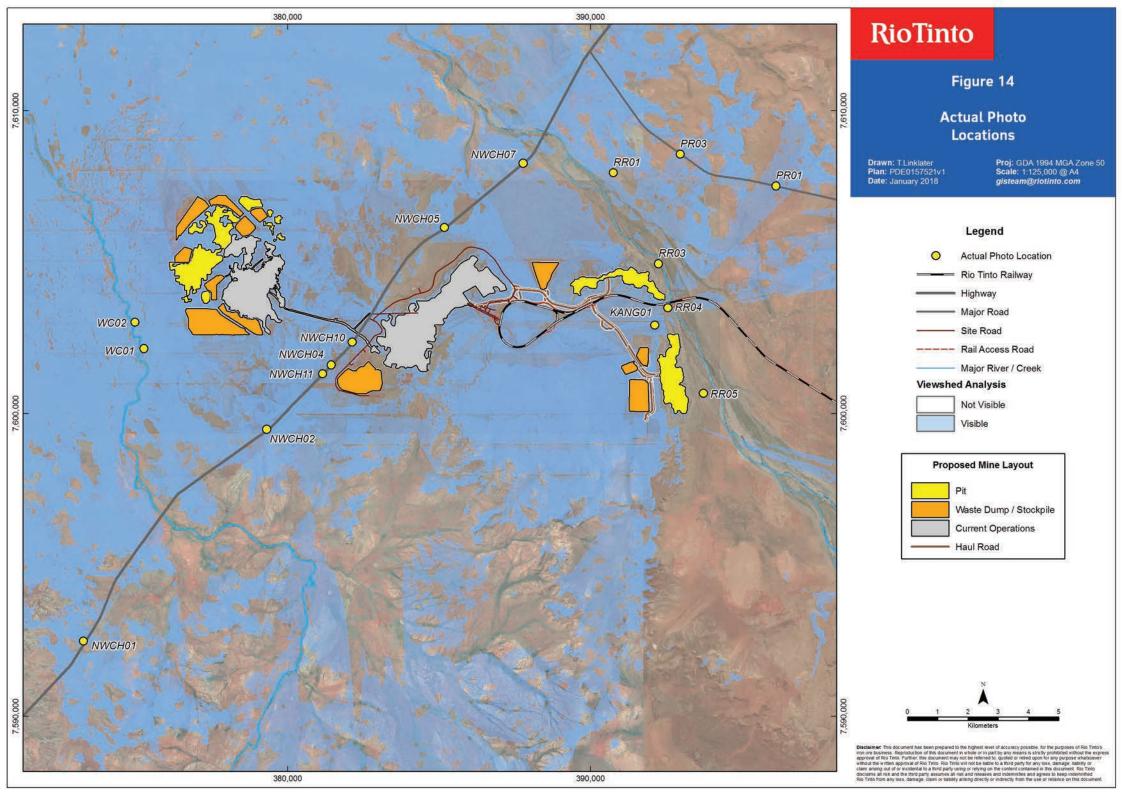
Figure 14 - Photo Location (Selected for Visual Impact)

Sites with the greatest potential for visual impact and sites of interest (such as views from the Robe River) were selected from the view shed analysis for field assessment. The field assessment resulted in a map of actual photo locations taken on the ground. These altered slightly from planned location in some cases due to access or view aspect. This data was used in the final phase of the Visual Impact Assessment.

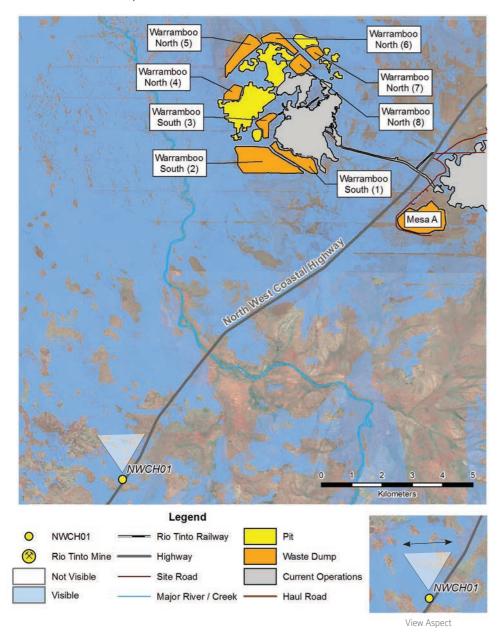
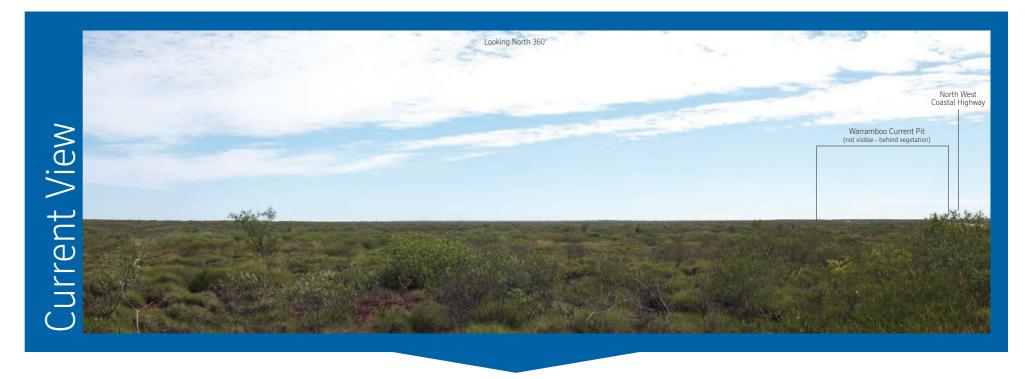
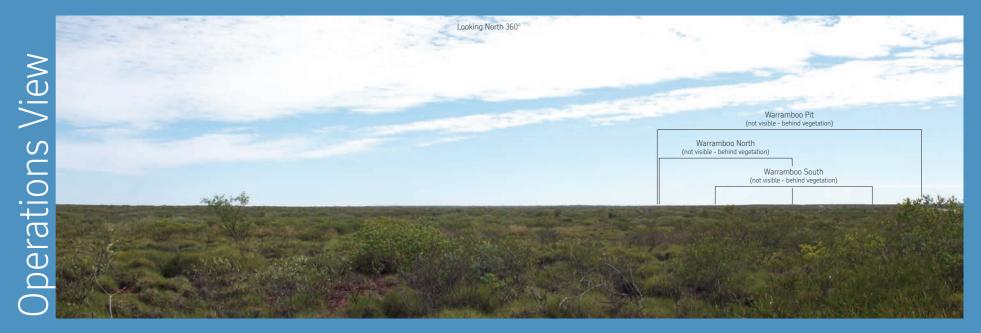
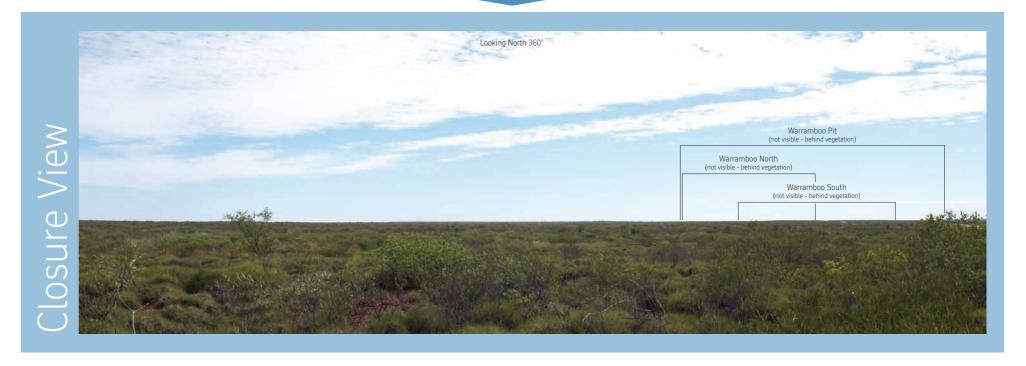
Figure 15 - North West Coastal Highway

Name #01 - NWCH01 - North West Coastal Highway

Direction North (Bearing 360°)

Description Very flat ground with low vegetation coverage.

Comments The photo was taken on the western side of the Highway.

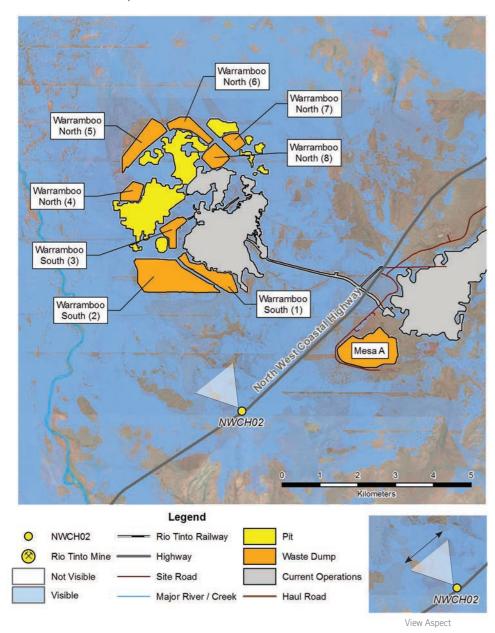
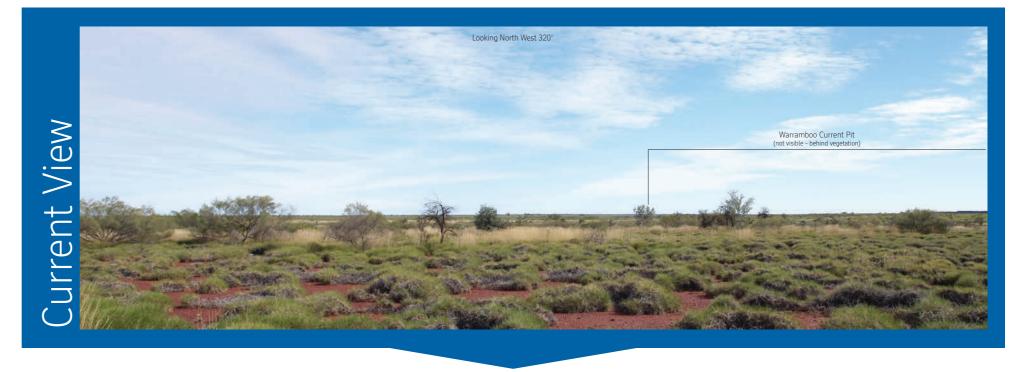
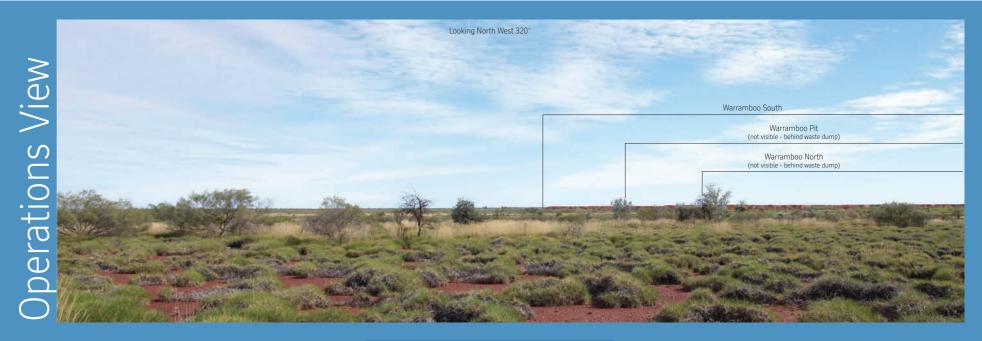
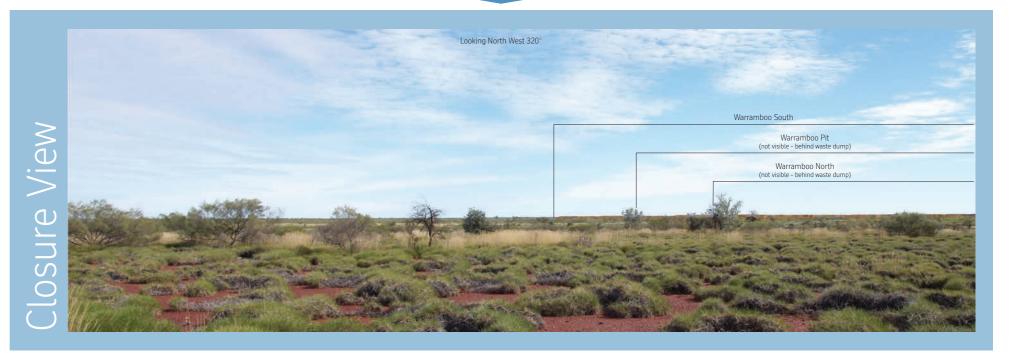
Figure 16 - North West Coastal Highway

Name #02 - NWCH02 - North West Coastal Highway

Direction North West (Bearing 320°)

**Description** Very flat ground with low vegetation coverage. Warramboo existing operations waste

dump in right hand side of view.

Comments The photo was taken on the western side of the Highway.

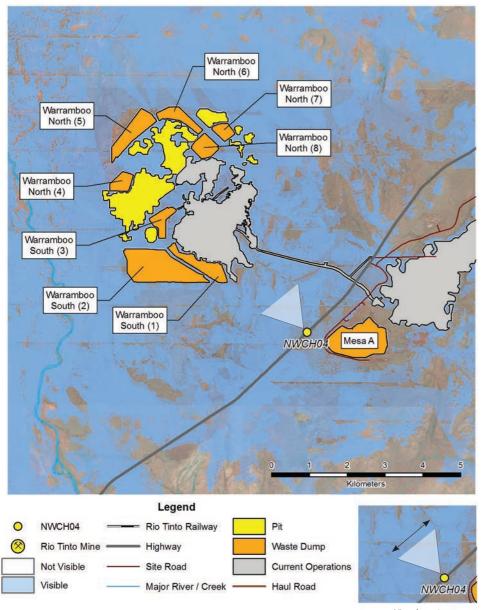
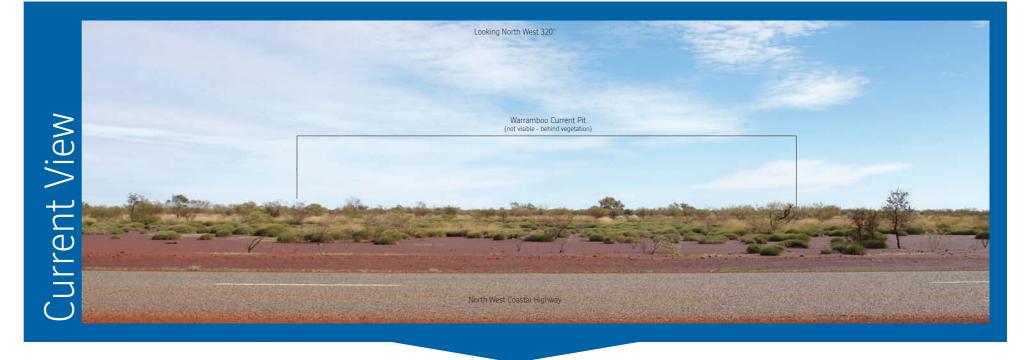
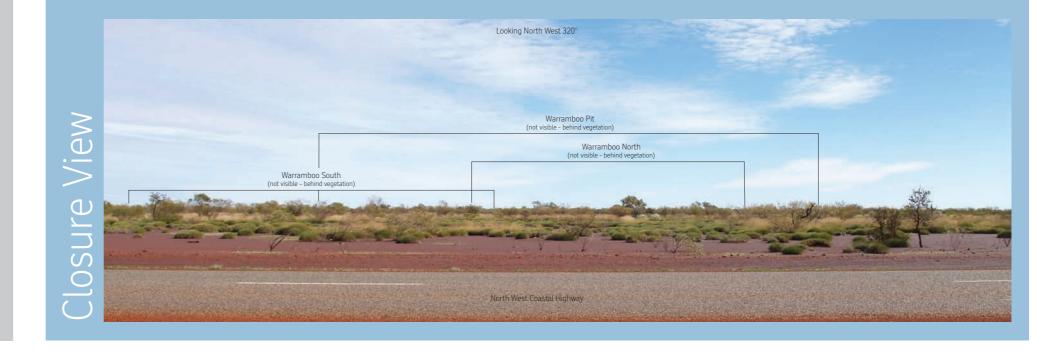
Figure 17 – North West Coastal Highway

Name #04 - NWCH04 - North West Coastal Highway

Direction North West (Bearing 320°)

Description Very flat ground with low vegetation coverage. Warramboo existing operations to the

north west across the road.

Comments The photo was taken on the eastern side of the Highway.

# Cooking North West 320\* Warramboo Pt. (rot visible - behind vegetation) Warramboo South (rot visible - behind vegetation) Warramboo North (rot visible - behind vegetation) North West Coatial Highway

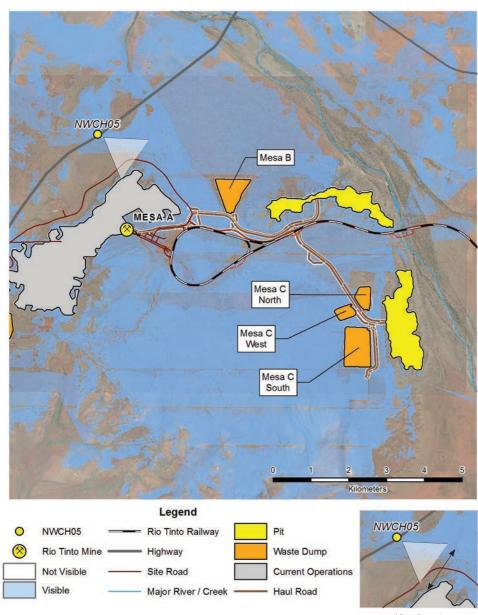
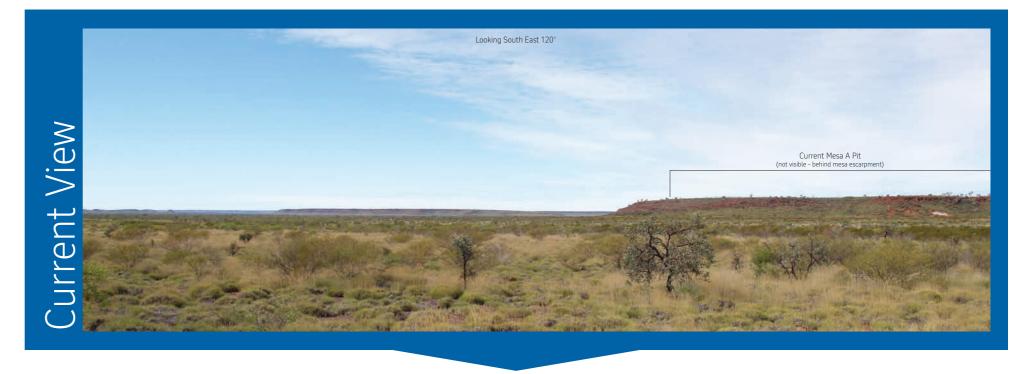
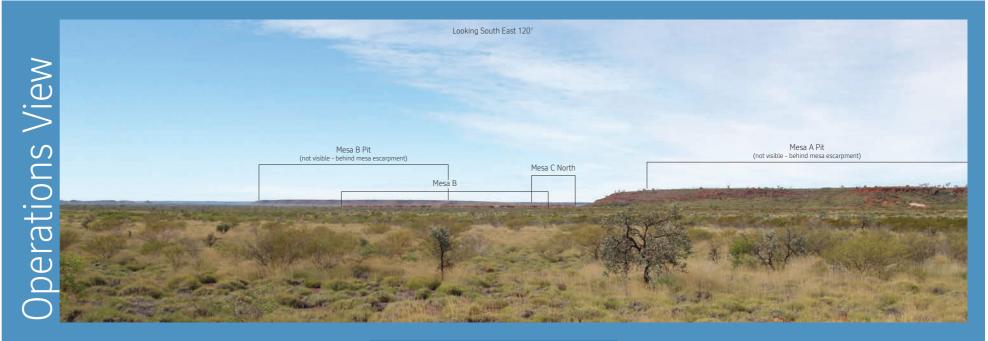
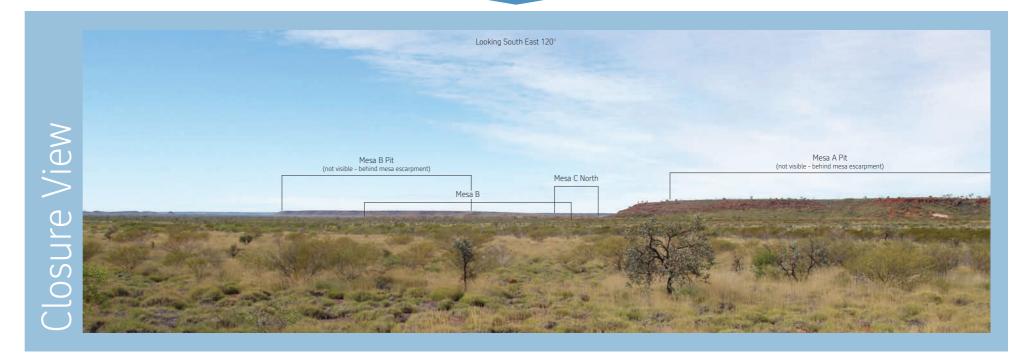
Figure 18 – North West Coastal Highway

Name #05 - NWCH05 - North West Coastal Highway

Direction South East (Bearing 120°)

**Description** Very flat ground with low vegetation coverage. South east view towards the Mesa.

Comments The photo was taken on the eastern side of the Highway.

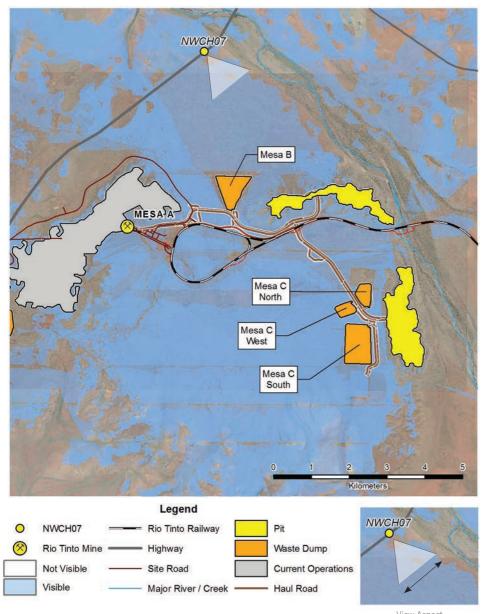
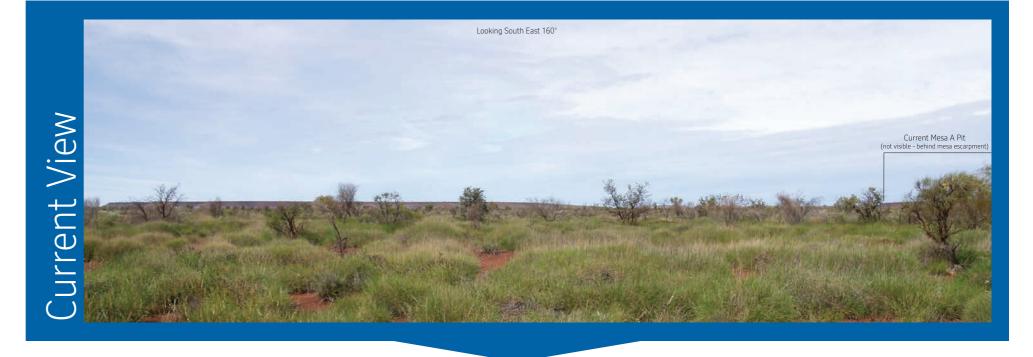
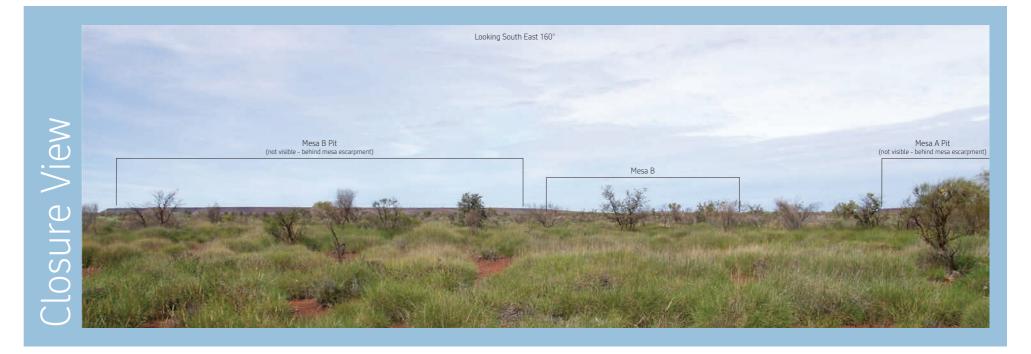
Figure 19 – North West Coastal Highway

Name #07 - NWCH07 - North West Coastal Highway

Direction South East (Bearing 160°)

Description Very flat ground with low vegetation coverage. South east view towards the Mesa A

operations and train loadout.

Comments The photo was taken on the eastern side of the Highway.

# Looking South East 160° Mesa B Pit (not violble - behind mesa escargment) Mesa B Mesa B Mesa B Mesa B

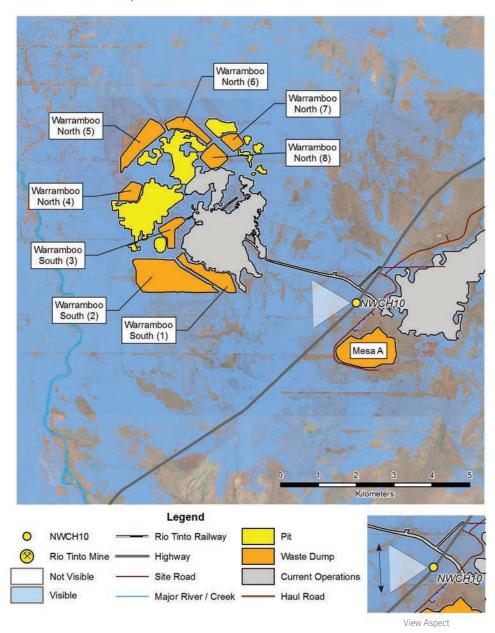
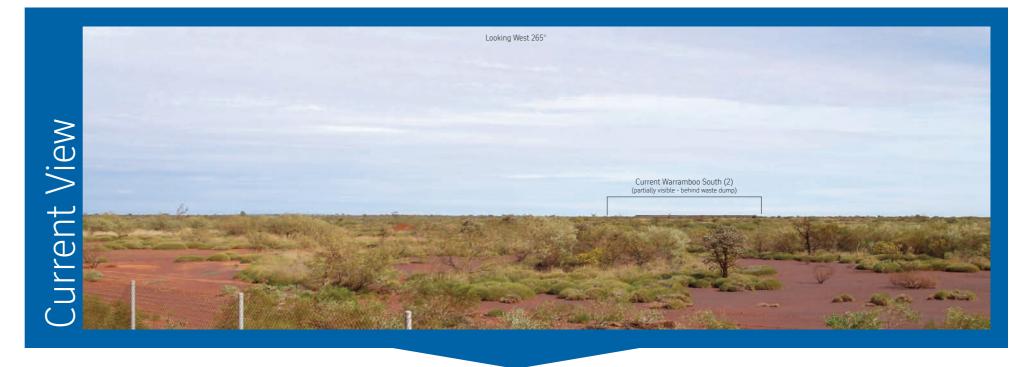
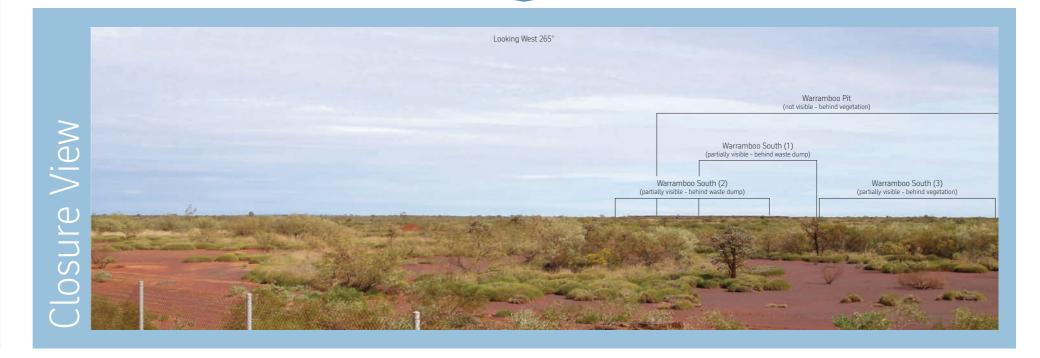
Figure 20 - North West Coastal Highway

Name #24 - NWCH10 - North West Coastal Highway

Direction West (Bearing 265°)

**Description** Elevated view towards existing Warramboo operations and low vegetation cover.

Comments Photo was taken on the western side of the highway, elevated on bridge over mine haul

road.

# NOT SUDJECTION Warramboo Pit (not visible - behind wagetation) Warramboo South (1) (gartally visible - behind waget dump) Warramboo South (2) (gartally visible - behind waget dump) (gartally visible - behind wagetation)

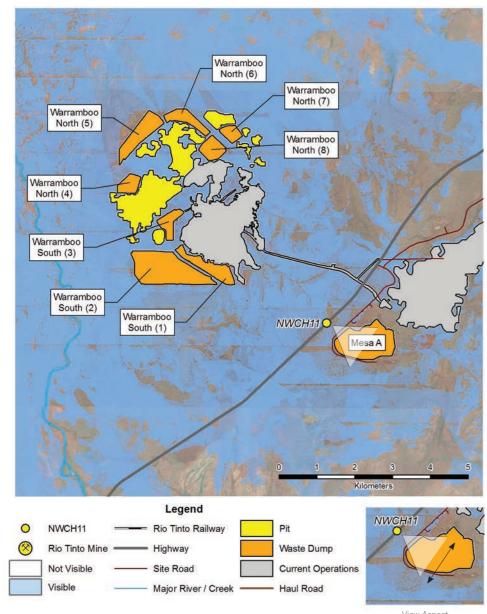
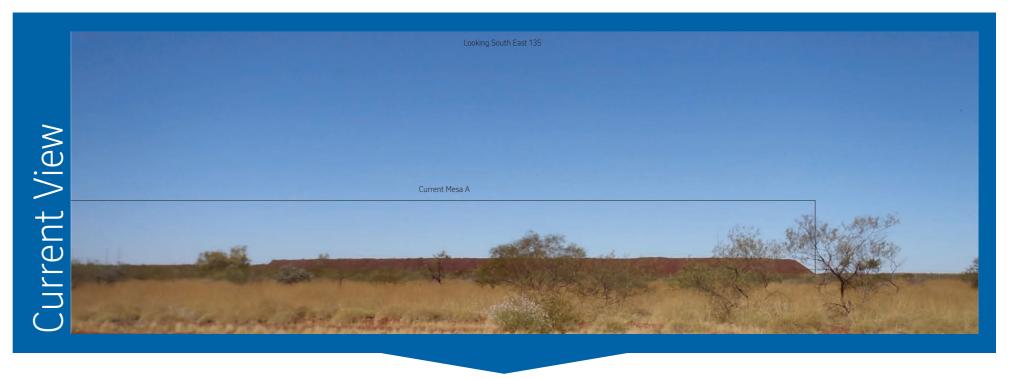
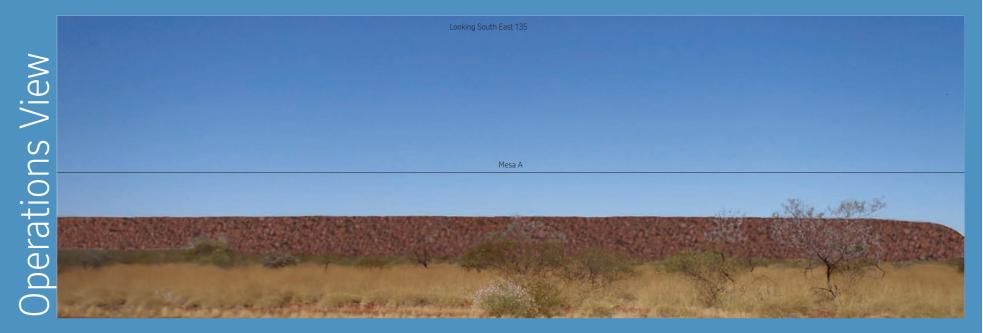
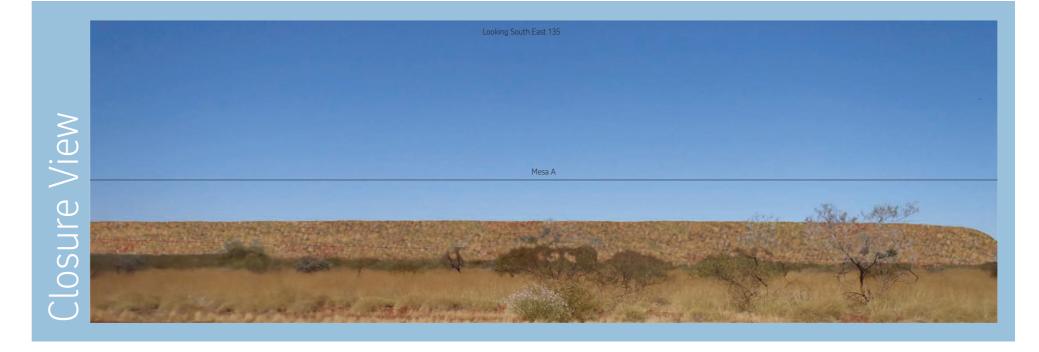
Figure 21 – North West Coastal Highway

Name #25 - NWCH11 - North West Coastal Highway

Direction South East (Bearing 135°)

Description Very flat ground with low vegetation coverage.

Comments The photo was taken on the western side of the Highway looking at existing

Mesa A Waste Dump

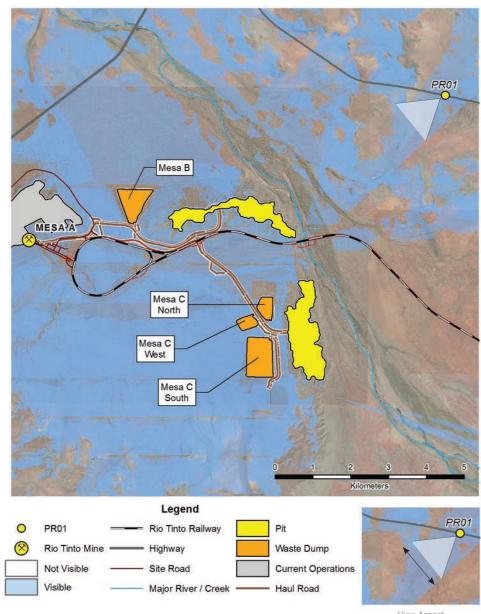
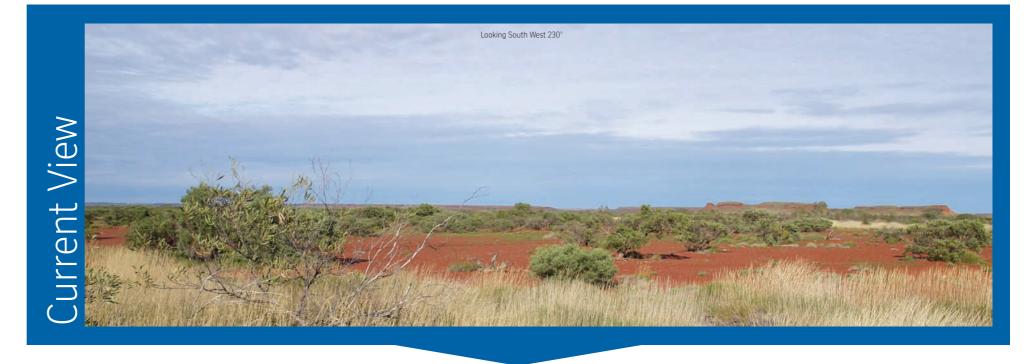
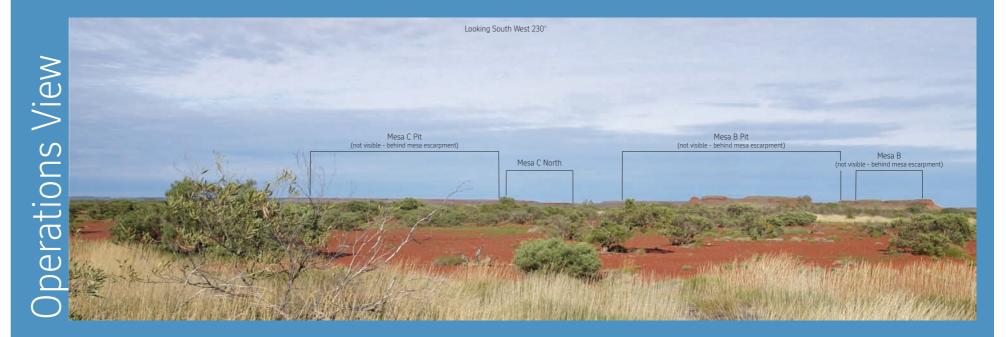
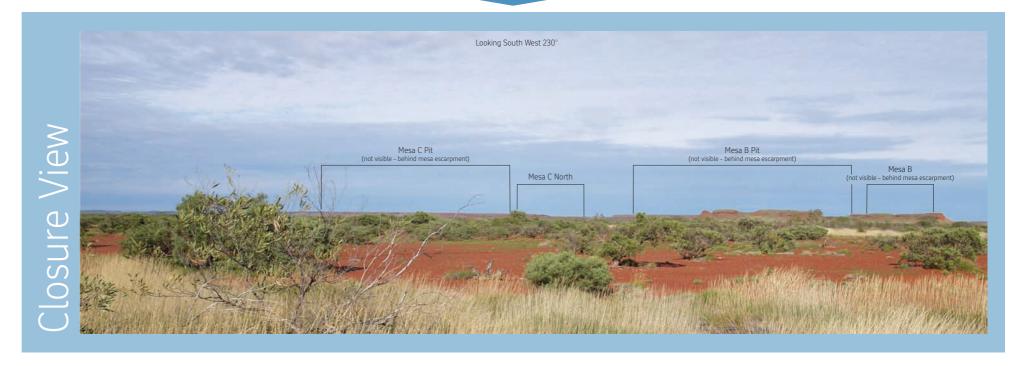
Figure 22 - Pannawonica Road

Name #10 - PR01 - Pannawonica Road

Direction South West (Bearing 230°)

**Description** Very flat ground with low vegetation coverage. South west view towards Mesa B & C.

Comments The photo was taken on the southern side of Pannawonica Road.

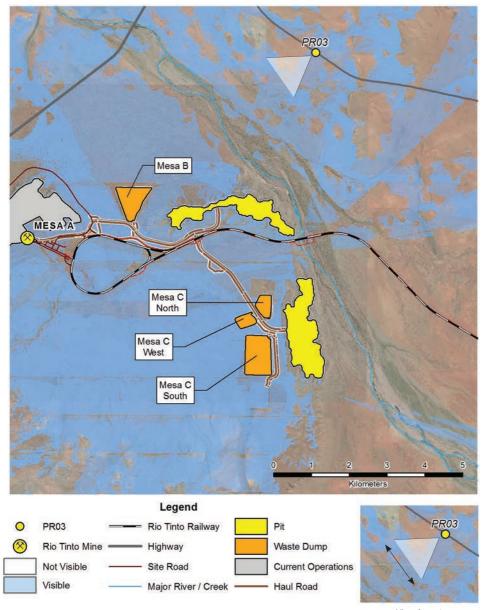
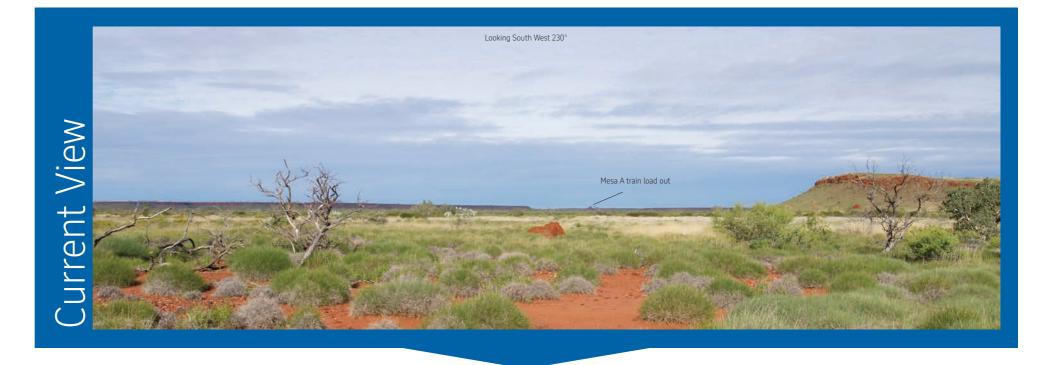
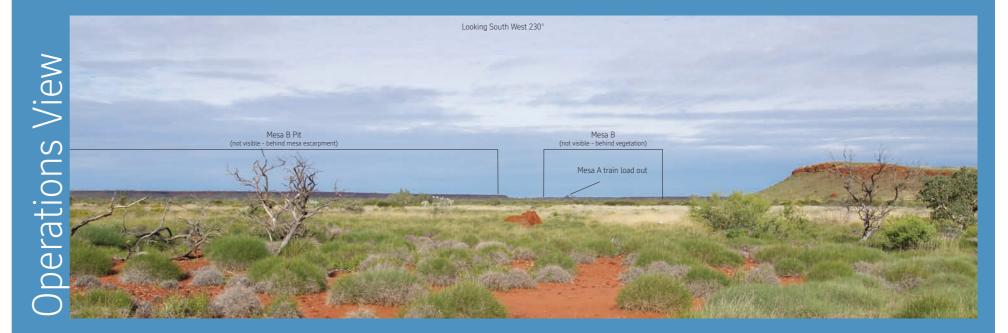
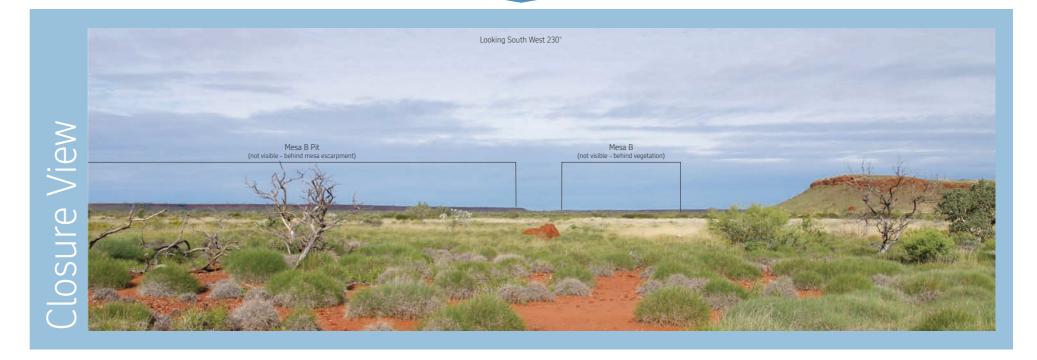
Figure 23 – Pannawonica Road

Name #12 - PR03 - Pannawonica Road

Direction South West (Bearing 230°)

Description Very flat ground with low vegetation coverage. South west view with clear line of sight

to Mesa A train loadout.

Comments The photo was taken on the southern side of Pannawonica Road.

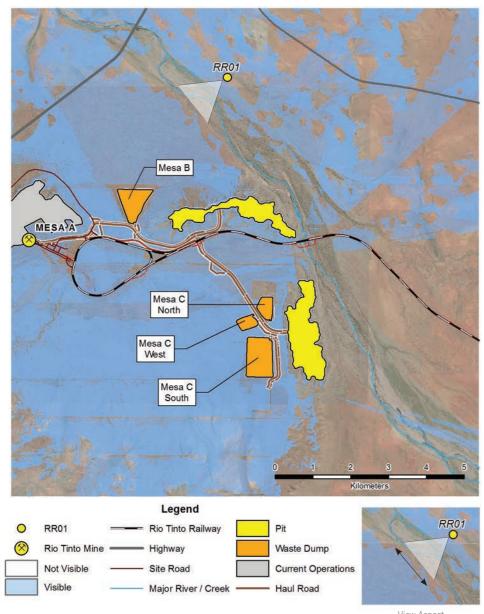
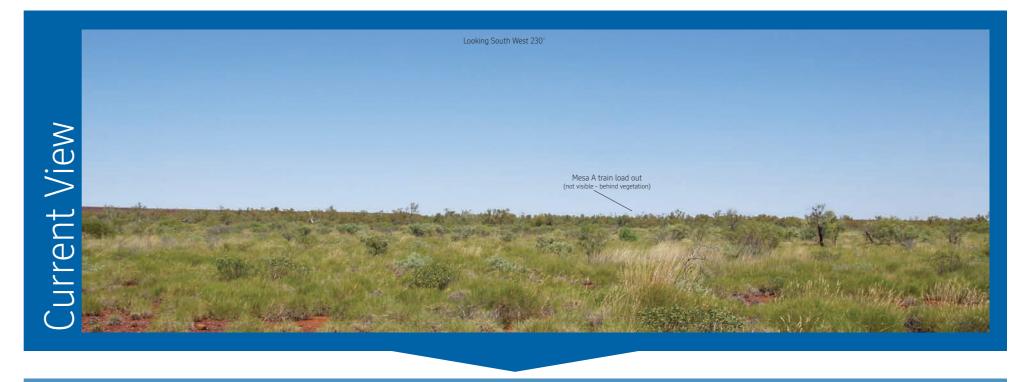
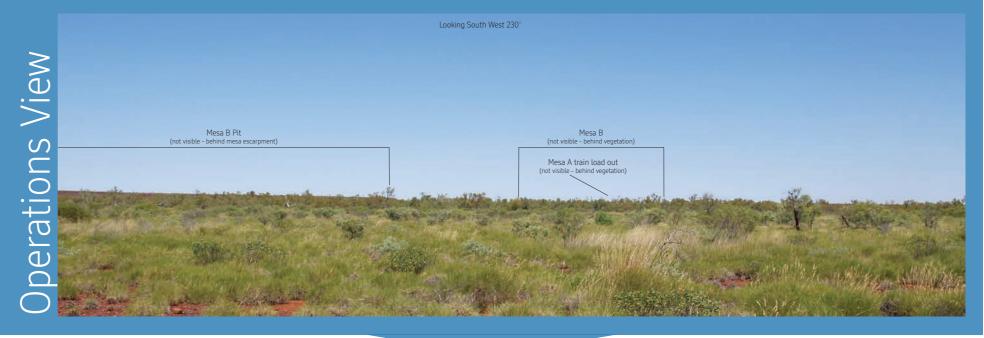
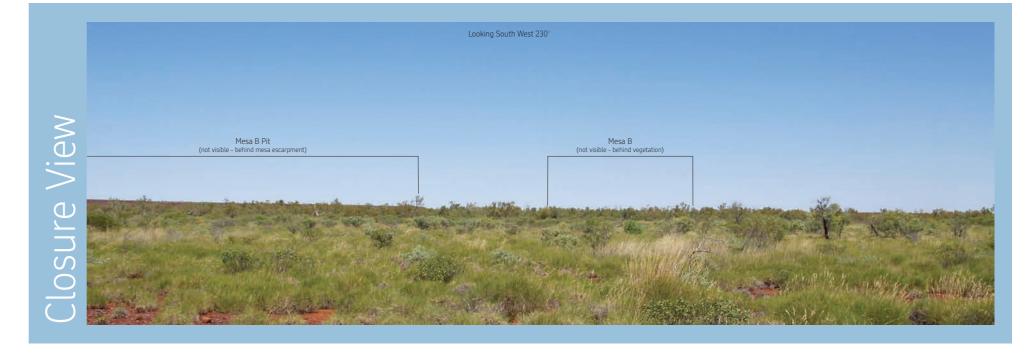
Figure 24 – Robe River

Name #13 - RR01 - Robe River

Direction South West (Bearing 230°)

Description Very flat ground with low vegetation coverage. South west view, with limited visibility of

Mesa B escarpment.

Comments The photo was taken on the north side of the Robe River from access track.

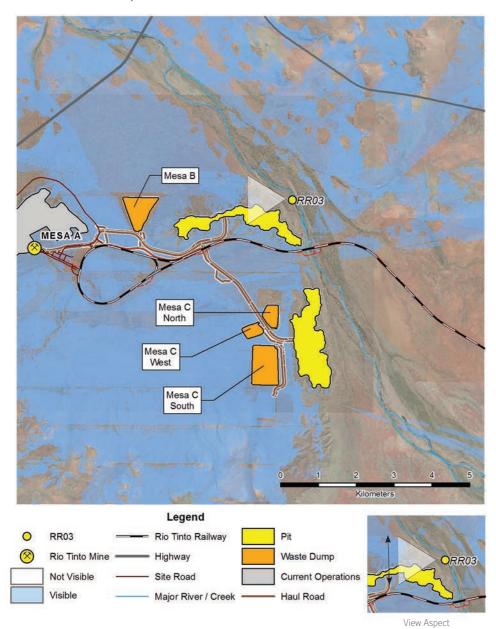
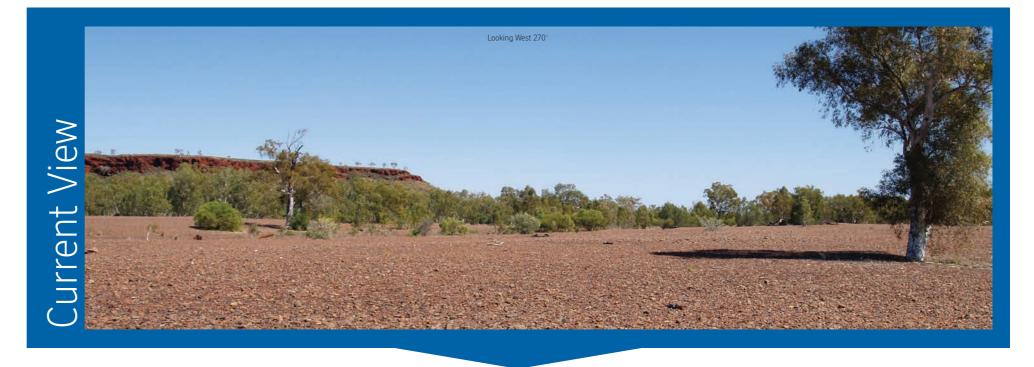
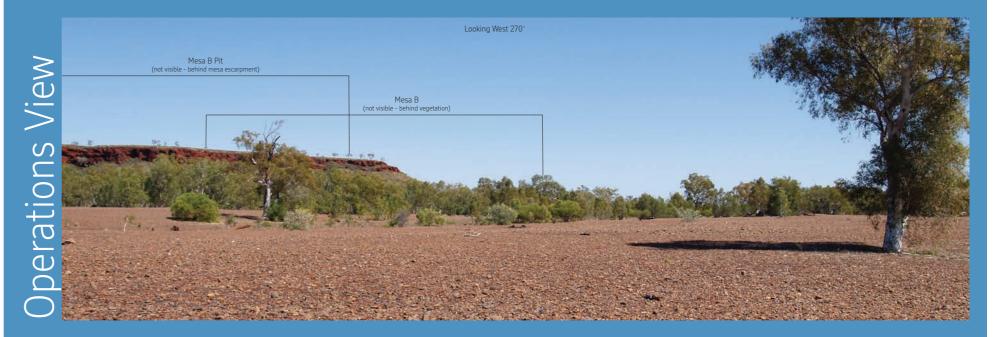
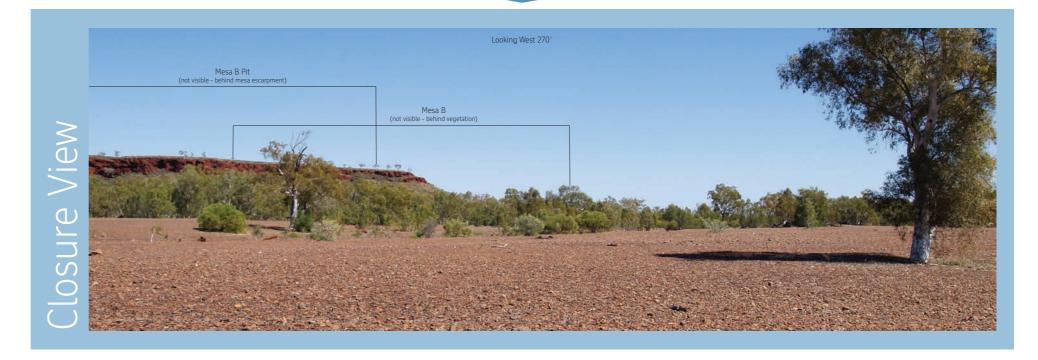
Figure 25 - Robe River

Name #15 - RR03 - Robe River

Direction West (Bearing 270°)

Description Very flat ground with low vegetation coverage. South west view towards Mesa B

escarpment and Robe River bed.

Comments The photo was taken on the north side of the Robe River from access track.

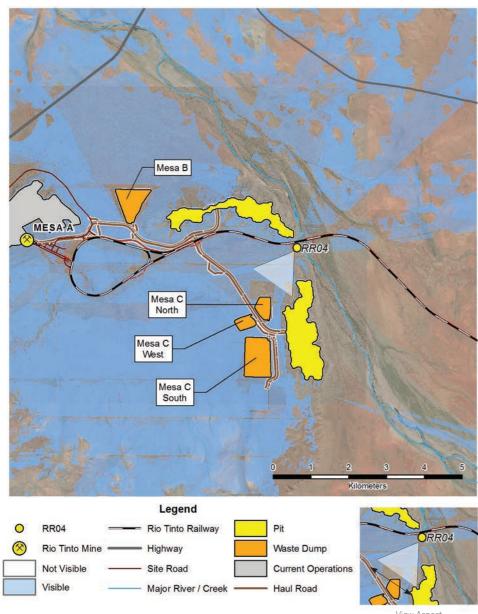
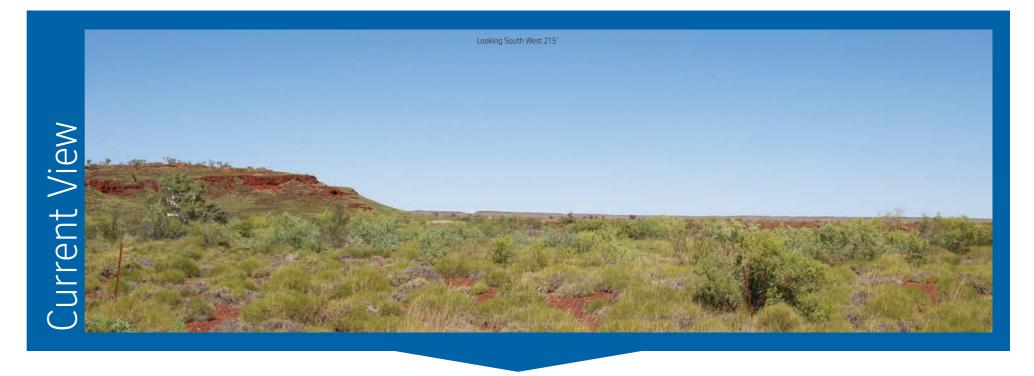
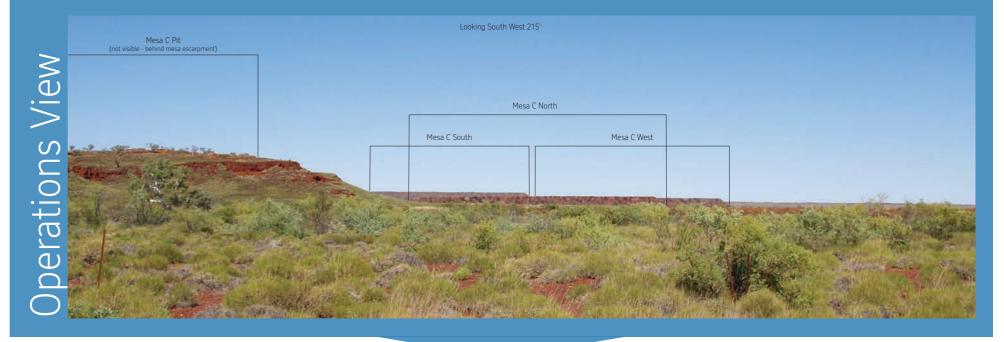
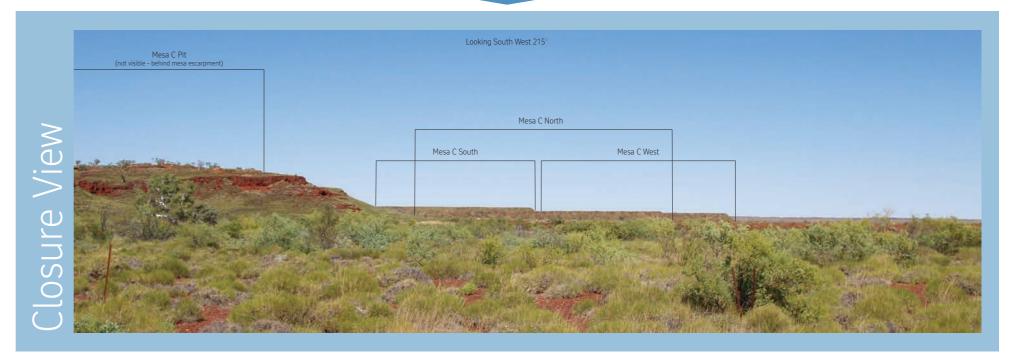
# Figure 26 – Robe River

Name #16 - RR04 - Robe River

Direction South West (Bearing 215°)

**Description** Slight elevation with moderate vegetation coverage. South west view towards Mesa C

escarpment and next to Robe River bed.

Comments The photo was taken on the south side of the Robe River, from access track on southern

side of Rio Tinto railway.

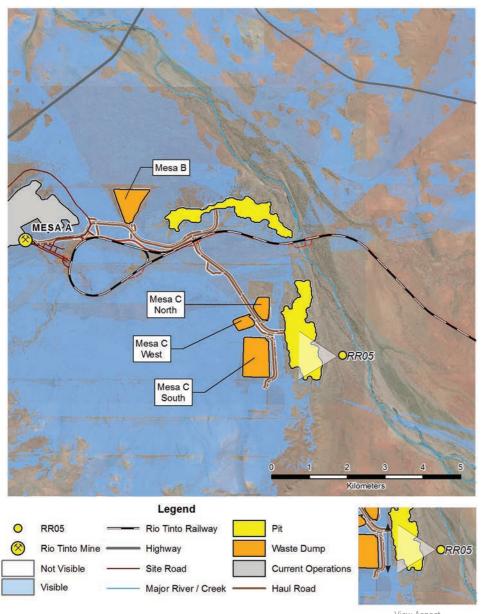
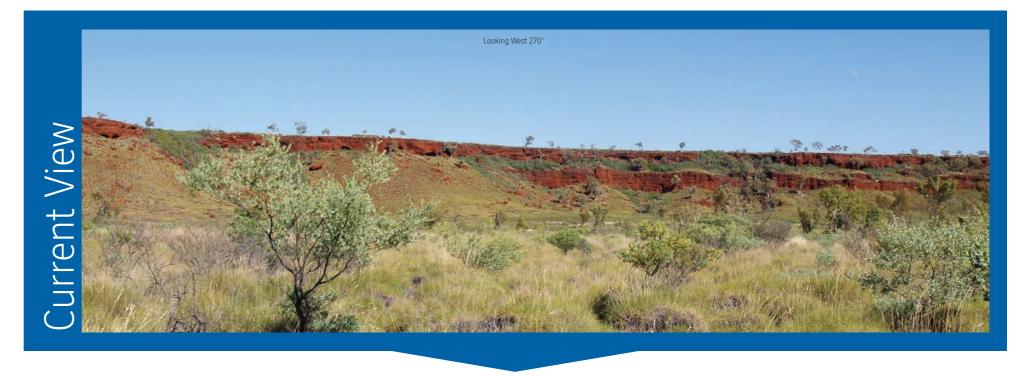
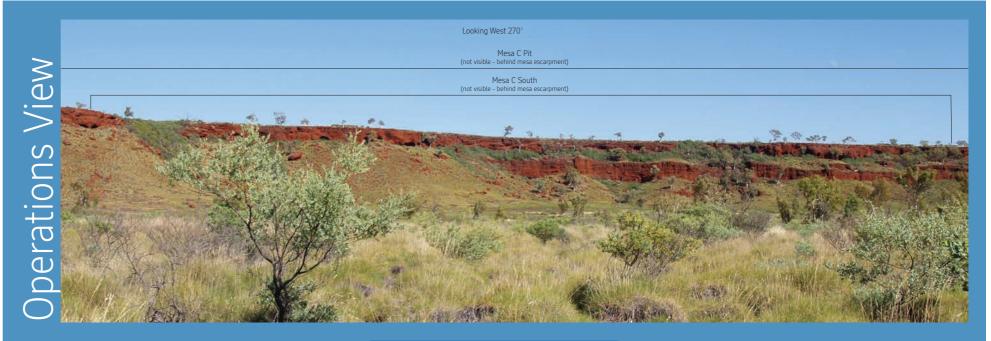
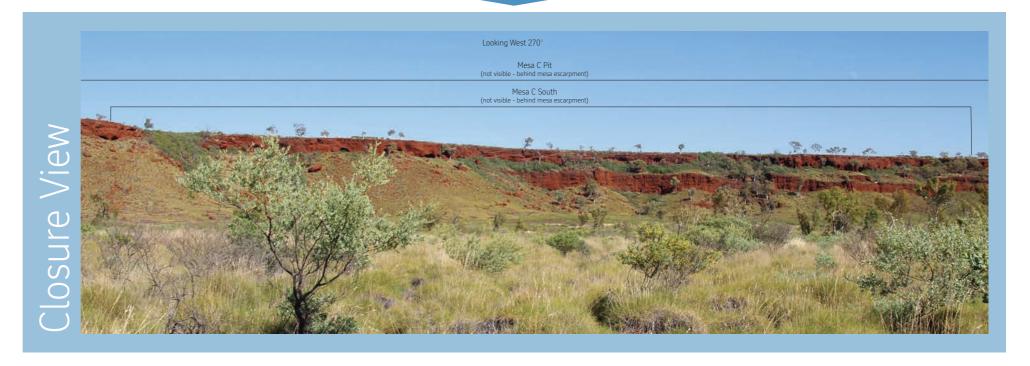
Figure 27 – Robe River

Name #17 - RR05 - Robe River

Direction West (Bearing 270°)

**Description** Slight elevation with low vegetation coverage. Looking directly at Mesa C escarpment.

Comments The photo was taken on the western side of the Robe River, clearly showing no visibility

of western side of Mesa C

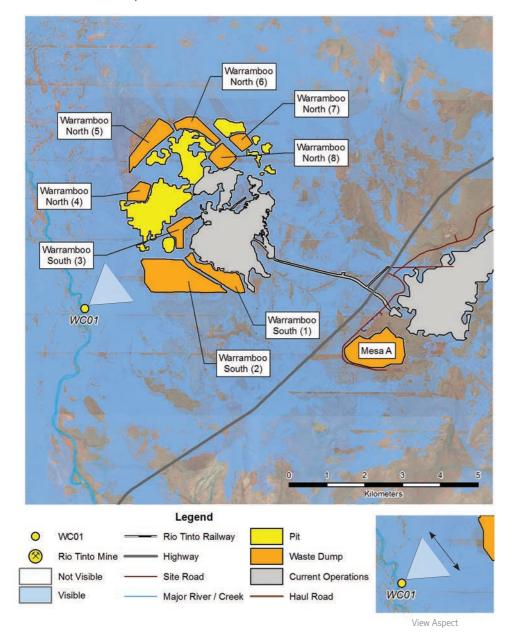
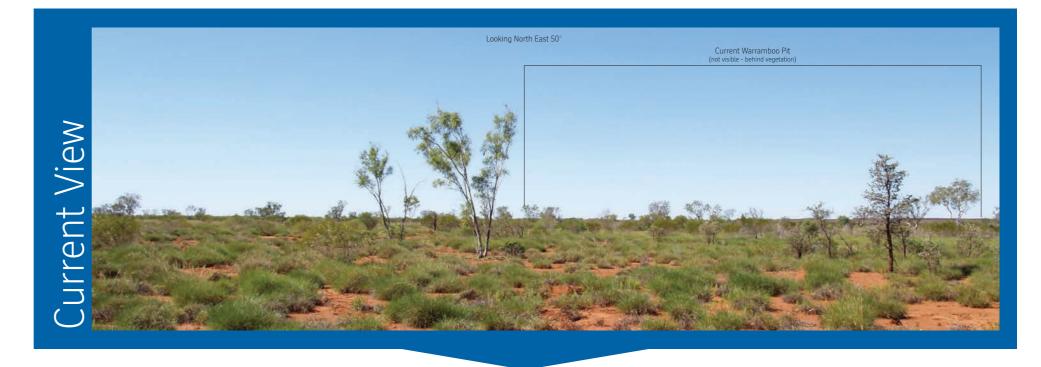
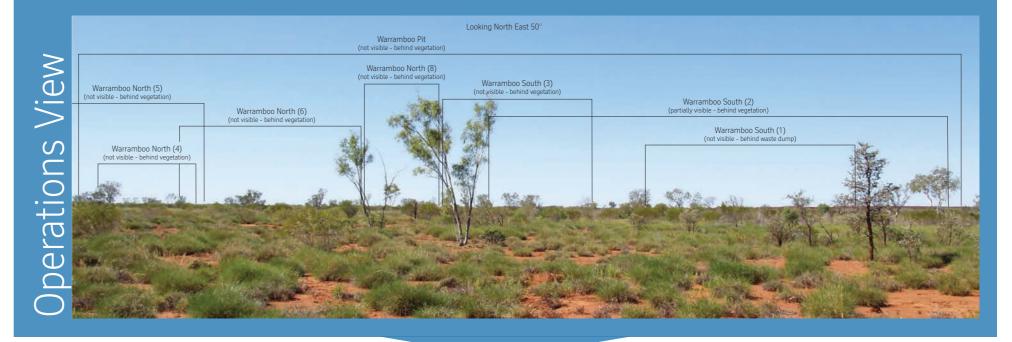
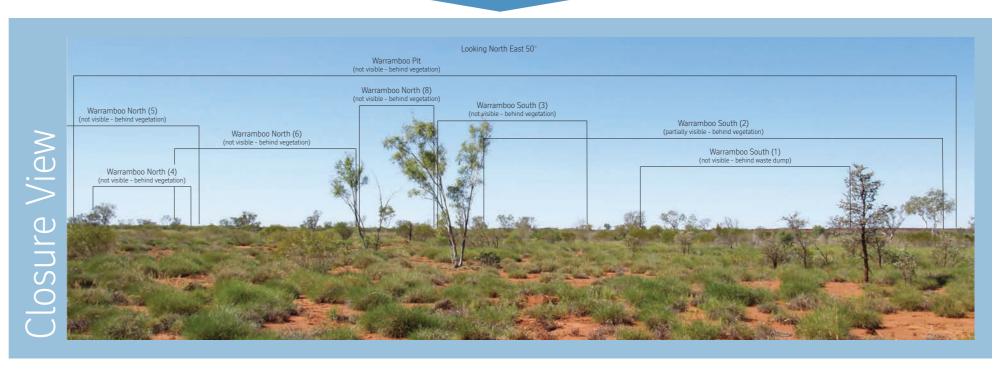
# Figure 28 – Warramboo Creek

Name #19 - WC01 - Warramboo Creek

Direction North East (Bearing 50°)

Description Flat ground with vegetation cover.

Comments Taken from north side of Warramboo Creek, looking north east towards proposed

nfrastructure
