The Rio Tinto Iron Ore GIS Team conducted the Visual Impact Assessment (VIA) for the proposed changes to the Warramboo mine & the proposed Mesa B/C Iron Ore Mine, located approximately 43 km west of Pannawonica. Field work was undertaken in July and August of 2016 and the assessment was undertaken as part of the environmental impact assessment for the proposed changes to the Waramboo mine site and for the proposed Mesa B/C mine development.

This report outlines the Warramboo & Mesa B/C VIA scope, methodology and results. The GIS Team was engaged to prepare a VIA report, which was developed in conjunction with several other environmental studies and reports to provide an overview of the likely impacts.

The overall objective was to assess the visual impact of the proposed mining operations at Warramboo & Mesa B/C and illustrate these impacts through photo montages. The key objectives were to:

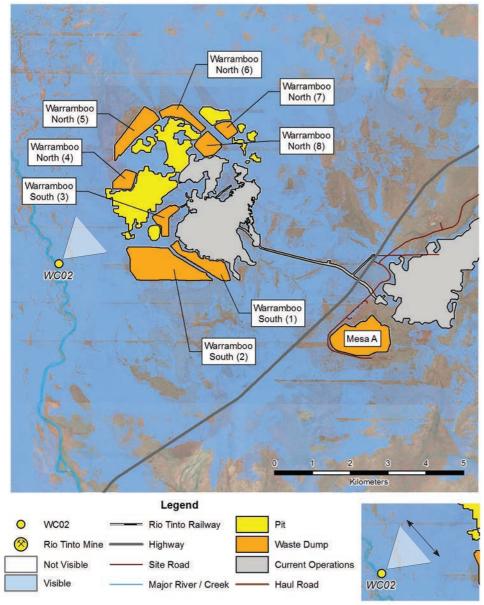
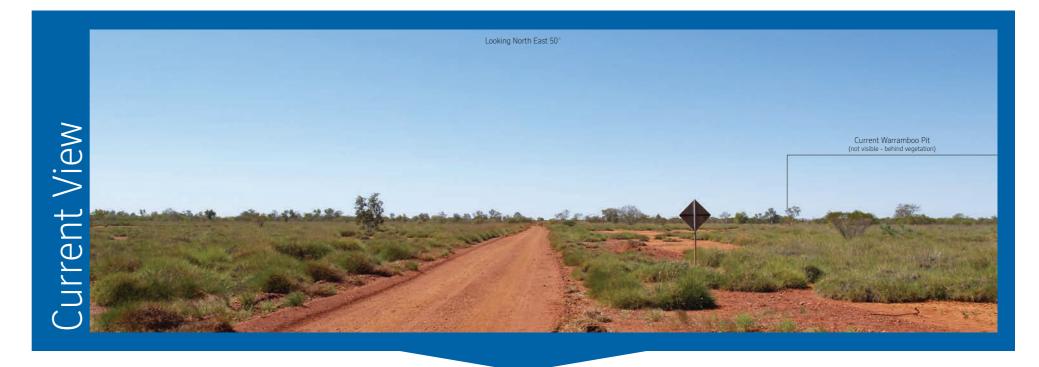
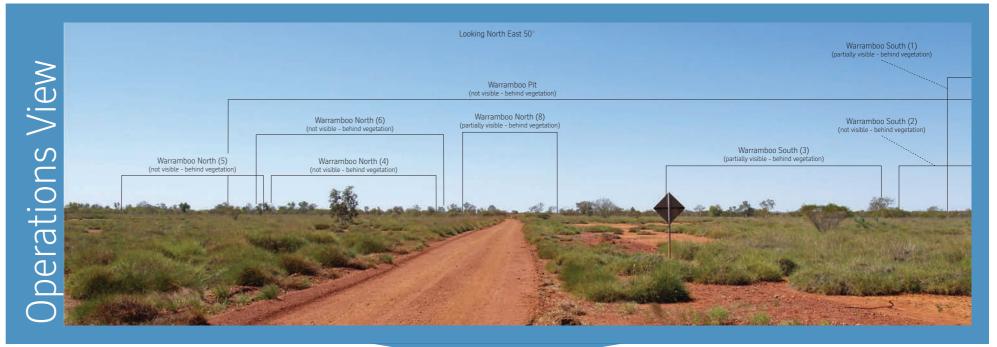
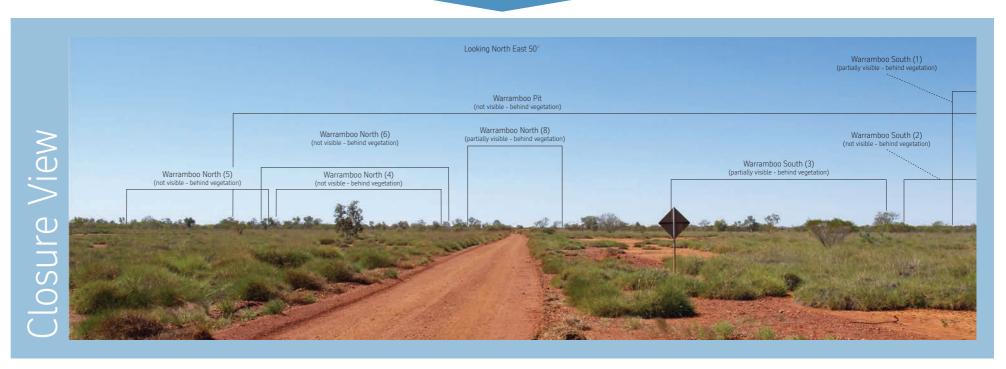
# Figure 29 – Warramboo Creek

Name #20 - WC02 - Warramboo Creek

Direction North East (Bearing 50°)

Description Flat ground with vegetation cover.

Comments Taken from north side of Warramboo Creek, looking north east down track (old NWCH)

towards Warramboo.

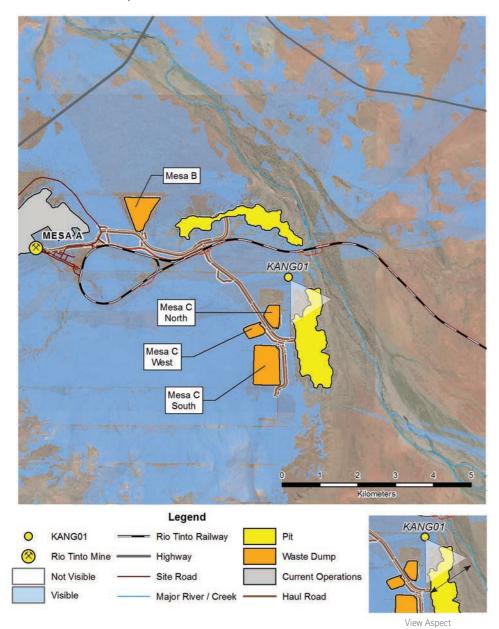
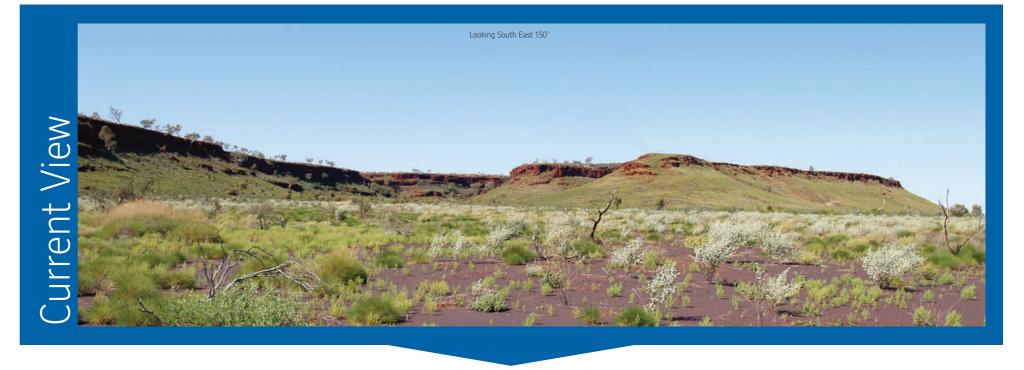
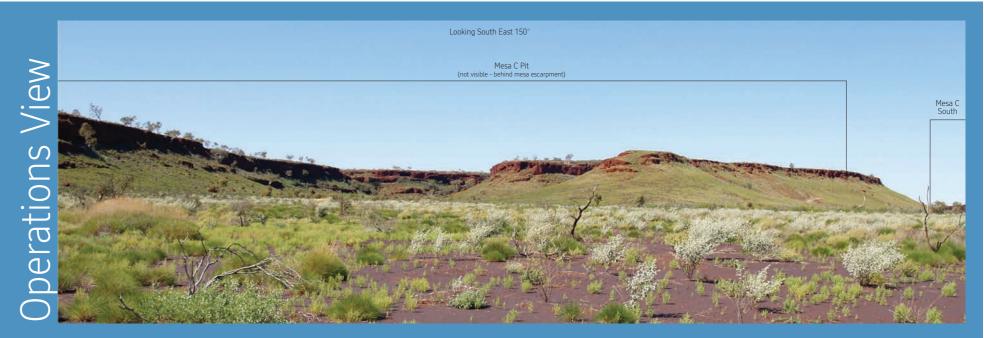
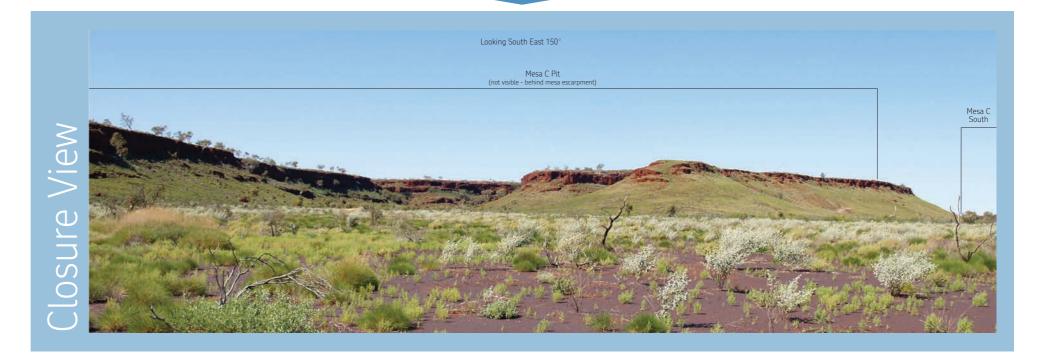
Figure 30 - Kang

Name #23 - KANG01

Direction South East (Bearing 150°)

**Description** Flat ground with vegetation cover. Looking directly at Mesa C escarpment.
