# Phillips River Gold Project Tectonic Resources NL - Kundip and Trilogy Projects

Topsoil characterisation at Kundip  
and Trilogy and recommendations  
for rehabilitation

August 2004

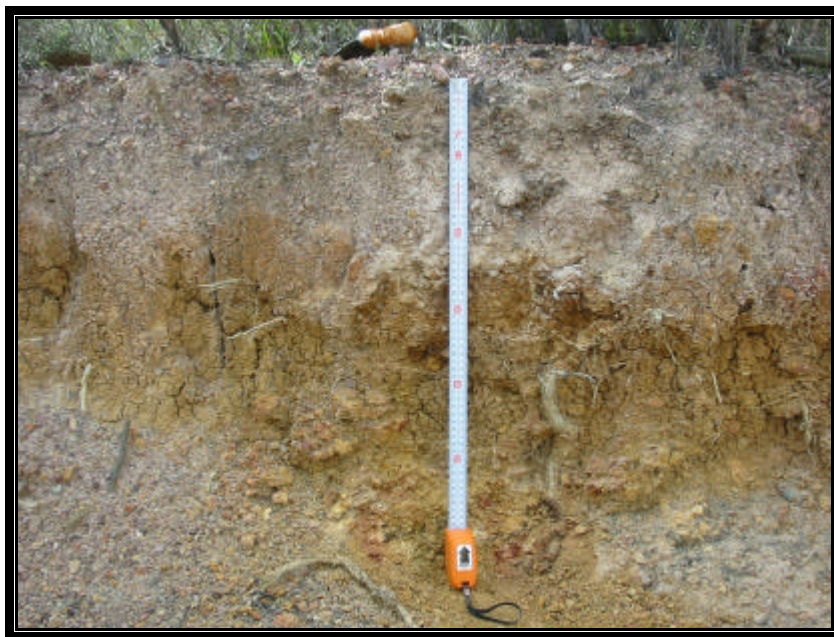
**Plate 1 F6-2 soil profile.**

Surface soils at Flag were typically gravelly loams overlying medium clays (**Table 1; Plate 1**). The topsoils were relatively stable with little tendency for slaking or dispersion. By contrast, the clay subsoils (below 15cm depth), were unstable, slaking quickly and with some evidence of dispersion. The difference in the relative stability of these horizons was evident in erosion and undercutting of the clay subsoil on exposed areas (**Plate 1**).

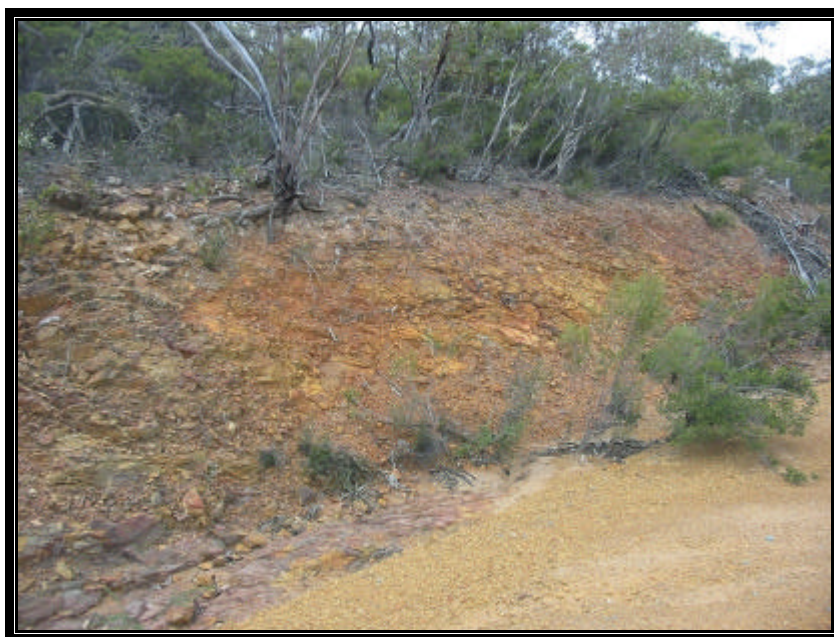
**Plate 2**      **Flag – rocky subsoil at road cutting to north of Flag shaft.**

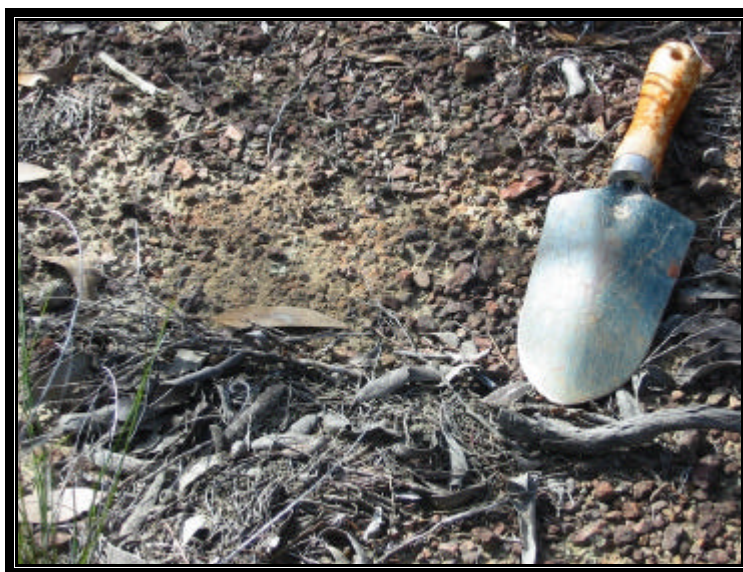
**Plate 3** HV4 soil surface – gravels, litter, cryptogams.

In well-vegetated areas of Harbour View, as for Flag area, the existing soil surface is physically well-protected with gravel lag, cryptogamic crusts and plant litter, and typically the soil crust is very firm (**Plate 3**). Cryptogamic crusts are a diverse assortment of macro- and micro-organisms within the top few millimetres of soil (Eldridge, 1996). These organisms may include principally, lichens, mosses, liverworts, cyanobacteria and fungi. These crusts can bind the soil particles together, providing a barrier against raindrops and erosion, and regulate the flow of water and nutrients through the soil (Eldridge, 1996). Cryptogamic crusts are destroyed during soil disturbance and their recovery under revegetation takes years to decades. In general, recovery is likely to be most rapid on moist soils that are fine-textured, stable, and vegetated (Belnap and Eldridge, 2004).

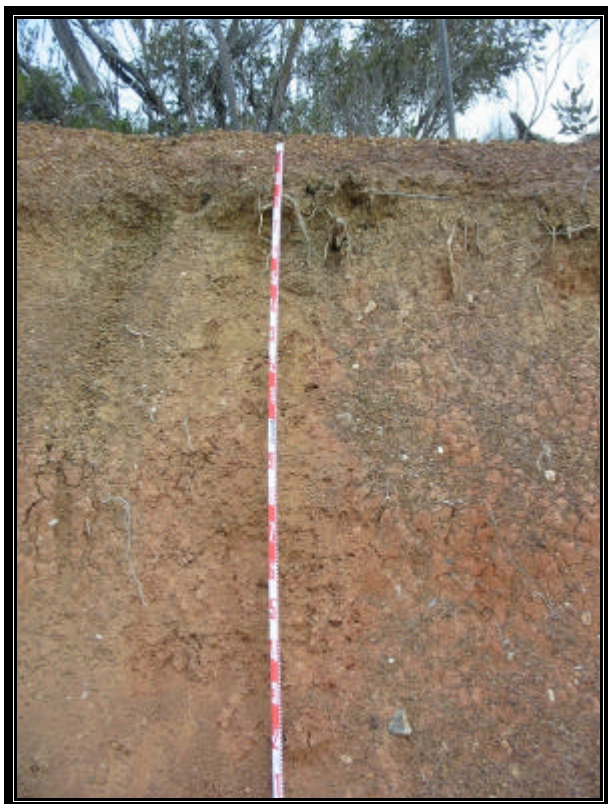
**Plate 7 H3 soil profile at the west end of Western Gem.**

Soils from the Hillsborough Deposit appeared to have similar physical properties as the other areas in the Kundip Project, but most samples were not able to be tested for slaking and dispersion due to the lack of aggregates in the collected samples. As with the other areas, the topsoils were gravelly, loamy sands overlying medium to heavy clay subsoils (**Table 1; Plate 6**). The underlying clays were similar to those recorded in the upper horizons in the exposed face of the Two Boys Pit (see section 3.1.3 above) and could be expected to be slightly acidic and slaking. A similar profile of gravelly topsoils over orange-brown clays and then red-brown cracking heavy clays was exposed in the Western Gem Pit further to the north of the area of this deposit (**Plate 7**).

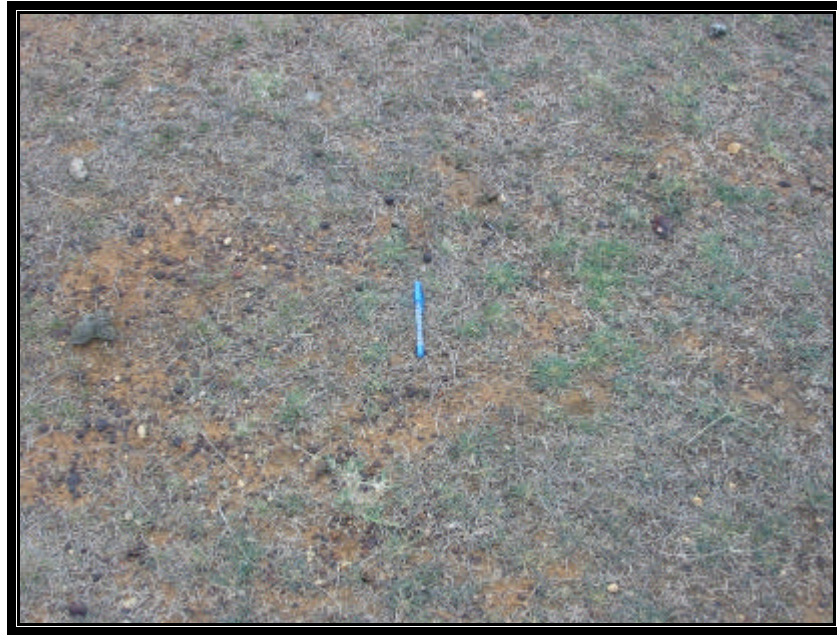
**Plate 9**      **T1 soil surface cover gravel and pasture.**

Soils were sampled at four sites across the area of the deposit (**Figure 2**). In general, the surface soil consisted of an organic-rich loam in the first 5cm, over a gravelly, brown, medium clay (5-20cm) (**Table 2**). Below this (to 60cm), the soil tended to become darker brown but with less gravel content (**Plate 10**). This general pattern was repeated across the area, except on the western edge (site T3) where there were white rocks visible on the surface and the clay subsoils were grey-pink-white, noticeably paler in colour when compared to the other three sampling sites (**Plate 11**).

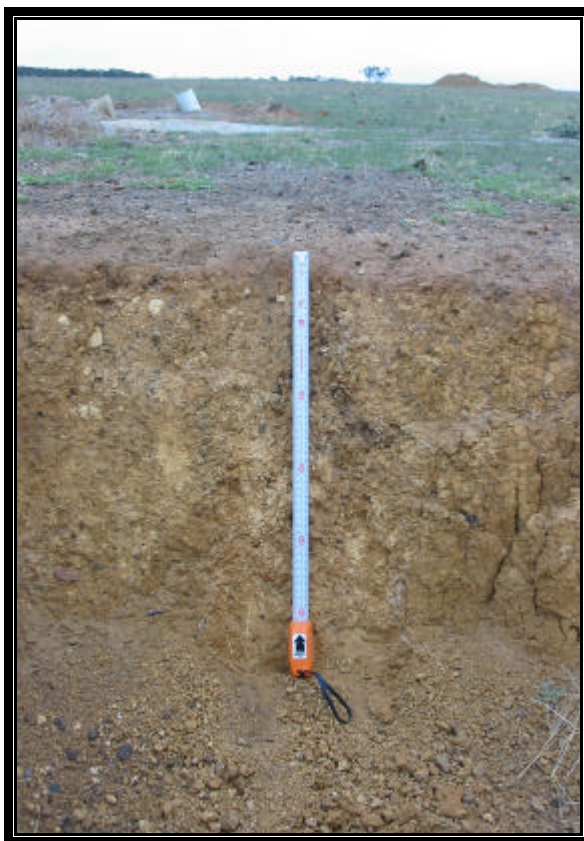
**Plate 10**      **T1 soil profile.**

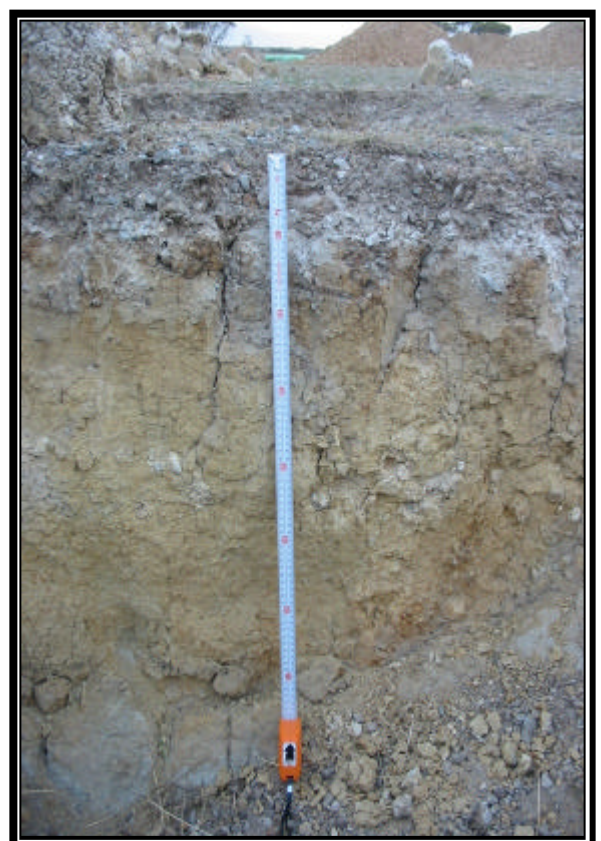
**Plate 11**      **T3 soil profile.**
