SUPPLIERS NAME	360 Environmental Pty Ltd
PURCHASE ORDER NO:	4300233403
DOCUMENT TITLE	Subsea 7 Bundle Facility Shoreline Movement Assessment
TOTAL NO OF PAGES	22
SUPPLIERS ORDER NO:

**Subsea 7 Bundle Facility
Shoreline Movement Assessment**

K1462, Report R967 Rev 1

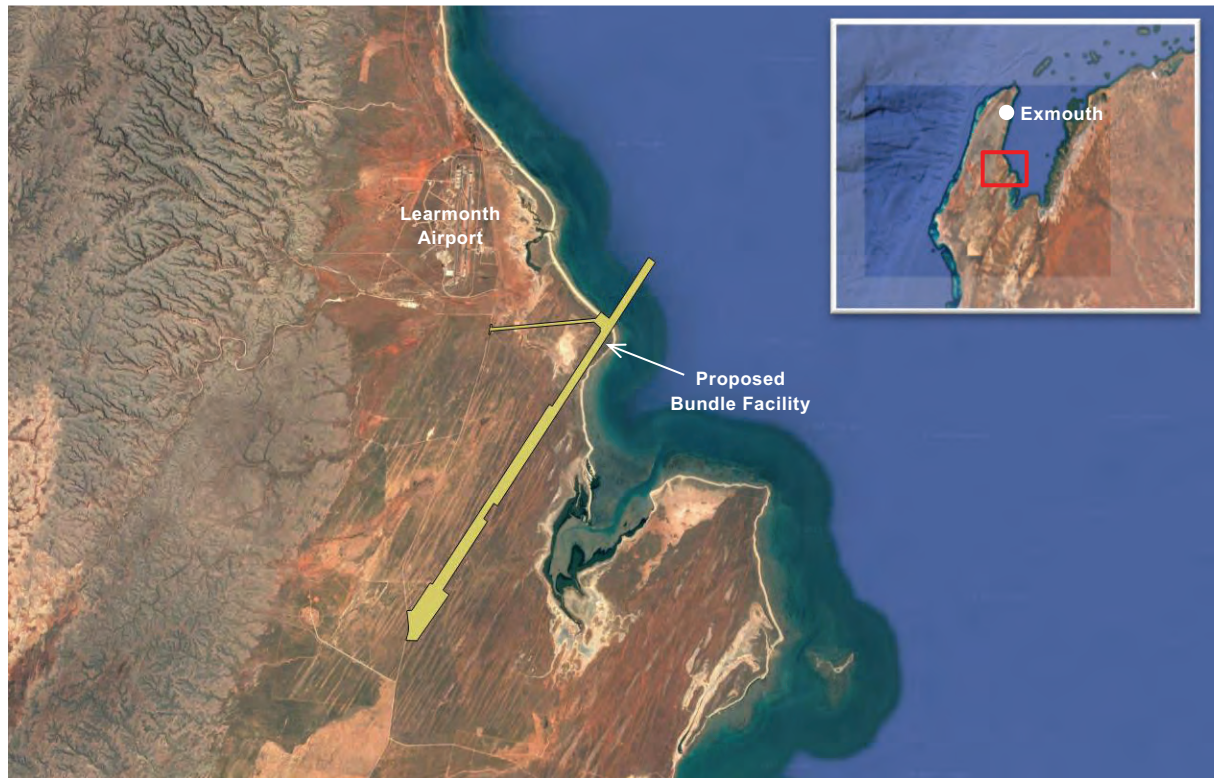
Figure 1.1 Proposed site location

Subsea 7 propose to construct a new pipeline bundle fabrication facility in north-west Western Australia. The proposed location of this facility is within the Exmouth Gulf, on the eastern side of the North West Cape. The location is adjacent to the Learmonth Airport, which is approximately 35 km south of Exmouth, as shown in Figure 1.1.

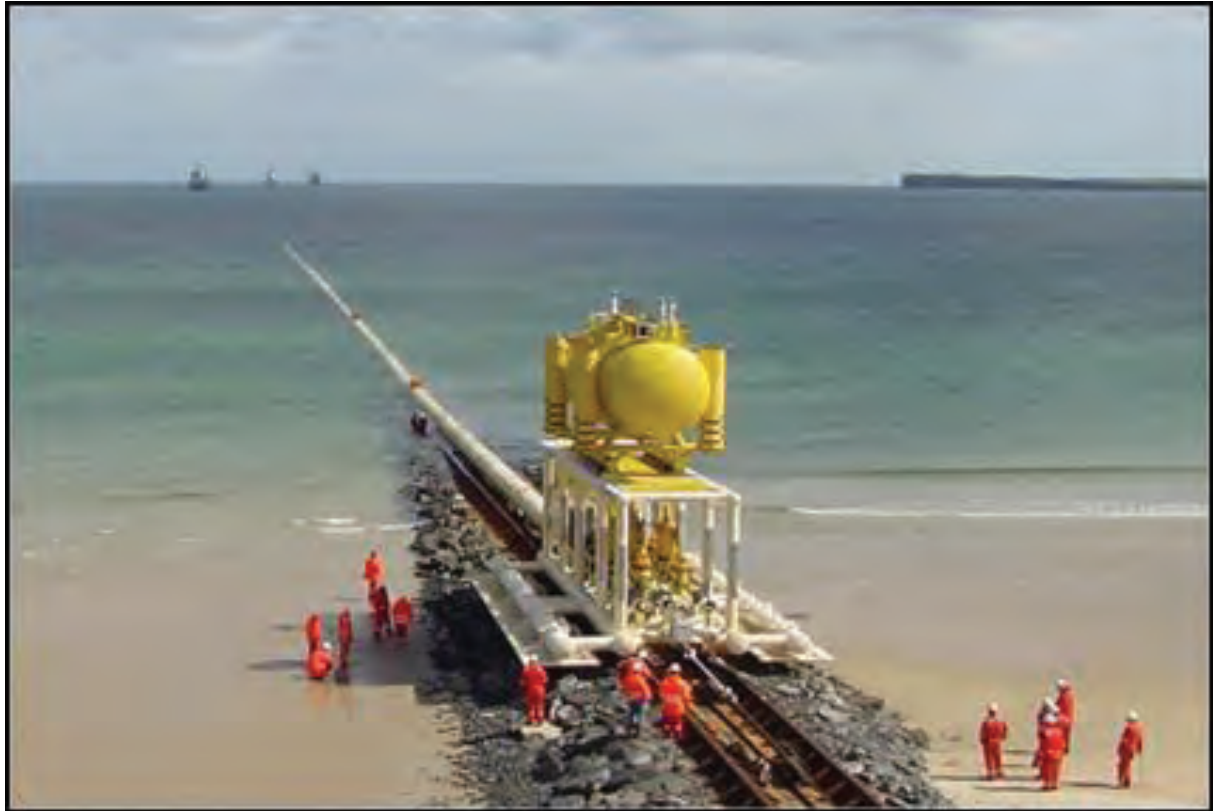
Figure 1.2 Indicative image of launchway structure from Wick with pipeline being launched

A key element of the pipeline bundle fabrication facility is the launchway, which enables the fabricated pipeline to be launched into the ocean for subsequent shipment and installation. The launchway requires the construction of a small shore perpendicular structure to support the launch rails over the nearshore area. A similar facility has existed in Wick in the far north of Scotland since 1978. A photograph of the launchway at Wick is provided in Figure 1.2 to give an indication of the size and form of the launchway.

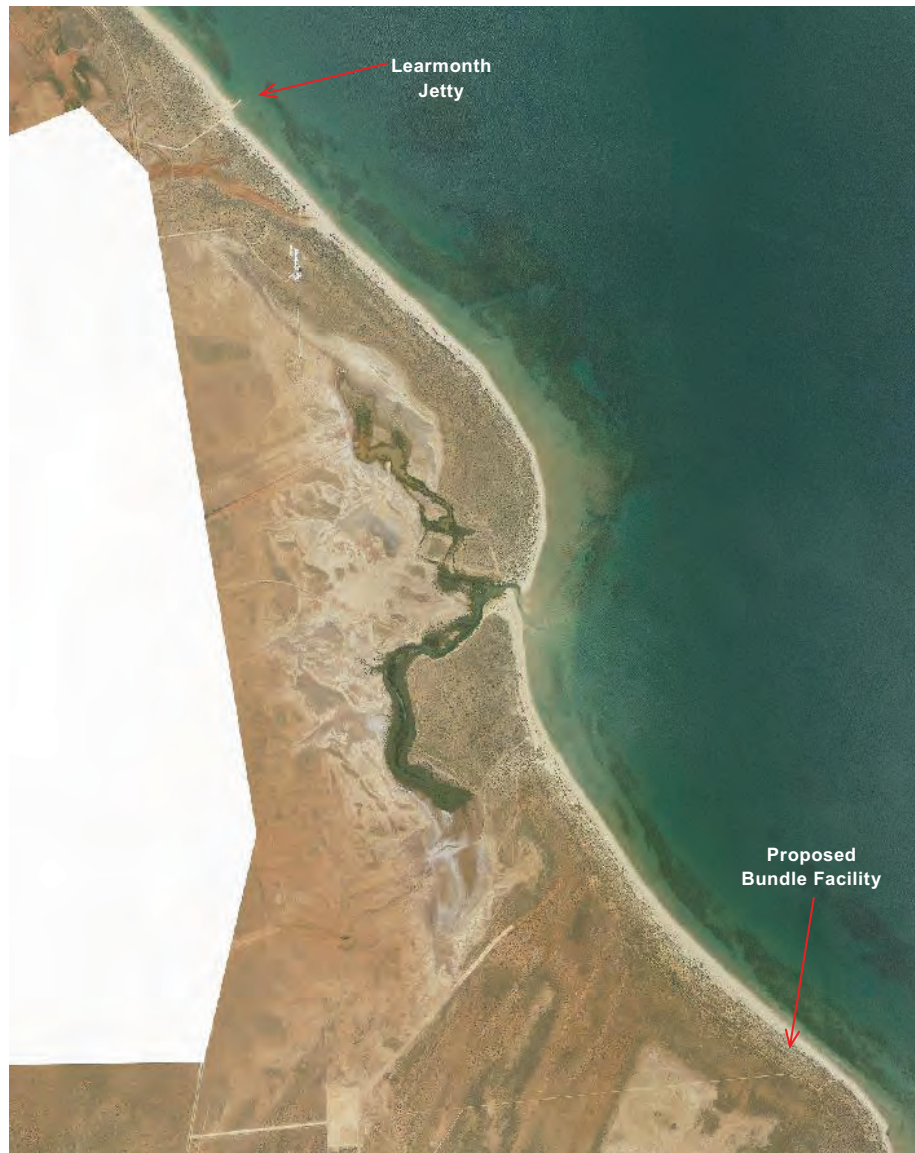
Figure 1.3 Location of Learmonth Jetty in relation to the propose bundle facility

The Learmonth Jetty and abutment was first constructed in 1955 for use in the oil drilling operations in the area. The design drawing of the original Learmonth Jetty is included in Appendix A and shows a total abutment length of approximately 80 m. For the purposes of this assessment it is assumed that the shoreline changes that have occurred due to the construction of the abutment will be similar to those that occur as a result of the launchway. This assumption is based on the fact that the exposure, aspect and nearshore bathymetry are similar at both sites, as shown in Figure 1.3.

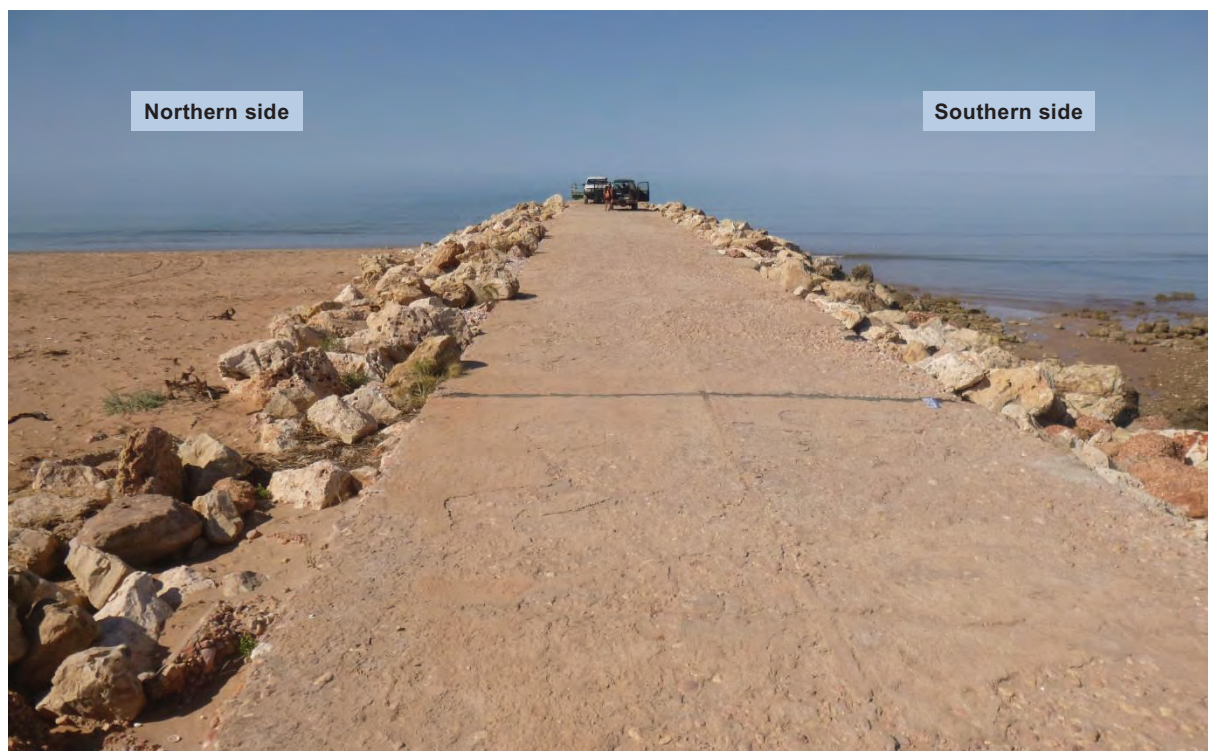
Figure 2.2 Photograph looking seaward from the base of the Learmonth Jetty abutment

Evidence of net longshore sediment transport is observed at the Learmonth Jetty abutment. Photographs of the jetty abutment and the beaches north and south are presented in Figures 2.2 and 2.3. These images clearly show the presence of a wide sandy beach on the northern side of the abutment, with a much narrower beach present on the southern side of the structure. This is indicative of southerly sediment transport.

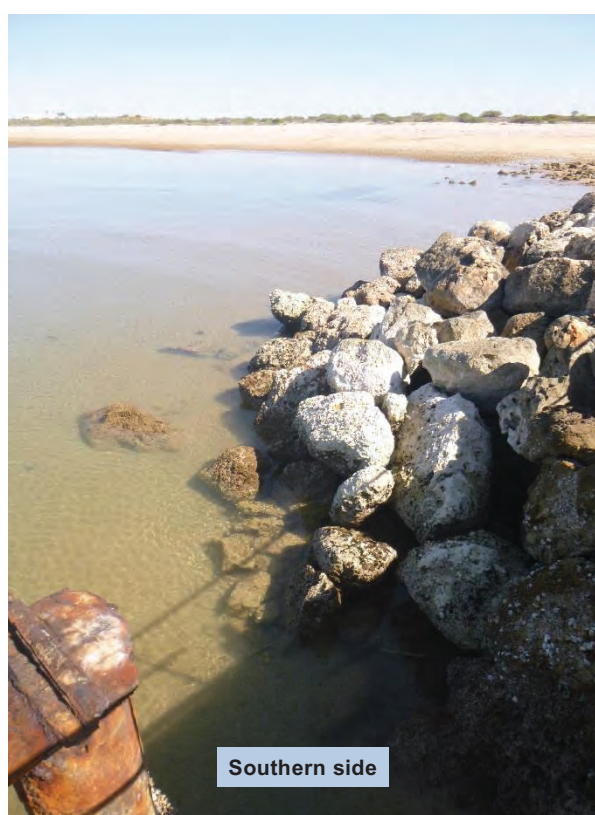
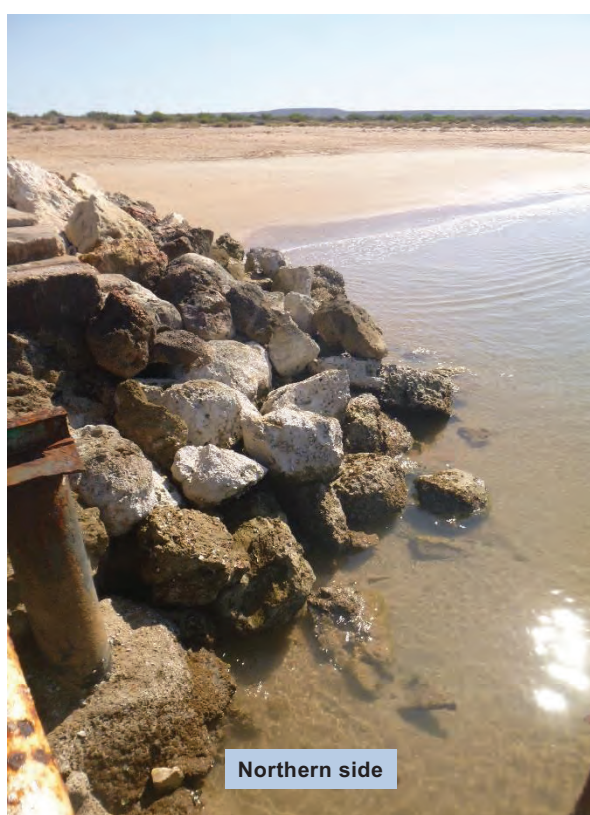
Figure 2.3 Photographs looking landward from the end of the Learmonth Jetty abutment

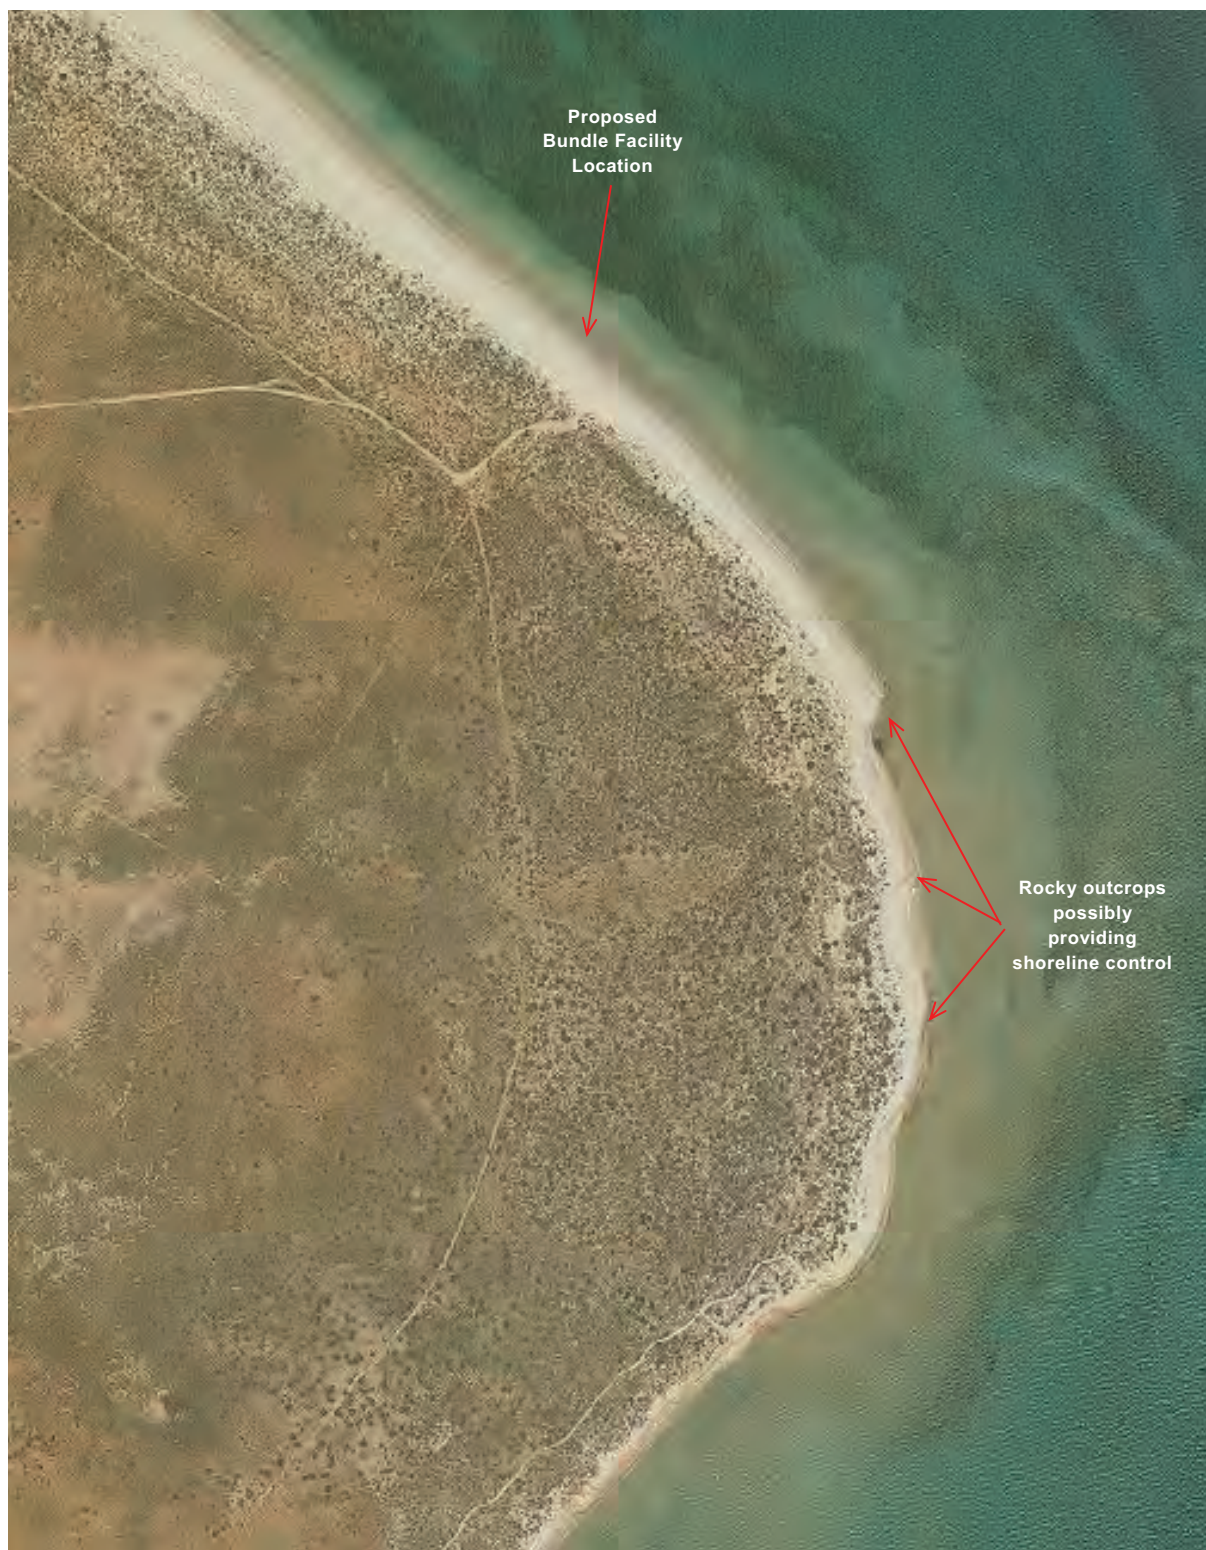
Figure 4.1 Shoreline south of the proposed bundle facility

- The shoreline south of the launchway would likely experience erosion in the first 1 to 2 decades following construction. Based on the observations at Learmonth Jetty, the extent of this erosion could be as much as 40 m and could extend for 1 km or more along the shoreline. However, this assertion is complicated by the fact that the shoreline to the south experiences a change in alignment and may be impacted by the presence of rock outcrops, which could exhibit a degree of shoreline control and potentially limit the extent of erosion (as shown in Figures 4.1 and 4.2).

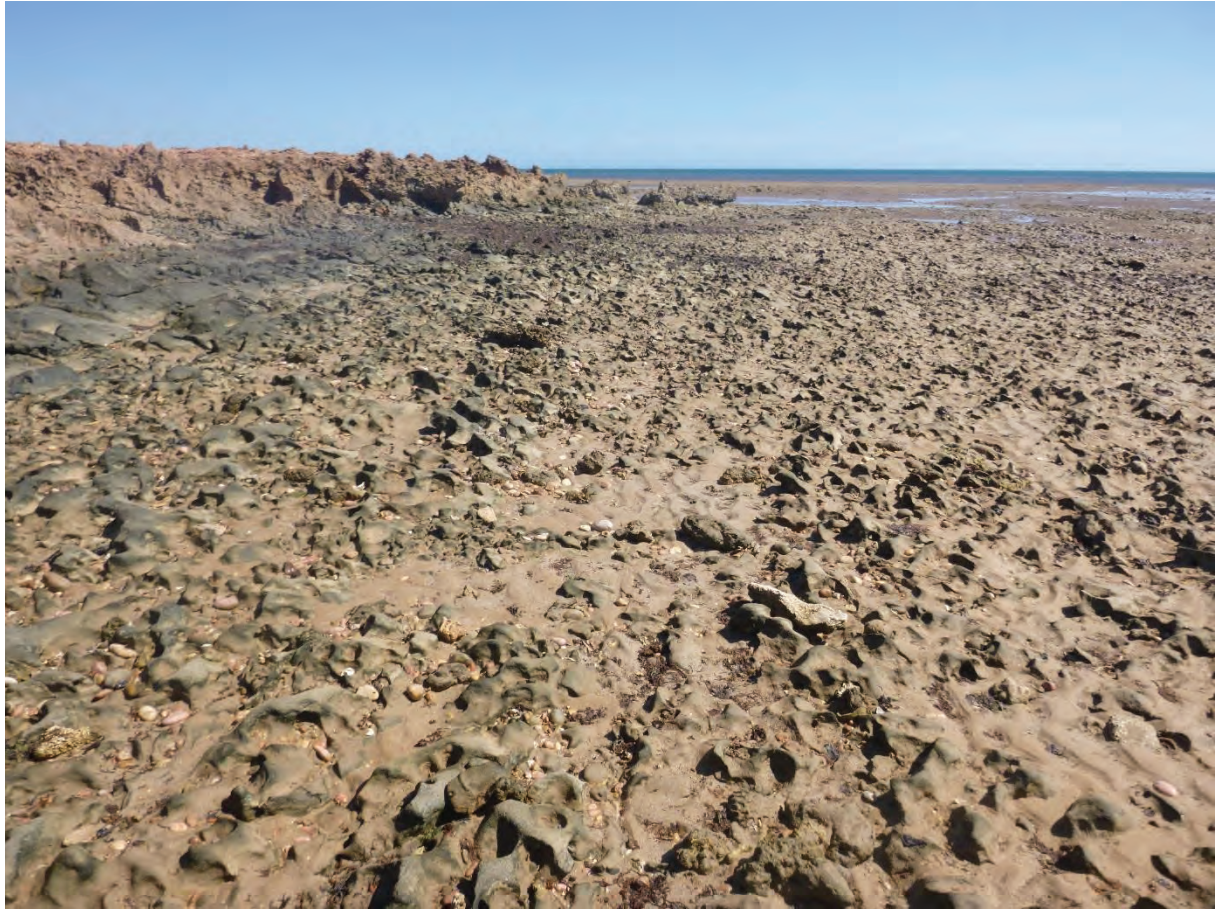
Figure 4.2 Ground level photograph of the rocky outcrop on the shoreline south of the proposed bundle facility
