# Subsea 7 Exmouth Gulf Current Monitoring Field Report

August 2018

This GHD Pty Ltd (GHD) field report summarises the Exmouth Gulf Current Monitoring campaign carried out from May – June 2018 for Subsea 7 (SS7). This project involved the supply of equipment, deployment/retrieval of equipment, and provision of QA/QC current speed and direction data at two prescribed SS7 sites within Exmouth Gulf over two tidal cycles. Additionally, photosynthetic available radiation (PAR) and turbidity measurements were made near the seabed from loggers attached to the seabed mounted current measurement instruments.

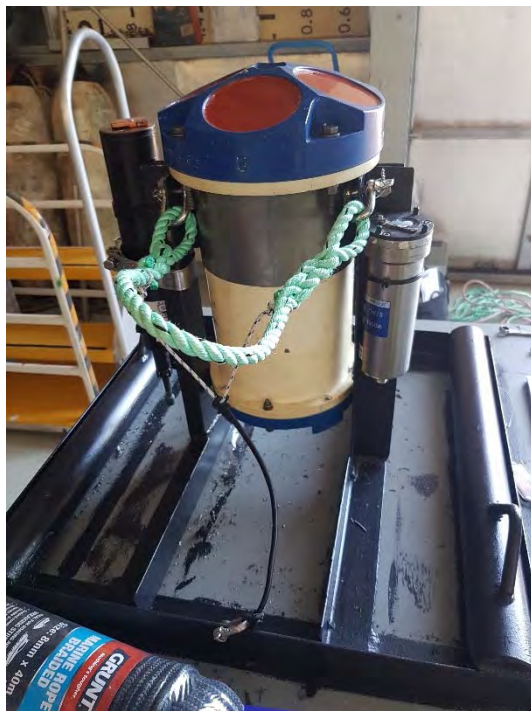
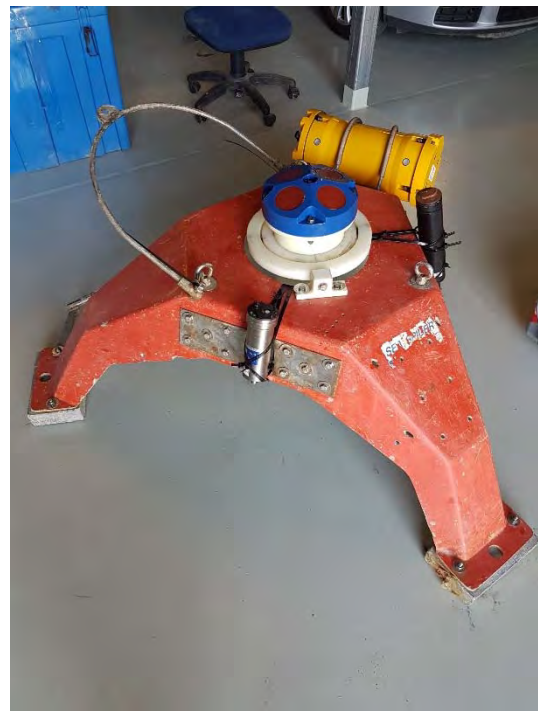
Figure 2 Loggers and ADCP setup pre-deployment for Parking (left) and Launchway (right)

- WETLabs NTU – Turbidity Logger (Figure 2, black cylinder) and;
- JFE Advantech (Kobe, Japan), Photosynthetically Available Radiation (PAR) Logger (Figure 2, silver cylinder).

These loggers were attached to each ADCP frame as shown in Figure 2. The turbidity and PAR loggers were set to 'burst' measurements with the following configuration:

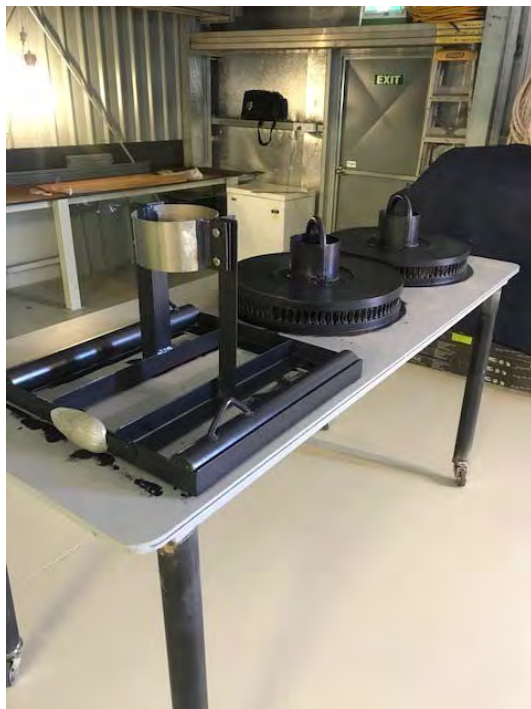
Figure 3 Photos showing ground anchors and ADCP frame (left), and davit and winch deployment (right)

Field equipment was retrieved through use of the vessel's davit crane and winch. The following recovery observations were noted in the field:

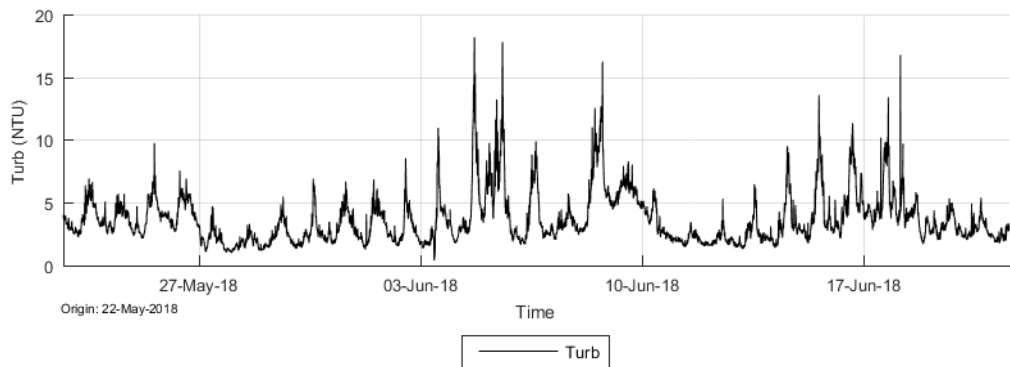
Figure 20 Turbidity recorded throughout monitoring event, note storm event 5th June, Parking
