ACID SULFATE SOILS INVESTIGATION LEARMONTH PIPELINE FABRICATION FACILITY

SUBSEA 7

DECEMBER 2018

LEARMONTH PIPELINE BUNDLE PROJECT ACID SULFATE SOIL INVESTIGATION

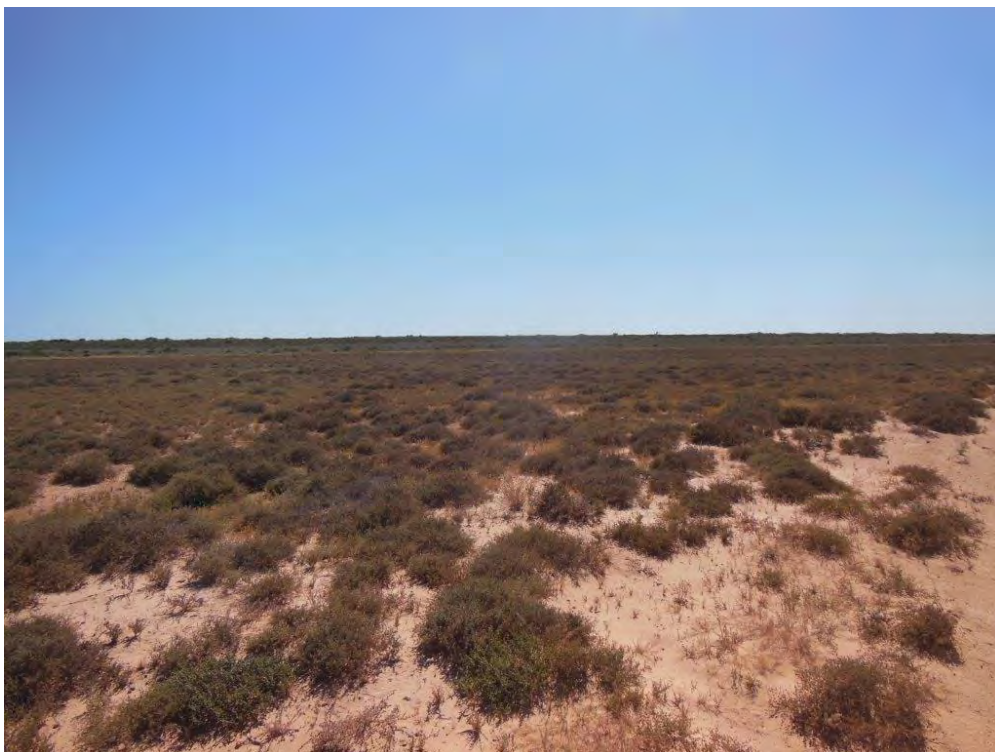
Site vegetation consists of samphire and saltbrush low shrubs, Bowgada low woodland on sandy ridges and plains, Snakewood shrubs on clay flats and tree to shrub steppe over hummock grasslands between red sand dune fields (GHD 2018). Photographs of the surrounding landscape was taken during the ASS investigation (19 September 2018) and shown in Plate 1 and Plate 2.

Plate 1: Site Photograph of Surrounding Landscape – Low Shrub/Grassland

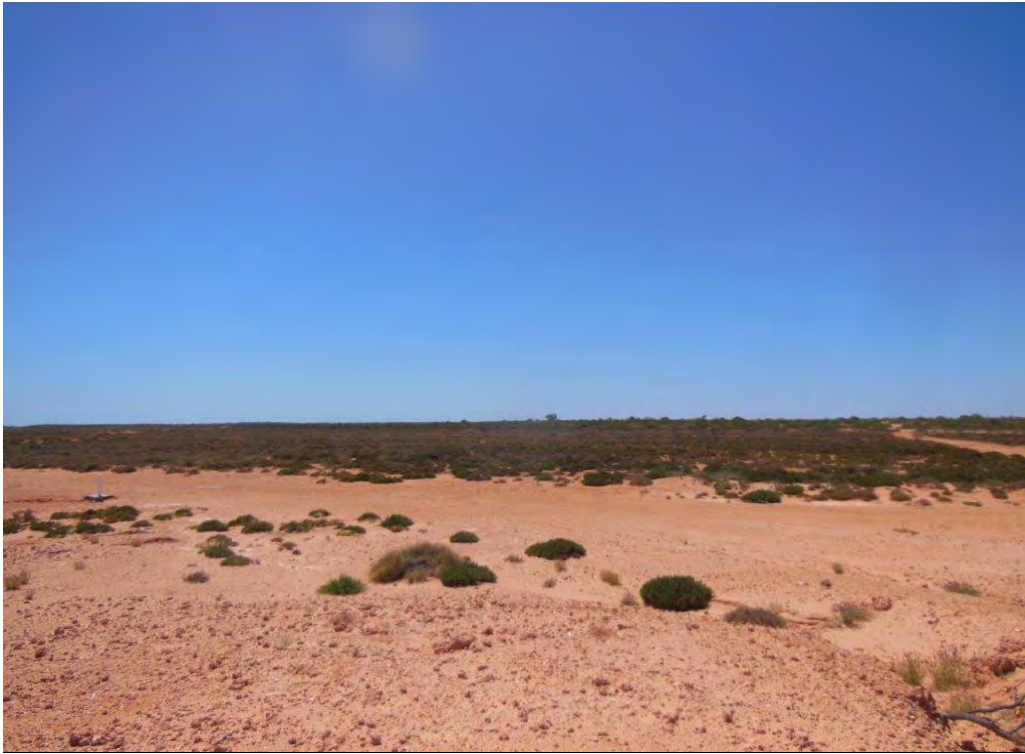
Plate 2: Site Photograph of Surrounding Landscape – Low Shrubland/Grassland with Isolated Eucalypts

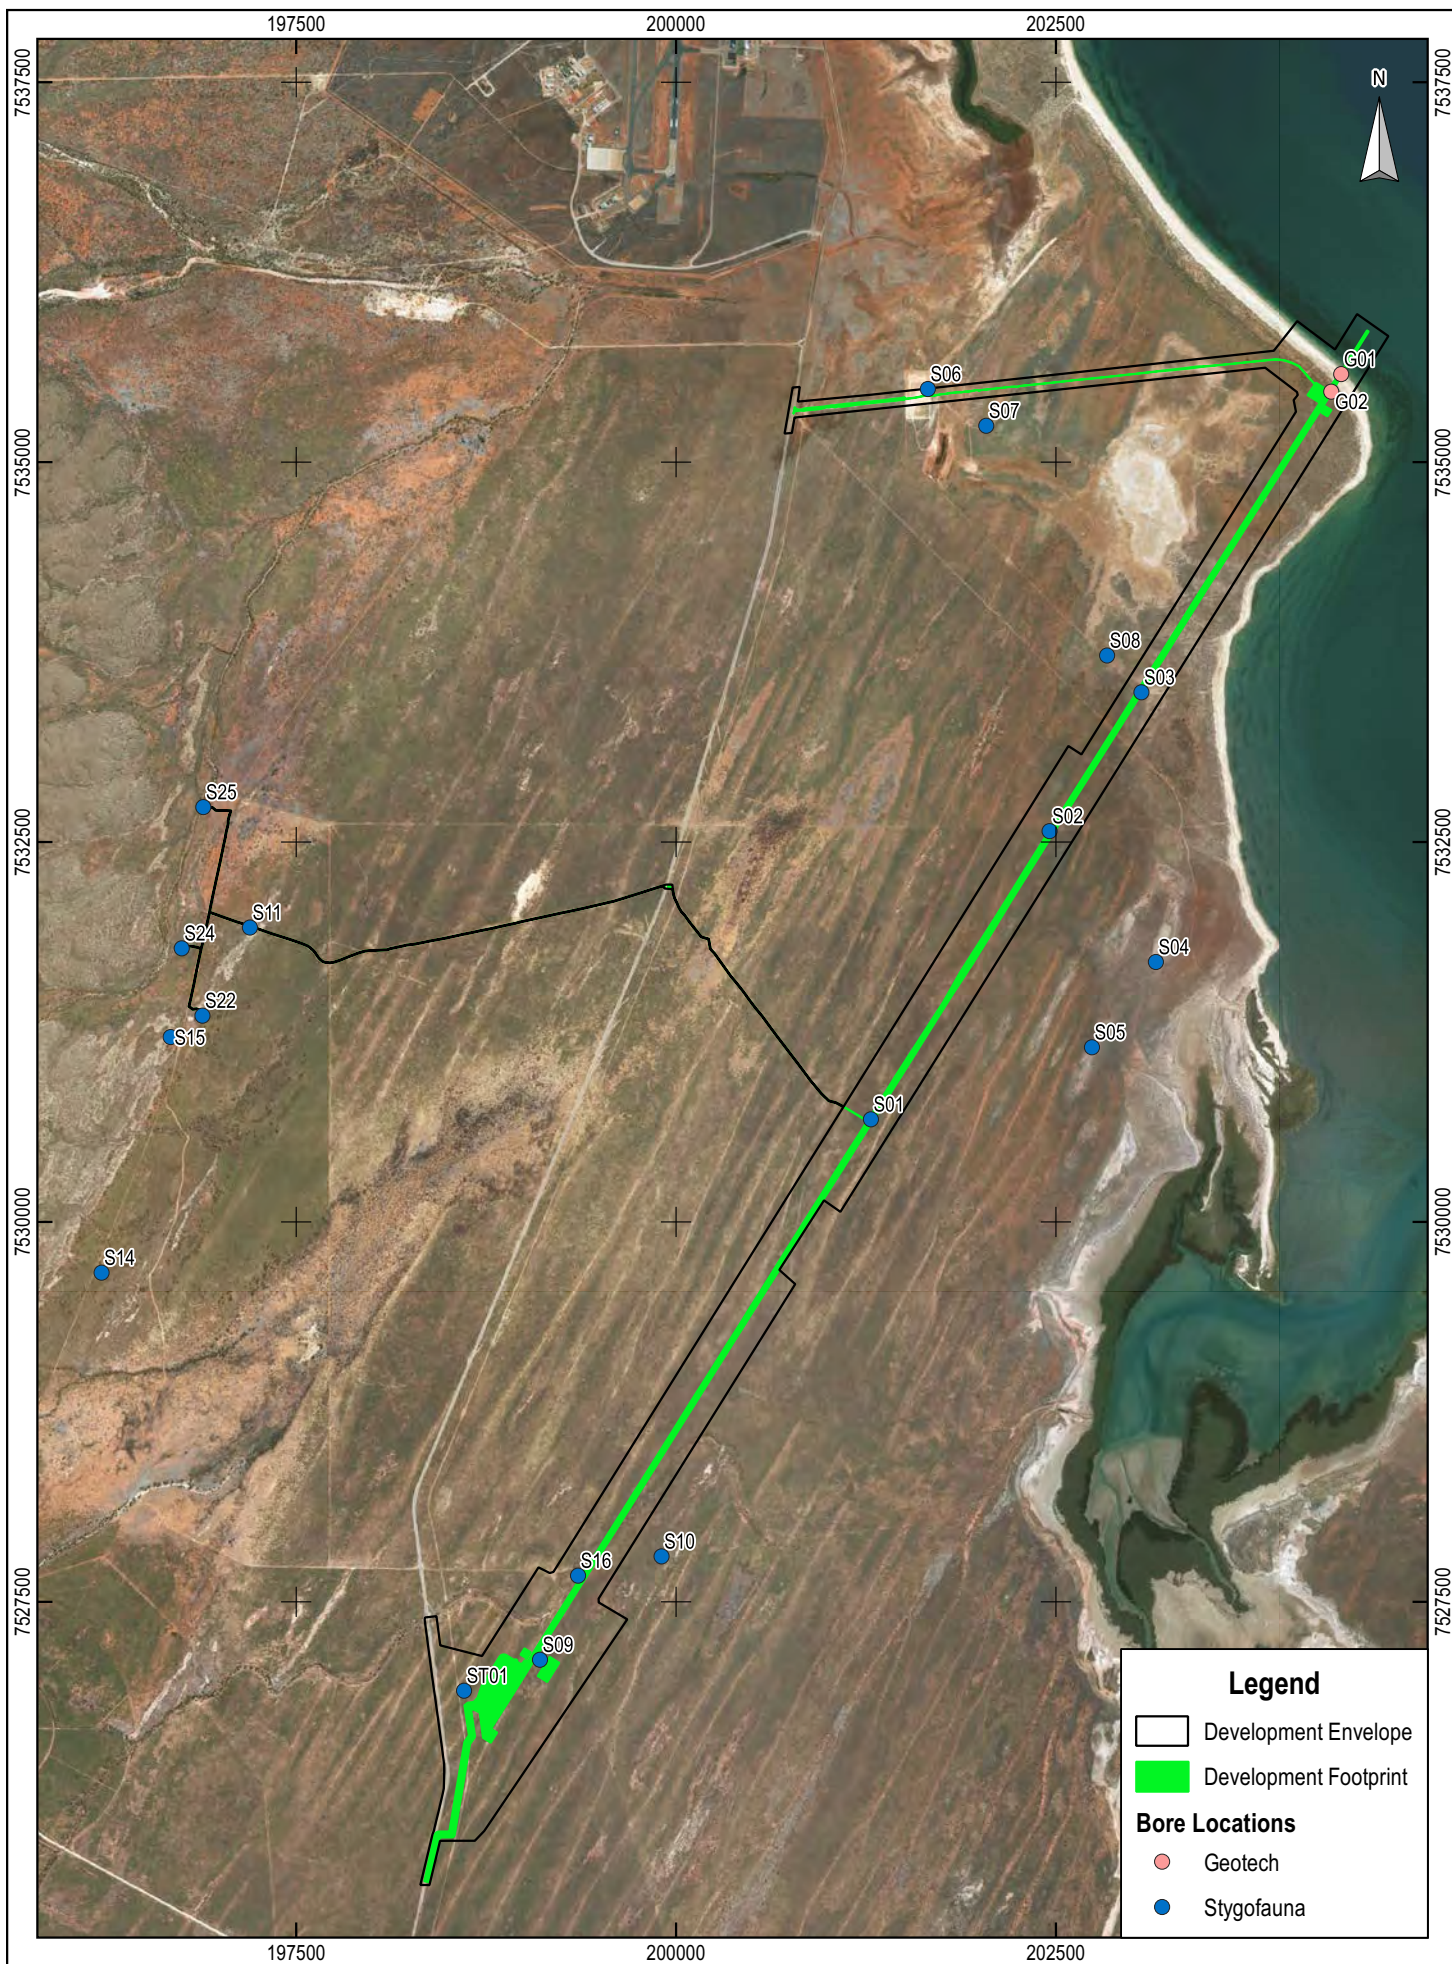
Figure 4

Boreholes were installed and soil profiles logged as part of stygofauna and geotechnical investigations within the Project in August 2018 (GHD 2018). Their locations are shown in Figure 4. Soil profiles in boreholes in relatively close proximity to current sampling locations of the acid sulfate soils investigation (Section 5.1) exhibited the following characteristics:

- Sand from 0 to 1 metres below ground level (mBGL) – red, poorly sorted loamy and clayey sand.
- Predominantly indurated/cemented layers of sandstone and limestone underlying sand strata to termination depth of the borehole. Sandstone was described as weakly cemented with increasing red clay content at depth. Limestone cement was described as moderately cemented with sub-angular platy fragments.

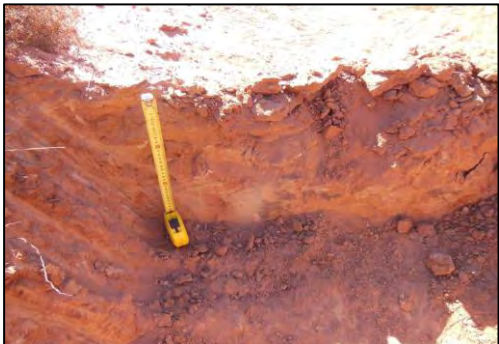
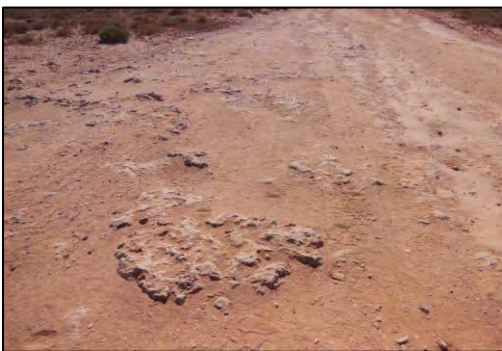
| <div> <div> Photo 1: Pit Profile </div> <div> Photo 2 </div> </div> | | | | | | |

| 0.25m + | Refusal - siliceous cemented layer (suspect limestone). Mixed ferruginous cobbles in siliceous cement. | | | | | |

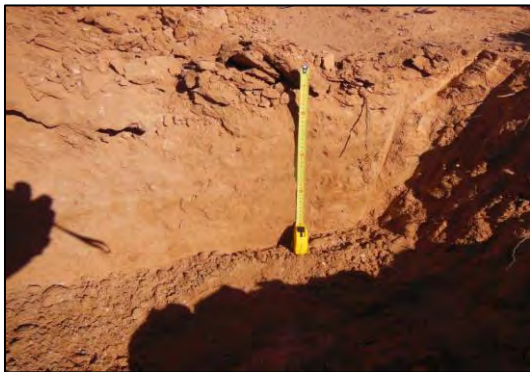
| Photo 1: Pit Profile | | | | | | |

| 0 - 0.25m | | Light brown loamy sand with moderate moisture. Shells observed mixed throughout soil. | | | | |
| 0.25 - 0.40m | | Light brown/grey clay loam with brown mottling. No shells observed in soil. Higher moisture and clay content compared to surface 0.25m horizon. | | | | |

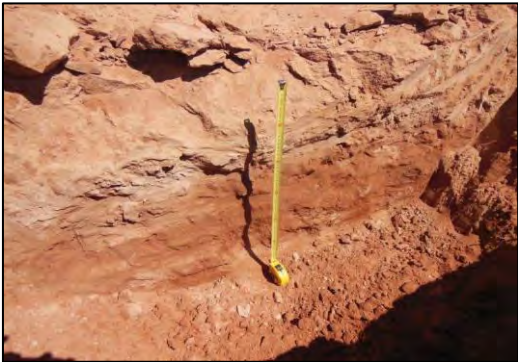
| Photo 1: Pit Profile | | | | Photo 2: Landscape | | |

| Sample Register | | ASS4 0-0.25m ASS4 0.25-0.50m DUP2 (ASS4 0.25-0.50m) | | | | |

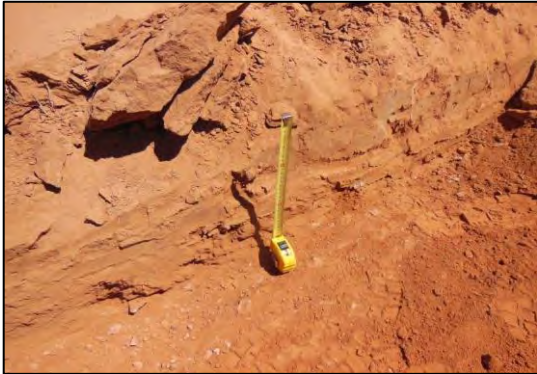
| Photo 1: Pit Profile | | | | Photo 2: Landscape | | |

| Sample Register | | ASS5 0-0.25m | | | | |

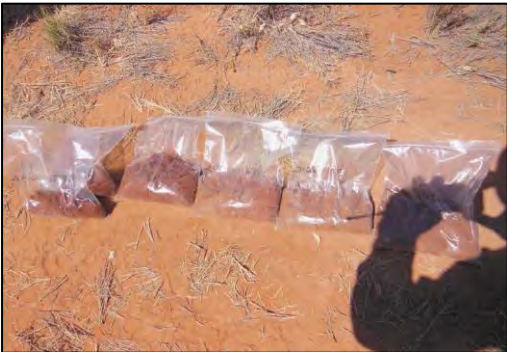
| Photo 1: Samples | | | | | | |

| 0.25 - 1.25m | Uniform profile - medium brown silty sand/loam. Moisture content increasing with depth and texture becoming coarser with depth. | | | | | |

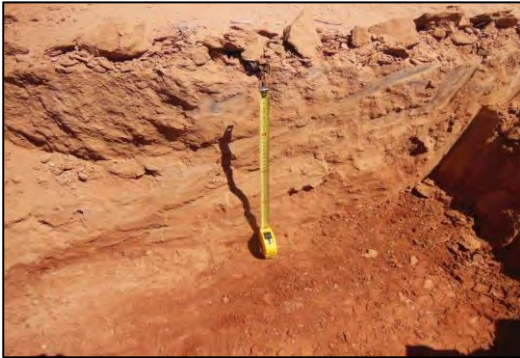
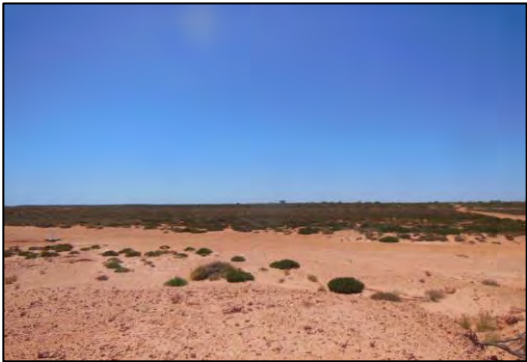
| <div> <div> Photo 1: Pit Profile </div> <div> Photo 2: Landscape </div> </div> | | | | | | |

| 0.50m + | | Refusal - siliceous cemented layer (suspect limestone). | | | | |

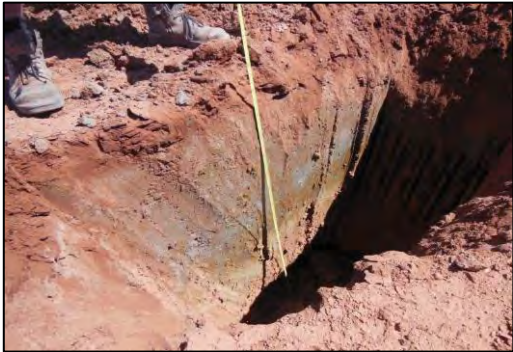
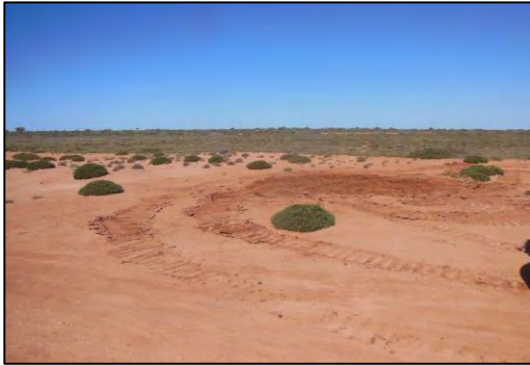
| Photo 1: Pit Profile | | | Photo 2: Landscape | | | |

- Subsoils were generally light to medium brown loams (brown/red in deeper soils). Sample location ASS8 (outside the project envelope) was an exception to other sampling locations in that the subsoil type was predominantly clay, grading from grey/blue (with yellow and orange mottling) to cream coloured clay near and below groundwater. No limestone/sandstone indurated layer was encountered at this location (ASS8) and was the only location where groundwater was observed.

| 0 - 0.15m | Quite moist medium brown loamy sand. | | | | | |
| 0.15 - 0.80m | Grey/blue clay loam (moist) with yellow/orange mottling. | | | | | |
