Pilbara Iron Ore and Infrastructure Project
Sediment Contaminants and Acid Sulphate Soils

Fortescue Metals Group

Oceanica Consulting Pty Ltd

Report No. 423/2

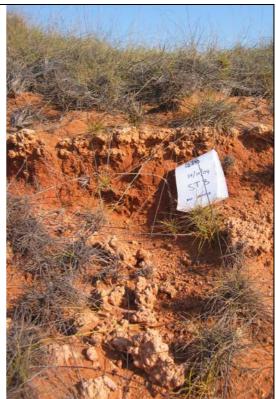
Site ST3 – Side of vegetated area showing limestone layer

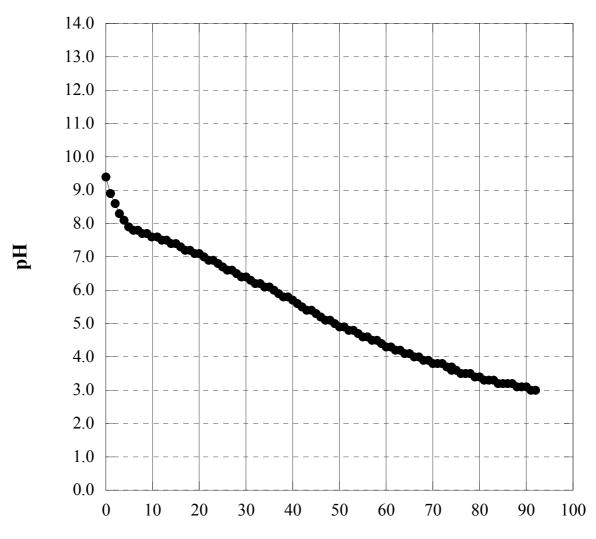
Figure 1

pH-Buffering Curve for Sample B16

Note: The H_2SO_4 -addition rate employed in the auto-titration corresponds to a sulphide-oxidation rate (SOR) of c. 6-7 x 10^5 mg SO_4 /kg/week (= c. 3-4 x 10^4 kg H_2SO_4 /tonne/year).

This SOR is therefore up to 10^4 - 10^5 **faster** than that typical for the weathering (at circum-neutral-pH) of soils/sediments, regoliths and bedrocks that contain "minute/trace-sulphides".

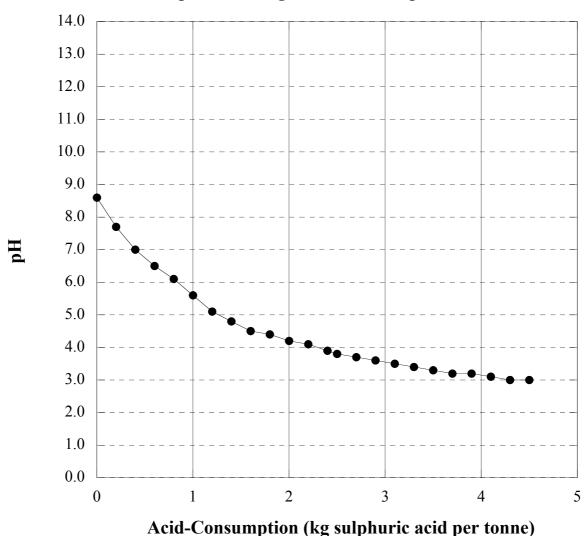
Figure 2
pH-Buffering Curve for Sample BP5

Note: The H_2SO_4 -addition rate employed in the auto-titration corresponds to a sulphide-oxidation rate (SOR) of c. 1-2 x 10^5 mg SO_4 /kg/week (= c. 5-6 x 10^3 kg H_2SO_4 /tonne/year).

This SOR is therefore up to 10^3 - 10^4 faster than that typical for the weathering (at circum-neutral-pH) of soils/sediments, regoliths and bedrocks that contain "minute/trace-sulphides".

The shape of the pH-buffering curve for sample BP5 (Figure 2) is consistent with that for a "gutless-groundmass" deficient in carbonate-minerals.

The location corresponding to sample BP5 is deficient in carbonate-minerals.
