Geotechnical Investigation DRAFT

Onslow Site Investigations

Prepared for Shire of Ashburton

Project Number: TW17084

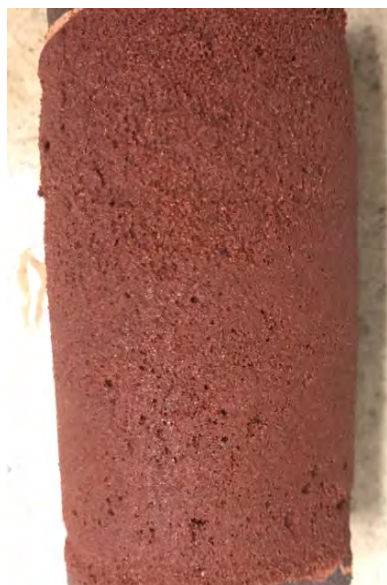
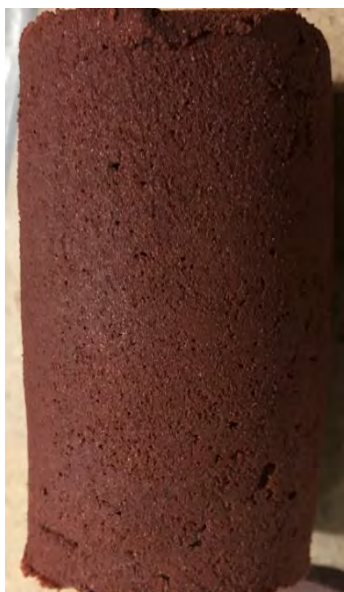
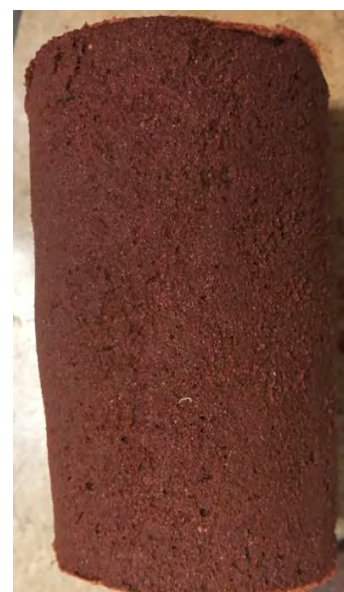
Failure Mode: Bulging Failures observed for all samples

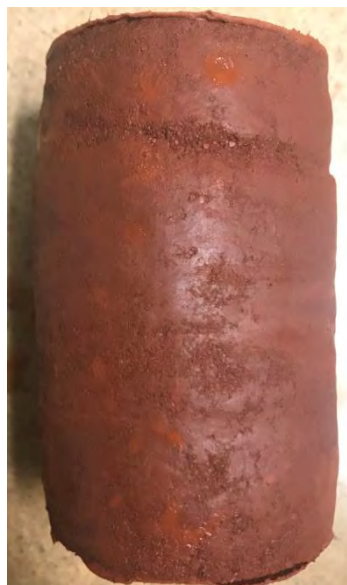
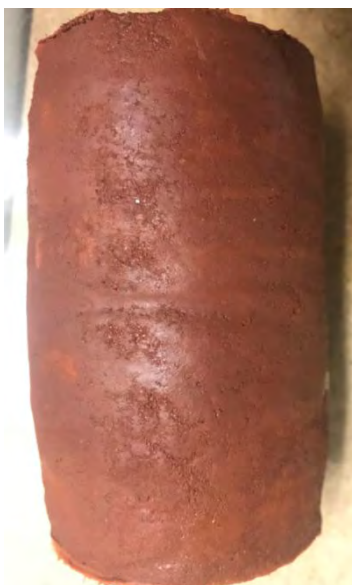
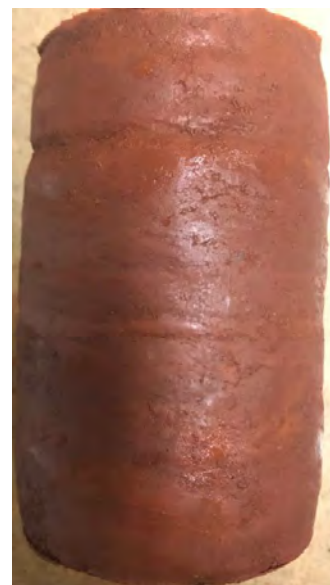
Failure Mode: Bulging Failures observed for all samples

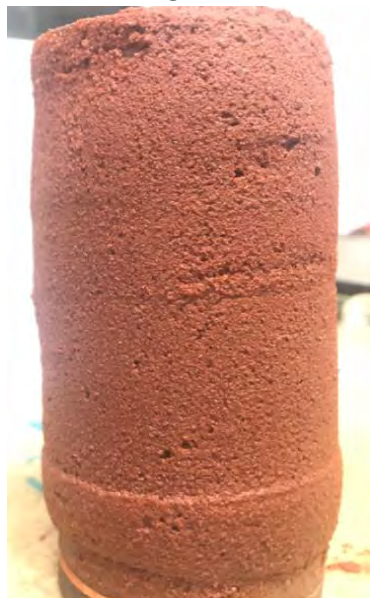
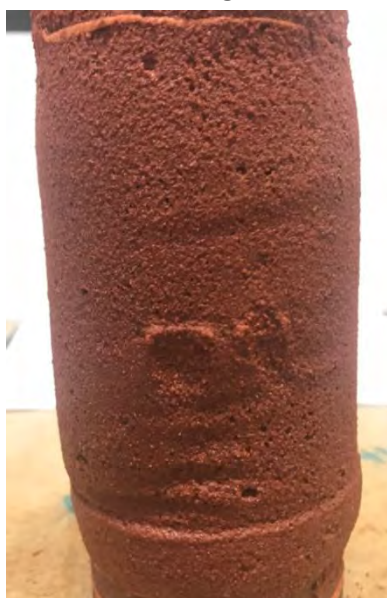
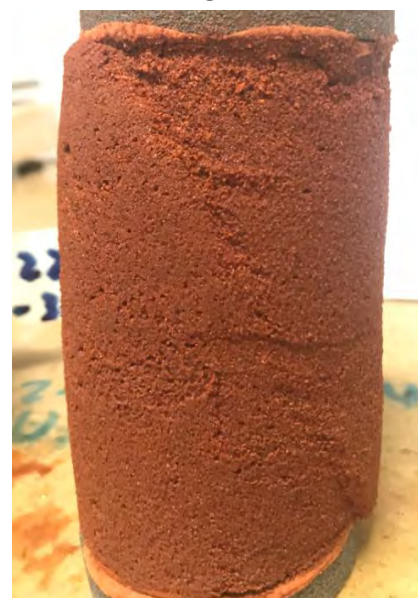
Failure Mode: Bulging Failures observed for all samples

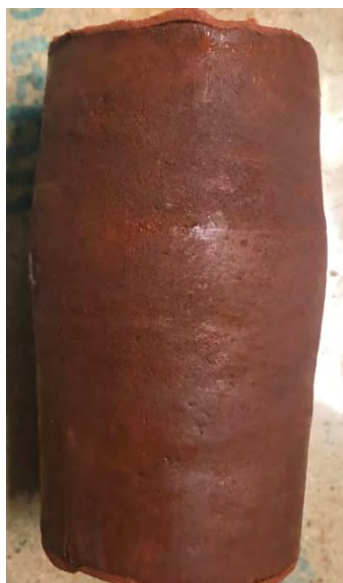
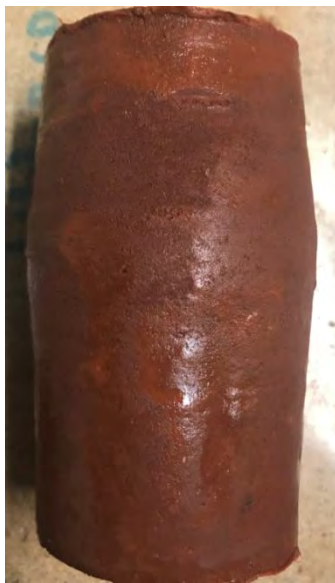
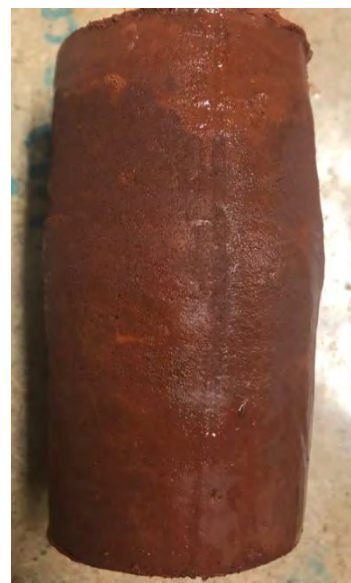
Failure Mode: Bulging Failures observed for all samples

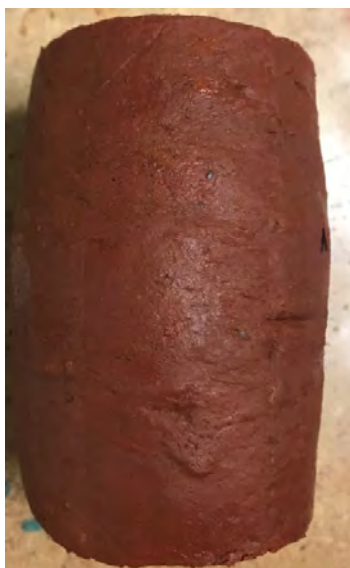
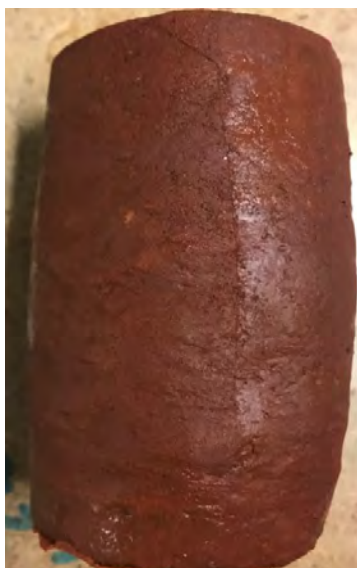
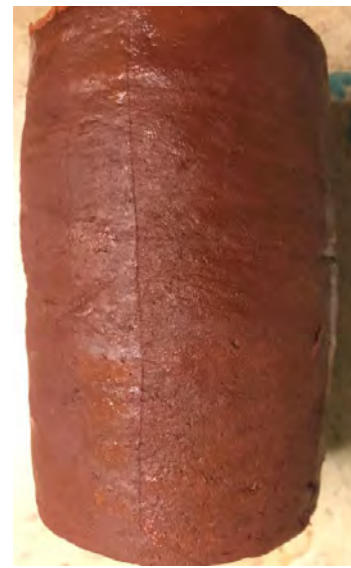
Failure Mode: Bulging Failures observed for all samples

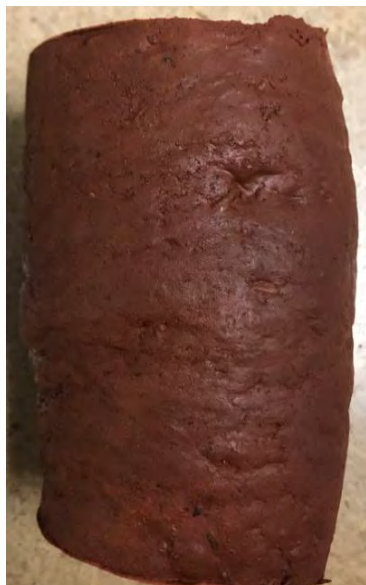
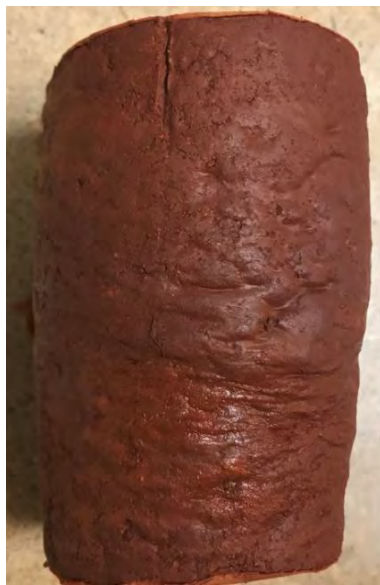
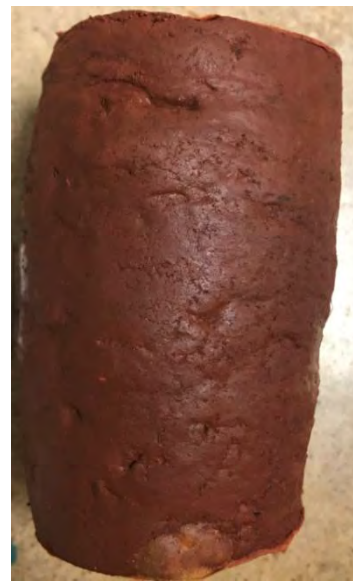
Failure Mode: Bulging Failures observed for all samples

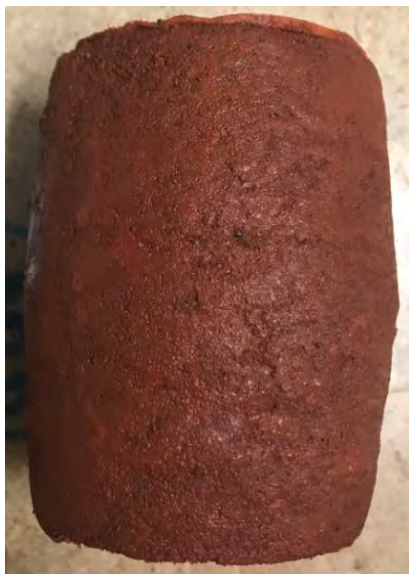
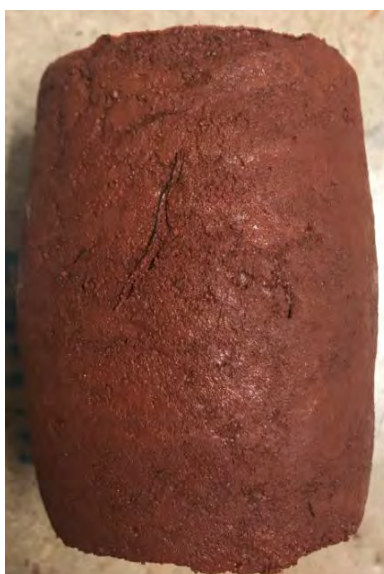
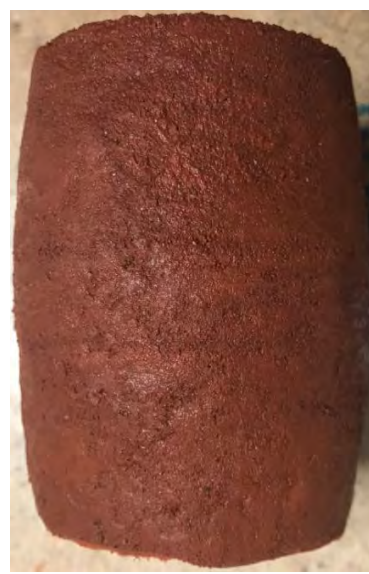
Failure Mode: Bulging Failures observed for all samples

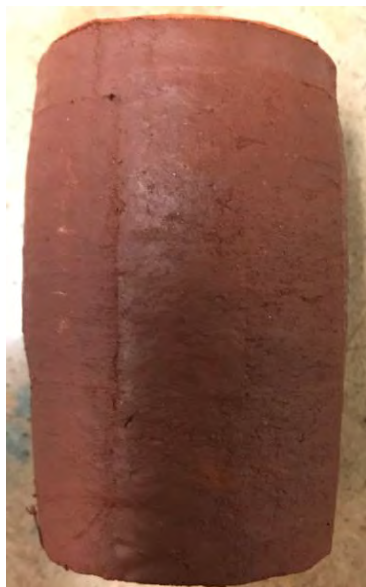
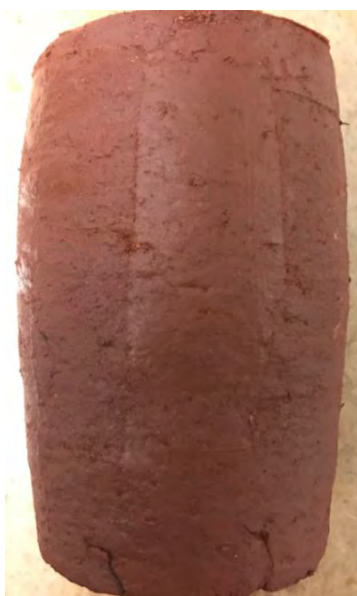
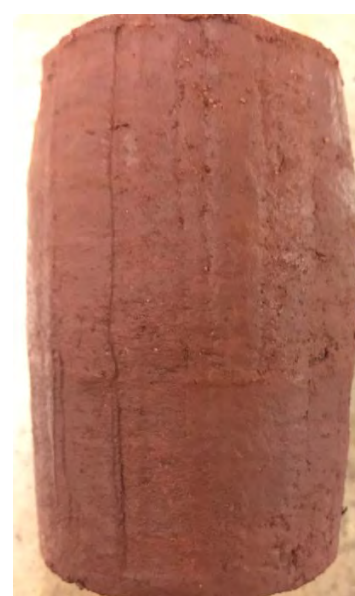
Failure Mode: Bulging Failures observed for all samples

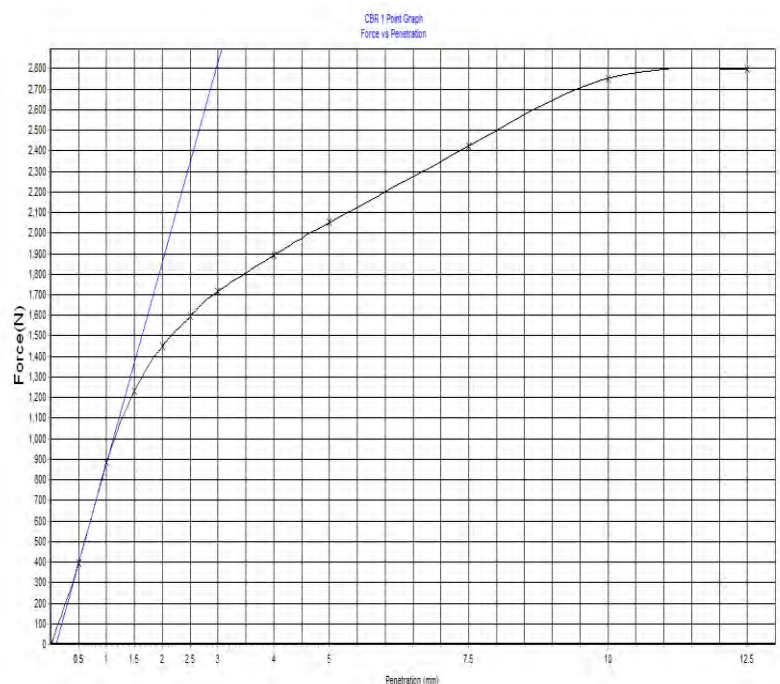
Moisture Method :	AS1289.2.1.1
Maximum Dry Density (t/m ³) :	2.161
Optimum Moisture Content (%) :	8.5
Compactive Effort :	Modified
Nominated Percentage of MDD :	95
Nominated Percentage of OMC :	100
Achieved Percentage of MDD :	95.0
Achieved Percentage of OMC :	99.0
Dry Density Before Soak (t/m ³) :	2.056
Dry Density After Soak (t/m ³) :	2.023
Moisture Content Before Soak (%) :	8.4
Moisture Content After Soak (%) :	11.7
Density Ratio After Soak (%) :	93.5
Field Moisture Content (%) :	3.5
Top Moisture Content - After Penetration (%) :	12.9
Total Moisture Content - After Penetration (%) :	10.8
Soak Condition :	Soaked
Soak Period (days) :	4
Swell (%) :	1.5
CBR Surcharge (kg) :	4.5
Oversize (%) :	18
Oversize Material Replaced (%) :	Excluded

CBR 2.5mm (%) :	12
CBR 5.0mm (%) :	10
CBR Value (%) :	12 @ 2.5mm
