Appendix:	A
Title:	Aerial 1985
Project:	Data Gap Assessment
Location:	Tonkin Highway Gap Project
Client:	Main Roads Western Australia

Contaminated Sites Investigation
CSBP Bayswater and
Tonkin Highway Road Reserve
Historical Imagery 1995

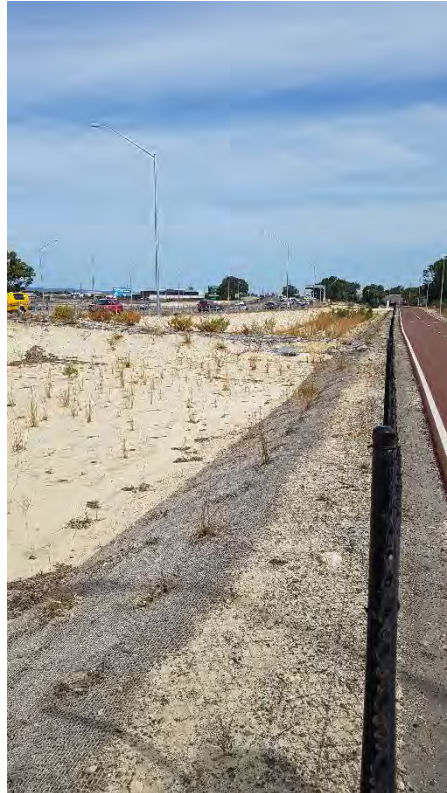
**Photo 1. View south showing Tonkin Highway, drainage swales and Principal Shared Pathway.
Photograph taken on from the western road verge at the north of site.**

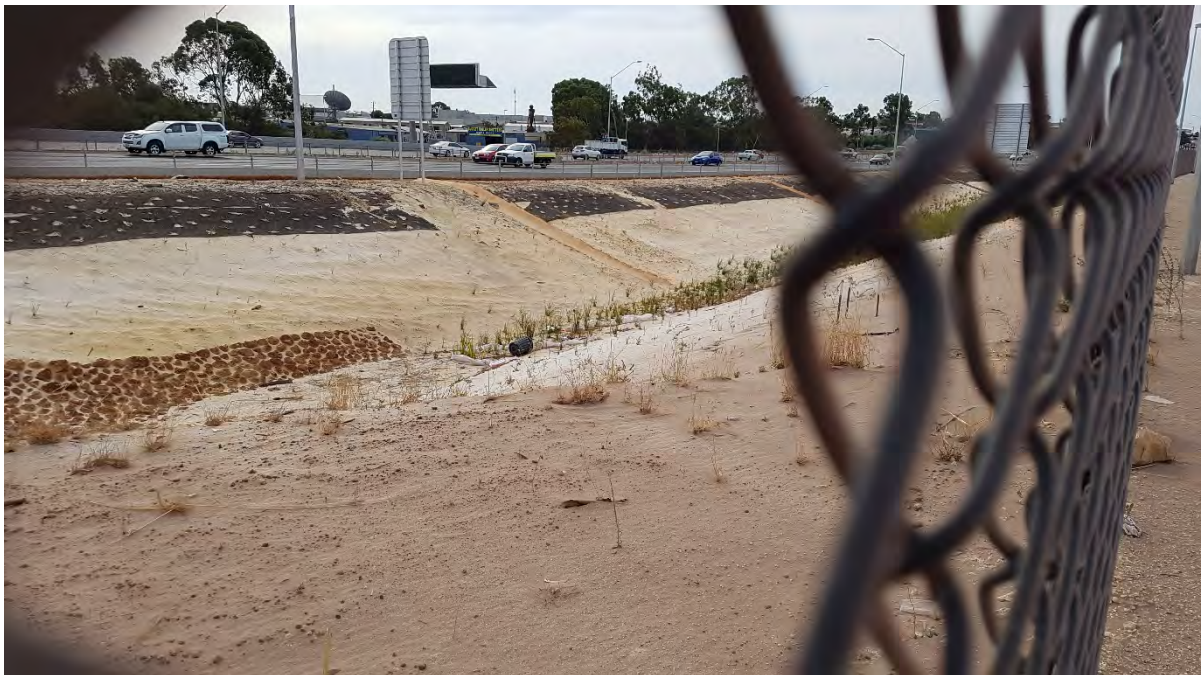
**Photo 2. View northwest showing drainage swales and Tonkin Highway. Photograph taken from the
eastern road verge, in the vicinity of the northern cinder pit.**

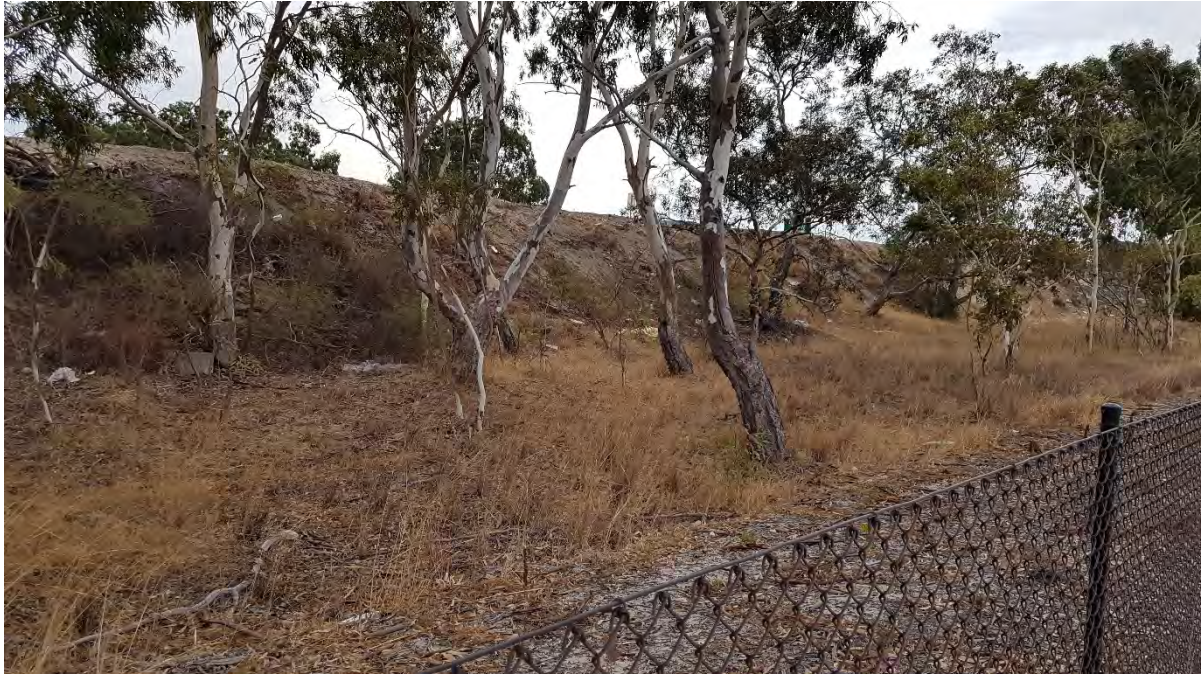
**Photo 3. View west showing steep embankment to Tonkin Road (and possible uncontrolled fill).
Photograph taken from eastern road verge, in the southern portion of the site.**

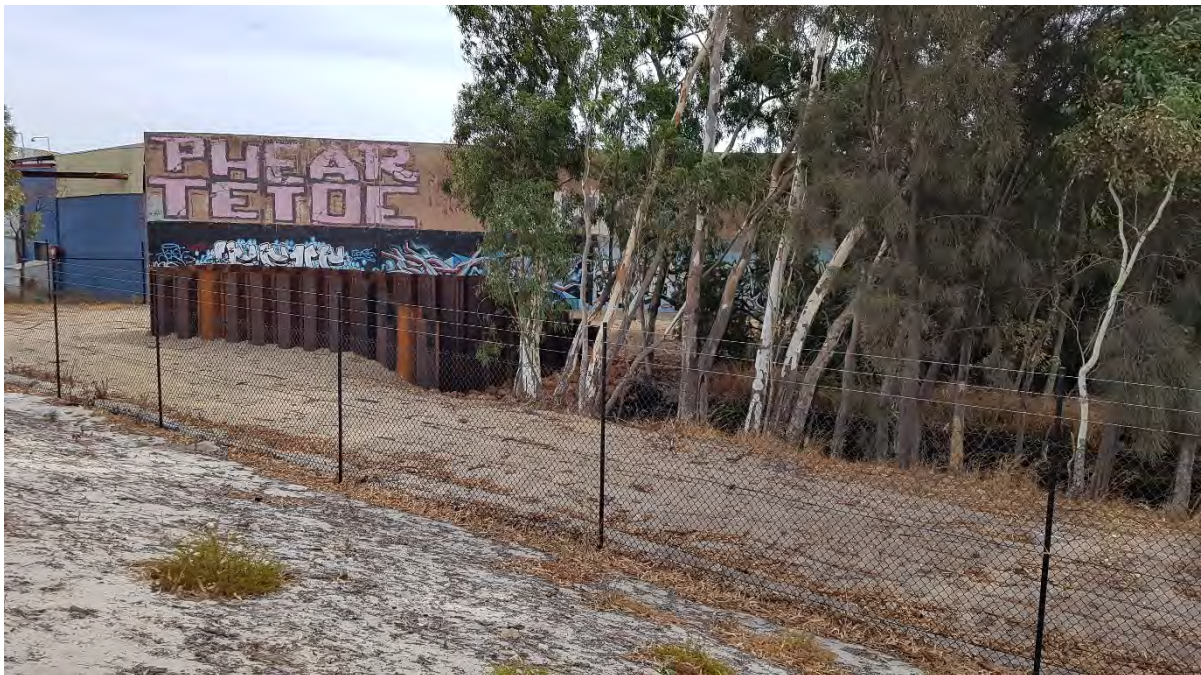
Photo 4. View southwest showing proximity to the drainage sump and Bayswater Main Drain (flowing underground from the sheet piling). Photograph taken from the western road verge.

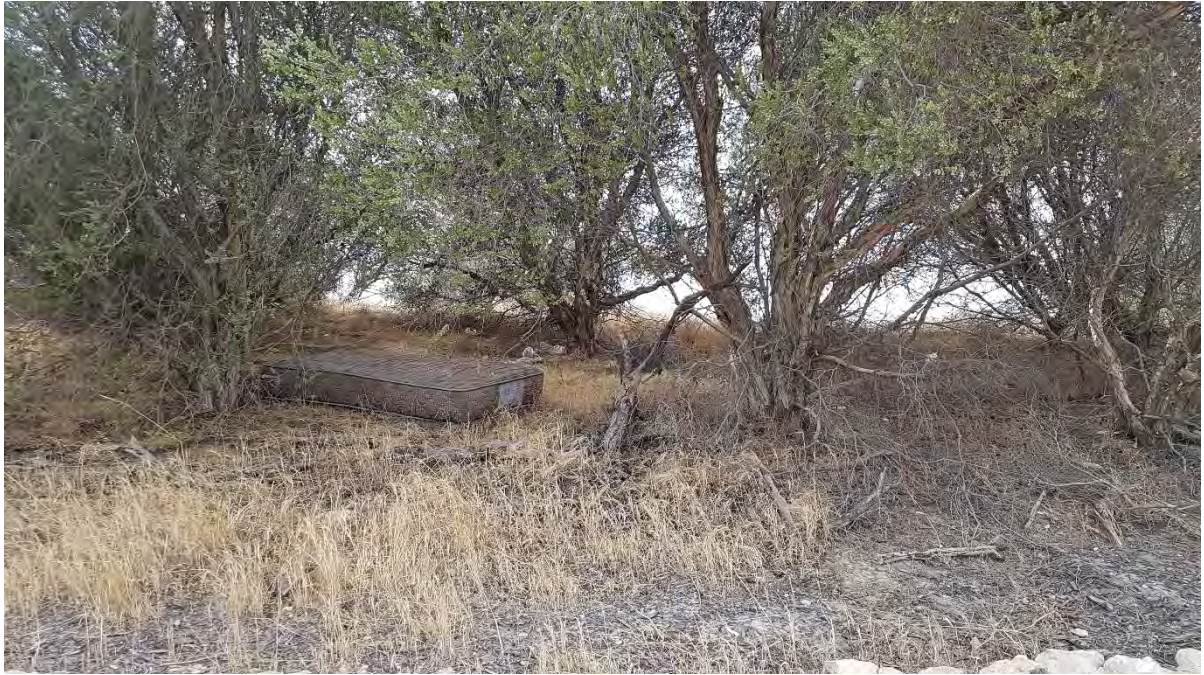
Photo 5. View north showing fly tipping beneath Tonkin Highway Bridge.

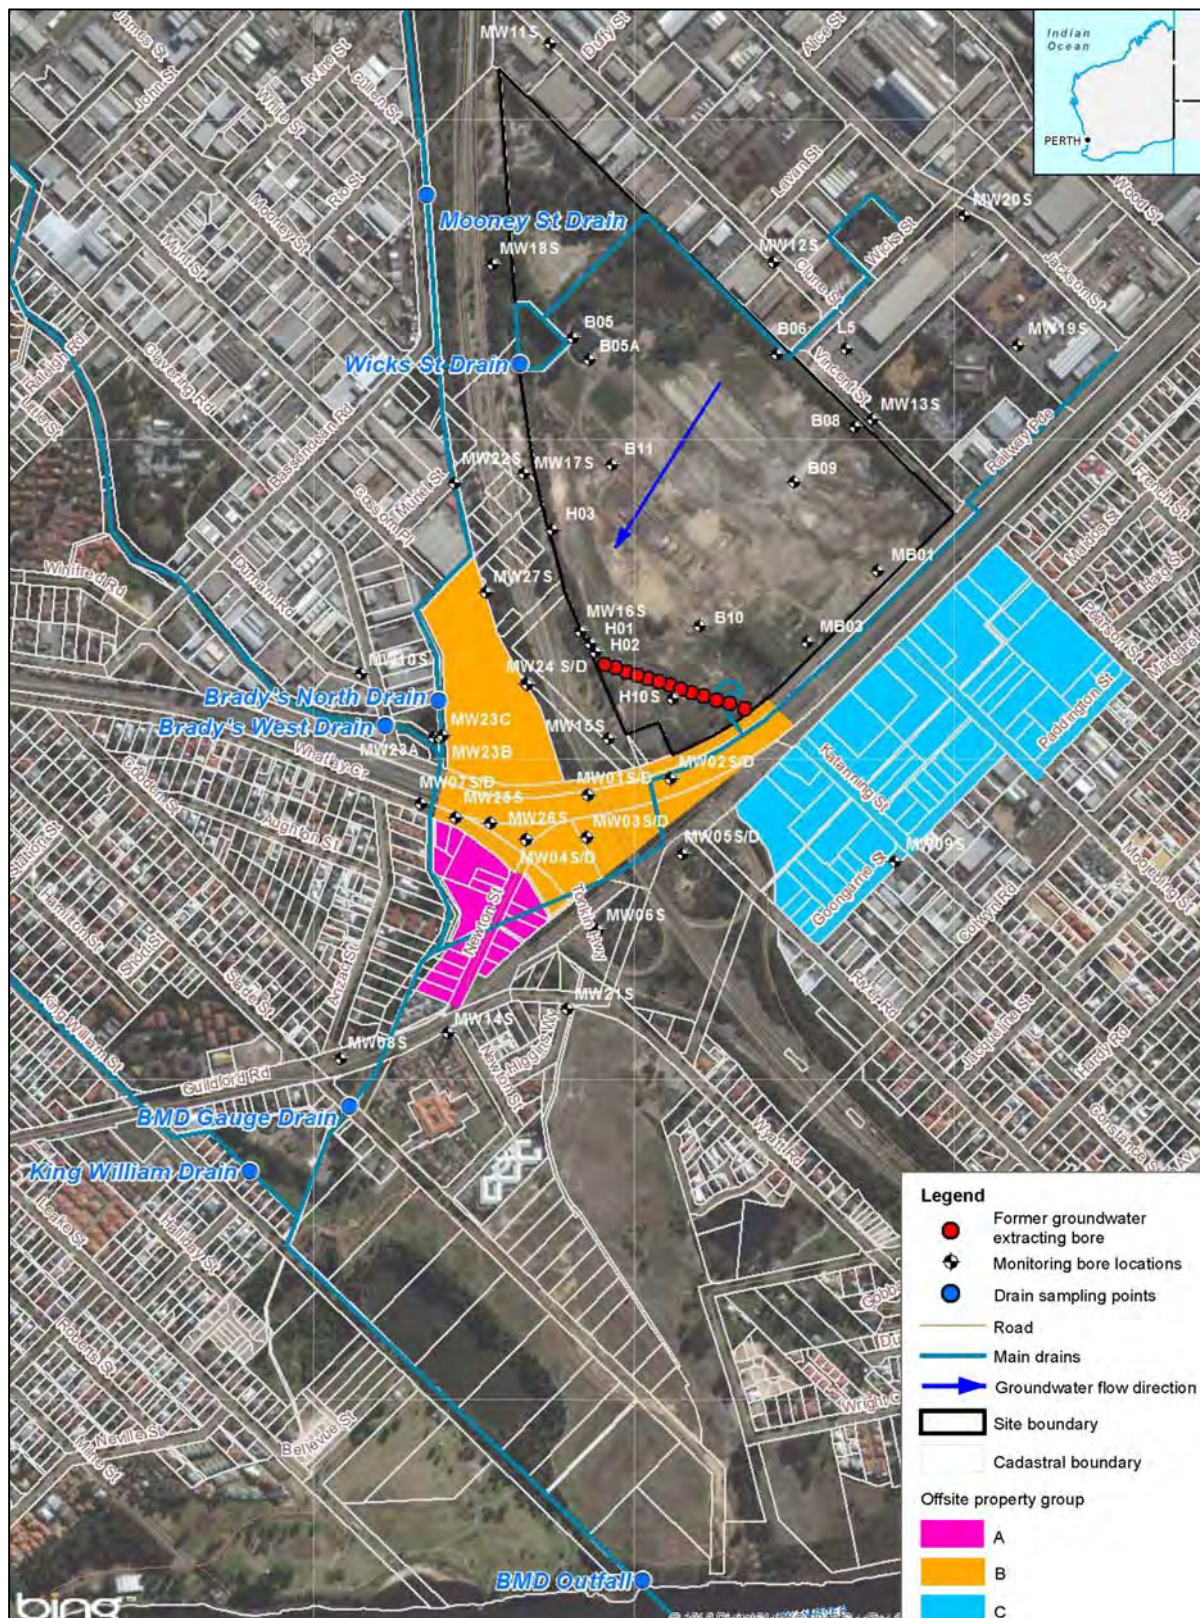
Figure 24: Post Remediation Risk Assessment Offsite Property Groups A, B and C

Each individual property group is presented in Figures 11B–11D (in Appendix A of the WQR (PB, 2013c) and reproduced as Figures 5 to 12 in **Appendix J**.
