Public Transport Authority

Yanciep Rail Extension

Phytophthora Dieback occurrence assessment – Version 2.0

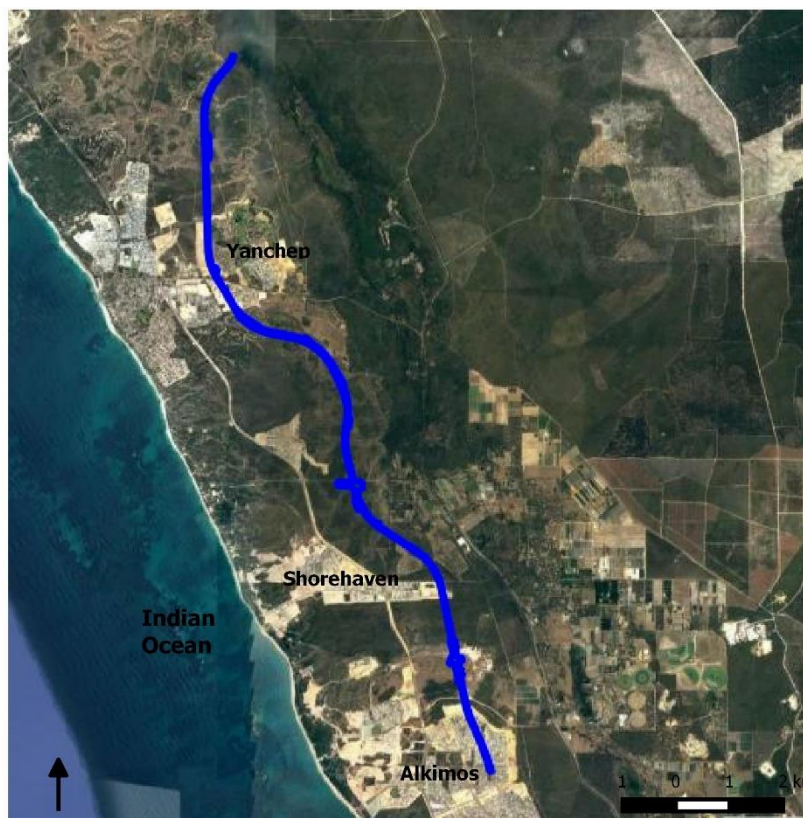
Figure 1 - Project Area

The project area extends from Alkimos in the south in a north north-westerly direction for approximately 16 kilometres, terminating around 3 kilometres north of Yanchep. The width of the project footprint varies considerably, however the average width in most sections is between 40 and 60 metres.
