Project: Butler to Yanchep Rail

## Appendix D Borehole Logs and Photographs

JOB NUMBER: 301012-02366

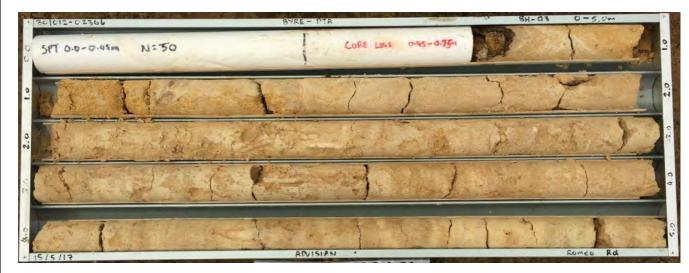
0.0 to 5.0m

Drill Contractor:National GeotechBore Size:96mmHole Angle:-90°Easting:376067Surface R.L.:39.10m (est.)Drill Model:Geoprobe 7822DTDrill Fluid:Biovis + Liqui-PolBearing:NANorthing:6501118Ref. System:AHD/GDA94

34.0		Ť		Siliceous CALCARE	NITE: fine to medium	grained,	Mwk-Mo	M			_	0,			1.60	
	2	33.5 1 33.0	6 <u>.0</u>			Siliceous CALCARE subrounded to rounc pale orange-brown, and cavities infilled v association with solu 100mm band of s quartz, subrounded, siliceous calcarenite	and, fine to medium g with fine to coarse gr	grained,	Vwk-Mo	L-M		4/100	20		0.32	0.24		_Highly fractured due to solution

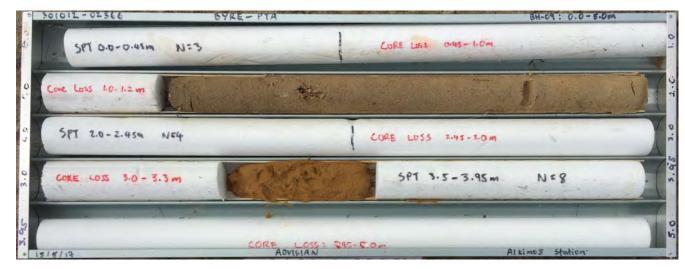
0.0 to 5.0m

Drill Contractor:National GeotechBore Size:96mmHole Angle: -90°Easting:375945Surface R.L.:41.50m (est.)Drill Model:Geoprobe 7822DTDrill Fluid:Biovis + Liqui-PolBearing:NANorthing:6501686Ref. System:AHD/GDA94

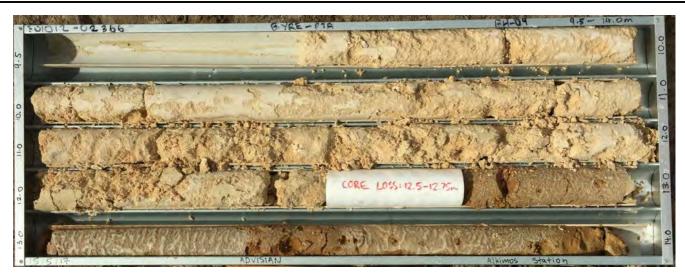
9.50 to 14.0m

Drill Contractor:National GeotechBore Size:96mmHole Angle:-90°Easting:375945Surface R.L.:41.50m (est.)Drill Model:Geoprobe 7822DTDrill Fluid:Biovis + Liqui-PolBearing:NANorthing:6501686Ref. System:AHD/GDA94

02366					CHEC							
Drill Co					Geotech		96mm	Hole Angl			Easting:		5945					ce R.L.: 41.50m (est.)
Drill Mo	odel:		Geo	probe	7822D	T Drill Fluid:	Biovis + Liqui-Pol	Bearing:	NA		Northing	g: 65	0168	6	1 -			ystem: AHD/GDA94
Method	Drill Rate (min/m)	RL (mAHD)	Depth (m)	Geological Unit	Graphic Log		erial Description		Weathering / Cementation	Estimated Strength	Defect Spacing (mm)	S S	RQD (%)	SPT	$\vdash$	PLI - diametral (MPa) G	PLI - lump (MPa)	
	NR		- 10 <u>.5</u> - - - 11.0			subangular to subrou brown-white, carbon	NITE: fine to medium unded quartz and she atte-cemented, trace eatures infilled with sa	ells, pale coarse sand,	Mwk	M		7/100	100		0.30	0.34	Coc	B, 0, Ir, R, Sd, Fi-2mm  - B, 0, Ir, R, Sd, Fi-2mm
OPEN HOLE	NR	29.5	- 11. <u>5</u> - 12. <u>0</u> - - 12.5	Tamala Limestone		medium grained qua highly fractured alon 50mm band of sa Calcareous Silica S/quartz, shells, pale y Siliceous CALCARE subangular to subrou brown-white, carbon Calcareous Silica S/quartz, shells, pale y Siliceous CALCARE	AND: fine to medium of cellow-white in the medium unded quartz and she late-cemented AND: fine to medium of cellow-white in the to medium of the the medium of the the medium of the the medium of the the medium unded quartz and she	grained, grained, grained, grained, grained, grained,	Wk-Mwk Uc Wk-Mwk Uc	L-M		8/100			0.58	0.31		B, <5, Ir, R, Sd, Fi-1mm  Highly fractured due to solution  B, <5, Ir, R, Sd, Fi-1mm

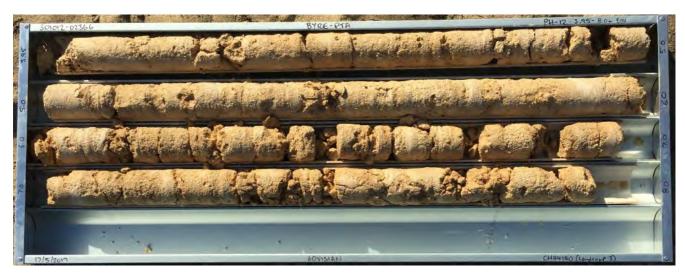
3.95 to 8.0m

Drill Contractor:National GeotechBore Size:96mmHole Angle:-90°Easting:375788Surface R.L.:31.70m (est.)Drill Model:Geoprobe 7822DTDrill Fluid:Biovis + Liqui-PolBearing:NANorthing:6502441Ref. System:AHD/GDA94

28.0 4. 27.5	Limestone		Siliceous CALCAREN subangular to rounde carbonate-cemented, grained	NITE: fine to medium kd, quartz, shell fragn , pale brown, with sor	grained, nents, ne coarse	Wk-Mwk Wk-Mo	L-M		1/100 SPT		3,10,18 N=28	-	1.34			- SPT: Recovery = 450mm  Highly fractured, medium strength rock separated by

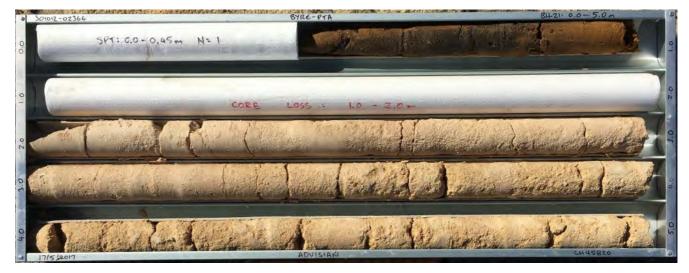
0.0 to 5.0m

Drill Contractor:National GeotechBore Size:96mmHole Angle:-90°Easting:375064Surface R.L.:45.50m (est.)Drill Model:Geoprobe 7822DTDrill Fluid:Biovis + Liqui-PolBearing:NANorthing:6503892Ref. System:AHD/GDA94

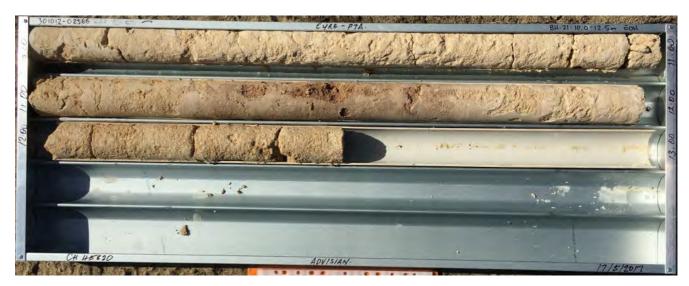
10.0 to 12.50m

Drill Contractor:National GeotechBore Size:96mmHole Angle:-90°Easting:375064Surface R.L.:45.50m (est.)Drill Model:Geoprobe 7822DTDrill Fluid:Biovis + Liqui-PolBearing:NANorthing:6503892Ref. System:AHD/GDA94

Surface R.L.: 45.50m (est.) Drill Contractor: National Geotech -90° Bore Size: 96mm Hole Angle: Easting: Drill Model: Drill Fluid: Geoprobe 7822DT Biovis + Liqui-Pol Bearing: NA Northing: 6503892 Ref. System: AHD/GDA94 Lab Results (min/m) diametral (MPa) Geological Unit Weathering / Cementation Core ivery (%) Defect Graphic Log PLI - axial (MPa) (MPa) RL (mAHD) Estimated Strength Drill Rate ( Spacing Depth (m) RQD (%) (mm) ) dwn Method Field Records / 20 60 2000 2000 Liff & C Recov SPT ncs Material Description F F Defect Description Calcreted CALCARENITE: see previous Mo-We Н B/Solution, 45, St, R, Sd, Siliceous CALCARENITE: fine to medium grained, Mwk-Mc M angular to subrounded, quartz, shell fragments, carbonate-cemented, trace calcrete in mottles and B, 40, PI, R, Sd/Si, Vn patches, white to pale yellow-white 7/100 35.0 10<u>.5</u> Tamala Limestone 83 B, 10, St, R, Sd, Vn B, 10, St-Wv, R, Sd/Si, Vn 34.5 **11.0** 10.95 - 11.1, highly fractured due to solution, infilled with .. becoming pale brown-white, fine to coarse grained, tending to calcareous sandstone in part sand OPEN HOL HQ-3 Calcareous Silica SAND: fine to coarse grained, subrounded to rounded, quartz, with carbonate (shell Uc D 34.0 11.<u>5</u> fragments), dark pink-brown, trace carbonate silt Siliceous CALCARENITE: fine to coarse grained, subangular to rounded, quartz, shell fragments, pale Mo-We Н 8 1.06 92 6 % brown-white 5.10 Tamala Limestone 33.5 **12.0** B, 10, PI, R, Cn ... tending to calcareous sandstone B, 5, Pl-Un, R, Sd, Vn B, 20, PI, R, Sd, Fi- 1mm 33.0 **12.5** End of BH-21 at 12.5m - Target Depth 32.5 **13.0** 32.0 **13.5** 31.5 **14.0** 31.0 **14.5**

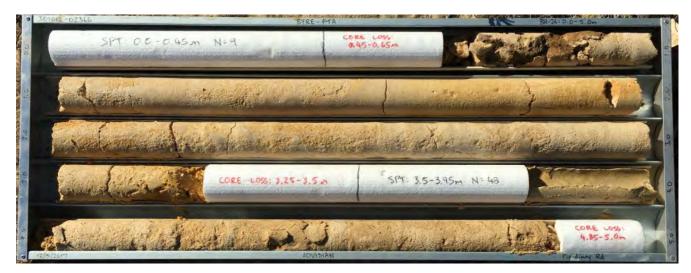
0.0 to 5.0m

Drill Contractor:National GeotechBore Size:96mmHole Angle:-90°Easting:374002Surface R.L.:45.0m (est.)Drill Model:Geoprobe 7822DTDrill Fluid:Biovis + Liqui-PolBearing:NANorthing:6505122Ref. System:AHD/GDA94

44.5	0 <u>.5</u>	Tar	CL	calcrete	CL	CL								-Core Loss: 0.45-0.70m
			44.0	1 <u>.0</u>			Calcareous SANDSTONE: fine to coarse grained, subrounded to rounded, pale yellow to pale orange-brown, carbonate-cemented, with some laminar and patches of calcrete to 1.6m 50mm interval, highly fractured due to solution, partly infilled with brown sand and organics (0.83-0.88m)	Mwk-We	M-H		4				0.20		-Solution induced break
		2	43.5	1 <u>.5</u>				Mwk	M		1/84	71					04.0

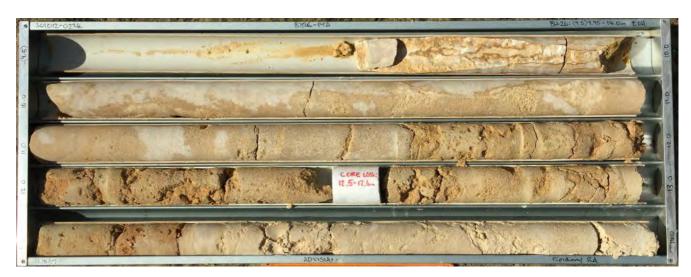
9.95 to 14.0m

Drill Contractor:National GeotechBore Size:96mmHole Angle:-90°Easting:374002Surface R.L.:45.0m (est.)Drill Model:Geoprobe 7822DTDrill Fluid:Biovis + Liqui-PolBearing:NANorthing:6505122Ref. System:AHD/GDA94

ctor:			Geotech	D Bore Size: 96mm Hole Angl	l <b>e</b> : -90		Easting:		4002			-	urf	300	R.L.: 45.0m (est.)
		odel:	J. 01 .			96016CT	_	90 NA		Northing:		4002 0512						stem: AHD/GDA94
ווע	11 1910			Get	γρισυθ	10220	Dilli Fiulu. Biovis + Liqui-Poi Bearing:	INA		Noruning:	05	0012	_	La		esul	_	nem. AHD/ODA94
Method	Casing	Drill Rate (min/m)	RL (mAHD)	Depth (m)	Geological Unit	Graphic Log	Material Description	Weathering / Cementation	Estimated Strength	Defect Spacing (mm)	Lift & Core Recovery (%)	RQD (%)	SPT	PLI - axial (MPa)	lba)	лРа)	UCS (MPa)	Field Records / Comments and Defect Description
		7	<u>3</u> 4.5 ′				Calcareous SANDSTONE: fine to medium grained, subrounded to rounded, quartz, carbonate-cemented, pale brown to pale orange-brown, trace coarse grained sand and shell fragments, patchy calcrete in part, subvertical solution cavity (pipe) from 6.9 to 10.25m, infilled with orange silica sand	We	Н		7/100	100		0.81	2.52		6.20	- J (solution), 50, Pl, R, Sd

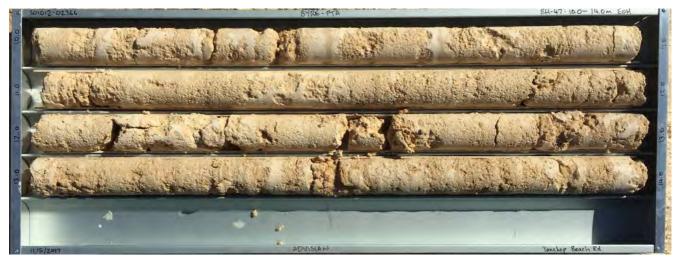
10.0 to 14.0m

Drill Contractor:National GeotechBore Size:96mmHole Angle:-90°Easting:371461Surface R.L.:38.0m (est.)Drill Model:Geoprobe 7822DTDrill Fluid:Biovis + Liqui-PolBearing:NANorthing:6508917Ref. System:AHD/GDA94

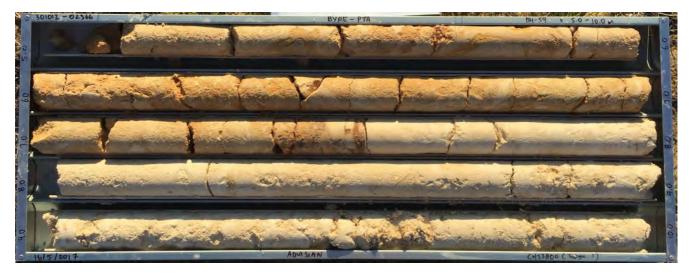
5.0 to 10.0m

Drill Contractor:National GeotechBore Size:96mmHole Angle:-90°Easting:371258Surface R.L.:41.50m (est.)Drill Model:Geoprobe 7822DTDrill Fluid:Biovis + Liqui-PolBearing:NANorthing:6510079Ref. System:AHD/GDA94

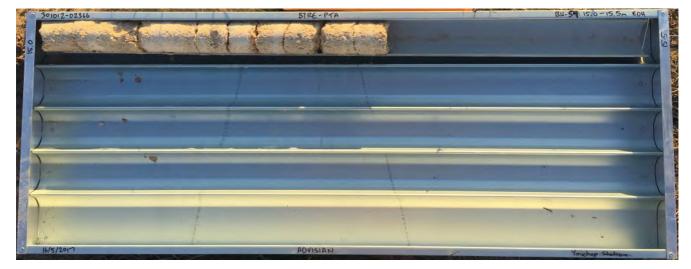
15.0 to 15.50m

Drill Contractor:National GeotechBore Size:96mmHole Angle:-90°Easting:371258Surface R.L.:41.50m (est.)Drill Model:Geoprobe 7822DTDrill Fluid:Biovis + Liqui-PolBearing:NANorthing:6510079Ref. System:AHD/GDA94

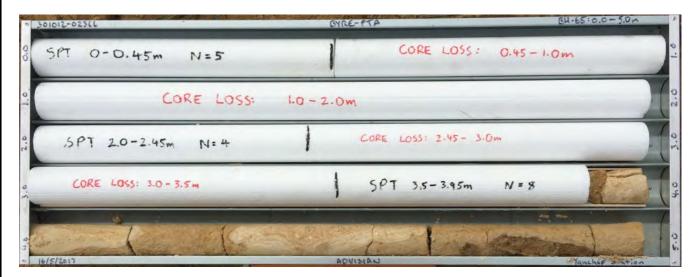
0.0 to 5.0m

Drill Contractor:National GeotechBore Size:96mmHole Angle:-90°Easting:371256Surface R.L.:38.0m (est.)Drill Model:Geoprobe 7822DTDrill Fluid:Biovis + Liqui-PolBearing:NANorthing:6510708Ref. System:AHD/GDA94

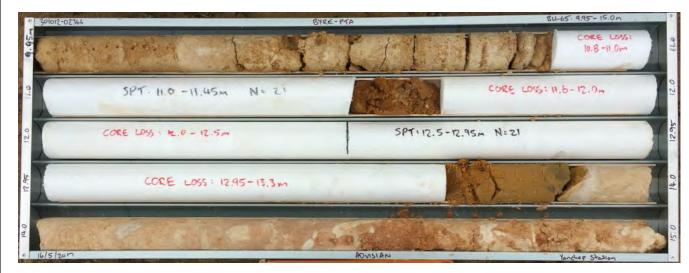
9.95 to 15.0m

Drill Contractor:National GeotechBore Size:96mmHole Angle:-90°Easting:371256Surface R.L.:38.0m (est.)Drill Model:Geoprobe 7822DTDrill Fluid:Biovis + Liqui-PolBearing:NANorthing:6510708Ref. System:AHD/GDA94
