Corunna Downs Project

Mine Closure Plan

179-LAH-EN-PLN-0002

Revision 3

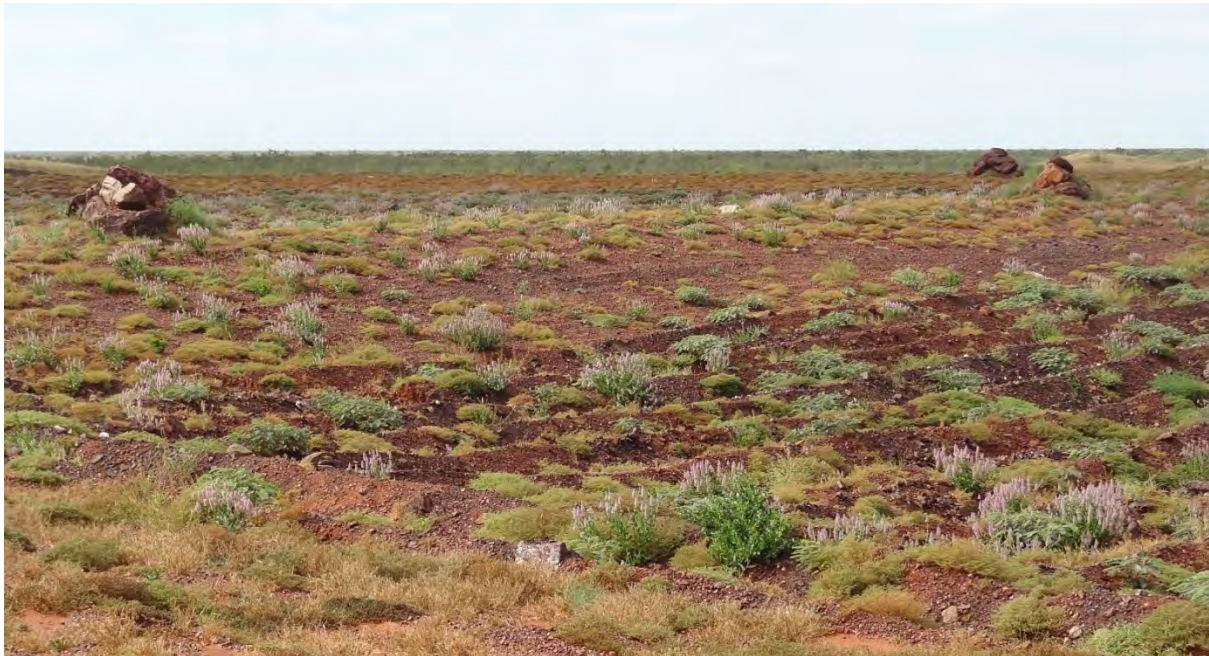
these areas. However, vegetation establishment at most of the sites is only premature, and fauna habitation is likely to be directly related to the occurrence of mature vegetation on disturbed areas. Birds and small invertebrates have been noted using the habitat zones.

Figure 7-10 – Fauna habitat zones developed at Atlas' Pardoo project

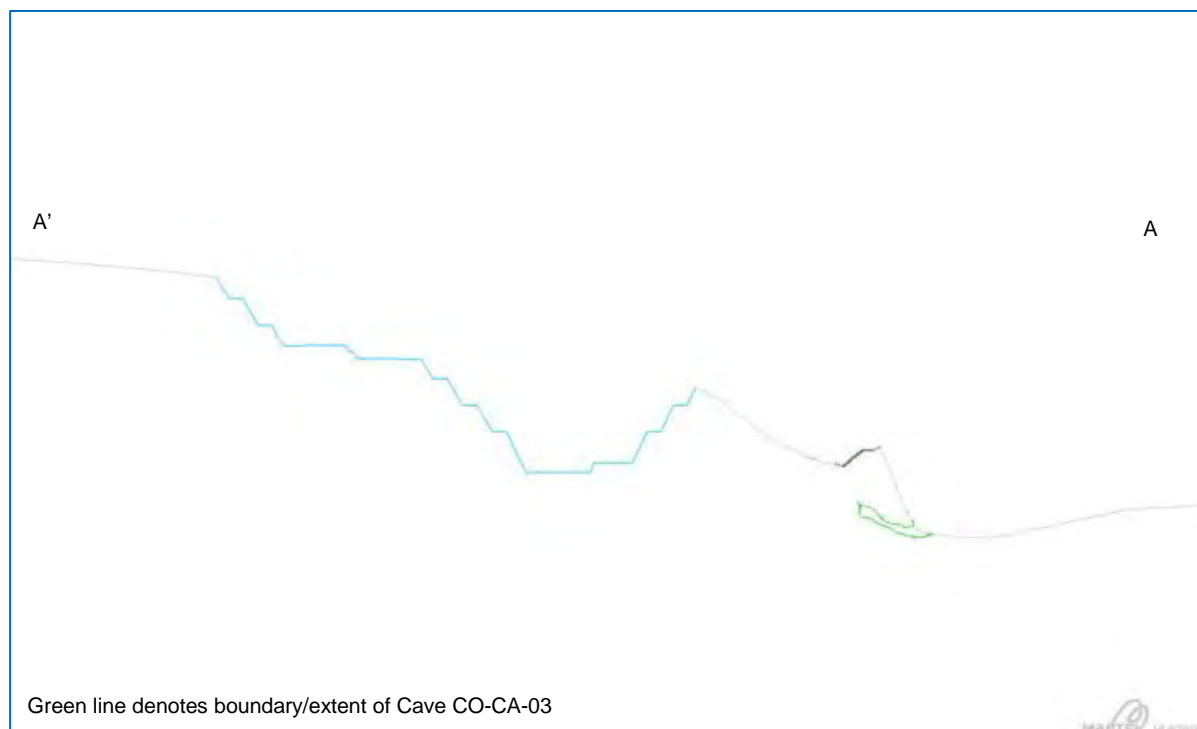
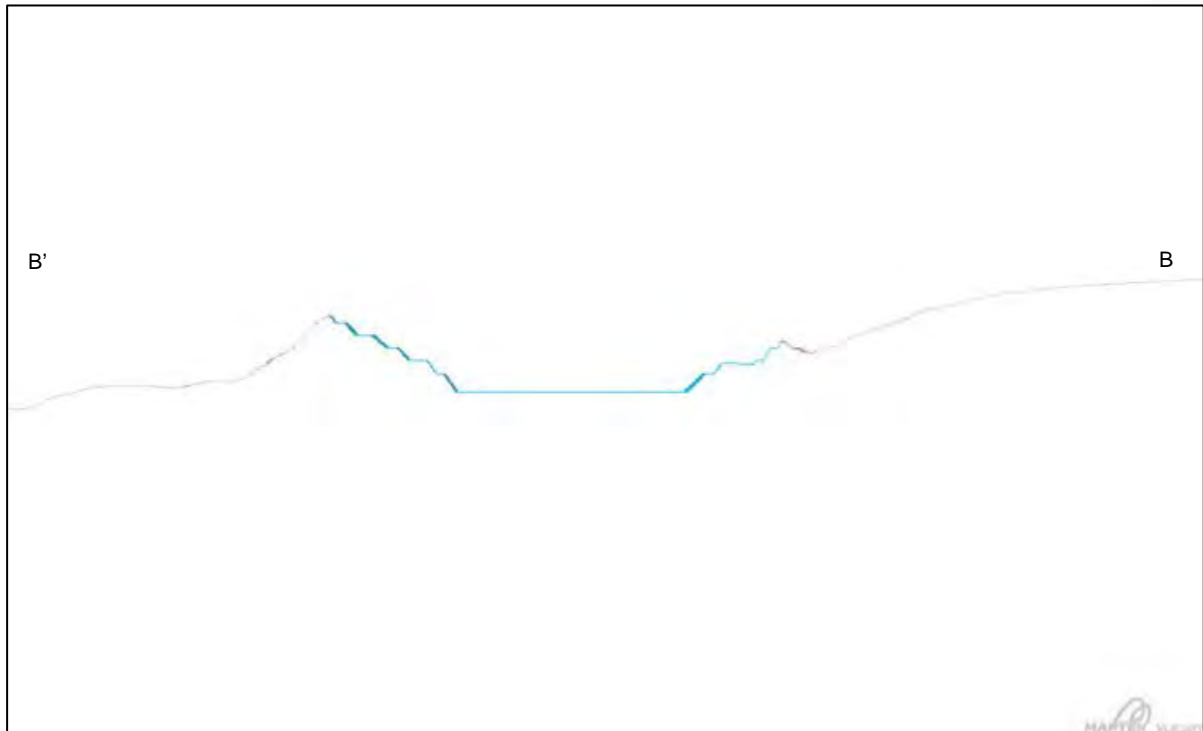
Figure 9-2 – Razorback Pit Plan View, Long-Section (Looking Southwest) and Cross-Section (Looking northwest)

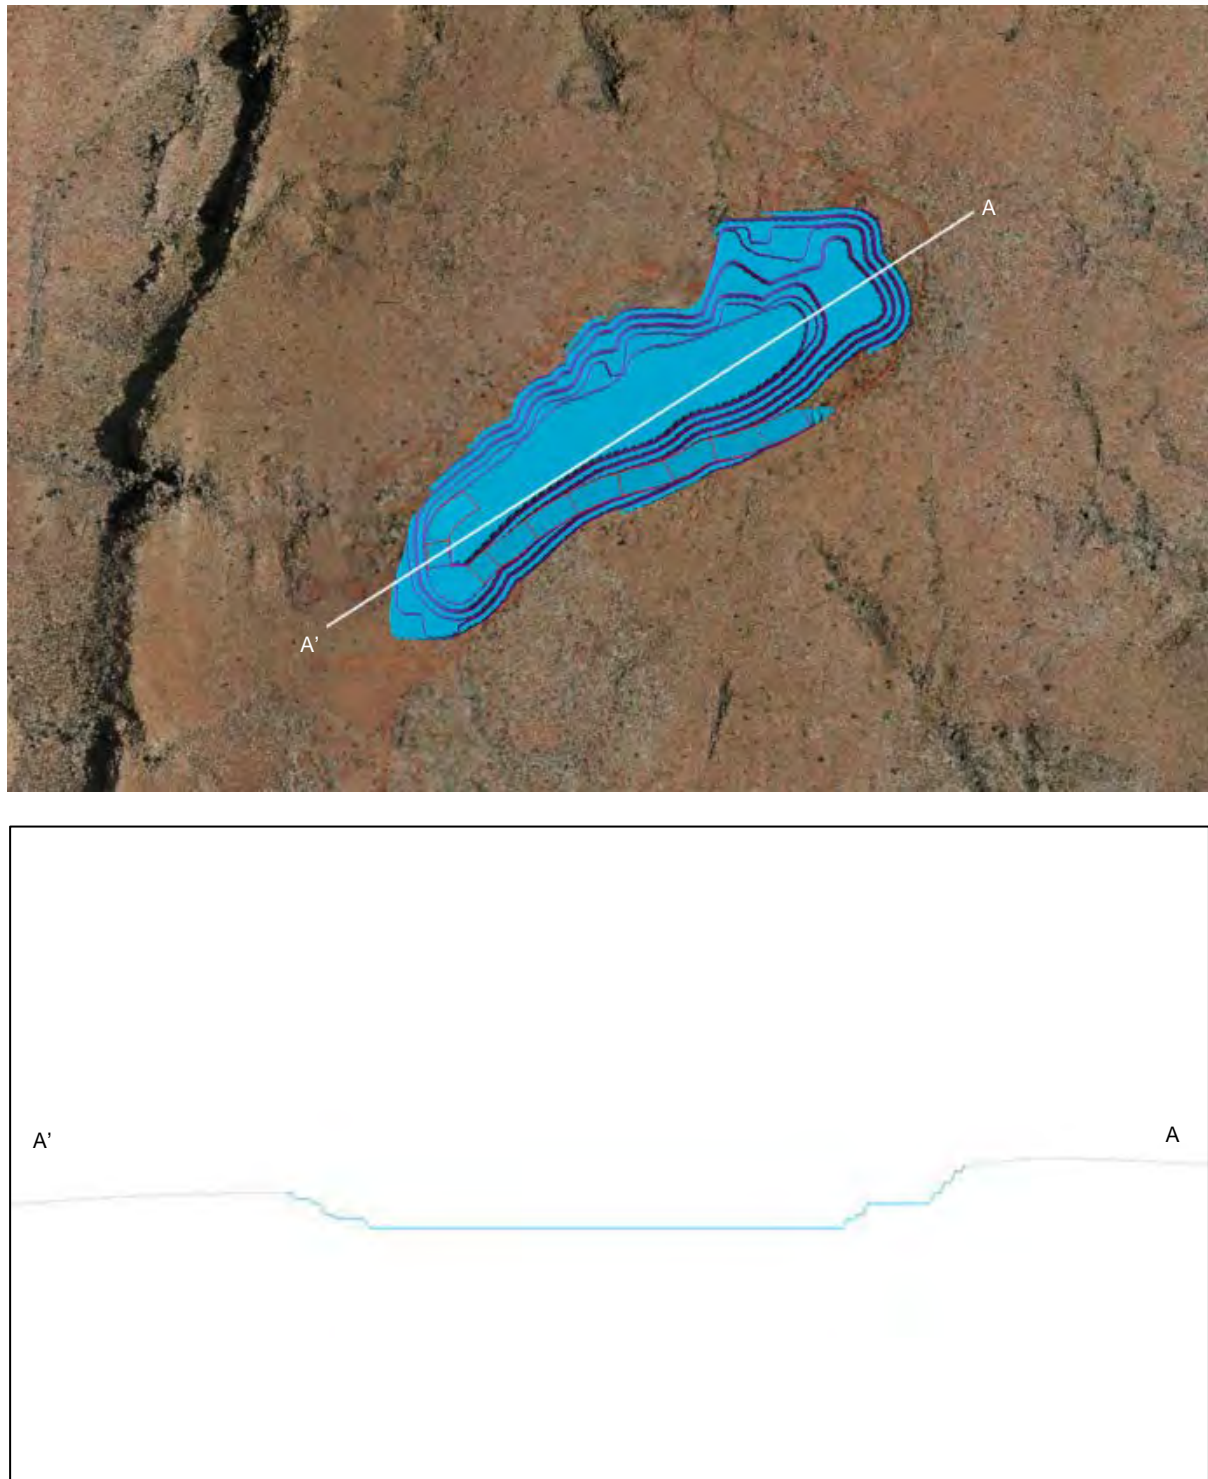
Figure 9-3 – Shark Gully Pit Plan View and Cross-Section (Looking Northwest)

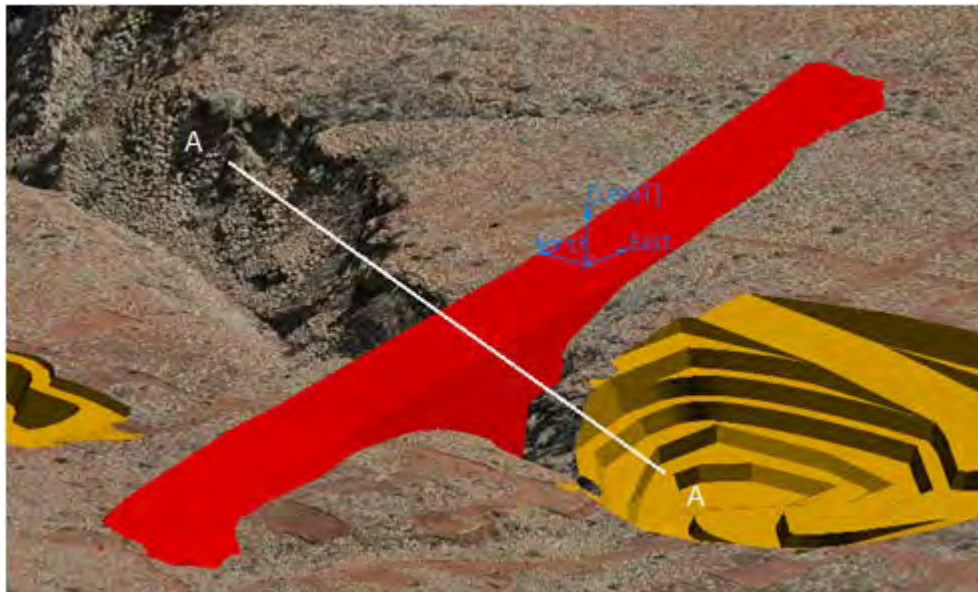
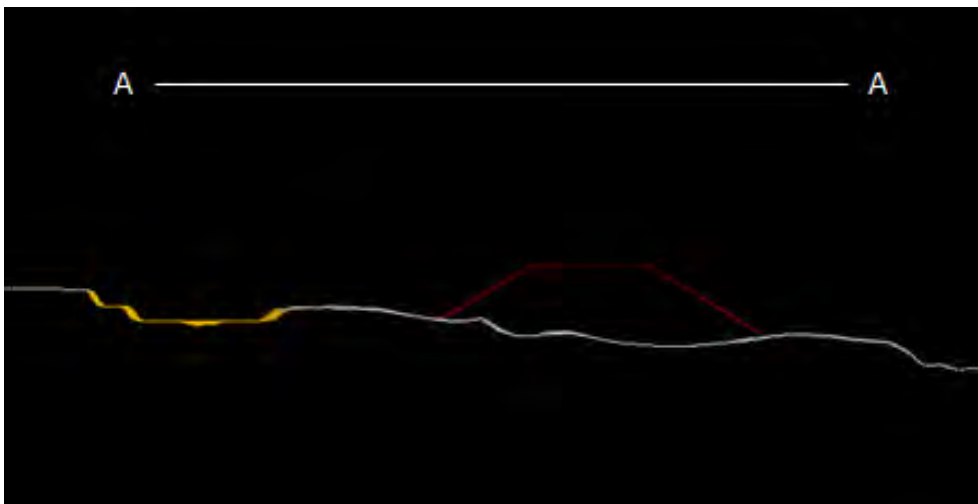
Figure 9-10 - Plan view and cross section of the land bridge (looking northwest)

The WRD's will be reprofiled to form stable structures. Where identified, waste units with deleterious physical properties will be not placed at or close to final landform surfaces. Any shale material will be buried 10 m below the landform surface. Surface water controls will be constructed and exposures with low stability rock will be armoured. Soil will be applied where available and landforms will be ripped on the contour and seeded to attain a self-sustaining vegetation community. Where soil is not available, Atlas will investigate the plant growth properties of waste rock. At Atlas' other sites, the use of additional seed and fertiliser have been implemented to improve the plant growth where soil as a growth medium is unavailable.

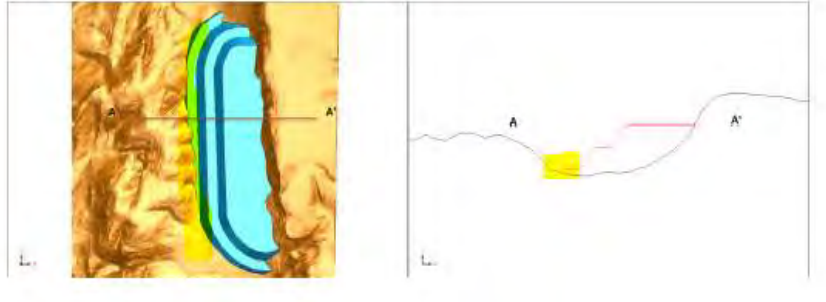
<p>Figure 3.7 – Split Rock Waste Dump Cross Section</p>
