Report of an Archaeological Heritage Assessment along Hamersley Road, Fitzgerald River National Park, Western Australia

A REPORT PREPARED FOR BRAD GOODE AND ASSOCIATES AND MAIN
ROADS WESTERN AUSTRALIA

DAVID GUILFOYLE

FEBRUARY 2009

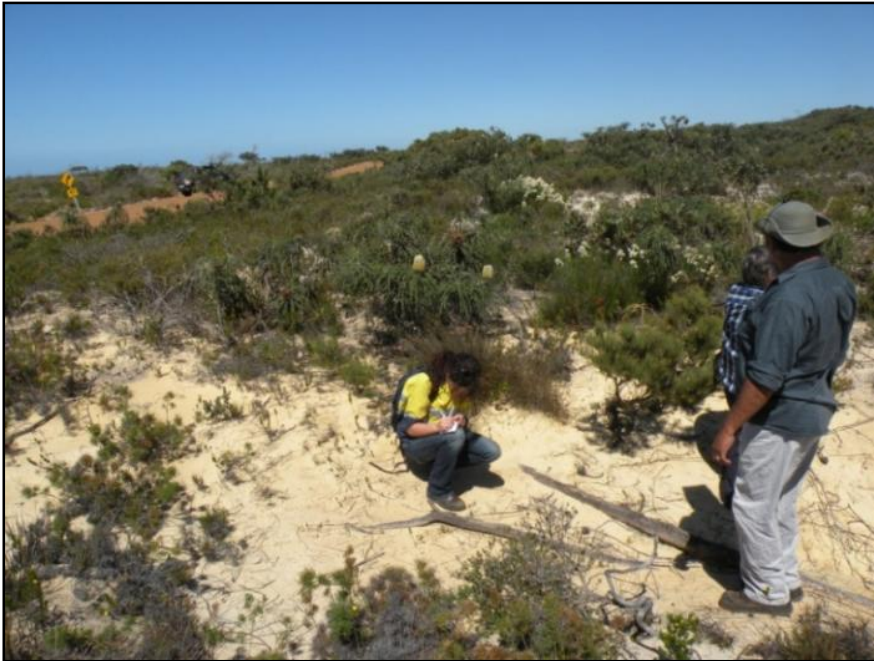
Figure 7. The majority of the cultural material identified was located in localized blow-outs or washes, implying that the area contains a relatively dense archaeological signature though mostly obscured by dense vegetation or buried by sand dune systems.

This point suggests that conditions were generally not favourable for positive artefact identification within the confines of the designated survey area. At the same time, the PDA encompasses a variety of different micro-environments suggesting that archaeological resources should be present within this general area, based on previous investigations. Also, areas of more stable, sedimentation processes, such as the lower-lying flats, are likely to contain additional, un-identified sub-surface material. The specific survey conditions justify the management recommendations outlined below.

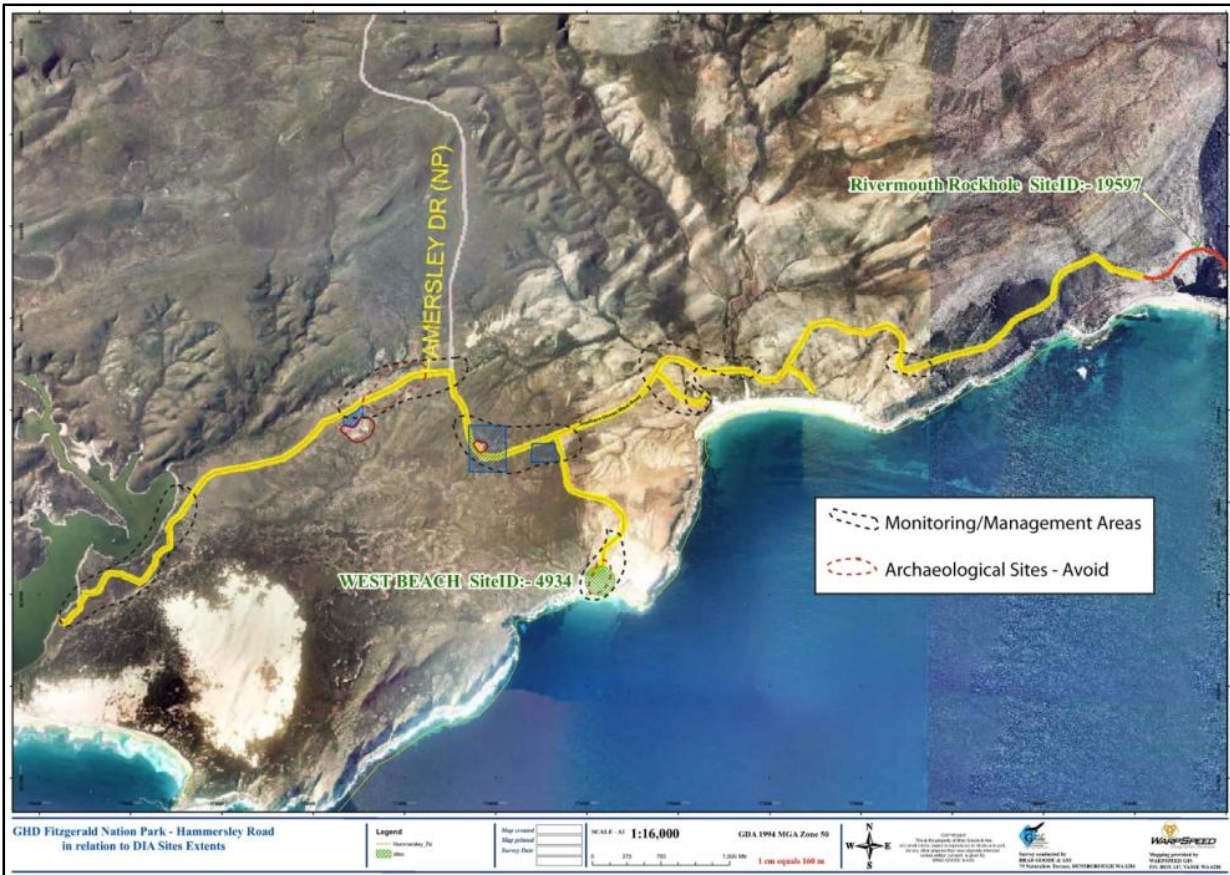
Figure 10. Map showing the distribution of sites and monitoring/management areas.

The map shown in Figure 10 outlines the results of the field survey, discussed in more detail below. The two archaeological sites are highly significant and must be avoided from any disturbance. A mitigation/heritage site protection plan should be instigated by the proponent. The Elders noted that the newly recorded site is highly significant and should not be disturbed (see ethnographic section).

The gravel areas contain artefacts in a context of previous disturbance and dense vegetation and should be monitored during ground clearing. A meeting subsequent to the archaeological survey was to be set up between the Nyungar community in Albany to discuss the Die-back management plans for the gravel pit areas, as during the ethnographic survey the Elders expressed concern with the plan to extract gravel from areas that all ready contain die-back (see ethnographic section).

Areas dashed green are areas of archaeological potential based on the environmental configuration (water crossings, creeks, vegetation mosaic) and/or presence of isolated finds. The Elders also requested archaeological monitoring at water crossings and at the car park at West Beach that contained the previously recorded site (see ethnographic report). Areas dashed green (Waypoints 177 and 183) are areas of erosion that require management/conservation efforts (see Figure 11).

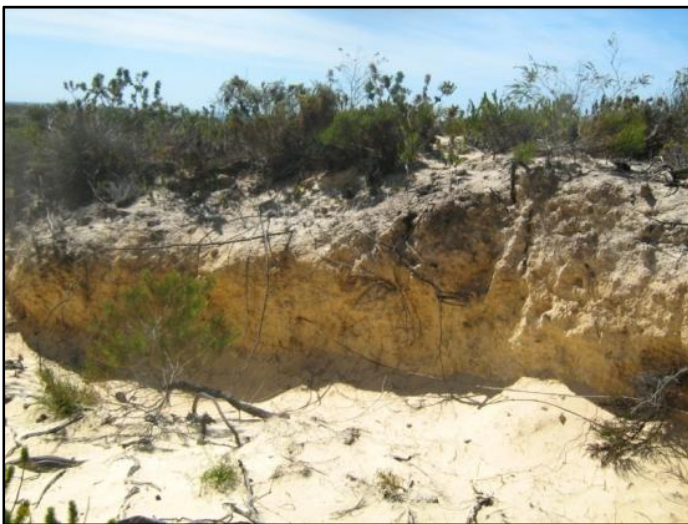
Figure 11. Stabilization of eroded areas is a positive step to minimize erosion and any disturbance to sub-surface archaeological deposits in the area.

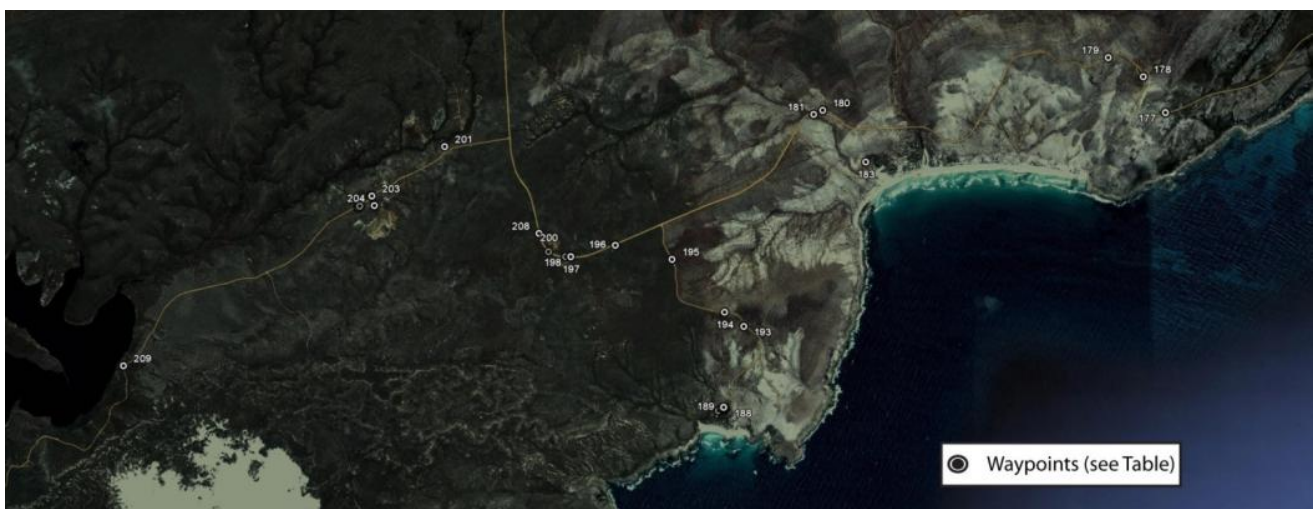
Figure 12. Map showing the distribution of waypoints associated with the survey (see Table 3).

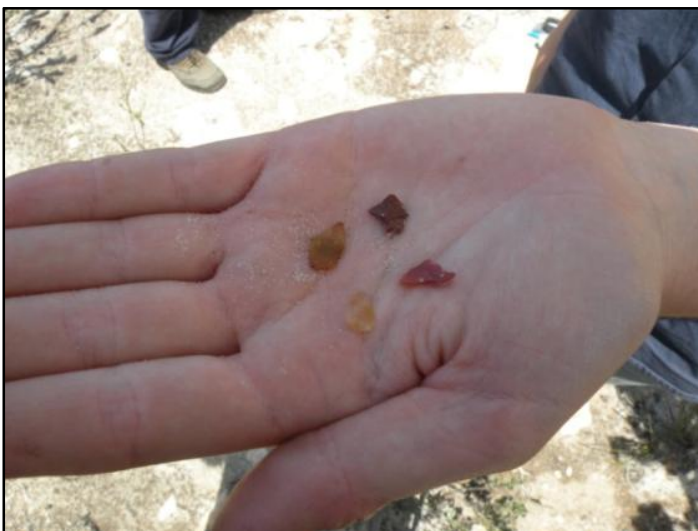
Investigations were limited to the current survey project, and it was noted that the site was truncated by the existing Hamersley Road, as artefacts were found on both sides of the Road, albeit at much lower densities on the southern side of the road. The Elders identified this artefact site as highly significant and have advised that they wished the site not to be affected. The archaeological assessment likewise **strongly recommends** that no work should take place in this area, and a wide conservation buffer zone be established to ensure no indirect impacts. A full-scale archaeological assessment is required at this highly significant heritage place (see recommendations below). Further consultations are required with the Traditional Owner Group to determine the management/mitigation process, including further archaeological work, as cultural protocols of access and methods of investigation/reporting must first be established.

Figure 14. Some of the chert artefacts identified in the large artefact scatter.

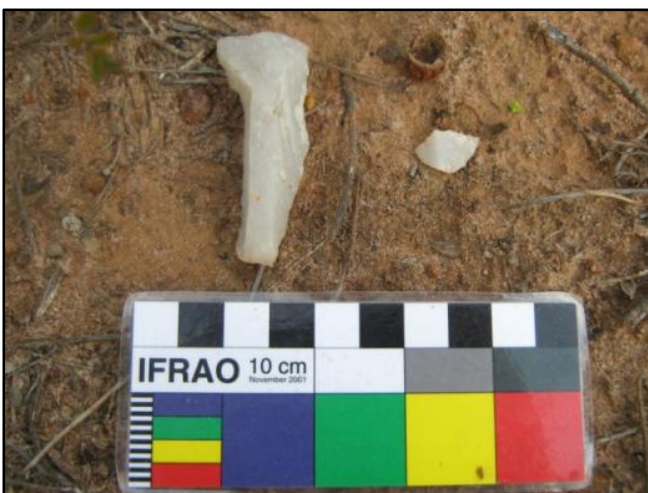
A total of six quartz flakes were located within or adjacent to this gravel pit suggesting that the area is likely to contain a small artefact scatter with potentially sub-surface deposits; given that the area was densely covered with vegetation and subject to previous disturbances. The area is very close to the significant site complex located during this survey, so a clear management plan and monitoring programme must be established for this area.

Figure 21. Quartz artefacts found within the gravel pit area.

It is recommended that if the area is to be disturbed, that initial ground clearing activities are monitored by Traditional Owner representatives and a qualified archaeologist.

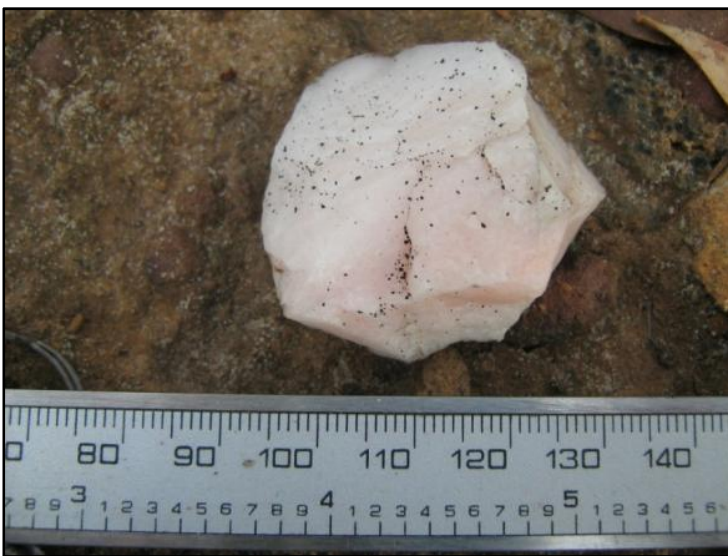
Figure 22. Quartz core found within gravel pit area.

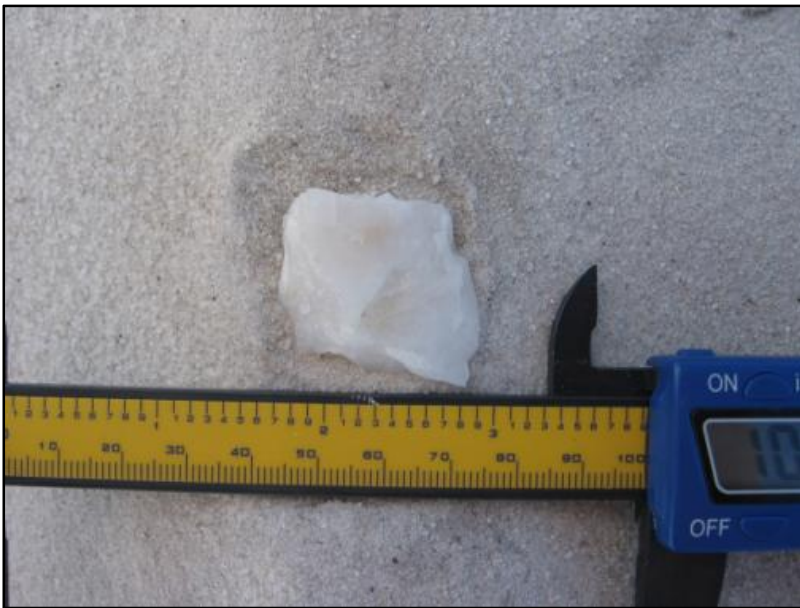
A small area within a horse paddock near Culham Inlet was the final proposed gravel pit area to be surveyed. This area was a sandy dune above a gravel bench highly disturbed by horses and tracks. A quartz artifact was located within a localized blowout and appeared to have been dug out by a fox or rabbit, with an animal burrow located nearby. Thus, there is some potential here for sub-surface cultural material.

Figure 26. Quartz artefact located within gravel pit area 5 that appears to have been dug out from an animal burrow (Waypoint 209).

If the area is to be disturbed, it is **recommended** that initial ground clearing activities are monitored by Traditional Owner representatives and a qualified archaeologist.
