## Spinifex Ridge

### Spinifex Ridge Creek Diversion Baseline Study

December 2006

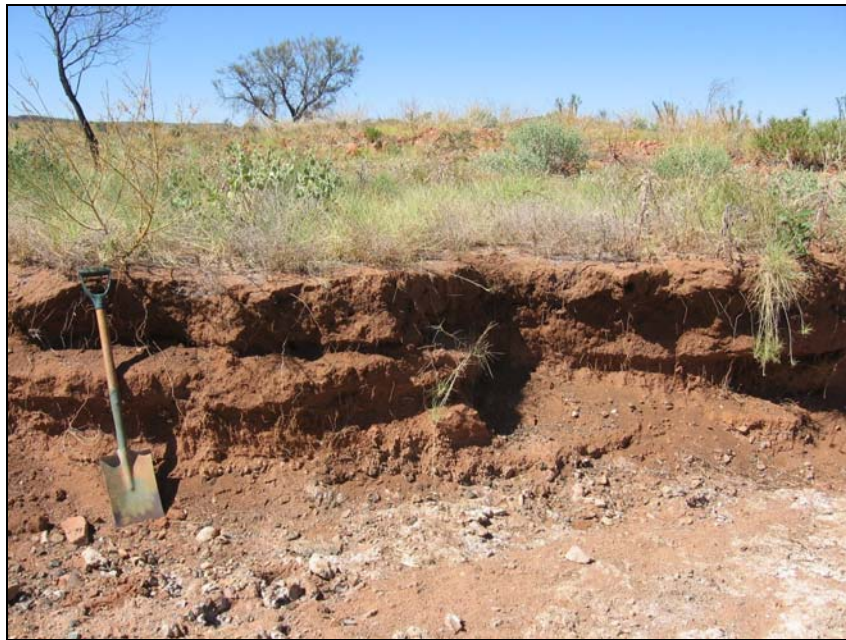
**Plate 1** Vertical bank on eastern side of Transect DS01

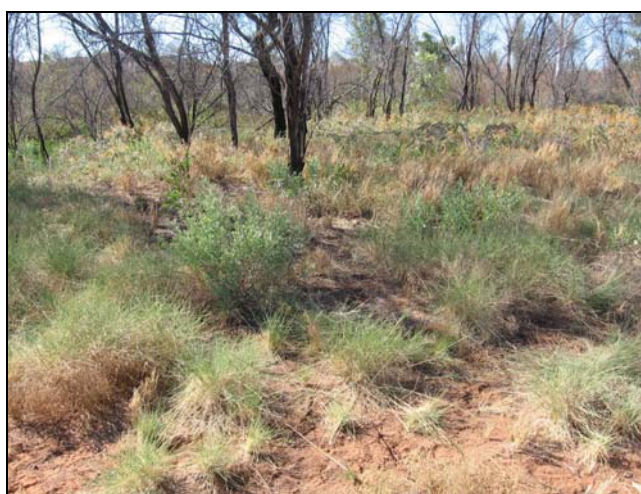
**Plate 3 Sample Site 1A**

**Soil surface:** weak platy crust at surface, approximately 5% sub-rounded coarse fragments and 20% litter cover.

**Vegetation:** *Hakea* sp. scattered tall shrubs over *Senna notabilis* and *Sida fibulifera* low shrubland over *Triodia pungens* open hummock grassland and *Cenchrus ciliaris* very open tussock grassland over *Ipomoea muelleri*, *Indigofera colutea* and *Euphorbia coghlanii* very open herbs.

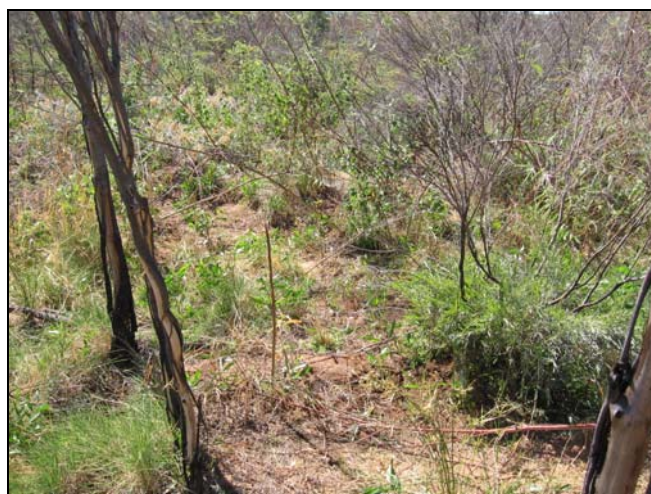
**Plate 5 Sample Site 1B**

**Soil surface:** loose sandy surface, < 5% sub-rounded coarse fragments and 10% litter cover.

**Vegetation:** *Eucalyptus camaldulensis* open woodland over *Acacia tumida*, *Melaleuca argentea* and *Petalostylis labicheoides* high open shrubland over *Senna notabilis* low scattered shrubs over *Triodia pungens* very open hummock grassland and *Cenchrus ciliaris* very open tussock grassland over *Cyperus vaginatus* open sedges over *Chloris pectinata* and *Pluchea rubelliflora* very open herbs.

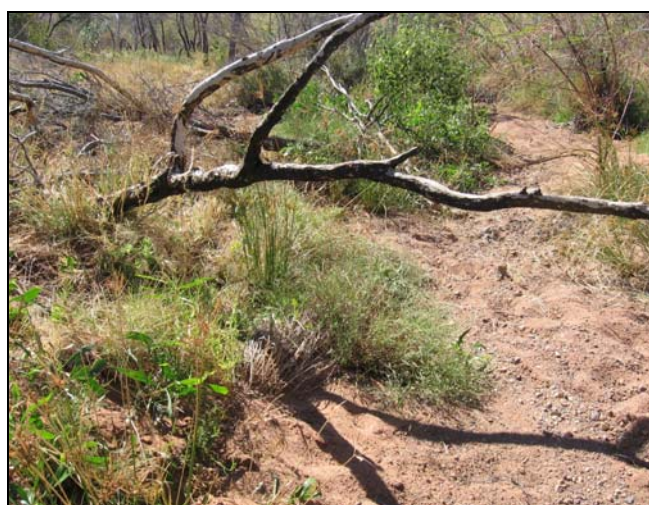
**Plate 7 Sample Site 1C**

**Soil surface:** loose sandy surface, approximately 20% sub-rounded coarse fragments and 5% litter cover.

**Vegetation:** *Eucalyptus camaldulensis* open woodland over *Acacia tumida*, *Melaleuca argentea* and *Petalostylis labicheoides* high open shrubland over *Senna notabilis* low scattered shrubs over *Triodia pungens* very open hummock grassland and *Cenchrus ciliaris* very open tussock grassland over *Cyperus vaginatus* open sedges over *Chloris pectinata* and *Pluchea rubelliflora* very open herbs.

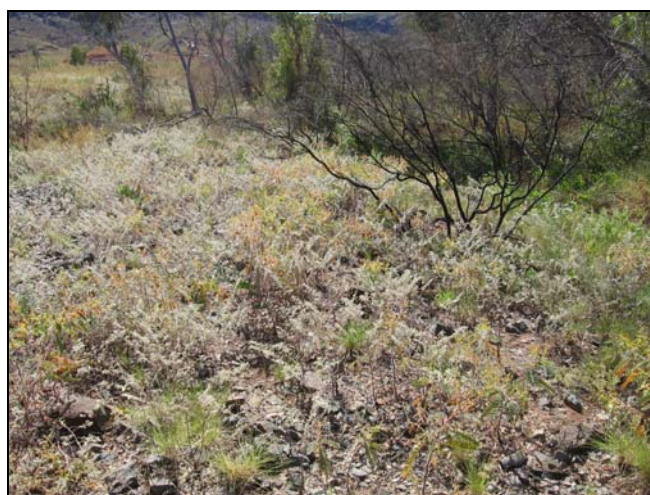
**Plate 9        Sample Site 2A**

**Soil surface:** loose sandy surface between rock fragments, approximately 75% sub-rounded and sub-angular coarse fragments and 5% litter cover.

**Vegetation:** *Eucalyptus camaldulensis* open woodland over *Petalostylis labicheoides* and *Acacia tumida* scattered tall shrubs over *Senna notabilis* and *Goodenia stobbsiana* low open shrubland over *Triodia pungens* very open hummock grassland and *Cenchrus ciliaris* very open tussock grassland over *Cyperus vaginatus* open sedges over *Pluchea rubelliflora* and *Corchorus incanus* very open herbs.

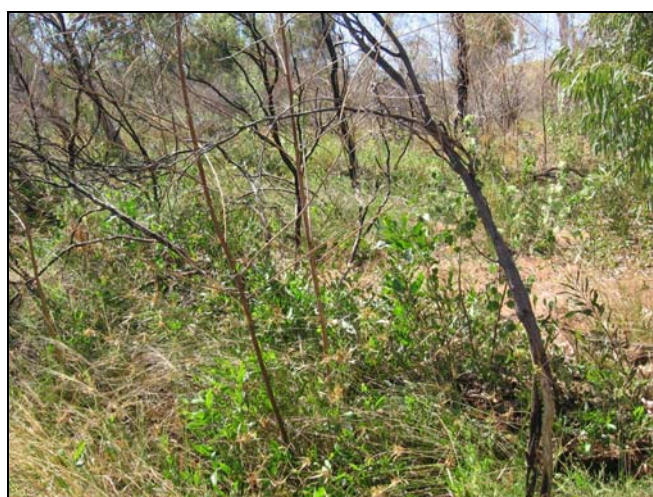
**Plate 11 Sample Site 2B**

**Soil surface:** loose sandy surface, <5% sub-rounded and sub-angular coarse fragments and 25% litter cover.

**Vegetation:** *Eucalyptus camaldulensis* open woodland over *Acacia tumida*, *Petalostylis labicheoides* and *Melaleuca argentea* high open shrubland over *Goodenia stobbsiana* low scattered shrubs over *Cenchrus ciliaris* scattered tussock grass over *Cyperus vaginatus* open sedges over *Pluchea rubelliflora* and *Setaria dielsii* very open herbs.

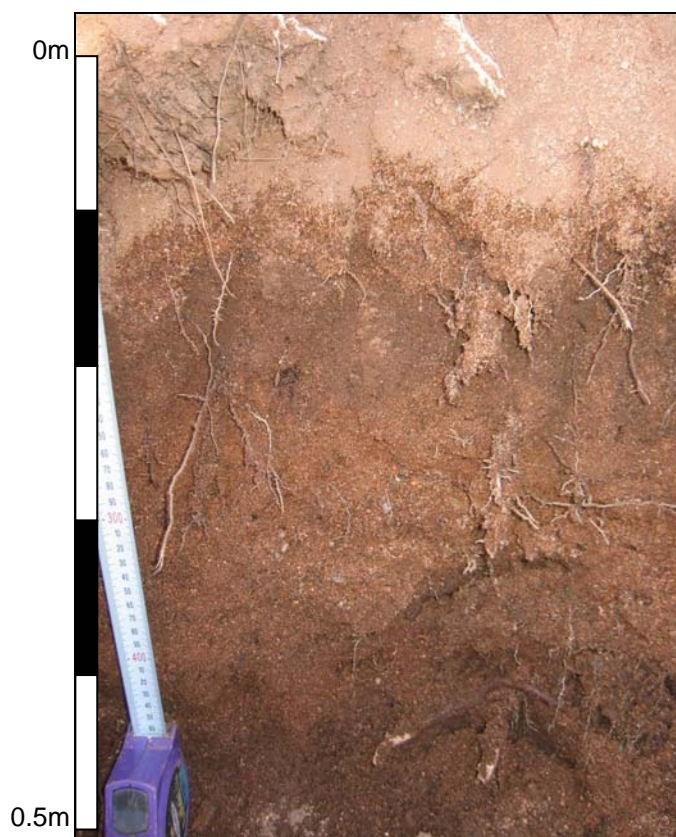
**Site 2C: Creek bed 0198295 mE  
7686865 mN**

**0-10cm:** predominantly single grained structure, some weak aggregates induced by root growth, approximately 5% sub-angular and sub-rounded coarse fragments, 2-5mm in size, abundant root growth.

**10-50cm:** predominantly single grained structure, approximately 5% sub-angular and sub-rounded coarse fragments, 2-10mm in size, common root abundance.

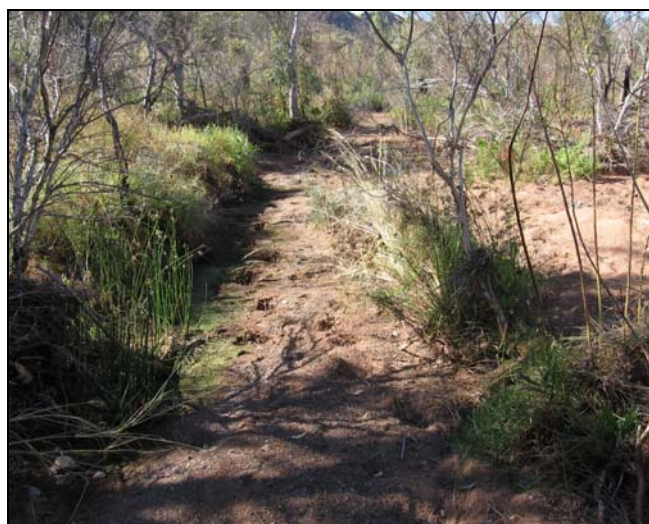
**Plate 13 Sample Site 2C**

**Soil surface:** loose sandy surface, <5% sub-rounded coarse fragments and 25% litter cover.

**Vegetation:** *Eucalyptus camaldulensis* open woodland over *Acacia tumida*, *Petalostylis labicheoides* and *Melaleuca argentea* high open shrubland over *Goodenia stobbsiana* low scattered shrubs over *Cenchrus ciliaris* scattered tussock grass over *Cyperus vaginatus* open sedges over *Pluchea rubelliflora* and *Setaria dielsii* very open herbs.

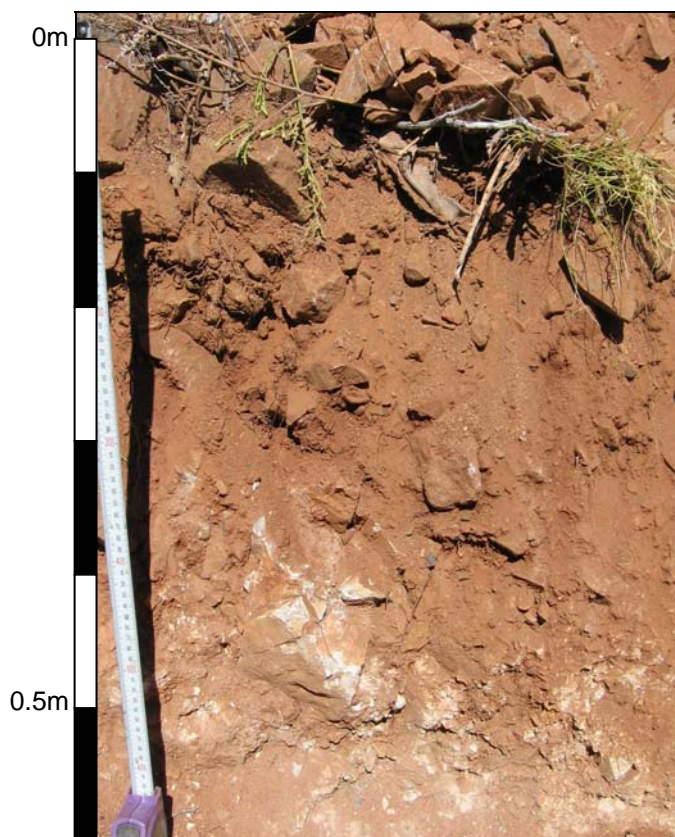
**Plate 14 Soil Profile at Site 3A**

*0-10cm:* predominantly single grained structure between rock fragments, approximately 75% sub-angular and sub-rounded coarse fragments, 2-100 mm in size, abundant root growth.

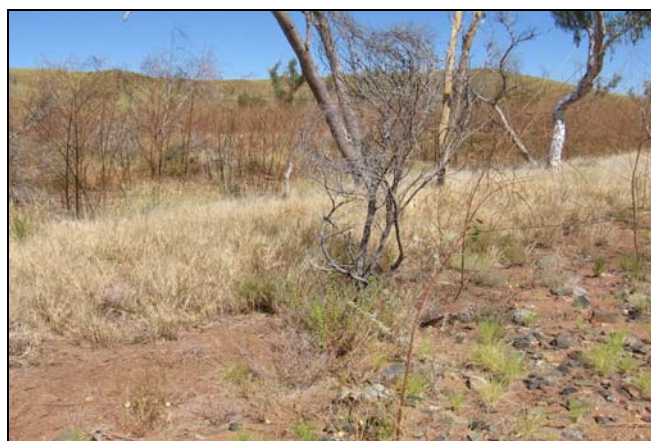
**Plate 15 Sample Site 3A**

*Soil surface:* loose sandy surface between rock fragments, approximately 60% sub-rounded and sub-angular coarse fragments and 5% litter cover.

*Vegetation:* *Corymbia opaca* open woodland over *Petalostylis labicheoides* scattered shrubs over *Corchorus incanus* low open shrubland over *Triodia pungens* very open hummock grassland and *Cenchrus ciliaris* scattered tussock grassland over mixed herbs.

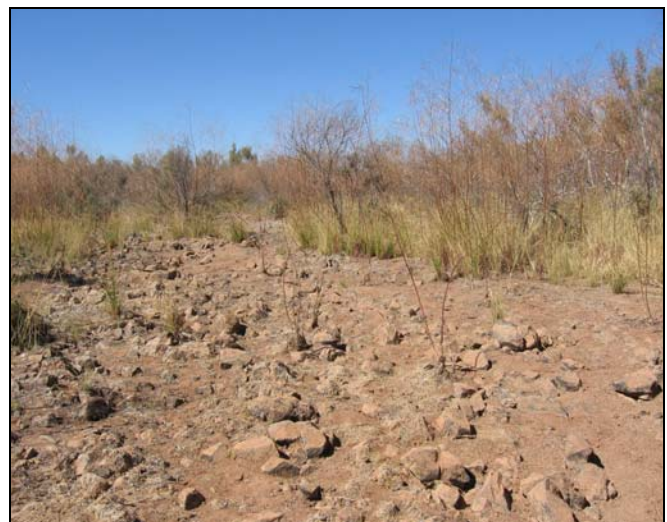
**Plate 17**      **Sample Site 3B**

*Soil surface:* creek bed, loose sandy surface between rock fragments, approximately 90% sub-rounded and sub-angular coarse fragment cover.

*Vegetation:* very open *Cenchrus ciliaris* tussock grassland.

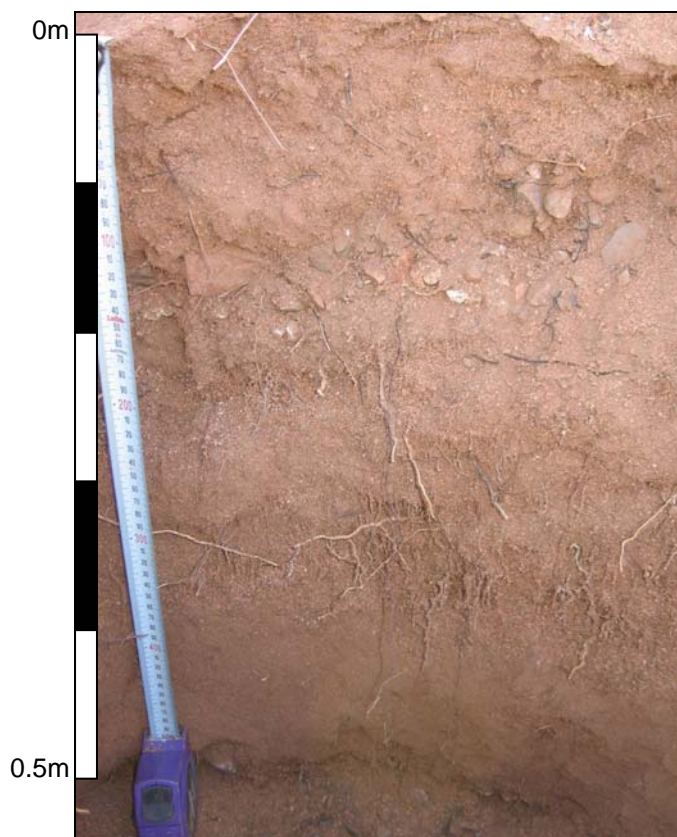
**Site 3C:**            **Upper creek bed**            **0198768 mE**  
**7687071 mN**

**0-5cm:** predominantly single grained, some weak polyhedral aggregates, approximately 5% sub-angular and sub-rounded coarse fragments, 2-5mm in size, common root abundance.

**10-20cm:** predominantly single grained, approximately 25% sub-rounded and rounded coarse fragments, 2-50mm in size, common root abundance.

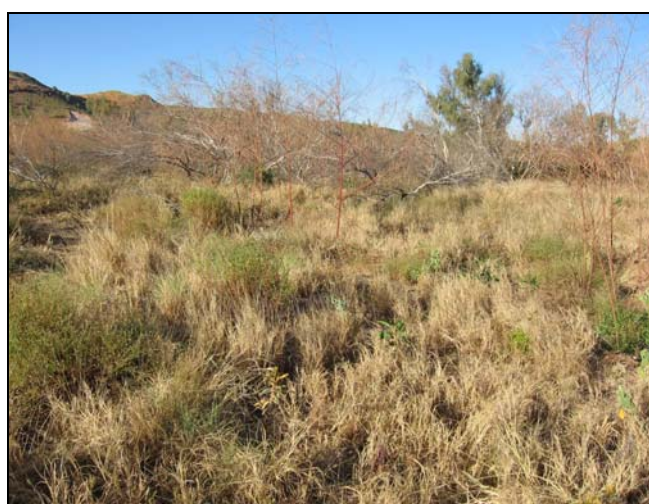
**Plate 19            Sample Site 3C**

**Soil surface:** weak platy crust at surface, approximately 20% sub-rounded coarse fragments and 50% litter cover.

**Vegetation:** *Corymbia opaca* and *Eucalyptus camaldulensis* woodland over *Melaleuca argentea* and *Petalostylis labicheoides* high shrubland over *Cyperus vaginatus* very open sedges over *Cenchrus ciliaris* open tussock grassland over mixed herbs.

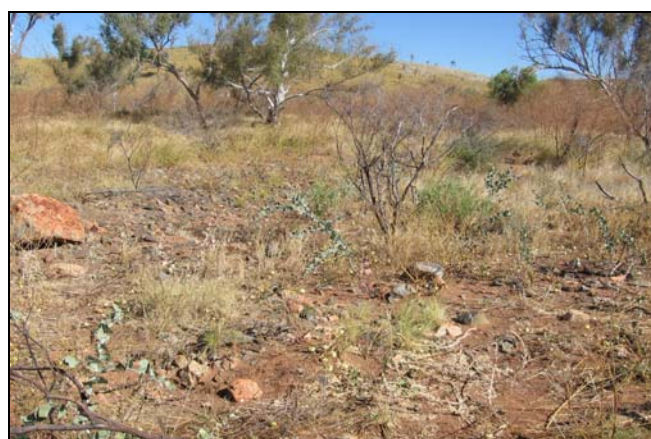
**Plate 21      Sample Site 4A**

**Soil surface:** weak platy crust between coarse fragments, approximately 50% sub-angular / sub-rounded coarse fragments and 20% litter cover.

**Vegetation:** *Eucalyptus camaldulensis* open woodland over *Melaleuca argentea* and *Petalostylis labicheoides* high open shrubland over *Goodenia stobbsiana* low open shrubland over *Triodia pungens* open hummock grassland over *Cenchrus ciliaris* very open tussock grassland over *Cyperus vaginatus* very open sedges over *Cleome viscosa* scattered herbs.

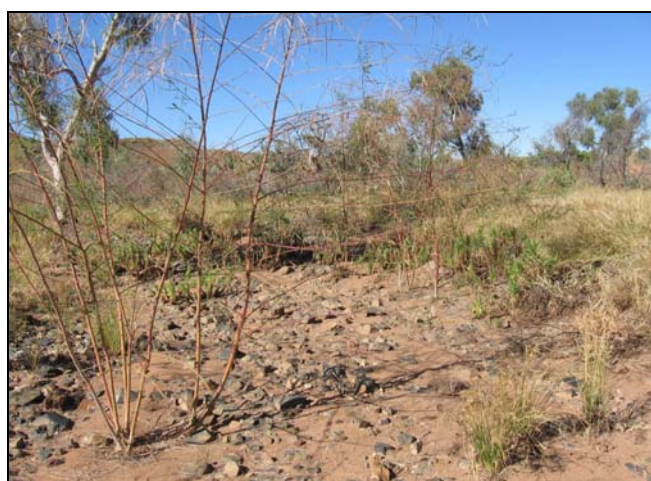
**Plate 23 Sample Site 4B**

**Soil surface:** creek bed, loose sandy surface between rock fragments, approximately 90% sub-rounded and sub-angular coarse fragment cover.

**Vegetation:** *Petalostylis labicheoides* high shrubland over *Goodenia stobbsiana* low open shrubland over *Cenchrus ciliaris* very open tussock grassland over *Cyperus vaginatus* very open sedges.

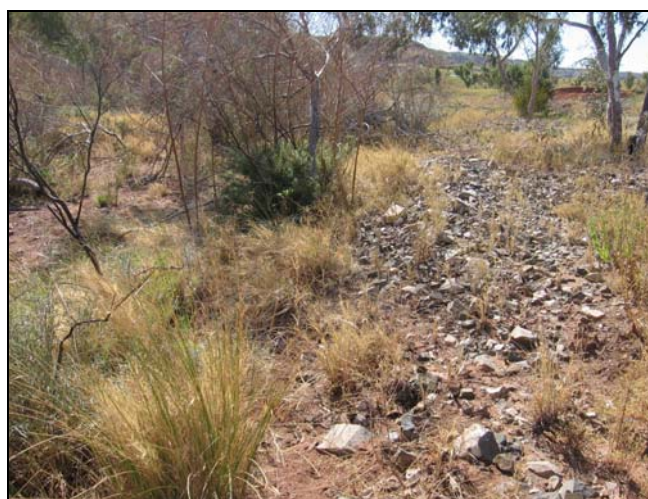
**Plate 25 Sample Site 4C**

**Soil surface:** loose sandy surface between rock fragments, approximately 75% sub-rounded coarse fragment and 10% litter cover.

**Vegetation:** *Eucalyptus camaldulensis* scattered trees over *Melaleuca argentea* and *Petalostylis labicheoides* high shrubland over *Goodenia stobbsiana* low open shrubland over *Cenchrus ciliaris* very open tussock grassland over *Cyperus vaginatus* very open sedges.

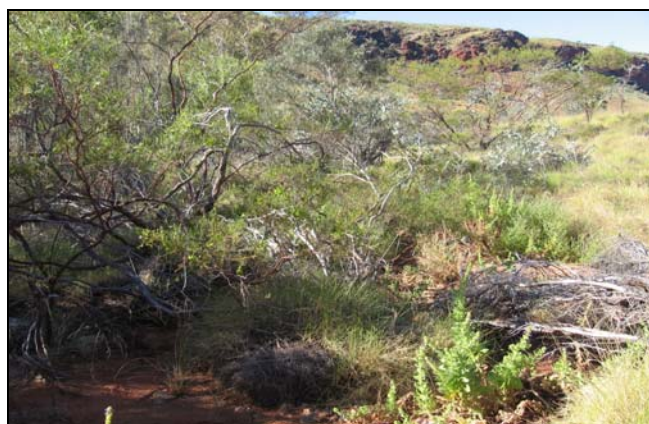
**Plate 27**

*Soil surface:* strong crust at surface, <5% coarse fragments, approximately 25% litter cover.

*Vegetation:* *Eucalyptus camaldulensis* woodland over *Melaleuca argentea* and *Petalostylis labicheoides* high open shrubland over *Cenchrus ciliaris* open tussock grassland.

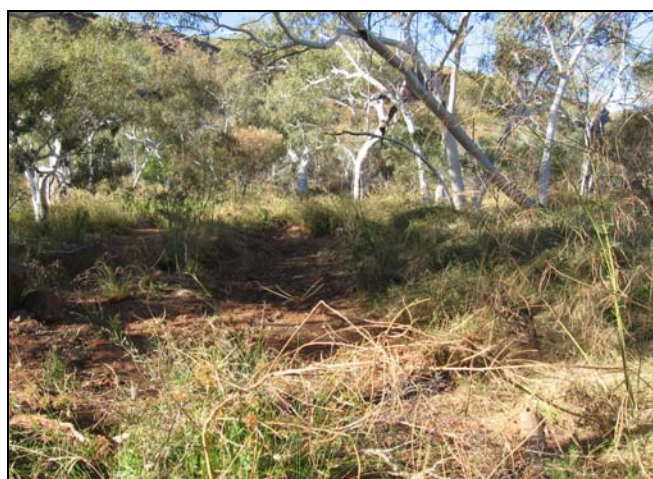
**Plate 29 Sample Site 5B**

**Soil surface:** predominantly loose sandy surface with a weak crust evident in some places, approximately 25% coarse fragment and 10% litter cover.

**Vegetation:** *Eucalyptus camaldulensis* woodland over *Melaleuca argentea* and *Petalostylis labicheoides* high open shrubland over *Cenchrus ciliaris* open tussock grassland.

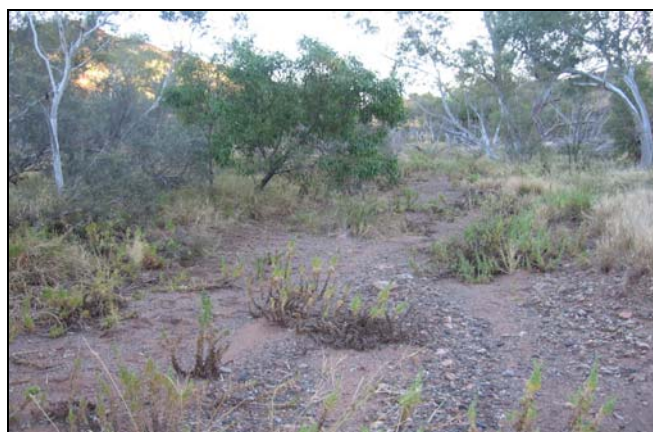
**Plate 33 Sample Site 6B**

*Soil surface:* creek bed, loose surface between coarse fragments, approximately 75% sub-rounded and sub-angular coarse fragment and <5% litter cover.

*Vegetation:* *Eucalyptus camaldulensis* and *Acacia coriacea* ssp *pendens* open woodland over *Melaleuca argentea* and *Petalostylis labicheoides* high shrubland over *Cenchrus ciliaris* very open tussock grassland over *Cyperus vaginatus* very open sedges over very open herbs.

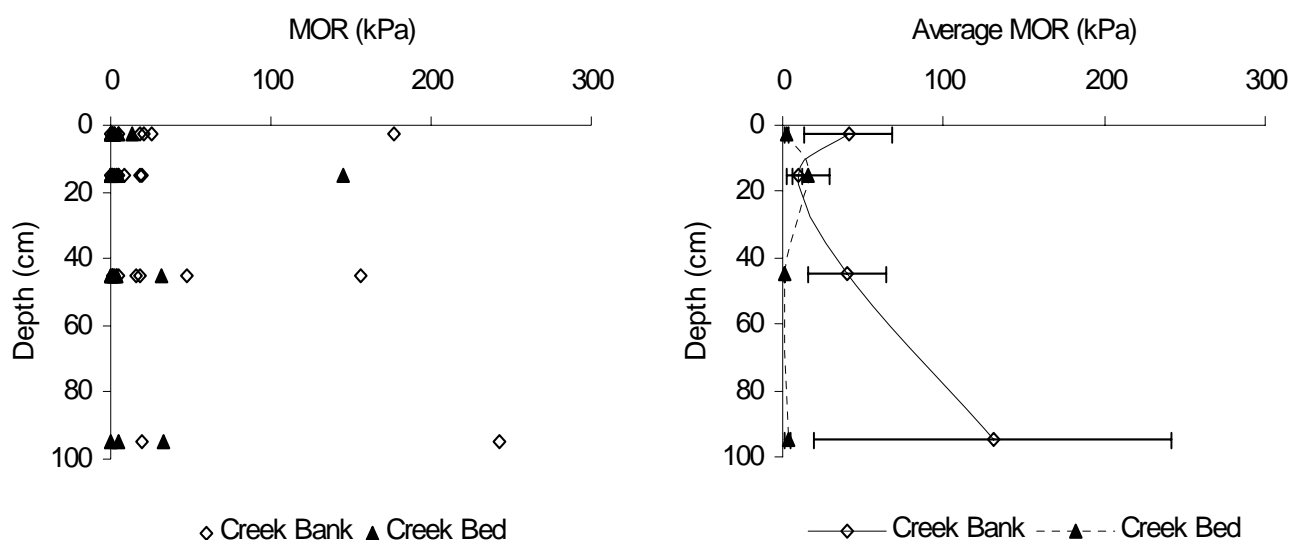
**Figure 6 Individual and average modulus of rupture (kPa) levels with corresponding sample depth, grouped into areas of creek bank and creek bed (error bars represent standard error)**

The soil materials (<2mm) of the creek banks and creek bed within the study area displayed a wide range of soil strength values (**Figure 6**), but were typically less than the level considered to be potentially problematic (60 kPa).

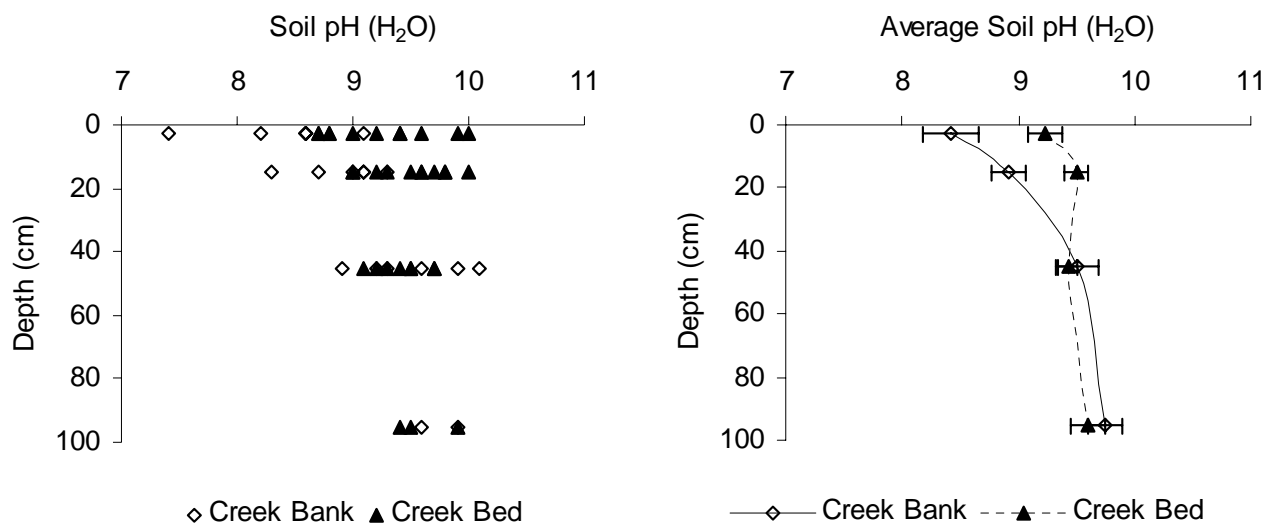
**Figure 7 Individual and average soil pH (H<sub>2</sub>O) levels with corresponding sample depth, grouped into areas of creek bank and creek bed (error bars represent standard error)**

Figure 7). The average soil pH, was slightly more alkaline than the soils of the surrounding Project Area (OES, *in press*). The soils within the creek bed tended to be the most alkaline. There was typically a slight increase in soil pH with increasing depth through both the creek bank and creek bed profiles.

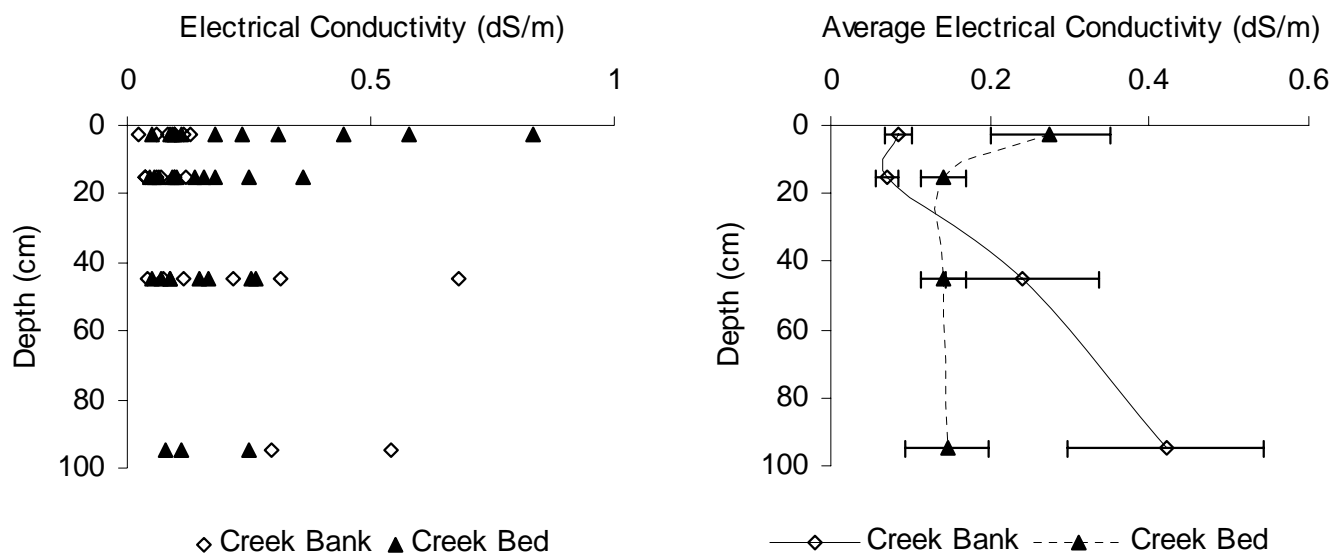
**Figure 8 Individual and average electrical conductivity (dS/m) levels with corresponding sample depth, grouped into areas of creek bank and creek bed (error bars represent standard error)**

The majority of soil materials sampled were classed as non to slightly saline based on standard CSIRO categories (**Appendix D**). Two of the surface samples from within the creek bed (Sites 2B and 4C), and soil from below 40cm on the creek bank at Site 1A, exhibited electrical conductivity values classed as 'moderately saline' (**Figure 8**).

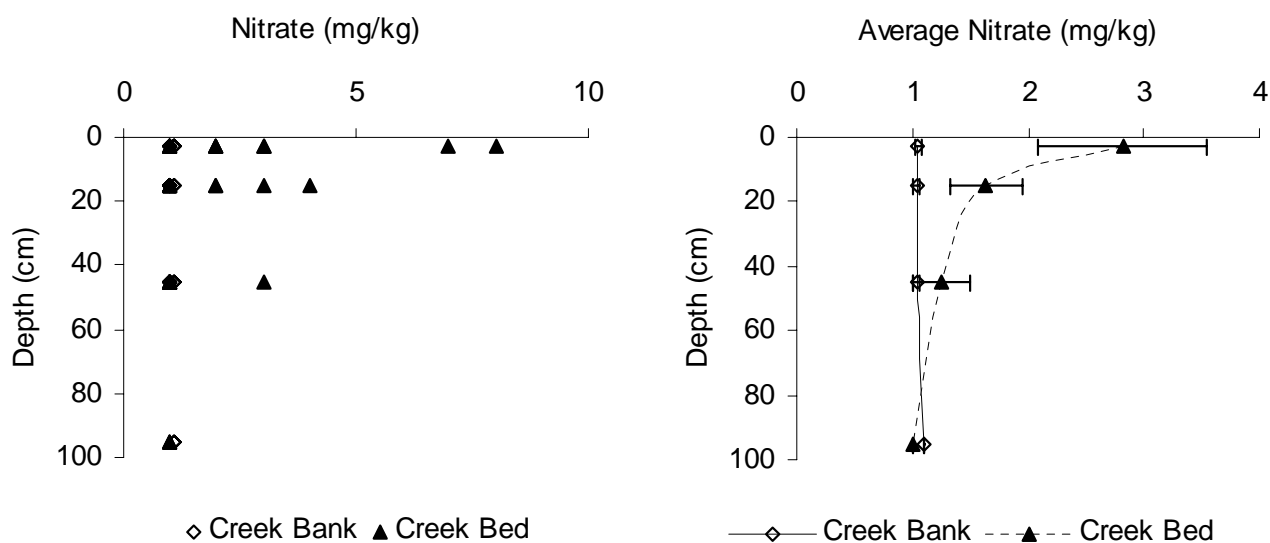
**Figure 9 Individual and average nitrate (mg/kg) levels with corresponding sample depth, grouped into areas of creek bank and creek bed (error bars represent standard error)**

The amount of plant-available nutrients within the soils sampled was generally low, as is typical of native soils. The majority of sites indicated little consistent trend in nutrient level (plant available N, P, K and S) corresponding to position within the creek profile. Average nitrate levels were slightly higher within the top 20cm of the creek bed compared to the corresponding depth in the creek bank soils (**Figure 9**).

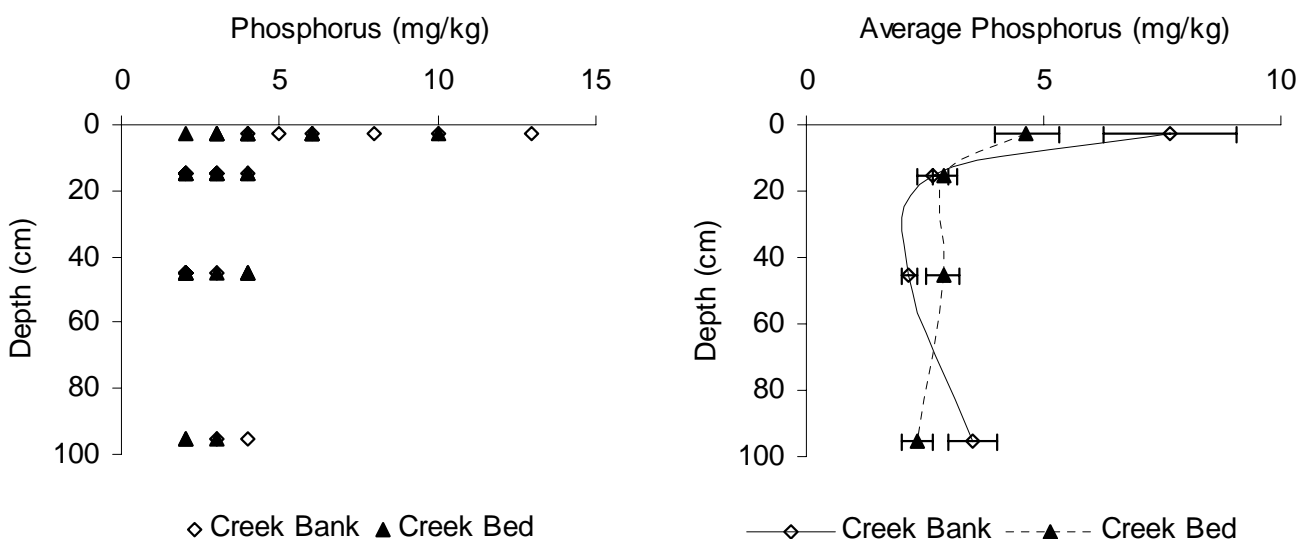
**Figure 11 Individual and average available phosphorus (mg/kg) levels with corresponding sample depth, grouped into areas of creek bank and creek bed (error bars represent standard error)**

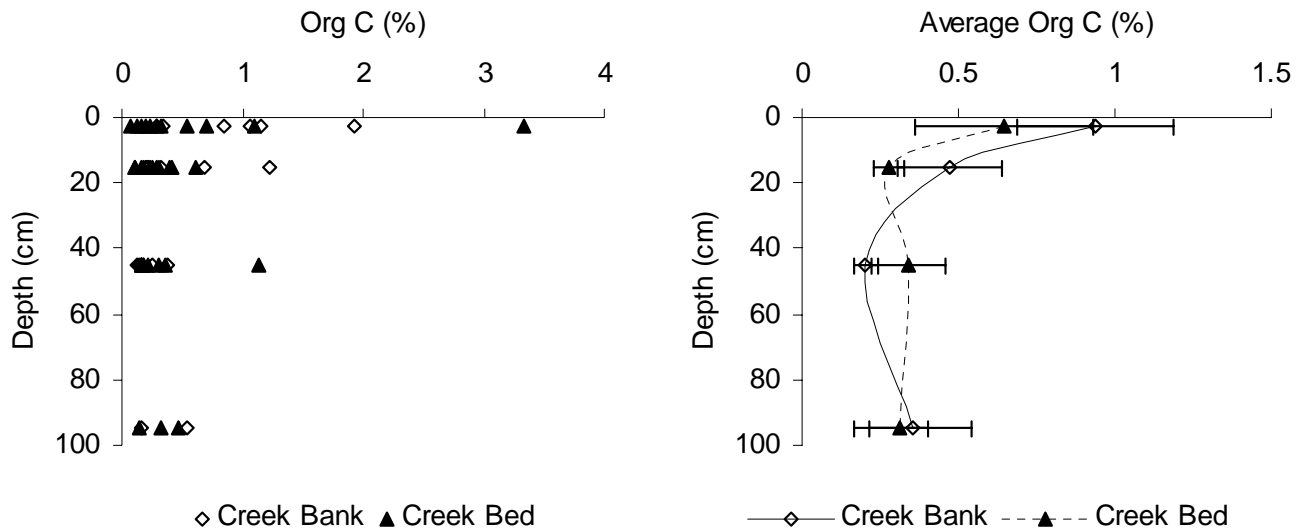
**Figure 14 Individual and average organic carbon (%) levels with corresponding sample depth, grouped into areas of creek bank and creek bed (error bars represent standard error).**
