**AN INVESTIGATION INTO THE SOILS  
AND SOIL LANDSCAPES OF THE  
DONGARA PROJECT AREA**

**Tiwest Pty Ltd**

**D. C. Blandford & Associates Pty Ltd**

**July, 2007**

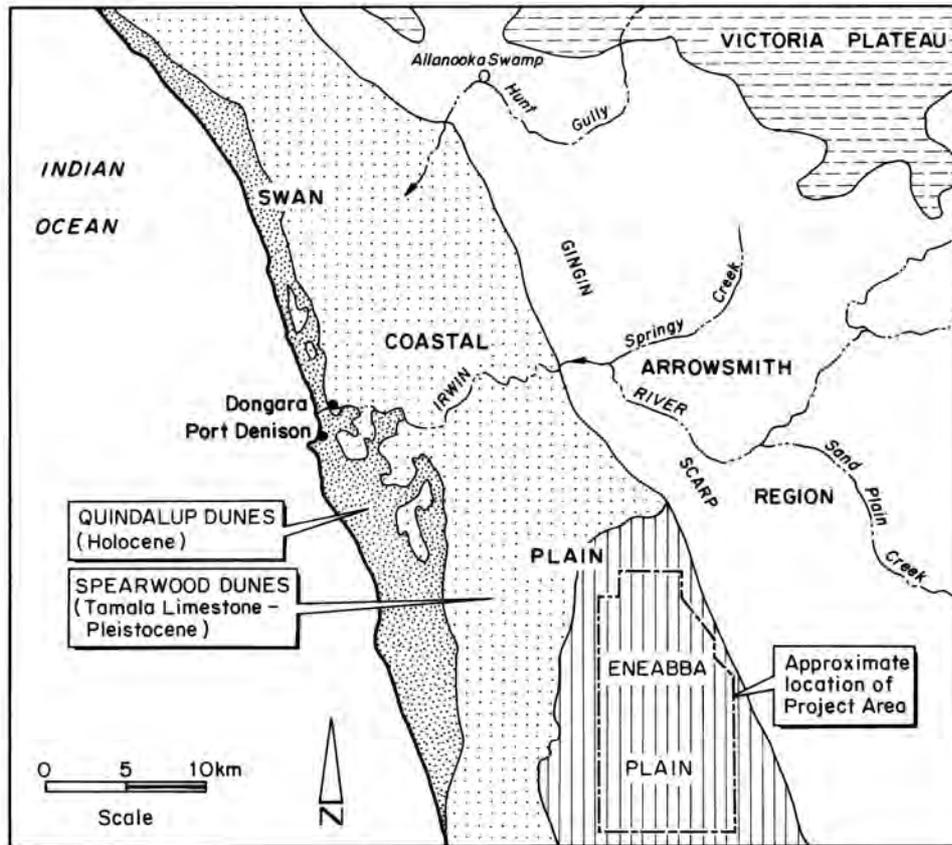
**Figure 1** Regional time-stratigraphic framework showing the location of the project area within the boundaries of the Eneabba Plain (modified from Mory, 1995)

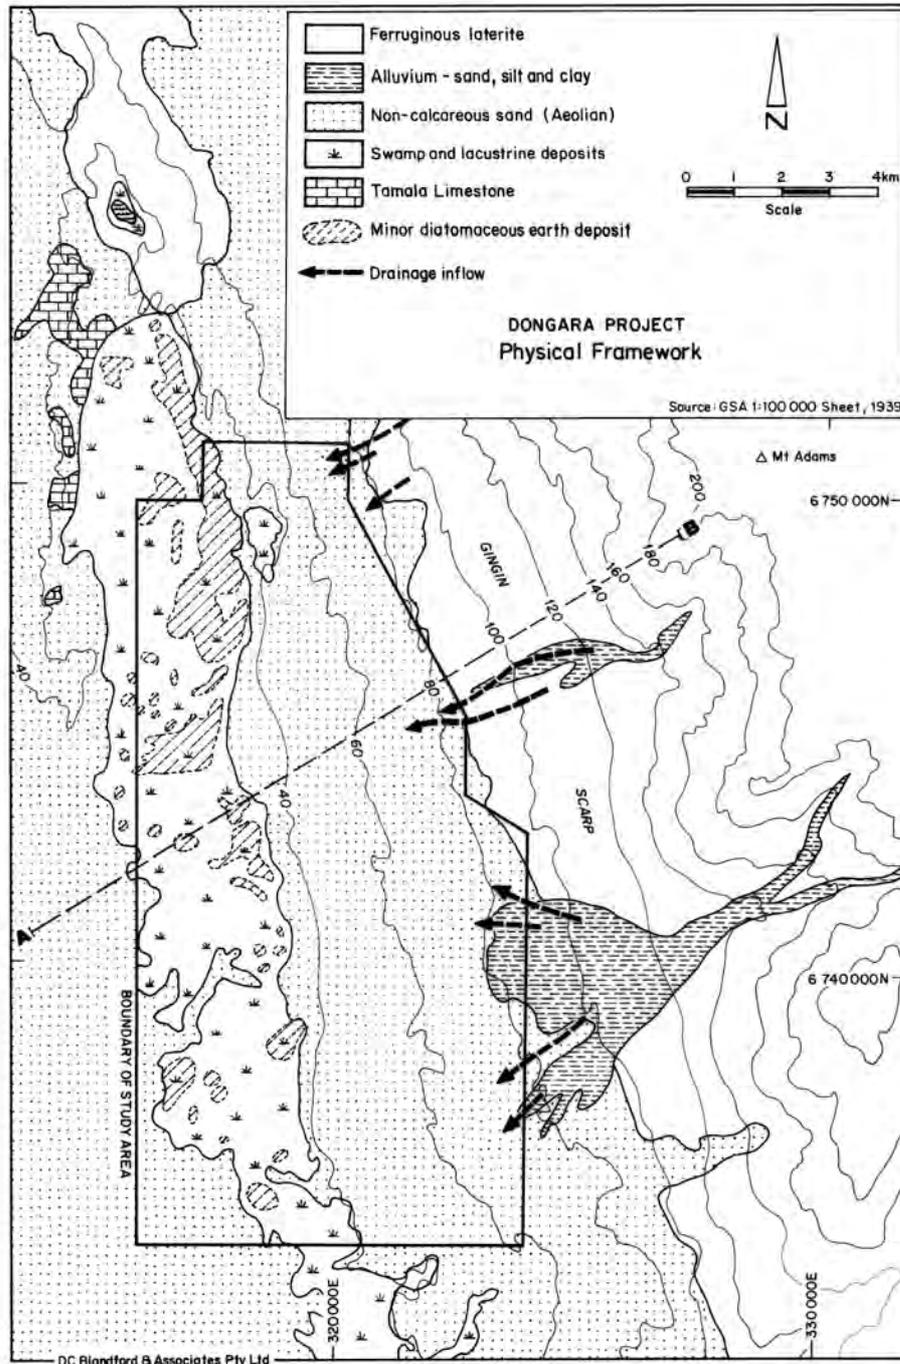
**Figure 2:** The physical framework of the Dongara project Area according to broad scale lithologic characteristics as defined by GSWA. The two major relict drainage systems are also evident. The directional drainage arrows have been added by the author (modified from Mory, 1995).

The physical framework of the project area, defined as surface lithology, is set out in Figure 2. The north-south axis of the area of investigation parallels the regional grain of the country, formed by two sub-parallel soil landscape systems. These are swamp and lacustrine deposits forming an irregular band running the full length of the area along the western side, and a larger area of non-calcareous sand over the remainder (Mory, 1995). The area is bounded on the east by the Gingin Scarp, which reaches its maximum elevation of 256m at Mt Adams. The Gingin Scarp which is characterised by a westerly facing slope of a generally uniform gradient and comprising sand over ferruginous laterite is the source area of a number of drainage systems that discharge onto the project area along its eastern boundary. The drainage systems present today are relicts of a larger palaeo drainage system that operated during much wetter periods, probably during the Pleistocene. These systems were modified by the onset of aridity, which resulted in an increase in sediment loads, and reduced periodicity of discharge events. Two major systems can be recognised, a smaller channel system entering the project area near the eastern end of Mount Adams road and a second, larger system that enters the project area south of the Tompkins Road – Mount Adams Road intersection. These systems are characterised by a series of outwash alluvial deposits. Neither of these contemporary drainage systems have continuous and well incised channels.

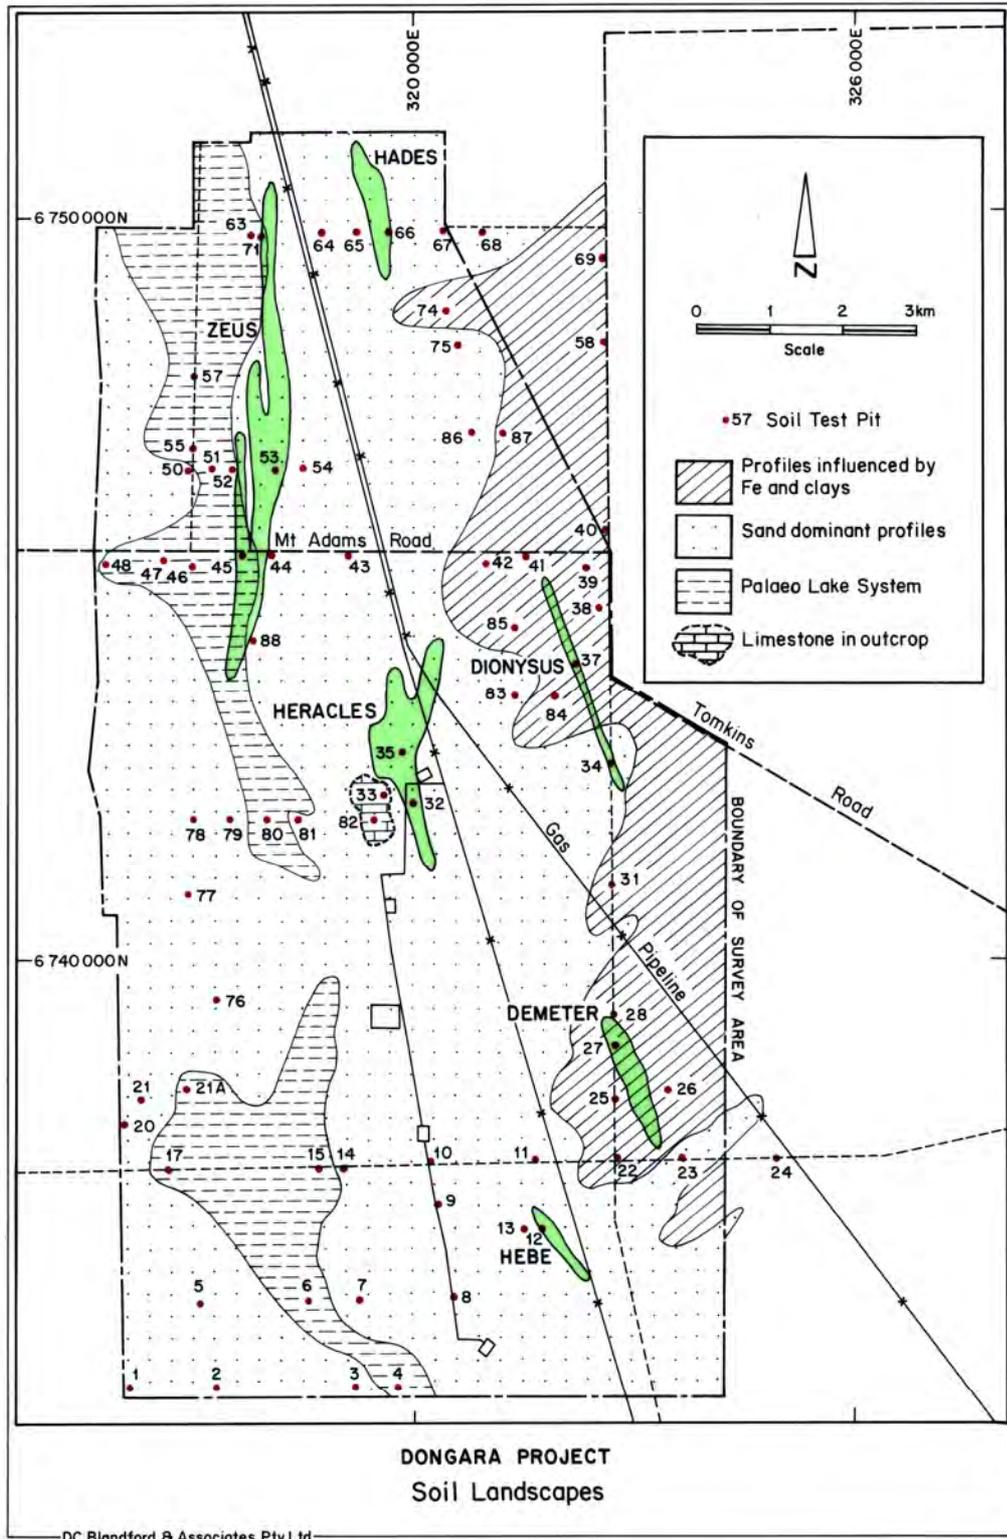
**Figure 3:** The soil landscapes of the Dongara project area.

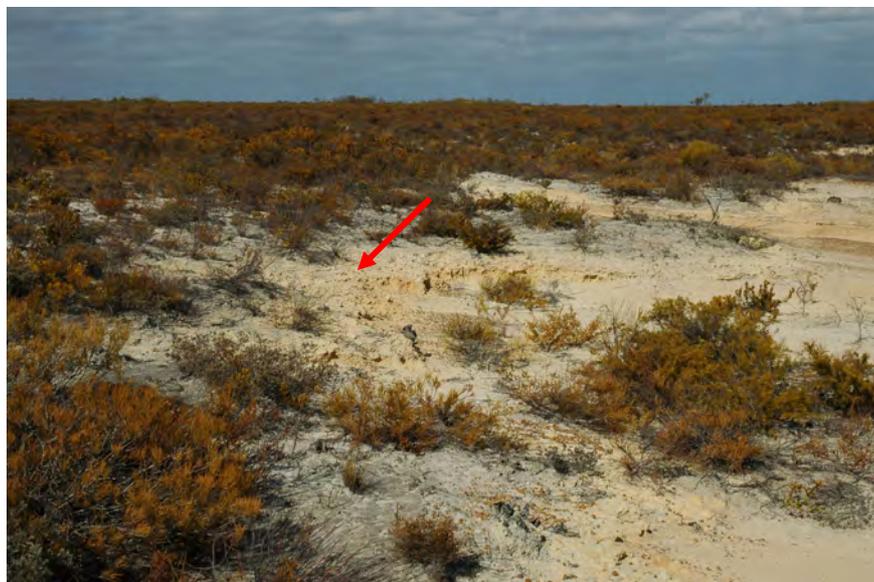
**Plate 3:** Truncated lateritic podsol soil at Site 39. The B horizon (arrowed) demonstrates spatially discrete dispersion.

The principal profile characteristics include duplex profiles, the presence of highly weathered to unweathered Ferricrete rubble, nodules, or pisolites, and profiles in which there is strong fabric development and elevated moisture retention. Typical profile characteristics of this landscape are given in Plates 1 to 3.

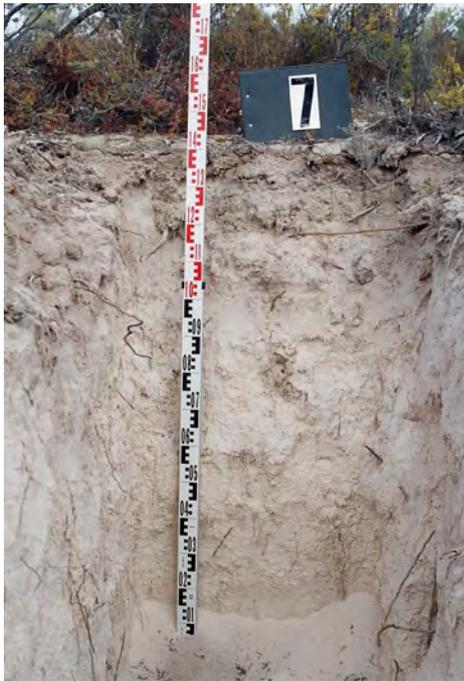
**Plate 4:** Deep white aeolian sand.

Many of the soil profiles developed within the sheet sands are characterised by a high degree of fabric development and induration. This level of material competence, which was demonstrated by non-collapse of profiles to depths exceeding 3m, is attributed, in part, to the greater age of the sediments at Dongara, relative to, say, the much younger sediments at Falcon and Cooljarloo. Characteristic soil profiles from this soil landscape are shown in Plates 4 to 7 and discussed further in Section 5.3.

The profiles shown in Plates 4 to 7 are typical of profiles in the central sand plain, and the reader is referred to Appendix I for additional photo coverage of soils in this landscape.

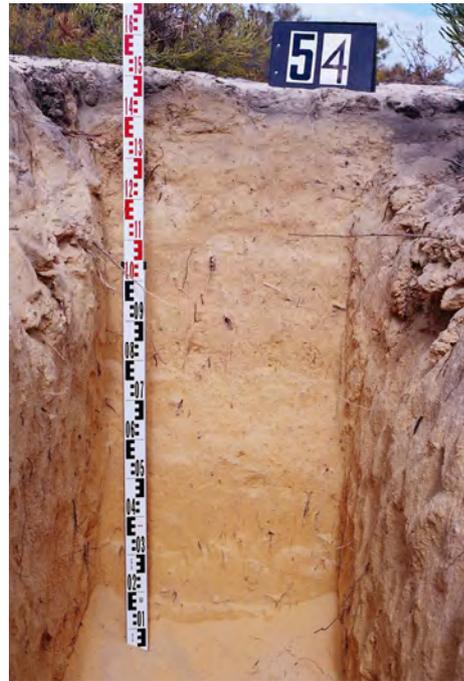
**Plate 5:** Deep fine to medium sand.

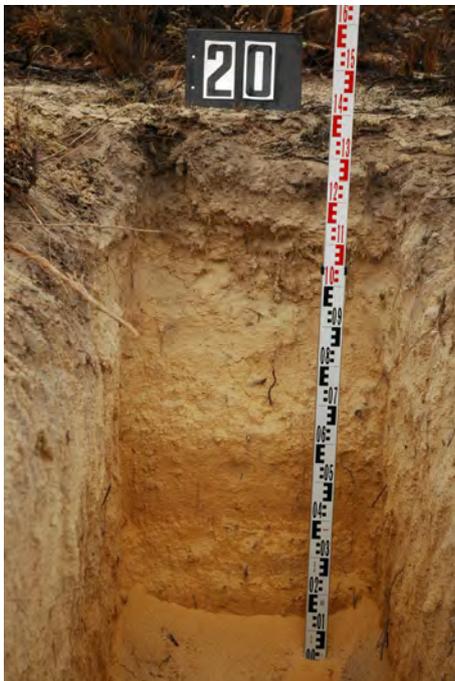
**Plate 6:** Deep aeolian sand.

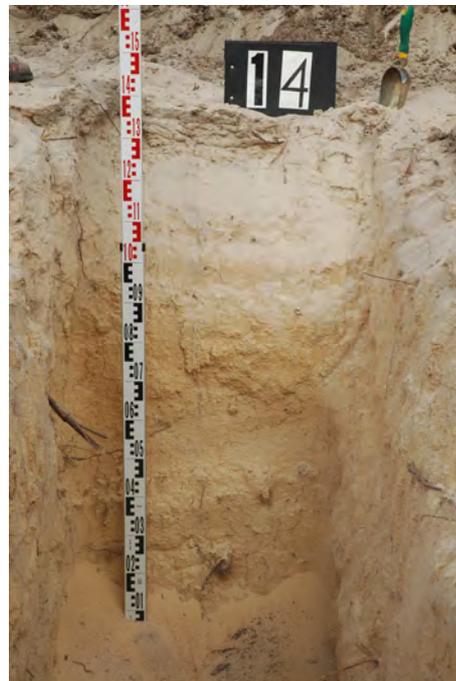
**Plate 7:** Fine-grained aeolian sand.

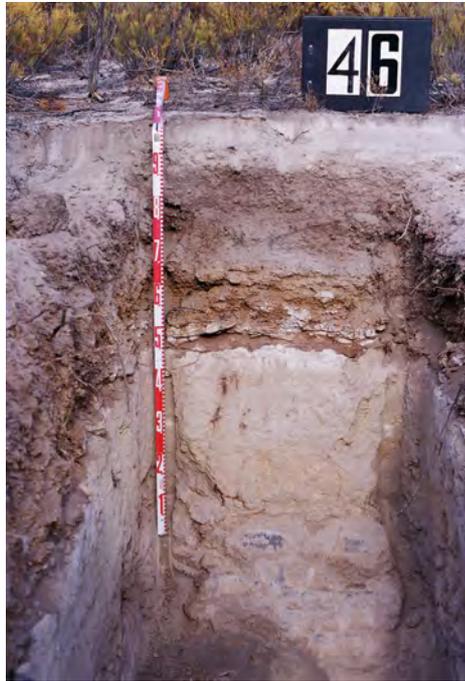
**Plate 8:**

Some profiles contain pedogenic silica as a key feature. Biogenic silica is also present at a number of sites where it may be inter-bedded or infused with calcium carbonate.

Typical characteristics of soil profiles within this landscape are shown in Plates 8 to 11.

Major profile characteristics are set out in Table 7 and Table 8, and the reader is referred to Plates 8 to 11 for typical profile stratigraphy.

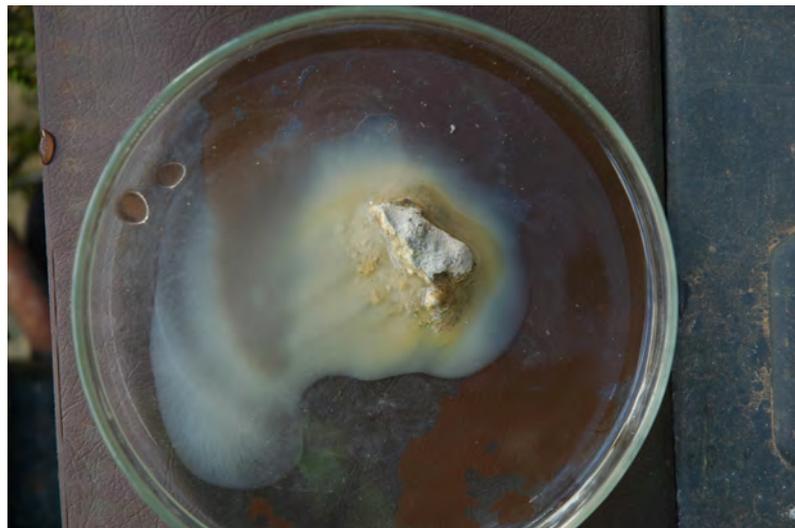
**Plate 12:** Typical dispersion characteristics from drill residue remaining at the surface, but the depth of this sediment is unknown. The response here shows an Ec 2(2).

An aggregate stability analysis was also carried out on drill residue left on the surface at a number of sites where the depth of origin of the drill residue was well below the depth excavated for the soil test pit. This material invariably demonstrated dispersion to some degree and both slaking and dispersion occurred within minutes of commencing the test. Typical dispersion characteristics are shown in Plate 12 below. The type and nature of the dispersion present indicates that current management practices for the control of dispersive soils can be adopted and implemented.

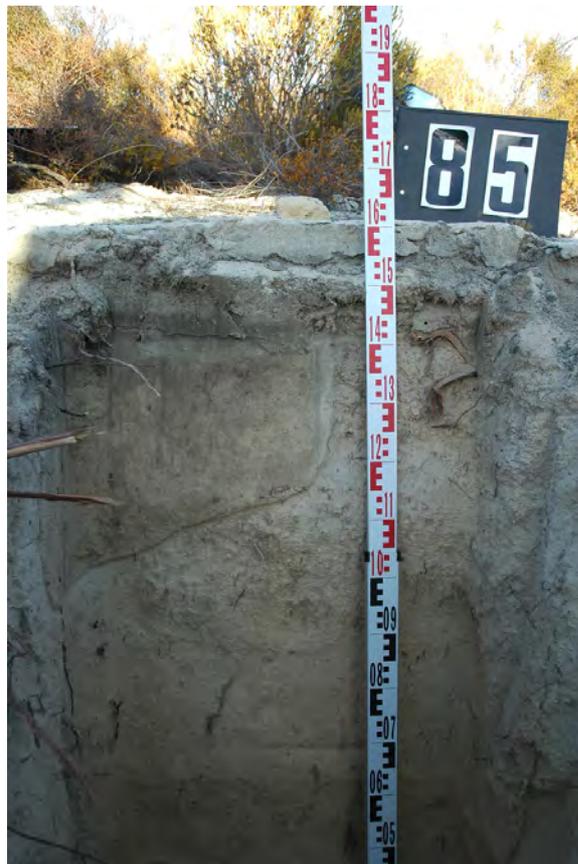
**Plate 13:** A lobe of wet soil exposed in the soil inspection pit at Site 85.

As a general rule, infiltration is not uniform as demonstrated by the upper profile at Site 85. This inspection pit, which was excavated approximately 12 hours after a brief rainfall event, clearly shows differential penetration of rainfall into the soil. The reasons for this are many and varied but hydrophobicity of surface sands will strongly influence penetration patterns, as will the presence of macro-porosity as well as micro textural differences and the effect this has on pore space connectivity. The spatially discrete penetration pattern shown in Plate 13 is significant in that the moisture content of the 'wet' soil on the left was 4% and that of the 'dry' soil on the right was 0.1% (both results presented as gravimetric moisture content). This is a very large discrepancy in soil moisture content and a satisfactory explanation may invoke the application of the percolation theory. It is possible that the 'wet' soil is hydrophilic and the 'dry' soil is hydrophobic. For such an argument to progress, it implies that the water repellent nature of the surface sands has penetrated the profile as indicated. Pursuing such detail was beyond the scope of this investigation

The water in the 'wet' lobe will not move into the dry lobe unless further significant rainfall is received. Conversely, evaporation will rapidly reduce the soil moisture content to that of the adjacent dry sand. Vegetation with roots penetrating the area of the wet soil will benefit from the increase in soil moisture availability, adding to the complexity of spatially discrete patches of non-stressed vegetation.

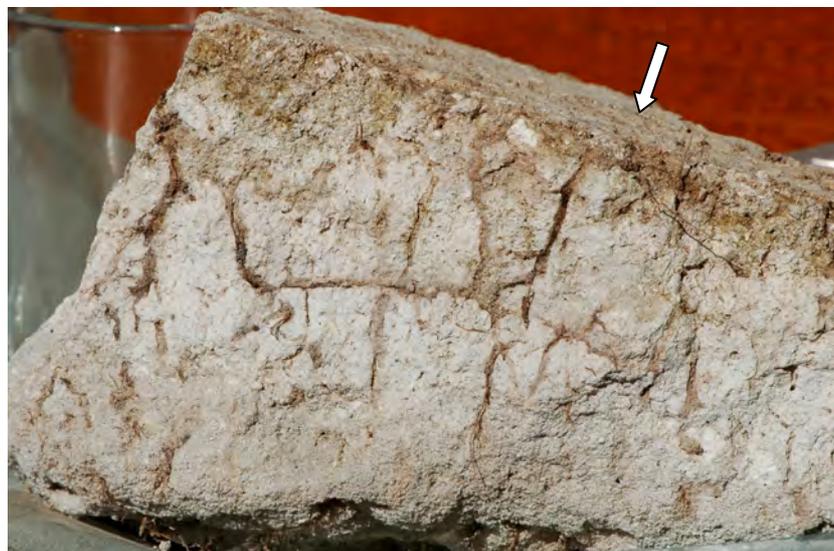
**Plate 14:** Pedogenic silica at Site 21A, 0.7m below the surface. The dark lines are roots and old root lines. The surface (arrowed) comprises secondary silica cementation.

The various profiles examined within the Western Relict Palaeo Lake Landscape tended to contain an admixture of macro forms in addition to partial silcrete *per se*. The mass of cemented pedogenic silica (Plate 14) is typical of macro-forms present.

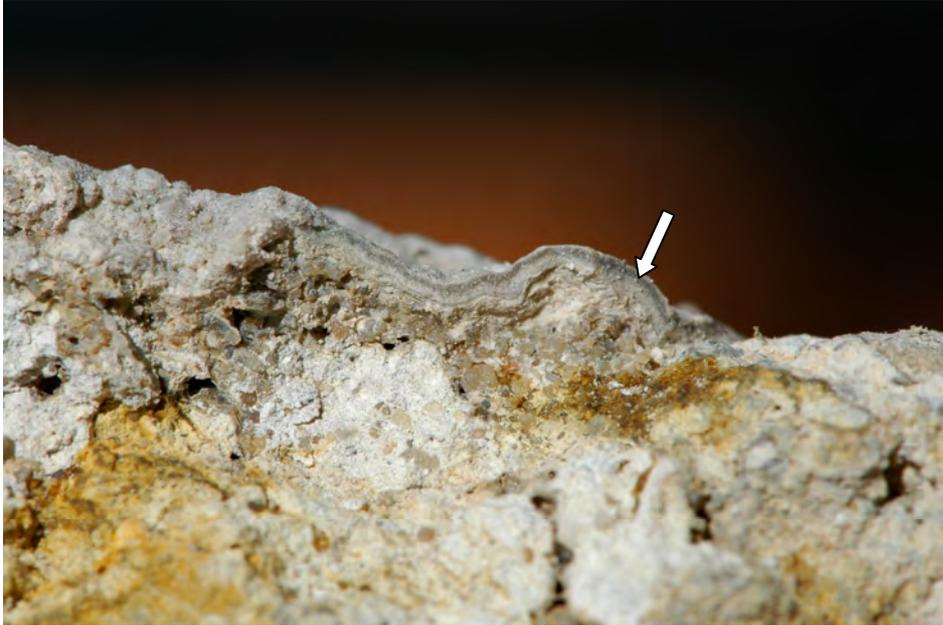
**Plate 15:** A competent and highly laminated secondary skin (micro capping structure) of precipitated silica (arrowed) forming a very hard thin surface layer over a (pseudo-breccia) silica mass.

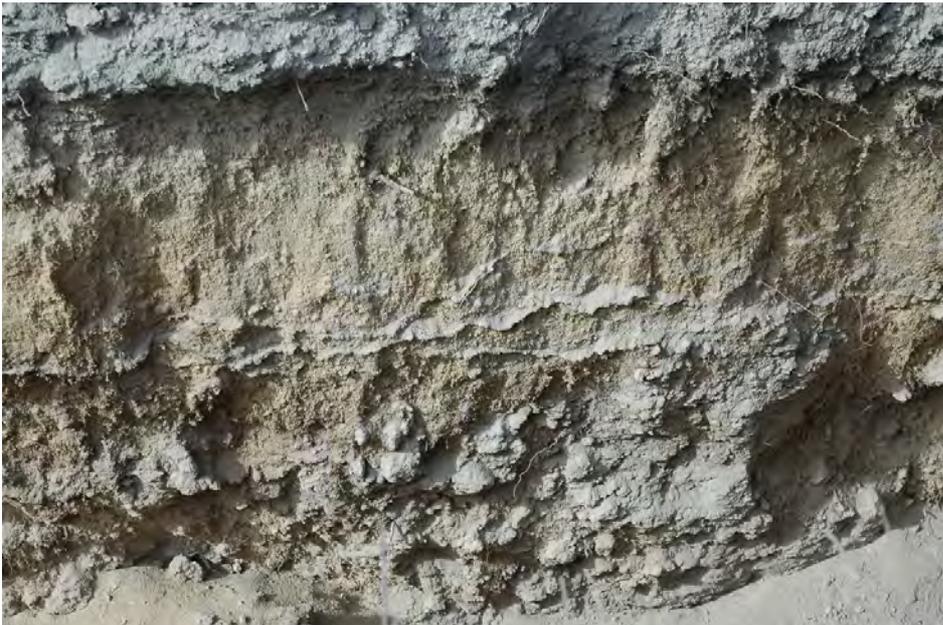
**Plate 16:** Globular to massive pedogenic silica towards the base of this profile with silica skins forming discrete thin platy structures below a granular to nodular silica horizon.

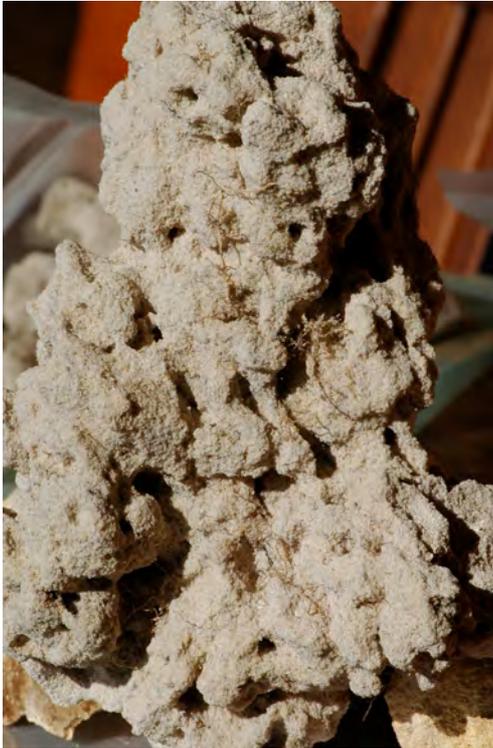
**Plate 17:** A large porous silica stalagmitic column from Site 15 with roots penetrating the very porous structure.

This latter material, which almost certainly derived its colour from Titania, can be readily mistaken for a crumb-structured clay loam but the silica aggregates simply break down to smaller aggregates under force. This makes any PSD analyses of this material meaningless as it would be possible to get a material of 100% clay (size). Silica columns (Plate 17) and silica stalagmites (Plate 18) are common features of many of the profiles examined.

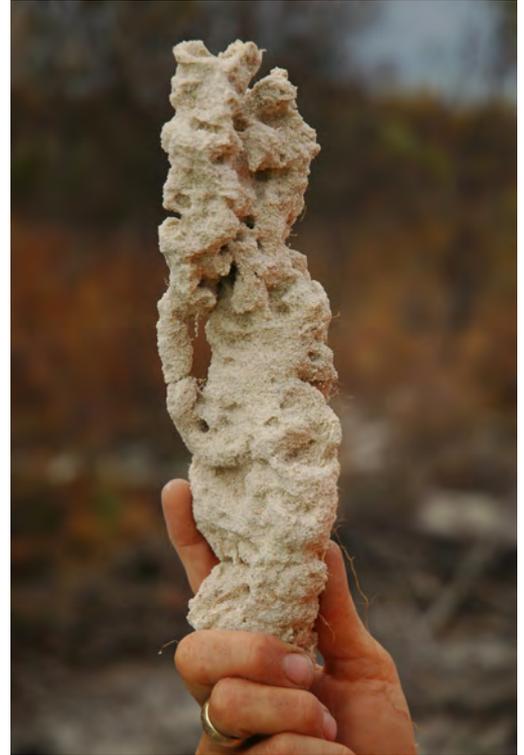
**Plate 18:** A competent silica stalagmite from Site 80.

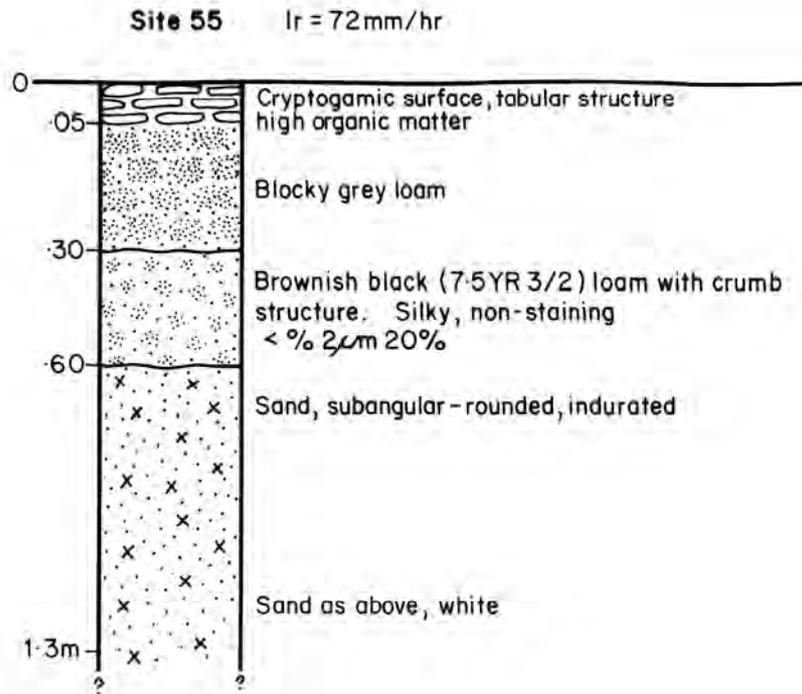
## SITE 55

**Note:** 0.05m to 0.6m is titanite stained crumb-structured (ped-sized), opaline pedogenic silica.

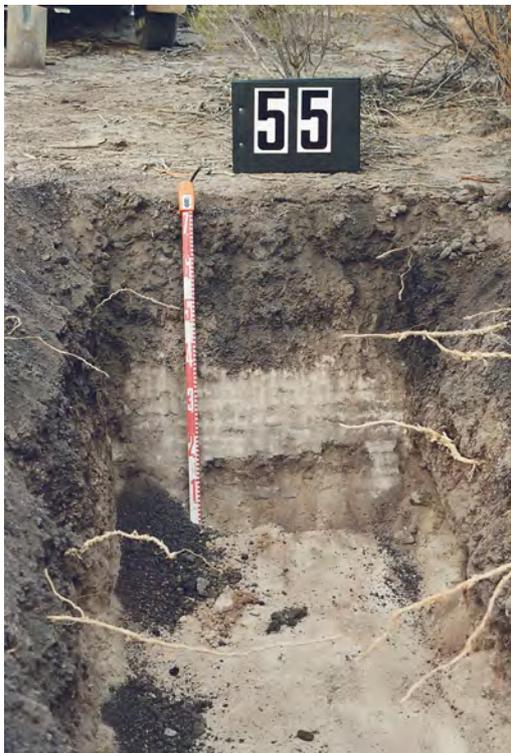
317022 E  
6746946 N

Thicket to 2.8m dominated by *Melaleuca huegelii* and *Acacia blakelyi* D55-1 (ID pending) over Open Low Scrub to 1.6m of *Banksia leptophylla*. There is 70% Cryptogam cover on the soil surface at the site.

Severe drought stress is evident at the site, with 70 to 95% deaths of the vegetation occurring.

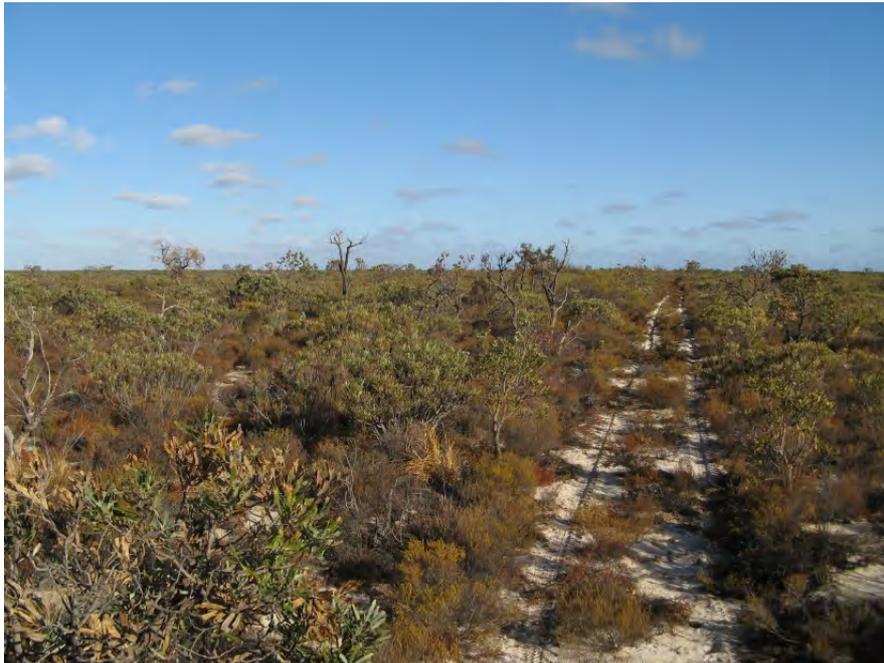
## BETWEEN SITE 77 and 78

Between soil pit sites 77 and 78 (at 316946 East and 6741303 North) there is an interdunal depression (60 x 100 m), with a Heath vegetation structure and iron staining at the soil surface. North of this depression is a widespread area of stressed vegetation.

All the *Eucalyptus tottiana* trees have died back with a few trees regenerating from epicormic buds at the base (coppice growth). *Nuytsia floribunda* and *Banksia menziesii* trees are also affected. The understorey vegetation is severely stressed and the sedge plant *Lomandra hastilis* that normally grows in the shelter of mallee-form *Eucalyptus tottiana* trees are now growing in isolated patches. Repeated fires, as well as drought stress over time is changing this Very Open Woodland into a Heath.

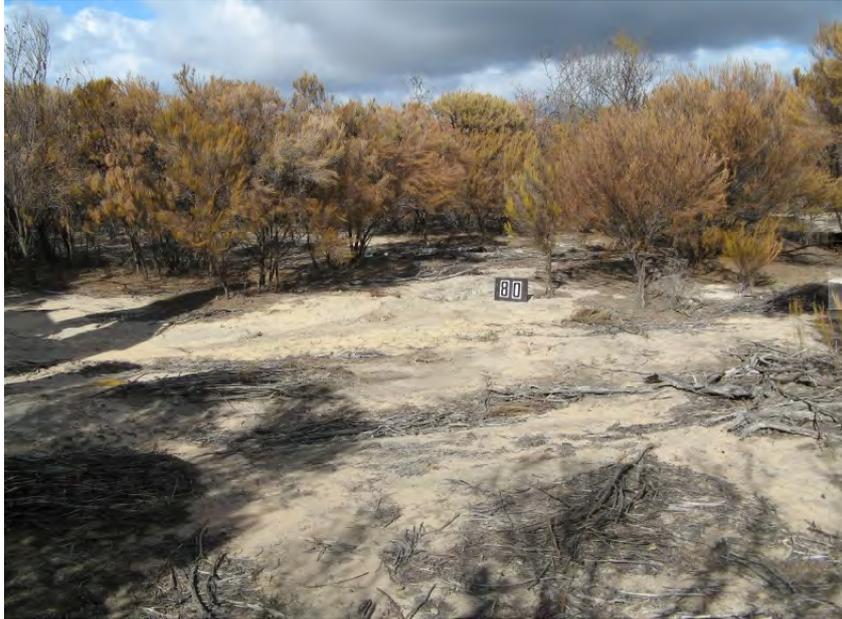
## SITE 80 (Continued)

Vegetation structure in this community varies from 40% vegetation cover over 50% litter cover and 10% bare ground to 90% vegetation cover over 100% litter cover. There is no small shrub or sedge layer here, which may indicate that the soils are inhospitable to shallow root systems, with little soil water availability to plants at the surface. Ground surface is very uneven with sinkholes where soil is collapsing inwards. Dry low density, grey friable soil, is present on the surface. Vegetation is exhibiting a severe drought stress response with 99% chlorosis and 70 to 95% death of vegetation at the site.

The soil pit is ~30 m east of a vegetation change boundary to a 1.6 m Heath of *Banksia attenuata* with very stressed scattered *Banksia menziesii* trees to 3.5 m. The Priority 4 species, *Banksia elegans* grows in higher numbers on the track edges and in the vegetation from ~200 m and continues east.

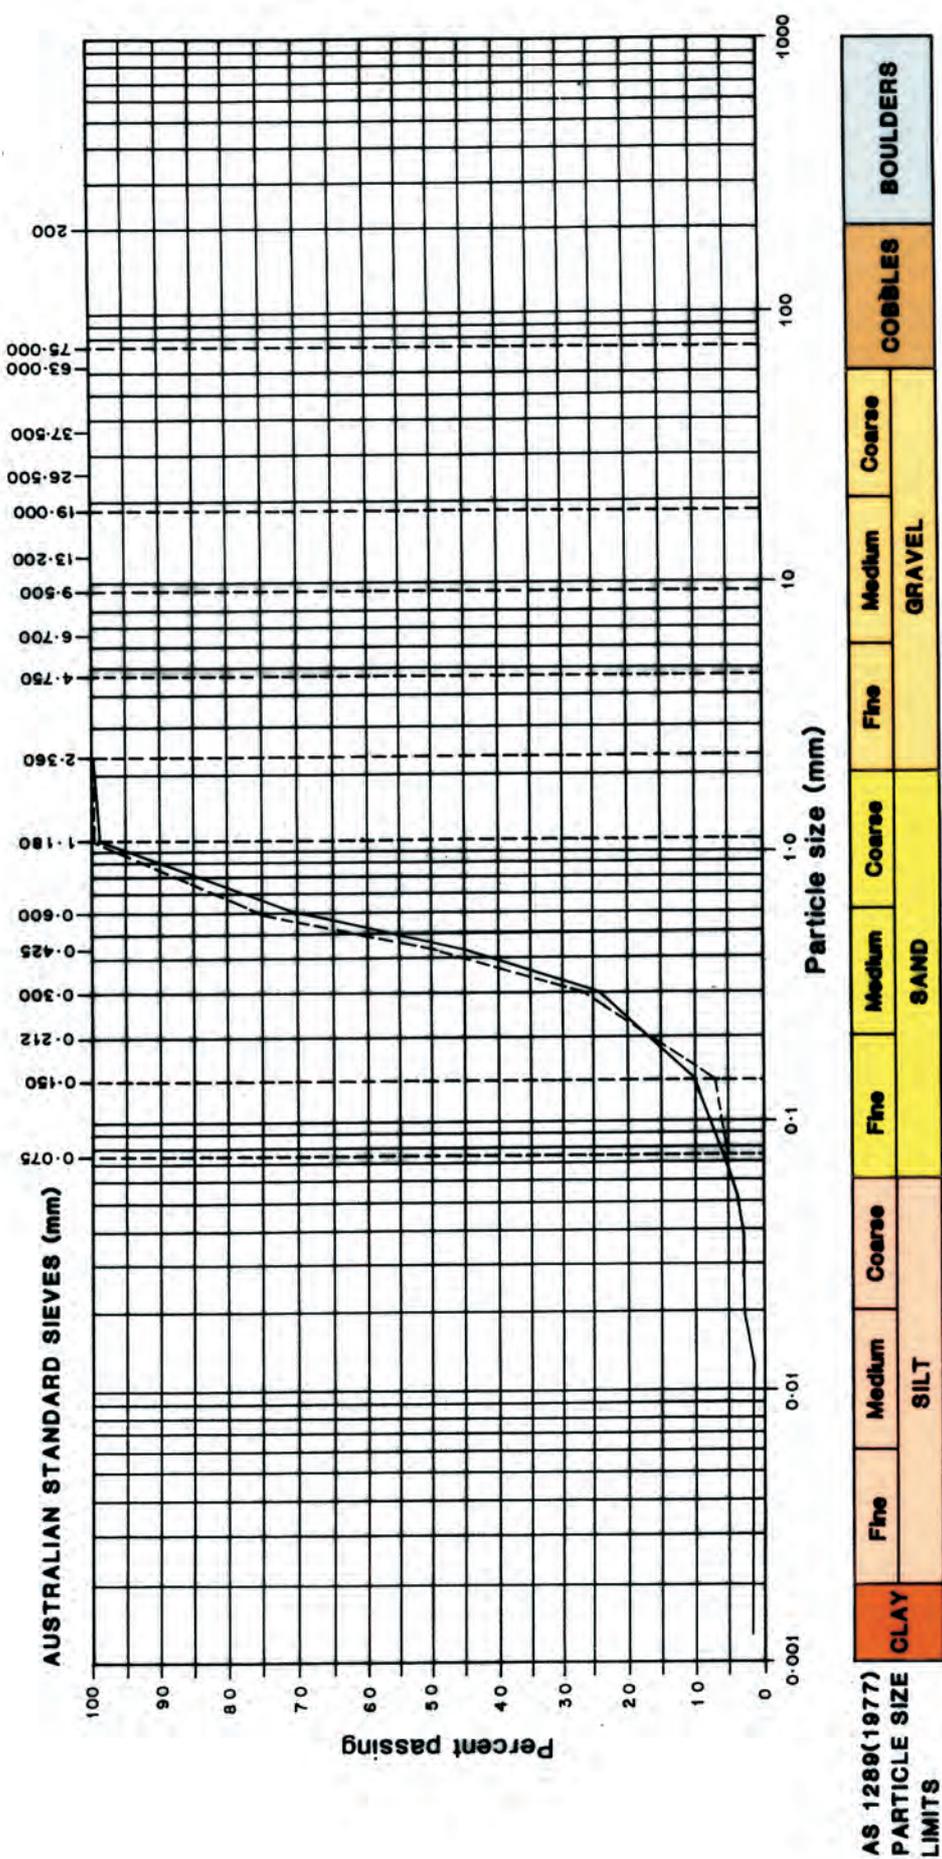
Site 17

**Particle Size Distribution**

17A - depth 100mm —————  
 17B - depth 500mm - - - - -

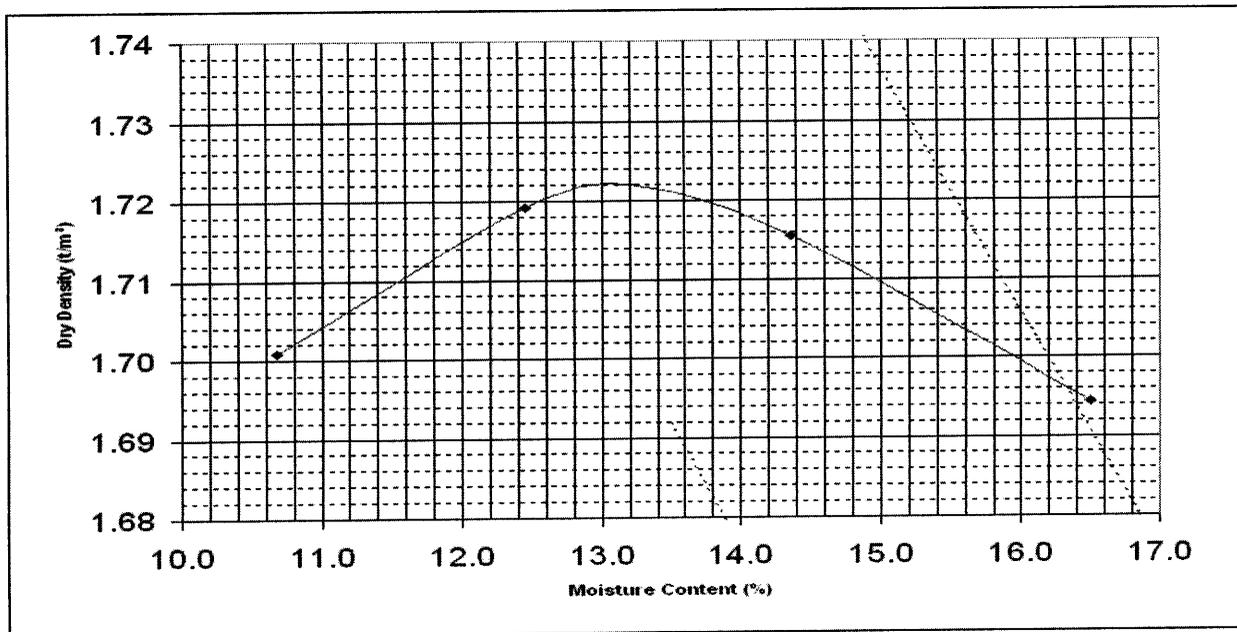
AS 1289.5.2.1

Modified Effort	
<b>Maximum Dry Density (t/m<sup>3</sup>)</b>	<b>1.72</b>
<b>Optimum Moisture Content (%)</b>	<b>13.0</b>
% Retained 19.0mm	0
% Retained 37.5mm	0

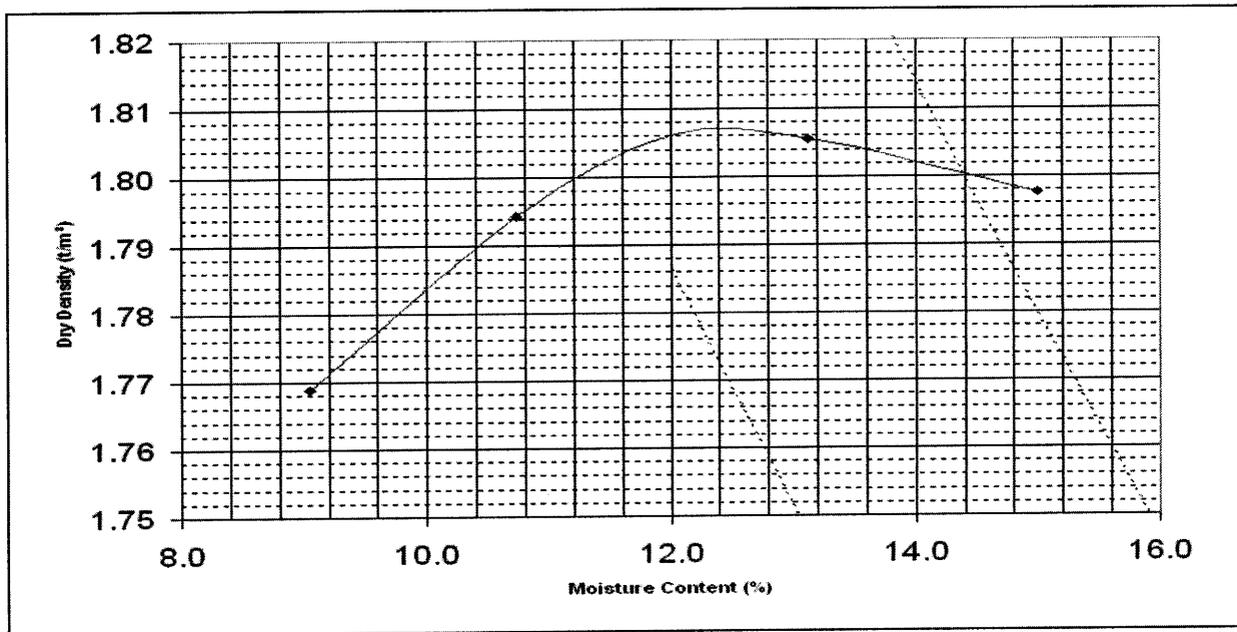
AS 1289.5.2.1

Modified Effort	
<b>Maximum Dry Density (t/m<sup>3</sup>)</b>	<b>1.81</b>
<b>Optimum Moisture Content (%)</b>	<b>12.5</b>
% Retained 19.0mm	0
% Retained 37.5mm	0

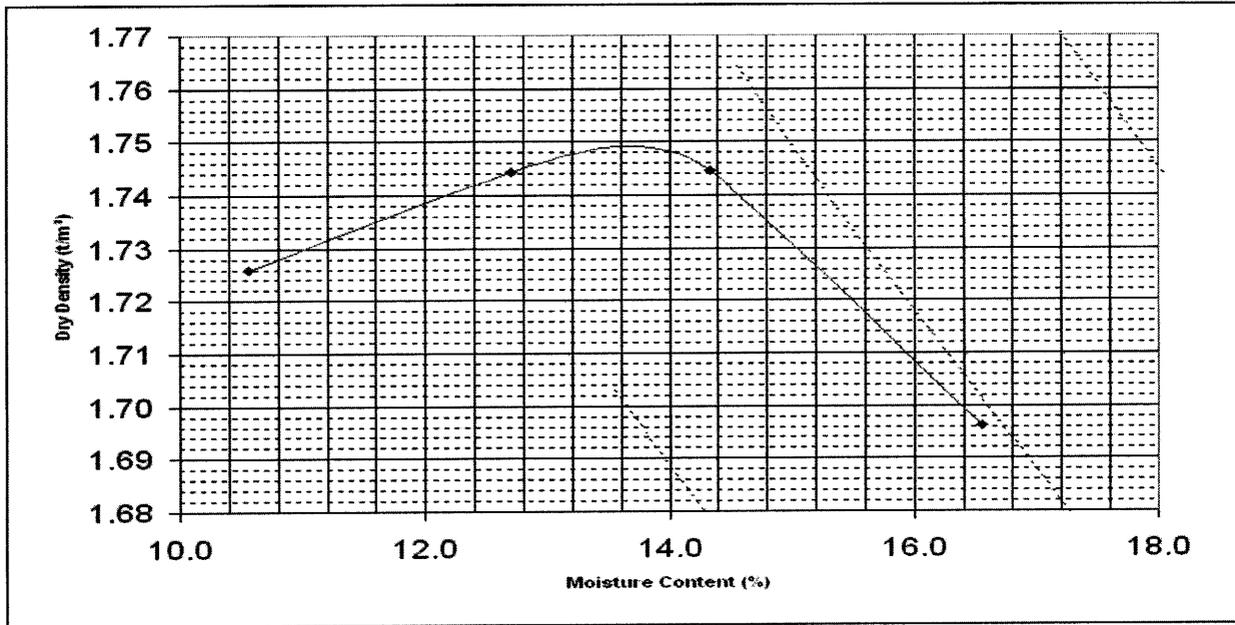
AS 1289.5.2.1

Modified Effort	
<b>Maximum Dry Density (t/m<sup>3</sup>)</b>	<b>1.75</b>
<b>Optimum Moisture Content (%)</b>	<b>13.5</b>
% Retained 19.0mm	0
% Retained 37.5mm	0

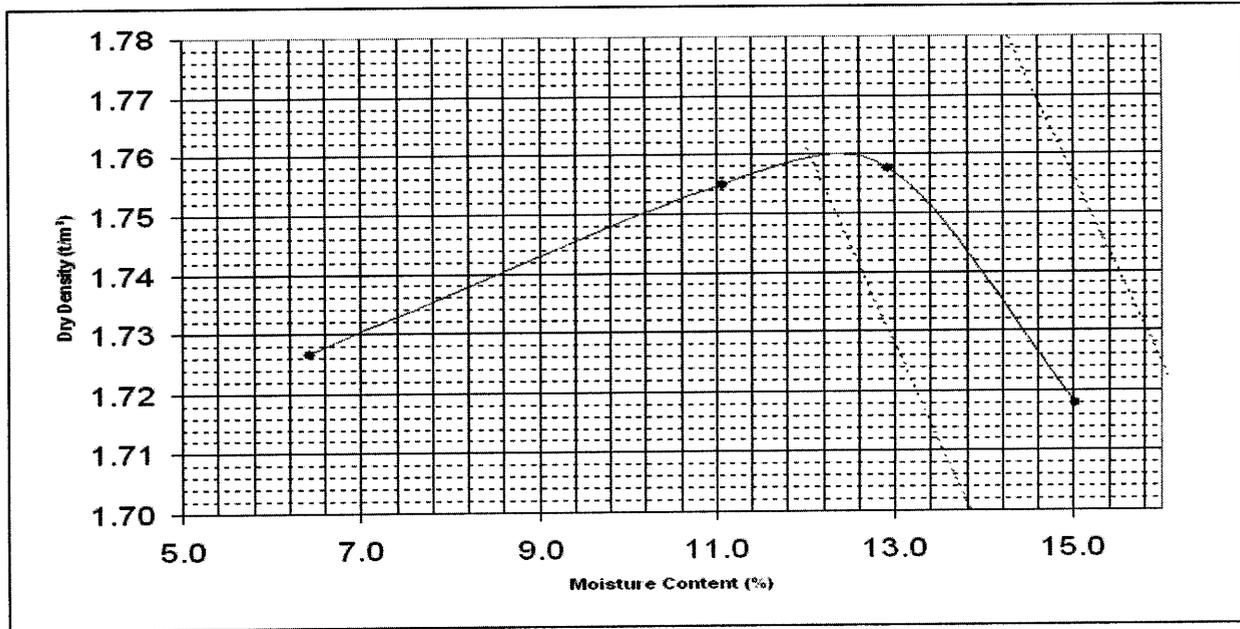
AS 1289.5.2.1

Modified Effort	
<b>Maximum Dry Density (t/m<sup>3</sup>)</b>	<b>1.76</b>
<b>Optimum Moisture Content (%)</b>	<b>12.5</b>
% Retained 19.0mm	0
% Retained 37.5mm	0

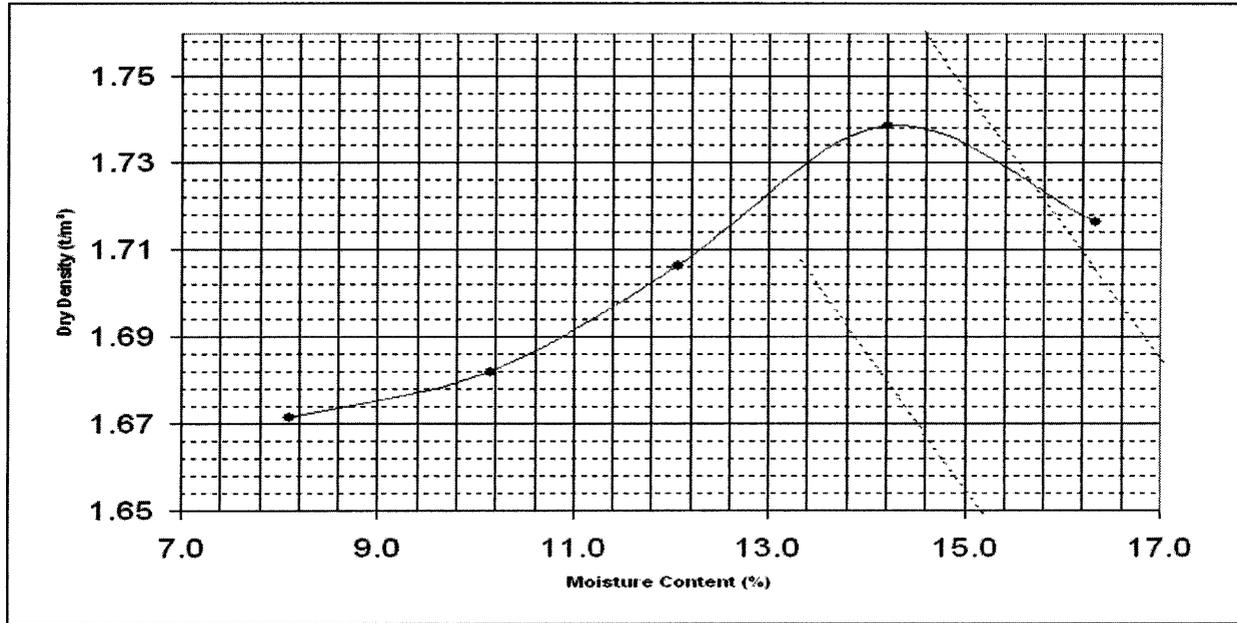
AS 1289.5.2.1

Modified Effort	
<b>Maximum Dry Density (t/m<sup>3</sup>)</b>	<b>1.74</b>
<b>Optimum Moisture Content (%)</b>	<b>14.5</b>
% Retained 19.0mm	0
% Retained 37.5mm	0
