**SOILS INVESTIGATIONS OF THE  
DONGARA PROJECT AREA**

**STAGE 2**

**Tiwest Pty Ltd**

**D.C.Blandford & Associates Pty Ltd**

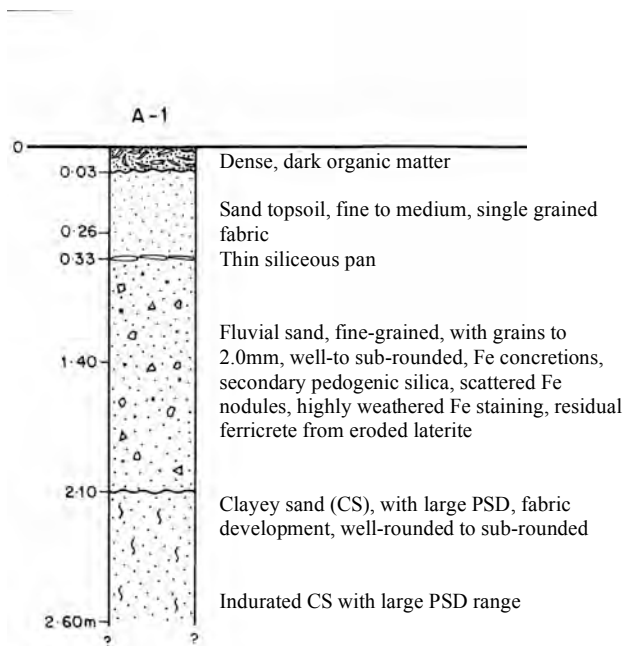
The sub-soil material at 2.6m demonstrated post compaction deflocculation with field indications of Class 3(2)

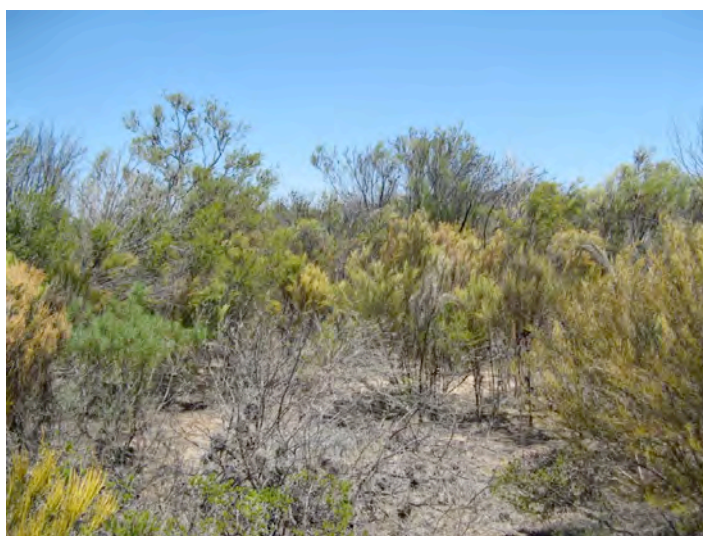
Drought stress within T2 vegetation at site A-3.  
(Photo and caption: A Harris)

Thicket to 2.5m dominated by *Allocasuarina campestris* over Low Scrub to 1.7m dominated by *Melaleuca systema* on a 1% slope within a low-lying area. A 2-10% surface coverage of cryptogams was recorded and surface water ponding was evident. The vegetation was exhibiting signs of drought stress with 30-70% of foliar cover recorded as dead or chlorotic. The most affected species were *Allocasuarina campestris* and *Banksia leptophylla* var. *melletica*. The site is within the vegetation community mapped by WEC as T2 and also matches the description.

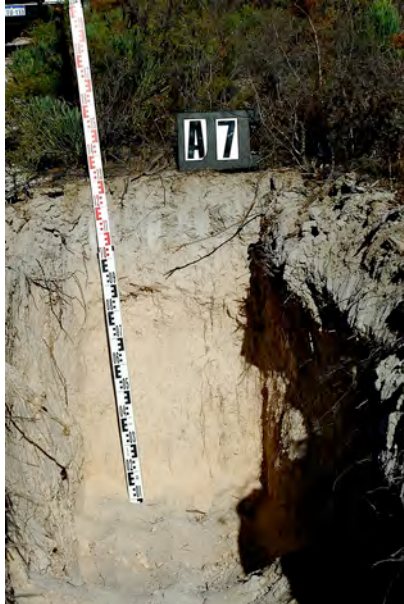
## SITE A-7

The topsoil at this site demonstrates post compaction deflocculation, with a field indication of Class 3(2).

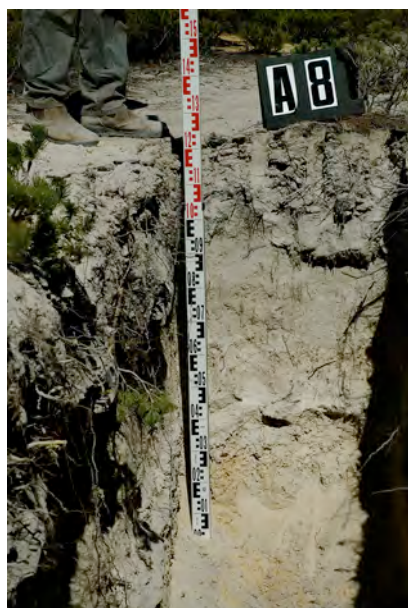
## SITE A-8

The surface material at this site demonstrated post compaction deflocculation with an indicated field class of 3(2)

Biogenic silica was present as a surface material at two of these sites, A-8, and A-11. It is suggested that minute amounts of clay were present as it was possible to get a 'ribbon' up to 5mm long when the material was sheared at field moisture capacity. Further, organic matter present in the sediment may have contained enough electrical charge to attract  $\text{Na}^+$  ions, resulting in dispersion. Site A-7 where the surface material was sand, also demonstrated PCD with an aggregate stability class of 3(1). This surface material appeared to be very low in clay but high in organic matter. The dispersion present at this site is shown in Plate 1.

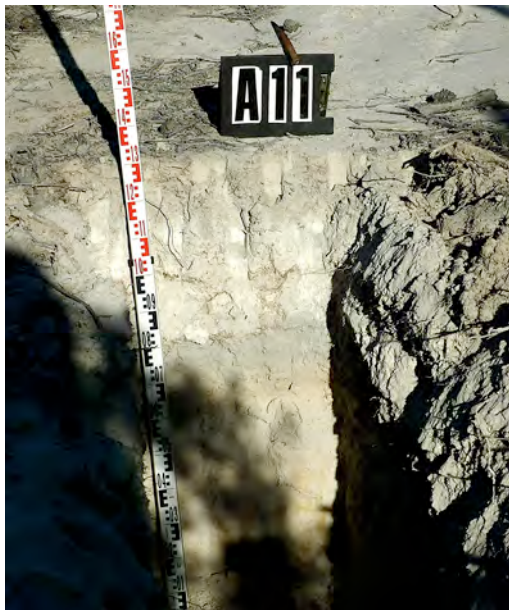
## SITE A-11

The surface material demonstrated post compaction deflocculation with a demonstrated field class of 3(1).  
Surface infiltration rate was 120 -180mm/h

The surface horizon at this site (biogenic silica combined with wind-blown dust) has similar characteristics to a low clay content soil material, with regard to water penetration. The pH level of 5.5 indicates moderately acid soils. The surface infiltration rate was measured at 120 to 180mm/hr. The dominant impact on surface conditions is the presence of an impeding layer at 0.2m below the surface.

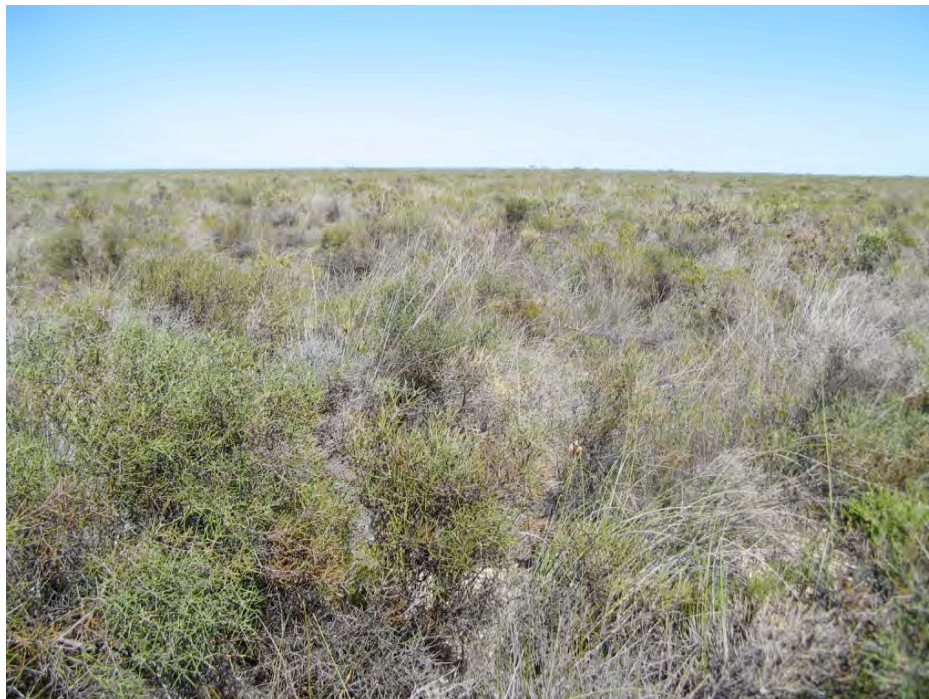
Vegetation typical of an H3 community (A. Harris: photo and caption)

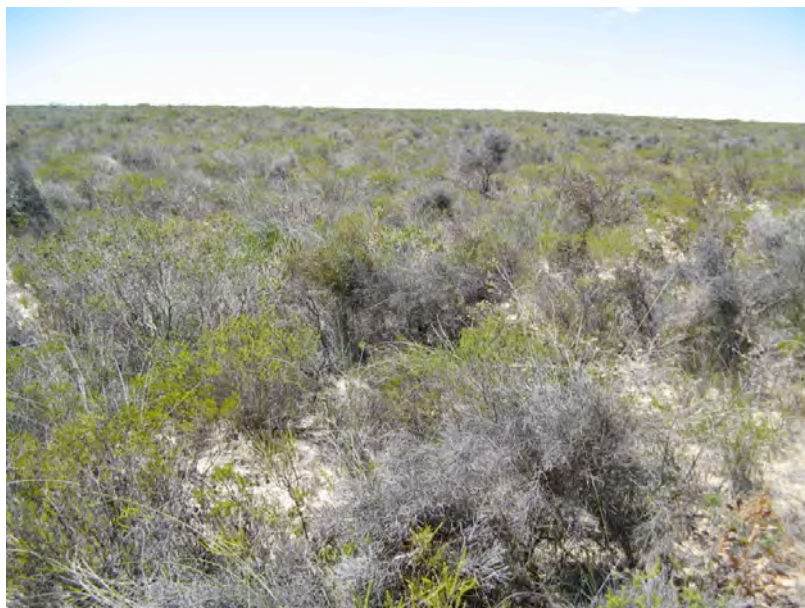
Vegetation of H3 showing drought stress (Photo and caption A. Harris).

Low Scrub to 1.1m of *Hakea polyanthema* P3 and *Eremaea beaufortioides* var. *microphylla* over Dwarf Scrub to 0.5m dominated by *Melaleuca leuropoma* over Very Open Tall Sedges to 0.6m dominated by *Ecdeiocolea monostachya* on a 2% slope within gently undulating terrain. Scattered *Banksia candolleana* occurs in the area. The Priority 3 species, *Isopogon tridens* occurs at the site. The vegetation was exhibiting signs of drought stress with 10-30% plant deaths recorded. The most affected species were *Hakea polyanthema*, and *Petrophile macrostachya*. Vegetation in the area is still regenerating from a fire <3yrs ago and the recent drought stress is now affecting it. The structure of the community will become a Heath over time with adequate rainfall.

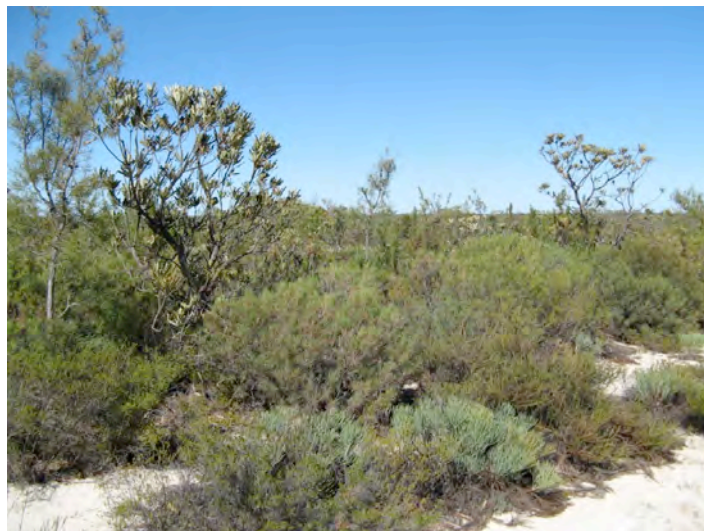
Vegetation within the W7 community (Photo and caption A.Harris)

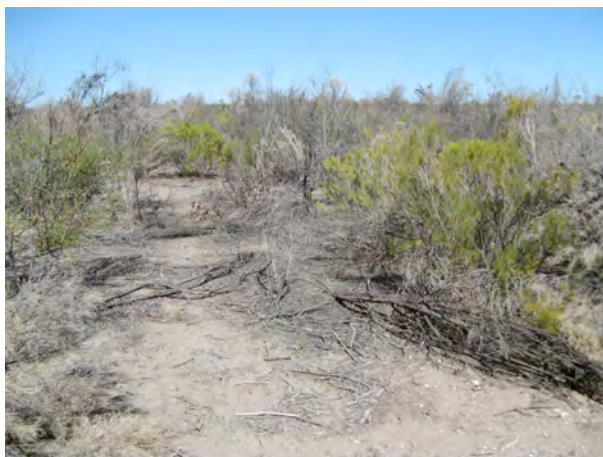
Vegetation within the T2 community showing severe drought stress.  
(Photo and caption: A Harris)

Open Scrub to 2.3m of *Allocasuarina campestris* over Low Scrub to 1.8m dominated by *Acacia rostellifera* and *Banksia leptophylla* var. *melletica* on a flat surface within a broad circular depression. The depression has steep edge slopes of 11%. The vegetation was exhibiting signs of severe drought stress with 30-70% of foliar cover recorded as dead. Between 80-100% of foliage on all dominant species was affected. Of note, is that all of the plants of the less dominant species, *Calothamnus quadrifidus* remained healthy. The site is within the vegetation community mapped by WEC as T2. Due to the severity of stress symptoms, the vegetation structure at this site has been altered from a Thicket to an Open Scrub over Low Scrub. The species description still matches that of the WEC community T2.

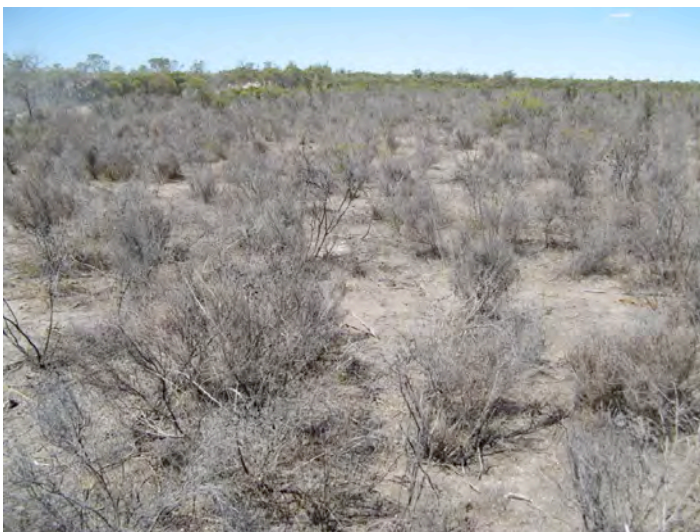
Vegetation showing severe symptoms of drought stress within an H1 community.  
(Photo and caption: A Harris)

The vegetation was exhibiting signs of severe drought stress with 30-70% of foliar cover recorded as dead. The most affected species were *Acacia scirpifolia*, *Melaleuca systema* and *Desmocladius asper*. Both *Calothamnus* species did not show stress symptoms. The site is within the vegetation community mapped by WEC as H1 (on the border of W6). The local vegetation structure in part matches the description of H1; however the dominant species are those of H4. The loss of foliar cover has altered the vegetation structure to that of a Scrub over Low Scrub rather than a Heath.
