Site visit report

From	Fanie Wessels
Department	D3 Assurance and Systems
To	Melinda Brand; Fiona Bell
CC	Ed Clarke, Alex Walter, Iain Daggers
Reviewed By	Iain Daggers
Reference	SVR_RVO_Mesa H Environmental sites Assessments
Date	19 October 2017

Geotechnical assessments – Potential diurnal Ghost Bat roost complexes at Robe Valley

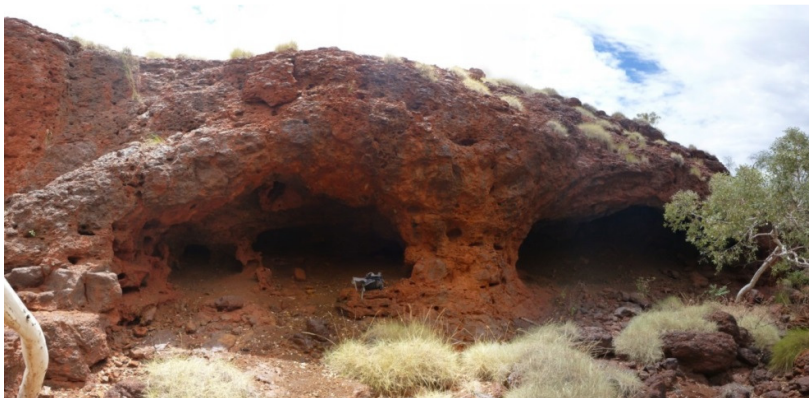
Figure 3: General view of Astron Cave 1

Astron Cave 1 is a large (20 W x 3.5 H x 12 m D) cave developed in hydrated hardcap. There are three different entrances and two pillars. The roof is dome shaped. The floor is sloped towards the entrances and is covered in sediment and some historical rock falls. There is relic bedding which is tight, short, undulating and rough. There are no major joint sets in the cave. There are smaller random discontinuities throughout which are short and tight. Some roof slabs have developed along bedding planes and there are signs of spalling on the roof and walls of the cave. The pillar to the north appears sound with no defects. The south pillar has bedding and some random defects throughout with cracks opening up. The brow appears stable, with some minor spalling. There is a moderate rock fall potential at this site. The likelihood of a structural instability of the cave is rated as low.

Based on the absence of large continuous structures that could lead to collapse of the cave the geotechnical sensitivity of this site is rated as low.

The recommended PPV threshold is 50mm/s.

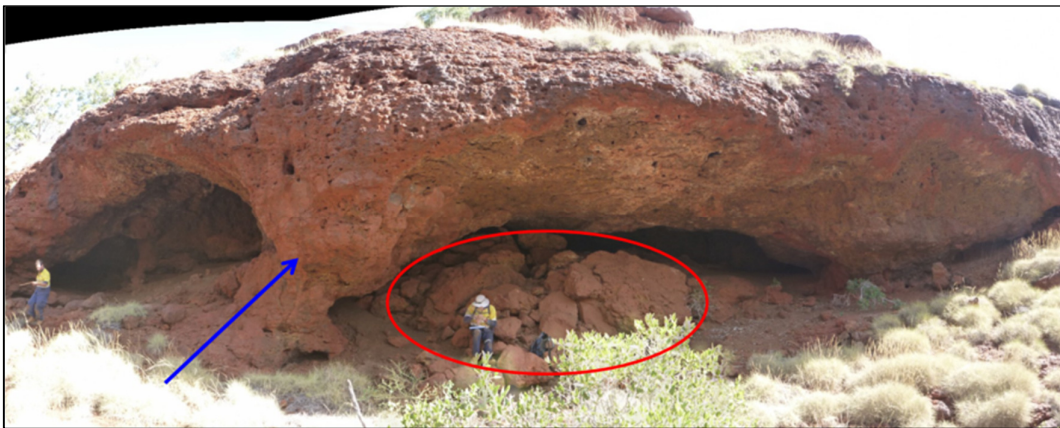
The site is a large (8 W x 4 H x 8 m D), wide cave developed in hydrated hardcap pisolite. It has a dome shaped roof, with a floor that inclines towards the rear with a large hump in the middle from historical rock falls, varying in size from medium to very large. These historical rock falls also partially obstruct the cave entrance. There is a secondary cavern at the western side of the cave and widely spaced relic bedding that disappears towards the rear of the cave where the structure becomes more massive. There is minor discontinuities near the entrance, however these are short and are not visible towards the rear of the cave. There is minor spalling around the centre pillar of the entrance, with potential for some smaller slabs to fail. These failures would not block the cave entrance. The roof and walls are stable inside the cave. The brow is stable with no signs of spalling or loose rocks above the brow. However the roof is a long unsupported span which increases the risk of failure. There is a moderate potential of rock fall in this cave but the likelihood of overall instability is rated as low.

The absence of large scale structures and low likelihood of overall instability results in a low geotechnical sensitivity rating of overall instability. The geotechnical sensitivity to rockfalls is also rated as low..

Figure 4: General view (MH16_31) Blue arrow indicates central pillar; red oval is historical rock falls.

The recommended PPV threshold is 50mm/s.

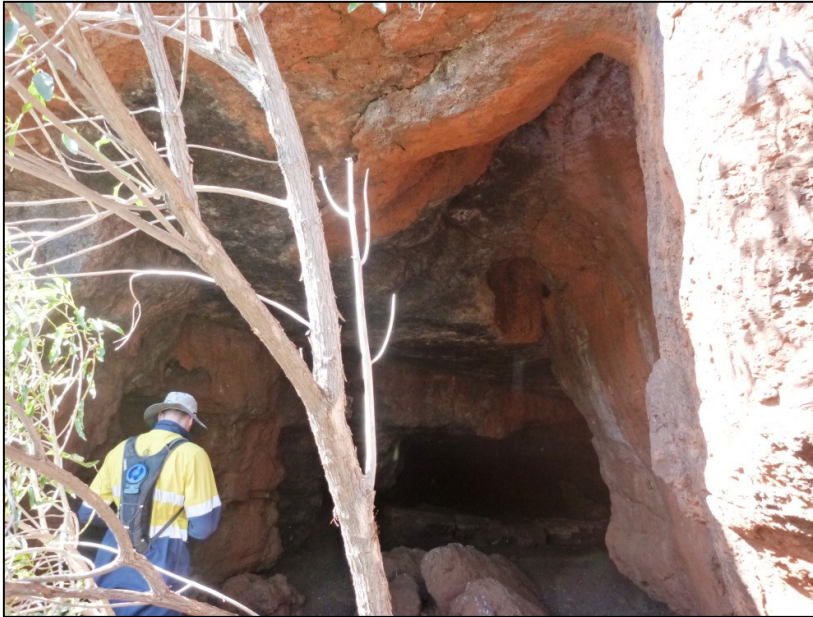
Figure 5 Entrance to Astron Cave 4.

Astron 4 is a large (7 W x 3.5 H x 25 m D), deep cave developed in hydrated hardcap pisolite. The cave is square shaped, with a flat roof controlled by relic bedding. There are large historical rock falls on the floor. The main structures in the cave are relic bedding planes spaced ± 1 m, tight, cemented and persistent through the whole cave. The floor rises towards the rear of the cave where the internal height is around 1.5 m. There are a number of additional random joint sets all widely spaced which are vertical to sub-vertical dipping which define side walls of the cave. The main structural concerns are the well-defined large blocks in the roof, similar to the historical rock falls on the floor of the cave. There is a moderate potential for rockfall in this cave. Due to the tabular shape and size of these rocks, it is not expected to impact on cave entrance, in the event of a rock fall. No large scale instabilities are expected.

The sensitivity for overall structural collapse is rated as low. Due to the large blocks in the roof which have potential to fall as well as historical rock fall evidence, the geotechnical rock fall sensitivity of the site is rated as medium.

The environmental PPV threshold of 50mm/s should apply to this location.

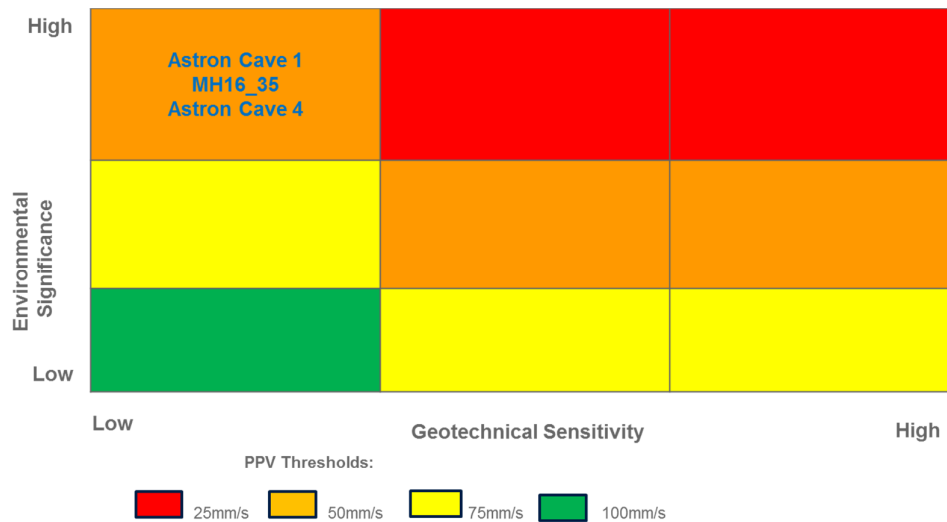
The recommended blast vibration thresholds are based on a combination of the environmental significance and the geotechnical sensitivity. The results are summarised in Table 2 and Figure 6. All the sites assessed have a recommended PPV threshold of 50mm/s.

Figure 6 PPV recommendations based on environmental geotechnical assessments. All the environmental thresholds are 50mm/s.

The scaled distance method as outlined in the Australian Standard AS2187.2:2006 should be used to determine the expected vibration levels at the sites. In the absence of site specific data, use of proxy constants $K = 1140$ and $b = -1.6$ can be used as a starting point. Should the calculated vibration levels exceed the recommended thresholds, the Drill and Blast team can:

- develop site specific K and b values, or
- modify the blast design to reduce the maximum charge weight.

Should the predicted estimated thresholds levels still be exceeded following these modifications, a more detailed blast management plan should be developed.
