Memo

To: Dee Thompson
Cc: Jeremy Bower
From: David Blakeway
Date: 21 June 2013
Subject: Cockatoo Island barge Wharf benthic habitat survey

Pluton Resources' document *Cockatoo Island Iron Ore Mine and Processing Facility Provision of information for the construction of a Barge Wharf (Tenements M04/448 and M04/235)* proposes the construction of a barge wharf on the south-eastern bank of the Cockatoo Island Iron Ore Project (at approximately 16°06'08"S, 123°36'54"E) and a redirection of the fuel line from its existing location to a new output point at the newly constructed barge wharf. The DEC requires sufficient information to determine that the proposed work will not pose an additional threat or concern to the environment on Cockatoo Island. This memo provides information on the benthic habitats in and around the proposed construction site.

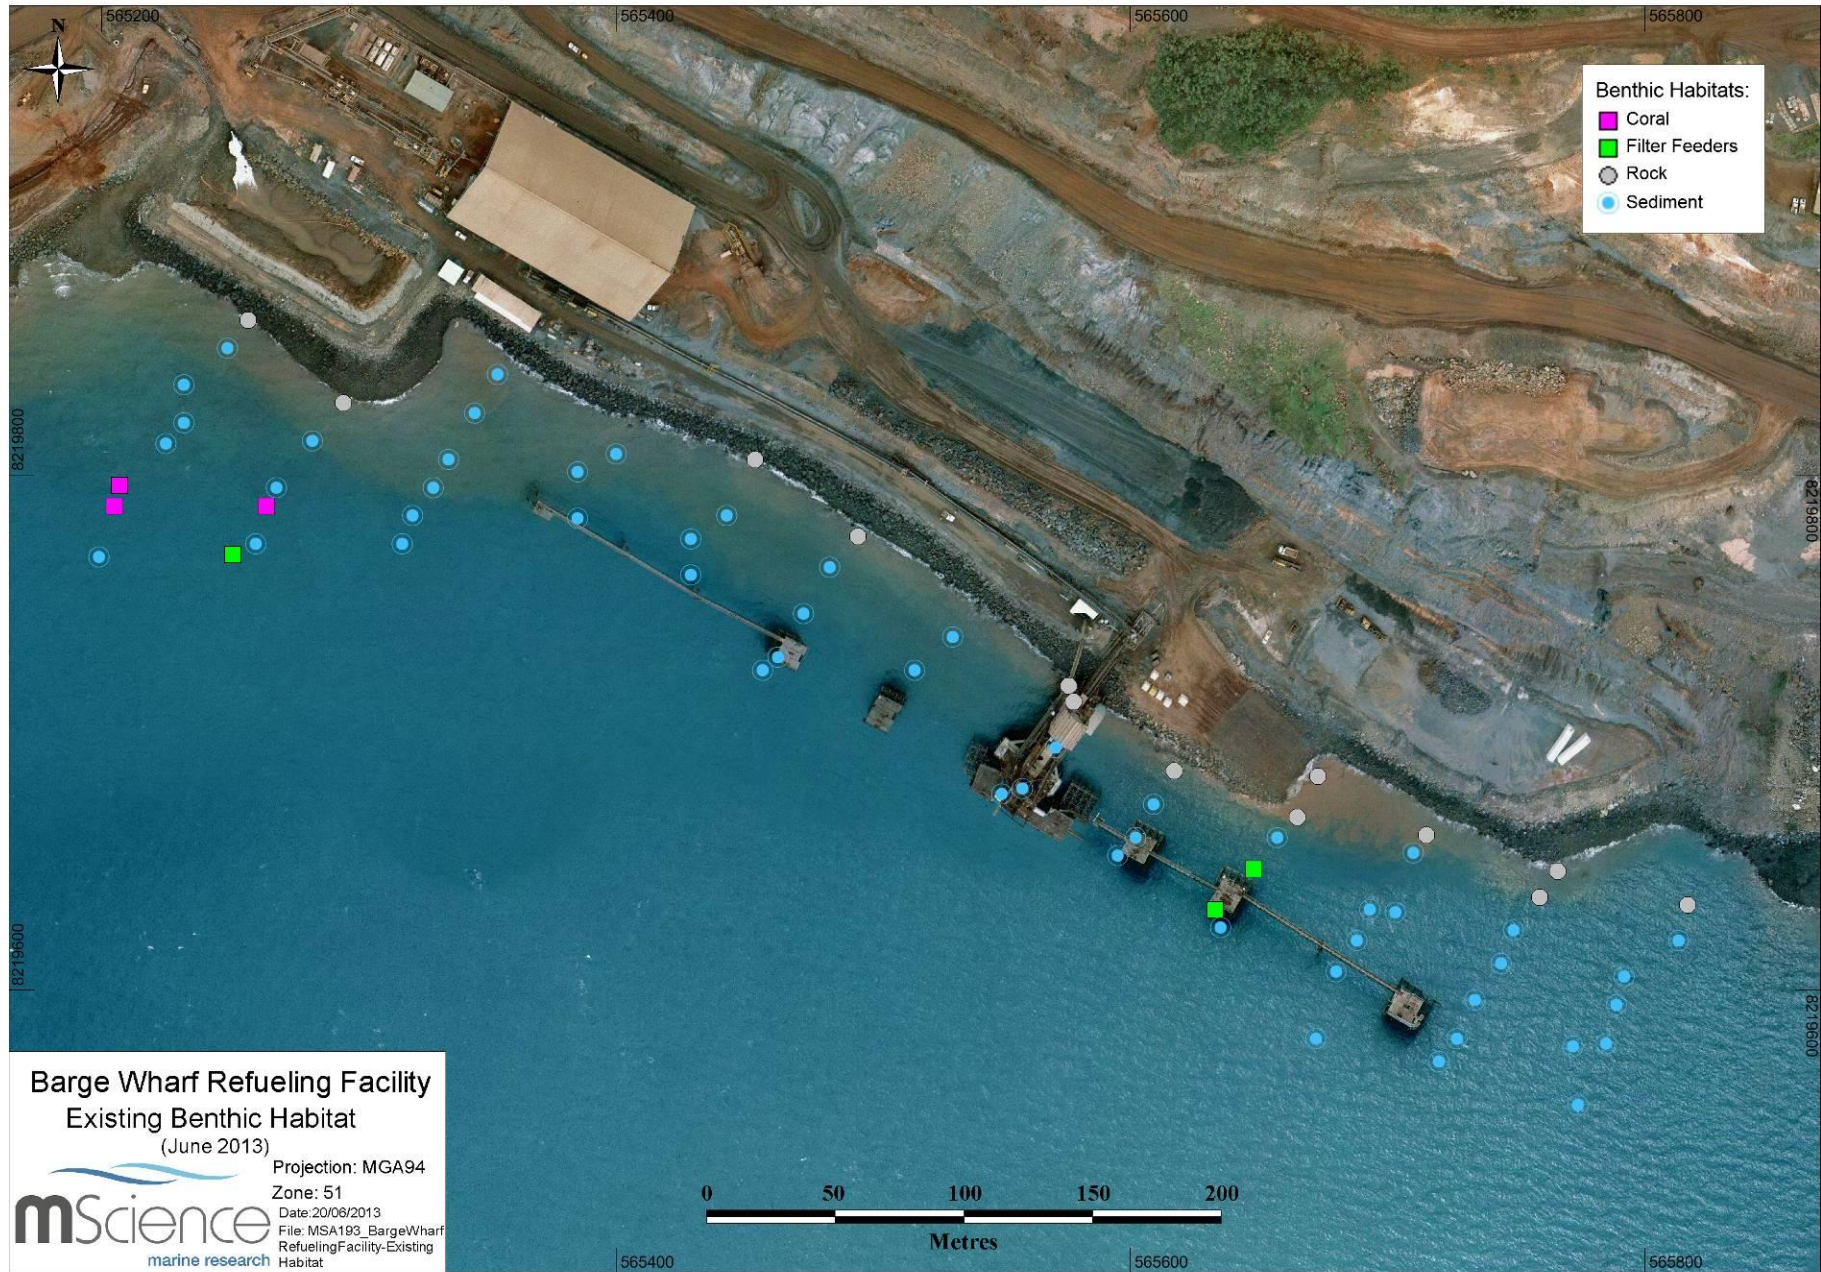
Figure 1. Study area with video survey points

The study area comprises a shallow nearshore flat between 10 and 30 m wide that drops off at its seaward edge into depths of approximately 10-15m below lowest astronomical tide (LAT). The Shiploader straddles the dropoff at approximately 6-12m below LAT. Four benthic habitat categories were identified in the survey area: rock, sediment, filter-feeding invertebrates and coral. The distribution of the four habitats is shown in Figure 1.

Filter-feeding invertebrates occupy hard substrate including coral rubble and shiploader pylons (Figure 6). The highest density of filter feeders, approximately 5-10%, occurred at two sites beneath the shiploader and one site off the Stage 3 Settlement Pond (Figure 1). The invertebrates include gorgonian soft coral 'sea whips', sponges, and crinoids. It is likely that similar invertebrate communities occupy most of the deeper pylons.

Live coral occurs in small patches on the coral rubble on the outer flat and upper reef slope at approximately 1 to 5m below LAT, approximately 500m from the proposed construction site (Figure 1). Live

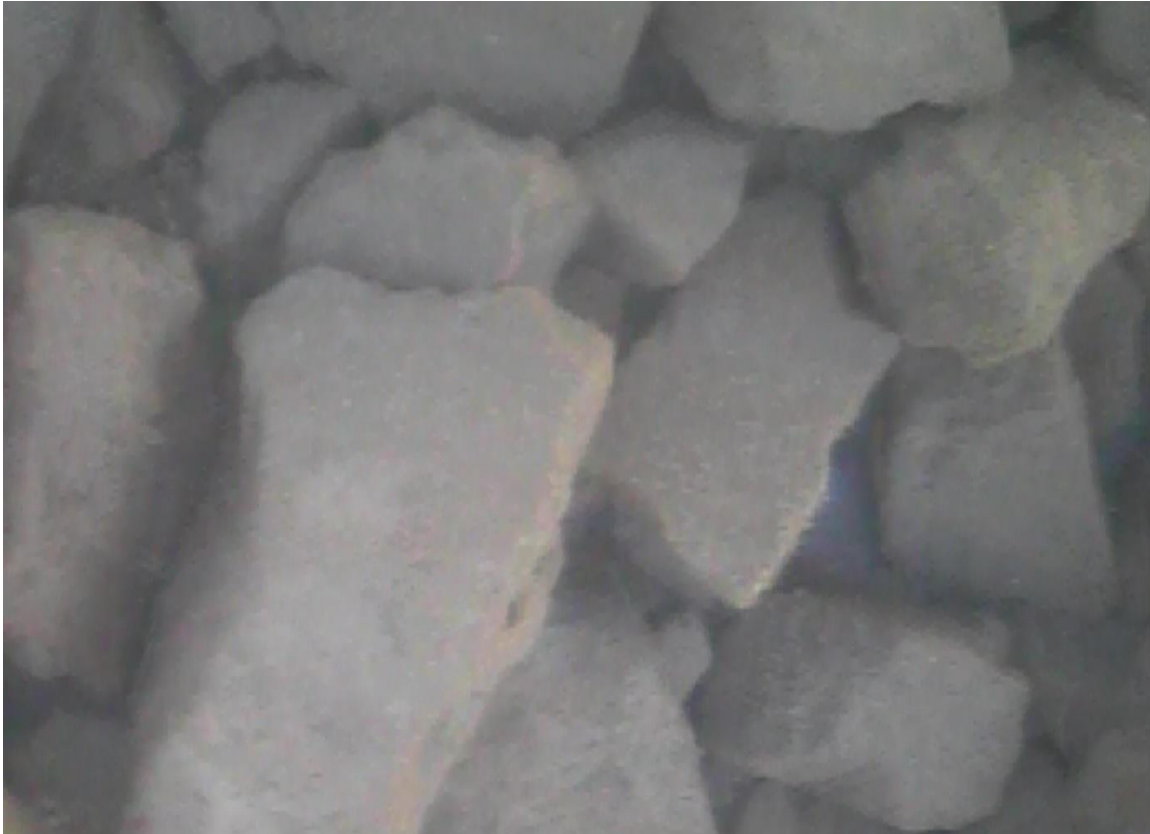
Figure 2. Rock at waypoint162

The rock unit is the base of the mine embankment. It consists of angular boulders up to approximately 0.5m diameter (Figure 3). Very few plants or animals grow on the rocks as they are exposed out of water for several hours during spring low tides.

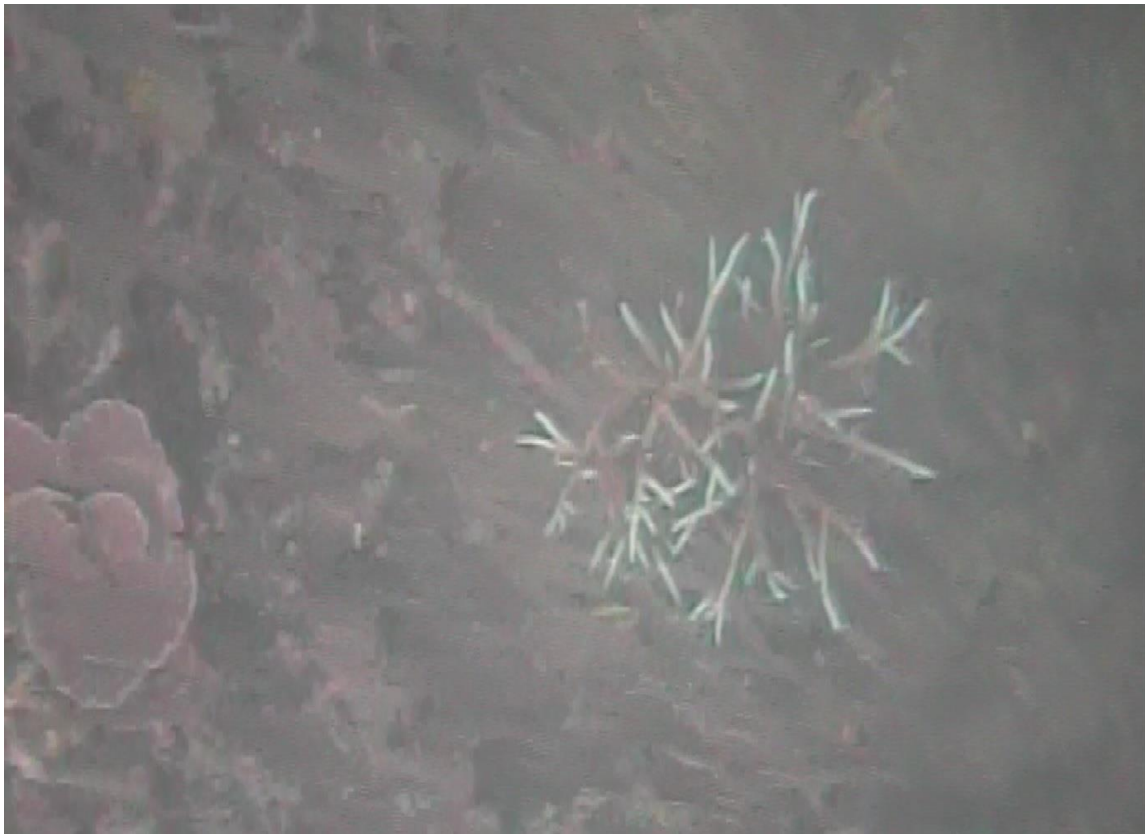
Figure 5. Coral genera *Montipora* (left) and *Acropora* (right) on coral rubble at waypoint 204

coral cover at these sites is approximately 10%. Coral genera are primarily *Acropora* and *Montipora* (Figure 7). Occasional coral colonies were also recorded on the shiploader pylons.
