Appendix C – Daily Rainfall at Paraburdoo for 2018

Appendix D - Surface water features of the Western Range Summary Table

Appendix E – Water Feature Photos

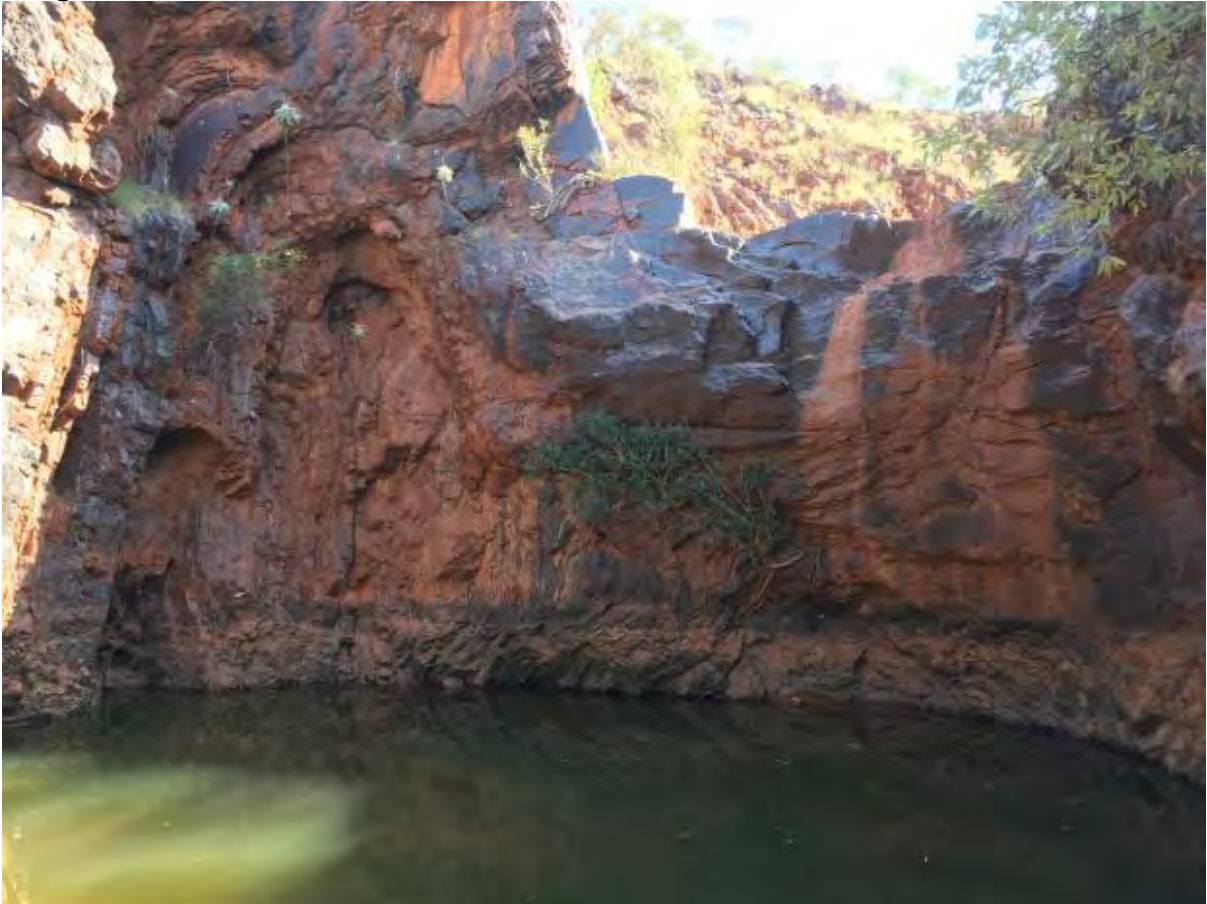
Pool G3_10 Looking Upstream (April 2018)

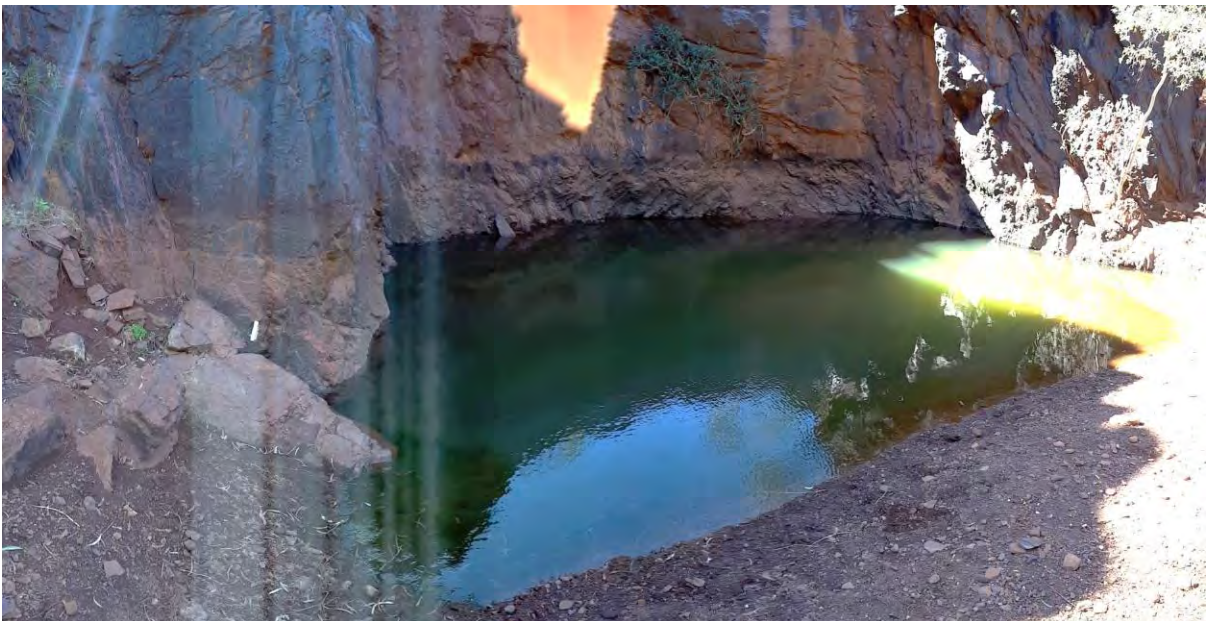
Pool G3_10 Looking Upstream (May 2018)

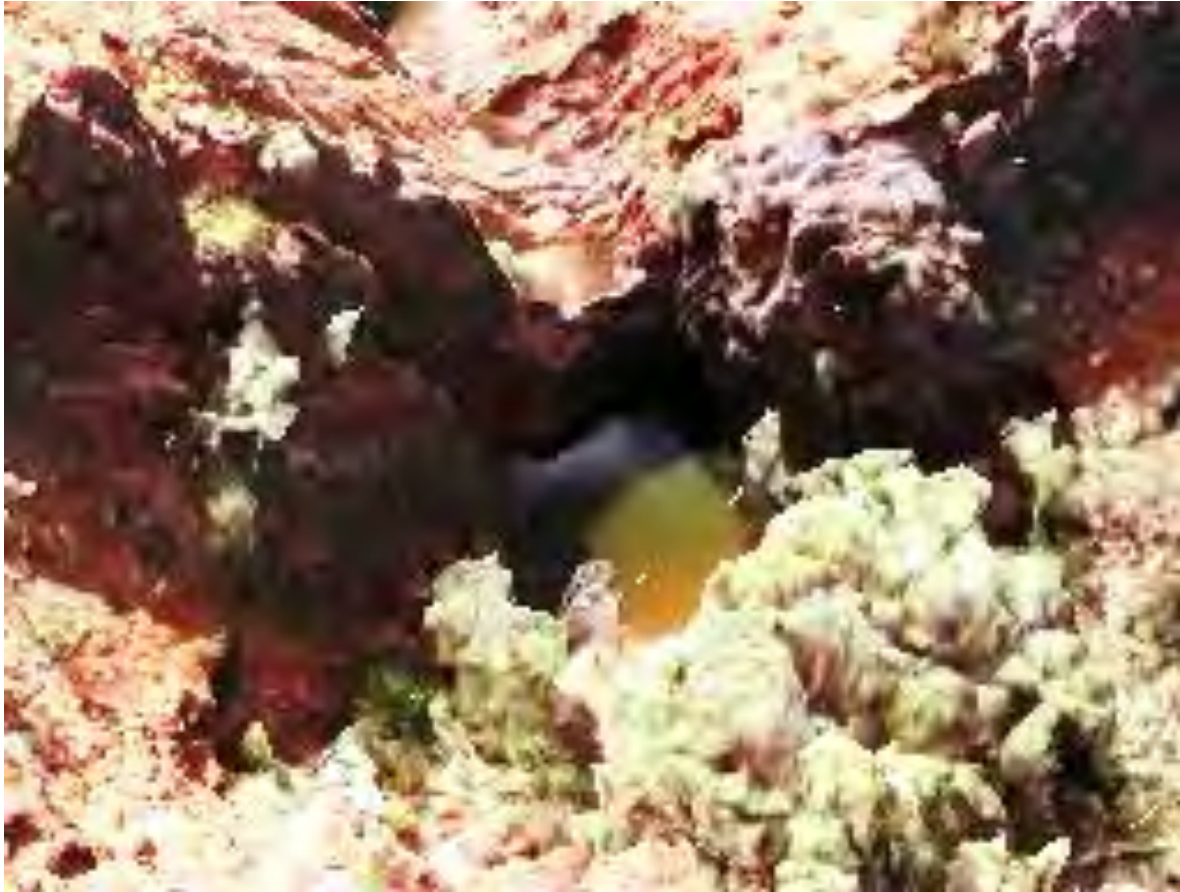
Pool G3_10 From Drone Survey (June 2018)

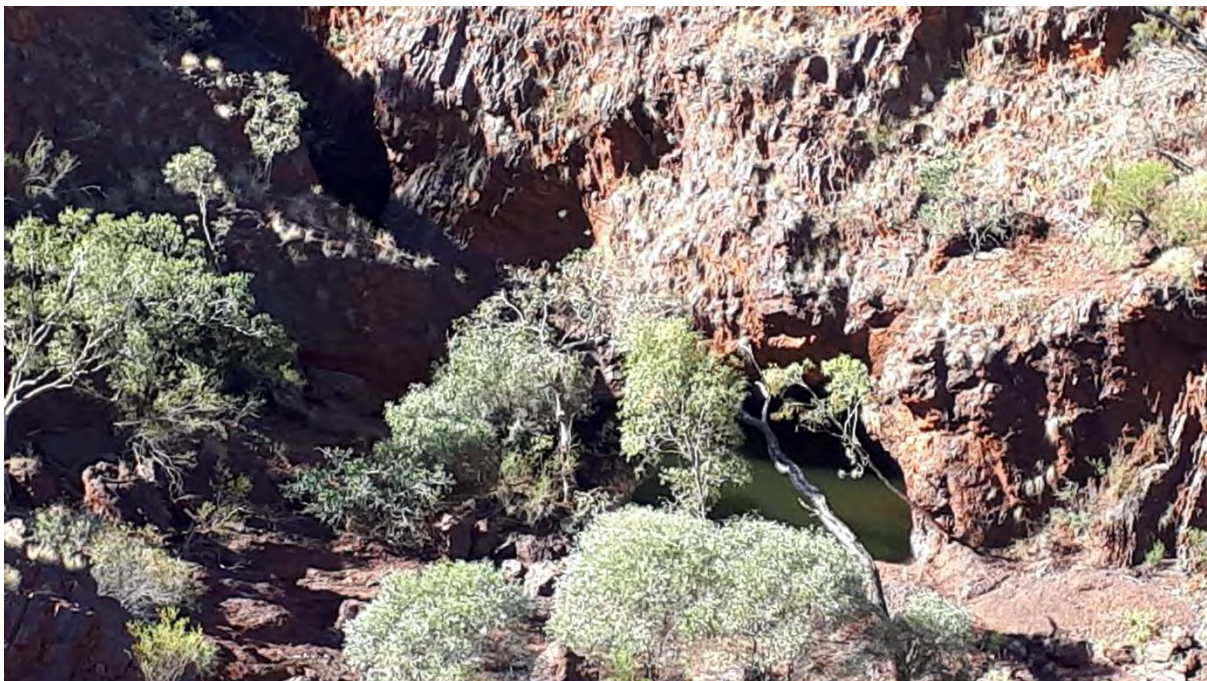
Pool G3_10 Taken from Adjacent Ridge, May 2018

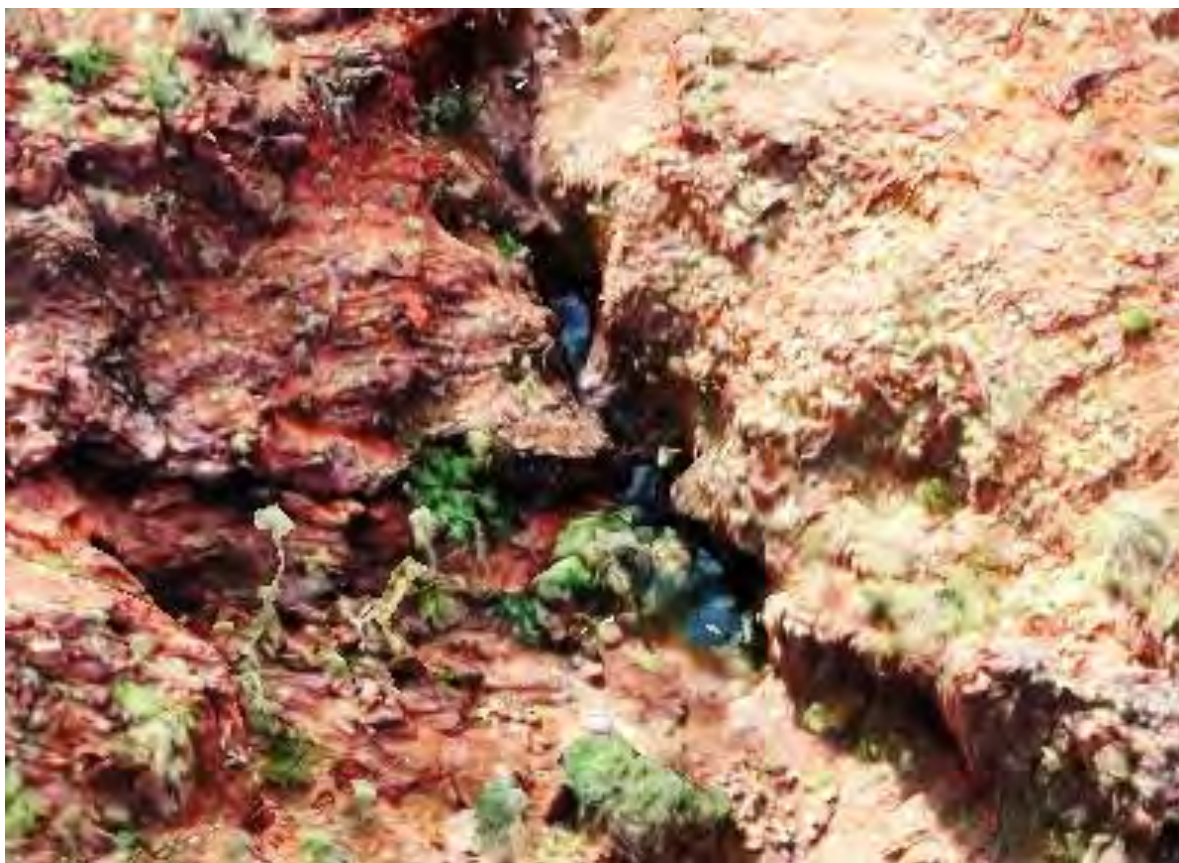
Pool G3_10 From Drone Survey (June 2018)

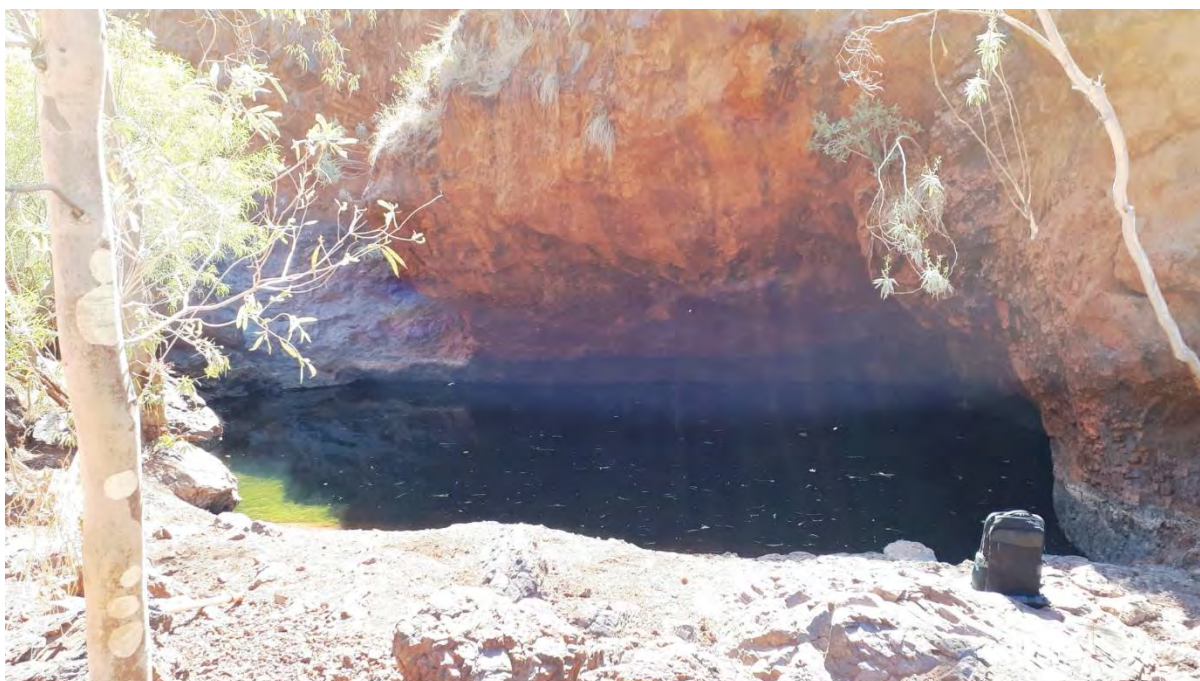
Pool G3_10 During Water Sampling in October 2018

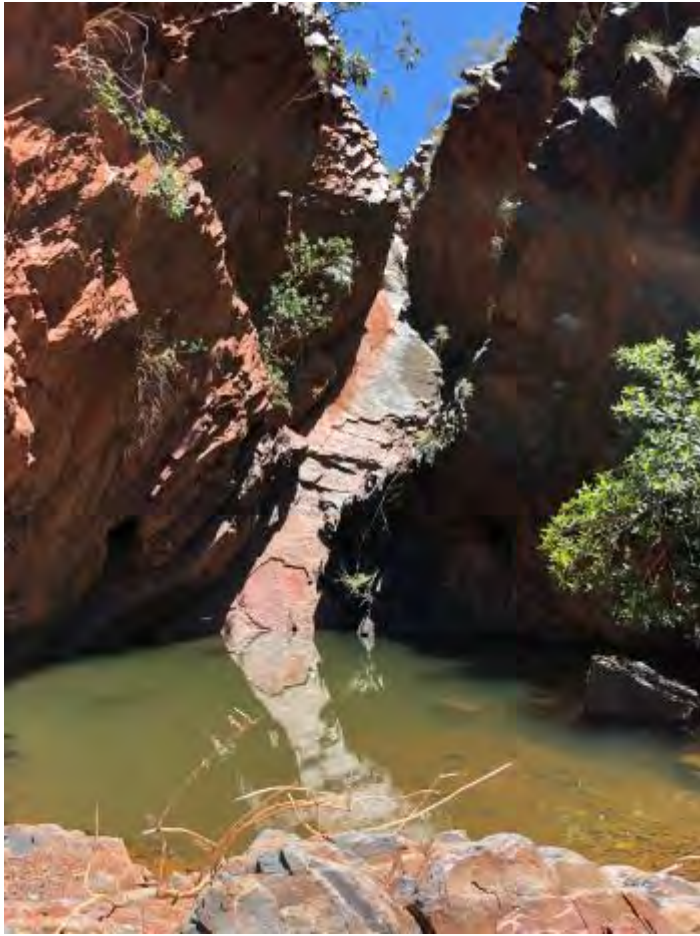
Pool G7_7 Looking North, from February 2018

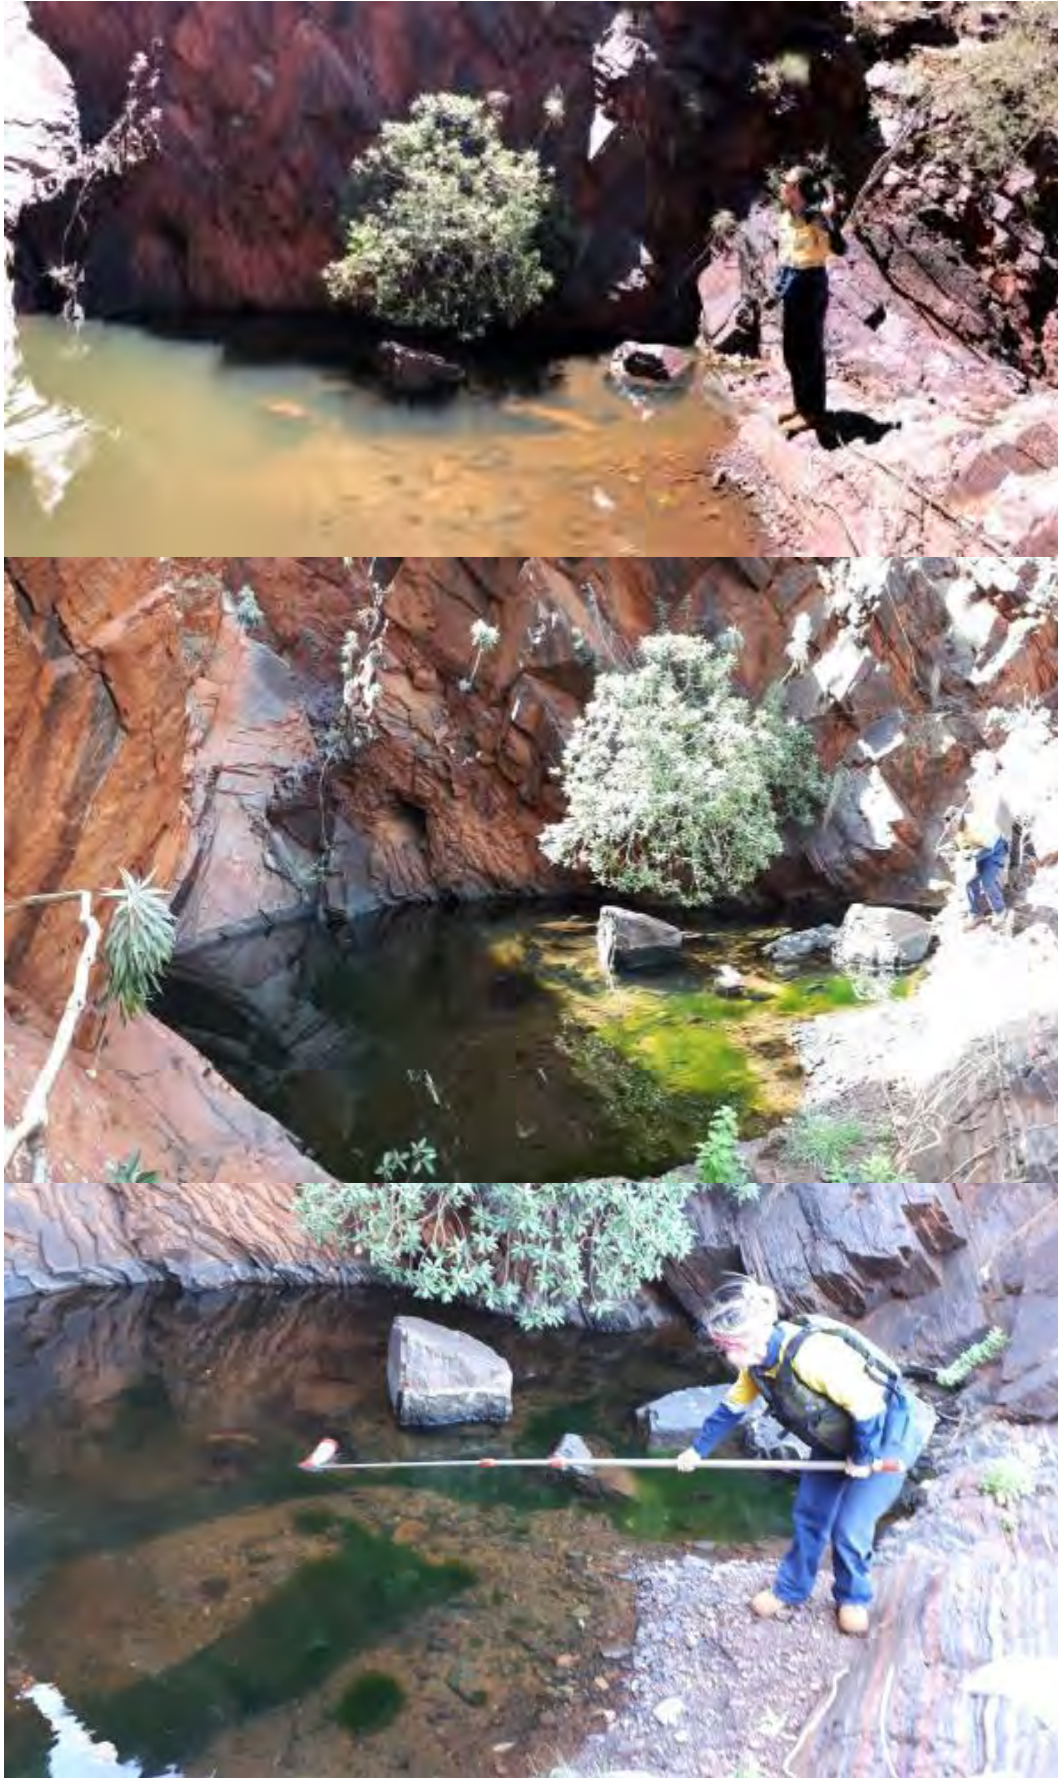
Pool G7_7 Looking East, from February (top), April (middle) and May (bottom) of 2018

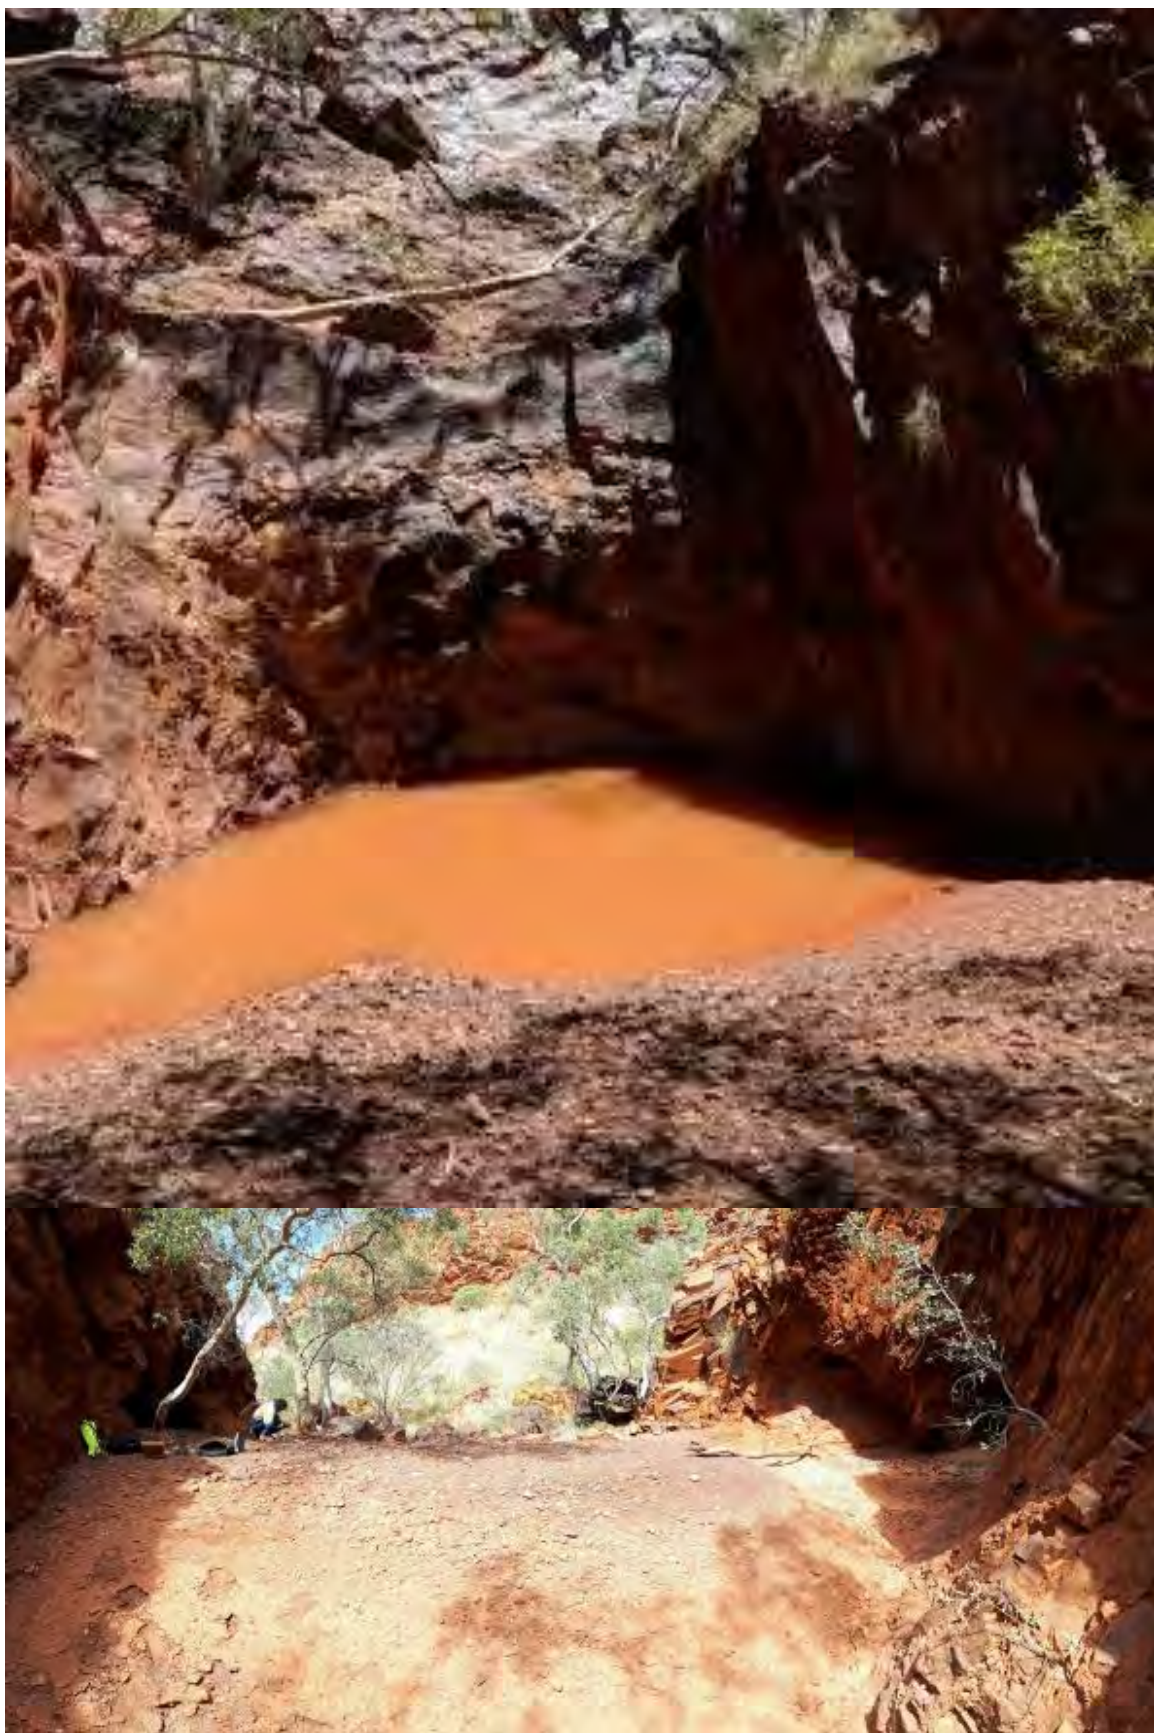
Pool G7A_3 Wet (Top image, looking upstream, February 2018) and Dry (bottom image, looking downstream, April 2018)

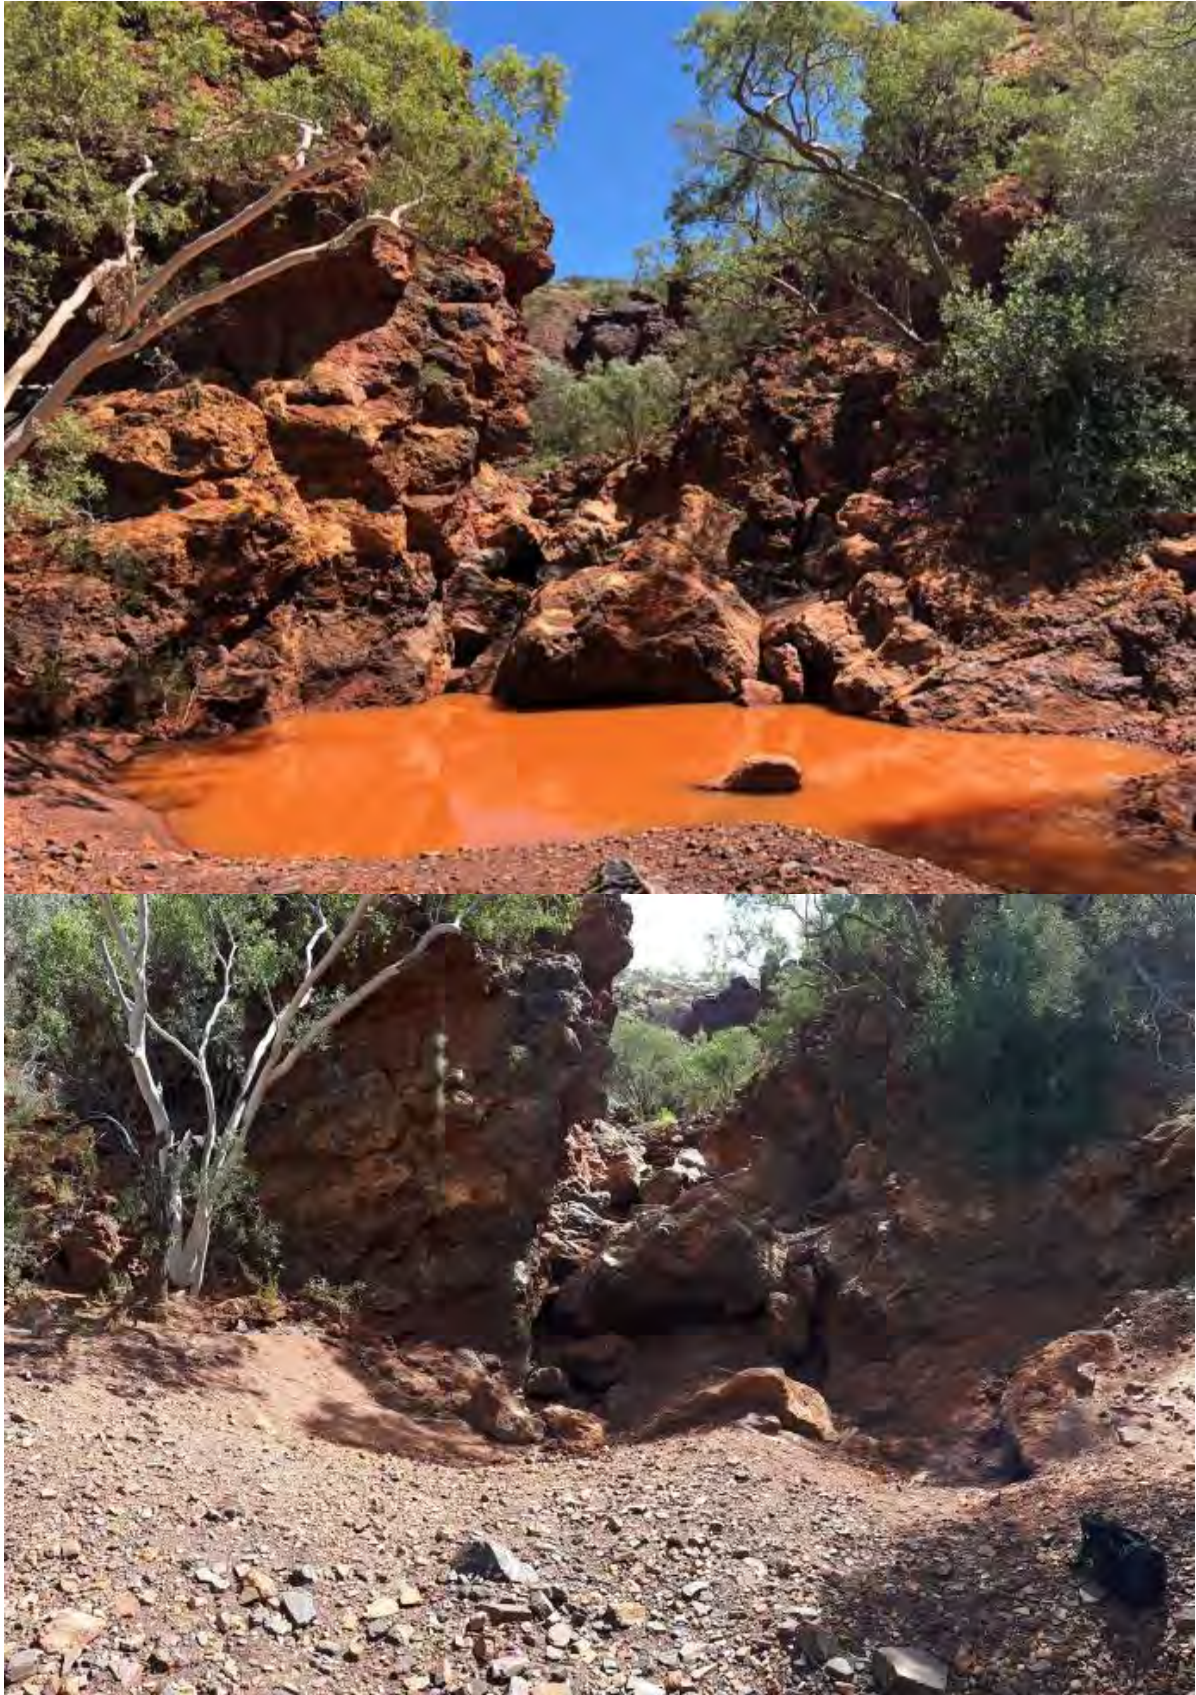
Wet conditions at Pool G7_10 (top image, February 2018) versus Dry (bottom image, April 2018)

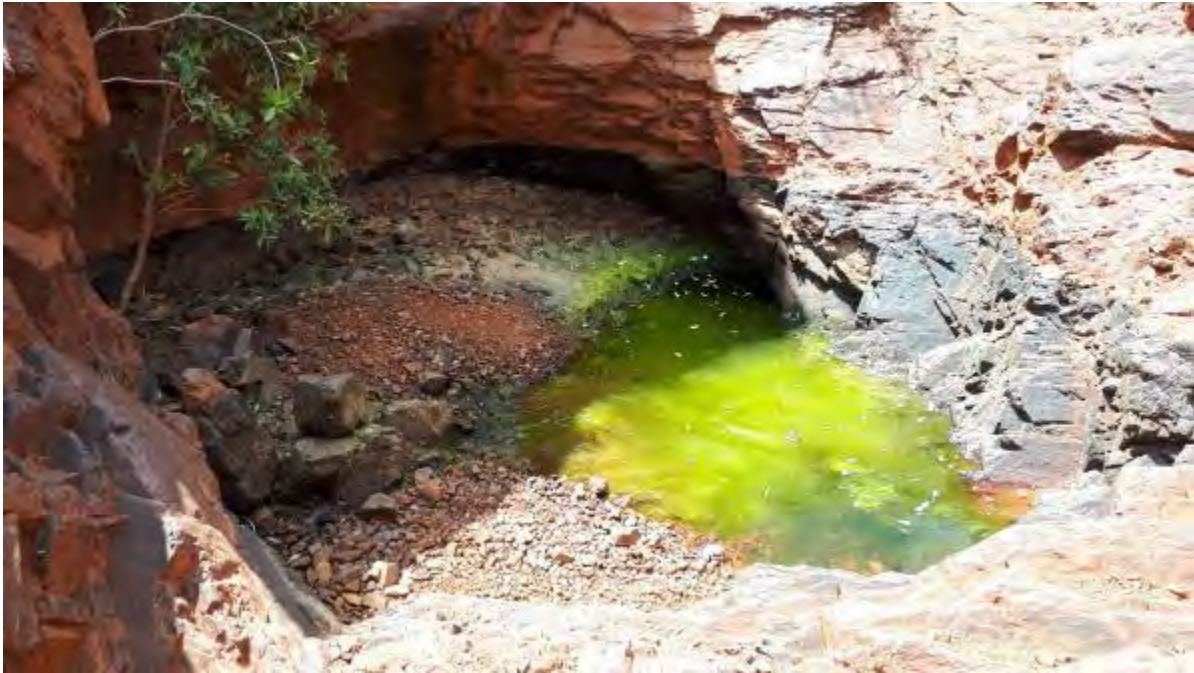
Pool G9_1 in October 2018

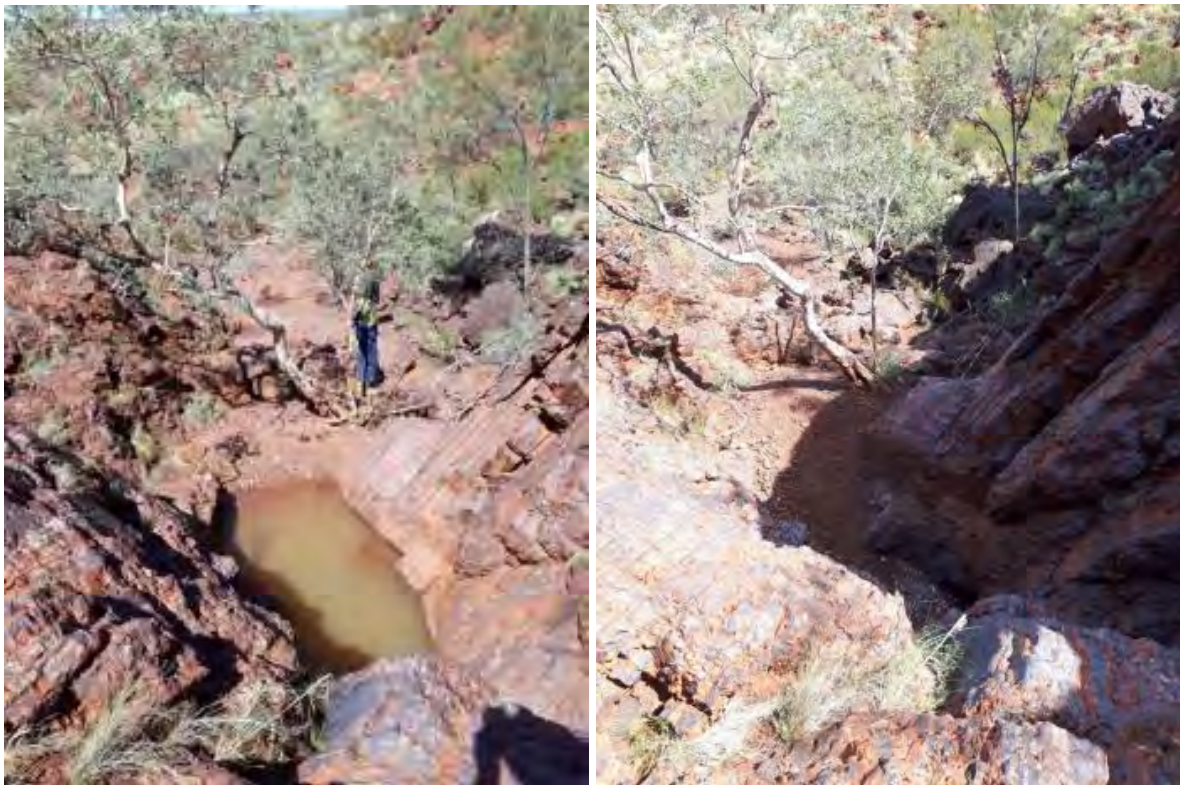
Wet Conditions at Pool G12_1 in February (Left) versus dry in April (right) 2018

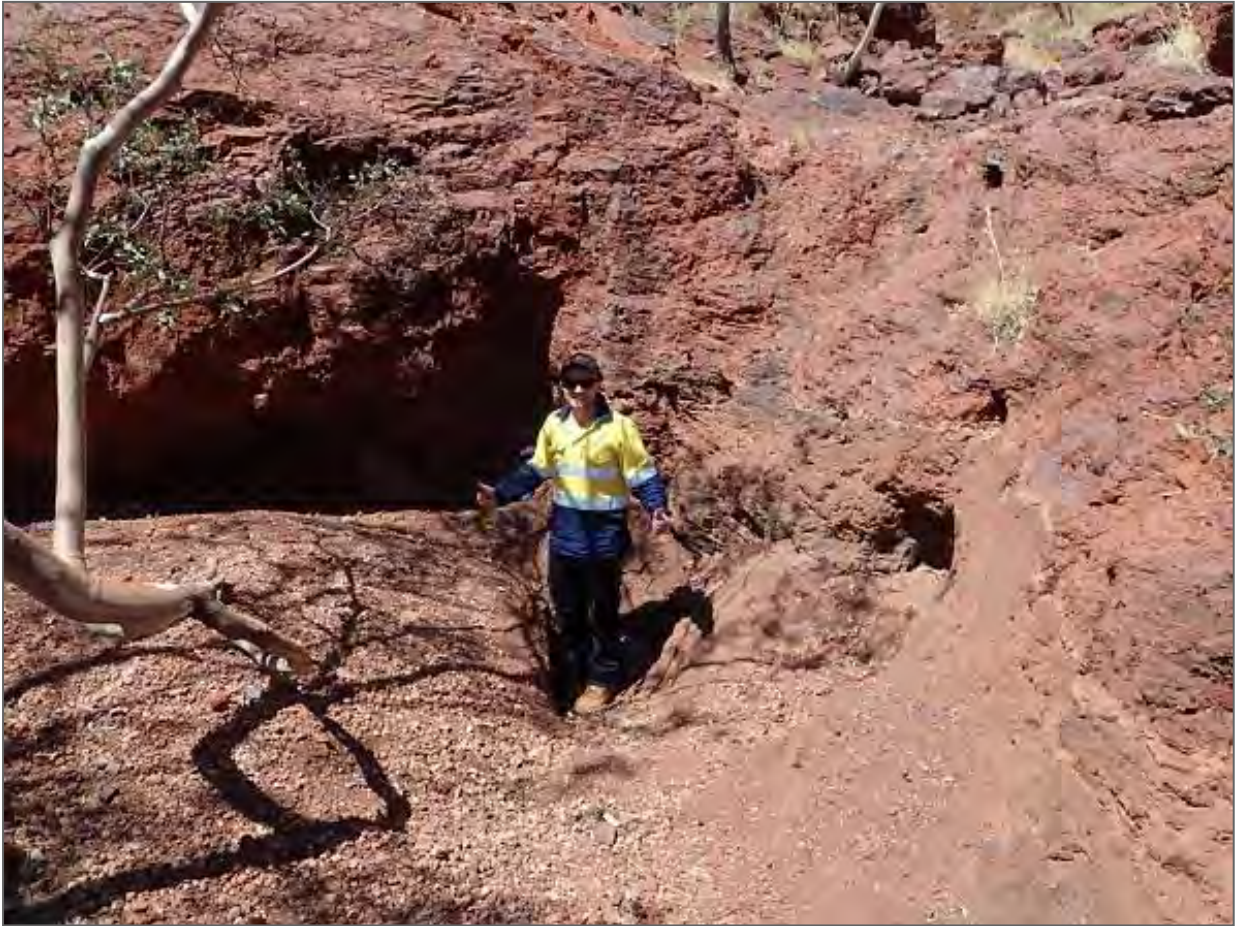
Dry Conditions (Dec 2017) Gorge 13 Pool 1 (G13_1) Looking Upstream

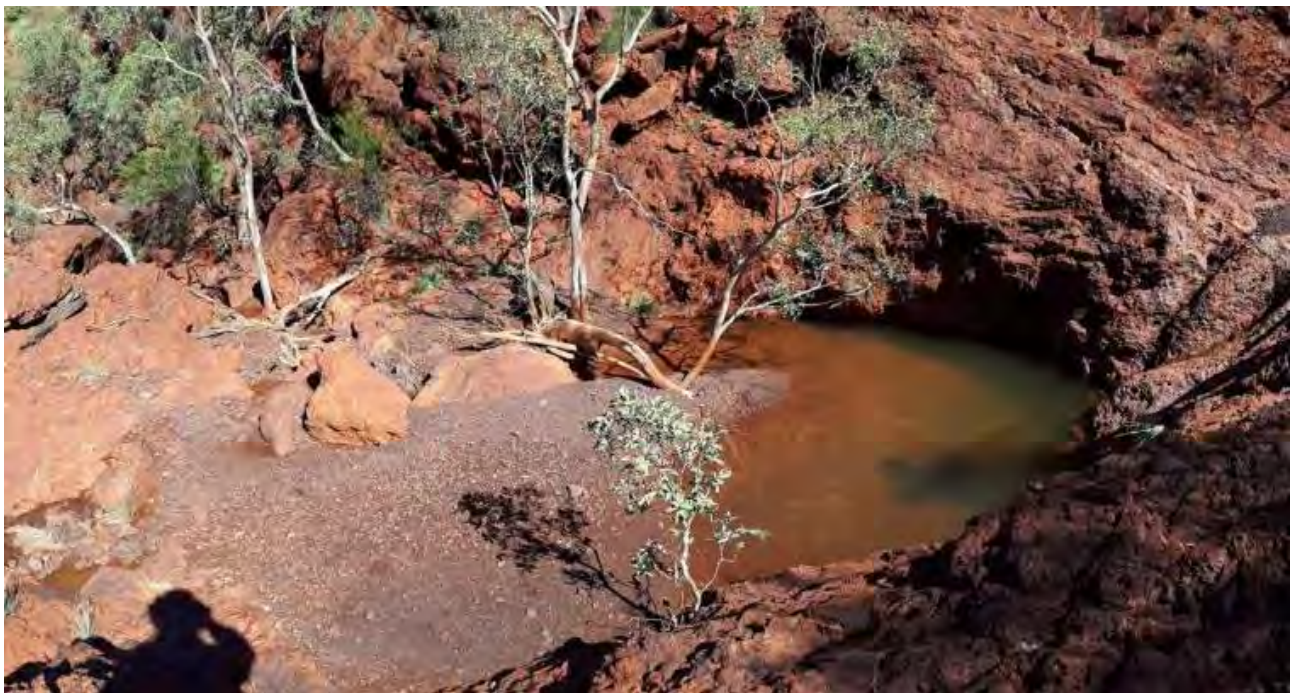
Wet Conditions (Feb 2018) Gorge 13 Pool 1 (G13_1) Upstream is right hand side

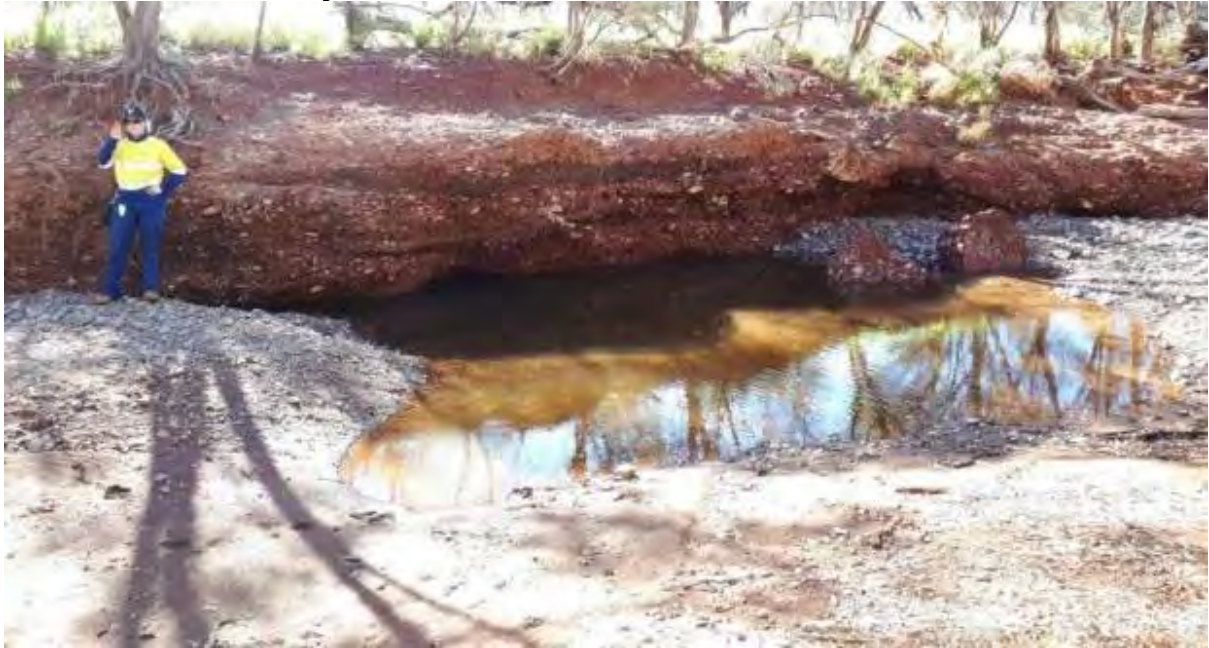
Six Mile Creek Tributary showing a 2 metre (approx.) bank height

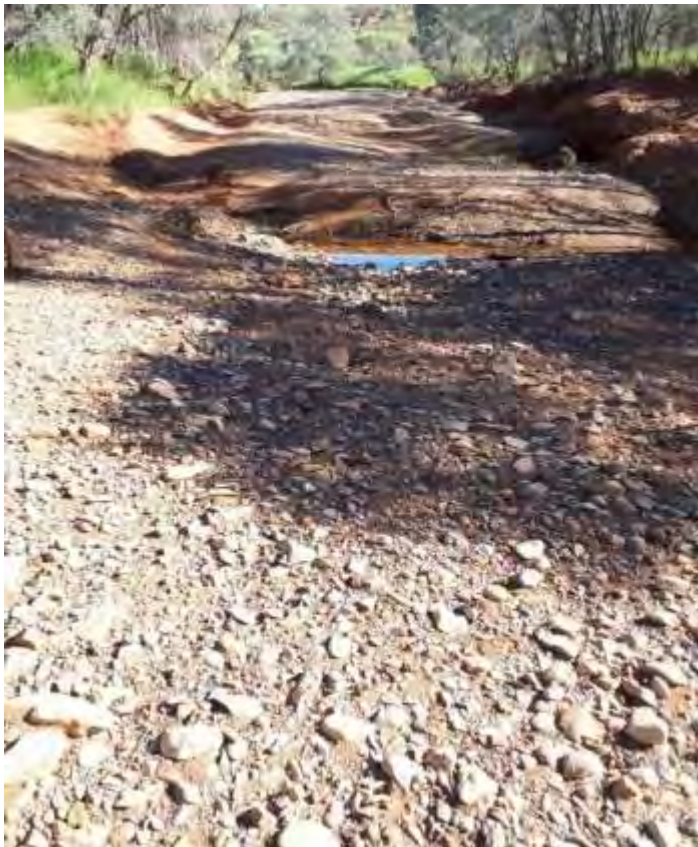
Undulating bed of Six Mile Creek with large pebbles indicating armouring against high velocity flows
