Surface Water Assessment

Eastern Range – 42 East, 47 East and 50E areas

May 2019

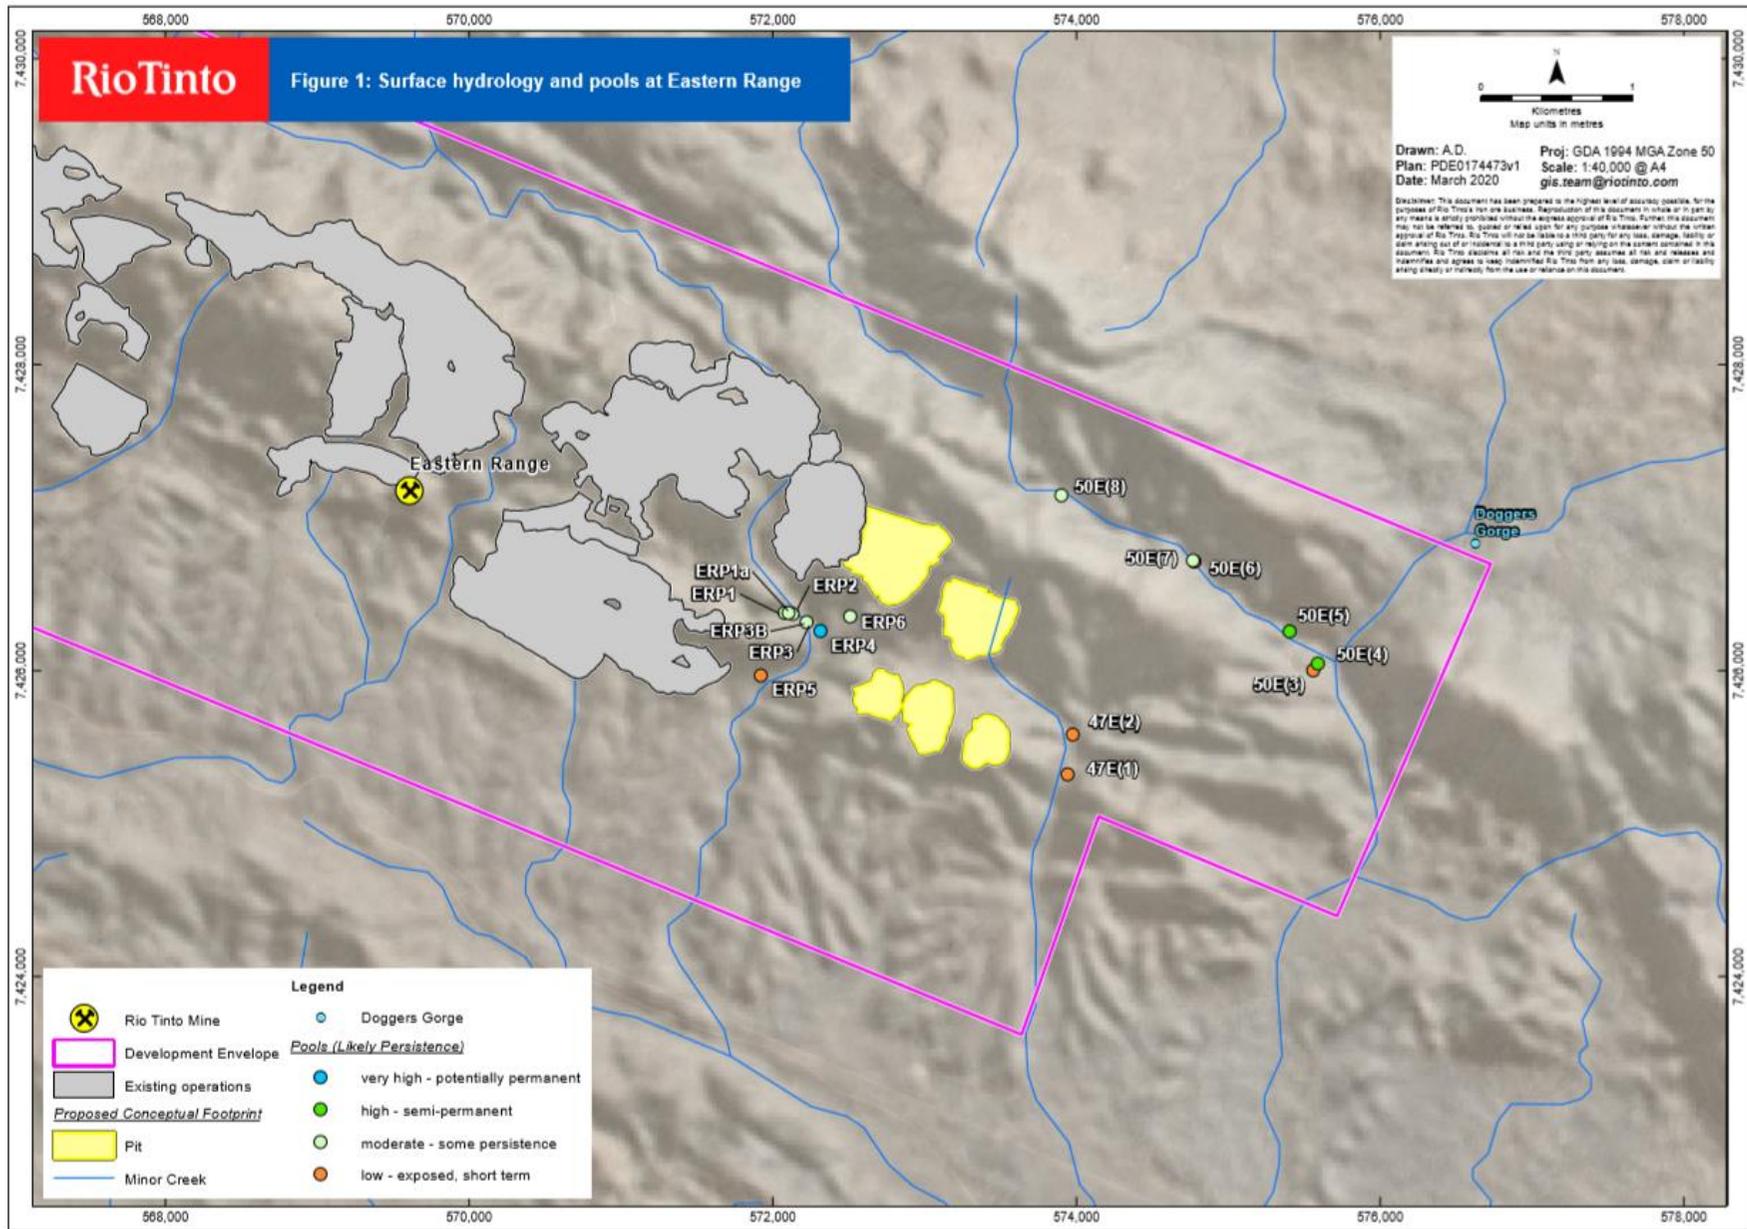
Figure 1 Eastern Range Surface Hydrology

Within the Eastern Range area the surface water regime is influenced by the steeply incised gullies hosted within the ridgeline. These gullies form headwaters to tributaries of the Seven Mile and Turee Creeks, with the majority flowing in a southerly direction, refer Figure 1.

Eastern Range comprises of parallel east-west trending Joffre, Whaleback Shale, and Dales Gorge Members. This is illustrated by the conceptual north-south cross section shown in Figure 1. Drainage in the 47E and 50E gorges presents a dendritic drainage patterns, with main direction of flow directions in the north-east to south-west, and north-west to south-east directions respectively, refer Figure 1 and Appendix A.

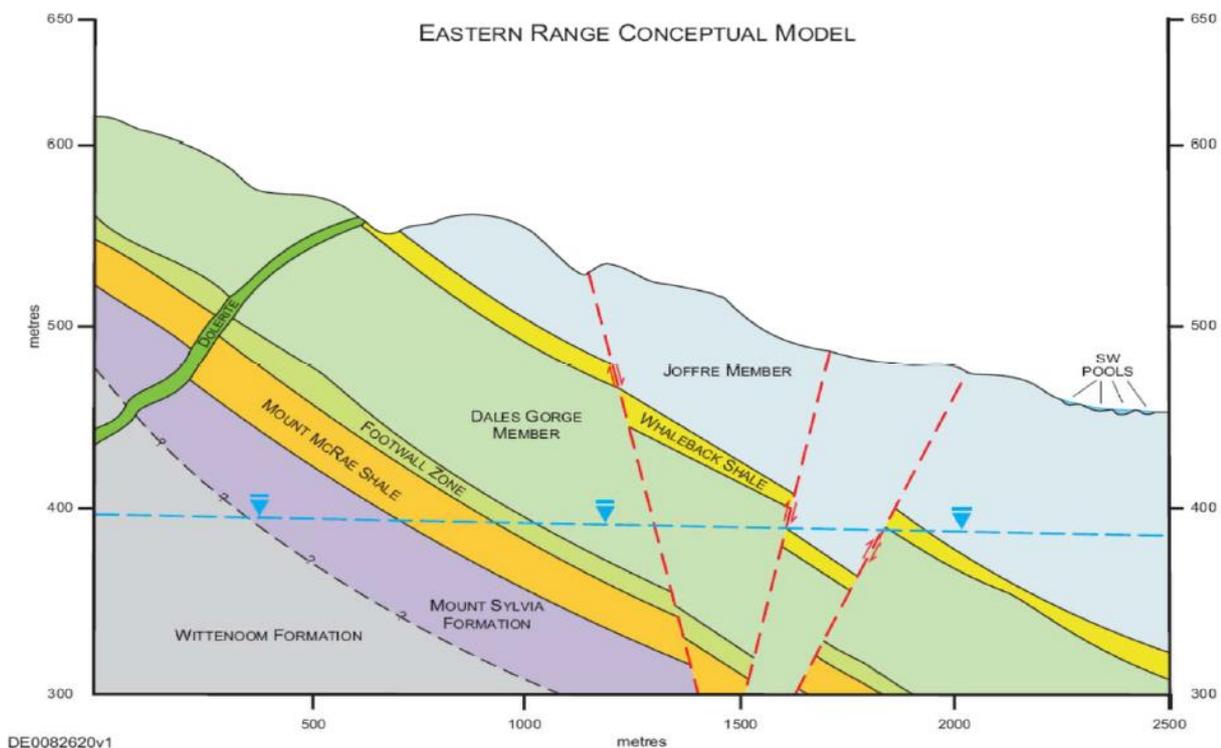
Figure 2: Conceptual Hydrogeological Cross Section of Eastern Range.

A previous investigation was undertaken in 2011 by Rio Tinto to conceptualise the mode of occurrence of the pools west of the assessment threshold. This included Python Pool in 24East gorge, MOC pools in the 32-37East gorge, and ERP pools in the 42East gorge. The pools are situated at ~100m above the assumed groundwater level (~350m AHD).

The investigation determined the source of water in the pools was incident rainfall and surface water flow from upper catchment that collects in sheltered depressions within impermeable bedrock where evaporation is minimal. Chloride and isotope data suggested there was no groundwater flow between the pools (RTIO-PDE-0143526). These pools were therefore deemed not dependent on local groundwater, however they may be sensitive to catchment change.

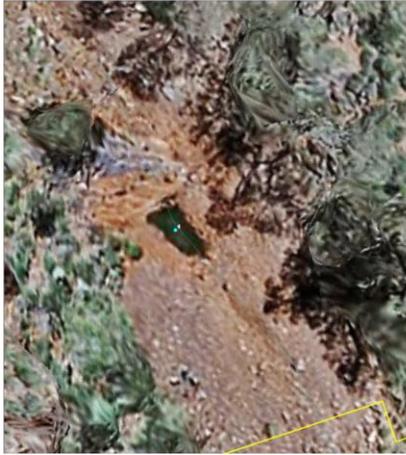
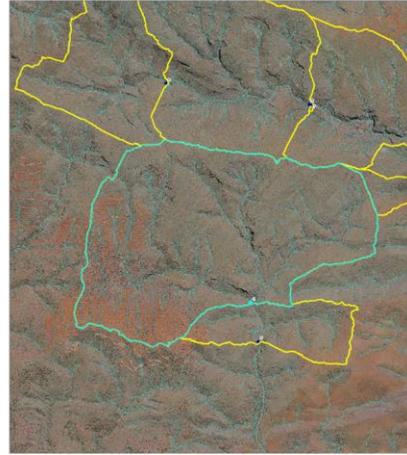
Pool 47E_1

Approx. 3m x 1m pool

Upper Catchment ~ 1.9km²

Two pools were identified in a gorge referred to as the 47E gorge (47E_1 and 47E_2). Development of the proposed 47E pits will result in minor reductions in contributing catchment area of these pools.

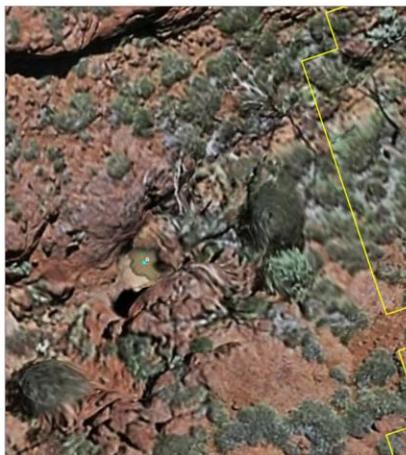
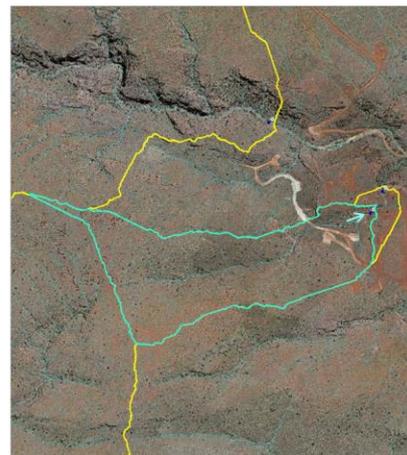
Pool 47E_2

Approx. 2m x 1m pool

Upper Catchment ~ 0.1km²

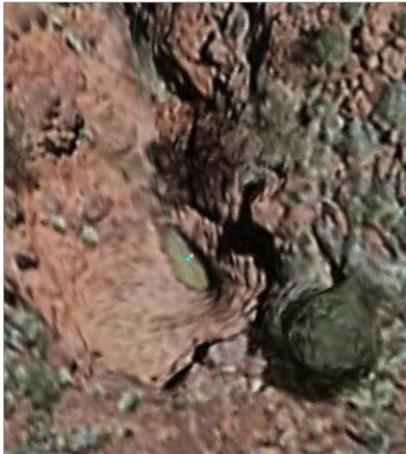
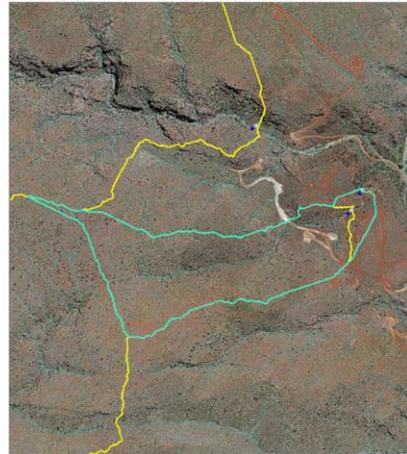
Pool 50E_3

Approx. 2m x 1m pool

Upper Catchment ~ 0.1km²

Six pools were identified in a gorge referred to as the 50E gorge (50E_3 to 50E_8). These pools will not be directly or indirectly impacted by the proposal as no mining is proposed in the 50E area.

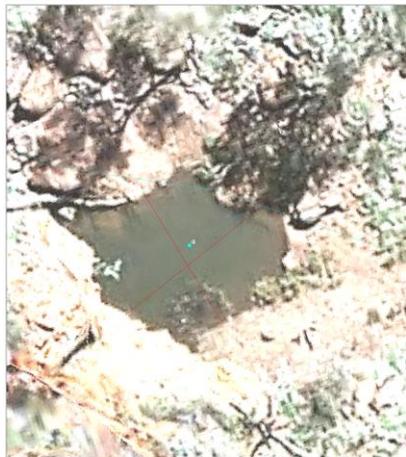
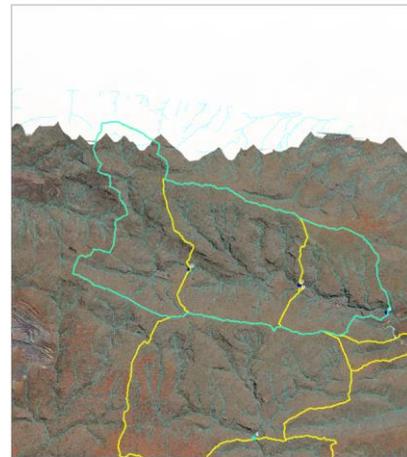
Pool 50E_4

Approx. 5m x 5m pool

Upper Catchment ~ 2.6km²

Pools 50E_4 and 50E_5 were the largest in surface area (according to March 2017 aerial imagery) and also have the largest catchments.

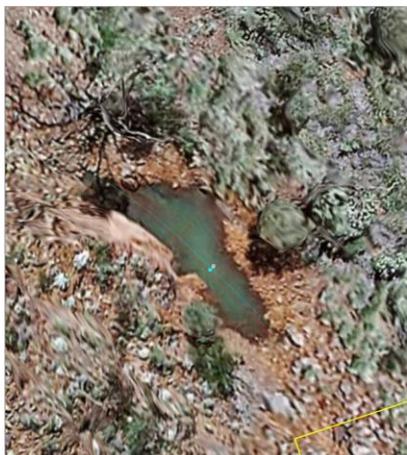
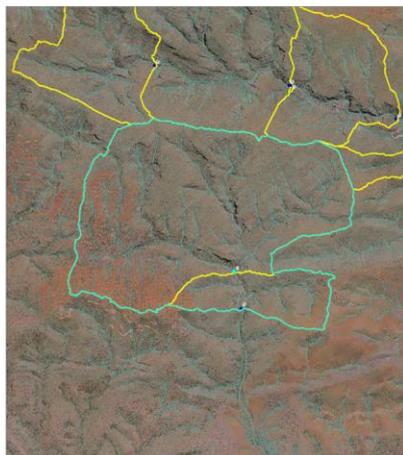
Pool 50E_5

Approx. 10m x 3m pool

Upper Catchment ~ 2.2km²

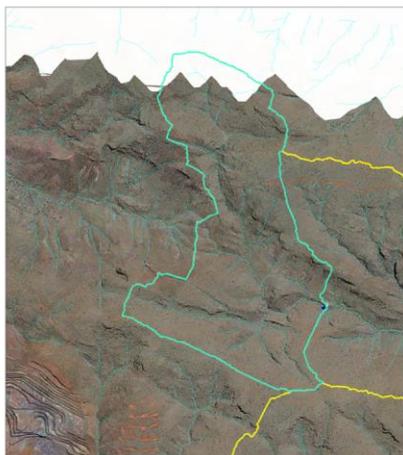
Pool 50E_6

Approx. 3m x 2m pool

Upper Catchment ~ .0.9km²

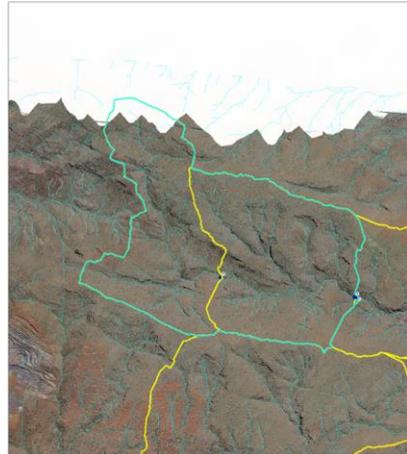
Pool 50E_7

Approx. 3m x 2m pool

Upper Catchment ~ 2.0km²

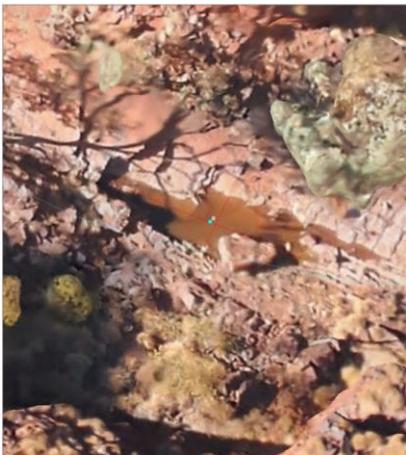
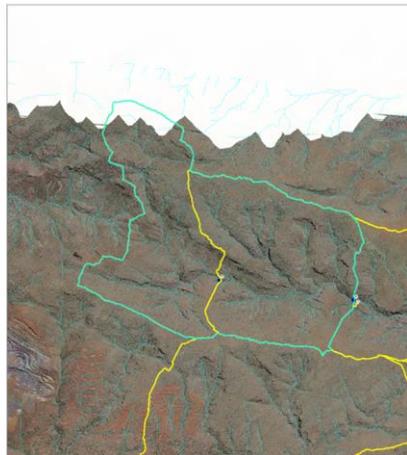
Pool 50E_8

Approx. 9m x 2m pool

Upper Catchment ~ 2.0km²

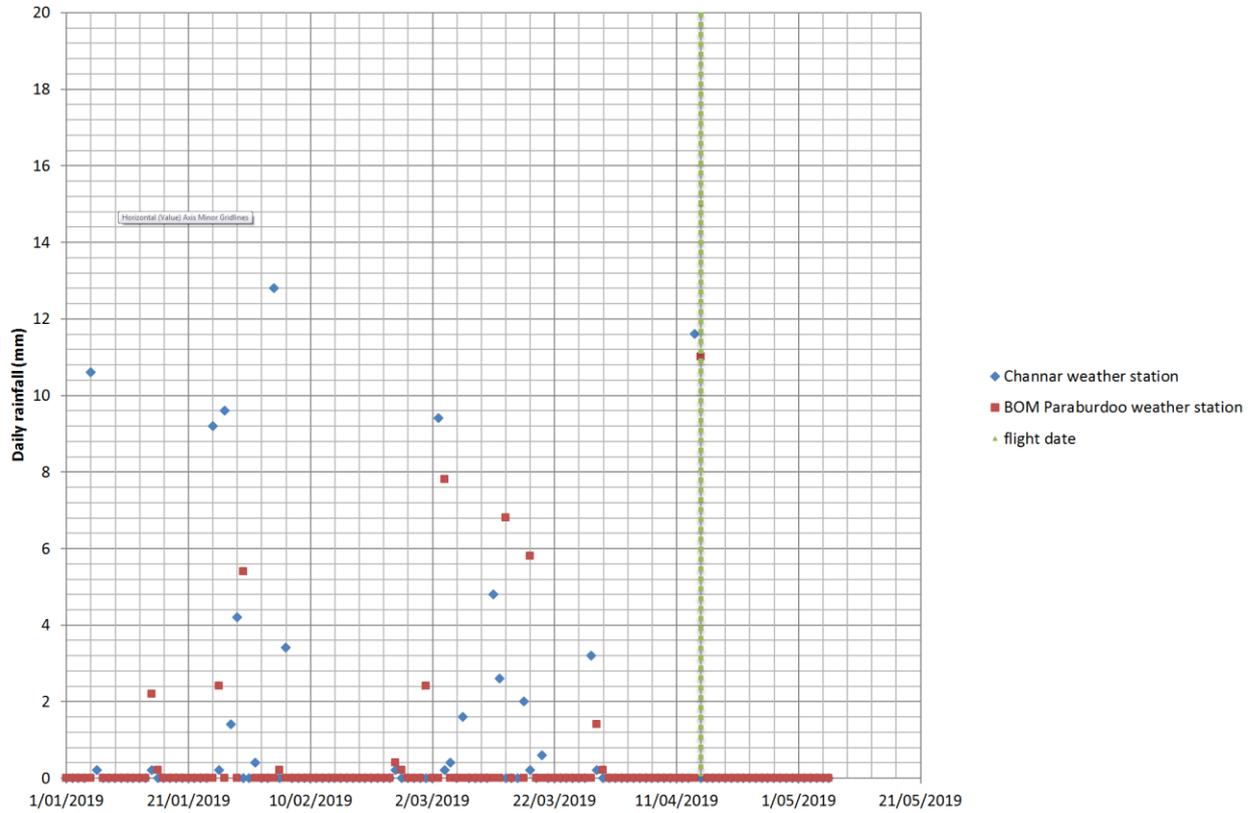
Figure 3: Antecedent rainfall records at closest Rainfall stations to the 50E gorges.

Appendix B - Eastern Range Antecedent Daily Rainfall for 16th April Aerial Imagery Capture

Daily rainfall data for the Q1 2019 period is presented in Appendix B. General climate data for Eastern Range and the wider Pilbara region is discussed in the Western Range & 4 East Extension PFS Surface Water Management Plan.
