REPORT ON FIELD INVESTIGATIONS:

**GROUND TRUTHING THE PRESENCE AND MANAGEMENT
CLASSIFICATION OF WETLANDS
LOT 123 MORTIMER RD, CASUARINA
CITY OF KWINANA**

27 March 2006

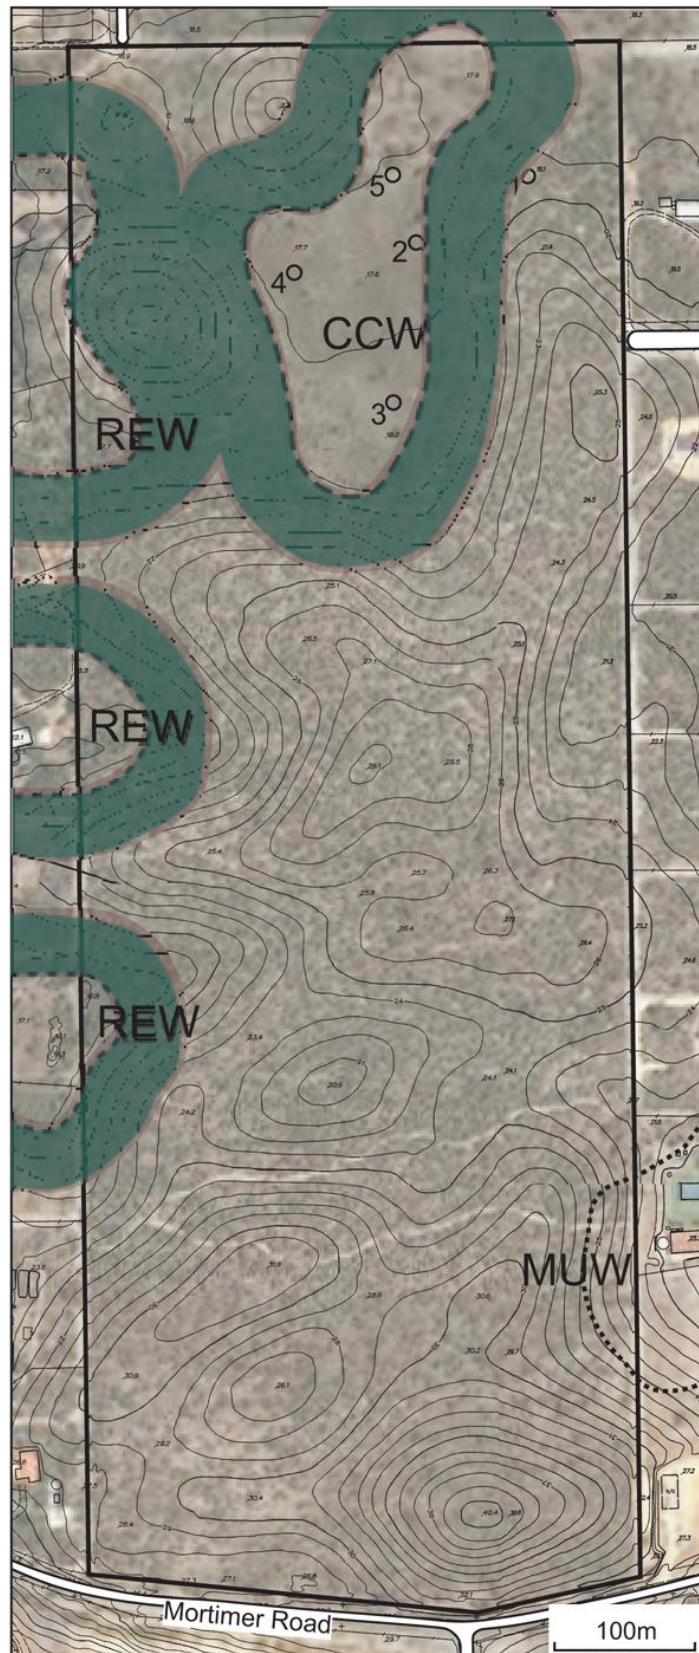
In 2002 part of the northern section of the property was classified as a Conservation Category Wetland (CCW) under the Department of Environment's Wetland Classification guidelines. Four other areas respectively classified as Resource Enhancement and Multiple Use Wetlands also overlap the site (see Figure 2).

Figure 2-Wetland classifications on the Mortimer Road site under the Geomorphic Data Set (Hill *et al.*, 1996) with the minimum requirement (50m) for protection buffer zones (CCW – Conservation Category wetland; REH – Resource Enhancement Wetland; MUW – Multiple Use wetland).

After holes were drilled, piezometers made from 50 mm slotted PVC pipe were inserted to a depth of 3.5 m (bottom 3 m slotted and end capped) with 0.5 m above the surface. Piezometer tops were capped and locations were logged by GPS. Bore locations are marked on Figure 2.
