Feasibility Study Kundip Tailings Storage Facility

Ravensthorpe Gold Project

ACH Minerals Pty Ltd

**October 2018
Rev 4**

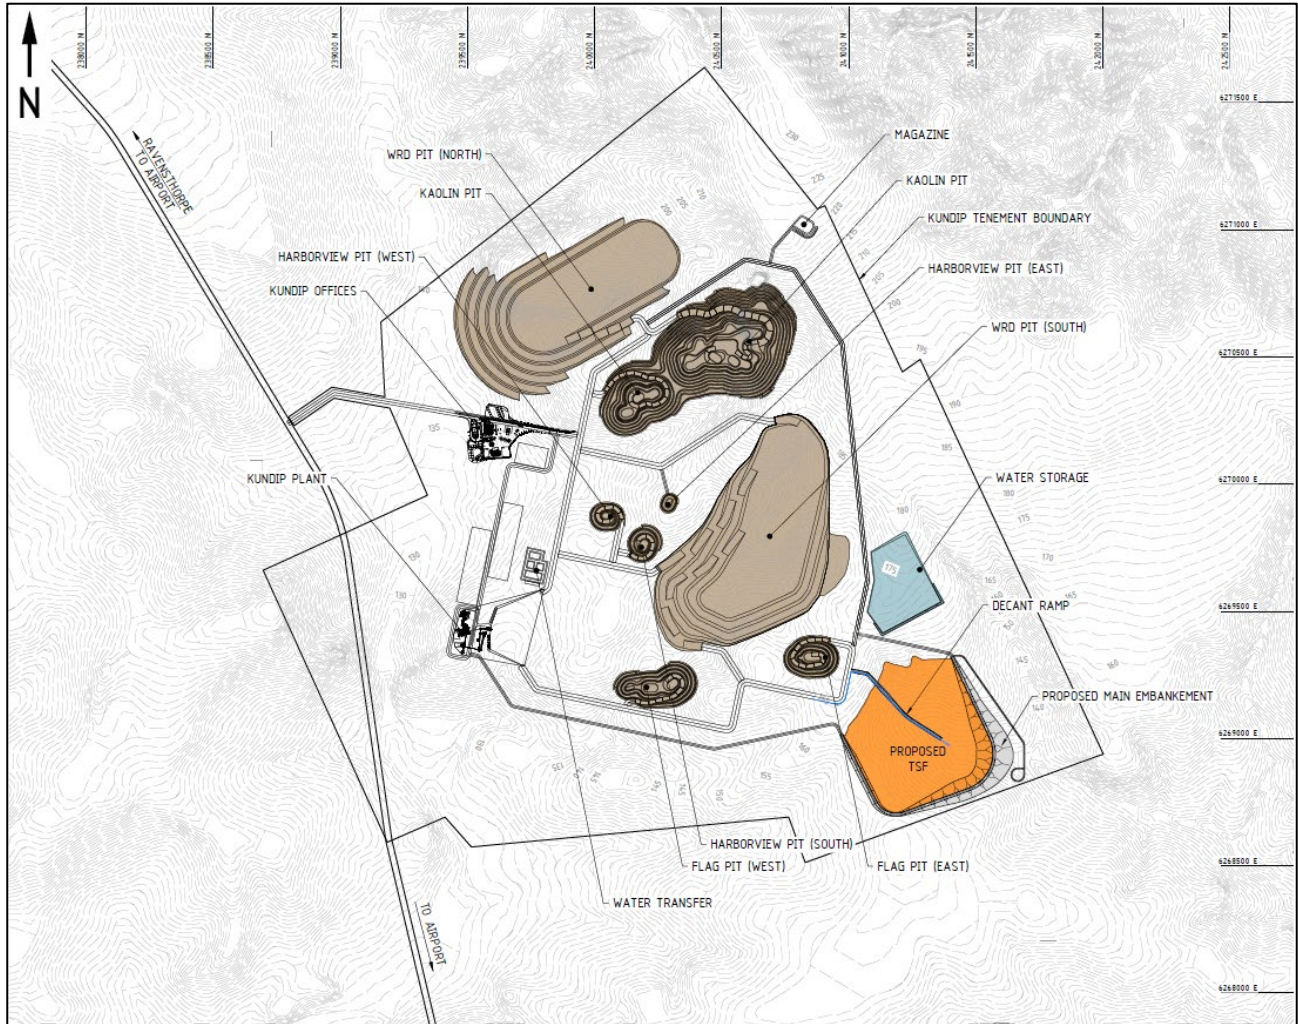
Figure 1: RGP Site layout

The Kundip Mine Site is situated approximately 20 km by road south-east of the town of Ravensthorpe and can be accessed from the Hopetoun-Ravensthorpe Road. The RGP site layout, Kundip mining tenements and location of the TSF relative the main project features is shown on Figure 1.

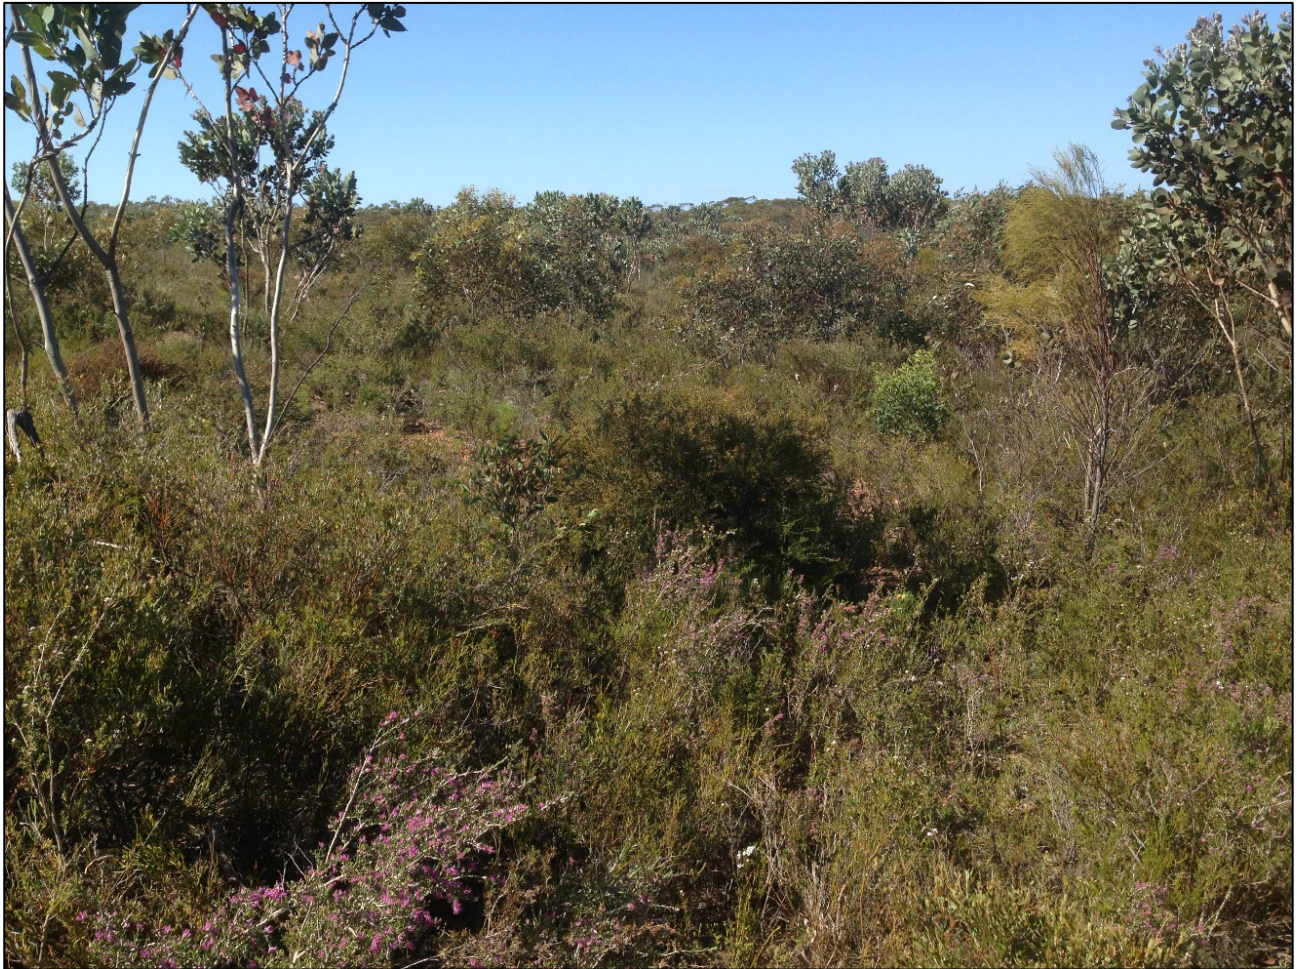
Figure 3: Proposed TSF location - upstream catchment.

The catchment upstream of the proposed TSF location is densely vegetated as shown on Figure 3.

An appropriate rational method runoff coefficient for heavily vegetated areas with loamy soil such as those observed for the TSF catchment would be in the range of $C = 0.05$ to 0.25 . Data gathered from the Australian Rainfall & Runoff Data Hub (accessed 6 November 2017) for the proposed TSF location indicate storm initial losses and continuing losses at 28.0 mm and 1.5 mm/hr respectively; roughly equating to a rational method runoff coefficient of $C = 0.21$ for a 1:100-yr 72-hr event. A conservative runoff coefficient of $C = 1.0$ and $C = 0.25$ for the tailings surface (18.9 ha) and upstream catchment (18.6 ha) respectively has been adopted.

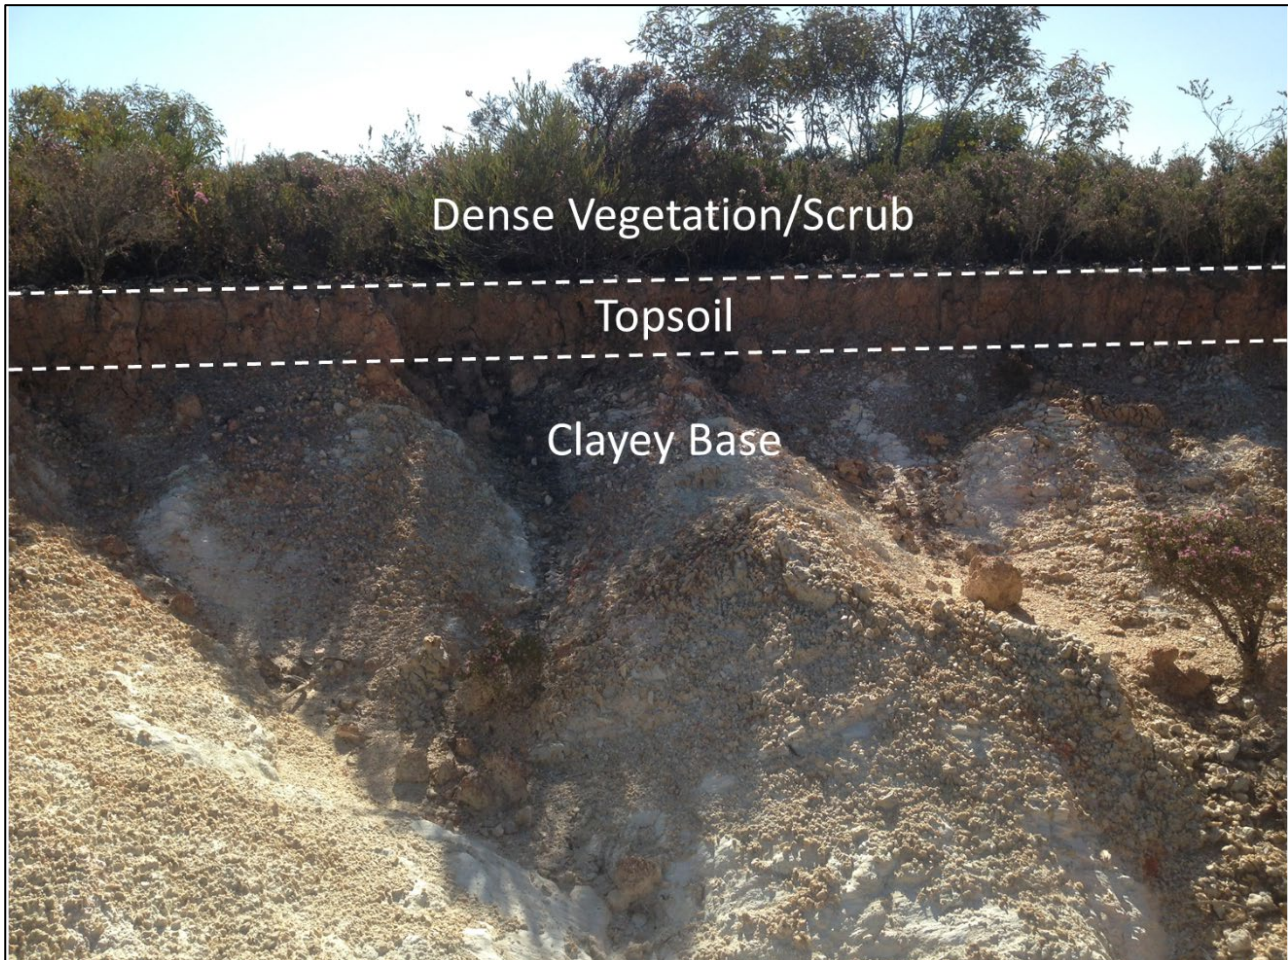
Figure 5: TSF basin - shallow subsurface conditions

Additionally, during a site visit undertaken on 19 October 2017, a portion of the TSF basin was accessible from an existing access track. In an area disturbed by previous prospecting activities a glimpse into the shallow subsurface conditions was gained by viewing the disturbed areas within the TSF basin. The exposed profile captured in Figure 5 shows dense vegetation/scrub underlain by 300 to 500 mm of topsoil with a clayey base below.

The geotechnical investigation undertaken by MHA further confirmed the general shallow subsurface stratigraphy. The foundation directly beneath the proposed TSF main embankment was not accessible during the site visit. At this stage it is assumed that the subsurface conditions beneath the main embankment are similar to the test locations immediately upstream of the embankment. Assumed geotechnical parameters for the embankment foundation are presented in Section 3.4.1.3.

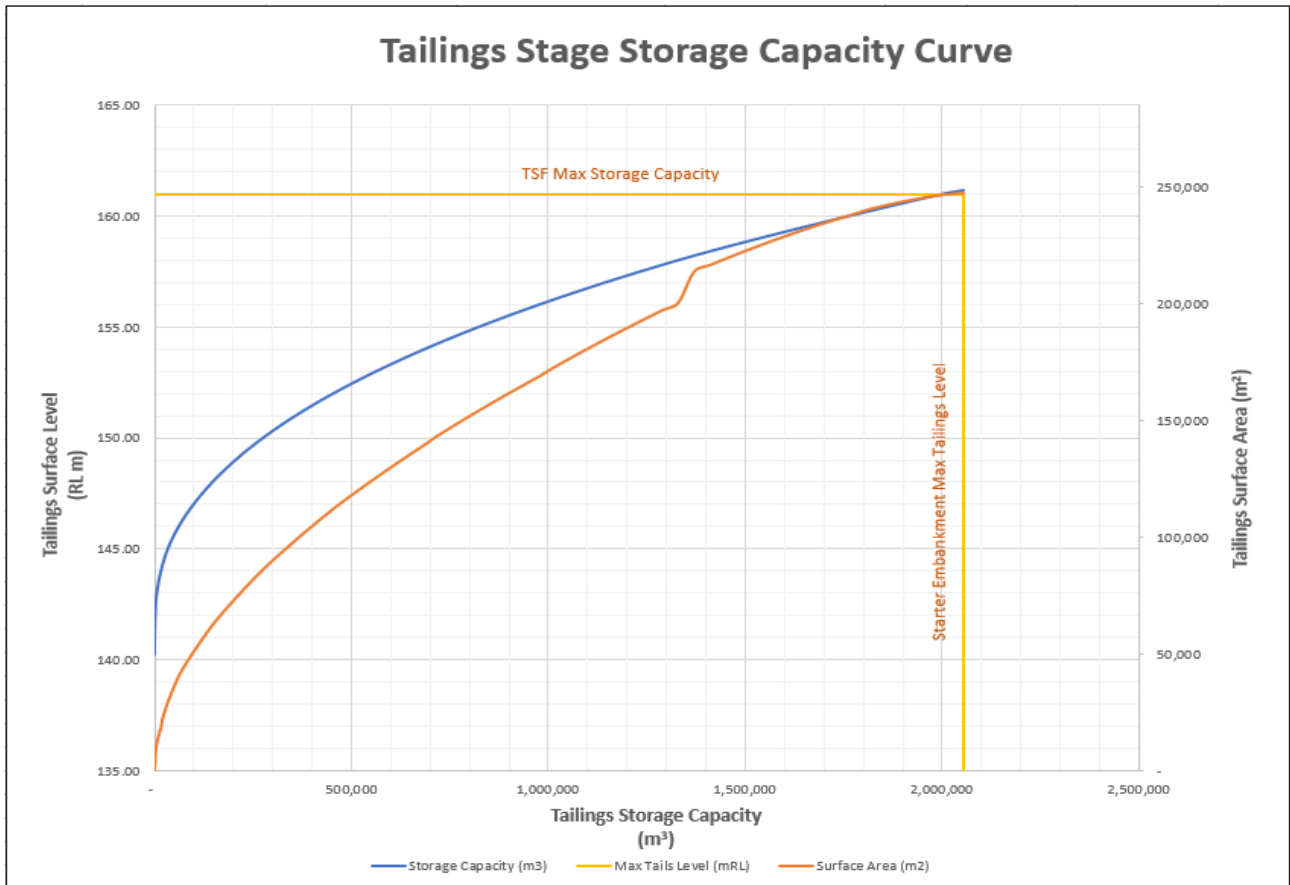
Figure 11: Tailings storage capacity curve

Development (filling) of the TSF is shown graphically on Figure 11 and Figure 12 in terms of storage volume, tailings surface area and time rate of rise.

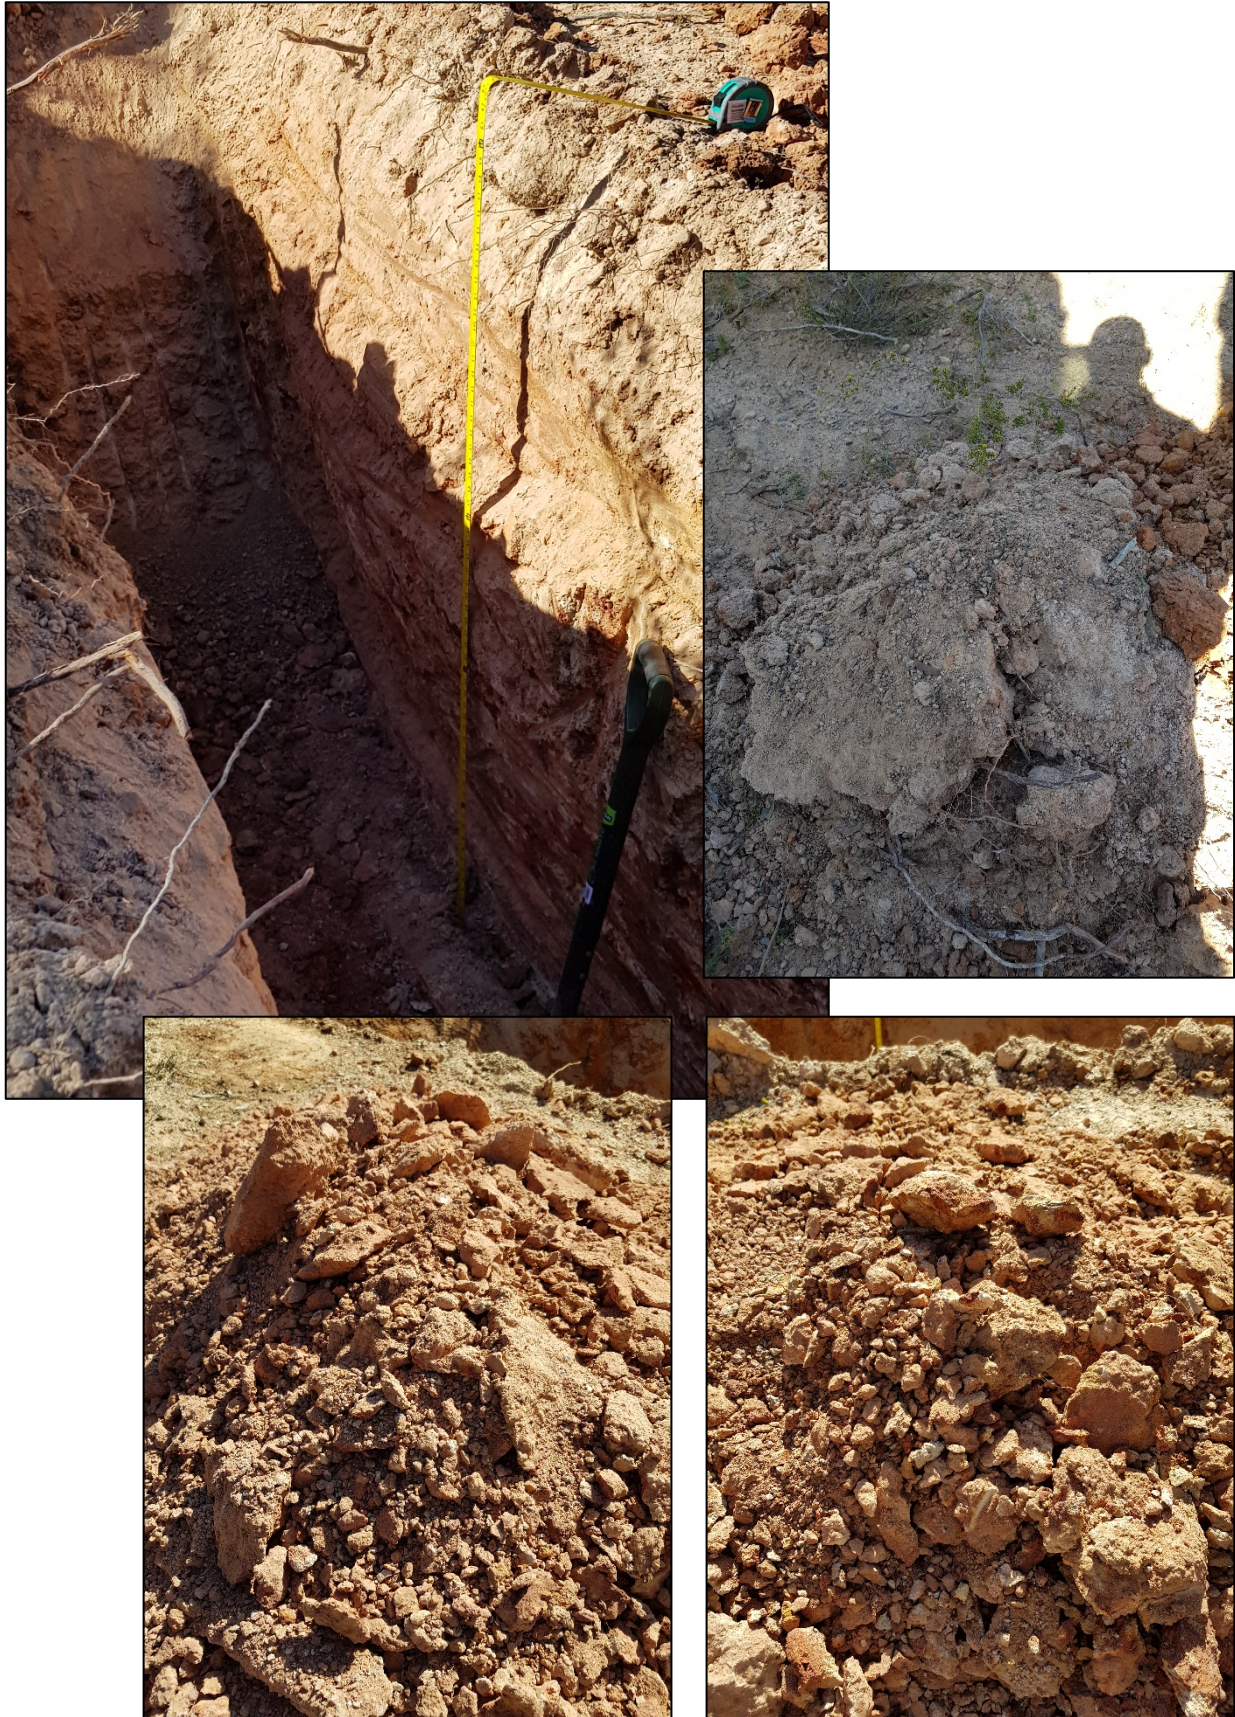
Test pit TP 01 – 1.6m to refusal, 3 soil horizons in a clockwise rotation starting top right; TOPSOIL, ALLUVIUM (red brown sandy silt) and ALLUVIUM (white mottled sandy silt).

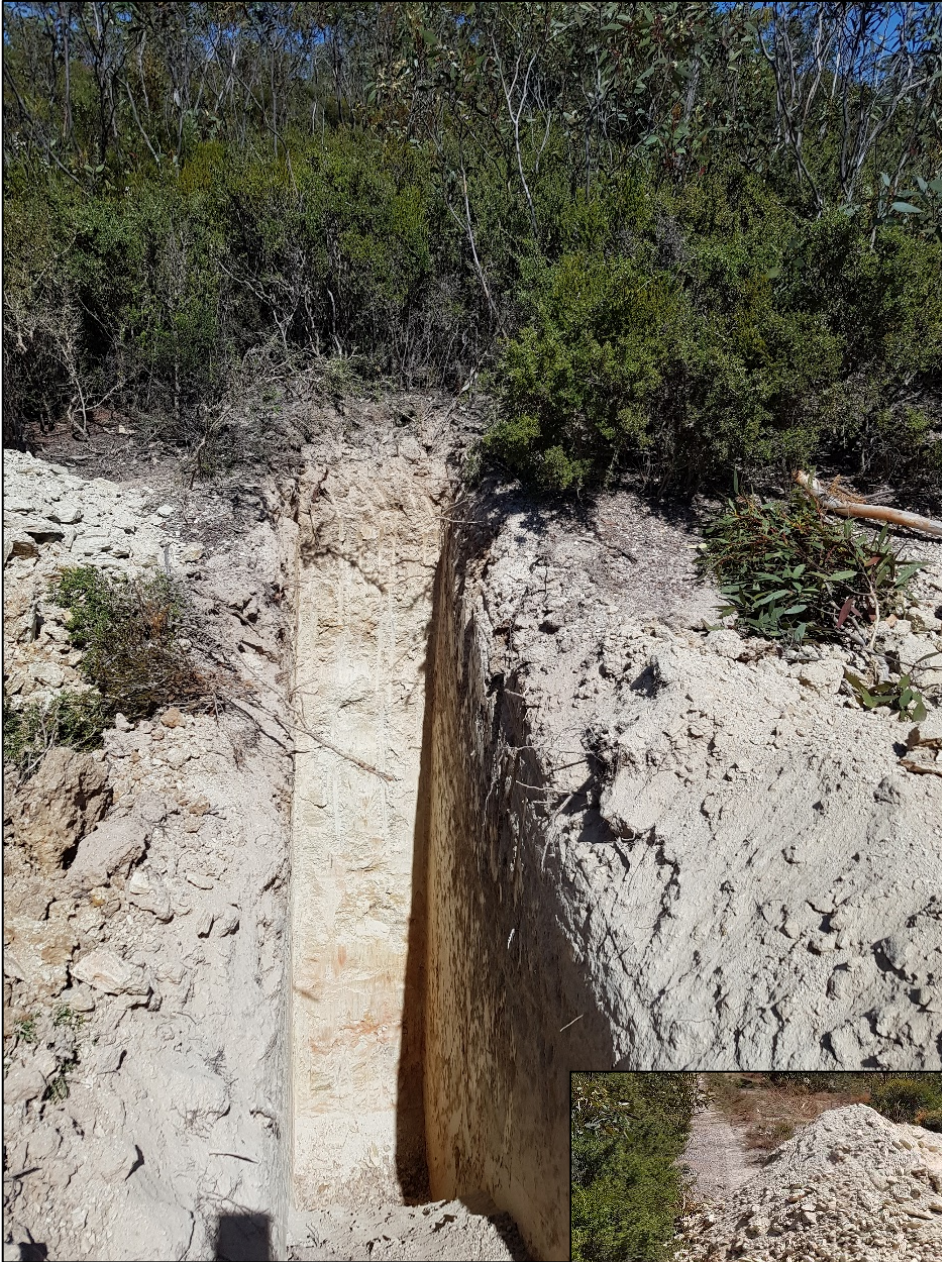
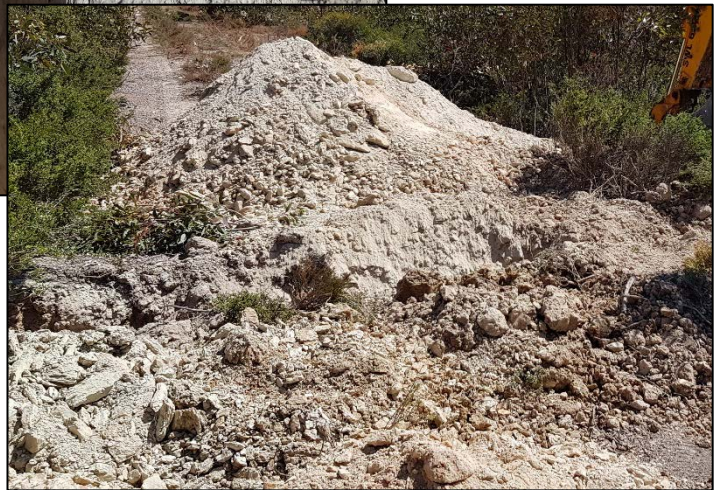
Test pit TP 03 – 3.0m to refusal, 2 soil horizons; TOPSOIL and ALLUVIUM (red brown sandy silt) and ALLUVIUM (white mottled sandy silt).

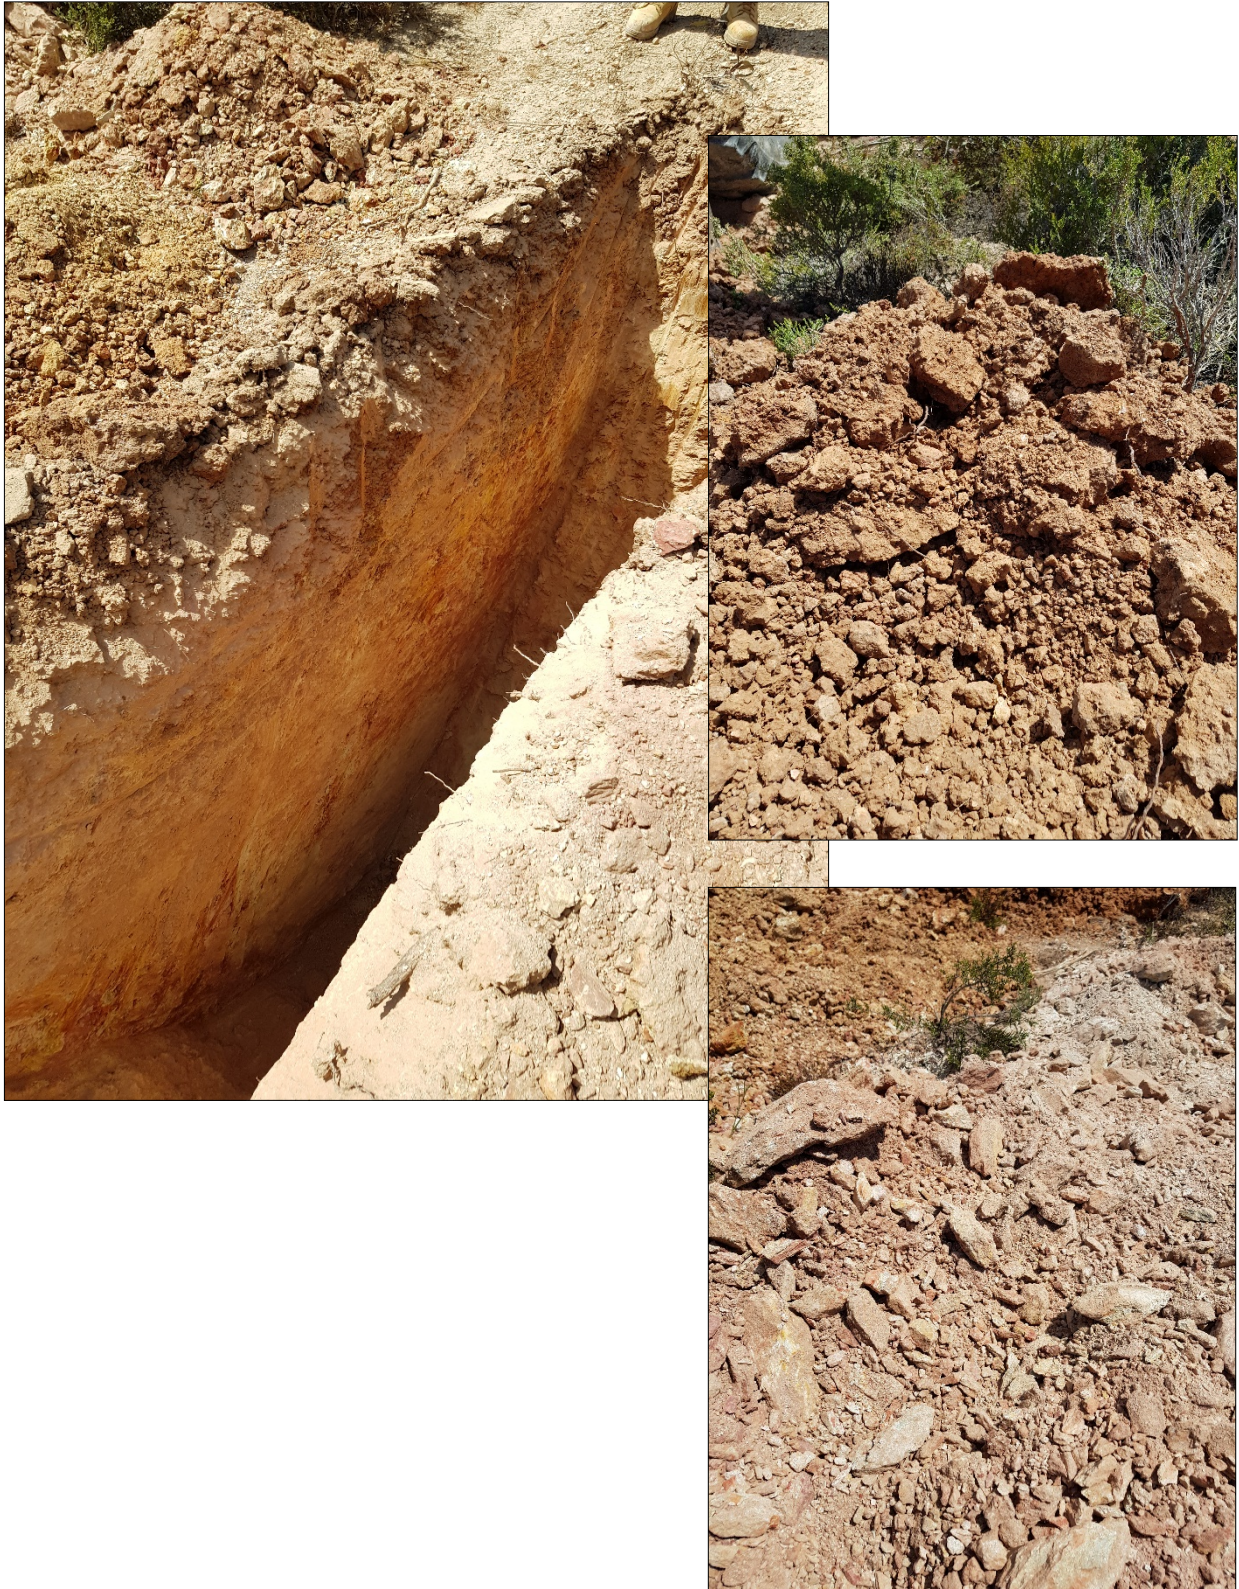
Test pit TP 04 – 3.1m terminated, 2 soil horizons; TOPSOIL and ALLUVIUM (red brown sandy silt) and ALLUVIUM (white mottled sandy silt).

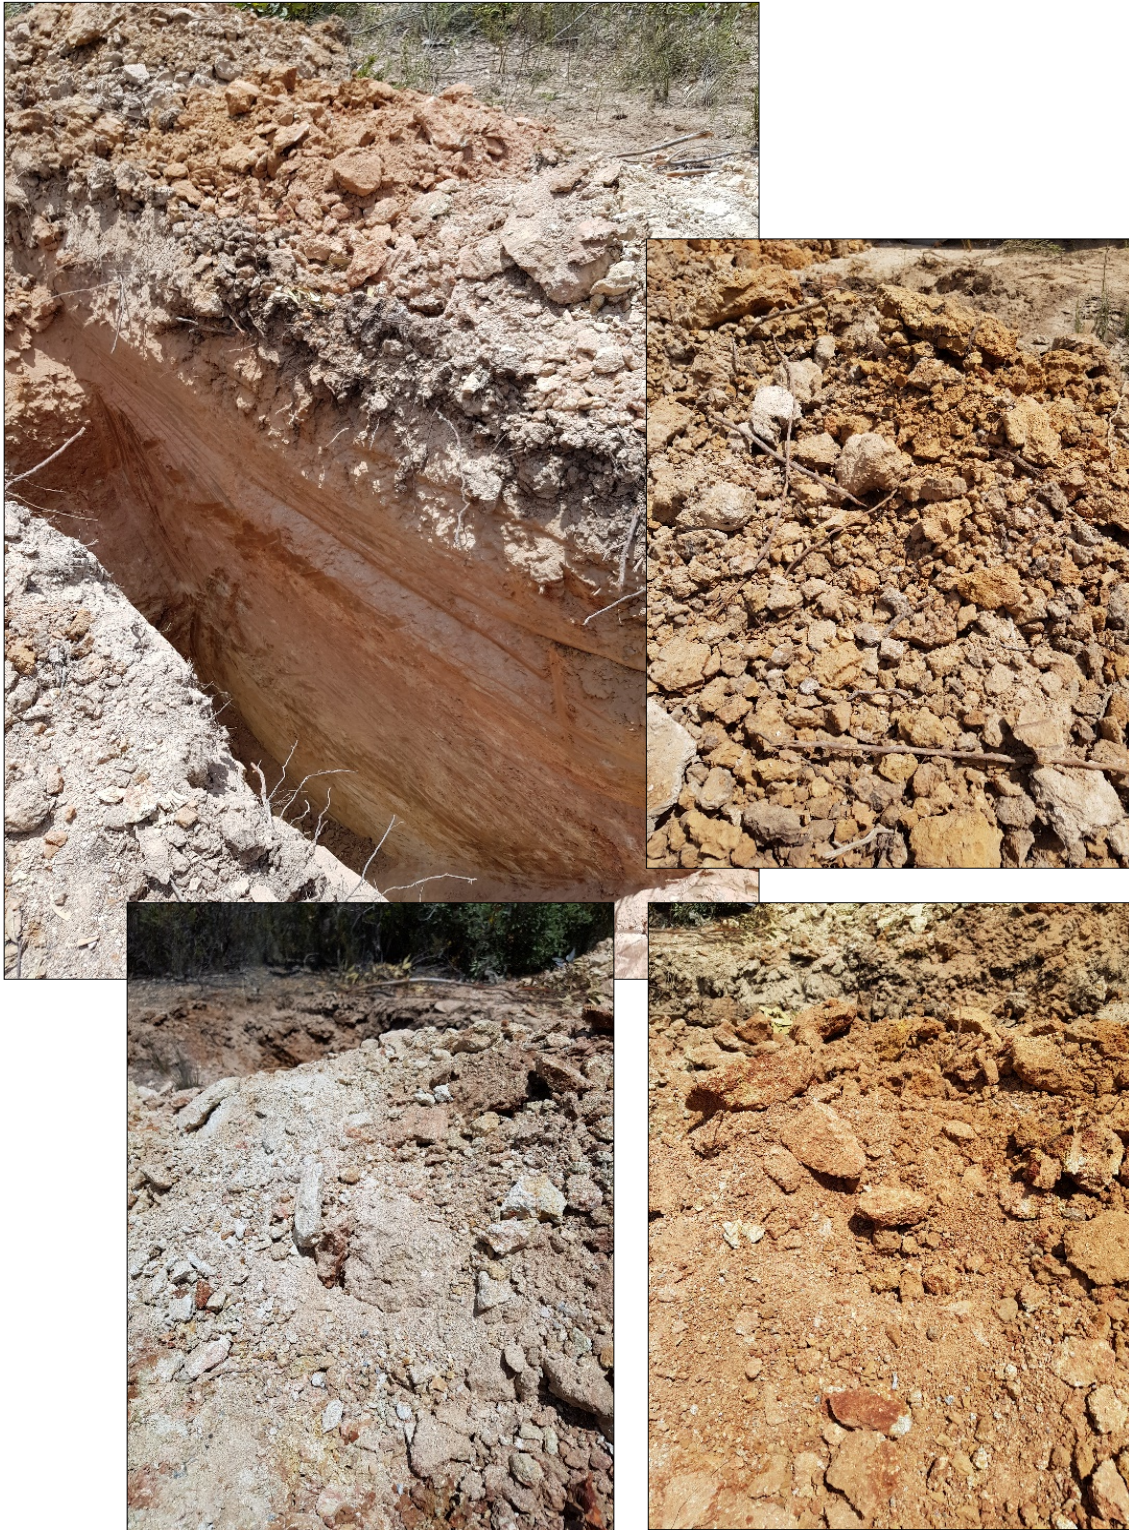
Test pit TP 05 – 2.9m terminated, 4 soil horizons; TOPSOIL and 3 grades of ALLUVIUM; light brown silt, red brown gravelly silt and grey white sandy silt.

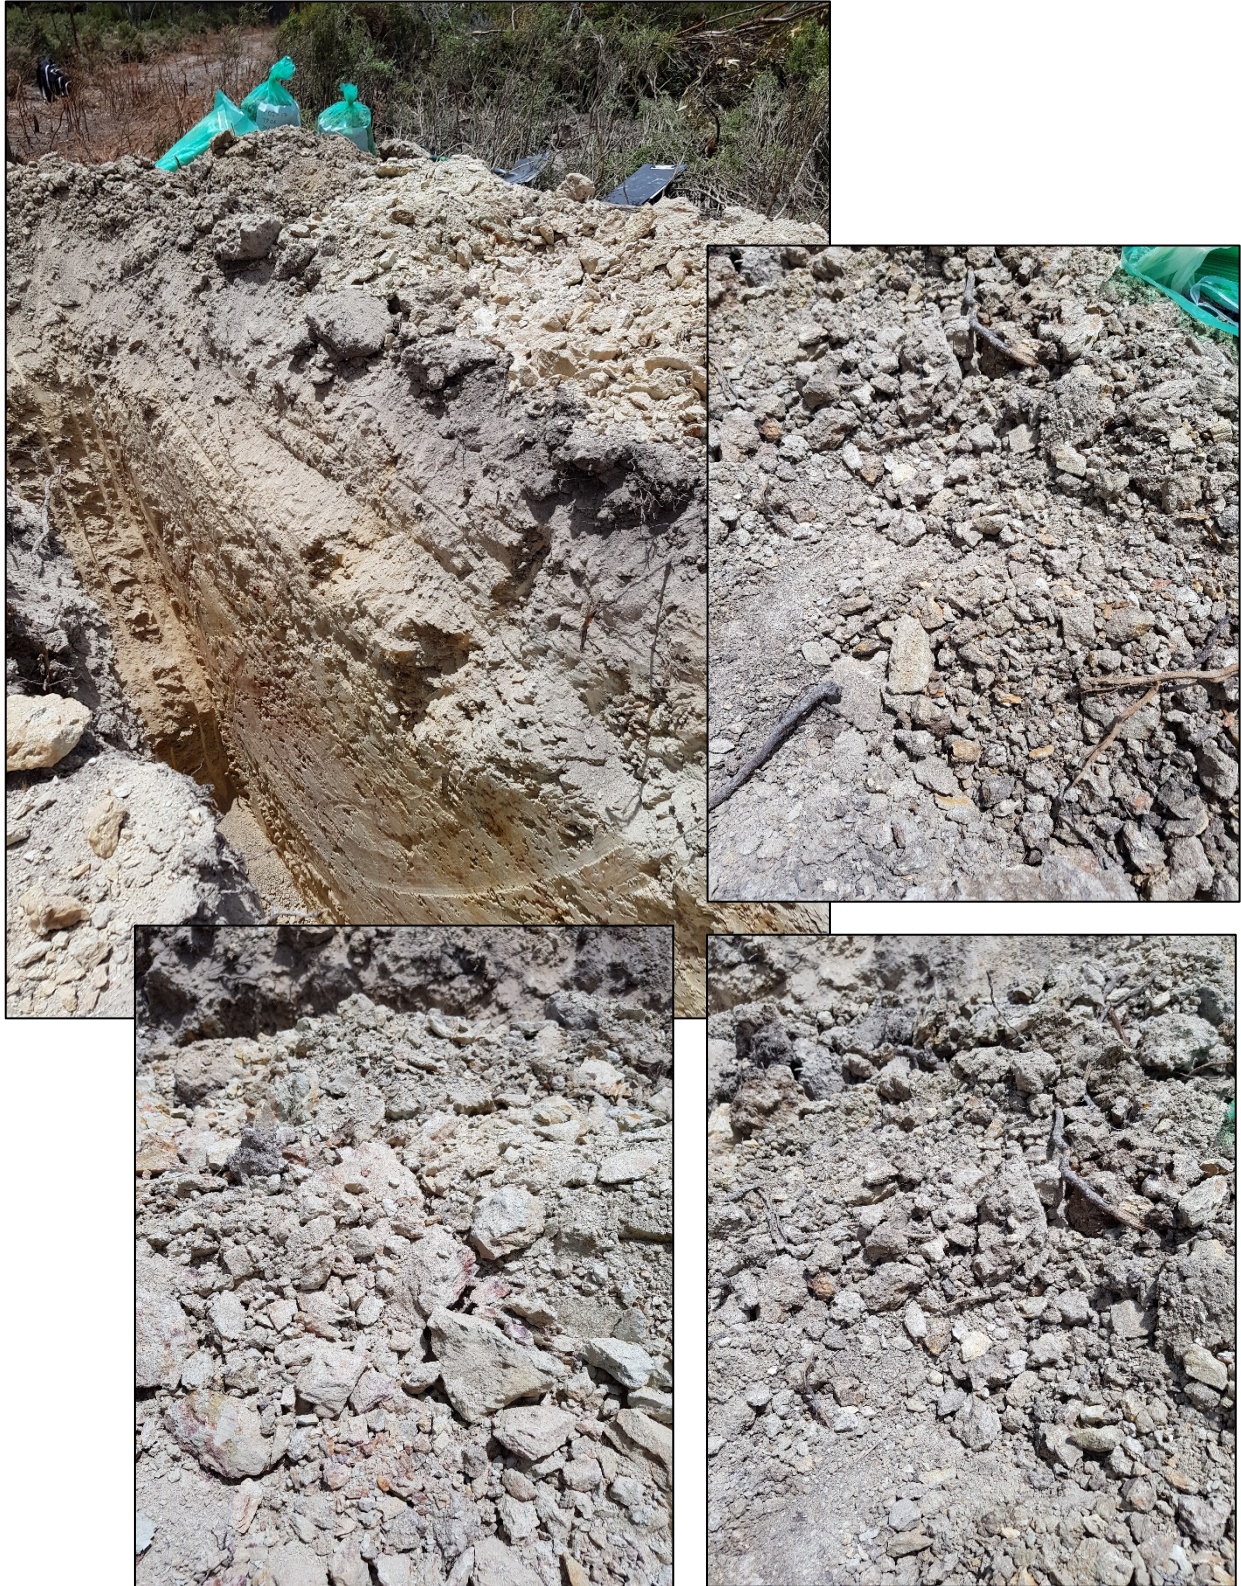
Test pit TP 06 – 2.7m terminated, 3 soil horizons; TOPSOIL and 2 grades of ALLUVIUM; predominantly composed of the grey white siltstone, however with darker grey gravelly material.

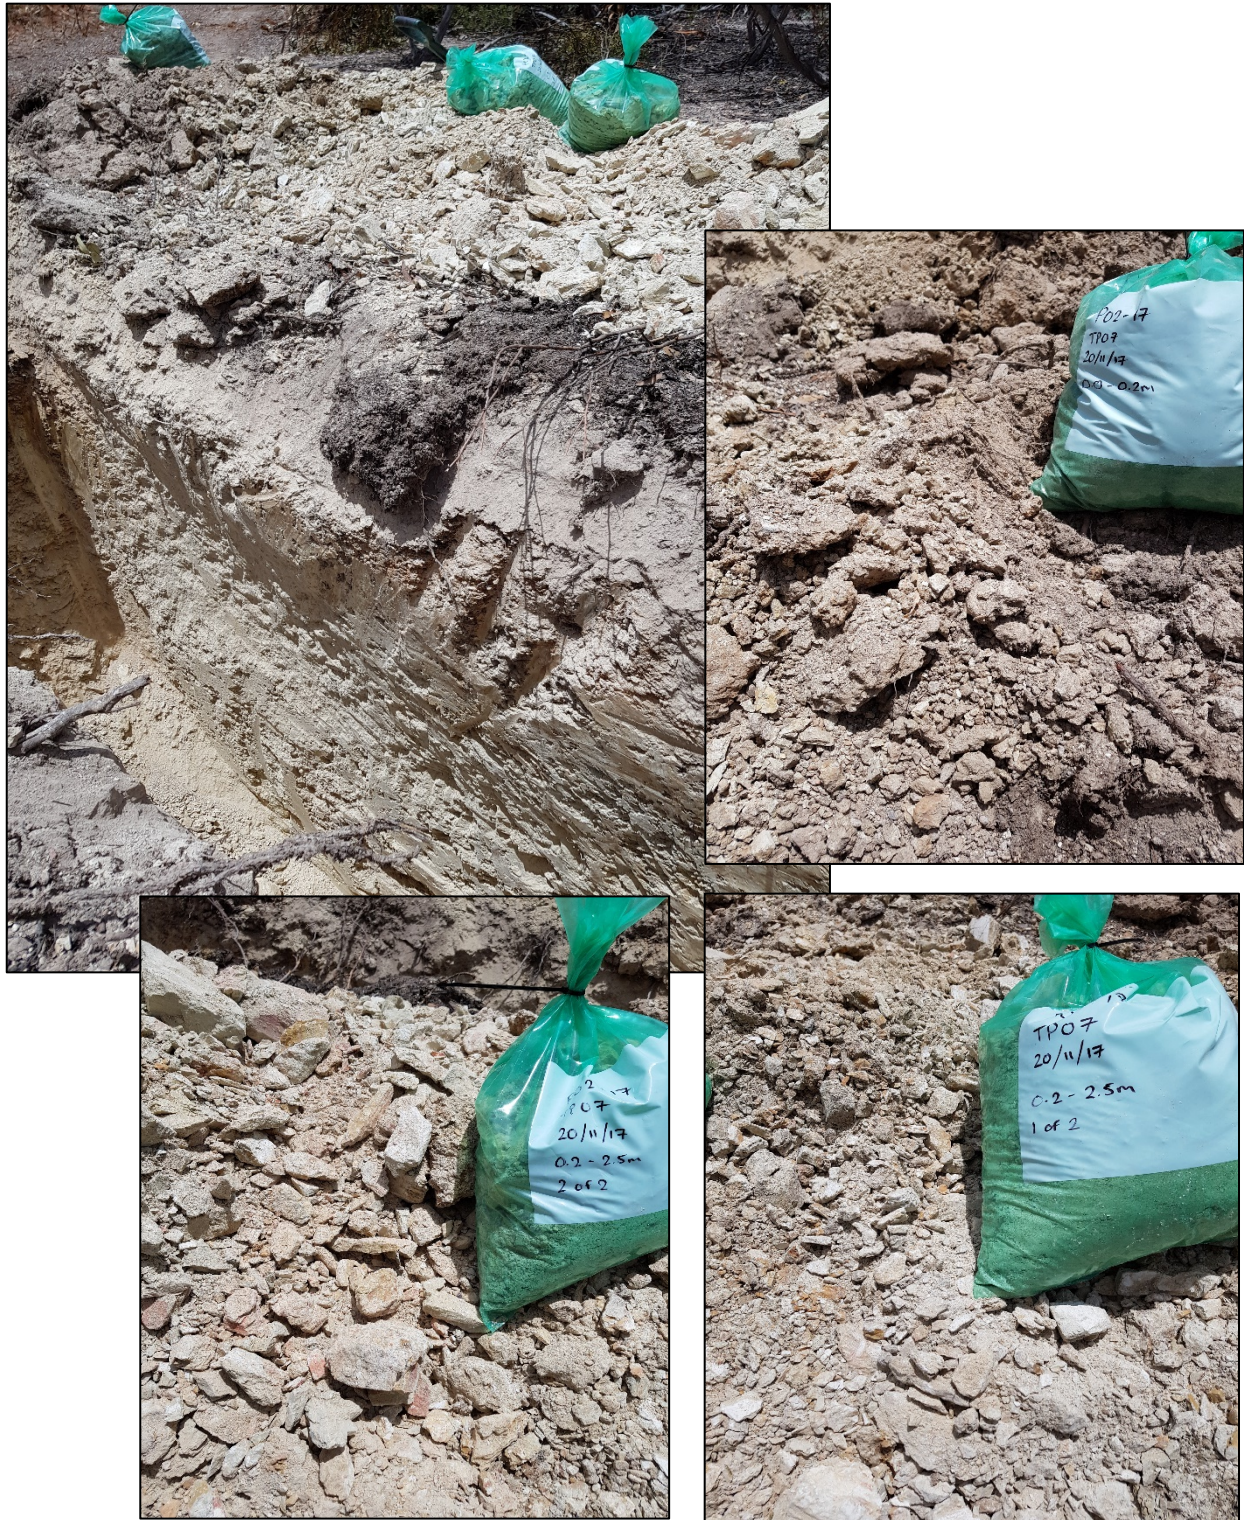
Test pit TP 07 – 2.5m terminated, 3 soil horizons; TOPSOIL and 2 grades of ALLUVIUM; 0.2m of dark grey surficial top soil blending into the typical white siltstone.

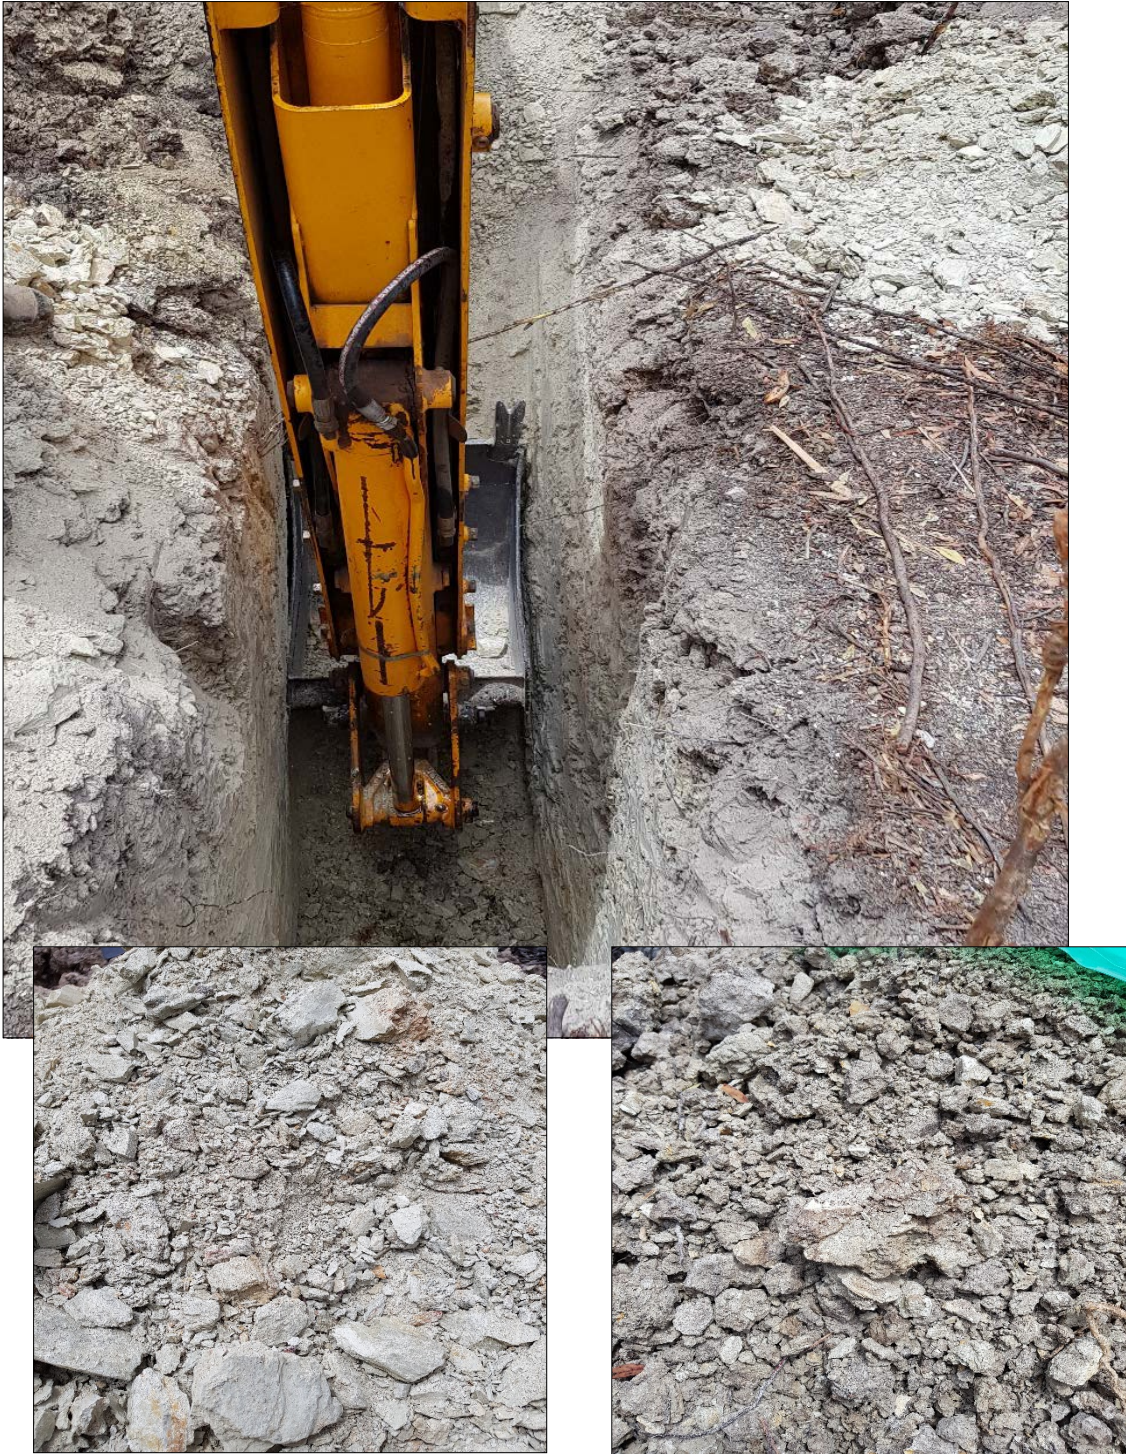
Test pit TP 08 – 2.2m terminated, 3 soil horizons; TOPSOIL and 2 grades of ALLUVIUM; 0.4m of dark grey surficial top soil blending into the white siltstone.

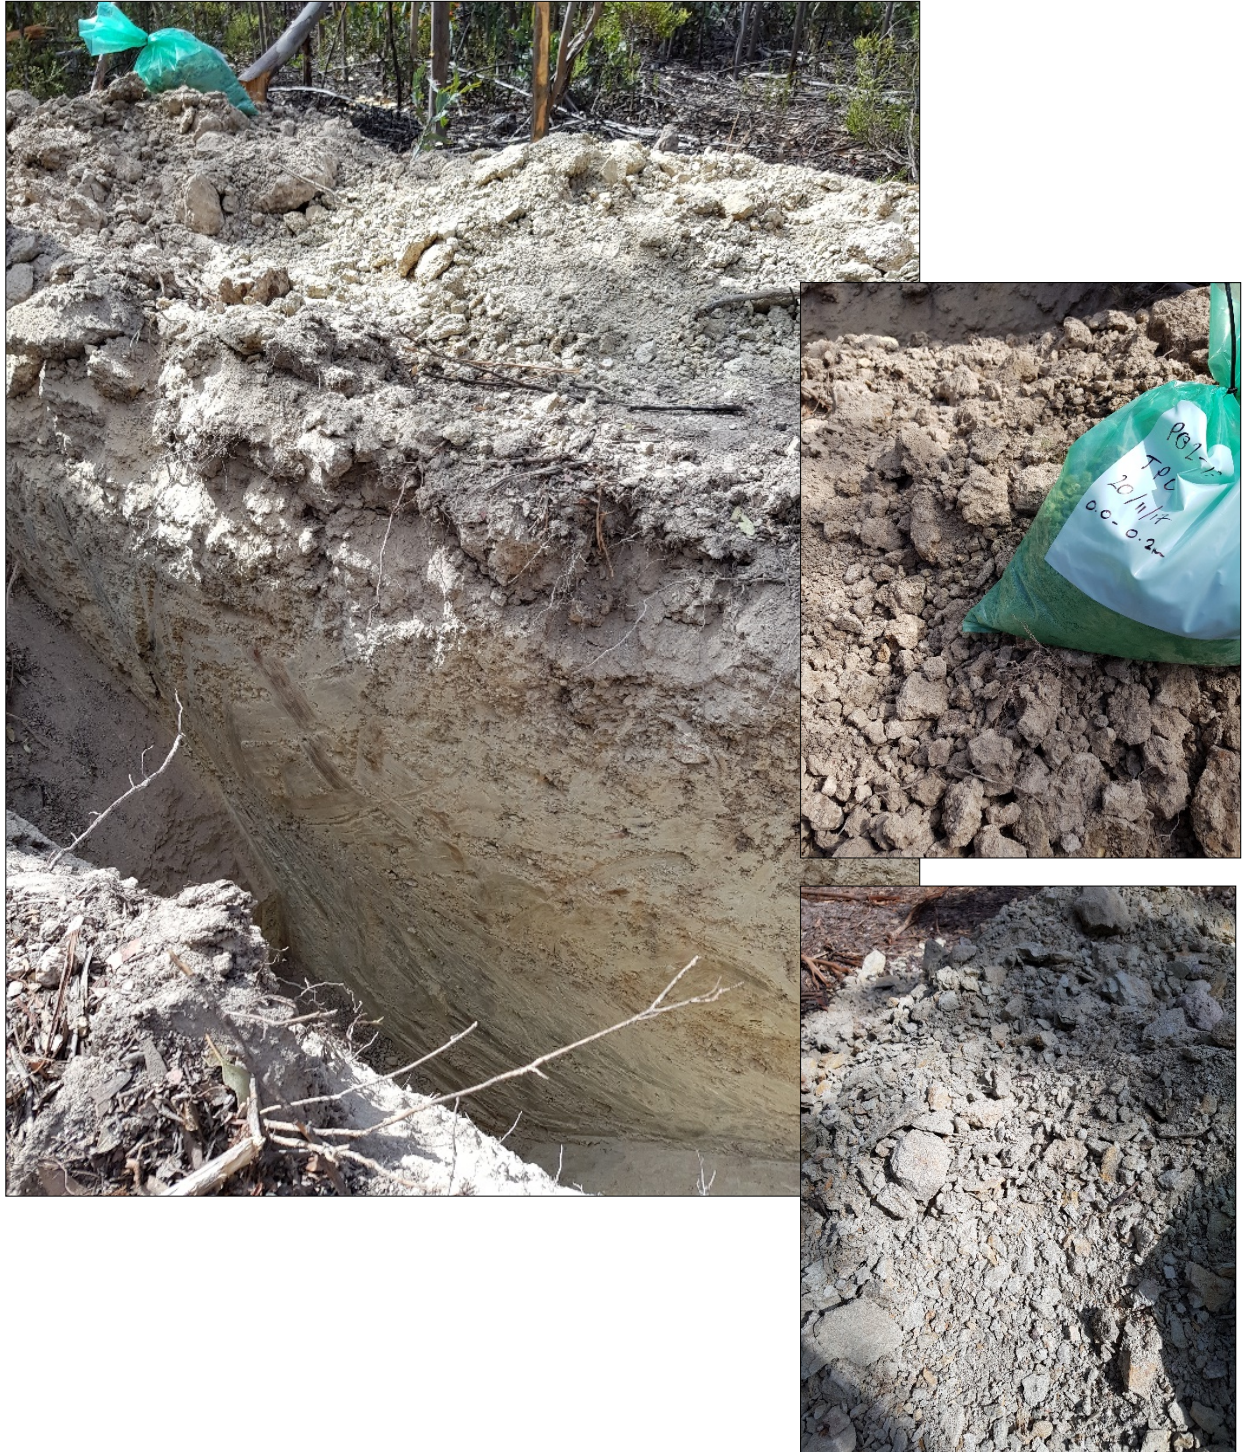
Test pit TP 09 – 2.2m terminated, 3 soil horizons. TOPSOIL and 2 grades of ALLUVIUM; grey surficial top soil blending into the white siltstone.
