## Preliminary Site Investigation

Anketell Road and Thomas Road Transport Corridor (West Site)

23 January 2024

## Preliminary Site Investigation, Anketell Road-Thomas Road Freight Corridor (West Site)

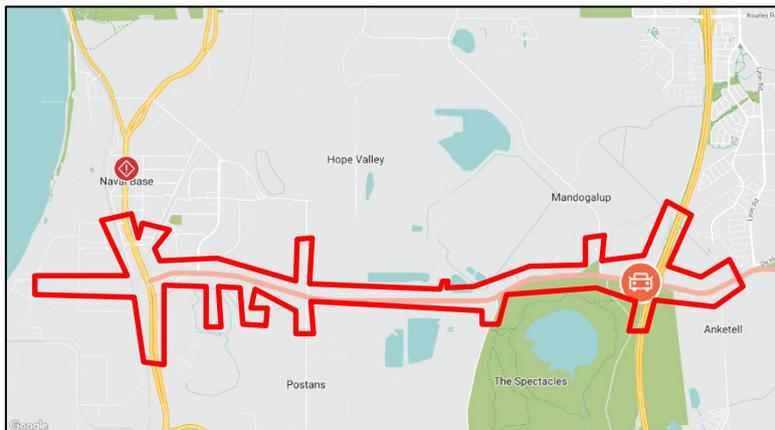
**Figure 2-1: Anketell Road Upgrade (the site)**

The site shown in **Figure 2-1** below outlines the area of expansion works proposed at the time of this report.

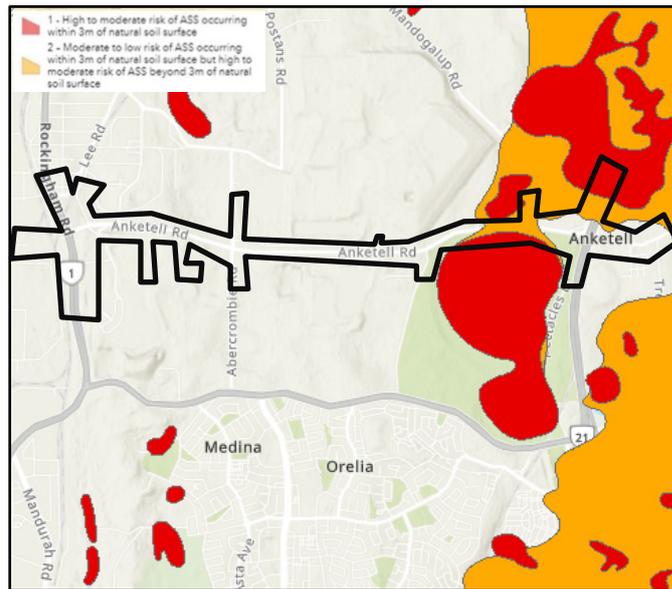
Figure 2-2: ASS Risk Map and Approximate Site Boundary (DWER 2017)

Review of the DWER ASS Risk Map (DWER 2023a), indicates that most of the site to the west of Clementi Road have no known risk of ASS. A moderate to low risk of ASS occurrence in the top 3 m of natural soils was shown between Clementi Road and Mandogalup Road before returning no known risk until Lyon Road. From Lyon Road to the eastern extent of the site is listed as a moderate to low risk of ASS. It is however noted that in several instances, as shown below in **Figure 2-2**, that there are areas of high to moderate risk within close proximity to the site (or within the site). Disturbance of these soils may lead to acidification and mobilisation of metals in surface water bodies.

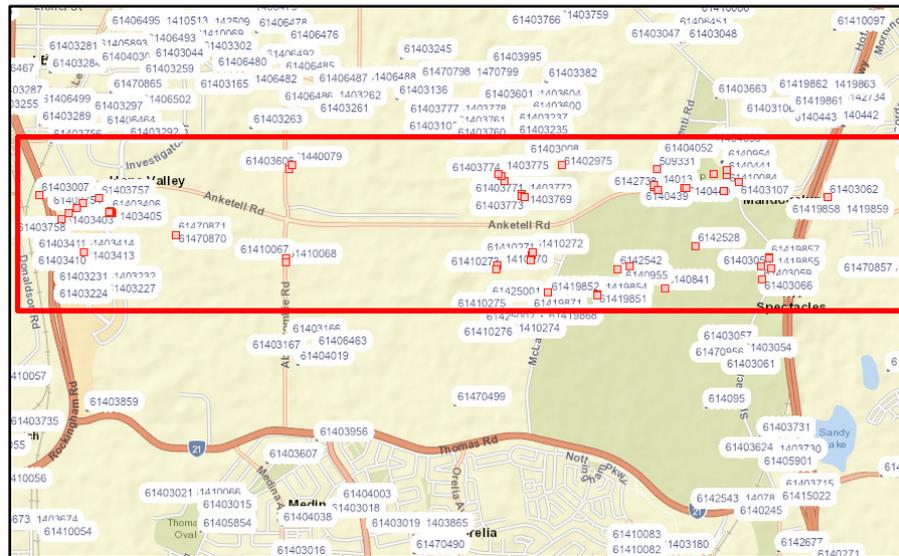
**Figure 2-3: WIR Registered Bore Selection**

Review of relative bore location and available information indicates groundwater bores may be associated with stormwater drainage, water catchments, or monitoring of groundwater conditions surrounding contaminating sites. Bores or monitoring wells observed on site are further described in **Appendix A**.

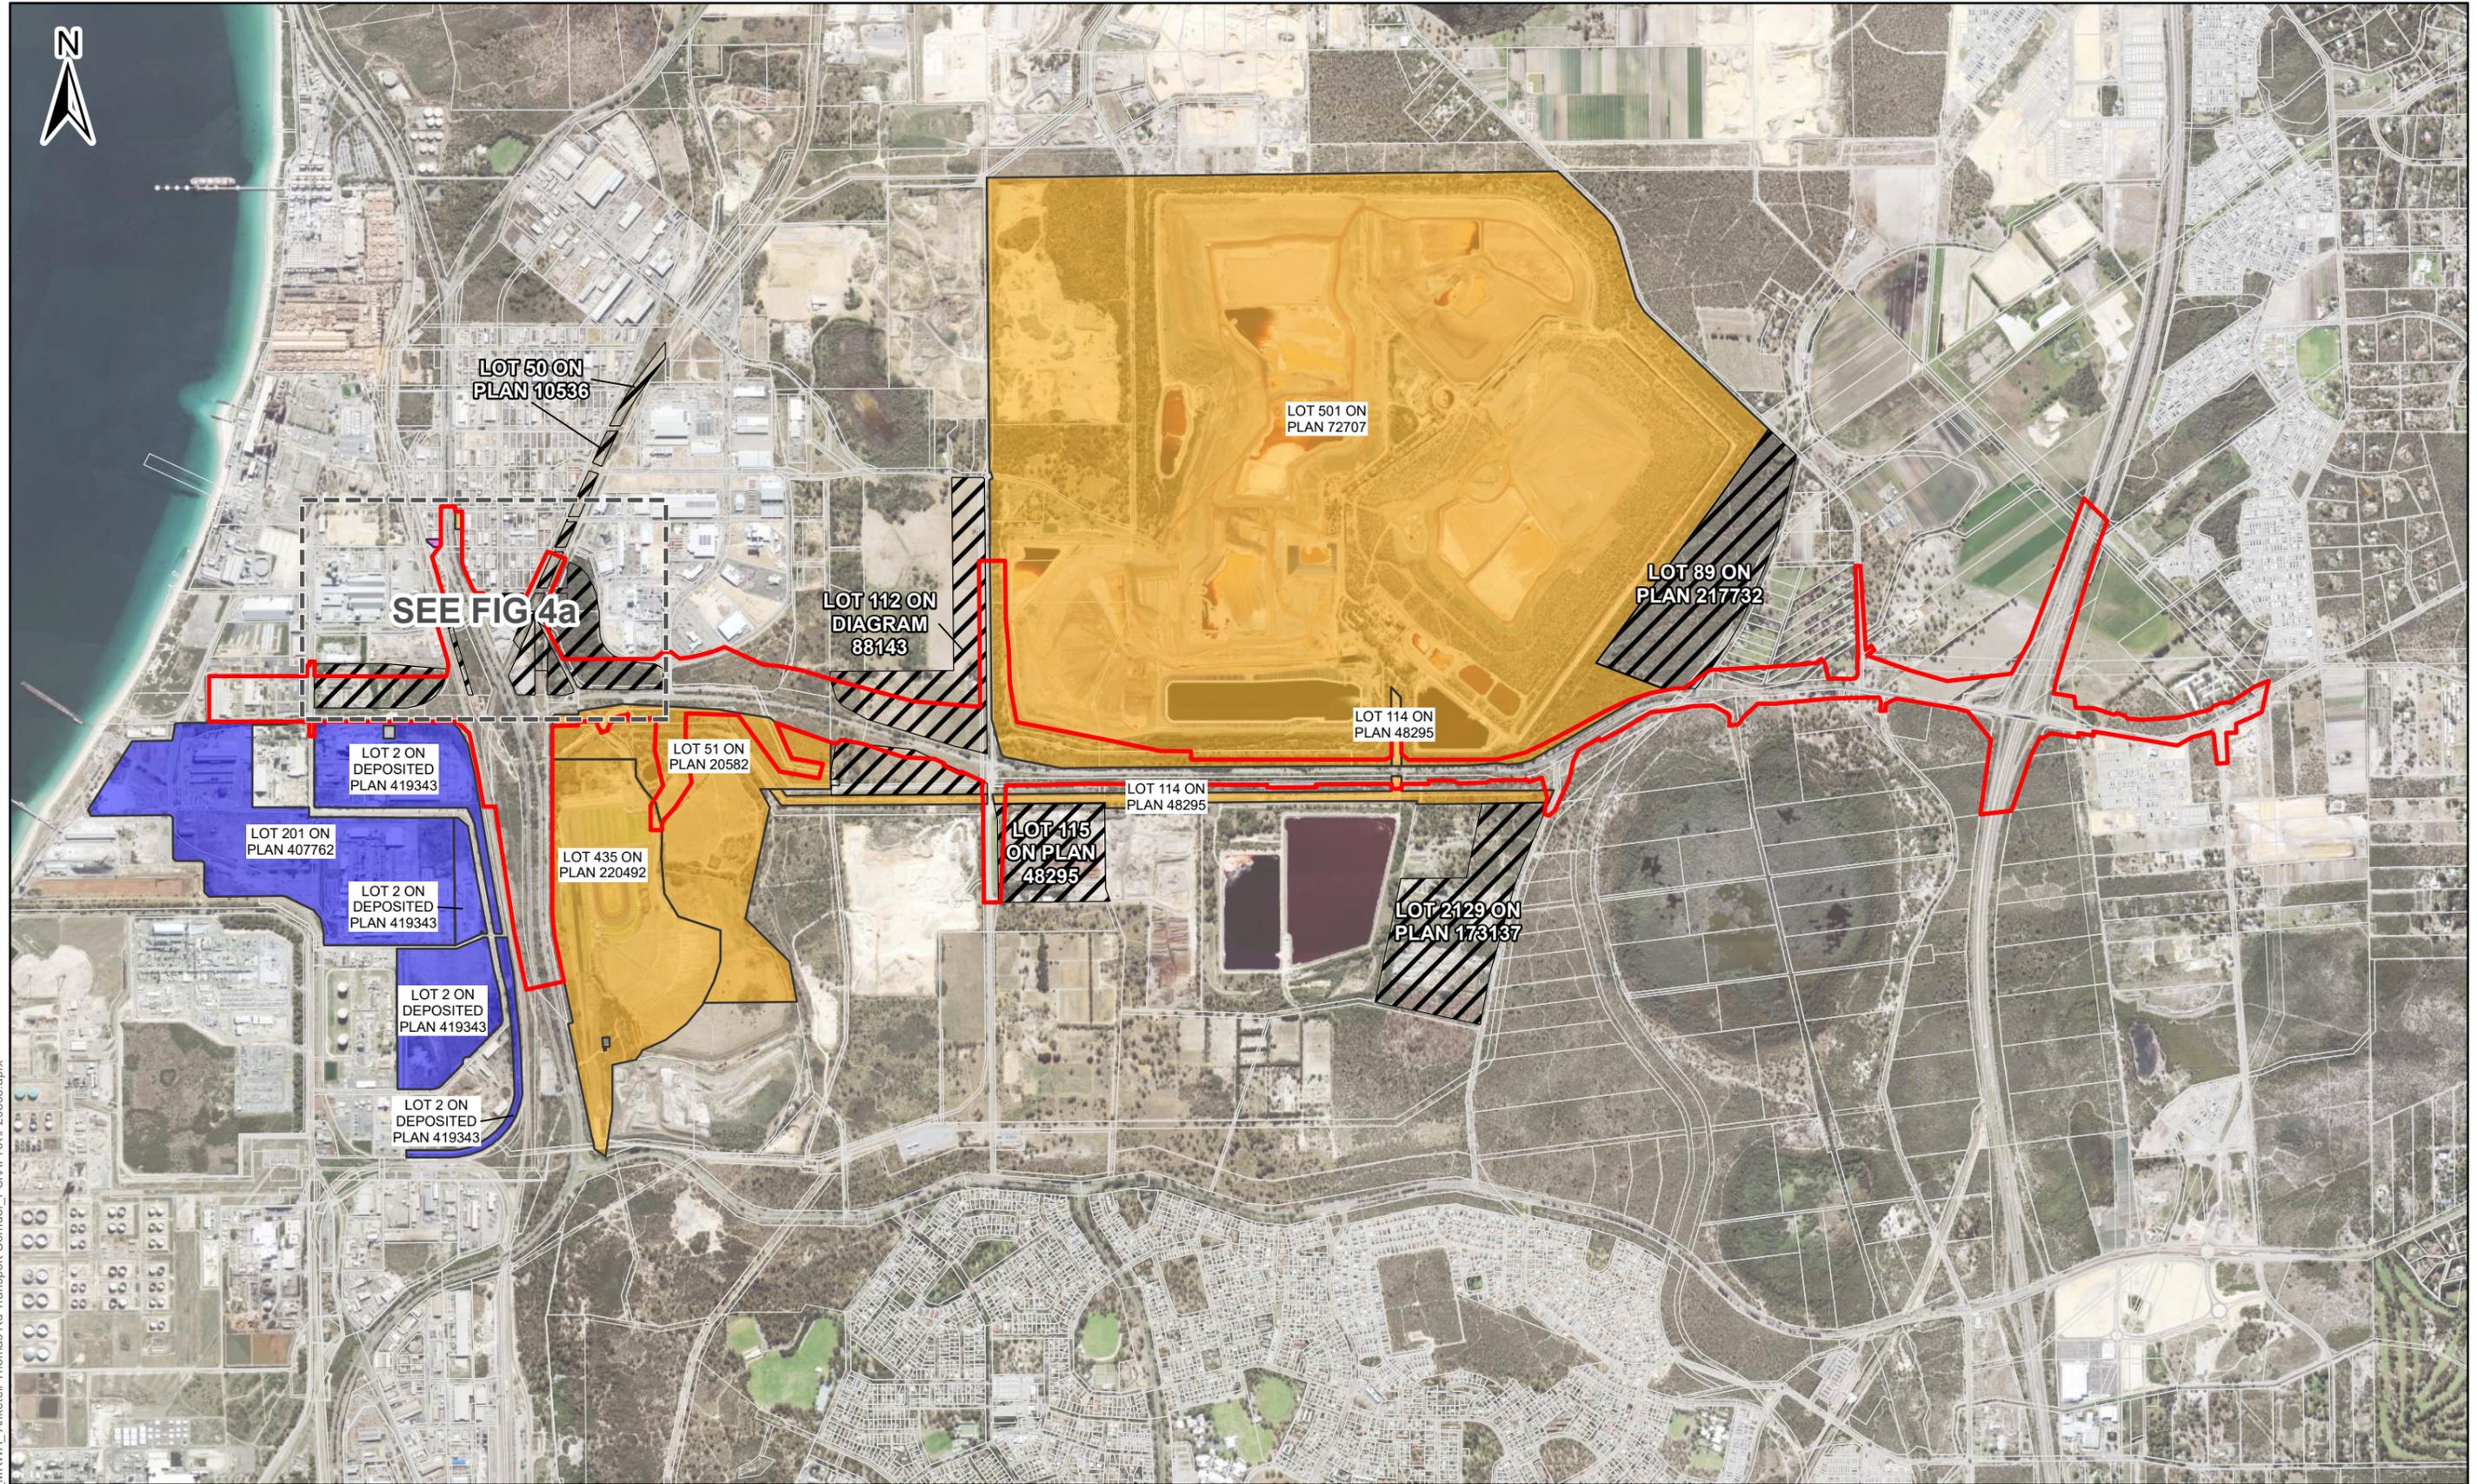
<b>Figure No:</b>	<b>3</b>
<b>Title:</b>	<b>Site Inspection Observations</b>
Project:	Anketell Road Transport Corridor Preliminary Site Investigation
Location:	Anketell Rd, Anketell, WA 6167
Client:	MRWA

Several fragments of PACM were observed on the ground surface on the northwest verge of the intersection of Beard Street and Rockingham Road. Fragments were bonded cement sheeting, in good condition and were approximately 20 x 30 x 5 mm in size. A fragment was collected for analysis (see point 90 on Figure 3).

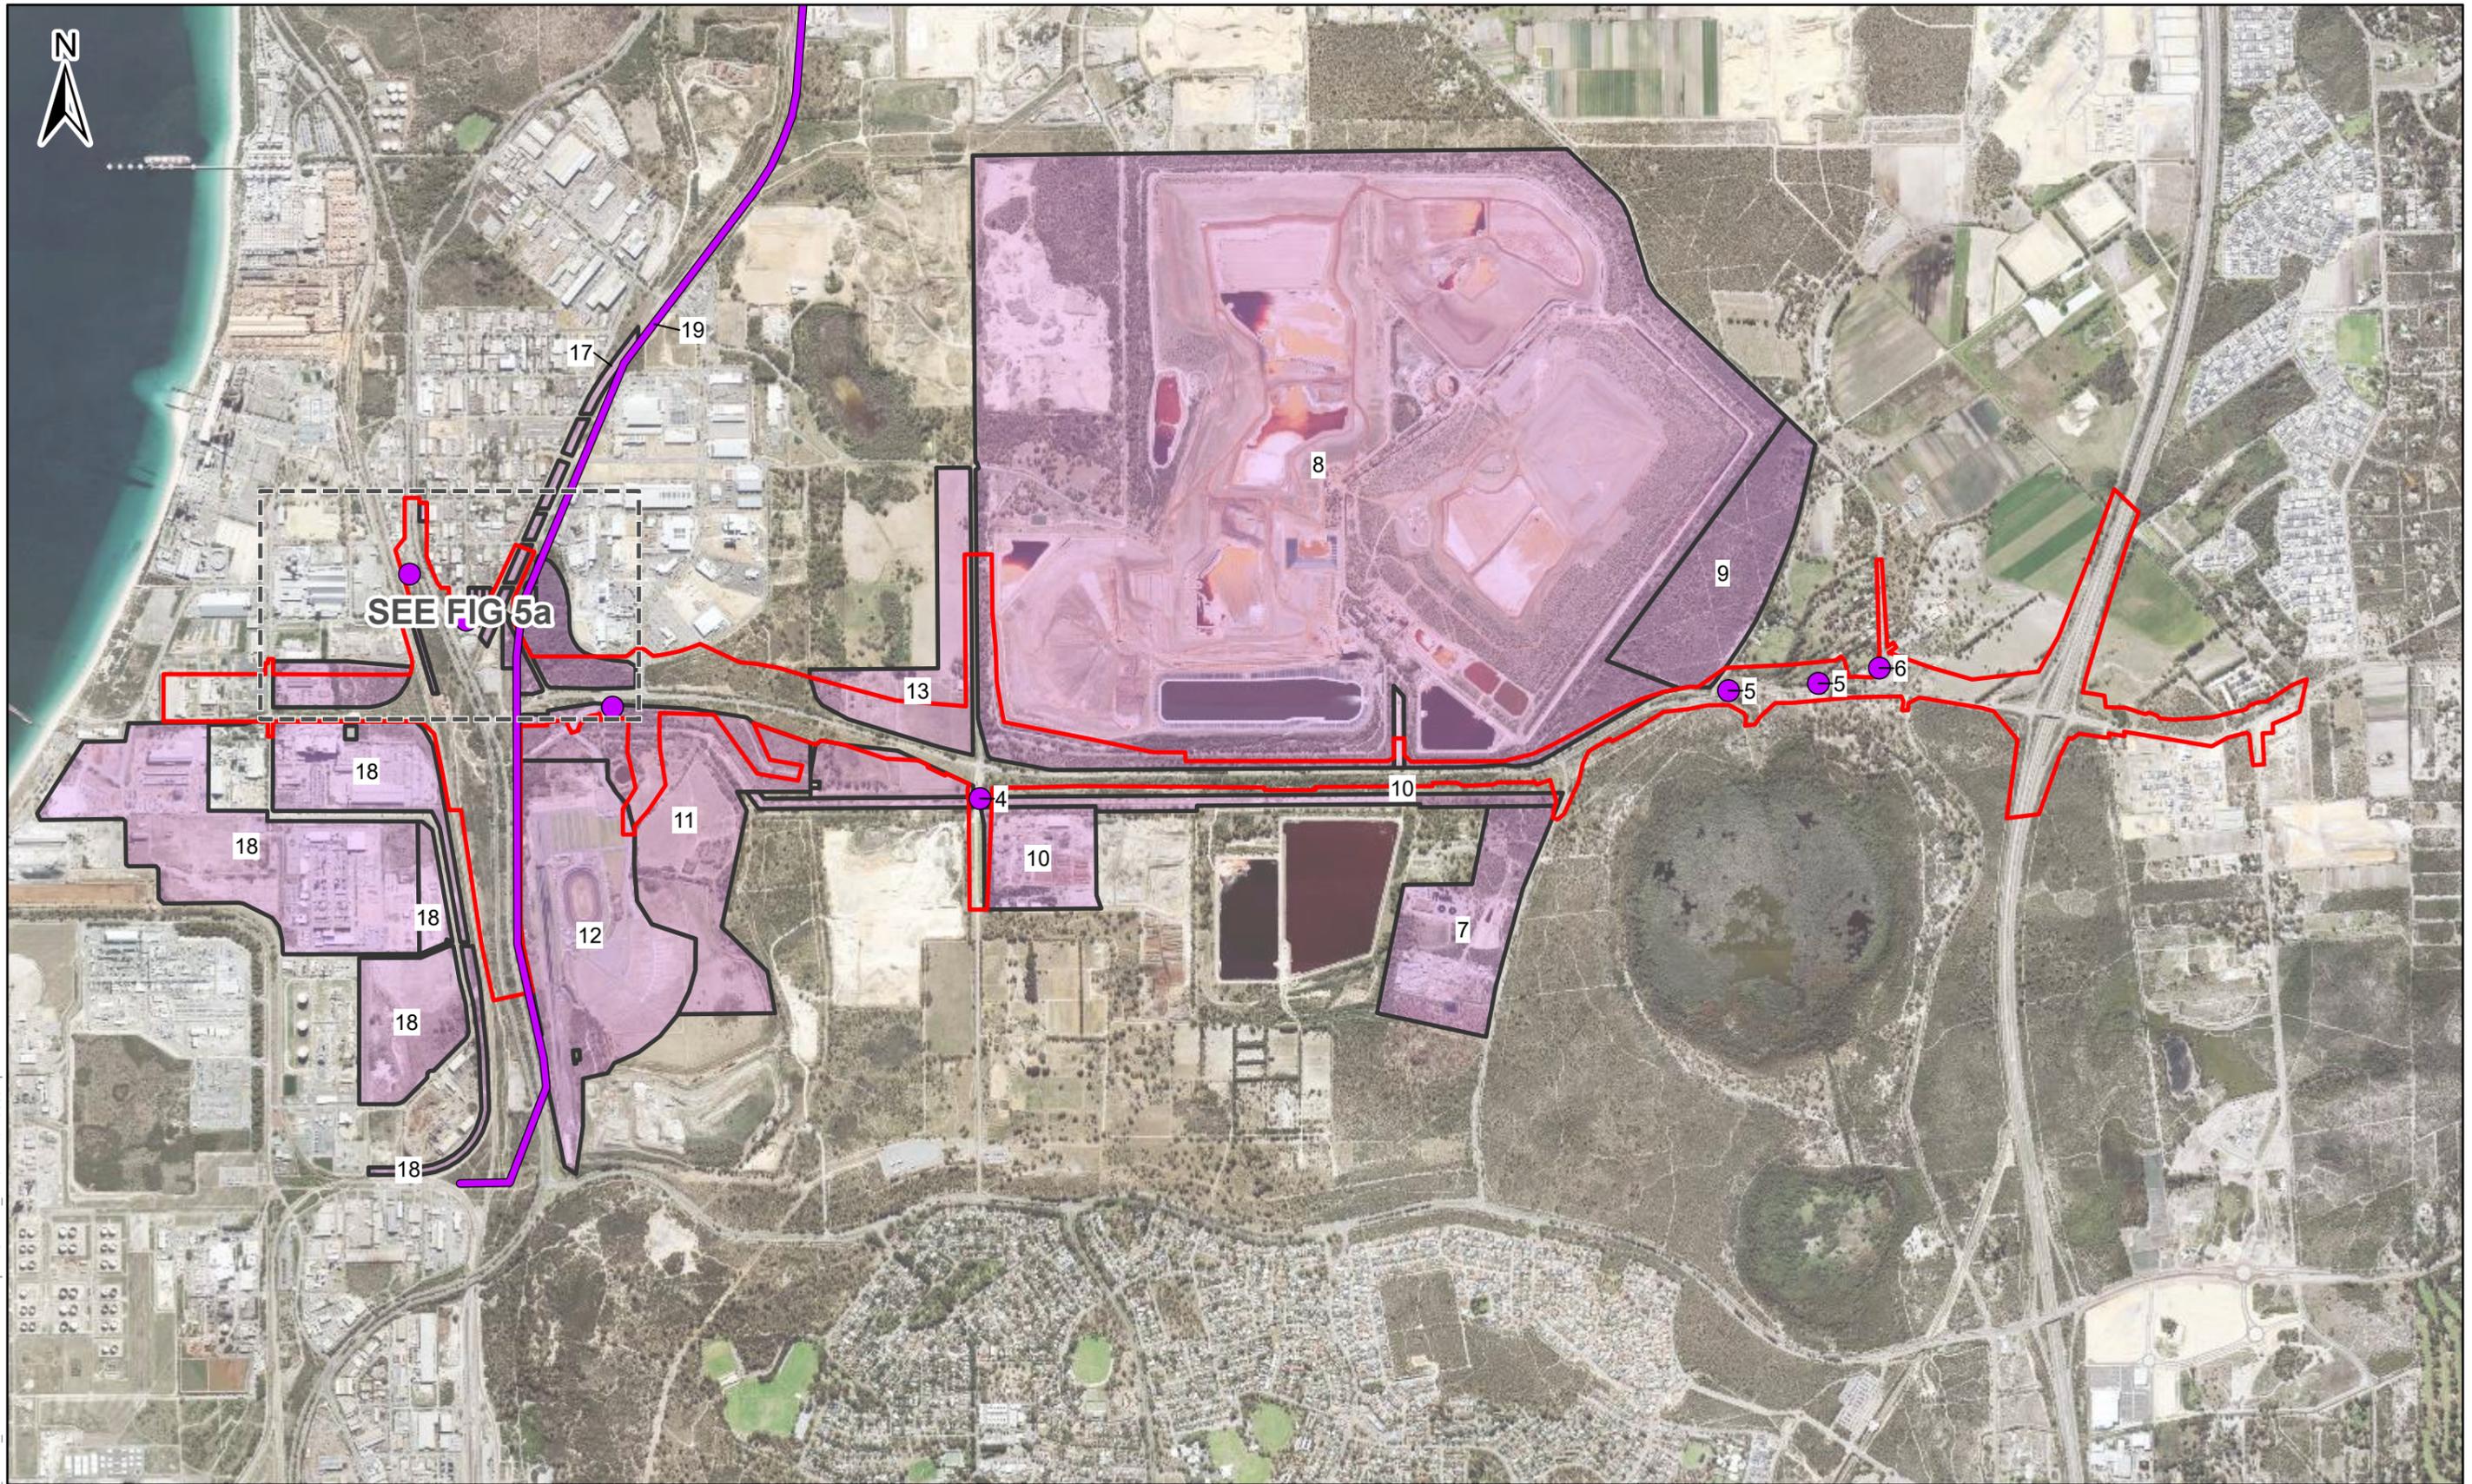
<b>Figure No:</b>	<b>5</b>
<b>Title:</b>	<b>Short Listed Areas of Potential Environmental Concern</b>
Project:	Anketell Road Transport Corridor Preliminary Site Investigation
Location:	Anketell Rd, Anketell, WA 6167
Client:	MRWA

Shortlisted APEC No.	Site Inspection Feature ID (Figure 1)	Description	Parcel ID/Address	Location relative to site	Evidence of Potential Contamination Issues and Relevance	CoPCs <sup>1</sup>	APEC Carried Through to CSM (Y/N)?
1	90	Scattered PACM Fragments	Lot 88 on Diagram 091262.	On-site Between Brown Av and Rockingham Rd.	<ul style="list-style-type: none"> <li>Visual evidence of PACM scatter (Photograph 90).</li> <li>No observed source.</li> <li>Likely from fly tipping (evidence of tyres adjacent to PACM scatter).</li> </ul>	ACM	Yes
NA	91	Small stockpile resembling local geology (Bassendean Sand)	Lot 88 on Diagram 091262.	On-site Between Brown Av and Rockingham Rd	<ul style="list-style-type: none"> <li>Visual evidence of PACM (APEC 1) nearby however not considered to be related to stockpile.</li> <li>Stockpile appeared to be white sand – consistent with local geology (Spearwood). Likely earthworks related.</li> </ul>	Nil	No

2	88	Better Choice Fuel Station	Lot 11 on Plan 412985 Lot	On-site Adjacent (to the east) of Rockingham Rd and Lee Rd (south of).	<ul style="list-style-type: none"> <li>Not a classified site under the CS Act.</li> <li>Fuel storage and dispensing is a higher risk potential contaminating land activity.</li> <li>Aerial imagery indicates that the site has been a fuel station since circa 2000, hence a fuel leaks and spills are plausible.</li> <li>No known investigations have taken place.</li> <li>Relevant as on-site.</li> </ul>	Hydrocarbons Lead	Yes
NA	92	Bullet Truck Wash	Lot 13 on Plan 412985	On-site Adjacent (to the east) of Rockingham Rd and Lee Rd (south of).	<ul style="list-style-type: none"> <li>Not a classified site under the CS Act.</li> <li>Immediately northeast of APEC 2.</li> <li>Aerial imagery indicates that site has been used as a truck use since circa 2010.</li> <li>No known investigations.</li> </ul>	Hydrocarbons	No

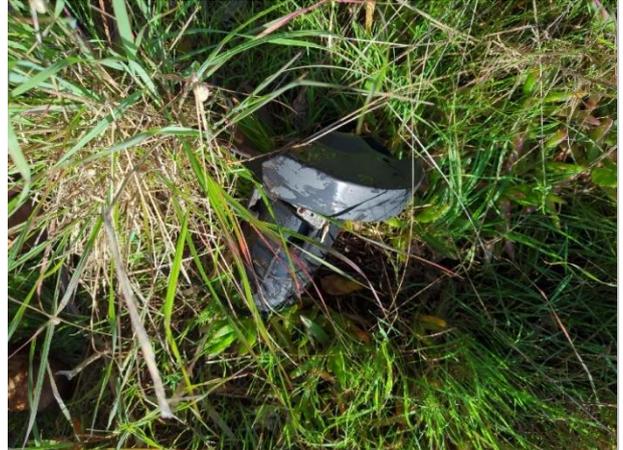
**Photo 15, Point ID 19 [14/08/23]** Fly Tipping - Mattress, on Anketell Rd/McLaughlan Rd intersection

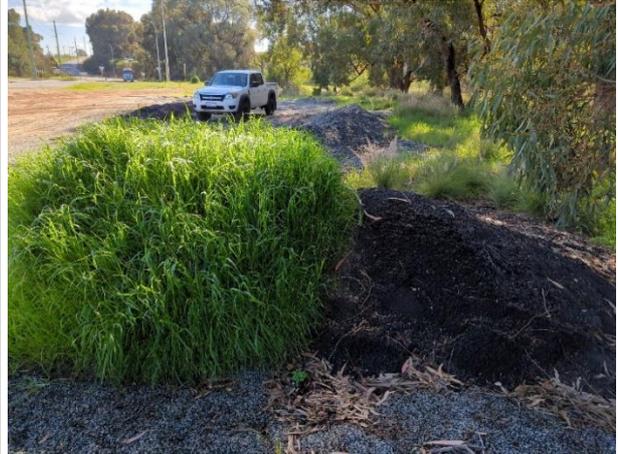
Various stockpiles or push ups were observed along the road reserve, some appeared to be natural fill and bitumen waste (Photographs 17-19 and 19 in **Appendix F**). The stockpiles may be derived from the limestone quarry or surrounding commercial sites.

**Photo 19, Point ID 24 [14/08/23]** Stockpile incl. bitumen, Anketell Rd, and Abercrombie Rd intersection

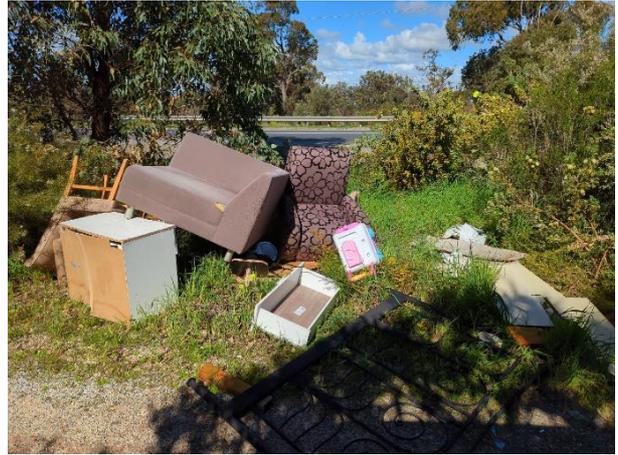
- Alongside a dirt track, immediately north of Anketell Rd that follows from the opposite of McLaughlan Rd to the west of Clementi Rd. Fly tipped material was observed at multiple locations alongside this dirt track. Materials observed include, tyres, wood, household furniture/items, textiles, glass, general waste (Photographs 66-68 and 70) in **Appendix F**).
  - Located on Lot 114 on Plan 48295. Fly tipping was observed alongside a dirt track to the east of Abercrombie Rd. Materials observed include tyres, mattresses, household furniture/items, textiles, cardboard, paint cans, plastics, glass, white goods, oil in (Photographs 30-43, and 45 in **Appendix F**).
-

**Photo 68, Point ID 69 [14/08/23]** Fly tipped material, dirt track east of Clementi Rd.

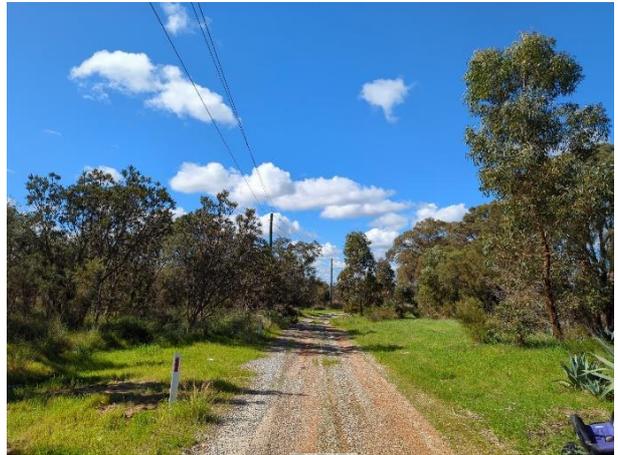
**Photo 70, Point ID 71 [14/08/23]** Fly tipped material - tyres, dirt track west of Clementi Rd.
