**To:** Fiona Taukulis  
Stantec, 41 Bishop St, Jolimont WA 6014

**From:** Nick Miles  
Agrimin Limited, 2C Loch Street  
Nedlands, Western Australia 6009.

**Date:** 8<sup>th</sup> August 2019

**Reference: Mackay Potash Project – Island Drilling, July 2019**

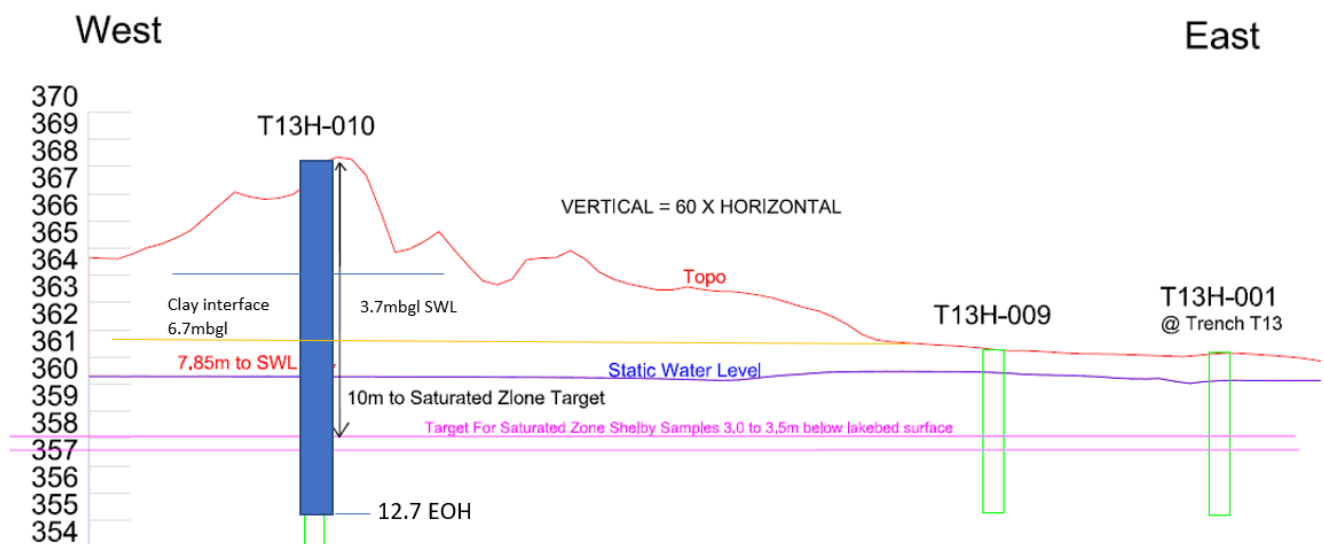
*Figure 1. LiDAR derived topography of T13's Island. Blue line indicates measures static water level. Yellow line indicates interception of lakebed clay in hole T13H-010.*

Every island hole essentially intercepted the same lithological profile. Aeolian sands, orange to red in colour are present at the surface. The sands quickly transition to a calcrete dominated lithology with increasing moisture content. The depth at which calcrete is intercepted varies depending on the thickness of the aeolian sands and in turn the physical size of the island. The lithology quickly becomes clay dominated until the hole has penetrated wholly lake-bed clay. This confirms that the island are deposit of non-lake bed material. This drilling campaign has not yielded any evidence to suggest the islands are connected to or remnant outcropping bedrock. The LiDAR derived plot of T13's island provided by Stantec (US) in figure 1, in conjunction with the drilling data, illustrates this.

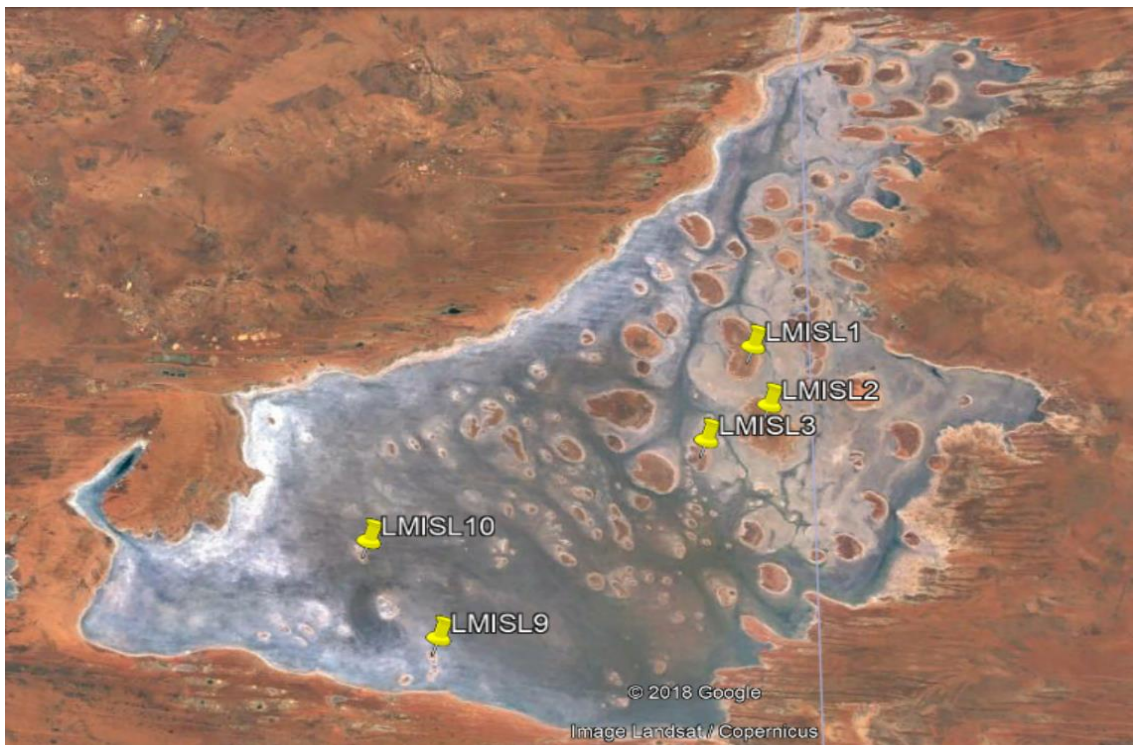
Figure 2. Map of Island drilling locations, Lake Mackay.

A vibracore drill rig was utilized to effectively penetrate the island sediments through to lakebed clay. 5 island holes were drilled LMISL1 to 3, LMISL9 and LMISL10 (see figure 2). A geologist was on-site during the drilling to log the lithology and collect core sample. It was important from a technical perspective to observe the transition from the island sediments into what can safely be identified as lake-bed clay sediments. All holes were cased with 50mm PVC to facilitate future macroinvertebrate sampling. Stantec will advise AMN when enough time has elapsed to begin a sampling program.

Hole ID	Easting	Northing	Depth (mbgl)
LMISL1	494002	7530043	12.7
LMISL2	495388	7523565	4
LMISL3	489221	7519854	4.6
LMISL9	463038	7499014	4
LMSISL10	456535	7509706	3.8

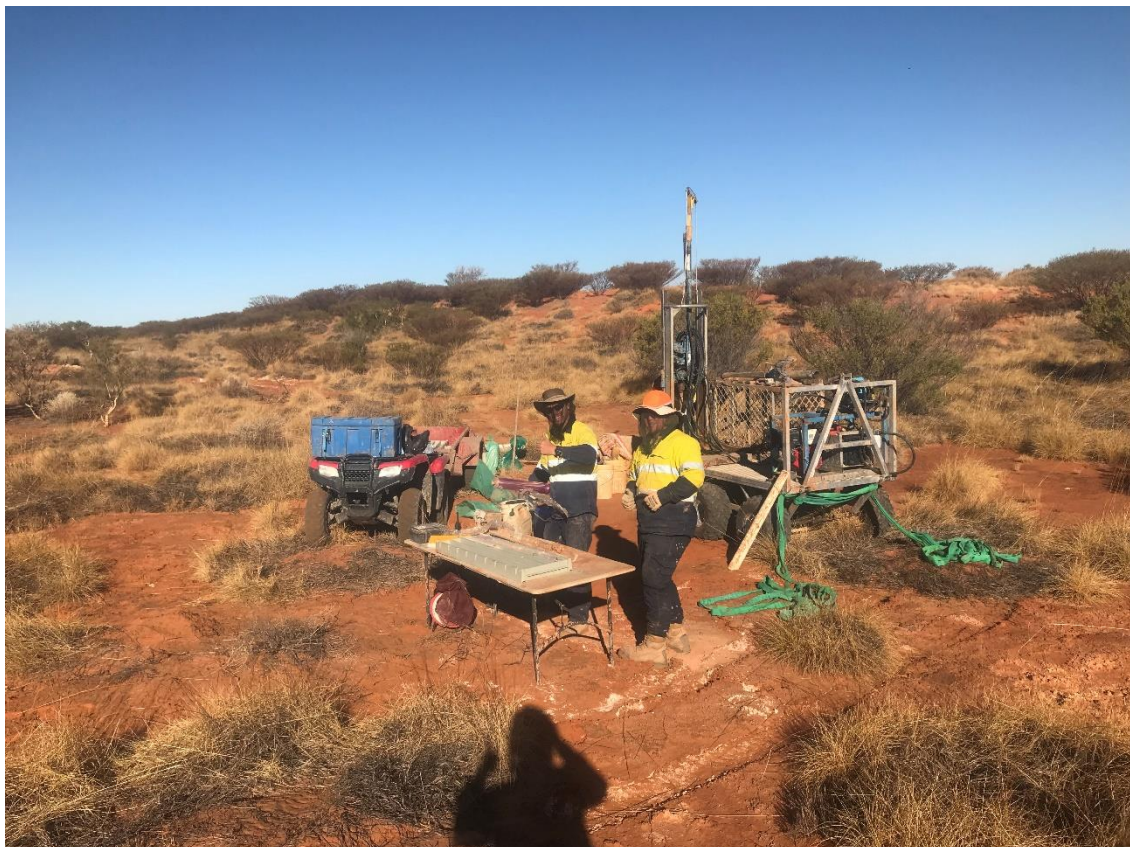
Figure 3: Island drilling in progress, T13H-010

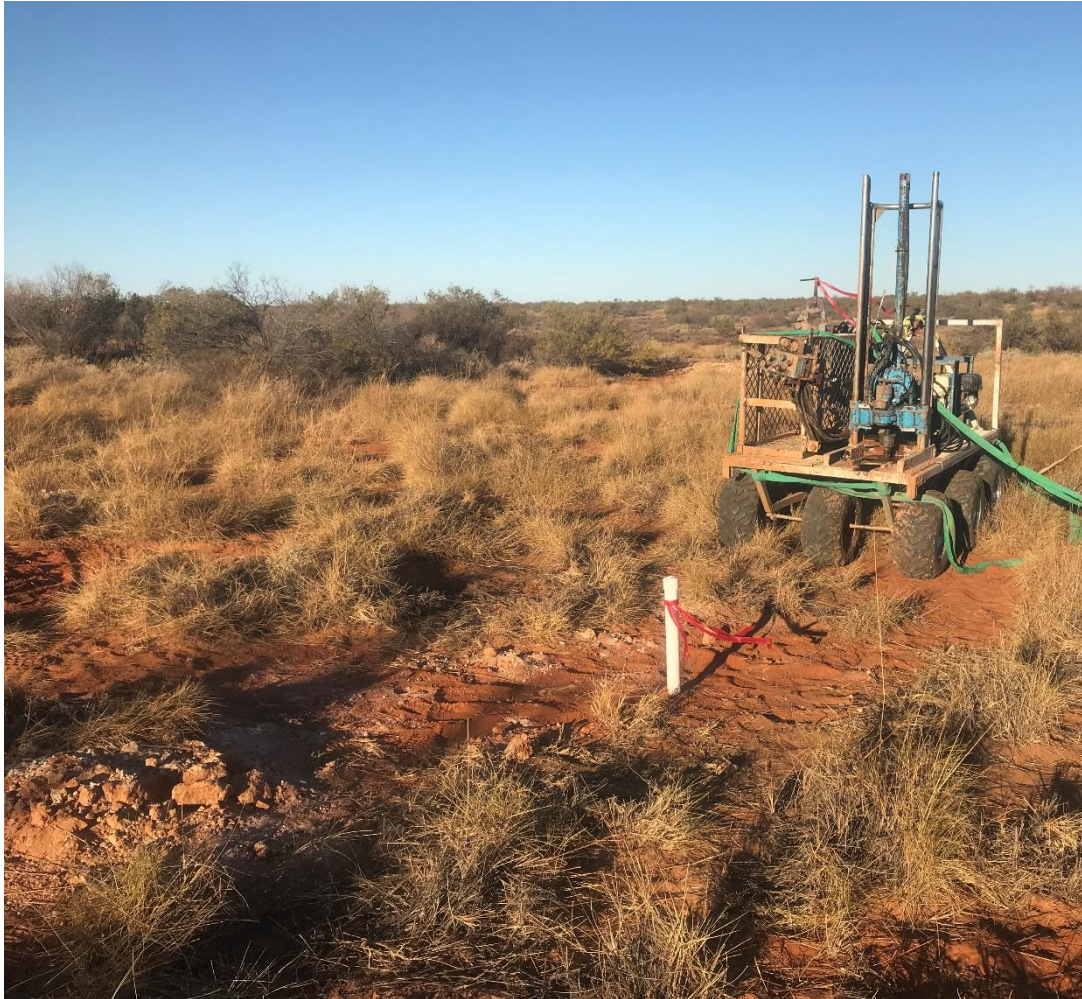
*Figure 4. Example of bore installation*

3.5m Slotted PVC + 1m solid PVC. 0.5m stick up. No gravel pack was installed. Hand compacted collar. Capped 50mm bore. Cored island sediments through to lakebed clay. All core was retained.
