MT WELD RARE EARTHS PROJECT MINE CLOSURE PLAN

PREPARED FOR **MT WELD MINING PTY LIMITED**

March 2021

Lynas - MTW-EN-PLA-0008

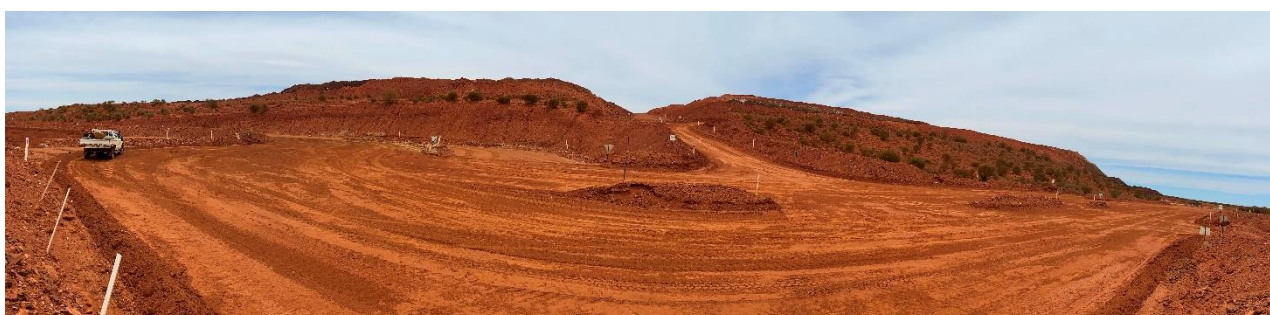
Plate 5-2: Rehabilitated Western Slope of the Waste Rock Landform (January 2021)

In October 2017, access to the top of the WRL was required to tip waste overburden and a ramp was installed in the centre of the rehabilitated section the western face of the WRL (Plate 5-2). This resulted in 0.69 ha of disturbance to the rehabilitated face (Lynas 2020a).

No detailed design report exists which documents the 2008 rehabilitation trial, however, from this cut into the WRL it appears that 'sandy alluvium' has been placed on the outer batter, then topsoiled, prior to ripping on the contour. It is feasible that the topsoil would have only been stockpiled for approximately one year, prior to its application on the WRL. There is no discernible difference in the sandy alluvium and topsoil, which forms a layer of between 400 to 600 mm (A. Cargill, pers. comm, Lynas, 2020).

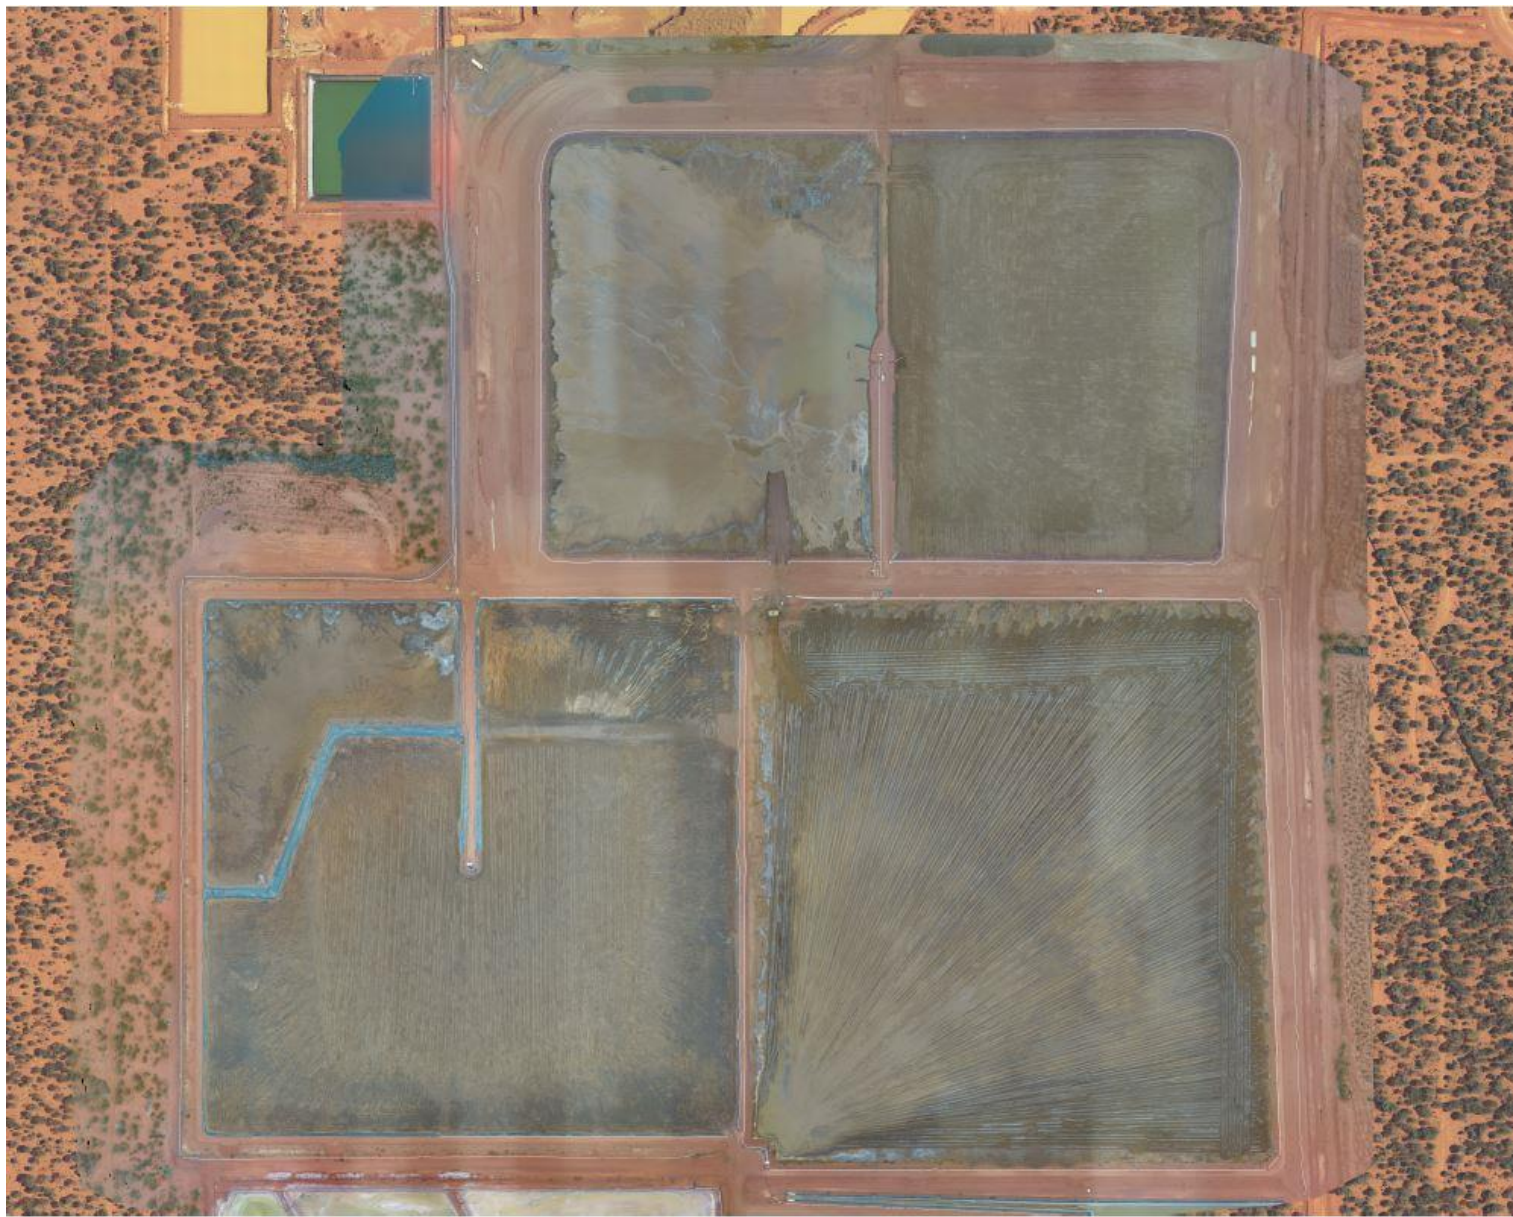
Plate 9-2: TSF 1, 2 and 3 February 2021 (photo supplied by Lynas 2021)

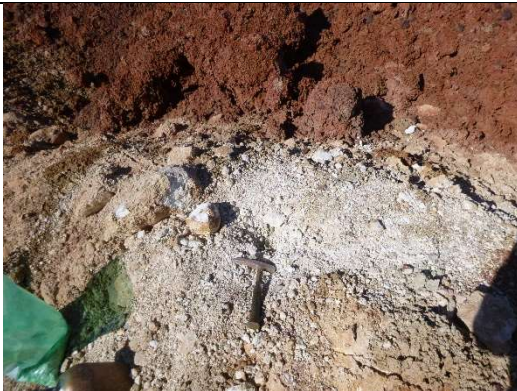
2.4 Project History

Client: Lynas Mt Weld
Observers: Lynas: RD, SF, MV, AC
Date & Time: 15:27 4/3/20
Datum: UTM, GDA 94, Zone 51J
Coordinates: **Easting:** 0455358 mE **Northing:** 6807593 mN
Landform: Single paddock dump amongst clay stockpile
Site Description: Clay stockpile - flat
Material: Calcrete limestone (dolomitic clay)

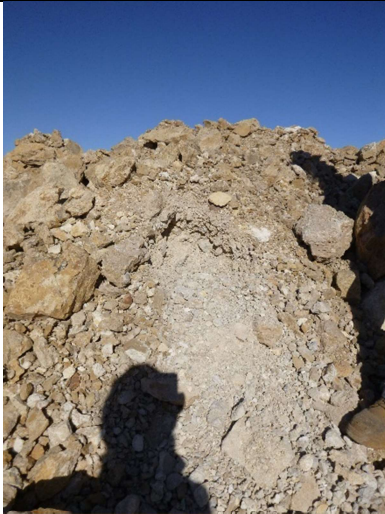
Photo A.b 5 CC03-SO

Client: Lynas Mt Weld
Observers: Lynas: RD, SF, MV, AC
Date & Time: 16:07 4/3/20
Datum: UTM, GDA 94, Zone 51J
Coordinates: **Easting:** 0456427 mE **Northing:** 6807522 mN
Landform: Calcrete limestone dump pile
Site Description:
Material: Calcrete limestone

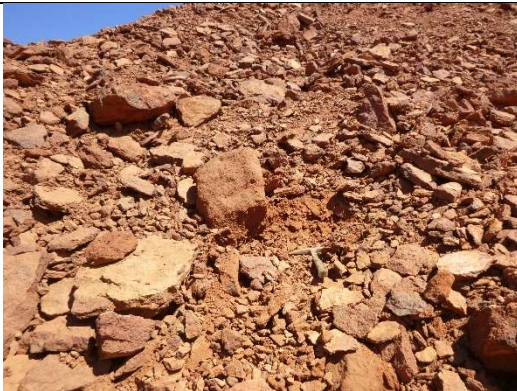
Photo A.b 28 AL01-SO

Client: Lynas Mt Weld
Observers: Lynas: RD, SF, MV, AC
Date & Time: 13:48 4/3/20
Datum: UTM, GDA 94, Zone 51J
Coordinates: **Eastings:** 0454850 mE **Northing:** 6807468 mN
Landform: TSF construction material – alluvium stockpile
Site Description: Waste dump ~ 45-50° slope angle
Material: Alluvium

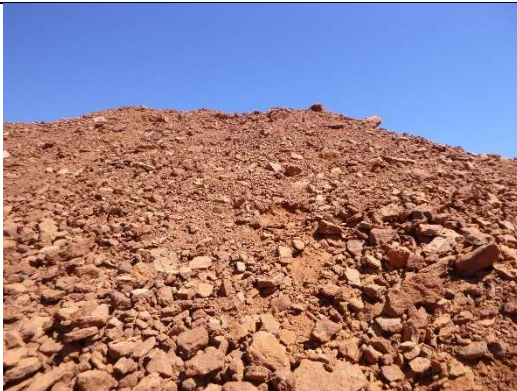
Photo A.b 30 AL02-SO

Client: Lynas Mt Weld
Observers: Lynas: RD, SF, MV, AC
Date & Time: 13:53 4/3/20
Datum: UTM, GDA 94, Zone 51J
Coordinates: **Easting:** 0454826 mE **Northing:** 6807470 mN
Landform: TSF construction material – alluvium stockpile
Site Description: Waste dump ~ 45°
Material: Alluvium

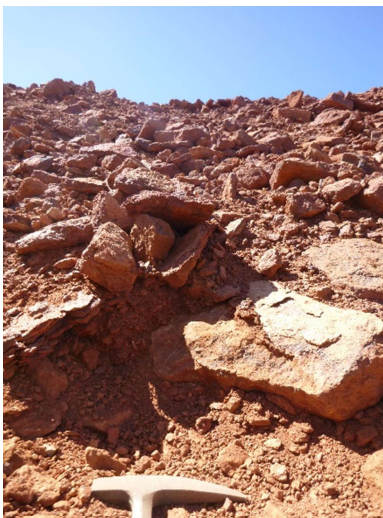
Photo A.b 39 AL05-SO.2

- Consolidated alluvium

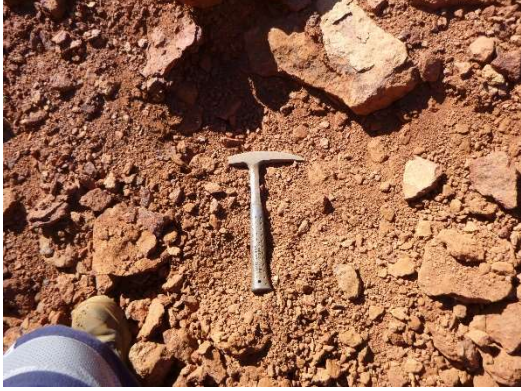
Photo A.b 40 AL05-SC

Client: Lynas Mt Weld
Observers: Lynas: RD, SF, MV, AC
Date & Time: 11:21 7/3/20
Datum: UTM, GDA 94, Zone 51J
Coordinates: **Easting:** 0457107 mE **Northing:** 6806352 mN
Landform: Windrow alluvium dump pile
Site Description: Windrow ~40° near floor control drain
Material: Alluvium
