## **APPENDIX L Soil Characterisation Report**

### **Addendum: Revised Soil Characterisation – Havieron Proposed Haul Road Route**

# HAVIERON SOIL CHARACTERISATION REPORT

Newcrest Mining Limited  
September 2020

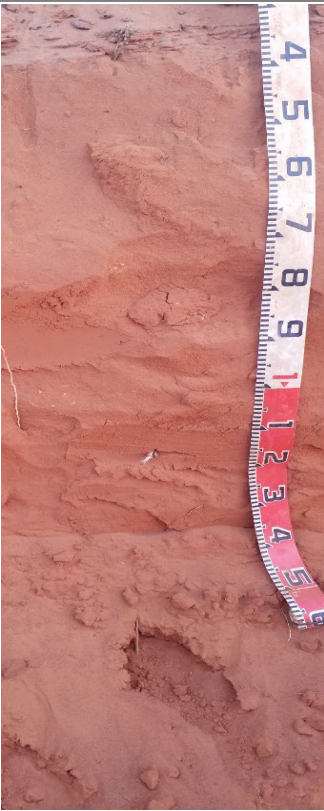
A (0-0.1m) Abrupt	2.5YR 4/8 Red	Loamy sand	Granular (single grained)	Very weak (dry)	Common, fine roots	7.0 0.0 dS/m
		B (0.1-1.4m)	2.5YR 4/8 Red	Loamy sand	Granular (single grained)	Very weak (dry)	Few, medium roots	200-300mm: 7.0 0.014 dS/m 500-600mm: 7.0 0.009 dS/m 1100- 1200mm: 6.5 0.017 dS/m

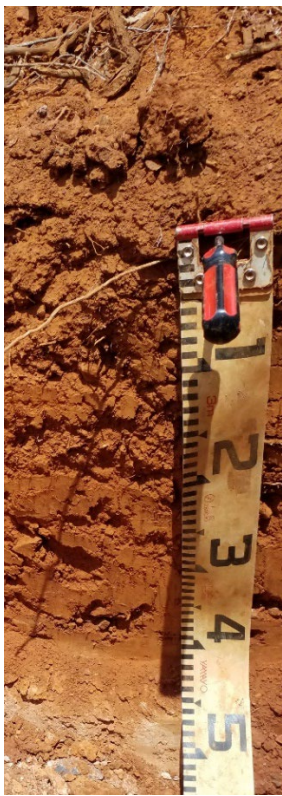
A (0-0.4m) Diffuse boundary	2.5YR 3/6 Dark red	Clayey sand 20-50% coarse fragments 2-6mm in size	Angular blocky (moderate)	Weak (dry)	Common, medium roots	0-100mm: 6.0 0.04 dS/m 200-300mm 5.9 0.001dS/m

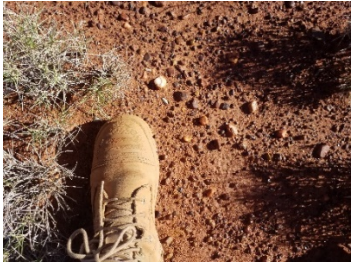
B21 (0.4-1.1m) Abrupt boundary	2.5YR 4/8 Red	Clayey sand 50-90% coarse fragments 2-6mm in size	Granular (single grain)	Very weak (dry)	Few, fine roots	6.3 0.01 dS/m

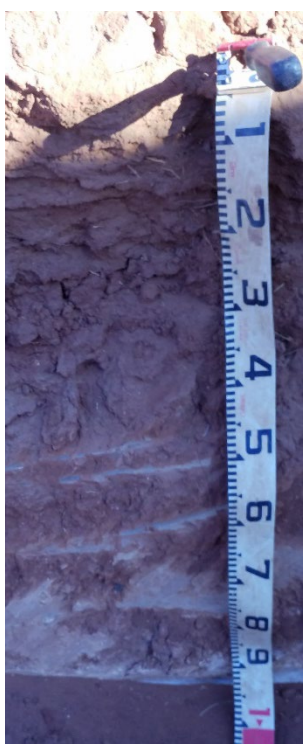
A (0-0.1m) Abrupt boundary	2.5YR 3/6 Dark red	Loamy sand	Polyhedral (Weak)	Weak (dry)	Few, fine roots	7.0 0.028 dS/m

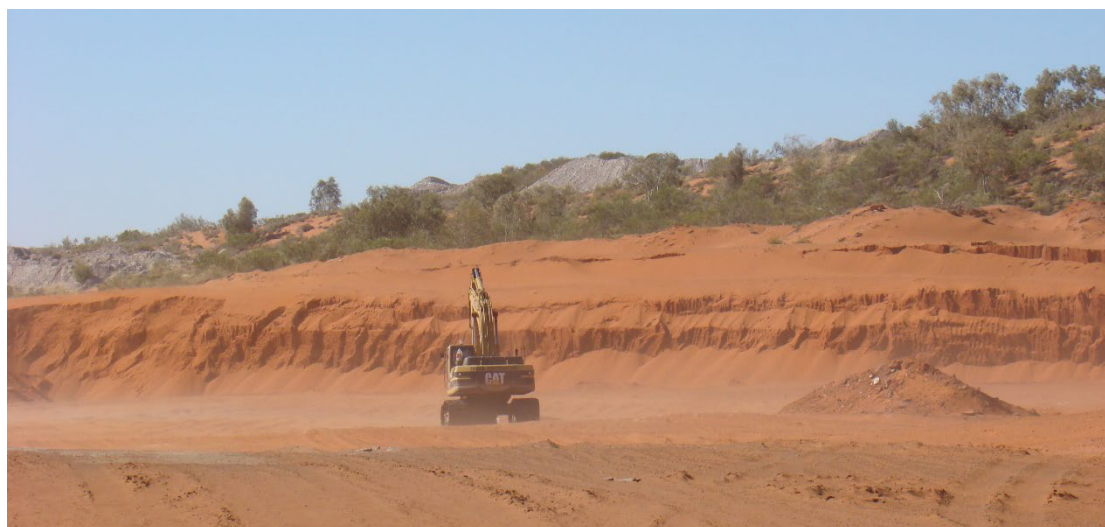
Particle size results similar to the surface sands have been recorded for Nifty, where sand dunes are disturbed as part of mining. At Nifty, the sand sampled by Landloch consist of ~2% clay, <1% silt, 40% fine sands and ~58% coarse sands. Sands within the dunes at Nifty were observed to remain quite sandy to significant depths (Figure 13).

**Figure 13:** Sandy textures occurring within sand dunes at Nifty.

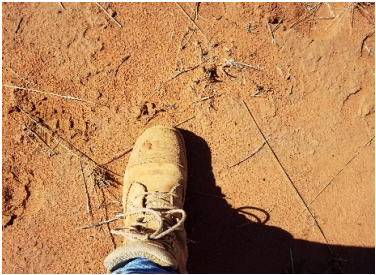
Soil Surface Condition Photo

Project Haverion	Date	Scribe I. Kelder	Location TP01	Observation Soil pit		Easting/ Latitude		Zone	ASC Mapped Tenosol	
Dominant Vegetation Form Non-woody			Ground Cover % Mid-dense (30-70%)		Aspect	Northing/ Longitude		Scale	ASC Ground Truth Kandosol	
Secondary Vegetation Form			Ground Cover %		Slope %	Rock Outcrop No rock outcrop		Erosion Type Wind		
Vegetation (species)						Drainage (site) Moderately well-drained		Erosion Extent Moderate		
Landform Flat			Soil Surface Condition (dry) Loose			Land Use Grazing		Erosion State Active		
Landscape Photo (North)

Other Photo			Microrelief N/A	
									Type	
									Vertical (m)	
									Horizontal (m)	
									Sampled	
									Other Information: 2-10mm coarse fragments on surface 40%

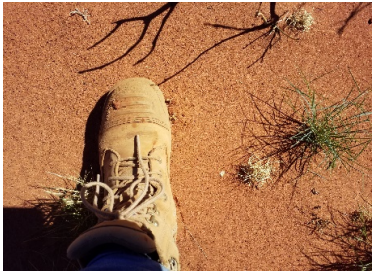
Soil Surface Condition Photo

Project Haverion	Date	Scribe I. Kelder	Location TP02	Observation Soil pit		Easting/ Latitude	Zone	ASC Mapped Tenosol
Dominant Vegetation Form Non-woody			Ground Cover % Sparse (10-30%)	Aspect		Northing/ Longitude	Scale	ASC Ground Truth Kandosol
Secondary Vegetation Form			Ground Cover %	Slope %		Rock Outcrop No rock outcrop	Erosion Type Wind	
Vegetation (species)						Drainage (site) Rapidly drained	Erosion Extent Moderate	
Landform Flat			Soil Surface Condition (dry) Firm			Land Use Grazing	Erosion State Active	
Landscape Photo (North)

Other Information: Surface crust 2mm thick in some areas, not present across entire site.

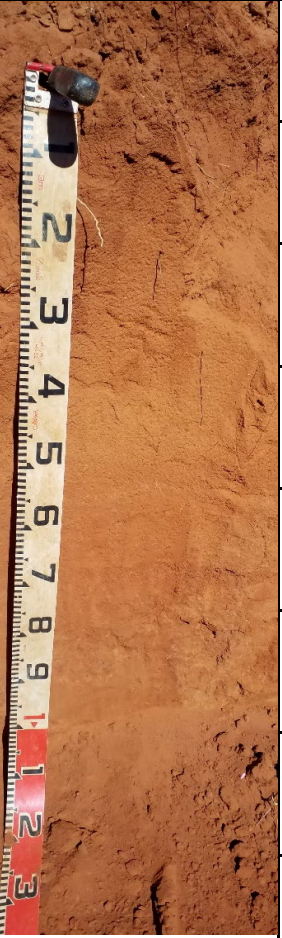
Abrupt	Loamy Sand	2.5YR 4/6 Red	None evident	None evident	None evident	Apedal	Single grain	Weak (dry)	Common (10-25) Fine (1-2 mm)	6.1	0.020	0-100
B21	100-900		Abrupt	Sandy Loam	2.5YR 3/6 Dark red	None evident	None evident	None evident	Apedal	Single grain	Very firm (dry)	Few (1-10) Fine (1-2 mm)	5.5 5.7	0.030 0.020	200-300 500-600
B22	900-1150		N/A	Sandy Clay Loam	2.5YR 3/4 Dark reddish brown	None evident	None evident	None evident	Apedal	Single grain	Strong (dry)	No roots (0)	6.3	0.040	900-1000
Other information: Hard clay at bottom of profile, no coarse fragments in profile. Texture increases with depth.

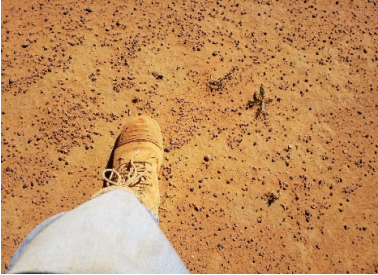
Soil Surface Condition Photo

Project Haverion	Date	Scribe I. Kelder	Location TP03	Observation Soil pit		Easting/ Latitude	Zone	ASC Mapped Tenosol	
Dominant Vegetation Form Non-woody		Ground Cover % Sparse (10-30%)		Aspect		Northing/ Longitude	Scale	ASC Ground Truth Kandosol	
Secondary Vegetation Form Woody		Ground Cover % Isolated Plants (<0.2%)		Slope %		Rock Outcrop No rock outcrop	Erosion Type None evident		
Vegetation (species)						Drainage (site) Imperfectly drained	Erosion Extent None evident		
Landform Flat			Soil Surface Condition (dry) Loose			Land Use Grazing	Erosion State None evident		
Landscape Photo (North)  			Landscape Photo (East)

Other Photo		Horizontal (m)	
								Sampled	
								Other Information: Gravel on surface 2-10mm 20%, some evidence of clay on the surface.

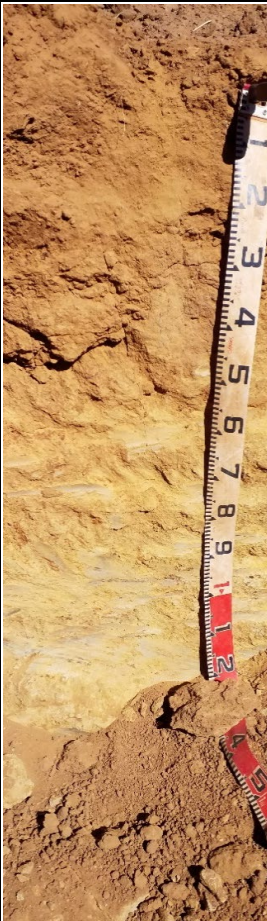
Abrupt	Sandy Clay Loam	2.5YR 4/4 Reddish brown	None evident	None evident	2-10 % 2-6 mm	Polyhedral	Weak	Weak (dry)	Few (1-10) Fine (1-2 mm)	6.0	0.026	0-100
B21	100-400		Abrupt	Sandy Clay Loam	5YR 4/4 Reddish brown	None evident	None evident	2-10 % 2-6 mm	Polyhedral	Weak	Firm (dry)	Few (1-10) Fine (1-2 mm)	6.5	0.021	200-300
B22	400-1200		N/A	Light Medium Clay	5YR 4/4 Reddish brown	Blue 5% Red 5%	None evident	2-10 % 2-6 mm	Apedal	Massive	Strong (dry)	Few (1-10) Fine (1-2 mm)	6.5 7.0	0.016 0.018	500-600 800-900
Other information: Massive clay from 400mm onward.

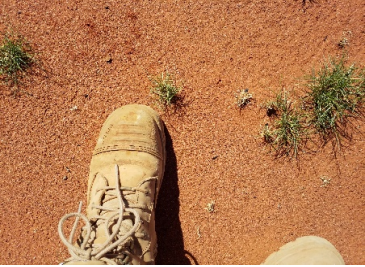
Soil Surface Condition Photo

Project Haverion	Date	Scribe I. Kelder	Location TP04	Observation Soil pit		Easting/ Latitude		Zone	ASC Mapped Tenosol	
Dominant Vegetation Form Non-woody			Ground Cover % Very sparse (0.2-10%)	Aspect		Northing/ Longitude		Scale	ASC Ground Truth Rudosol	
Secondary Vegetation Form Woody			Ground Cover % Very sparse (0.2-10%)	Slope %		Rock Outcrop No rock outcrop		Erosion Type Wind		
Vegetation (species)						Drainage (site) Well-drained		Erosion Extent Moderate		
Landform Flat			Soil Surface Condition (dry) Soft			Land Use Grazing		Erosion State Active		
Landscape Photo (North)

Other Photo			Microrelief N/A	
									Type	
									Vertical (m)	
									Horizontal (m)	
									Sampled	
									Other Information: Wind blown sands on surface.

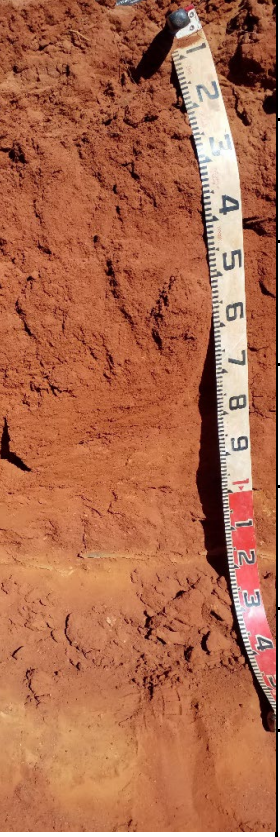
Abrupt	Loamy Sand	2.5YR 3/6 Dark red	None evident	None evident	None evident	Apedal	Single grain	Weak (dry)	Few (1-10) Fine (1-2 mm)	6.5	0.016	0-100
B	200-1000		Abrupt	Clayey Sand	2.5YR 3/6 Dark red	None evident	None evident	None evident	Apedal	Single grain	Firm (dry)	Few (1-10) Fine (1-2 mm)	6.5 7.0	0.014 0.018	200-300 600-700
2B	1000-1200		N/A	Sandy Loam	2.5YR 3/6 Dark red	Cream 5%	None evident	None evident	Apedal	Single grain	Very firm (dry)	No roots (0)	7.0	0.016	1000-1100
Other information: Typical sands, slight clay increase at depth. Arenic Rudosol.

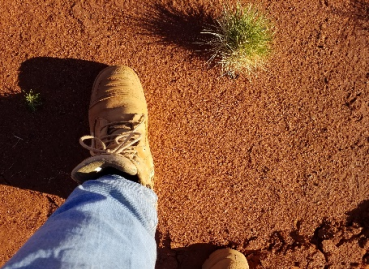
Soil Surface Condition Photo

Project Haverion	Date	Scribe I. Kelder	Location TP05	Observation Soil pit		Easting/ Latitude	Zone	ASC Mapped Tenosol
Dominant Vegetation Form Non-woody		Ground Cover % Sparse (10-30%)		Aspect		Northing/ Longitude	Scale	ASC Ground Truth Rudosol
Secondary Vegetation Form Woody		Ground Cover % Isolated Plants (<0.2%)		Slope %		Rock Outcrop No rock outcrop	Erosion Type None evident	
Vegetation (species)						Drainage (site) Moderately well-drained	Erosion Extent None evident	
Landform Flat			Soil Surface Condition (dry) Firm			Land Use Grazing	Erosion State None evident	
Landscape Photo (North)

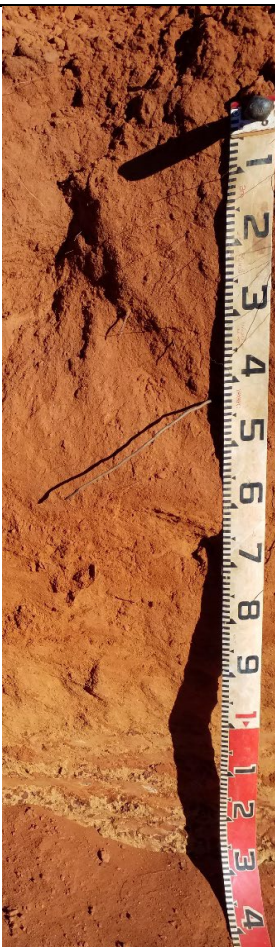
abrupt	Loamy Sand	2.5YR 4/6 Red	None evident	None evident	2-10 % 2-6 mm	Apedal	Single grain	Weak (dry)	Common (10-25) Fine (1-2 mm)	6.5	0.010	0-100
B21	50-900		Clear	Loamy Sand	2.5YR 3/6 Dark red	None evident	None evident	2-10 % 2-6 mm	Apedal	Single grain	Firm (dry)	Common (10-25) Fine (1-2 mm)	6.0 6.0	0.013 0.018	200-300 500-600
B22	900-1000		Abrupt	Clayey Sand	2.5YR 3/6 Dark red	None evident	None evident	2-10 % 2-6 mm	Apedal	Single grain	Firm (dry)	No roots (0)	6.5	0.015	900-1000
2B	1000-1300		N/A	Sandy Clay Loam	2.5YR 3/6 Dark red	None evident	None evident	20-50 % 2-6 mm	Apedal	Single grain	Firm (dry)	No roots (0)

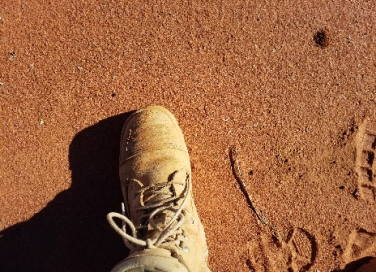
Soil Surface Condition Photo

Project Haverion	Date	Scribe I. Kelder	Location TP06	Observation Soil pit		Easting/ Latitude		Zone	ASC Mapped Tenosol	
Dominant Vegetation Form Non-woody			Ground Cover % Mid-dense (30-70%)		Aspect	Northing/ Longitude		Scale	ASC Ground Truth Rudosol	
Secondary Vegetation Form			Ground Cover %		Slope %	Rock Outcrop No rock outcrop		Erosion Type Wind		
Vegetation (species)						Drainage (site) Rapidly drained		Erosion Extent Minor or present		
Landform Lower slope			Soil Surface Condition (dry) Loose			Land Use Grazing		Erosion State Partially stabilised		
Landscape Photo (North)

Other Photo			Microrelief N/A	
									Type	
									Vertical (m)	
									Horizontal (m)	
									Sampled	
									Other Information: Higher density of vegetation than nearby site

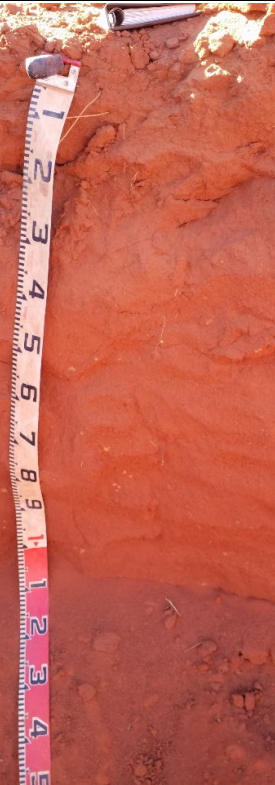
Abrupt	Loamy Sand	2.5YR 3/6 Dark red	None evident	None evident	None evident	Apedal	Single grain	Weak (dry)	Few (1-10) Fine (1-2 mm)	6.0	0.100	0-100
B	100-1100		N/A	Clayey Sand	2.5YR 3/6 Dark red	5% yellow	None evident	None evident	Apedal	Single grain	Firm (dry)	Few (1-10) Very fine (<1 mm)	5.5 6.0 6.0	0.038 0.016 0.015	200-300 500-600 800-900
Other information: Deep sands. Arenic Rudosol.

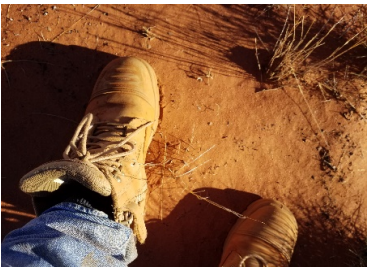
Soil Surface Condition Photo

Project Haverion	Date	Scribe I. Kelder	Location TP07	Observation Soil pit		Easting/ Latitude	Zone	ASC Mapped Tenosol
Dominant Vegetation Form Non-woody			Ground Cover % Mid-dense (30-70%)	Aspect		Northing/ Longitude	Scale	ASC Ground Truth Kandosol
Secondary Vegetation Form Woody			Ground Cover % Isolated Plants (<0.2%)	Slope %		Rock Outcrop No rock outcrop	Erosion Type Wind	
Vegetation (species)						Drainage (site) Moderately well-drained	Erosion Extent Moderate	
Landform Lower slope			Soil Surface Condition (dry) Loose			Land Use Grazing	Erosion State Active	
Landscape Photo (North)

Other Photo		Microrelief N/A
								Type Vertical (m)
Dominant Vegetation Photo 1			Dominant Vegetation Photo 2			Other Vegetation Photo		Horizontal (m)  Sampled  Other Information: Clear evidence of wind erosion of aelion sands.

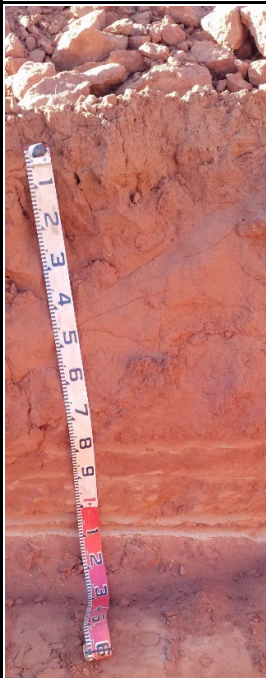
Abrupt	Loamy Sand	2.5YR 3/4 Dark reddish brown	None evident	None evident	None evident	Apedal	Single grain	Weak (dry)	Few (1-10) Fine (1-2 mm)	6.3	0.010	0-100
B	50-750		Clear	Clayey Sand	2.5YR 3/4 Dark reddish brown	None evident	None evident	None evident	Apedal	Single grain	Firm (dry)	Few (1-10) Fine (1-2 mm)	6.3	0.060	200-300
2B21	750-1000		Clear	Loam	2.5YR 3/4 Dark reddish brown	None evident	None evident	None evident	Apedal	Single grain	Very firm (dry)	No roots (0)	6.1	0.070	800-900
2B22	1000-1150		N/A	Sandy Clay Loam	2.5YR 3/4 Dark reddish brown	2% white	<2 % Unidentified	None evident	Apedal	Massive	Strong (dry)	No roots (0)	7.1	0.020	1000-1100

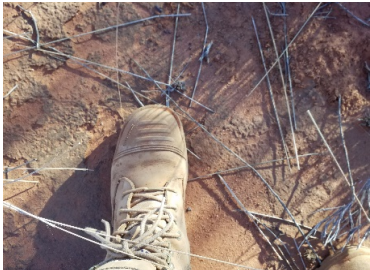
Soil Surface Condition Photo

Project Haverion	Date	Scribe I. Kelder	Location TP08	Observation Soil pit		Easting/ Latitude	Zone	ASC Mapped Tenosol
Dominant Vegetation Form Non-woody		Ground Cover % Sparse (10-30%)		Aspect		Northing/ Longitude		Scale ASC Ground Truth Kandosol
Secondary Vegetation Form Woody		Ground Cover % Sparse (10-30%)		Slope %		Rock Outcrop No rock outcrop		Erosion Type None evident
Vegetation (species)						Drainage (site) Imperfectly drained		Erosion Extent None evident
Landform Flat			Soil Surface Condition (dry) Firm			Land Use Cleared		Erosion State None evident
Landscape Photo (North)

Other Information: Cleared area in core yard laydown, sand dune 100m away

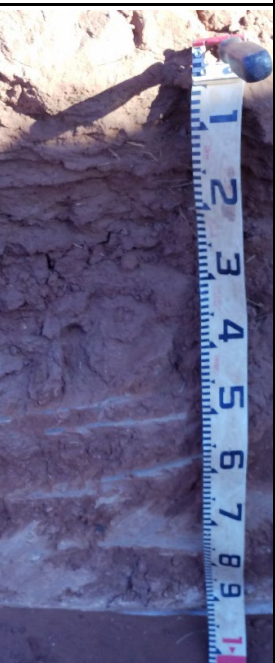
Abrupt	Loamy Sand	2.5YR 3/6 Dark red	None evident	None evident	None evident	Polyhedral	Weak	Weak (dry)	Few (1-10) Fine (1-2 mm)	7.0	0.028	0-100
B1	100-450		Gradual	Clay Loam	2.5YR 4/6 Red	None evident	None evident	None evident	Polyhedral	Weak	Firm (dry)	Few (1-10) Fine (1-2 mm)	7.0	0.092	200-300
B2	450-900		N/A	Light Medium Clay	2.5YR 4/8 Red	White 10%	<2 % Unidentified	None evident	Subangular blocky	Weak	Strong (dry)	No roots (0)	7.5 8.0	0.113 0.780	500-600 700-800
Other information: black gravel 2% at 100mm onwards

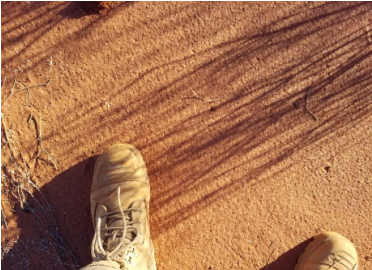
Soil Surface Condition Photo

Project Haverion	Date	Scribe I. Kelder	Location TP09	Observation Soil pit		Easting/ Latitude		Zone	ASC Mapped Tenosol	
Dominant Vegetation Form Non-woody			Ground Cover % Mid-dense (30-70%)	Aspect		Northing/ Longitude		Scale	ASC Ground Truth Rudosol	
Secondary Vegetation Form			Ground Cover %		Slope %		Rock Outcrop No rock outcrop	Erosion Type Wind		
Vegetation (species)						Drainage (site) Well-drained		Erosion Extent Moderate		
Landform Mid-slope			Soil Surface Condition (dry) Firm			Land Use Grazing		Erosion State Active		
Landscape Photo (North)

Other Photo			Microrelief N/A	
									Type	
									Vertical (m)	
									Horizontal (m)	
									Sampled	
									Other Information: 100m from sand dune.	
Dominant Vegetation Photo 1			Dominant Vegetation Photo 2			Other Vegetation Photo

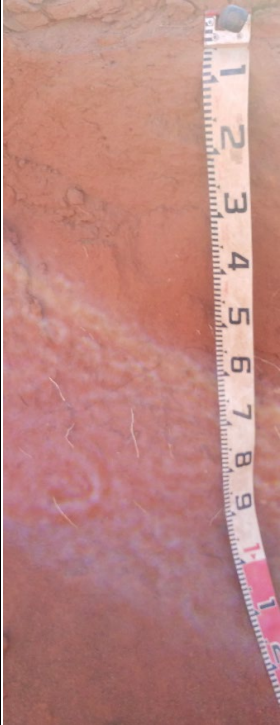
Abrupt	Loamy Sand	2.5YR 3/6 Dark red	None evident	None evident	None evident	Apedal	Single grain	Very weak (dry)	Few (1-10) Fine (1-2 mm)	6.0	0.009	0-100
B	50-1000		N/A	Clayey Sand	2.5YR 3/6 Dark red	2% Yellow	None evident	None evident	Apedal	Single grain	Firm (dry)	Few (1-10) Fine (1-2 mm)	5.5 6.0 6.0	0.033 0.014 0.017	200-300 500-600 800-900
Other information: Very consistent, roots down to 1000mm.

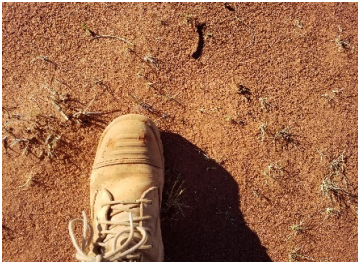
Soil Surface Condition Photo

Project Haverion	Date	Scribe I. Kelder	Location TP10	Observation Soil pit	Easting/ Latitude	Zone	ASC Mapped Tenosol
Dominant Vegetation Form Non-woody		Ground Cover % Sparse (10-30%)		Aspect	Northing/ Longitude	Scale	ASC Ground Truth Kandosol
Secondary Vegetation Form Woody		Ground Cover % Isolated Plants (<0.2%)		Slope %	Rock Outcrop No rock outcrop	Erosion Type Wind	
Vegetation (species)					Drainage (site) Imperfectly drained	Erosion Extent Minor or present	
Landform Flat			Soil Surface Condition (dry) Soft		Land Use Grazing	Erosion State Active	
Landscape Photo (North)

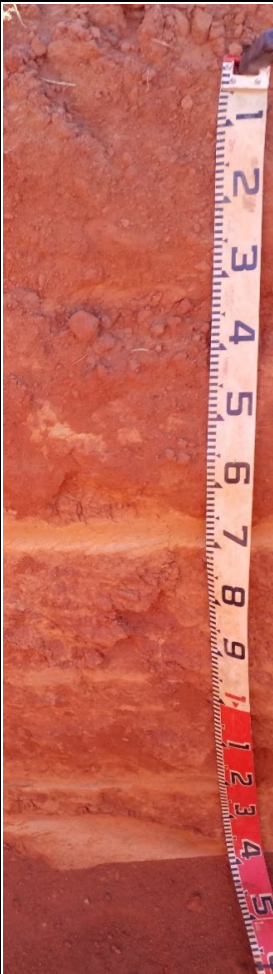
Abrupt	Loamy Sand	2.5YR 3/6 Dark red	None evident	None evident	None evident	Polyhedral	Weak	Very weak (dry)	Few (1-10) Fine (1-2 mm)	6.0	0.014	0-100
B21	100-450		Abrupt	Sandy Clay Loam	2.5YR 3/6 Dark red	None evident	None evident	None evident	Polyhedral	Weak	Firm (dry)	Few (1-10) Fine (1-2 mm)	7.0	0.118	200-300
B22	450-1400		N/A	Loam	2.5YR 4/6 Red	None evident	None evident	None evident	Polyhedral	Weak	Very firm (dry)	No roots (0)	7.5 8.0	0.071 0.053	500-600 900-1000
<b>Other information:</b> Clay at 100 - 450, texture change at 450 onwards (slight decrease in clay despite shearing)

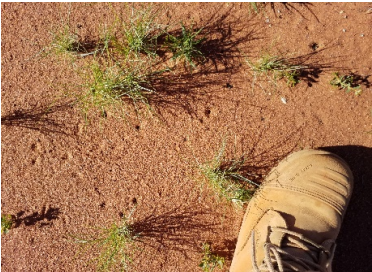
Soil Surface Condition Photo

Project Haverion	Date	Scribe I. Kelder	Location TP11	Observation Soil pit		Easting/ Latitude		Zone	ASC Mapped Tenosol	
Dominant Vegetation Form Non-woody			Ground Cover % Sparse (10-30%)		Aspect	Northing/ Longitude		Scale	ASC Ground Truth Rudosol	
Secondary Vegetation Form Woody			Ground Cover % Isolated Plants (<0.2%)		Slope %	Rock Outcrop No rock outcrop		Erosion Type Wind		
Vegetation (species)						Drainage (site) Rapidly drained		Erosion Extent Moderate		
Landform Flat			Soil Surface Condition (dry) Loose			Land Use Grazing		Erosion State Active		
Landscape Photo (North)

Other Photo			Microrelief N/A	
									Type	
									Vertical (m)	
									Horizontal (m)	
									Sampled	
									Other Information: Wind blown aelion sand

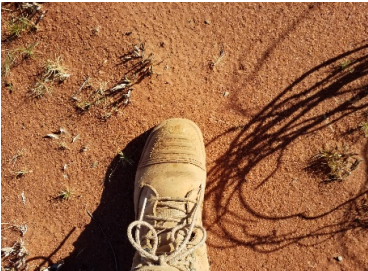
Soil Surface Condition Photo

Project Haverion	Date	Scribe I. Kelder	Location TP12	Observation Soil pit		Easting/ Latitude		Zone	ASC Mapped Tenosol	
Dominant Vegetation Form Non-woody			Ground Cover % Mid-dense (30-70%)	Aspect		Northing/ Longitude		Scale	ASC Ground Truth Rudosol	
Secondary Vegetation Form Woody			Ground Cover % Very sparse (0.2-10%)	Slope %		Rock Outcrop No rock outcrop		Erosion Type Wind		
Vegetation (species)						Drainage (site) Rapidly drained		Erosion Extent Moderate		
Landform Mid-slope			Soil Surface Condition (dry) Loose			Land Use Grazing		Erosion State Active		
Landscape Photo (North)

Other Photo			Microrelief N/A	
									Type	
									Vertical (m)	
									Horizontal (m)	
									Sampled	
									Other Information: Wind blown sands

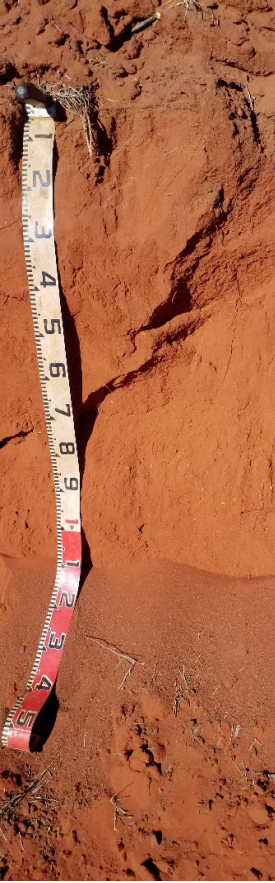
Abrupt	Loamy Sand	2.5YR 3/6 Dark red	None evident	None evident	None evident	Apedal	Single grain	Loose (dry)	Few (1-10) Fine (1-2 mm)	6.5	0.017	0-100
B	50-1100		N/A	Loamy Sand	2.5YR 3/6 Dark red	Yellow 5%	<2 % Carbonates	None evident	Apedal	Single grain	Very weak (dry)	Few (1-10) Medium (2-5 mm)	5.5 6.0 6.0	0.010 0.020 0.011	200-300 500-600 800-900
<b>Other information:</b> Consistent sands down the profile. 1mm thick layer of black at very top of profile (organic matter?).

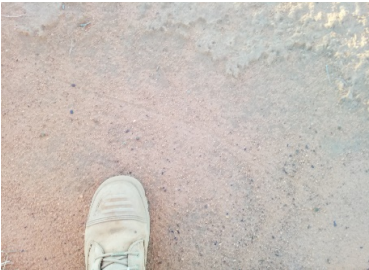
Soil Surface Condition Photo

Project Haverion	Date	Scribe I. Kelder	Location TP13	Observation Soil pit		Easting/ Latitude		Zone	ASC Mapped Tenosol	
Dominant Vegetation Form Non-woody			Ground Cover % Mid-dense (30-70%)		Aspect	Northing/ Longitude		Scale	ASC Ground Truth Kandosol	
Secondary Vegetation Form			Ground Cover %		Slope %	Rock Outcrop No rock outcrop		Erosion Type Wind		
Vegetation (species)						Drainage (site) Imperfectly drained		Erosion Extent Minor or present		
Landform Flat			Soil Surface Condition (dry) Loose			Land Use Grazing		Erosion State Active		
Landscape Photo (North)

Other Photo			Microrelief N/A	
									Type	
									Vertical (m)	
									Horizontal (m)	
									Sampled	
									Other Information: Wind blown sands.	
Dominant Vegetation Photo 1			Dominant Vegetation Photo 2			Other Vegetation Photo

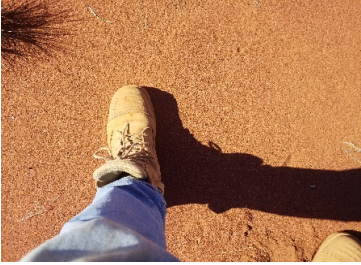
Soil Surface Condition Photo

Project Haverion	Date	Scribe I. Kelder	Location TP14	Observation Soil pit		Easting/ Latitude	Zone	ASC Mapped Calcarosol
Dominant Vegetation Form Non-woody			Ground Cover % Mid-dense (30-70%)	Aspect		Northing/ Longitude	Scale	ASC Ground Truth Rudosol
Secondary Vegetation Form Woody			Ground Cover % Very sparse (0.2-10%)	Slope %		Rock Outcrop No rock outcrop	Erosion Type None evident	
Vegetation (species)						Drainage (site) Rapidly drained	Erosion Extent None evident	
Landform Lower slope			Soil Surface Condition (dry) Soft			Land Use Grazing	Erosion State None evident	
Landscape Photo (North)

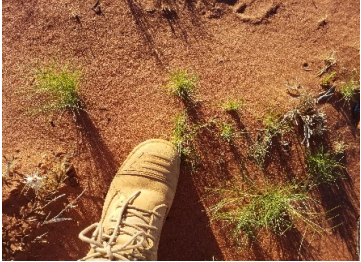
Soil Surface Condition Photo

Project Haverion	Date	Scribe I. Kelder	Location TP15	Observation Soil pit		Easting/ Latitude		Zone	ASC Mapped Tenosol	
Dominant Vegetation Form Non-woody			Ground Cover % Mid-dense (30-70%)	Aspect		Northing/ Longitude		Scale	ASC Ground Truth Rudosol	
Secondary Vegetation Form Woody			Ground Cover % Sparse (10-30%)	Slope %		Rock Outcrop No rock outcrop		Erosion Type Wind		
Vegetation (species)						Drainage (site) Well-drained		Erosion Extent Moderate		
Landform Mid-slope			Soil Surface Condition (dry) Loose			Land Use Grazing		Erosion State Active		
Landscape Photo (North)

Other Photo			Microrelief N/A	
									Type	
									Vertical (m)	
									Horizontal (m)	
									Sampled	
									Other Information: Some plants covered in sand mounds, wind erosion prevalent

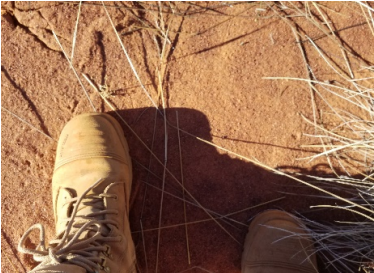
Soil Surface Condition Photo

Other Photo			Microrelief N/A	
									Type	
									Vertical (m)	
									Horizontal (m)	
									Sampled	
									Other Information: Slight surface crust 1mm thick.

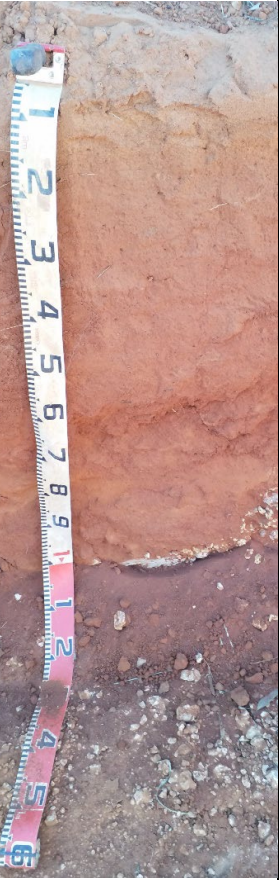
Abrupt	Loamy Sand	2.5YR 3/4 Dark reddish brown	None evident	None evident	None evident	Granular	Single grain	Weak (dry)	Common (10-25) Fine (1-2 mm)	7.0	0.011	0-100
B	100-900		Clear	Loamy Sand	2.5YR 3/6 Dark red	None evident	None evident	None evident	Granular	Single grain	Firm (dry)	Few (1-10) Fine (1-2 mm)	7.5 7.5 7.5	0.014 0.032 0.021	200-300 500-600 800-900
C	900-1000		N/A	None evident	None evident	None evident	None evident	None evident	None evident	None evident	None evident	No roots (0)			
<b>Other information:</b> Looks to be wind deposited sands, hard rock at bottom of profile.

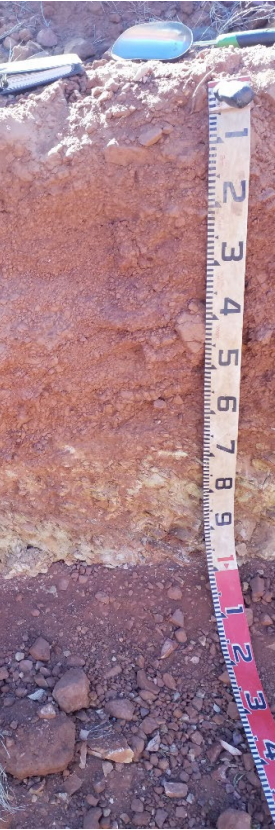
Abrupt	Sandy Loam	2.5YR 3/6 Dark red	5% White and green sheared clay	2-10 % Clayey	10-20mm 80%	Subangular blocky	Weak	Firm (dry)	Few (1-10) Fine (1-2 mm)	6.5 6.5 6.5	0.019 0.017 0.014	0-100 200-300 500-600
C	700-1000		N/A	None evident	None evident	None evident	2-10 % Clayey	50-90 % 60-200 mm	Apedal	Single grain	None evident	No roots (0)			
<b>Other information:</b> Portions of clay present at 400mm, profile increases in clay content slightly at depth, variable sized coarse fragments throughout, c horizon is weathered and white,

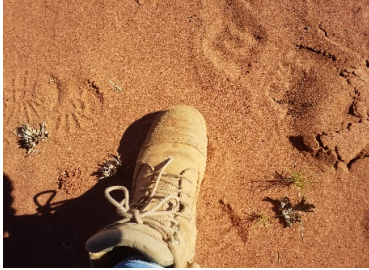
Soil Surface Condition Photo

Sampled
Other Information: Loose sands and nothing else

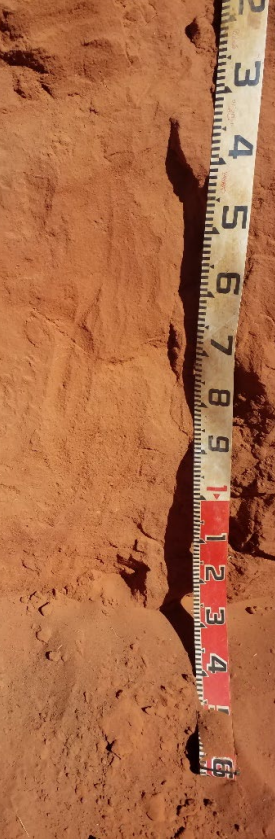
Abrupt	Loamy Sand (fine)	2.5YR 3/4 Dark reddish brown	None evident	None evident	2-10 % 2-6 mm	Granular	Single grain	Loose (dry)	Few (1-10) Fine (1-2 mm)	6.5	0.012	0-100
B21	50-800		Gradual	Loamy Sand (fine)	2.5YR 3/6 Dark red	None evident	None evident	2-10 % 2-6 mm	Granular	Single grain	Very weak (dry)	Few (1-10) Fine (1-2 mm)	6.5 6.5	0.008 0.012	200-300 500-600
B22	800-1300		N/A	Loamy Sand (fine)	2.5YR 3/6 Dark red	None evident	None evident	<2 % 2-6 mm	Granular	Single grain	Weak (dry)	No roots (0)	6.0	0.012	900-1000
<b>Other information:</b> Single grain sand. A few thin black layers at the top of the profile approximately 1mm thick, then into consistent sands.

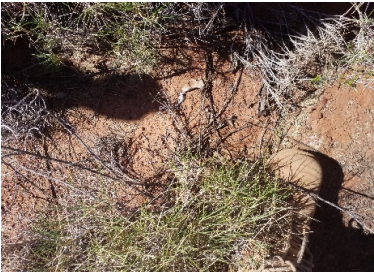
Soil Surface Condition Photo

Other Photo		Microrelief N/A
							Type
							Vertical (m)
							Horizontal (m)
							Sampled
							Other Information: Good shrub cover, scattered rocks on surface, leaf litter 20%

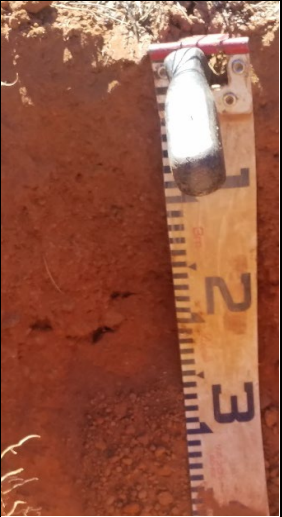
N/A	Loamy Sand	2.5YR 3/4 Dark reddish brown	None evident	None evident	20-50 % 2-6 mm	Polyhedral	Weak	Firm (dry)	Common (10-25) Fine (1-2 mm)	6.5	0.015	0-100
<b>Other information:</b> Consistent horizon.

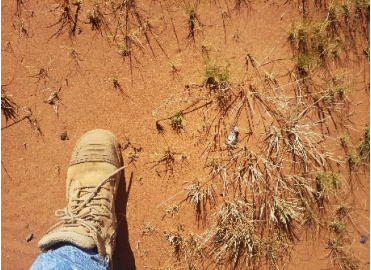
Soil Surface Condition Photo

Other Photo		Microrelief N/A
							Type
							Vertical (m)
							Horizontal (m)
							Sampled
							Other Information: Very sandy, some rock 10-20mm at 5%.
Dominant Vegetation Photo 1		Dominant Vegetation Photo 2			Other Vegetation Photo
