**FINAL REPORT
RESPONSE TO SUBMISSIONS
(Volume 2: Appendices)**

Proposed Relocation of the Voyager Quarry
Land Clearing and Quarry Expansion, Avon Loc 1881,
Lot 14 Horton Road, The Lakes
(EPA Assessment Number 1413)

BGC (Australia) Pty Ltd

**PROPOSED RELOCATION OF THE VOYAGER QUARRY
RESPONSE TO SUBMISSIONS
VOLUME 2: APPENDICES**

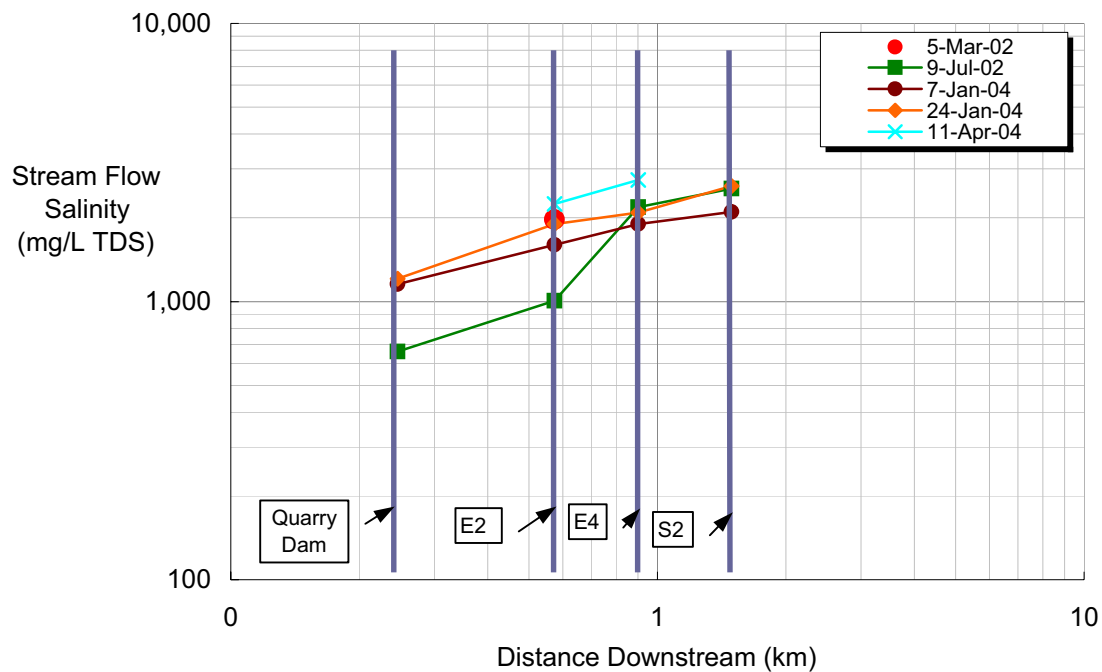
Job No.	50846-008-562		BGC Quarries Response to Submissions related to the Proposed Expansion of BGC Voyager Quarry - Surface Water Issues OBSERVED STREAM FLOW NORTH OF EXISTING QUARRY	Figure 5

Figure 5: Observed Stream Flow North of the Existing Quarry

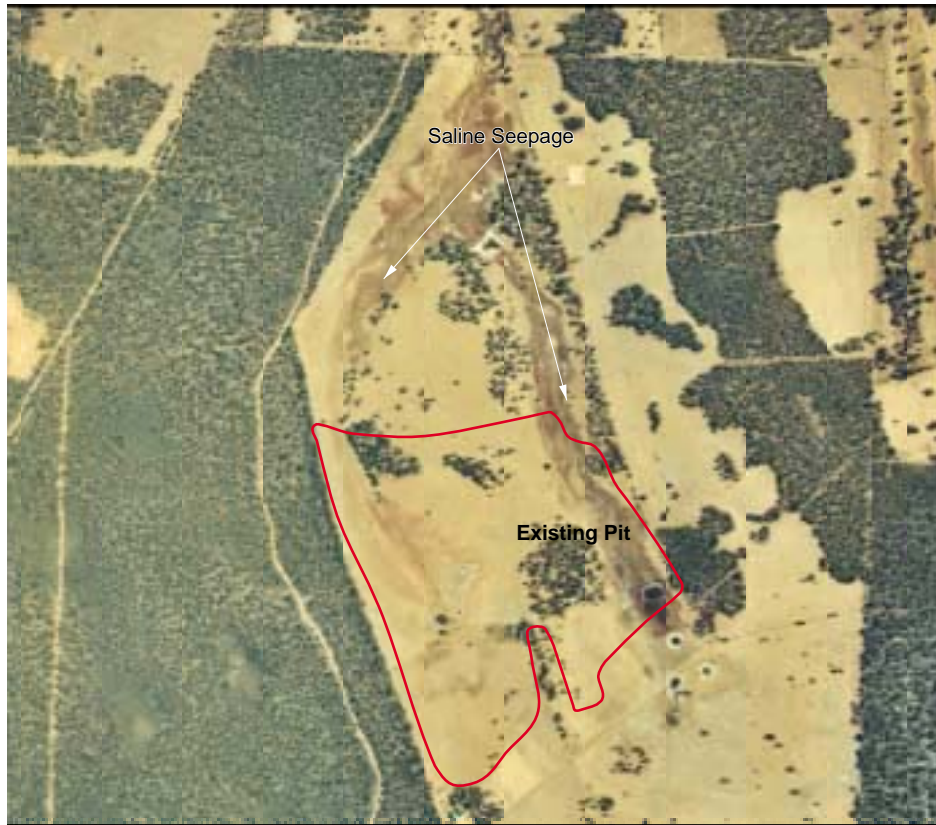
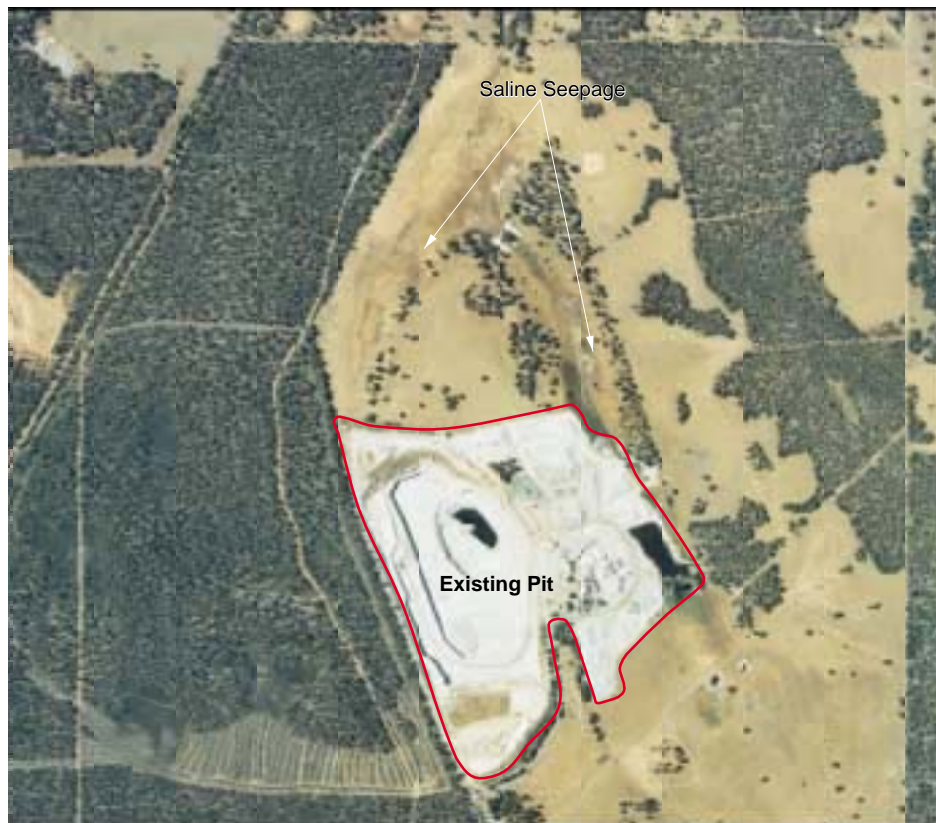
(a) 10 February 1989

The photographs have been used to identify major fracture lineaments and dolerite dykes in the granite bedrock, and to compare surface expressions of soil salinity before and after the excavation of the existing quarry.

There are a number of lineaments visible in the air photographs which reflect dolerite dykes or regional fracture zones. These are on Figure 1. The most prominent set is west-northwest in orientation; in the existing quarry this set corresponds with sub-vertical dolerite dykes. The margins of the dykes are fractured, except for the northern margin of the dyke in the north wall of the quarry, which is annealed. Individual fracture zones close with depth, and are unlikely to be open below 50-60 m from surface.

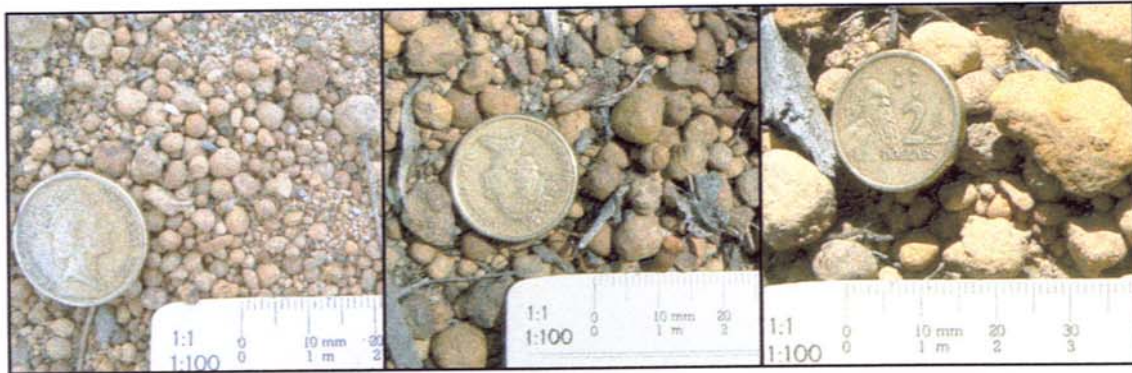
Figure 1: Examples of small, medium and large-sized grained gravel's.

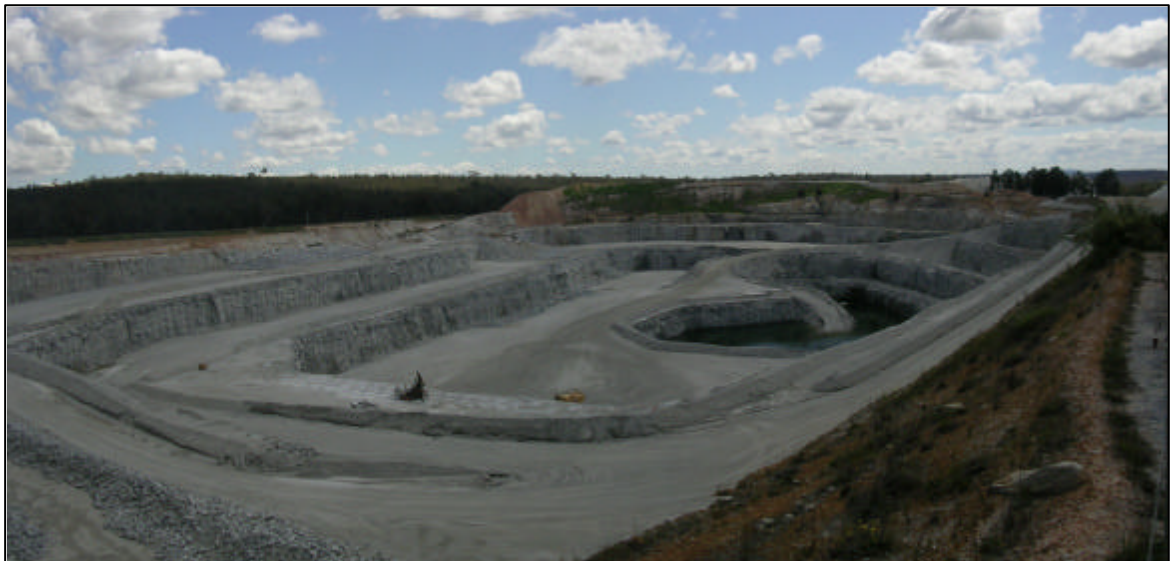
A photograph that shows the current quarry pit, as observed on 27 September 2004, is given in **Figure 2-1**. This photograph shows the high level of attention that has been given, by BGC, to both the design and operation of the current quarry.

Figure 2-1: Photograph (towards North) Showing Quarry Pit at 26 September 2004

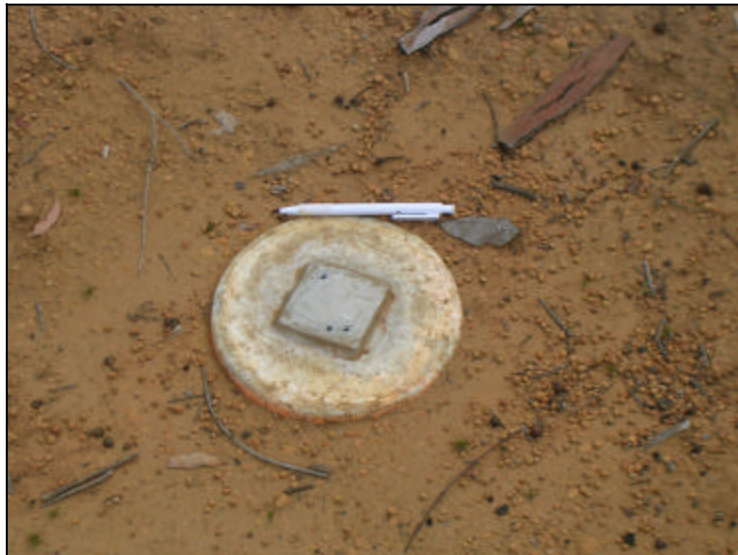
Figure 7-1: Vibration Monitoring Pad Near Lot 5 Horton Road

Vibration and air overpressure monitoring has been carried out at a site near to the residence at Lot 5 Horton Road (closest residence) and also at a site closer to the quarry as a control measure and at the initiative of BGC Voyager Quarry management. The monitoring positions have been permanently established at both locations. At both of the monitoring stations the vibration monitor is mounted on top of a concrete pad that is about 400mm diameter and extends into the ground for up to about 1000mm. The concrete column was formed using a rapid set concrete and it is suspected that it will have a strength of at least 15 MPa. A typical vibration monitor set-up pad is shown in **Figure 7-1**.

A monitor set up such as that shown in Figure 7-1 will help to reduce the scatter of data by ensuring that the vibration sensor is properly coupled to the ground. SRK consider that the monitor set-up for monitoring that is done for compliance purposes is appropriate.
