Technical Note

Project:	Learmonth Benthic Habitat Survey
From:	BMT
To:	MBS Environmental
Date:	25 February 2020
Doc Ref:	R-1557_00-1
Subject:	Verification of Benthic Habitat in the Exmouth Gulf

1 Introduction

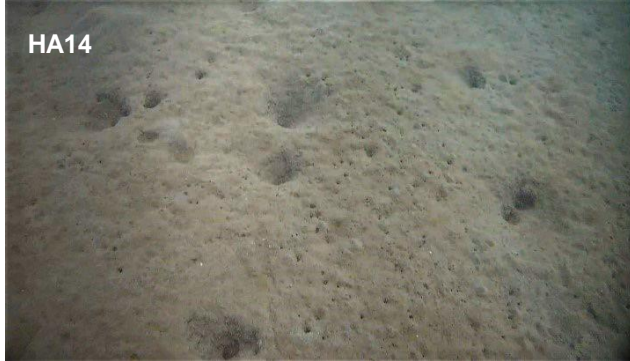
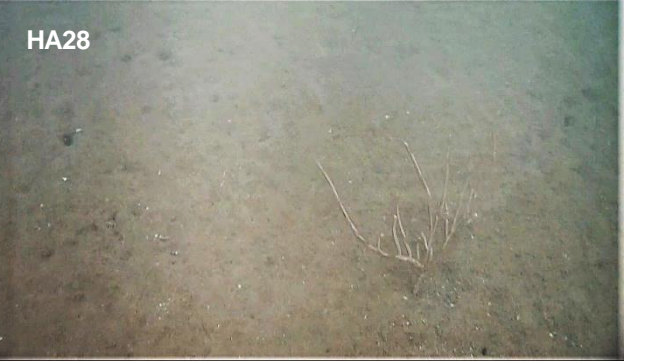
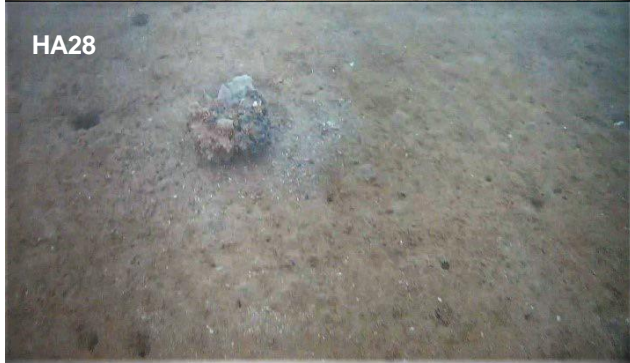
Table 2.1 Benthic habitat classifications with example images from towed video

Category	Description		
<p>Soft sediment</p>	<p>Mud and sand dominated habitat with bioturbation and rare occurrences of macroalgae and filter feeders</p>

Three benthic habitat categories were developed to classify the range of habitats observed during the video tows. These included soft sediment, sand and rock rubble, and seagrass. Full descriptions of each habitat type and example images are provided in Table 2.1.

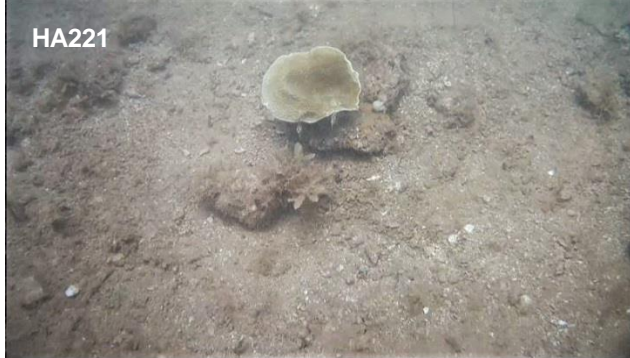
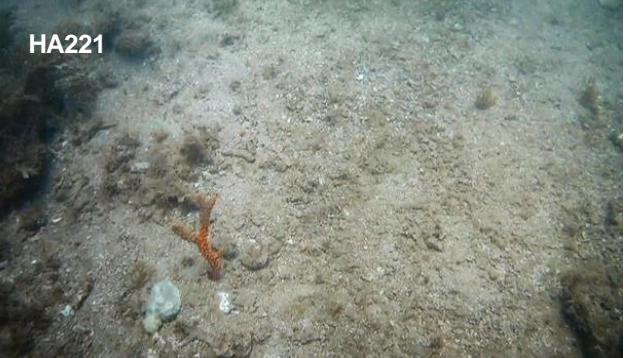
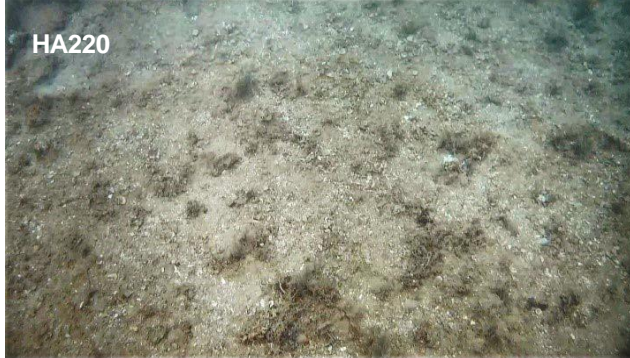
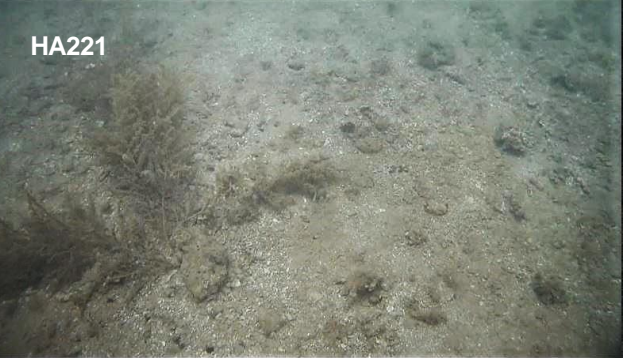
Category	Description		
Sand and rock rubble	Coarse sand with rock rubble, turf algae and/or macroalgae and occasional filter feeders

Benthic habitat classifications and descriptions for each transect are displayed in Table 3.1 and Figure 3.1. Transects located to the north of the Off Bottom Tow area were predominately coarse sand substrate with rock rubble and turf algae (HA220 and HA221). Macroalgae and occasional filter feeders (marine sponges, feather stars) were also observed growing on the rock rubble at these sites. Transects surveyed within the Off Bottom Tow area were all observed to be soft sediment (HA34, HA19, HA14, HA8, HA119 and HA2), with the rare occurrence of filter feeders (e.g. marine sponges) and macroalgae at HA28. Transects surveyed to the south of Heron Point were largely characterised by a sparse cover of ephemeral seagrass growing on soft sediment, with rare occurrences of filter feeders (e.g. marine sponges and feather stars; AS6C and AS27).

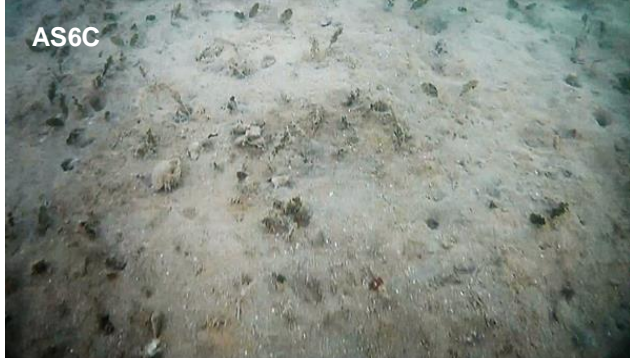
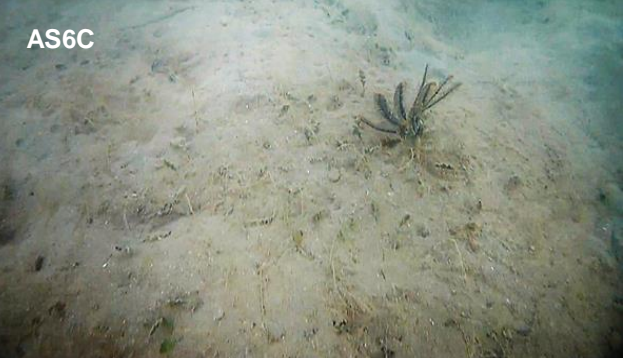
<p>AS6C</p>
		Seagrass	Mud and sand dominated habitat with sparse <i>Halodule uninervis</i> and <i>Halophila ovalis</i> and rare occurrence of filter feeders.
