Great Northern Highway

Bindoon Bypass Environmental Review Document | Response to Submissions

Document Number :	GNH-CN12-EN01-RPT-8004
Revision :	9
Date :	31 / 05 / 2022
Contract Number :	CN12-EN01
Client Contract Number :	10/13

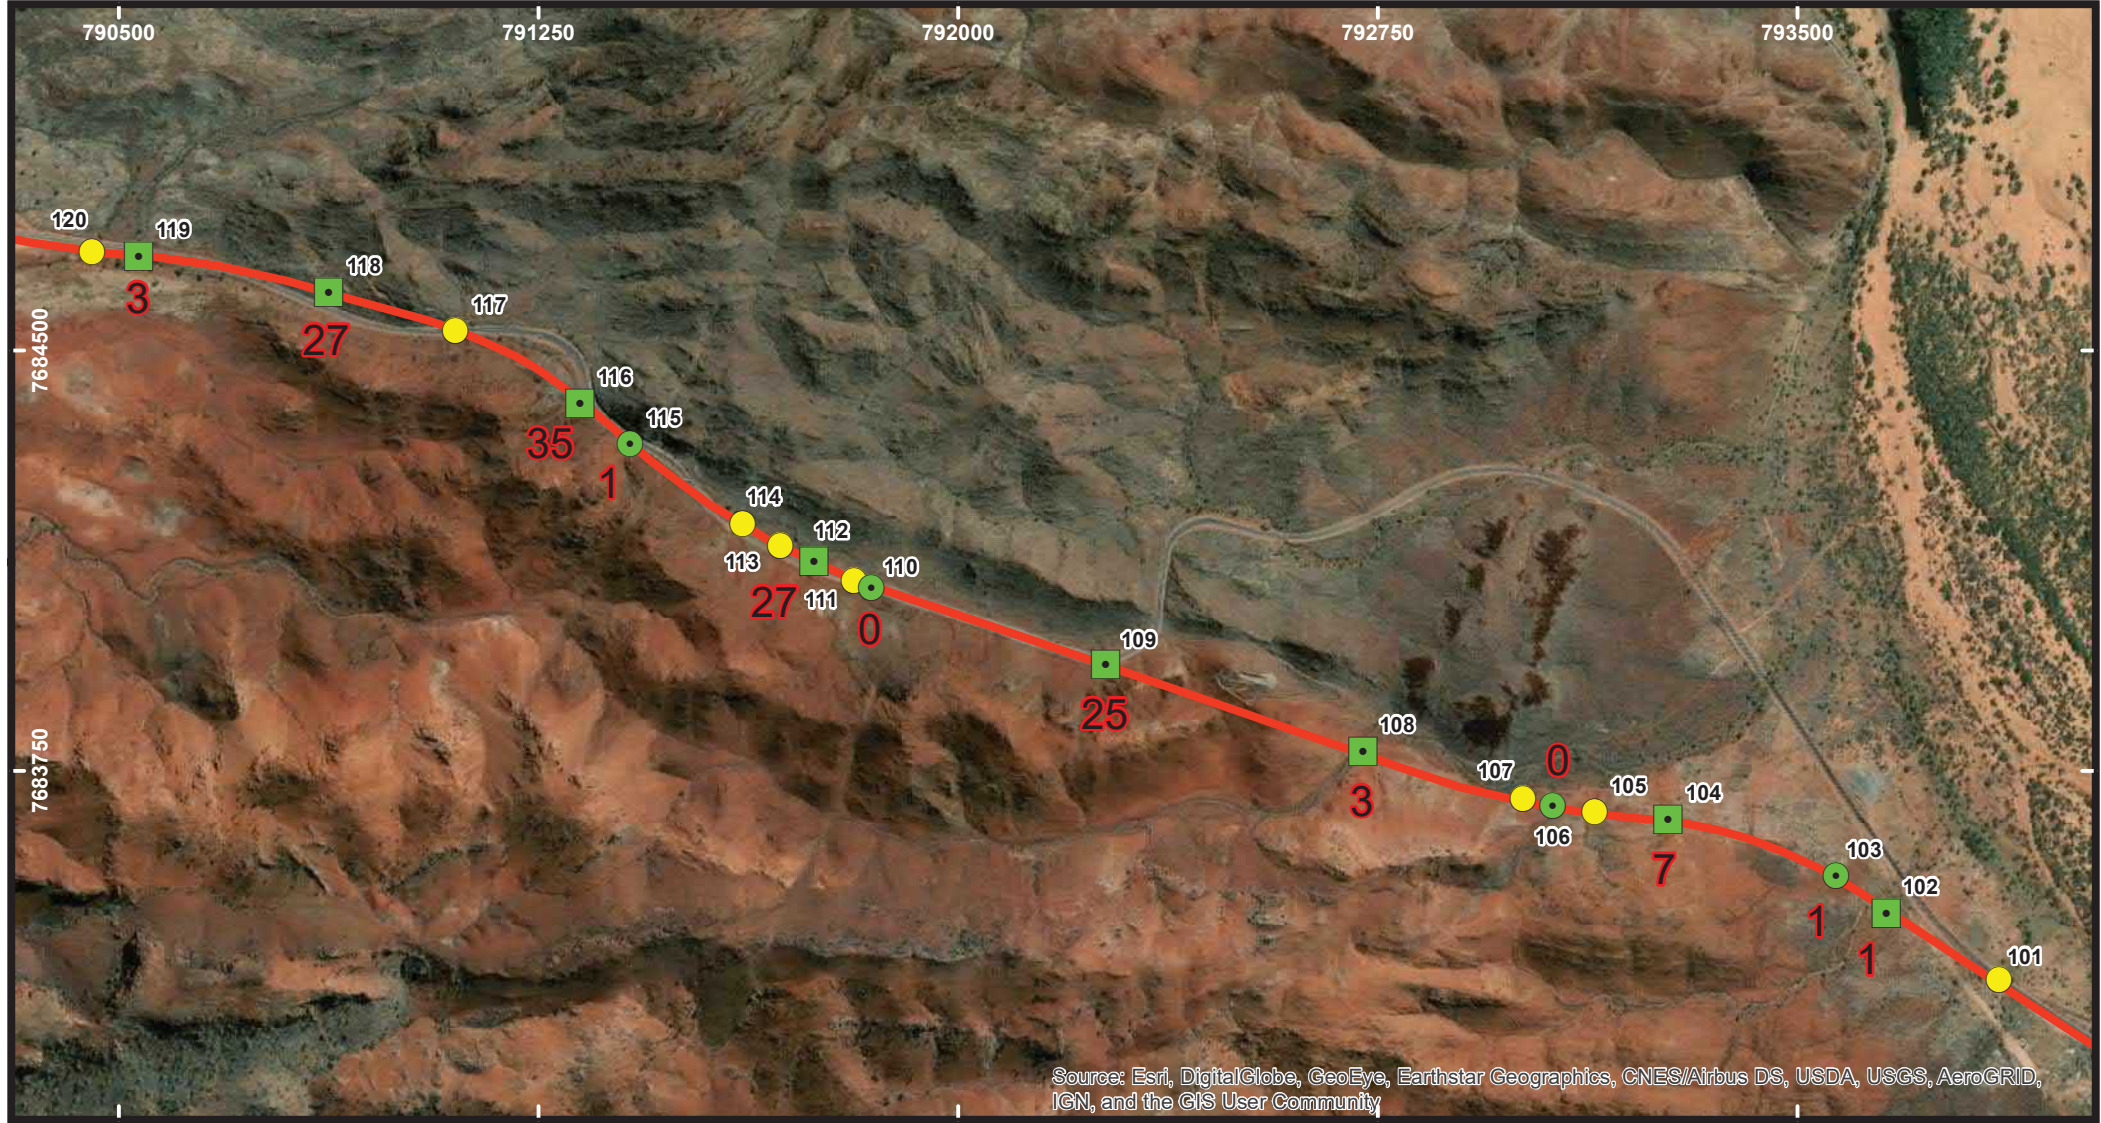
- Road Alignment
- Box Culvert (Monitored)
- Pipe Culvert (Monitored)
- Pipe Culvert (Not Monitored)
