## ORE BODY 25 PIT 3

### Homestead Creek Management at Closure

Prepared for: BHP Billiton Iron Ore

DOCUMENT NO.: 1495040100-RG-002

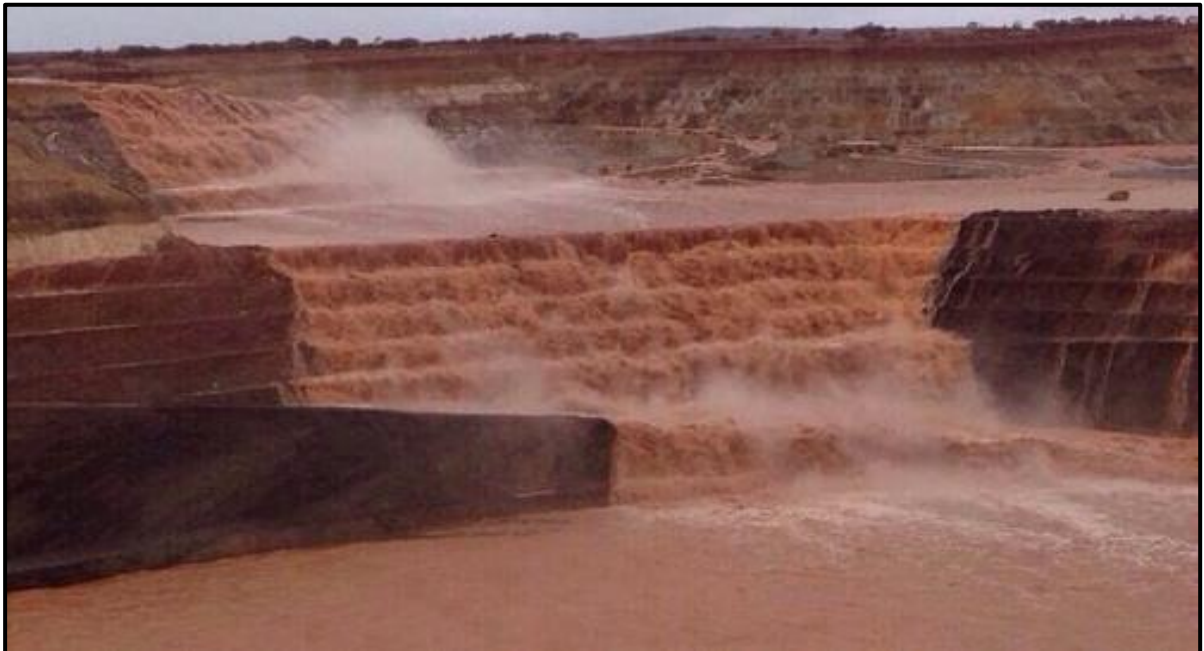
Figure 3. Overflow into open mining pit following heavy rainfall February 2014 in Western Australia

Figure 3 shows a Western Australian example in which a flood bund failed after heavy rains in February 2014, diverting the adjacent creek flow into the open pit. The dewatering and pit wall stabilisation required after such a scenario can force an operational halt that lasts for many months. If floodplain flows spill into an open pit in the post-closure timeframe when no maintenance activities are undertaken, a head cut may form and capture the entire creek flow, trapping all future bed load and all low flows indefinitely. The outputs of the surface water models are used as inputs into closure planning strategy, and are used in the early operational stages of a mine to subsequently inform conceptual closure landform design and options assessments for solutions to prevent creek capture.

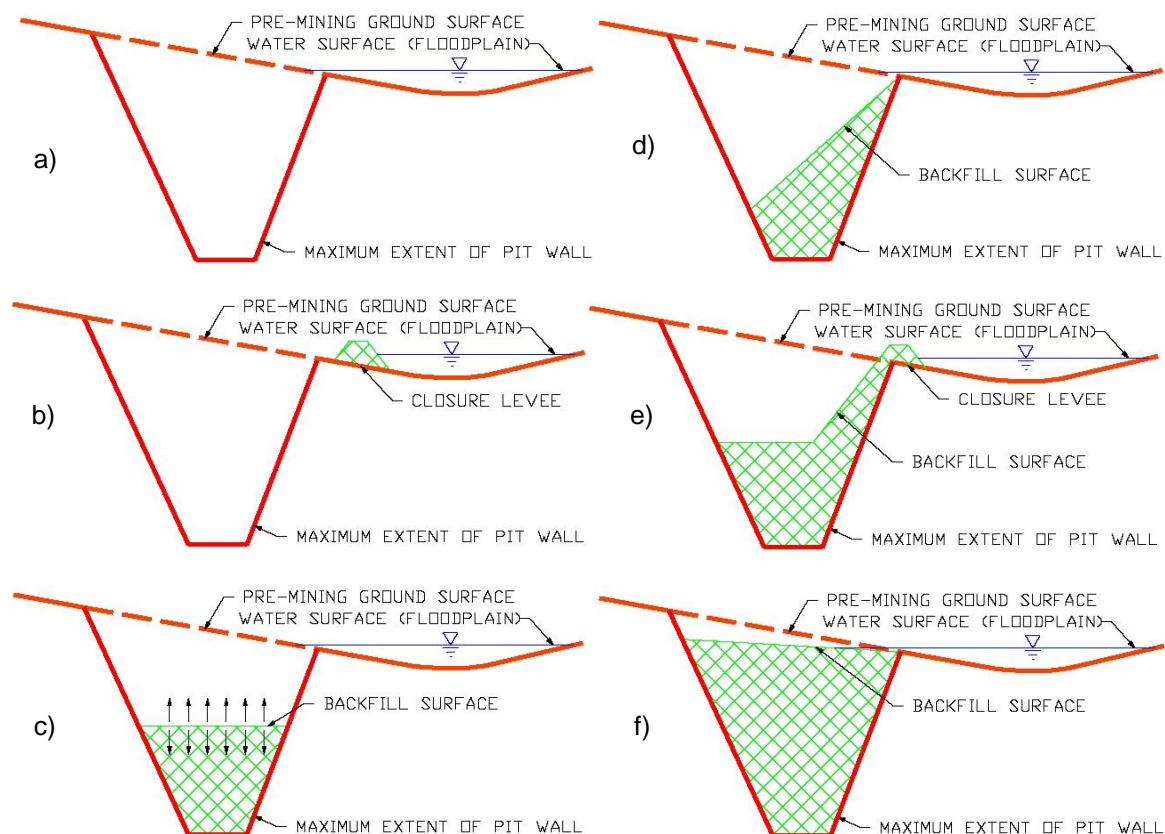
Figure 13. Schematic backfill sections for pits within floodplains

Options for pit closure may be simplified into three conditions: 1) no backfill, 2) partial backfill, or 3) complete backfill. Any of these conditions could be undertaken with or without a closure levee or diversion structures in place. Scenarios involving a permanent pit lake may need further hydrogeological or water quality assessments; however, for the purposes of this study, permanent pit lake scenarios are assumed to be viable options for Pit 3. Figure 13 shows some typical options for closure scenarios involving open pits located in floodplain areas.
