## MEMO REPORT

COMPANY:	Wildcat Resources Limited
ATTENTION:	Ajanth (AJ) Saverimutto, Managing Director
FROM:	Matt Holmes, Significant Environmental Services
DATE:	18 October 2024
DESCRIPTION:	<b>Tabba Tabba Lithium Project – Soil Characterisation Study</b>

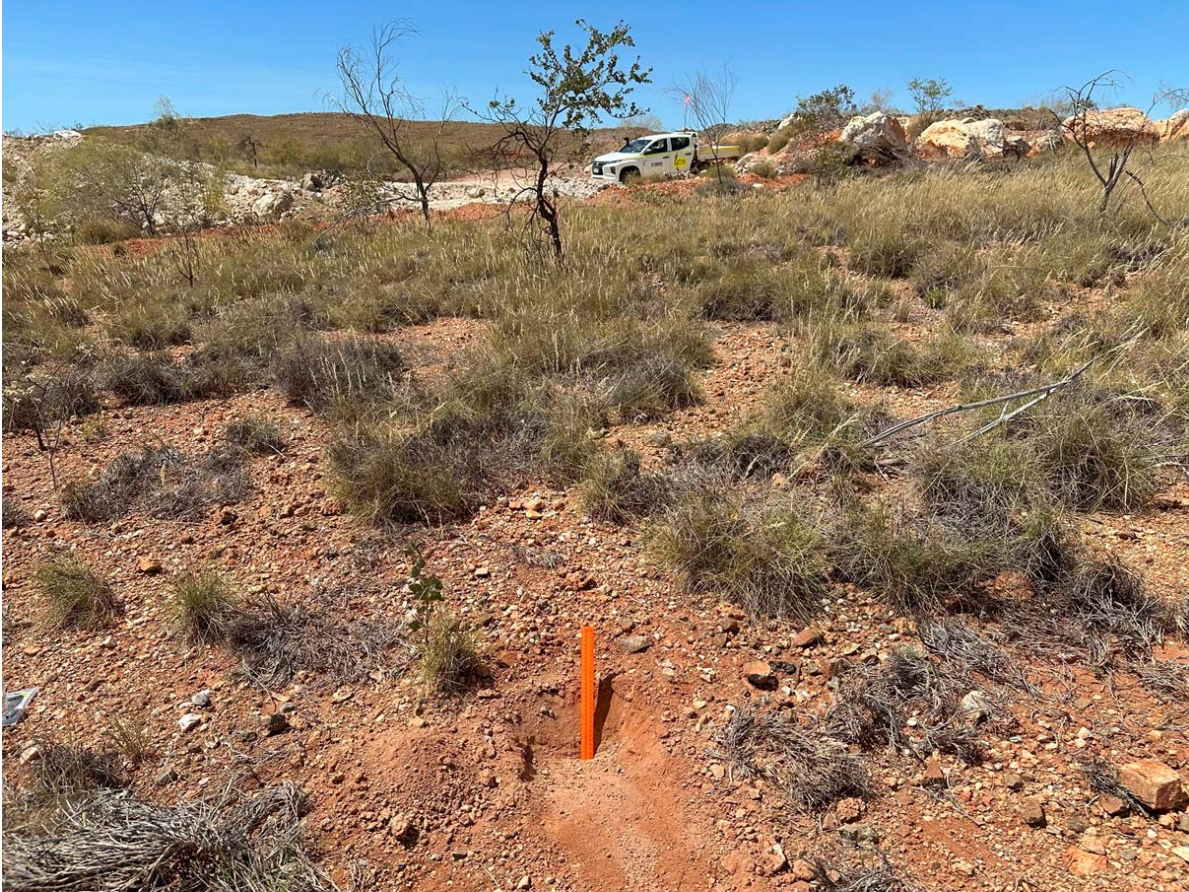
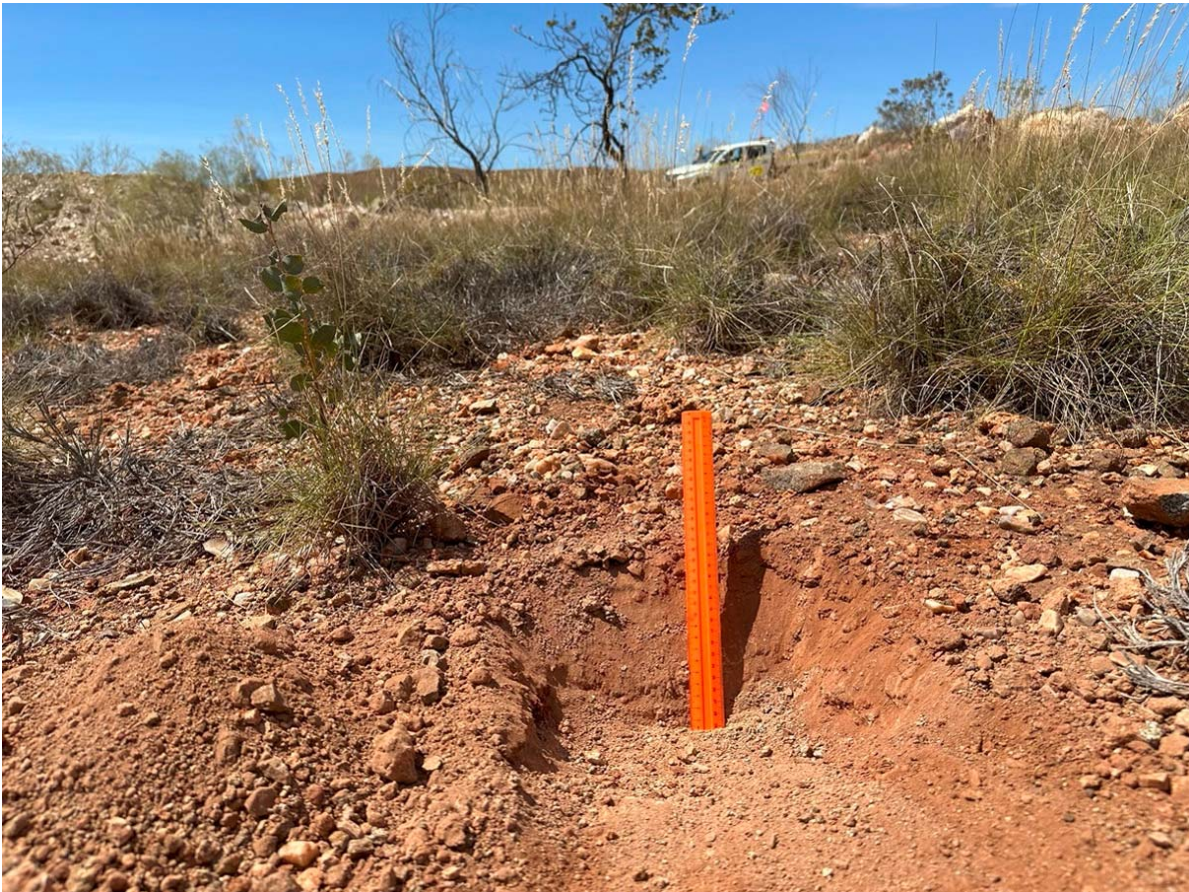
Figure 5: S1 soil sampling location – Pit (northern extent), looking north direction on Hillside gentle slope

Photo of landscape and ground surface

Photo of soil profile

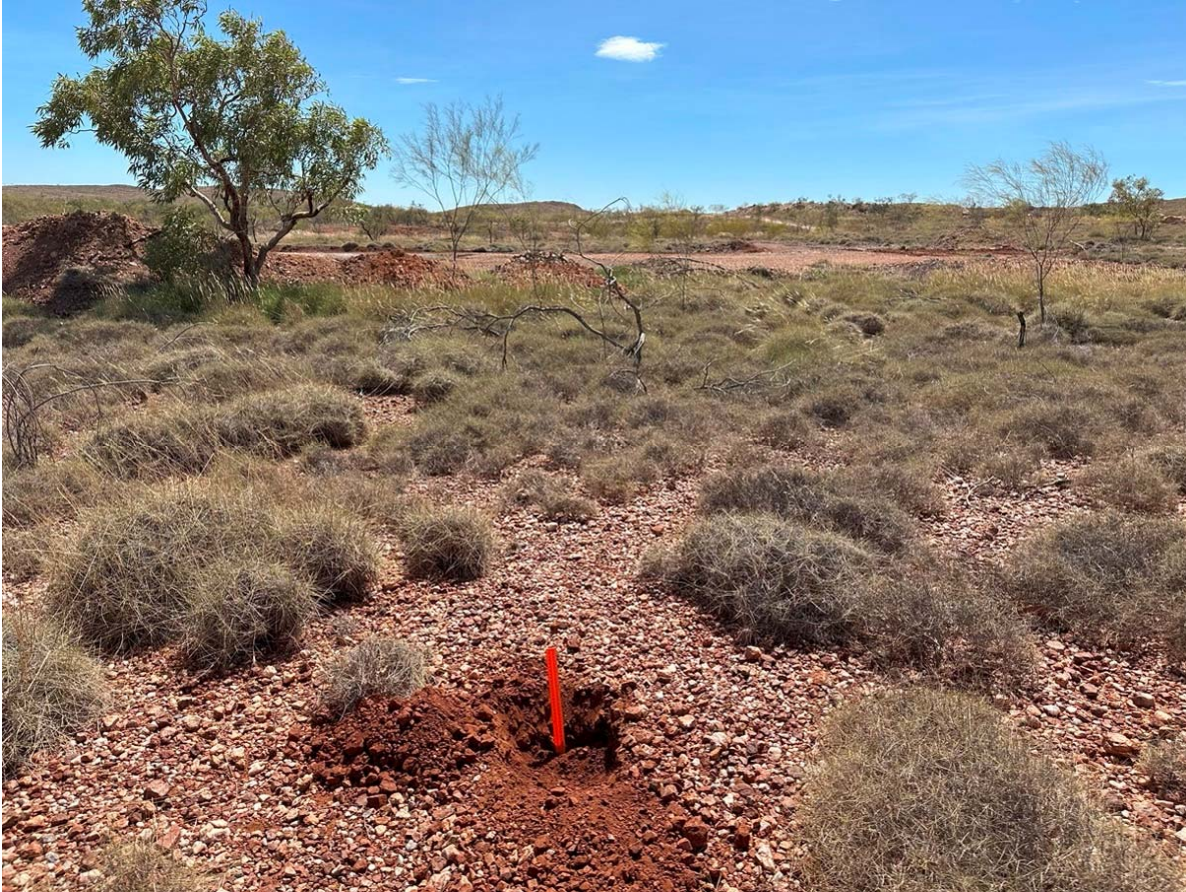
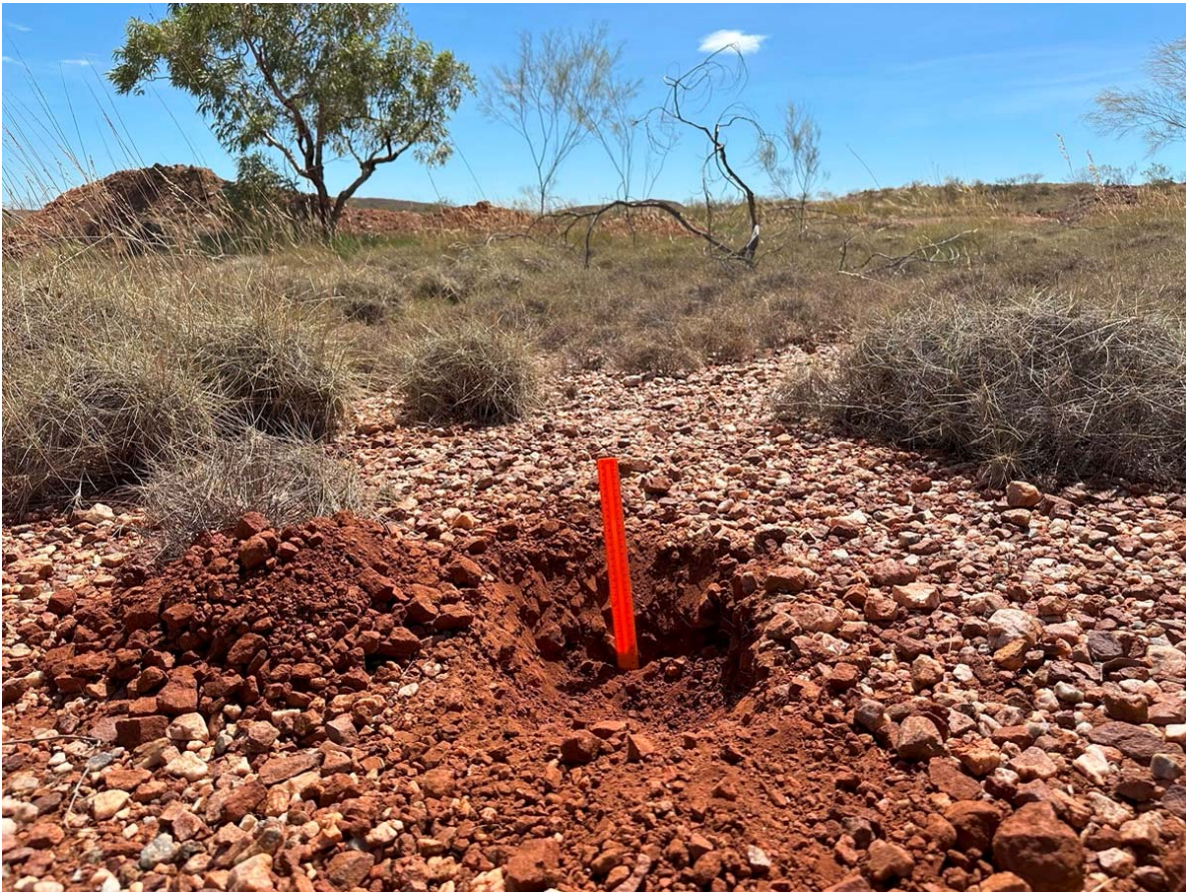
Figure 6: S2 soil sampling location – Pit (central extent), looking north direction on Hillside gentle slope

Photo of landscape and ground surface

Photo of soil profile

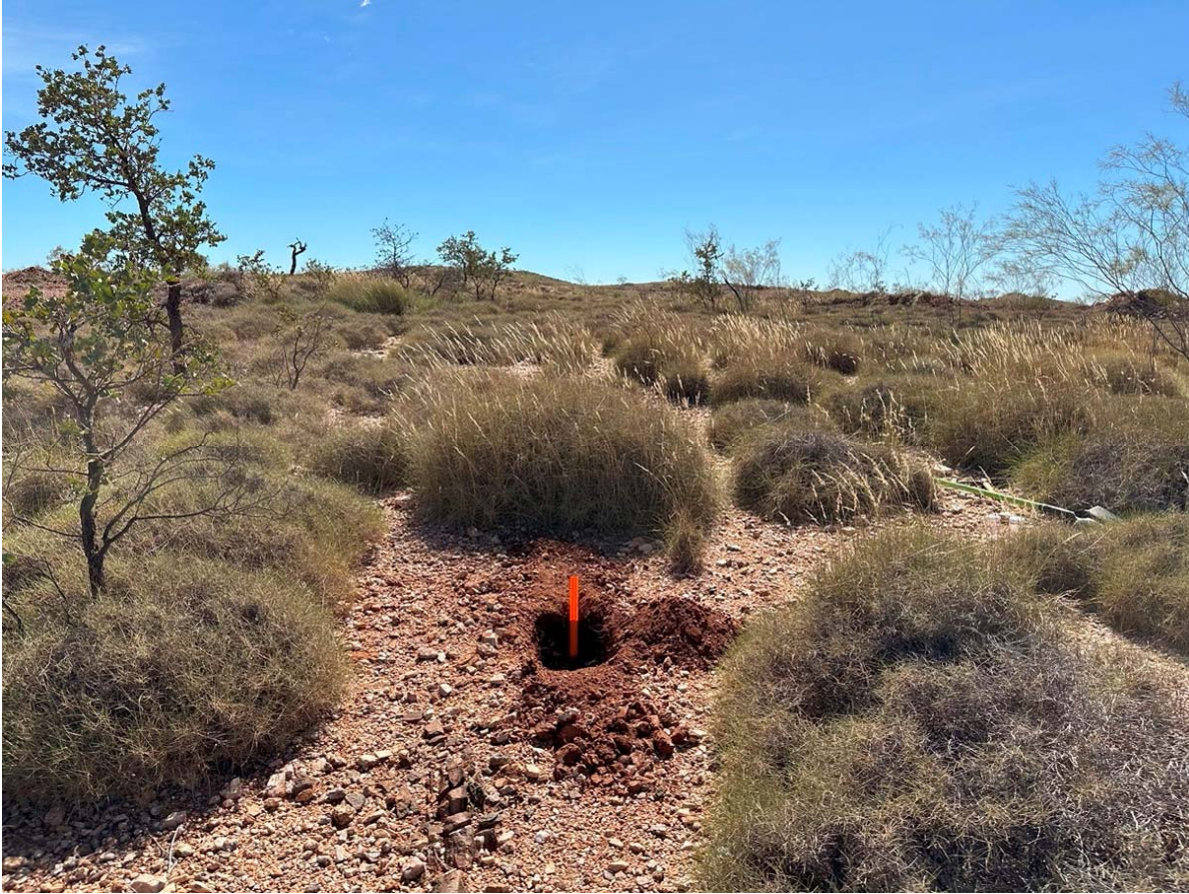
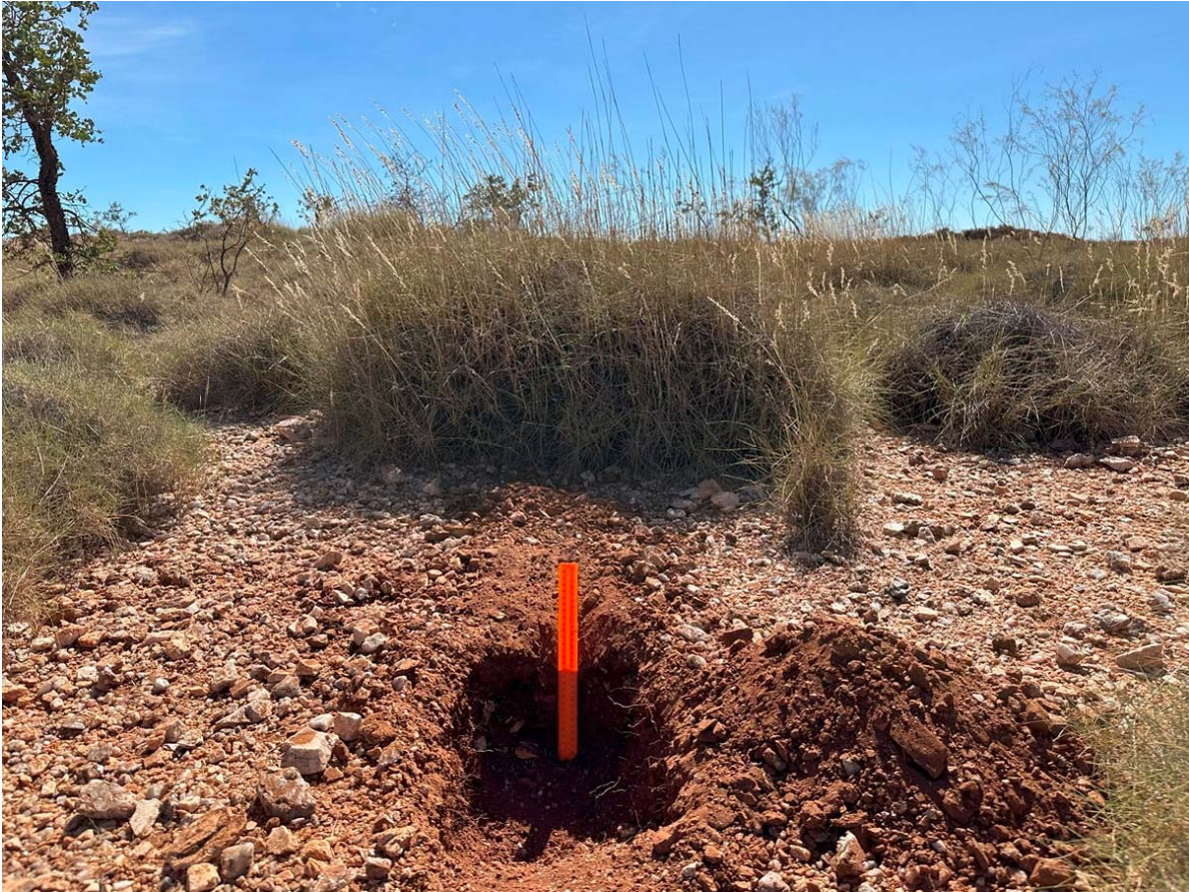
Figure 7: S3 soil sampling location – Pit (southern extent), looking north direction on Hillside gentle slope

Photo of landscape and ground surface

Photo of soil profile

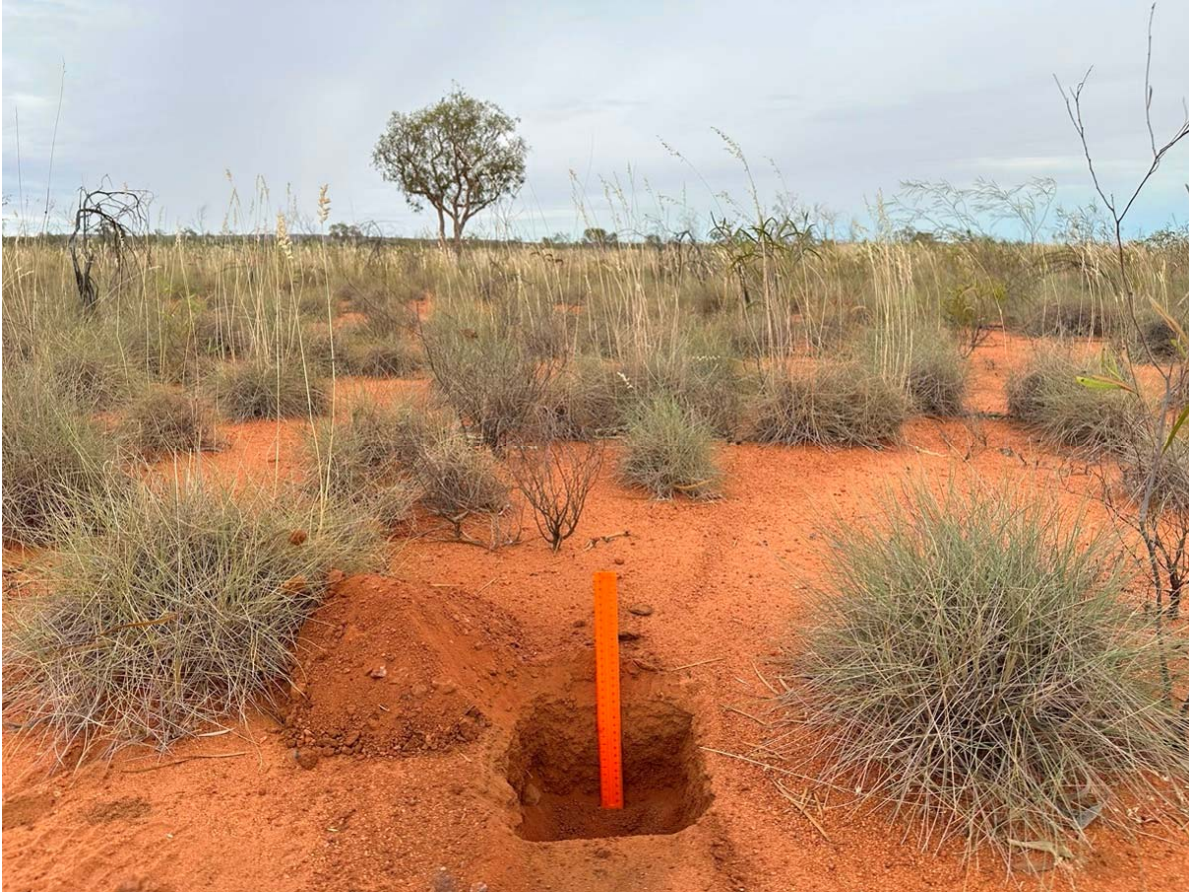
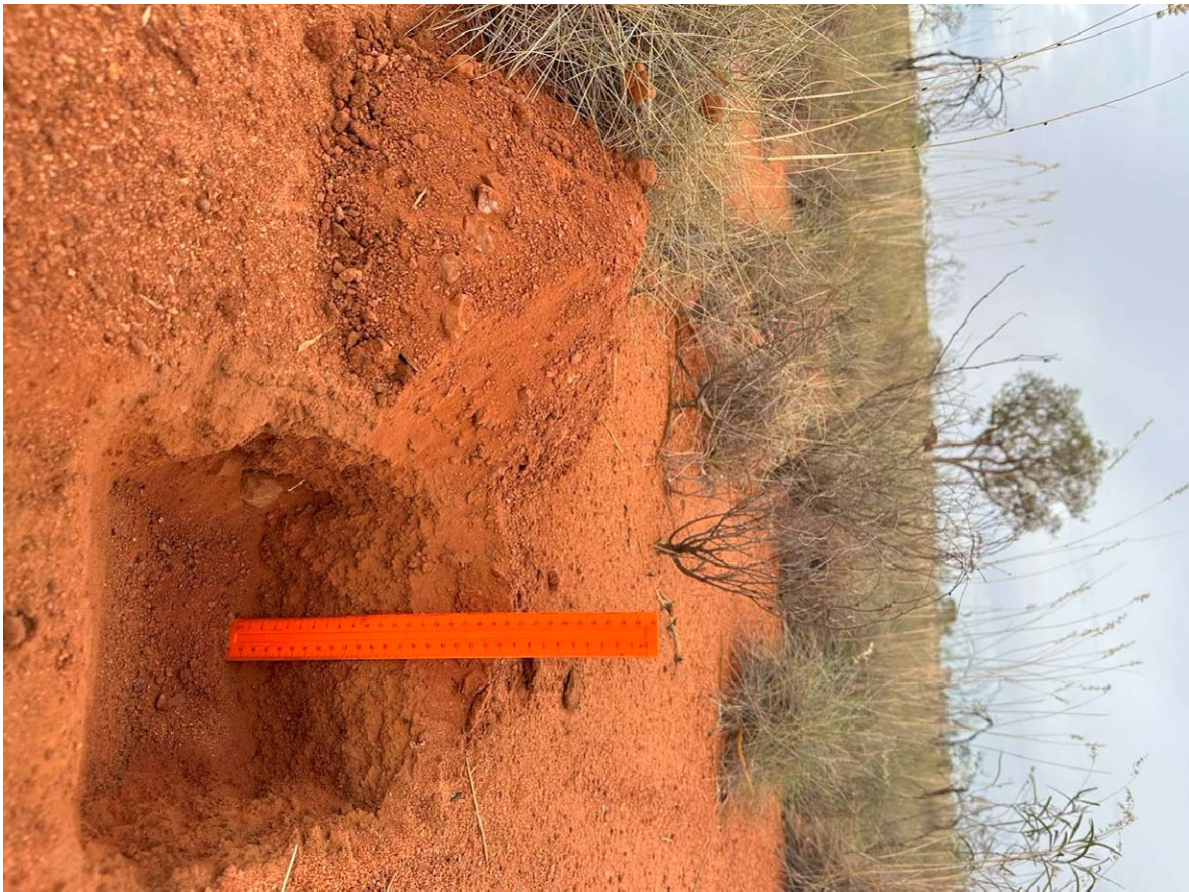
Figure 8: S4 soil sampling location – WRD area, looking north direction on Flat Plain

Photo of landscape and ground surface

Photo of soil profile

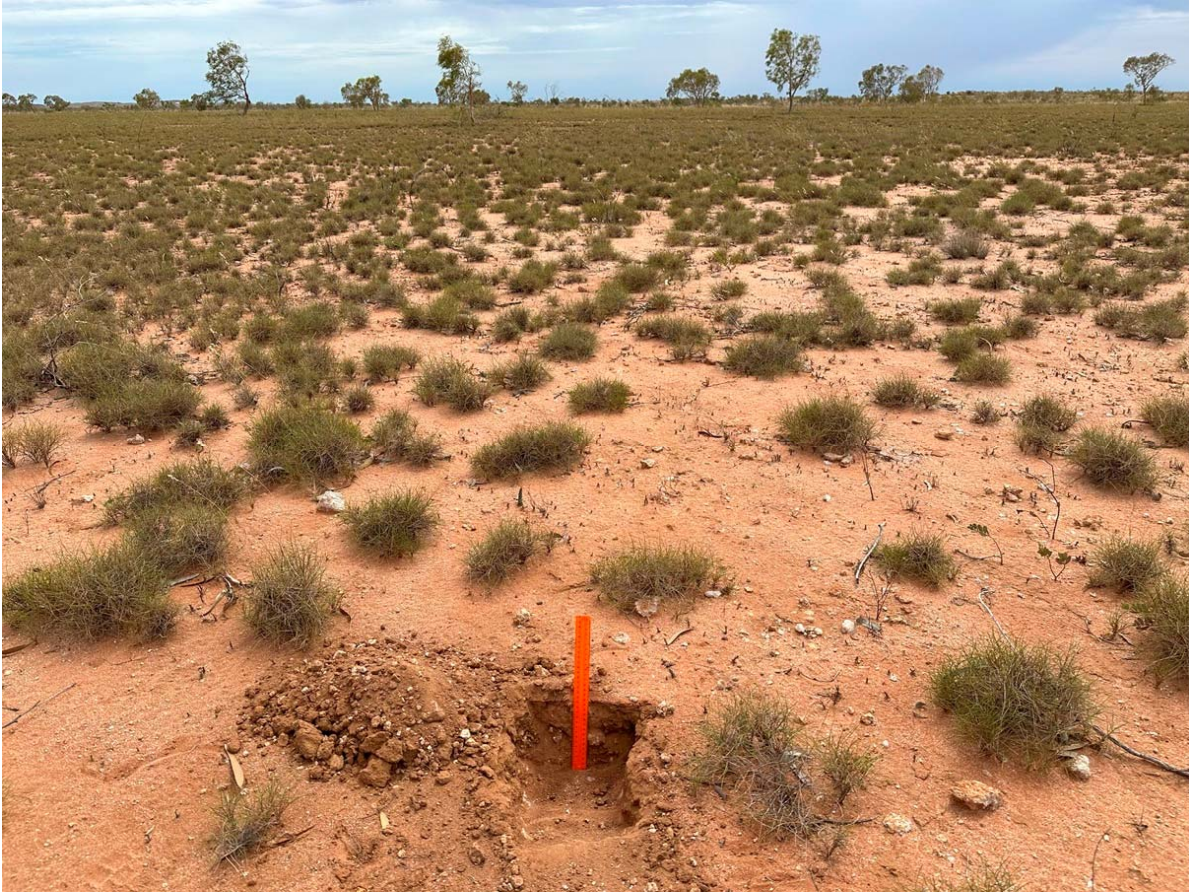
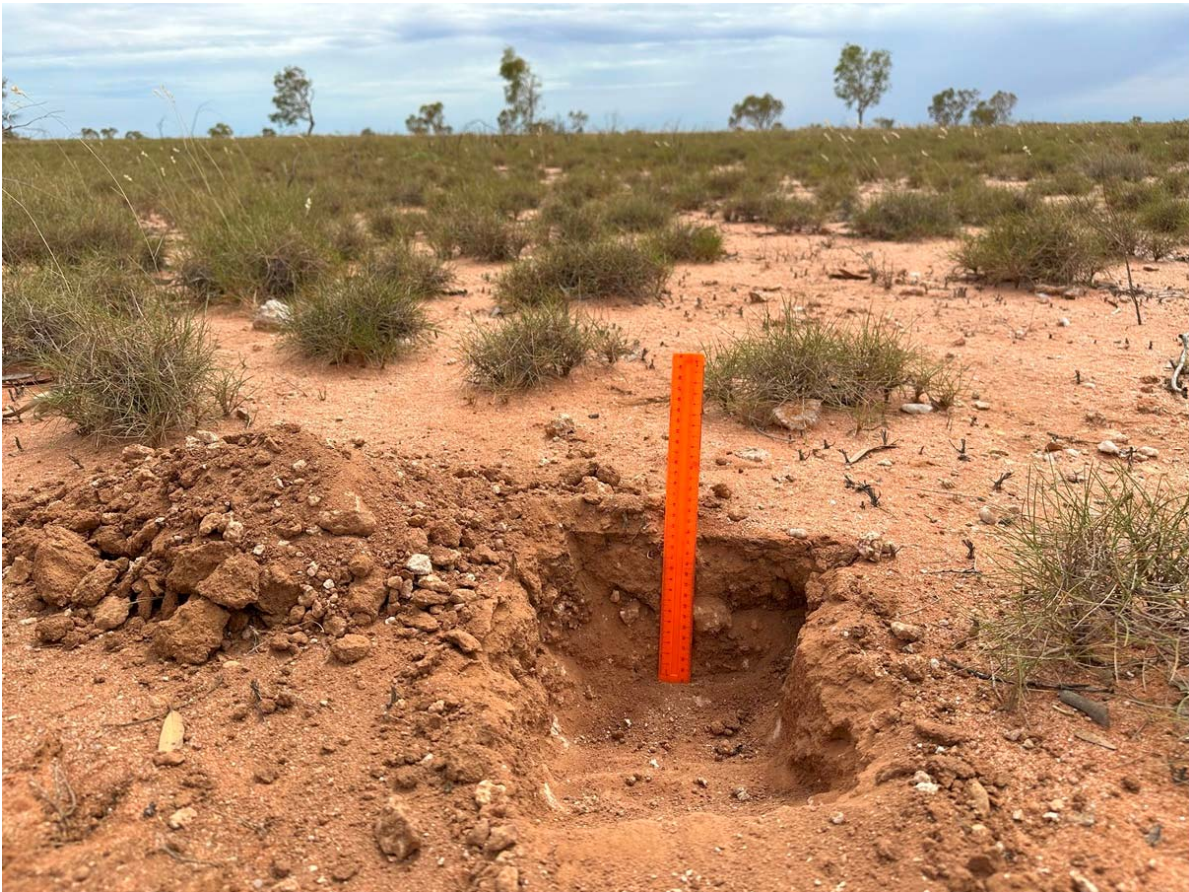
Figure 9: S5 soil sampling location – **TSF area**, looking north direction on Flat Plain

Photo of landscape and ground surface

Photo of soil profile

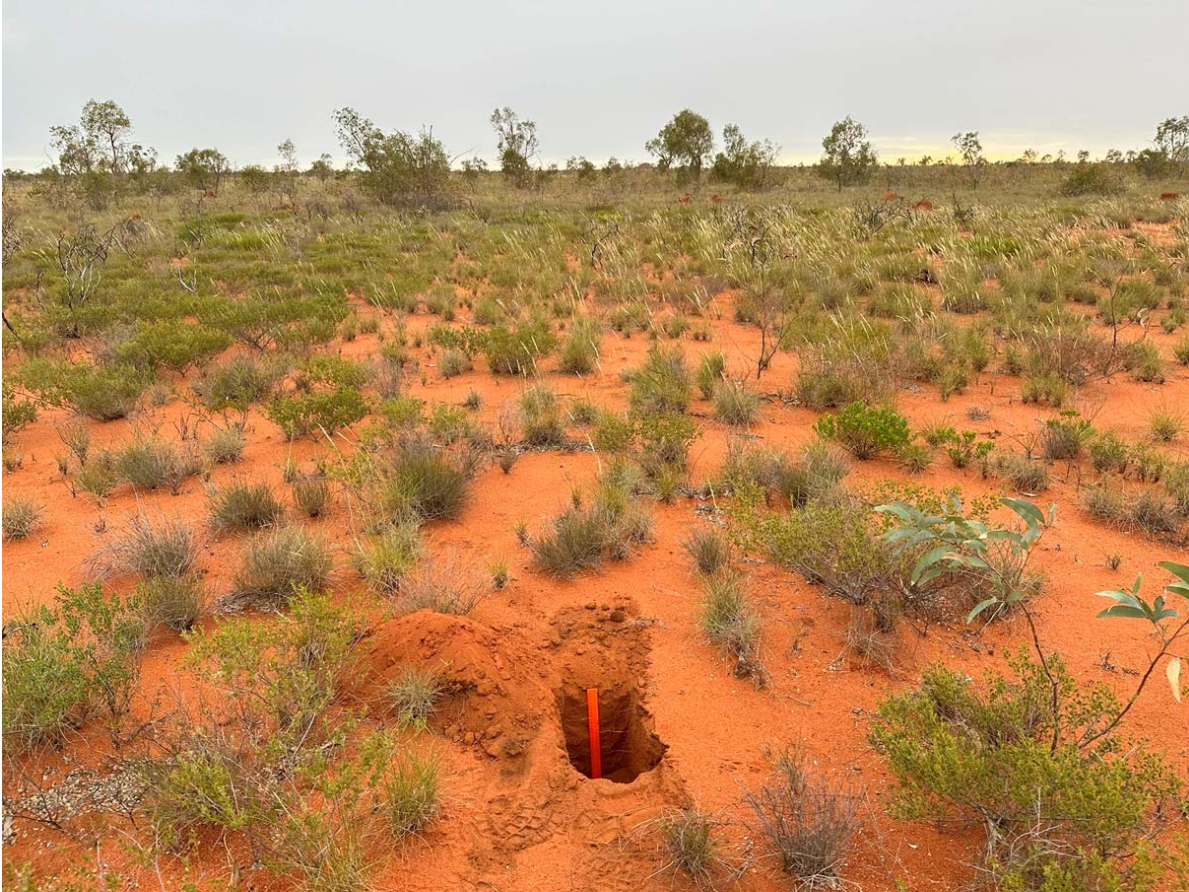
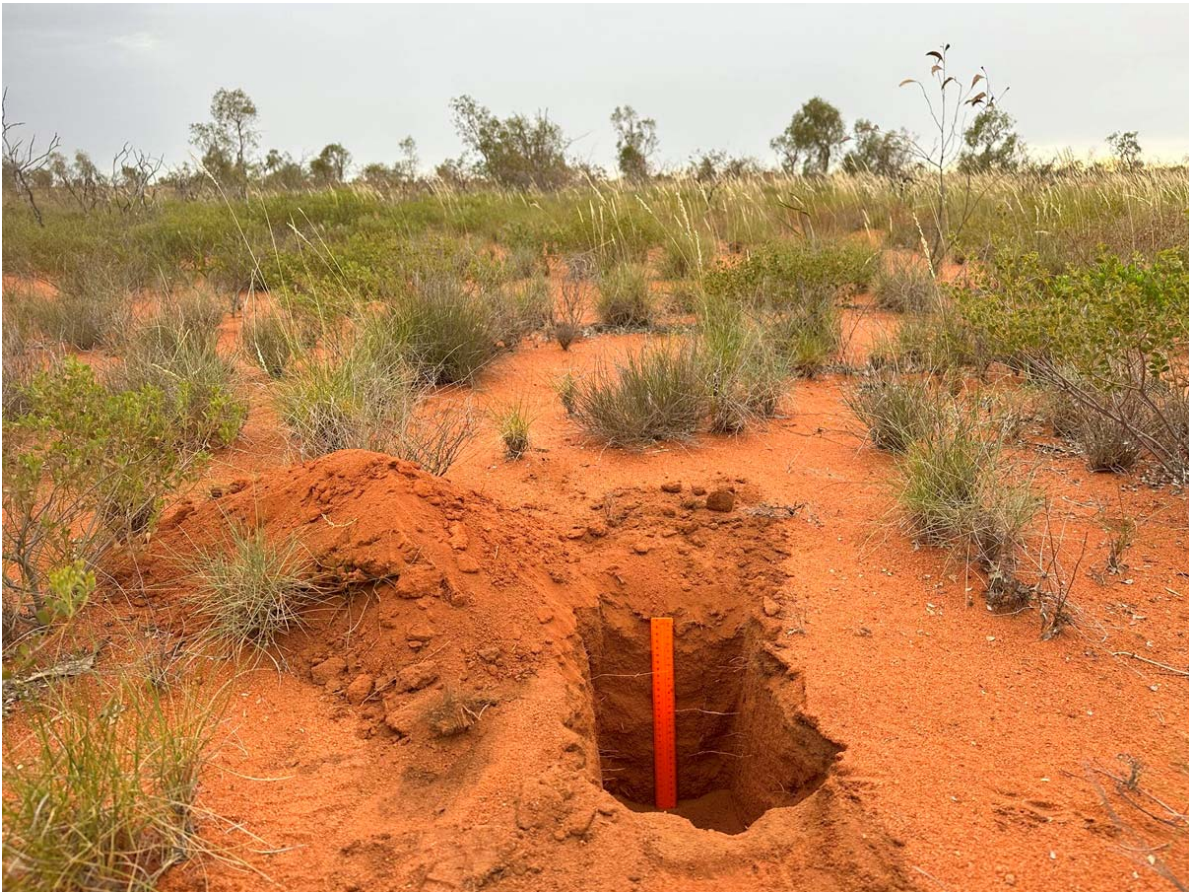
Figure 10: S6 soil sampling location – **Process Plant area**, looking north direction on Flat Plain

Photo of landscape and ground surface

Photo of soil profile

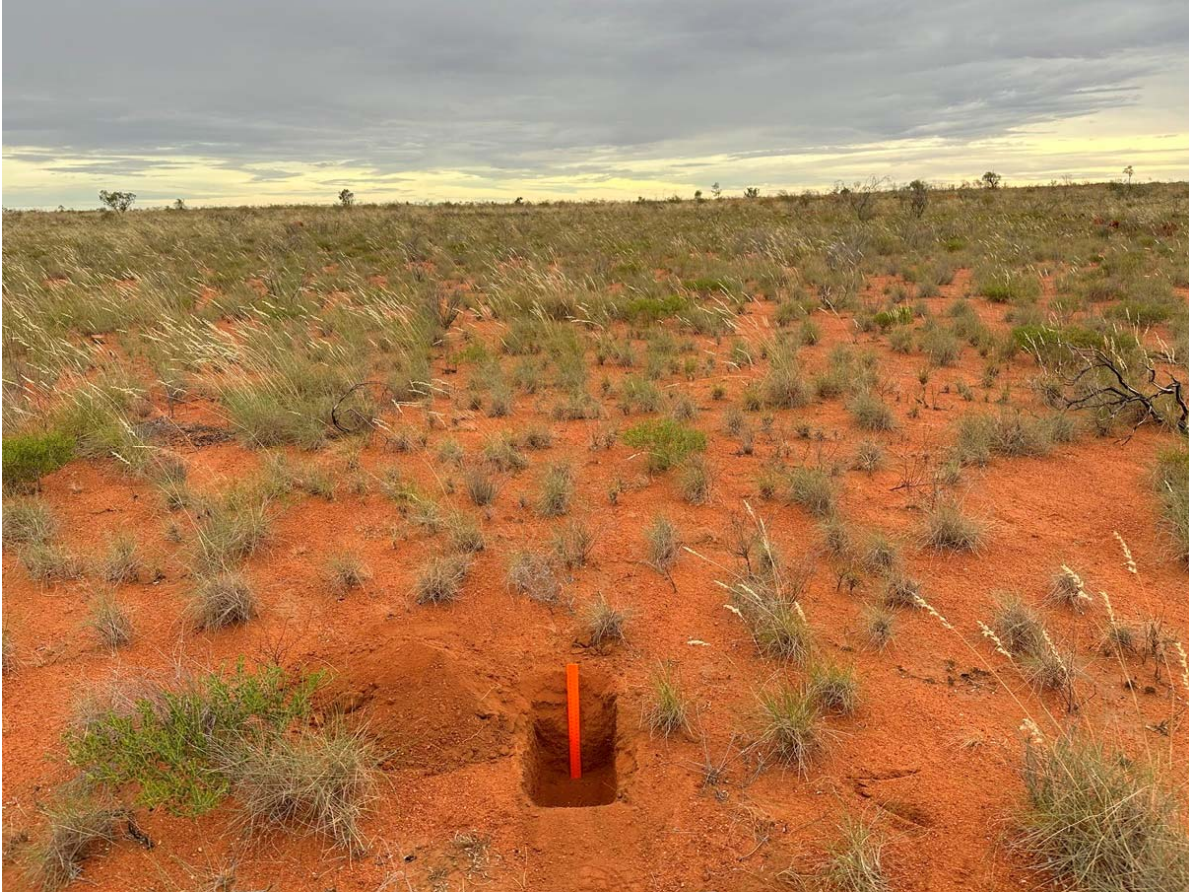
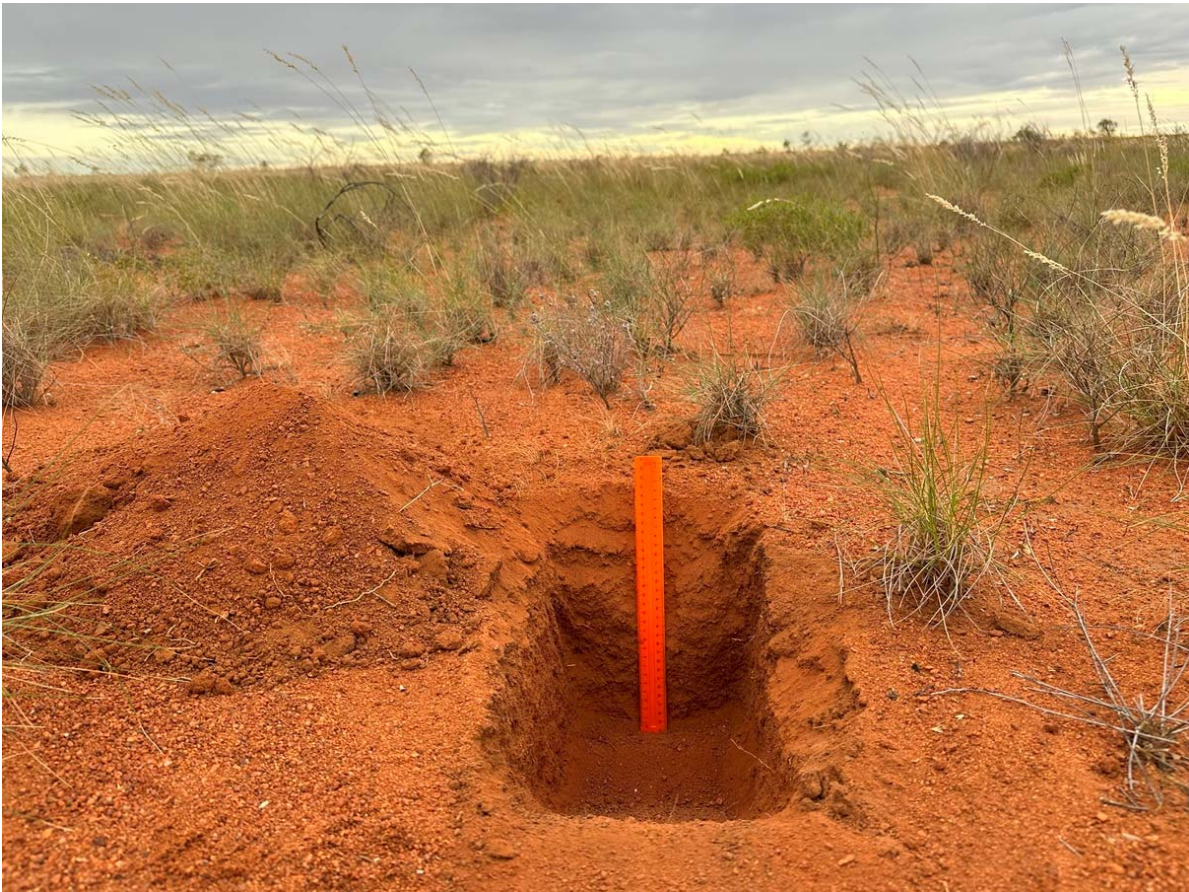
Figure 11: S7 soil sampling location – Magazine area, looking north direction on Flat Plain

Photo of landscape and ground surface

Photo of soil profile

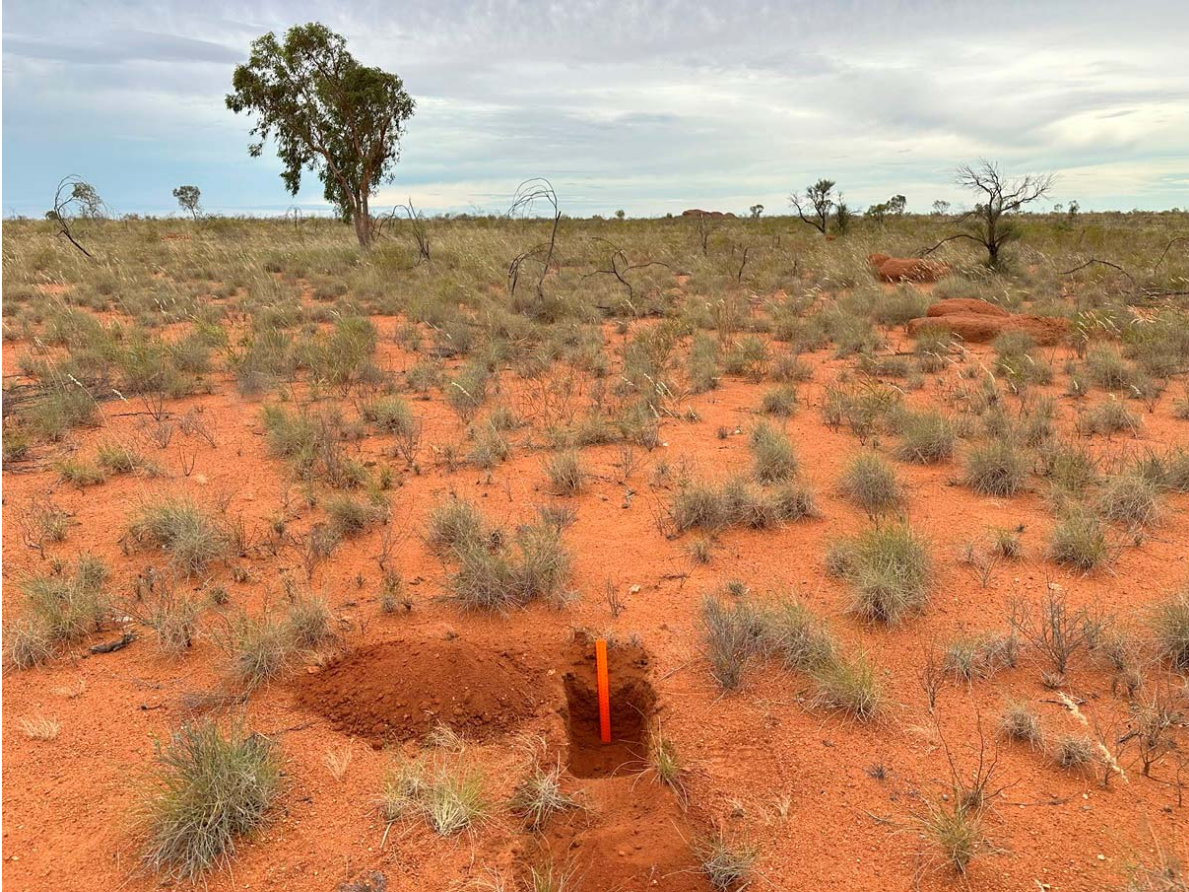
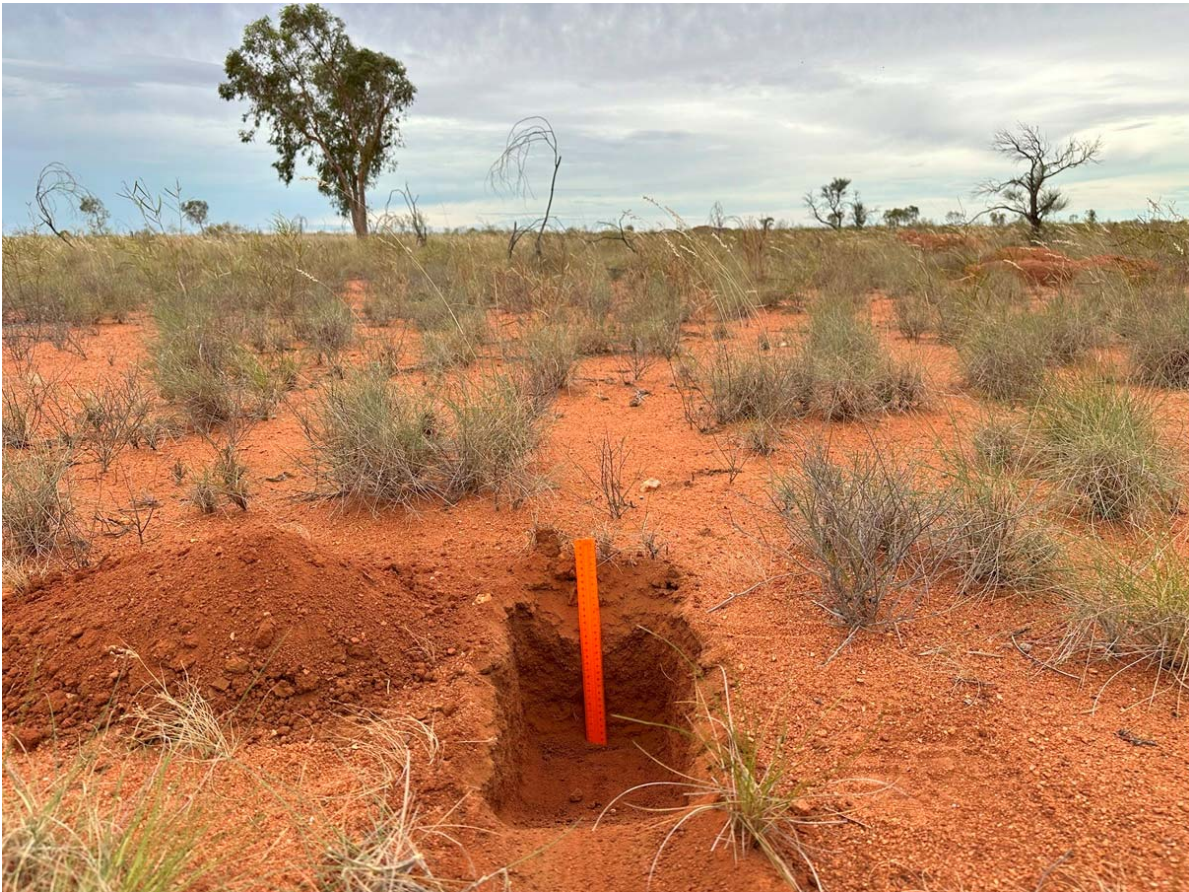
Figure 12: S8 soil sampling location – **Borrow Pit area**, looking north direction on Flat Plain

Photo of landscape and ground surface

Photo of soil profile

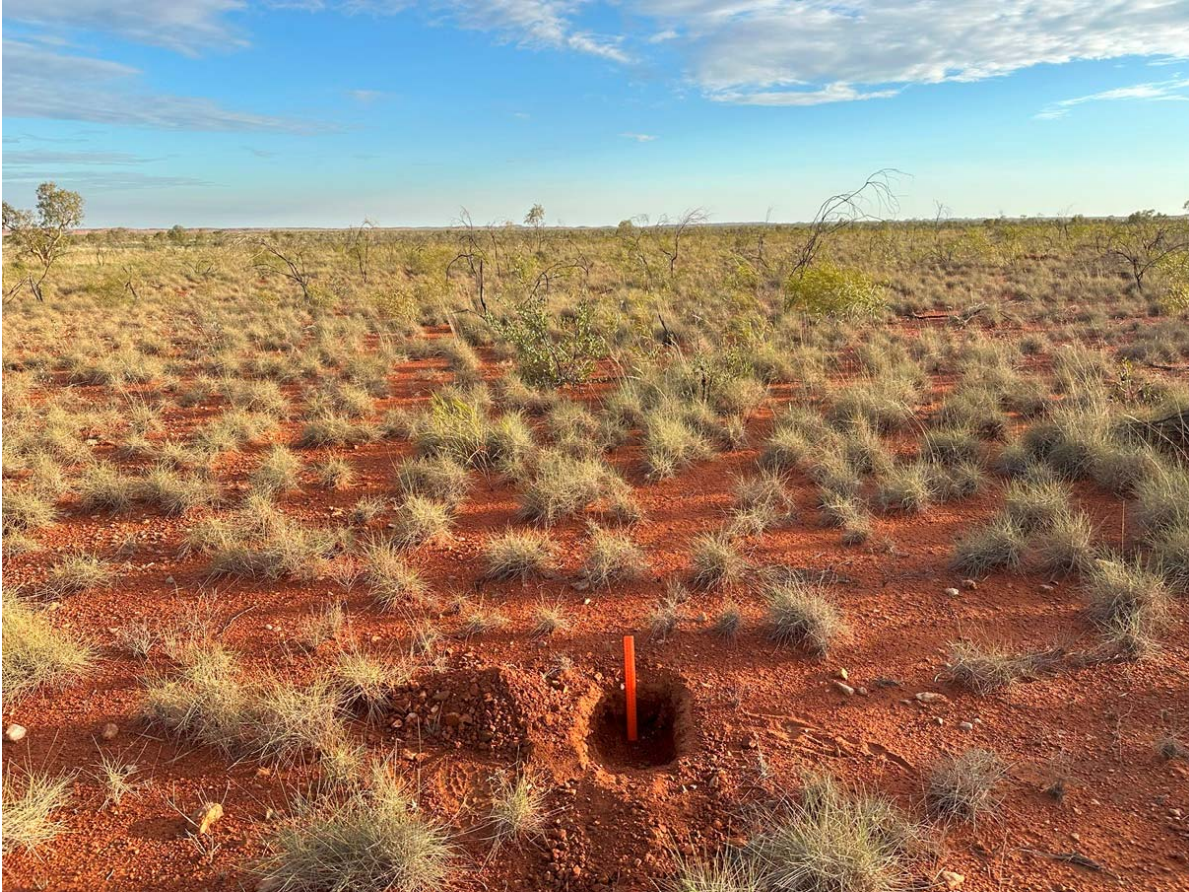
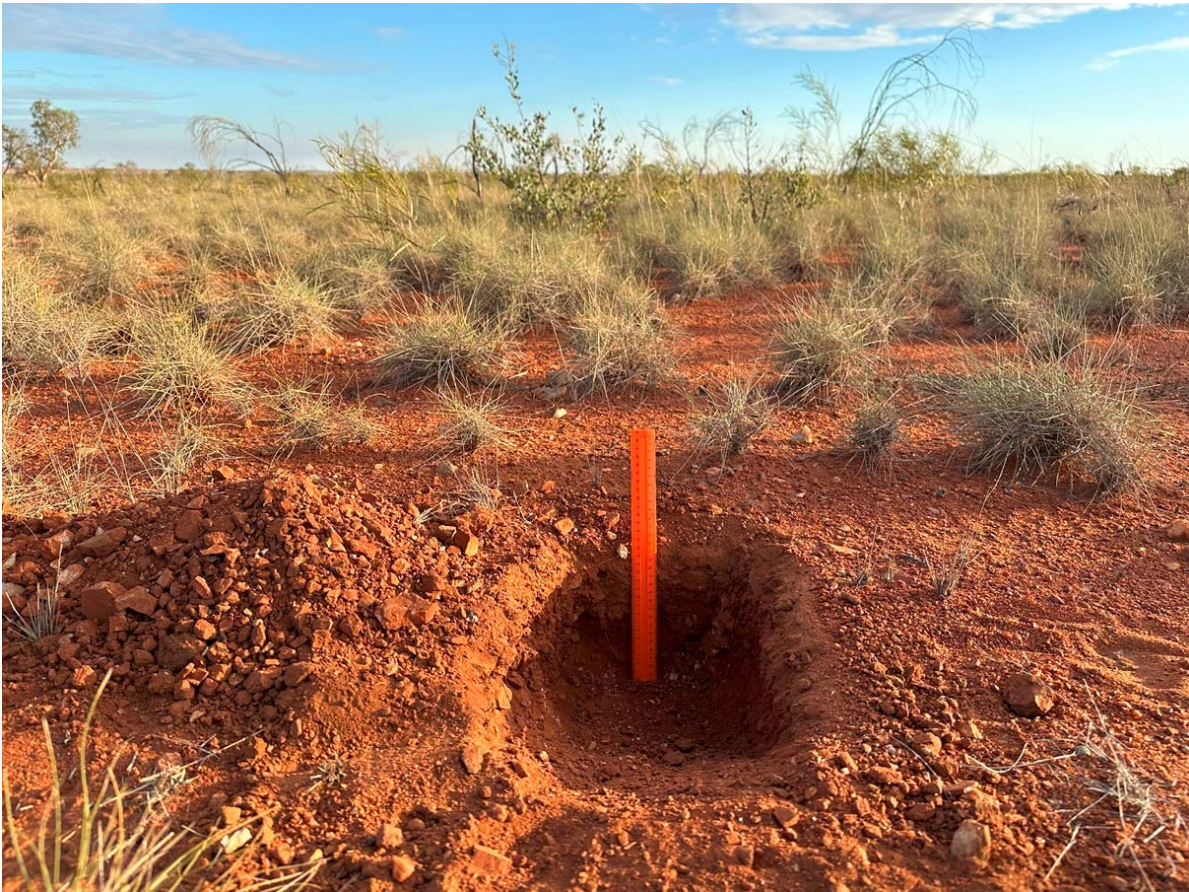
Figure 13: S9 soil sampling location – **Accommodation Camp area**, looking north direction on Undulating Plain

Photo of landscape and ground surface

Photo of soil profile

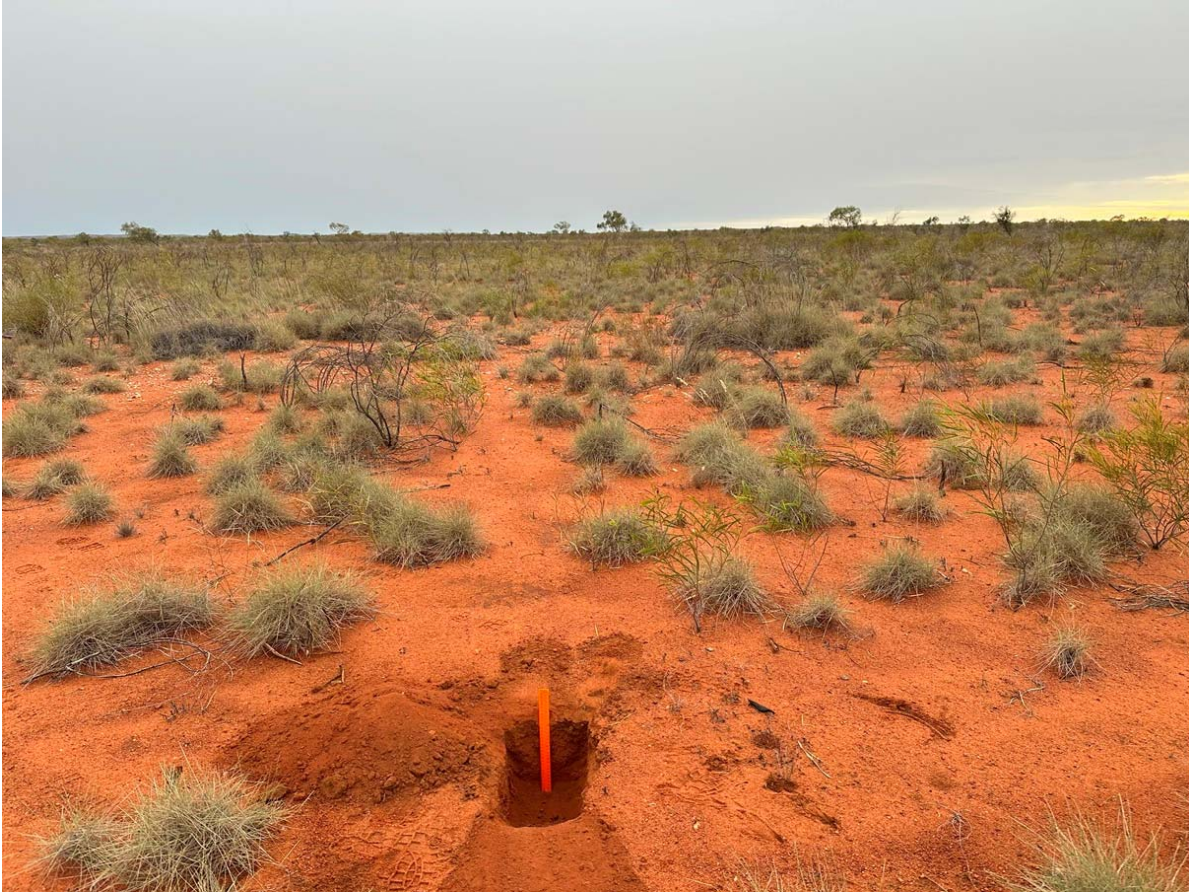
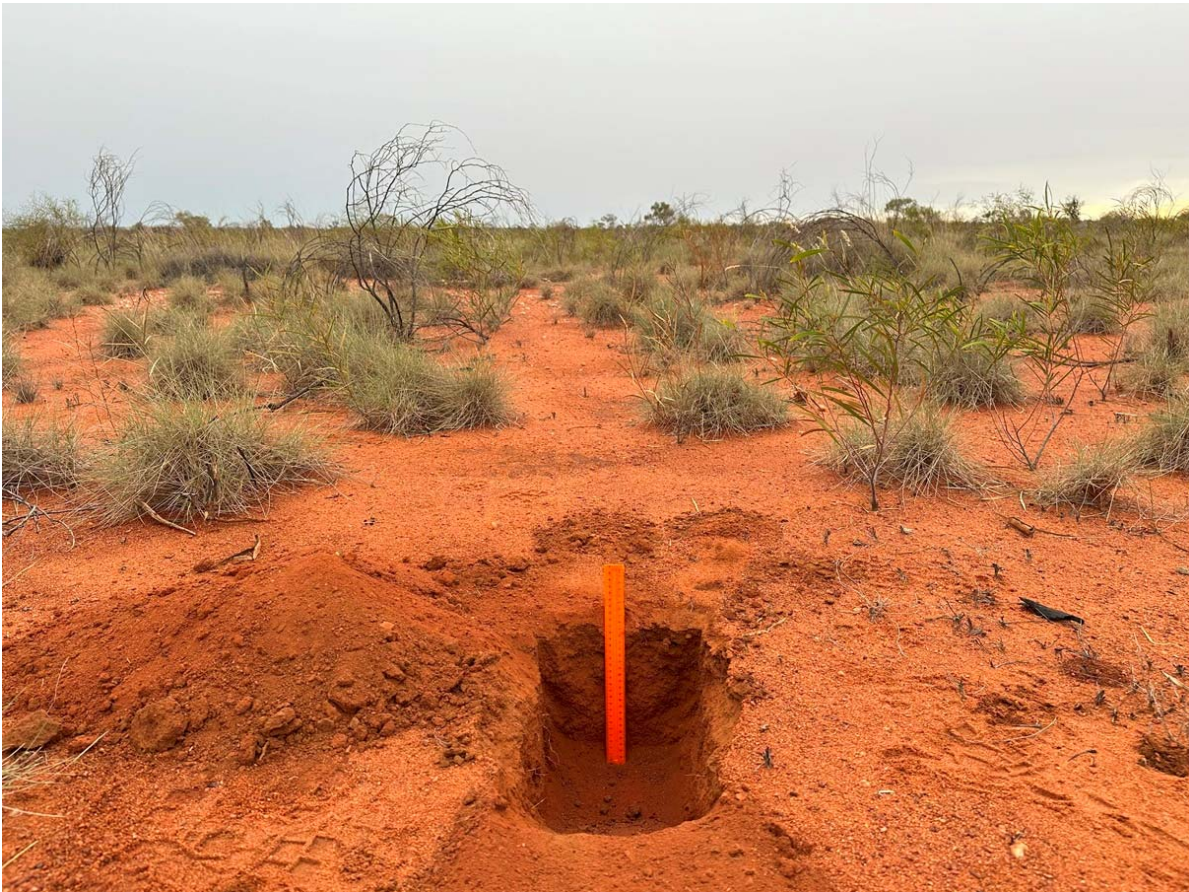
Figure 14: S10 soil sampling location – **Airstrip area**, looking north direction on Flat Plain

Photo of landscape and ground surface

Photo of soil profile
