# Sampling Analysis Quality Plan

## Perth Entertainment and Sports Precinct Burswood Peninsula, WA

Prepared For: Main Roads WA  
Don Aitken Centre,  
Waterloo Crescent Perth  
WA 6004

Report Date: 13 June 2025

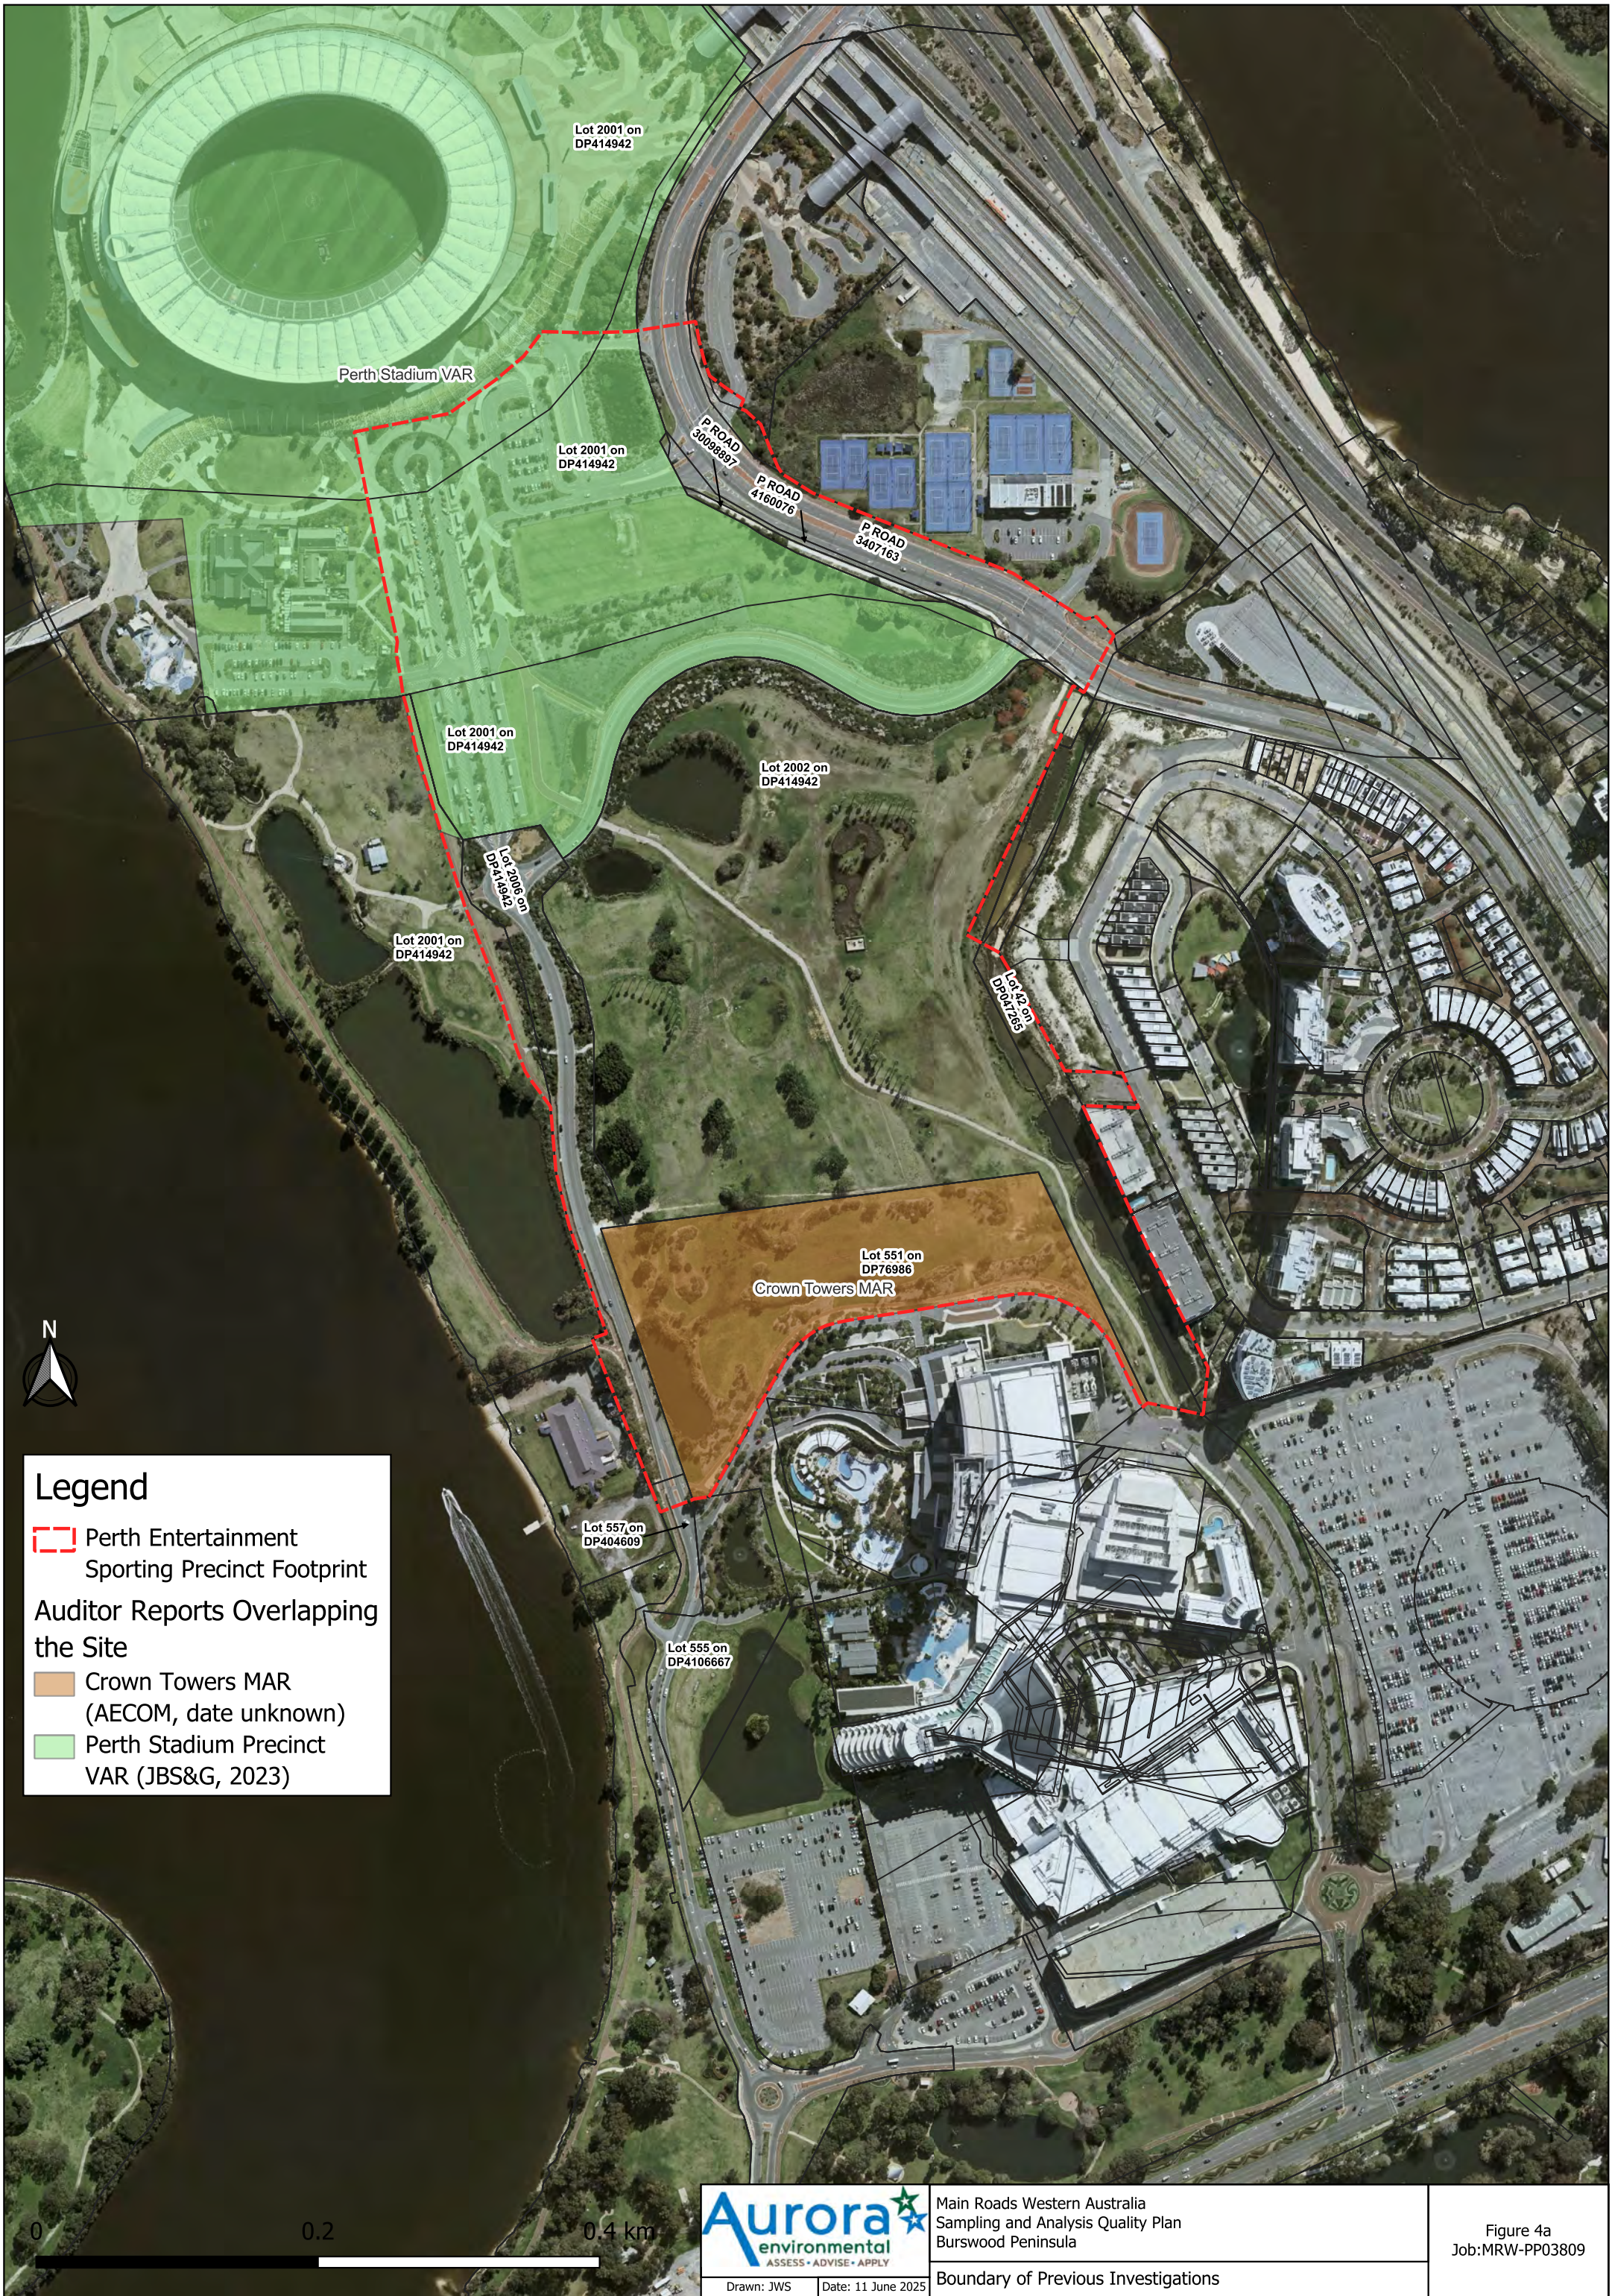
Superseded map from Golder (2012)  
used to add detail to Coffey  
Tetrattech (2024) map.

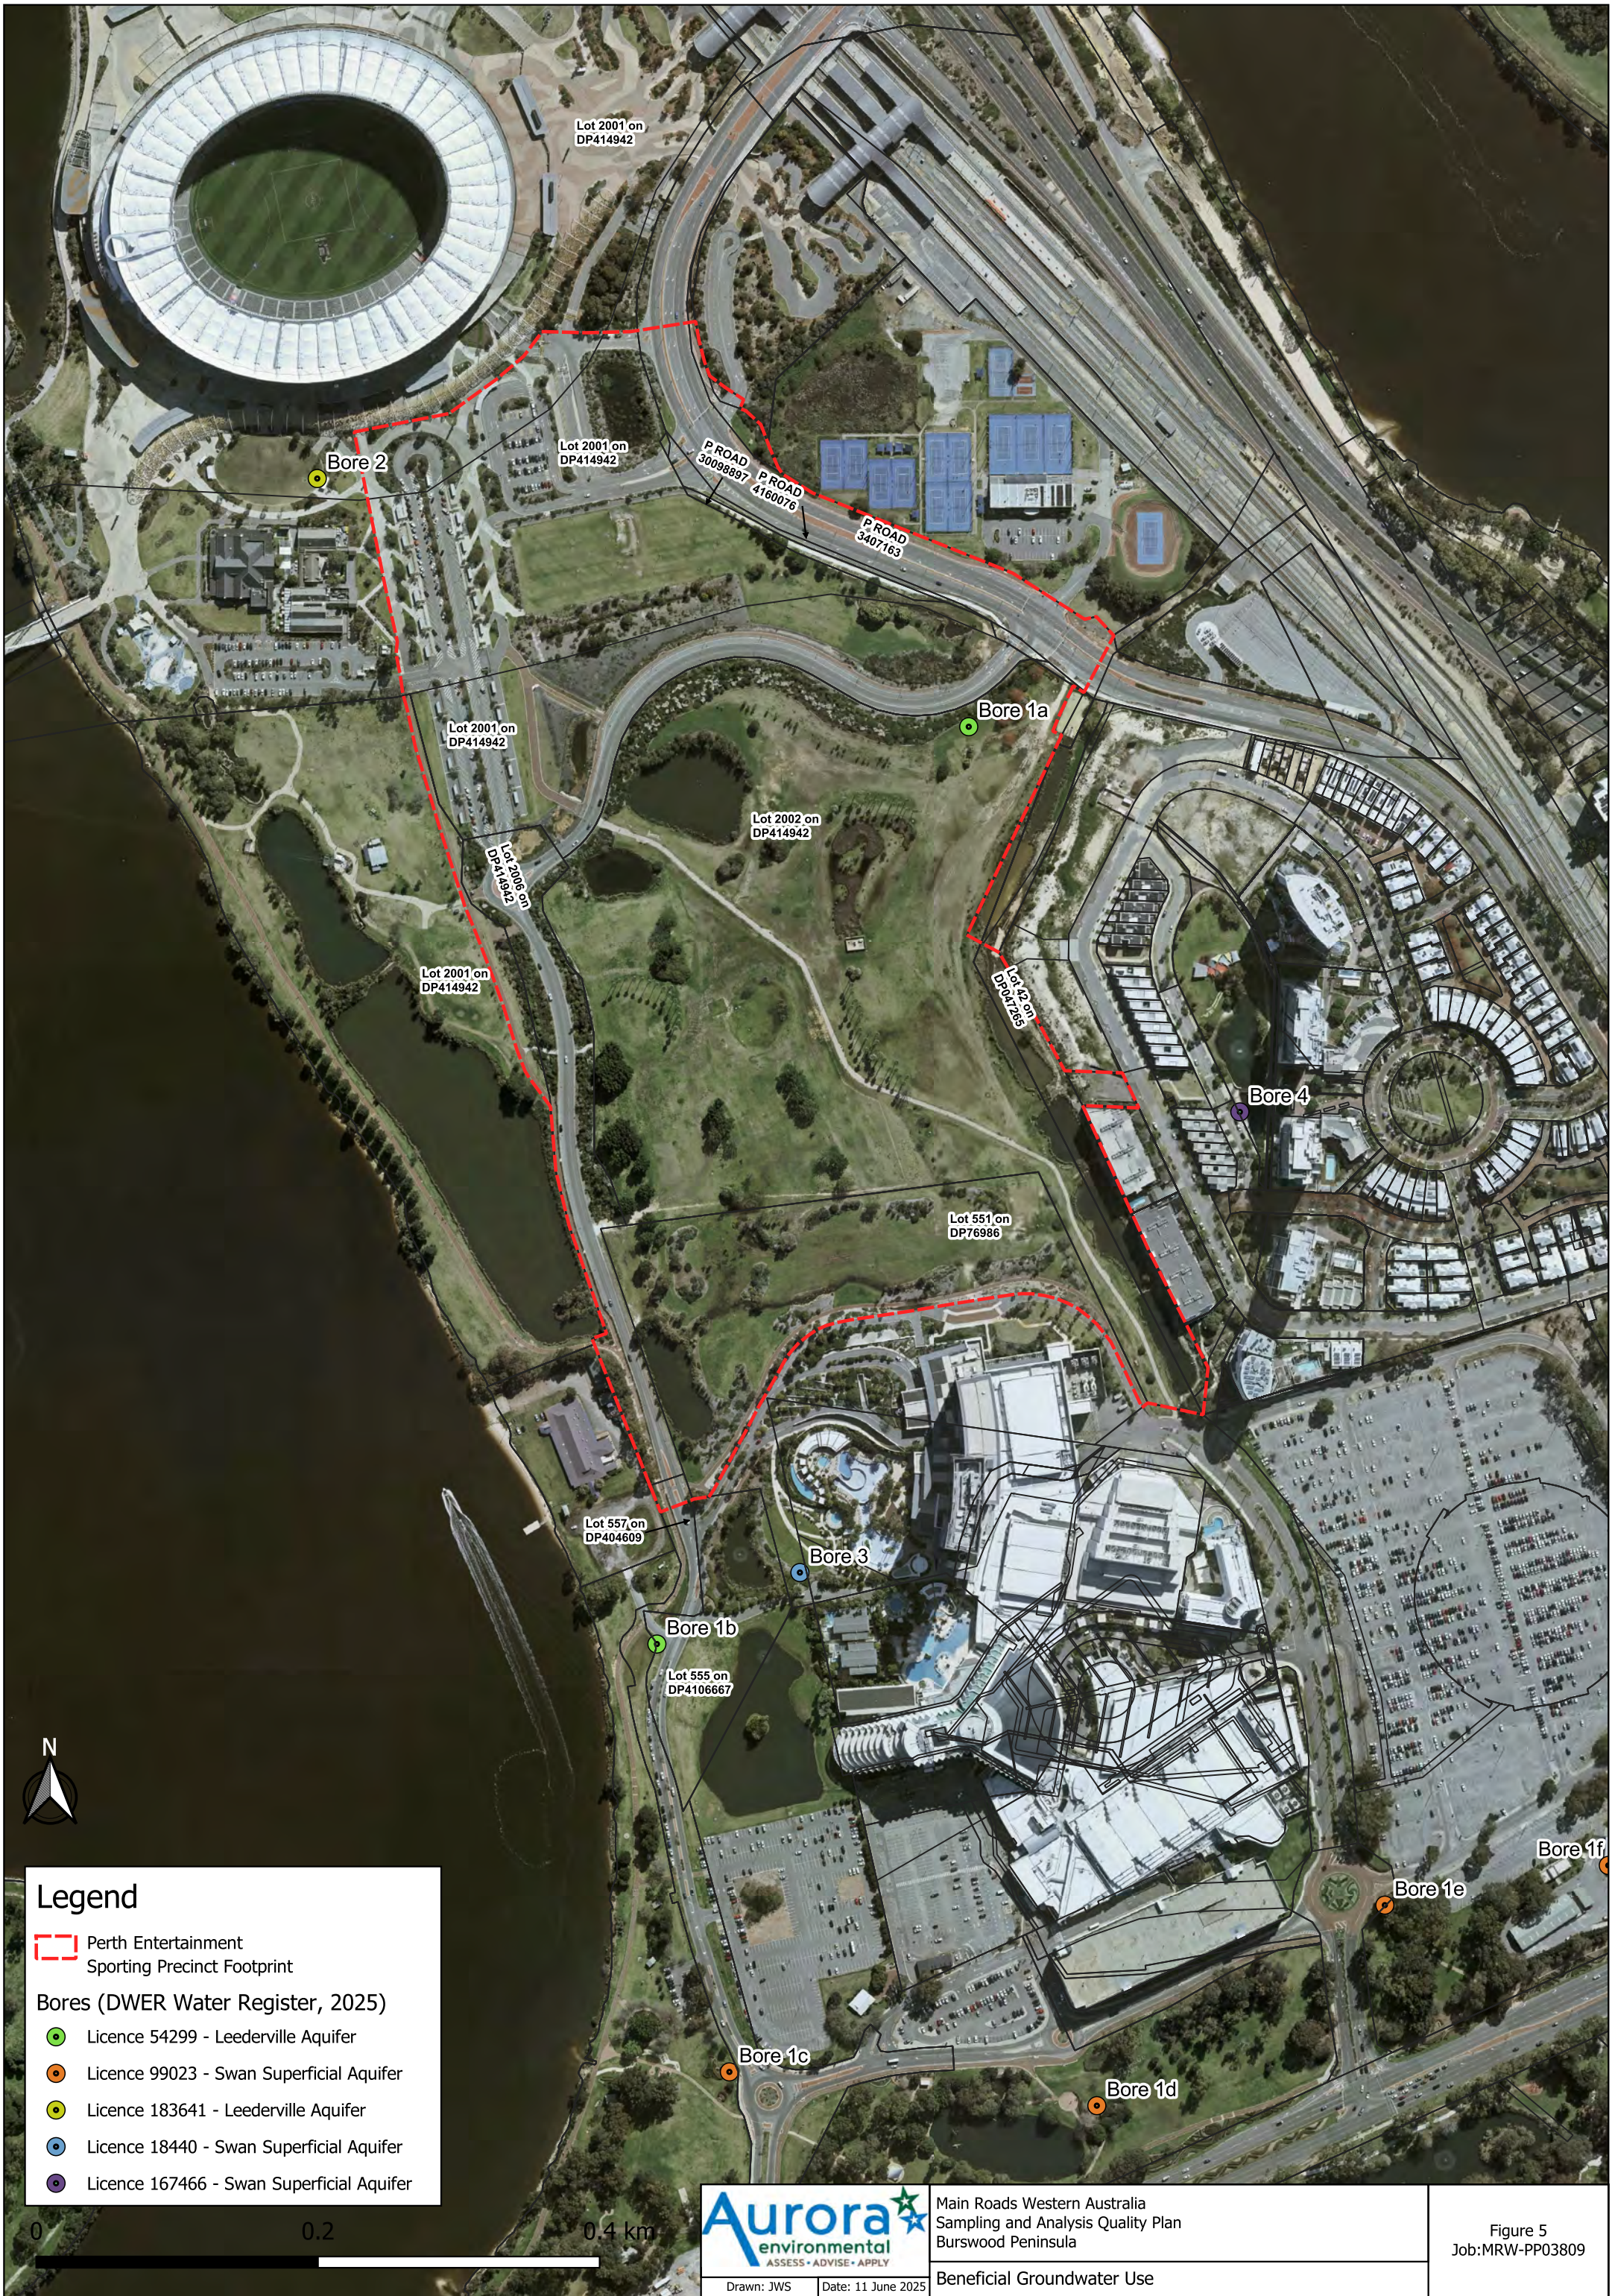
- Perth Entertainment Sporting Precinct Footprint
- Bores (DWER Water Register, 2025)**
  - Licence 54299 - Leederville Aquifer
  - Licence 99023 - Swan Superficial Aquifer
  - Licence 183641 - Leederville Aquifer
  - Licence 18440 - Swan Superficial Aquifer
  - Licence 167466 - Swan Superficial Aquifer

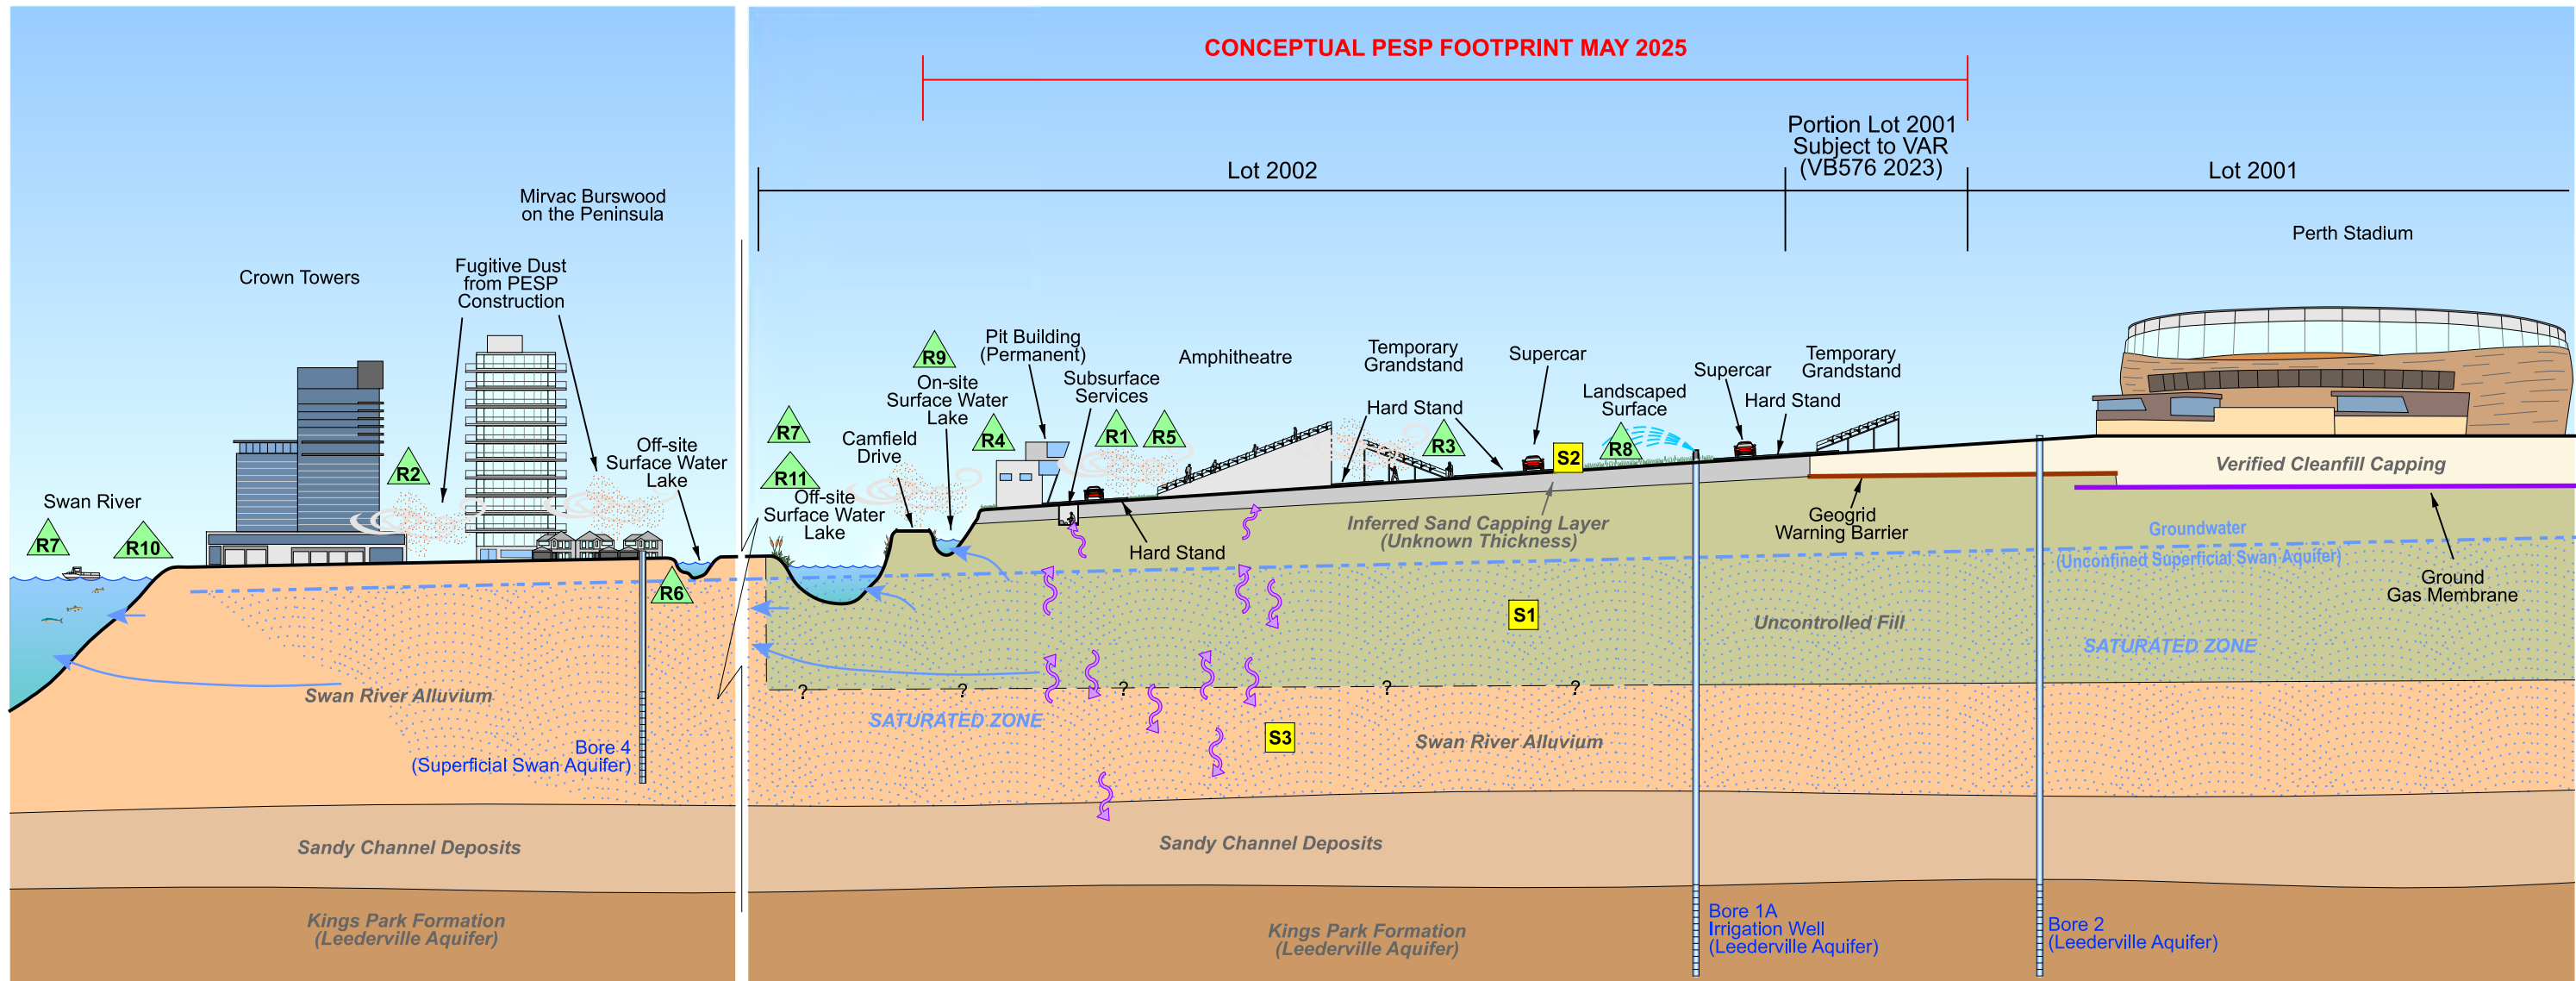
Exposure Pathways:

- Soils**
- P1** Direct and indirect contact with contaminated soils may occur through ingestion or direct contact.
  - P2** Terrestrial flora and fauna may be exposed to contaminants via direct contact with impacted soils (e.g. rooting depth, burrowing) or indirect exposure through uptake of contaminants into plants or bioaccumulation.

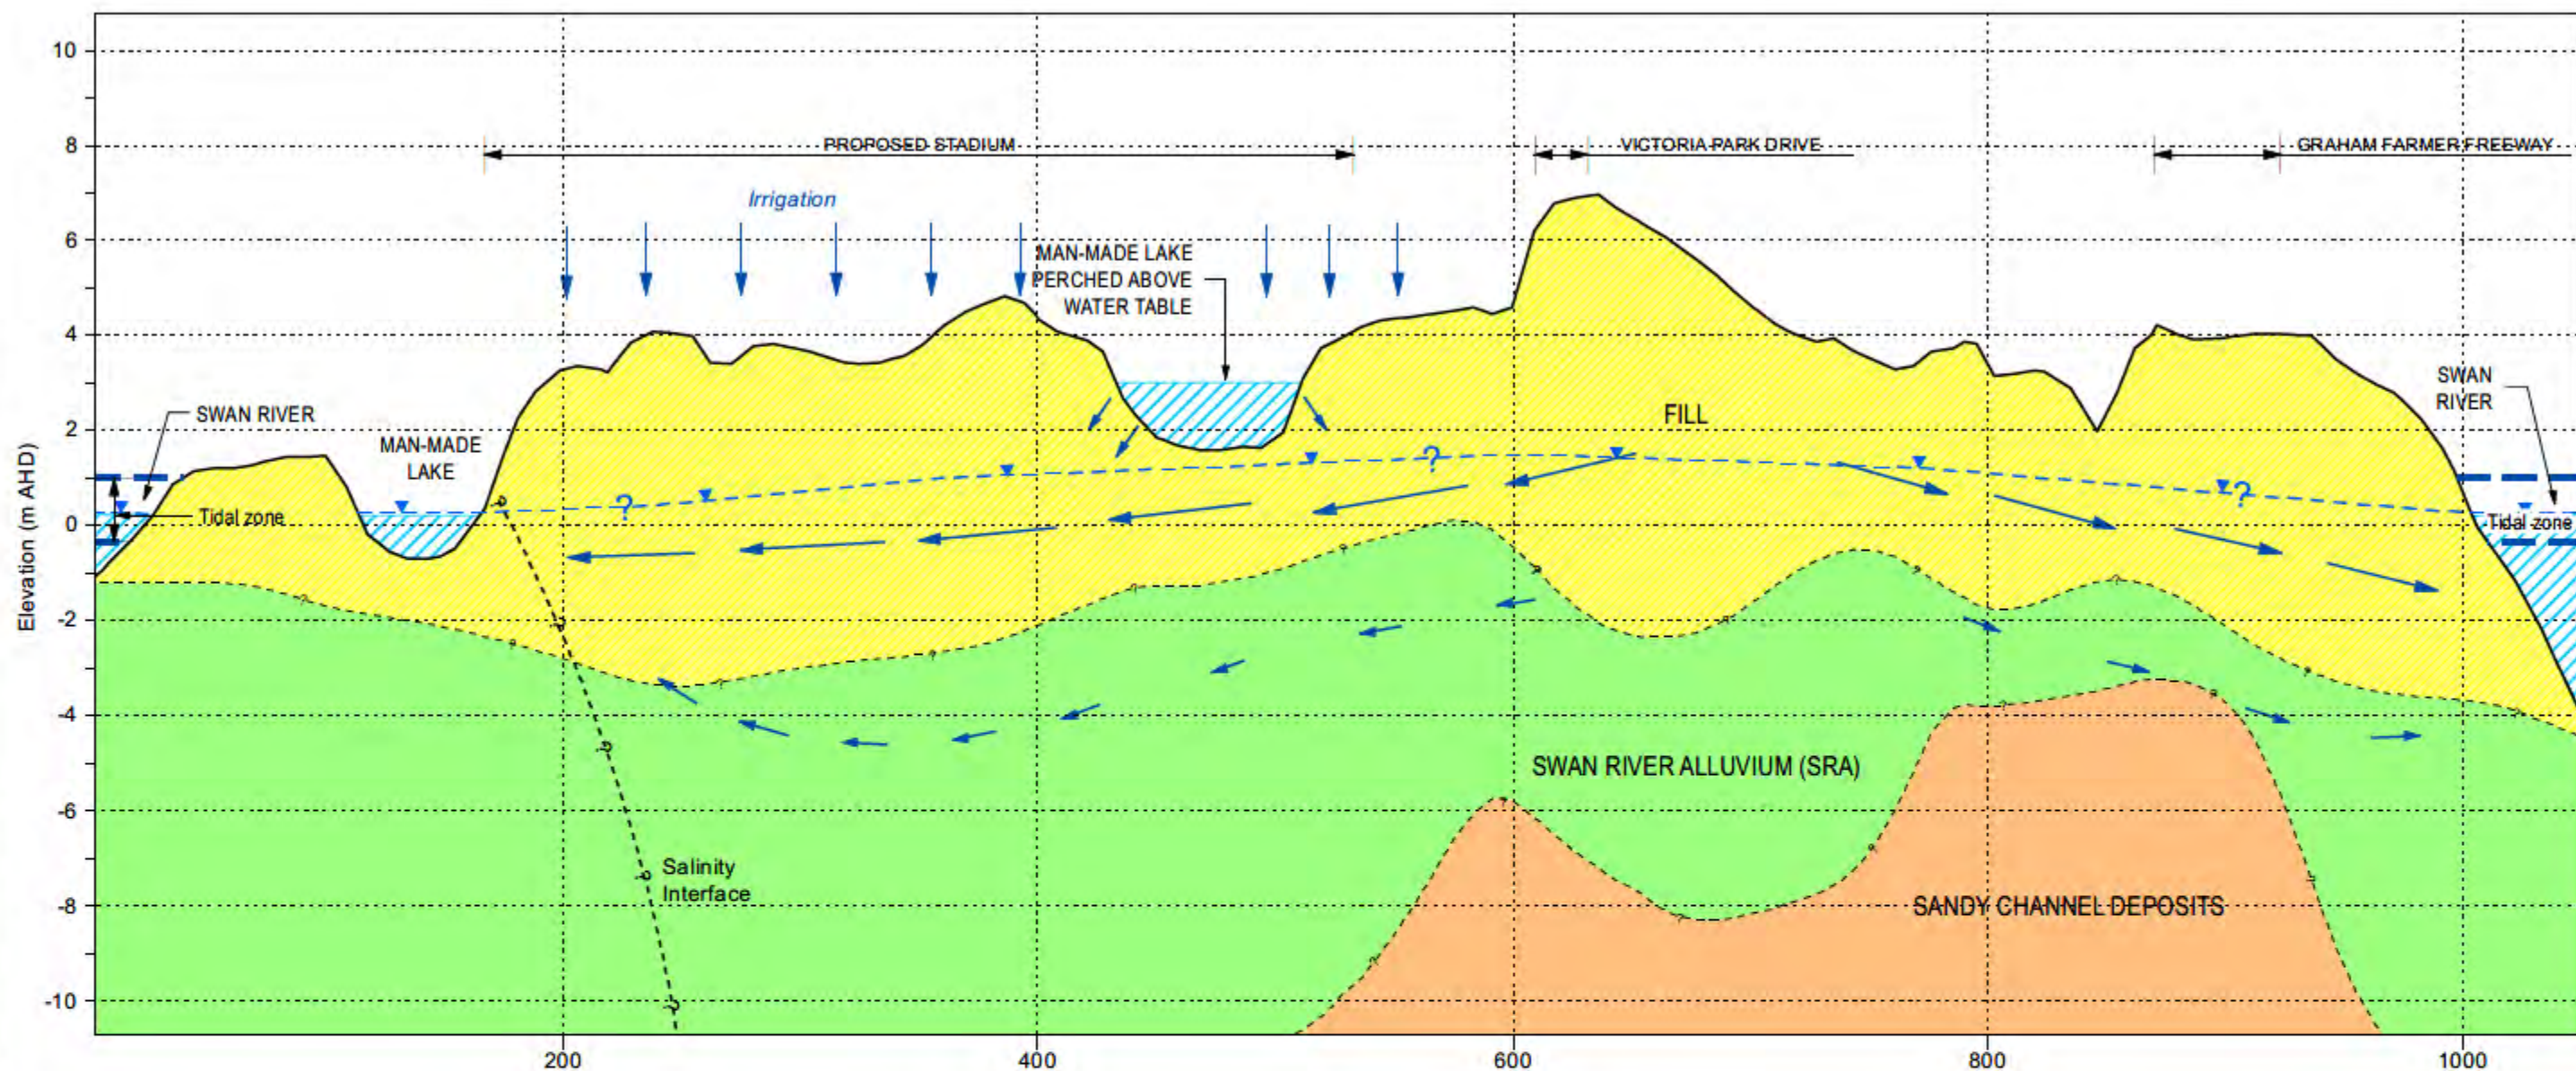
- Estimated Groundwater Flow Path
- Groundwater Level
- Groundwater Contour (May 2003)
- Section Location
