# Clean Energy Link - North

T0621770: NBT – MUL WGA Double Circuit

## GEOTECHNICAL INVESTIGATION REPORT

Job No. PER2025-0250AF | Version 0

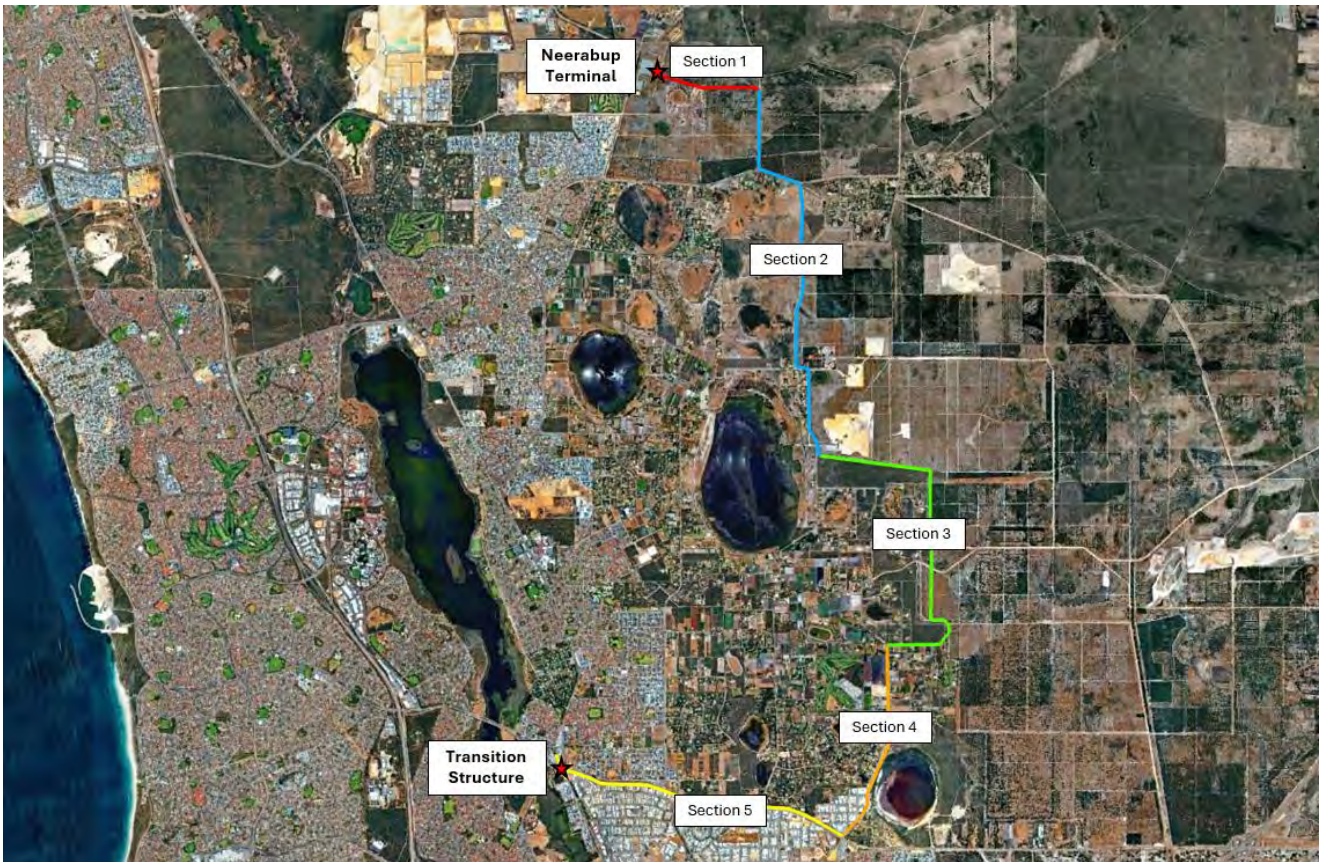
Figure 1: Proposed Alignment Route

The alignment route is shown in Figure 1 below.

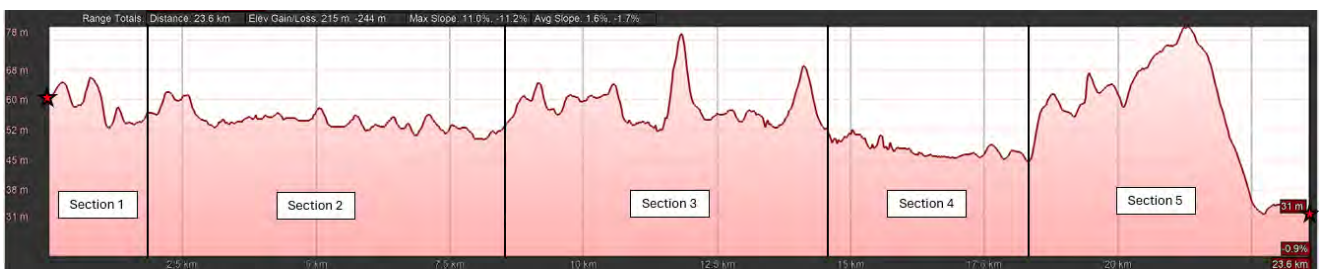
Figure 2: Proposed Alignment Section

For illustrative purposes, a cross section of the alignment has been generated from Google Earth showing the general topography of the alignment and is reproduced in Figure 2. Significant vertical exaggeration has been applied.

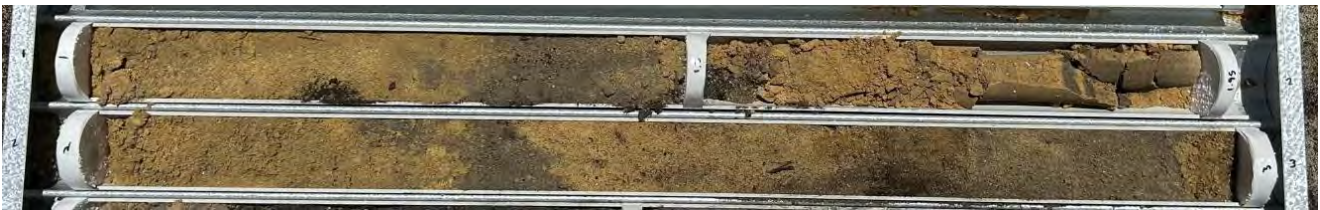
Figure 4: Fill Material (BH149 1.0 – 2.0m)

Fill was encountered at multiple locations along the alignment at depths of generally up to 1.0 m, however locally deeper deposits up to 4.5 m deep were observed along Ocean Reef Road. Fill is expected to occur along most of the alignment in areas of development.

Fill materials were variable in composition but generally comprised reworked granular material (predominantly fine to coarse grained, quartz sand with traces of fine-grained gravel) with a low fines content. Fill materials were observed to be generally consistent across the alignment.

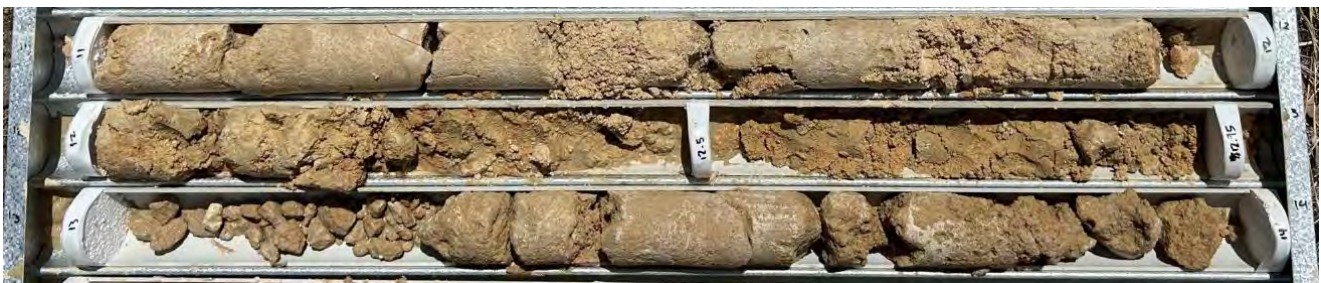
Figure 6: Tamala Limestone (BH161 11.0 – 14.0 m)

- **Sandy Gravel/gravelly Sand:** Fine to coarse grained, angular to sub-angular quartz and carbonate sand, intermixed with fine to coarse gravel sized gravel and trace cobbles of calcarenite. Yellow to pale orange. These materials are assumed to represent an extremely weathered limestone profile and are found both within the transition zone from soil to rock and as highly weathered zones within the limestone profile. This subunit likely represents the upper limit of potential rock strength materials.
- **Impure Calcarenite:** fine to medium grained calcarenite, pale yellow orange, cemented mixture of quartz and calcium carbonates, with traces of fines and gravel throughout. This unit represents the rock quality material of the Tamala Limestone.

Tamala Limestone displays an irregular and unpredictable surface profile due of chemical weathering, meaning that the depth of the Limestone rock head can rapidly change over short distances. Colloquially these variations in the rock surface are referred to as limestone pinnacles. Accordingly, limestone may be present both shallower and deeper than what has been encountered in this investigation.

Tamala Limestone was encountered beneath Tamala Sand from 7.7 m bgl (RL 57.2 m AHD) in BH161 and inferred to be present between 9.8 m and 14.9 m bgl (RL 66.1 m AHD to RL 37.9 m AHD) in nearby CPT locations (CPTu158, 162, 163, 164, and 175) based on an increase in the scatter of CPT  $q_c$  or upon encountering refusal. Tamala Limestone was moderately to extremely weathered. Extremely weathered material comprised medium dense to very dense mixtures of sand and gravel with trace calcarenite cobbles. Rock strength material was low to high strength. Limestone was only observed directly in BH161, and the properties of the Tamala Limestone may vary elsewhere.

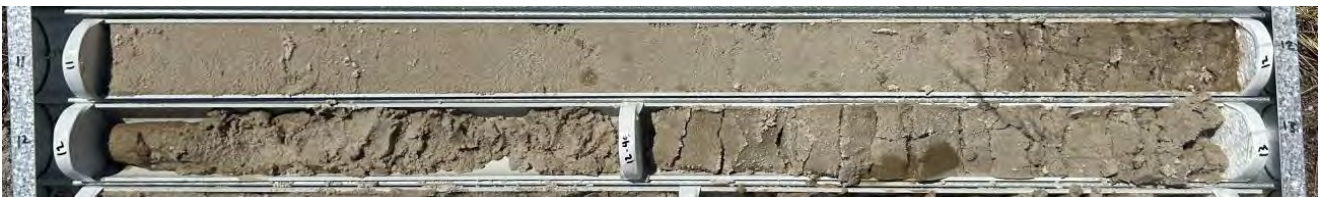
Figure 8: Bassendean Sand (BH37 11.0 – 13.0 m)

Bassendean Sand was one of the primary units encountered across the site. It was generally logged as a fine to medium grained, sub-angular to rounded, pale grey to dark grey and brown quartz sand with trace fines content. Bassendean Sand is differentiated from Tamala Sand by its colour (generally grey/brown as opposed to yellow/orange), a higher relative density, and an absence of calcium carbonate content generally associated with Tamala Limestone.

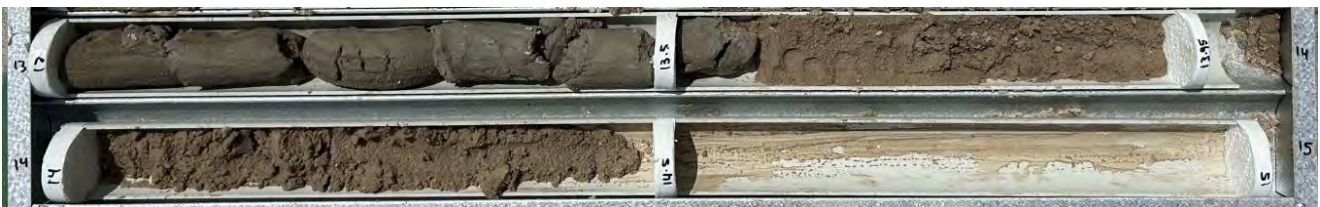
Figure 9: Gngara Sand (BH133 13.0 – 15.0 m)

Gngara Sand is interpreted at depth through a short section of the alignment near Gngara Lake and sporadically through the northern section of the alignment. Gngara Sand was observed as grey to brown, sand dominated profile with lenses of clayey sand and sandy clay. These lenses were typically deeper in the profile (>10 m deep) and more prominent near Gngara Lake.

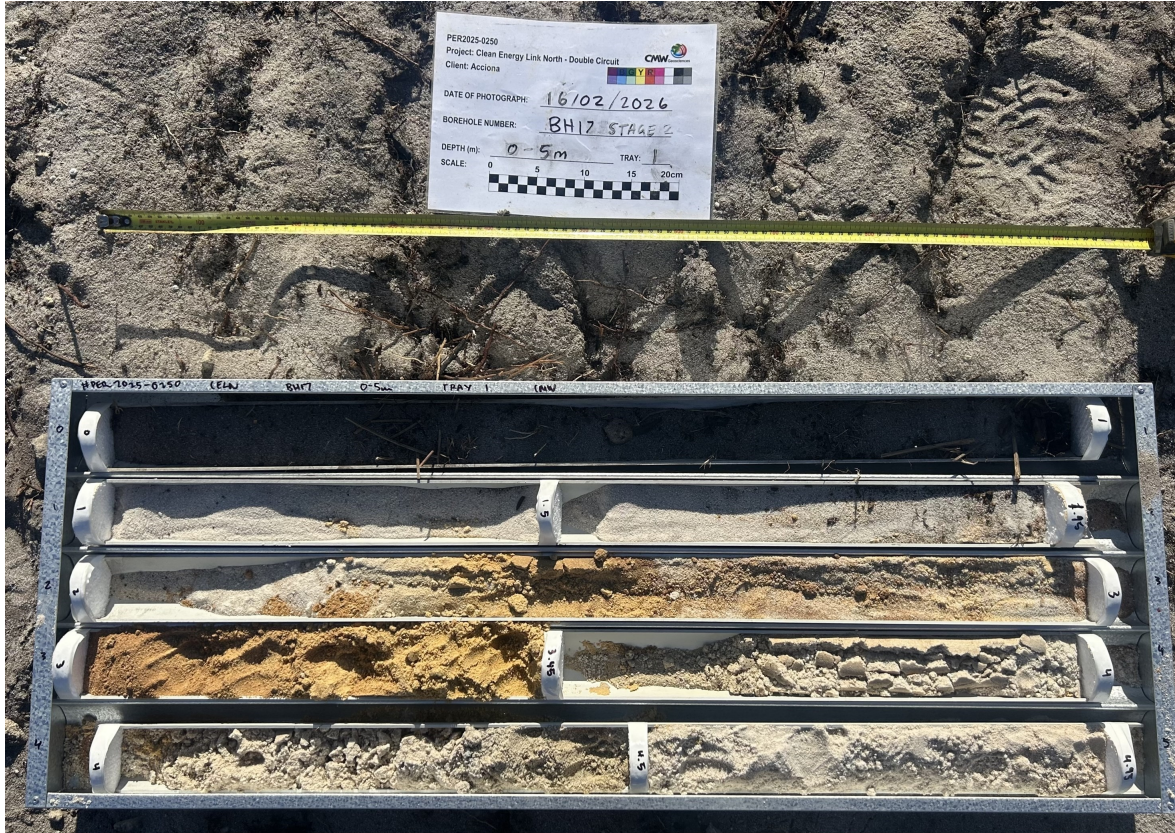
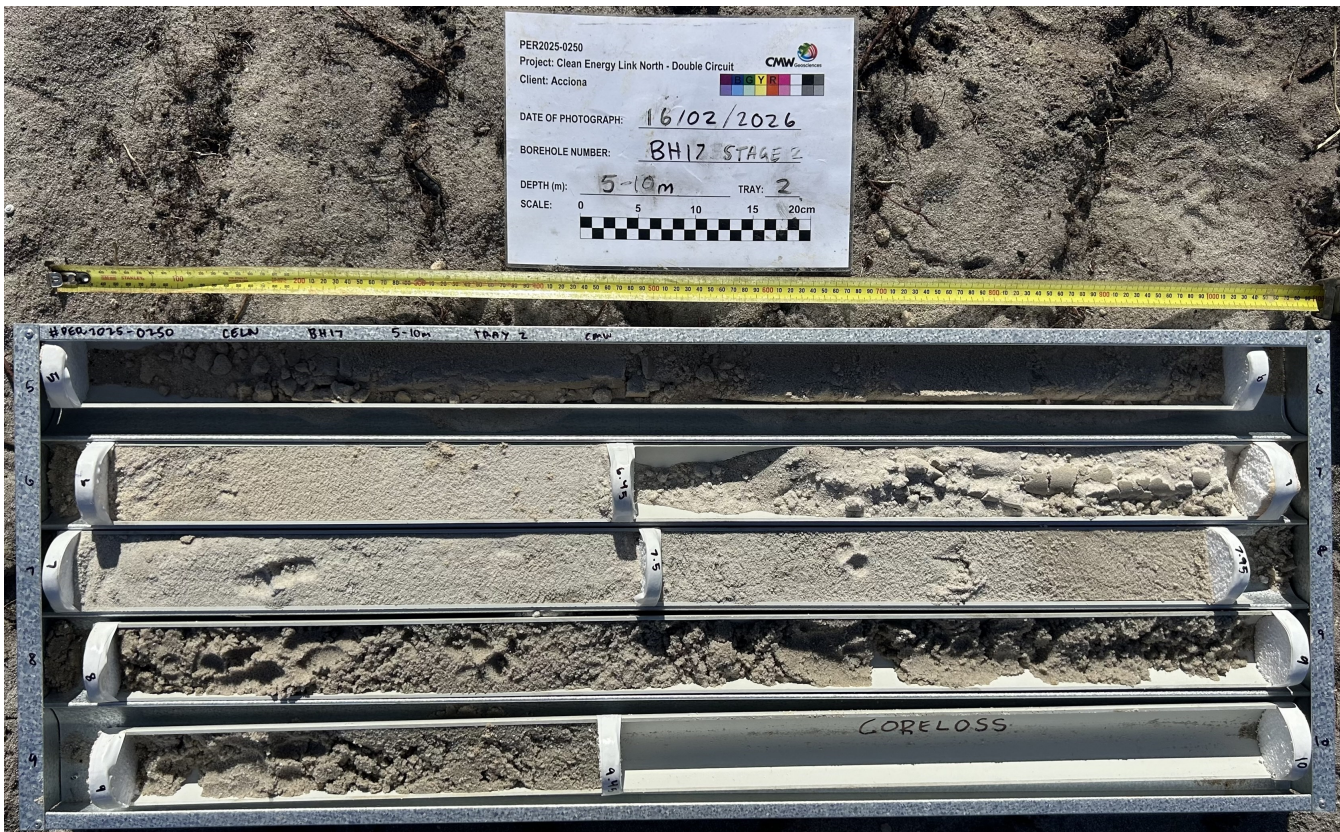
# CORE PHOTOGRAPH SHEET - BH17

Client: Acciona  
Project: Clean Energy Link North Project - Double Circuit  
Location: Perth  
Project ID: PER2025-0250  
Date: 16/02/2026

All core was placed in PVC splits and metal core trays before being photographed. Individual splits were wrapped in plastic sleeves (lay-flat) to maintain the sample integrity and moisture content. Boreholes were logged in accordance with AS1726-2017 (Geotechnical Site Investigations).

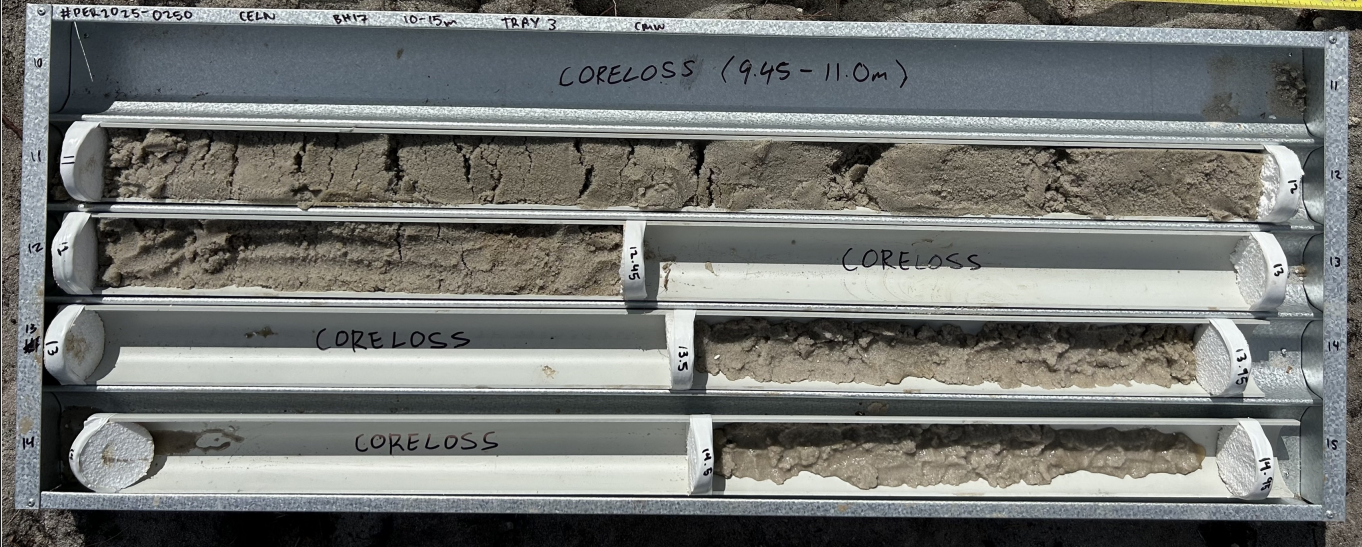
# CORE PHOTOGRAPH SHEET - BH17

PER2025-0250  
Project: Clean Energy Link North - Double Circuit  
Client: Acciona  
DATE OF PHOTOGRAPH: 16/02/2026  
BOREHOLE NUMBER: BH17 STAGE 2  
DEPTH (m): 10-15m TRAY: 3  
SCALE: 0 5 10 15 20cm

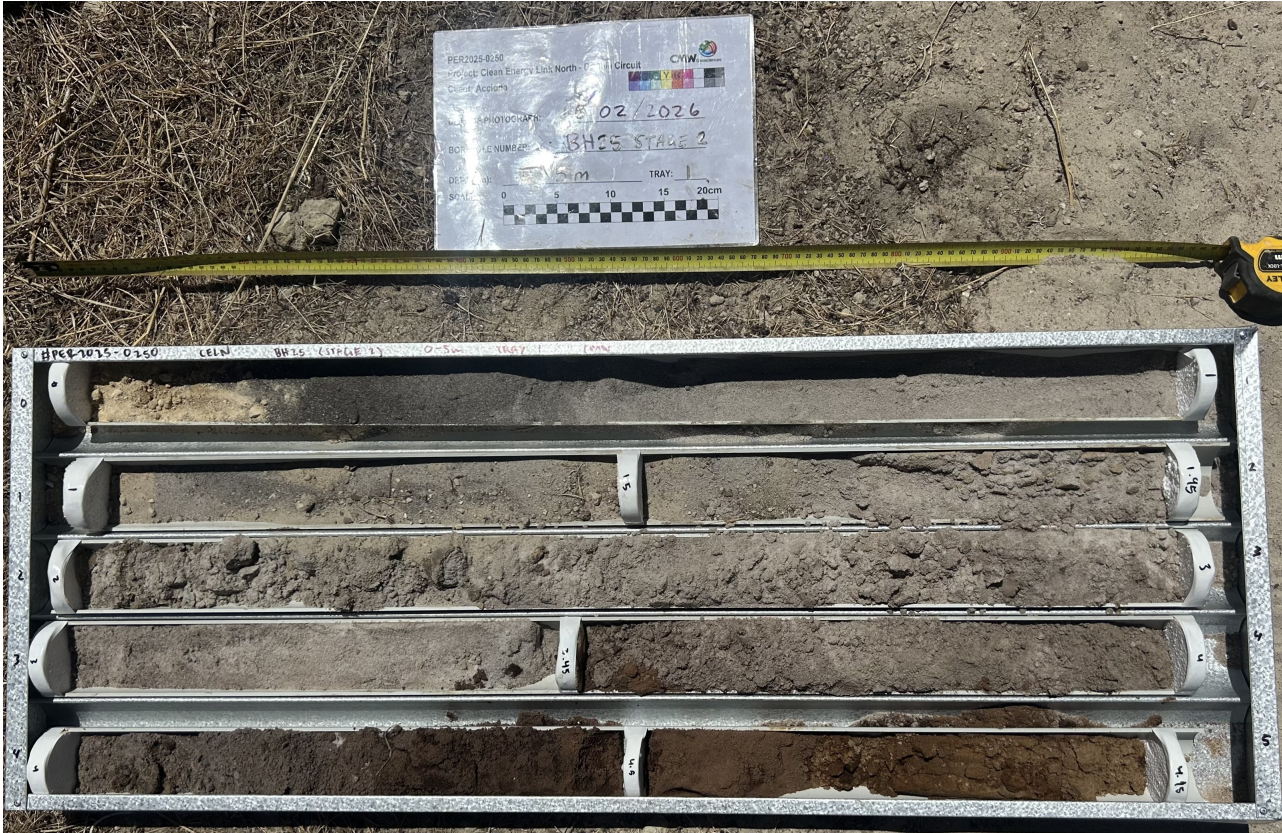
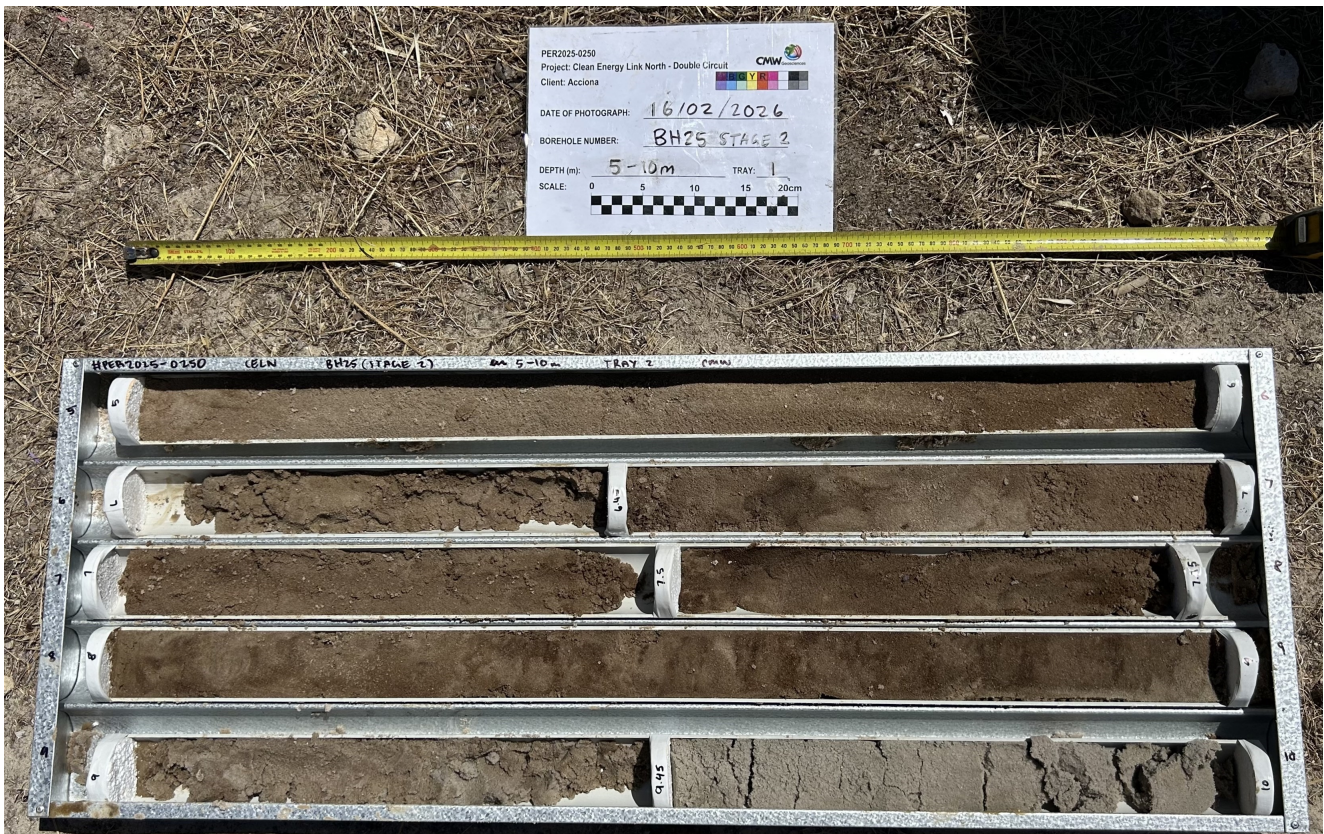
# CORE PHOTOGRAPH SHEET - BH25

Client: Acciona  
Project: Clean Energy Link North Project - Double Circuit  
Location: Perth  
Project ID: PER2025-0250  
Date: 16/02/2026

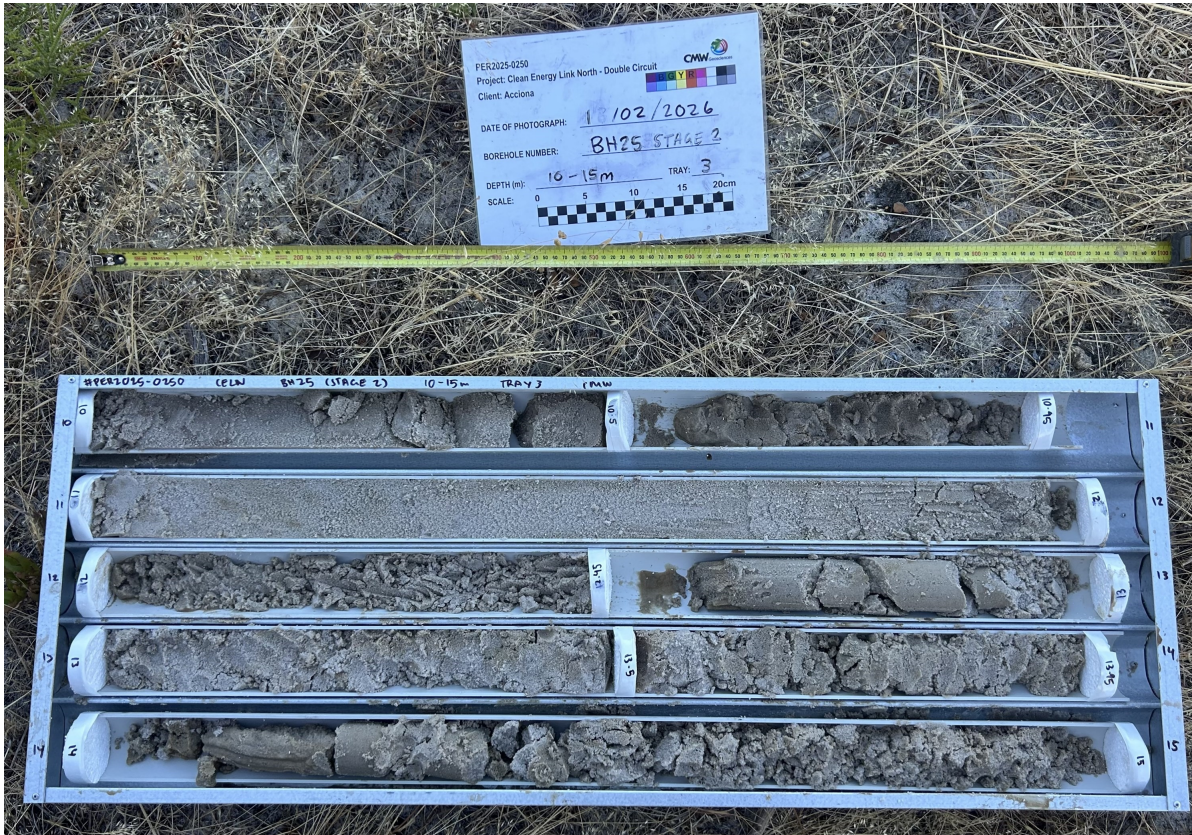
# CORE PHOTOGRAPH SHEET - BH25

Client: Acciona  
Project: Clean Energy Link North Project - Double Circuit  
Location: Perth  
Project ID: PER2025-0250  
Date: 16/02/2026

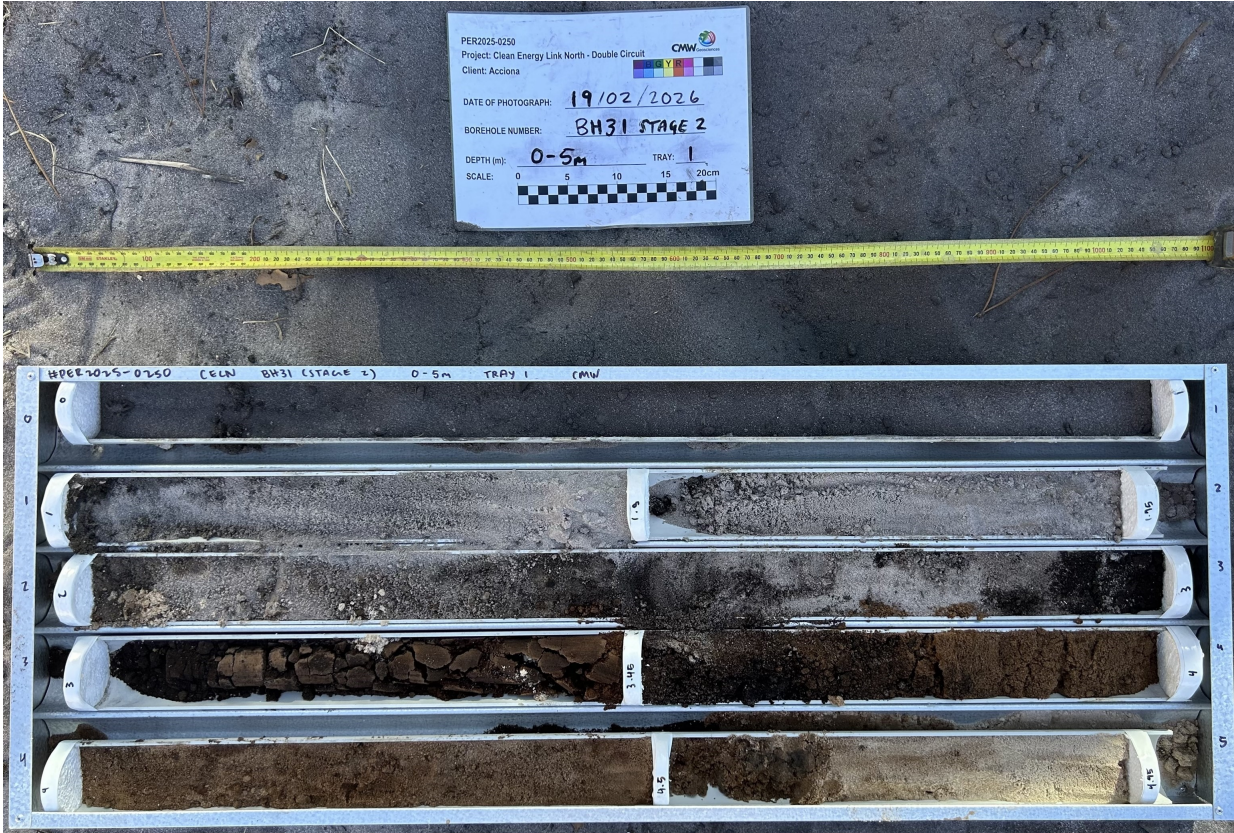
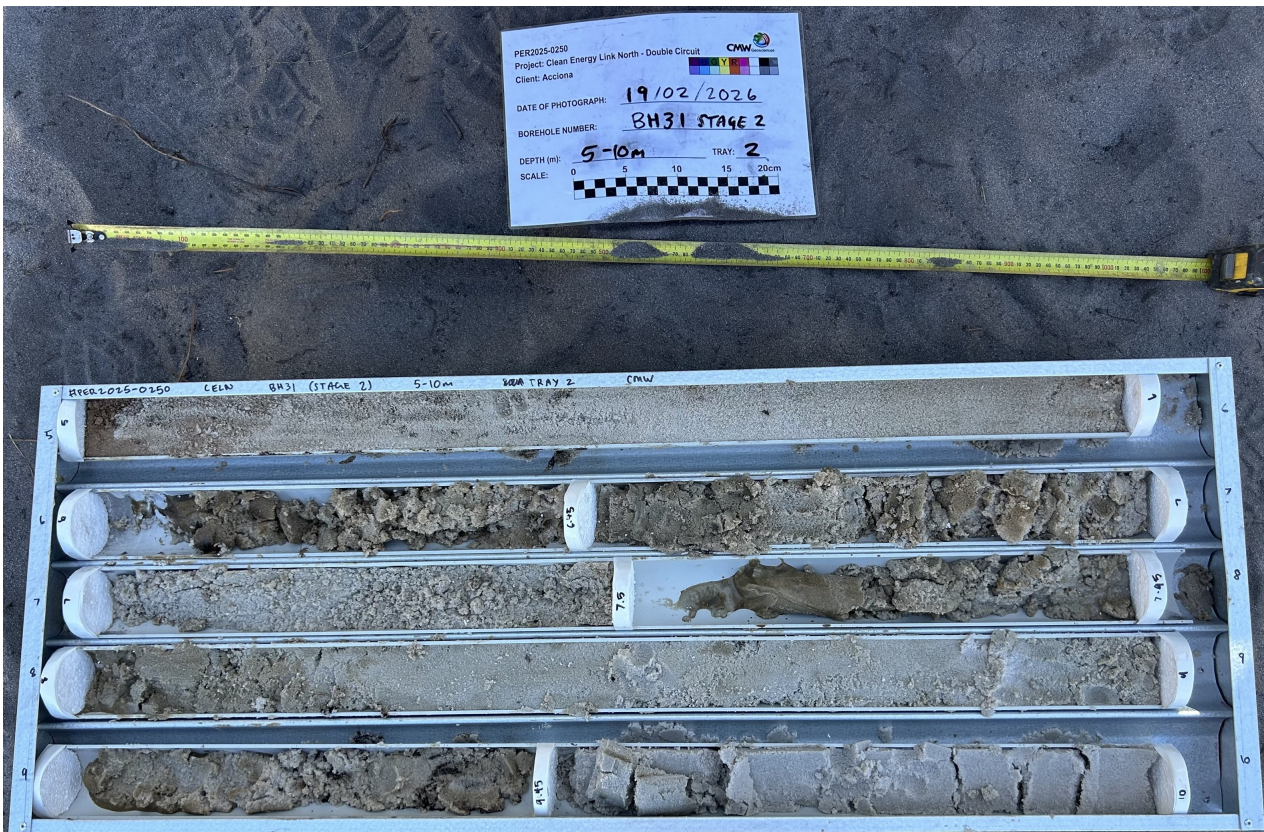
# CORE PHOTOGRAPH SHEET - BH31

Client: Acciona  
Project: Clean Energy Link North Project - Double Circuit  
Location: Perth  
Project ID: PER2025-0250  
Date: 19/02/2026

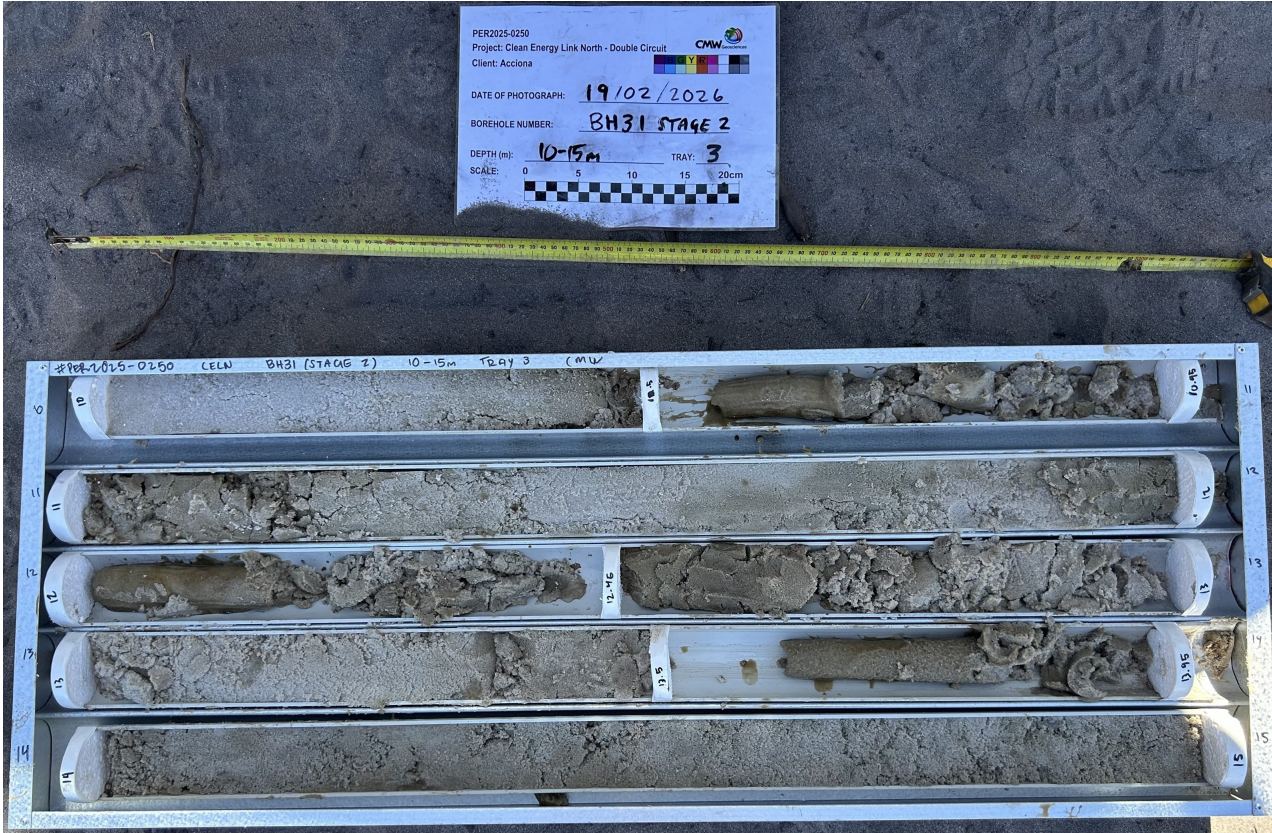
# CORE PHOTOGRAPH SHEET - BH31

Client: Acciona  
Project: Clean Energy Link North Project - Double Circuit  
Location: Perth  
Project ID: PER2025-0250  
Date: 19/02/2026

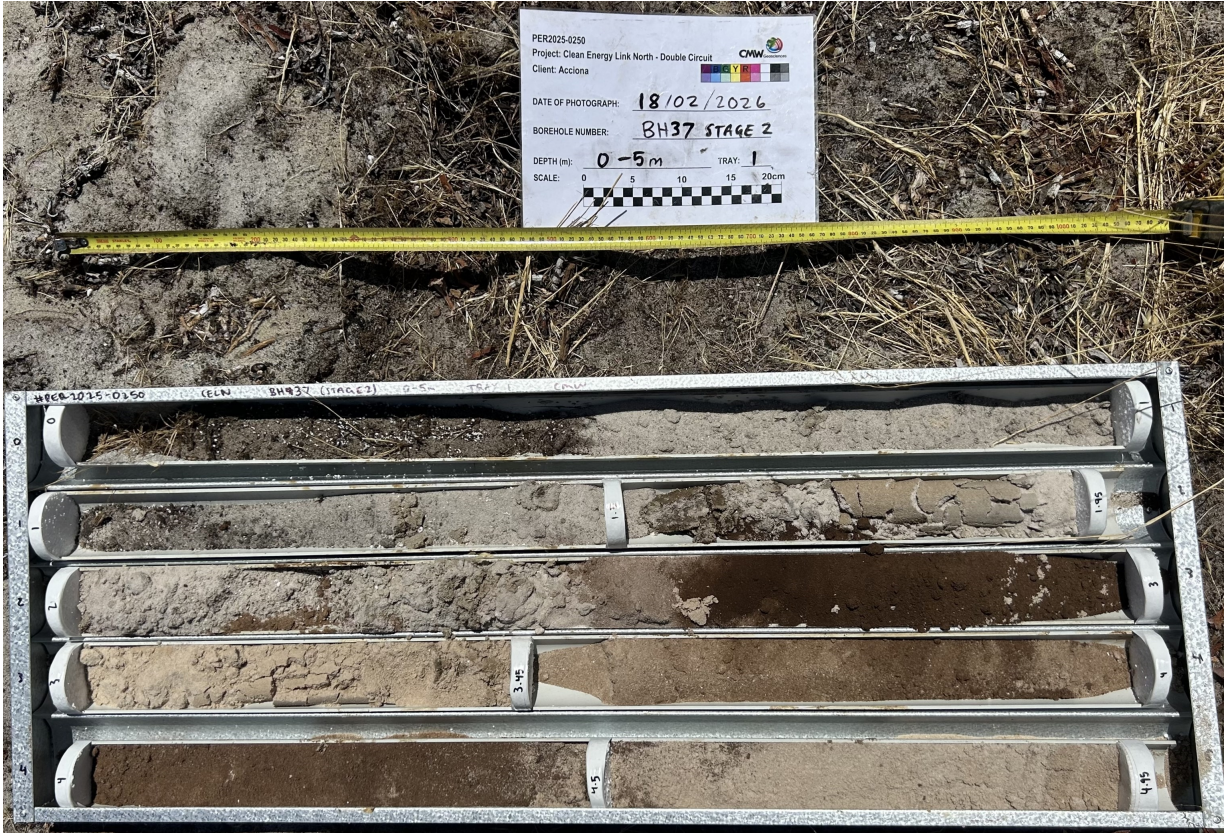
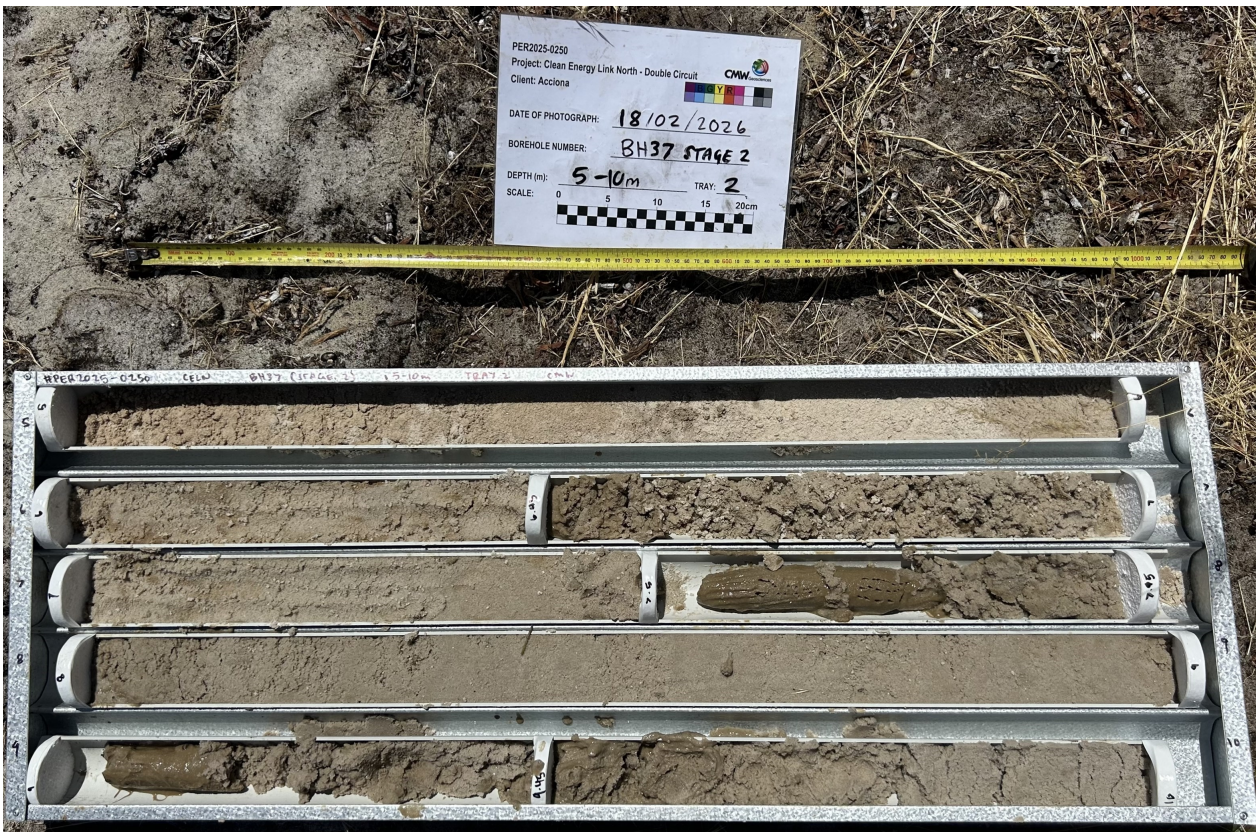
# CORE PHOTOGRAPH SHEET - BH37

Client: Acciona  
Project: Clean Energy Link North Project - Double Circuit  
Location: Perth  
Project ID: PER2025-0250  
Date: 18/02/2026
